34 Beacon Street

PRESERVATION TECHNOLOGY ASSOCIATES, LLC

34 Beacon Street, Boston, MA
Condition of Entry Door
February, 2018

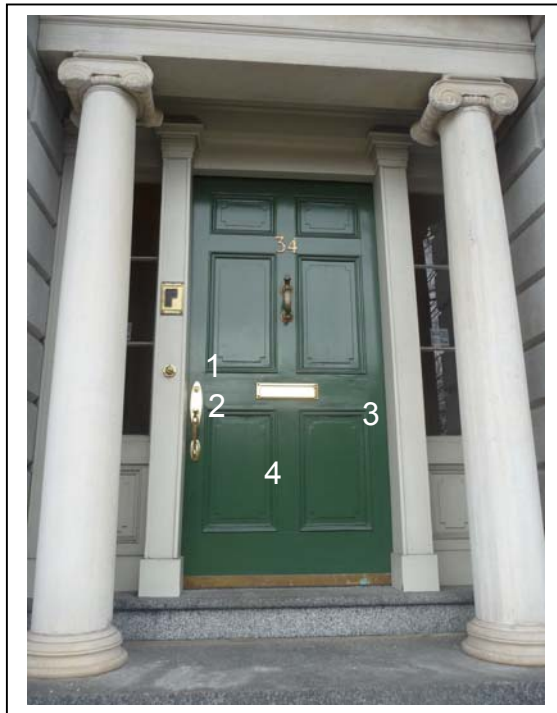
Cracks were noted in areas that were anticipated as a result of the cyclic thermal movement of the various components of the wood door such as the joining of the styles and rails and corners of moldings. Additional cracks were also noted at the center rail, some of which were very short. At the east end of this rail the crack was probed with a fine blade and found to be at least 3/4" deep, but no distress was noted on either side of the cracks and some of the cracking at the center rail may be the joining/lamination of boards to form this wider rail.

Samples were taken and reviewed under the binocular microscope; the location of these samples is shown in the photo below:

This inspection found the door to be in good and serviceable condition with no sign of weakness or excessive wear for a door of its age and type. The last restoration clearly stripped the paint and performed some level of repair. Most of that repair appears to be well done, with very minor exceptions at the very small areas noted that could have been consolidated before they were filled. At this time we recommend no additional treatment except for repair to paints or sealants probed during this inspection. Future work when full repainting is anticipated should include removing and replacing sealants between sections and moldings and minor consolidation and filling (paint must be stripped from these small areas to accomplish this work).

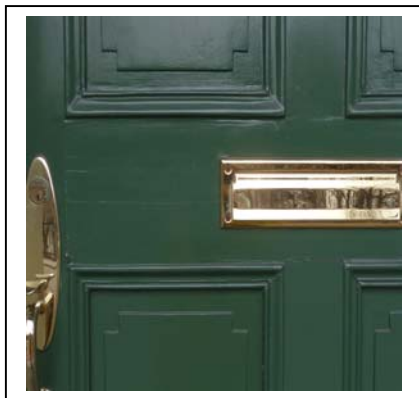
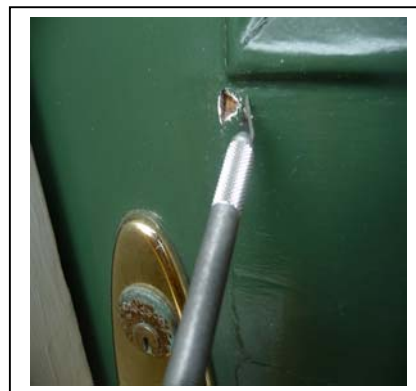
Sample 1: At the left end of the lock rail, top. This sample was found to have a small amount of what appeared to be an epoxy filler, followed by a white primer and the green paint top coat. The wood under the filler was somewhat friable over a small area, less than one square inch

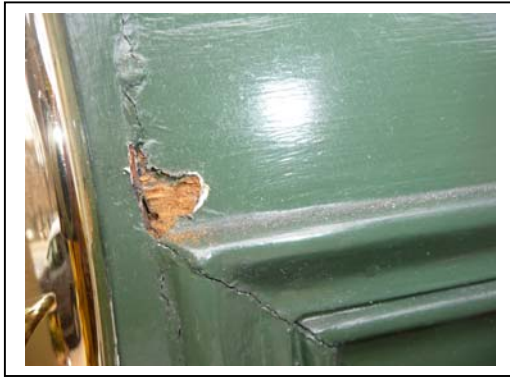
Sample 2: This sample was taken from a "lump" near the lock on the lower part of the sample rail, directly below sample 1. This sample contained only paint. The wood was also friable over a very small area.

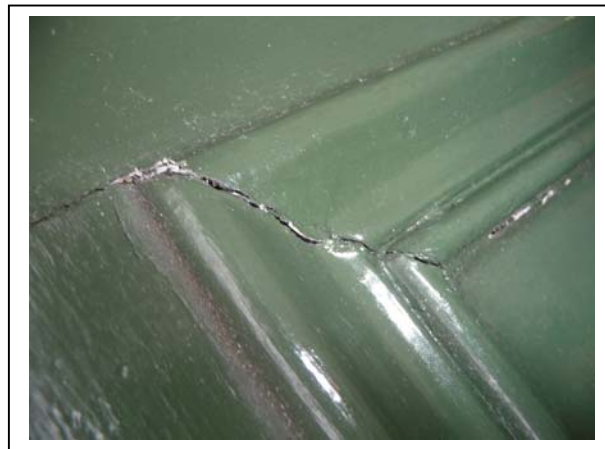
Sample 3: This sample was taken from a crack between molding sections at the top of the lower east panel. It was found to contain only primer and paint.

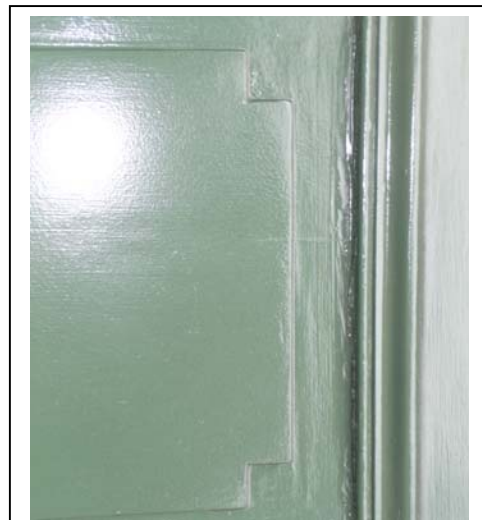
Sample 4: This sample was taken from the middle of the right side of the lower west panel between the panel and the molding. The sample was found to contain only sealant and paint.
