# TransMITTAL

Date	7 November 2018
Attn	Mr. Joseph Comish
Company	Back Bay Architectural Commission
From	Ronald Margolis, AIA
Project	267/268 Newbury Street, Boston, MA
M+F Job No.	2014300
To be returned by

August 28, 2018

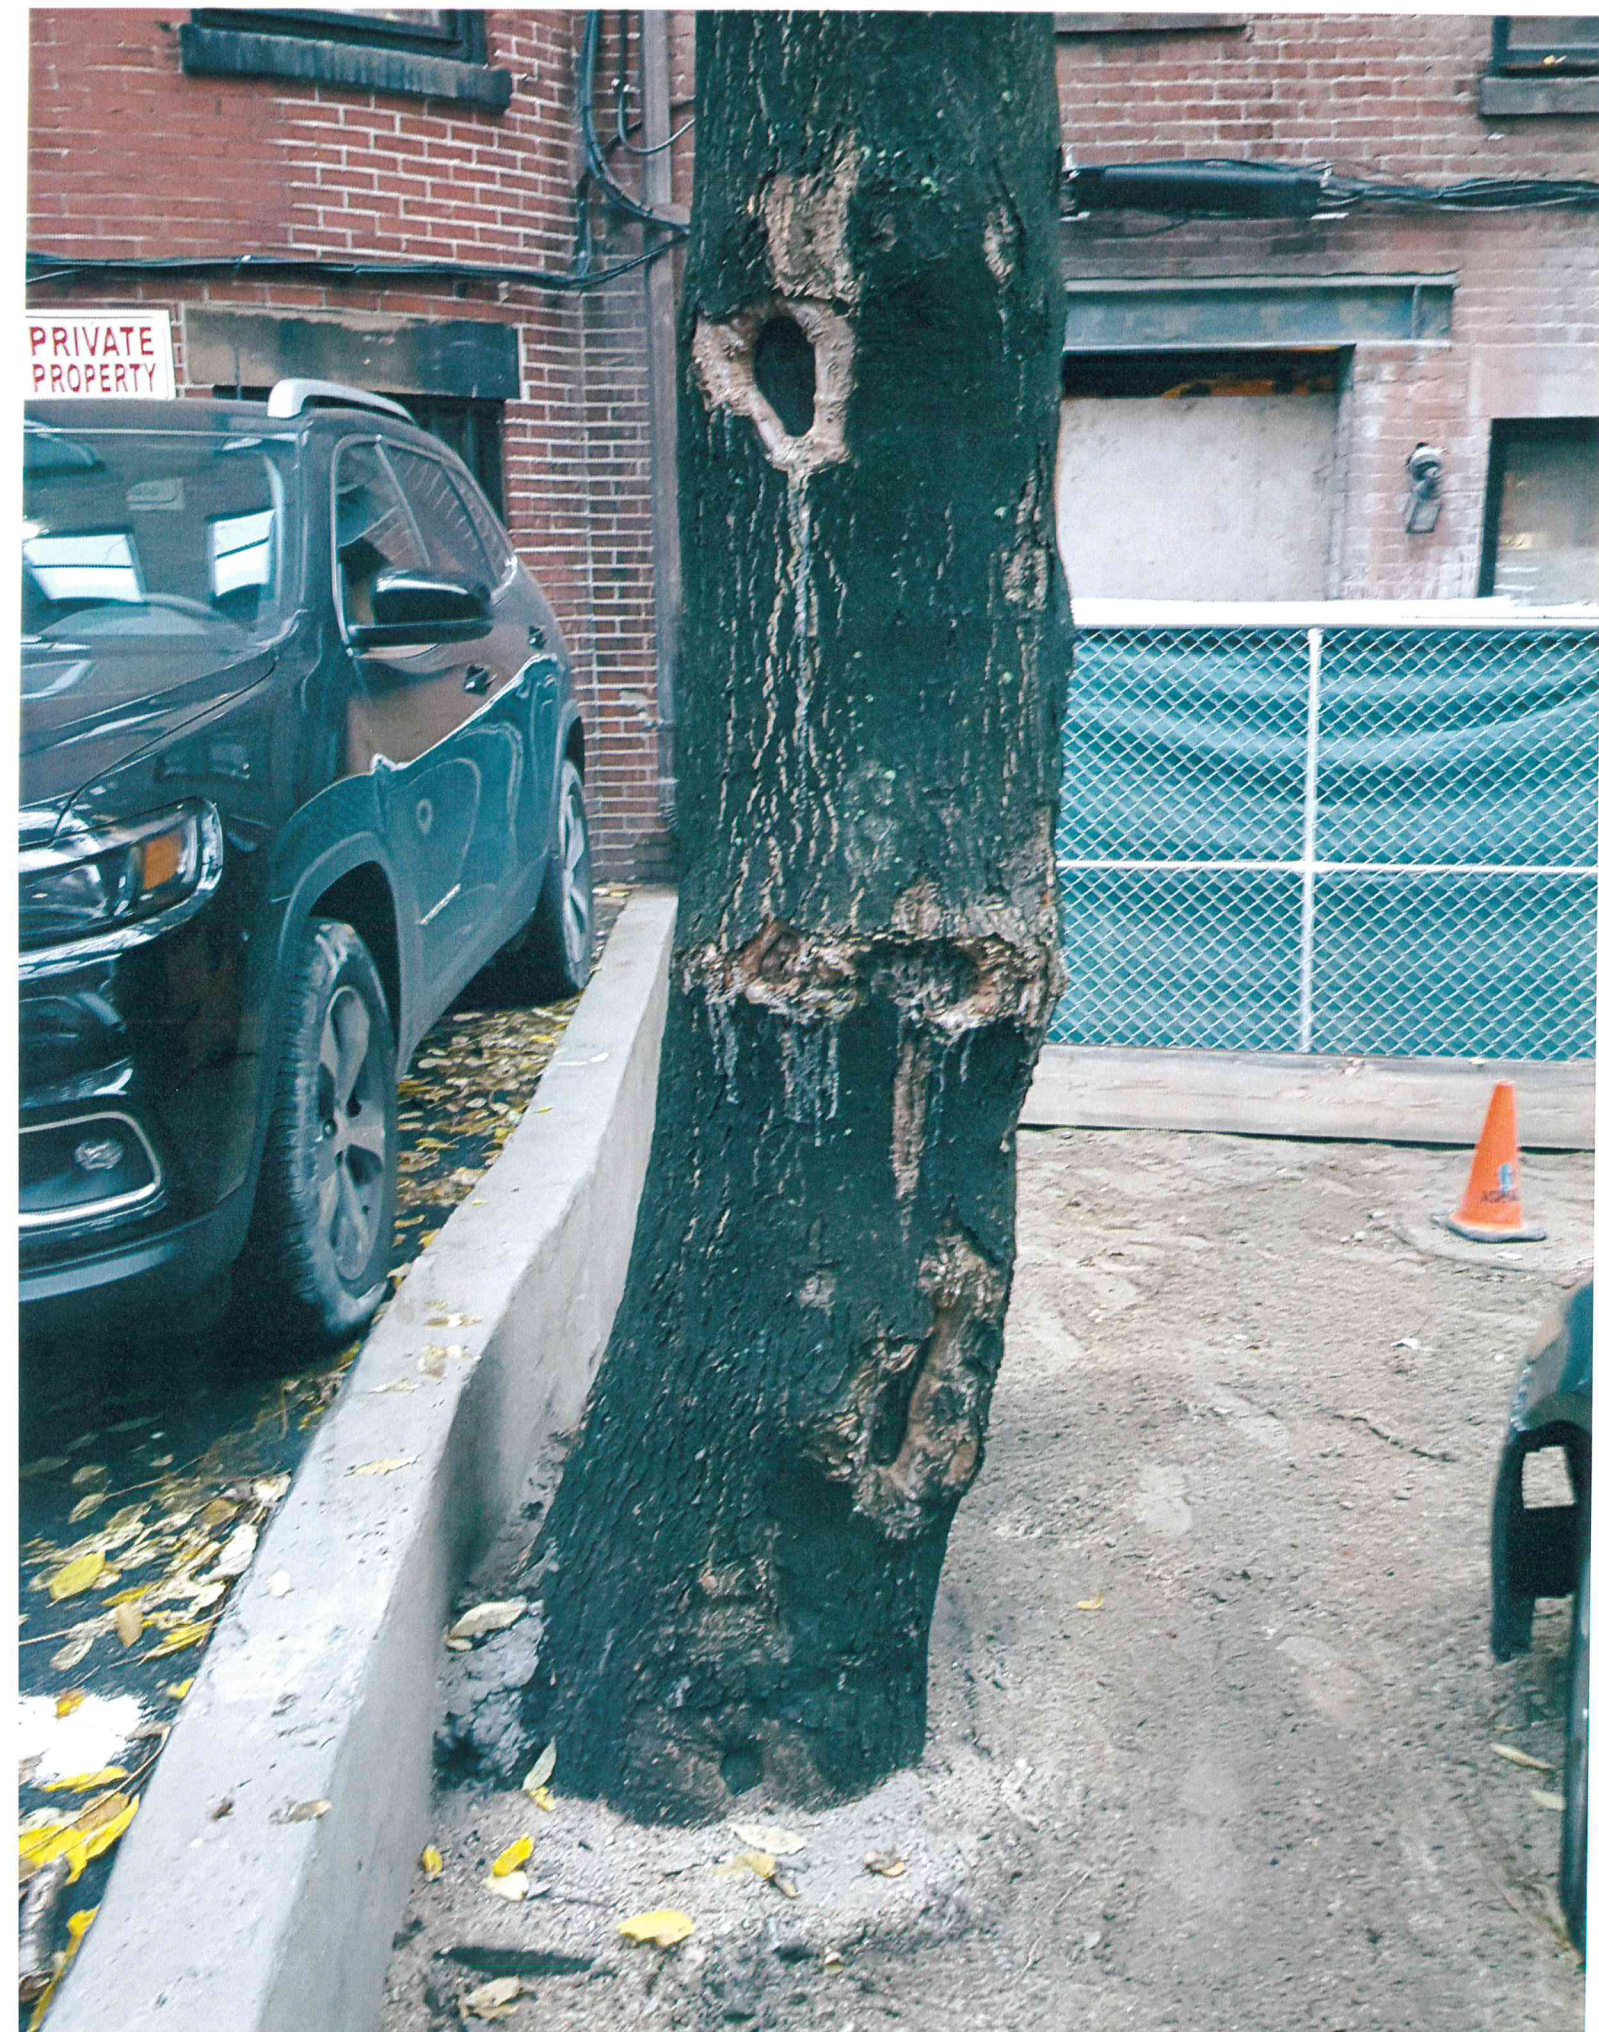
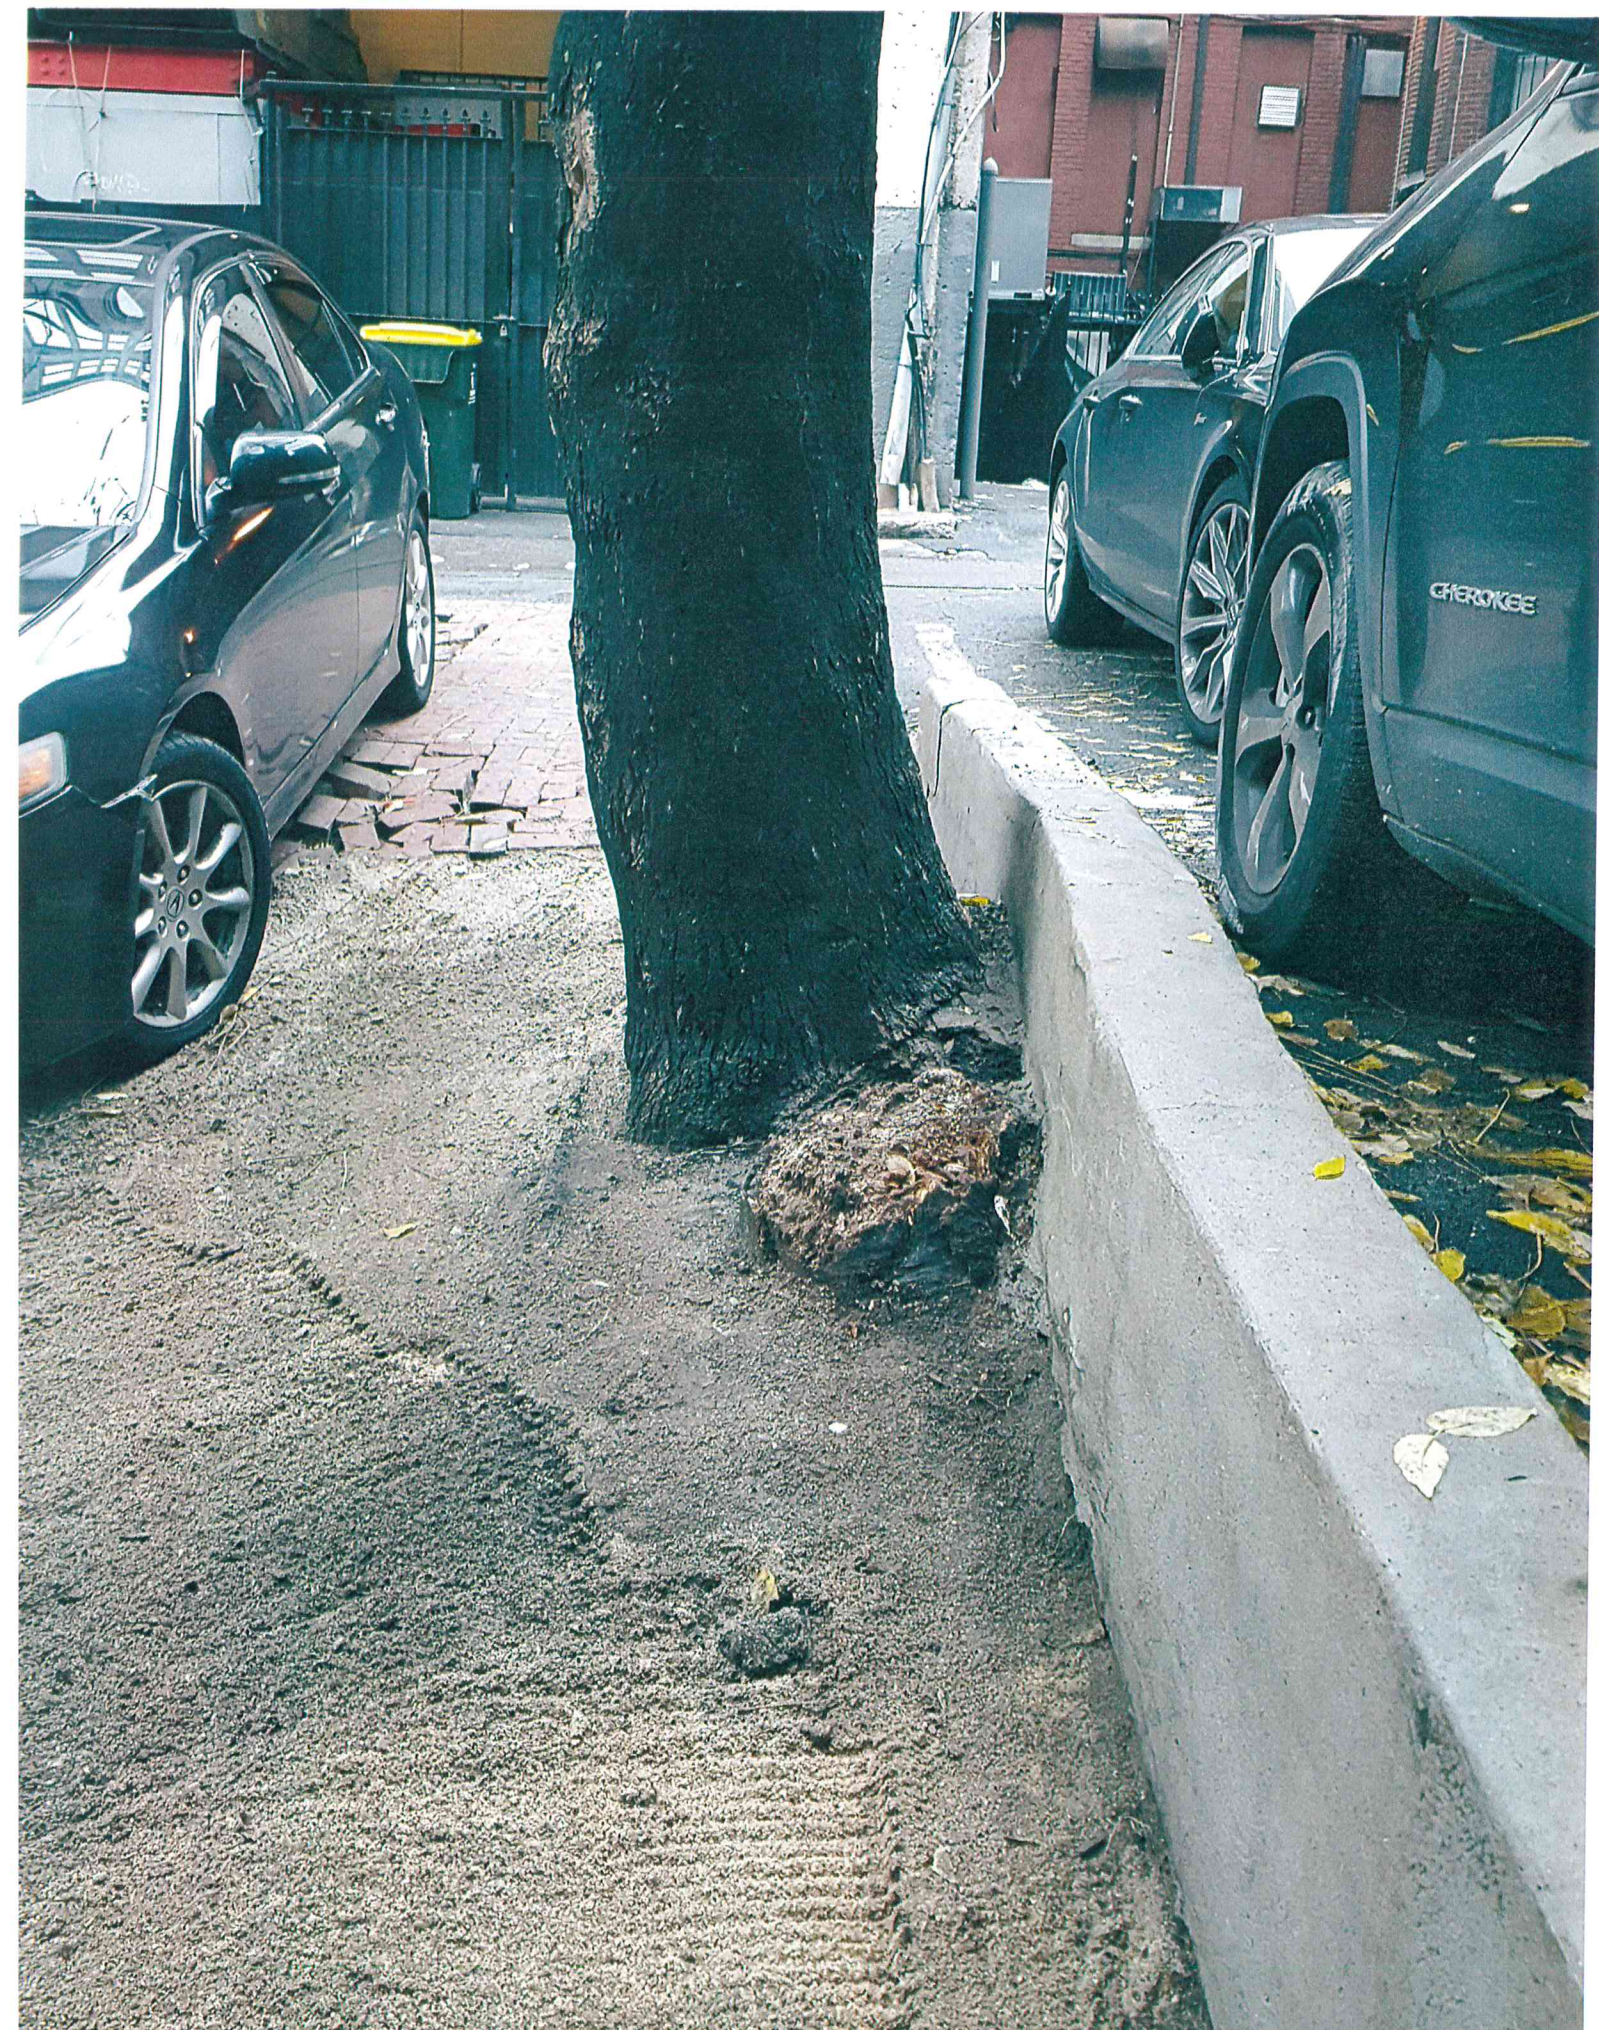
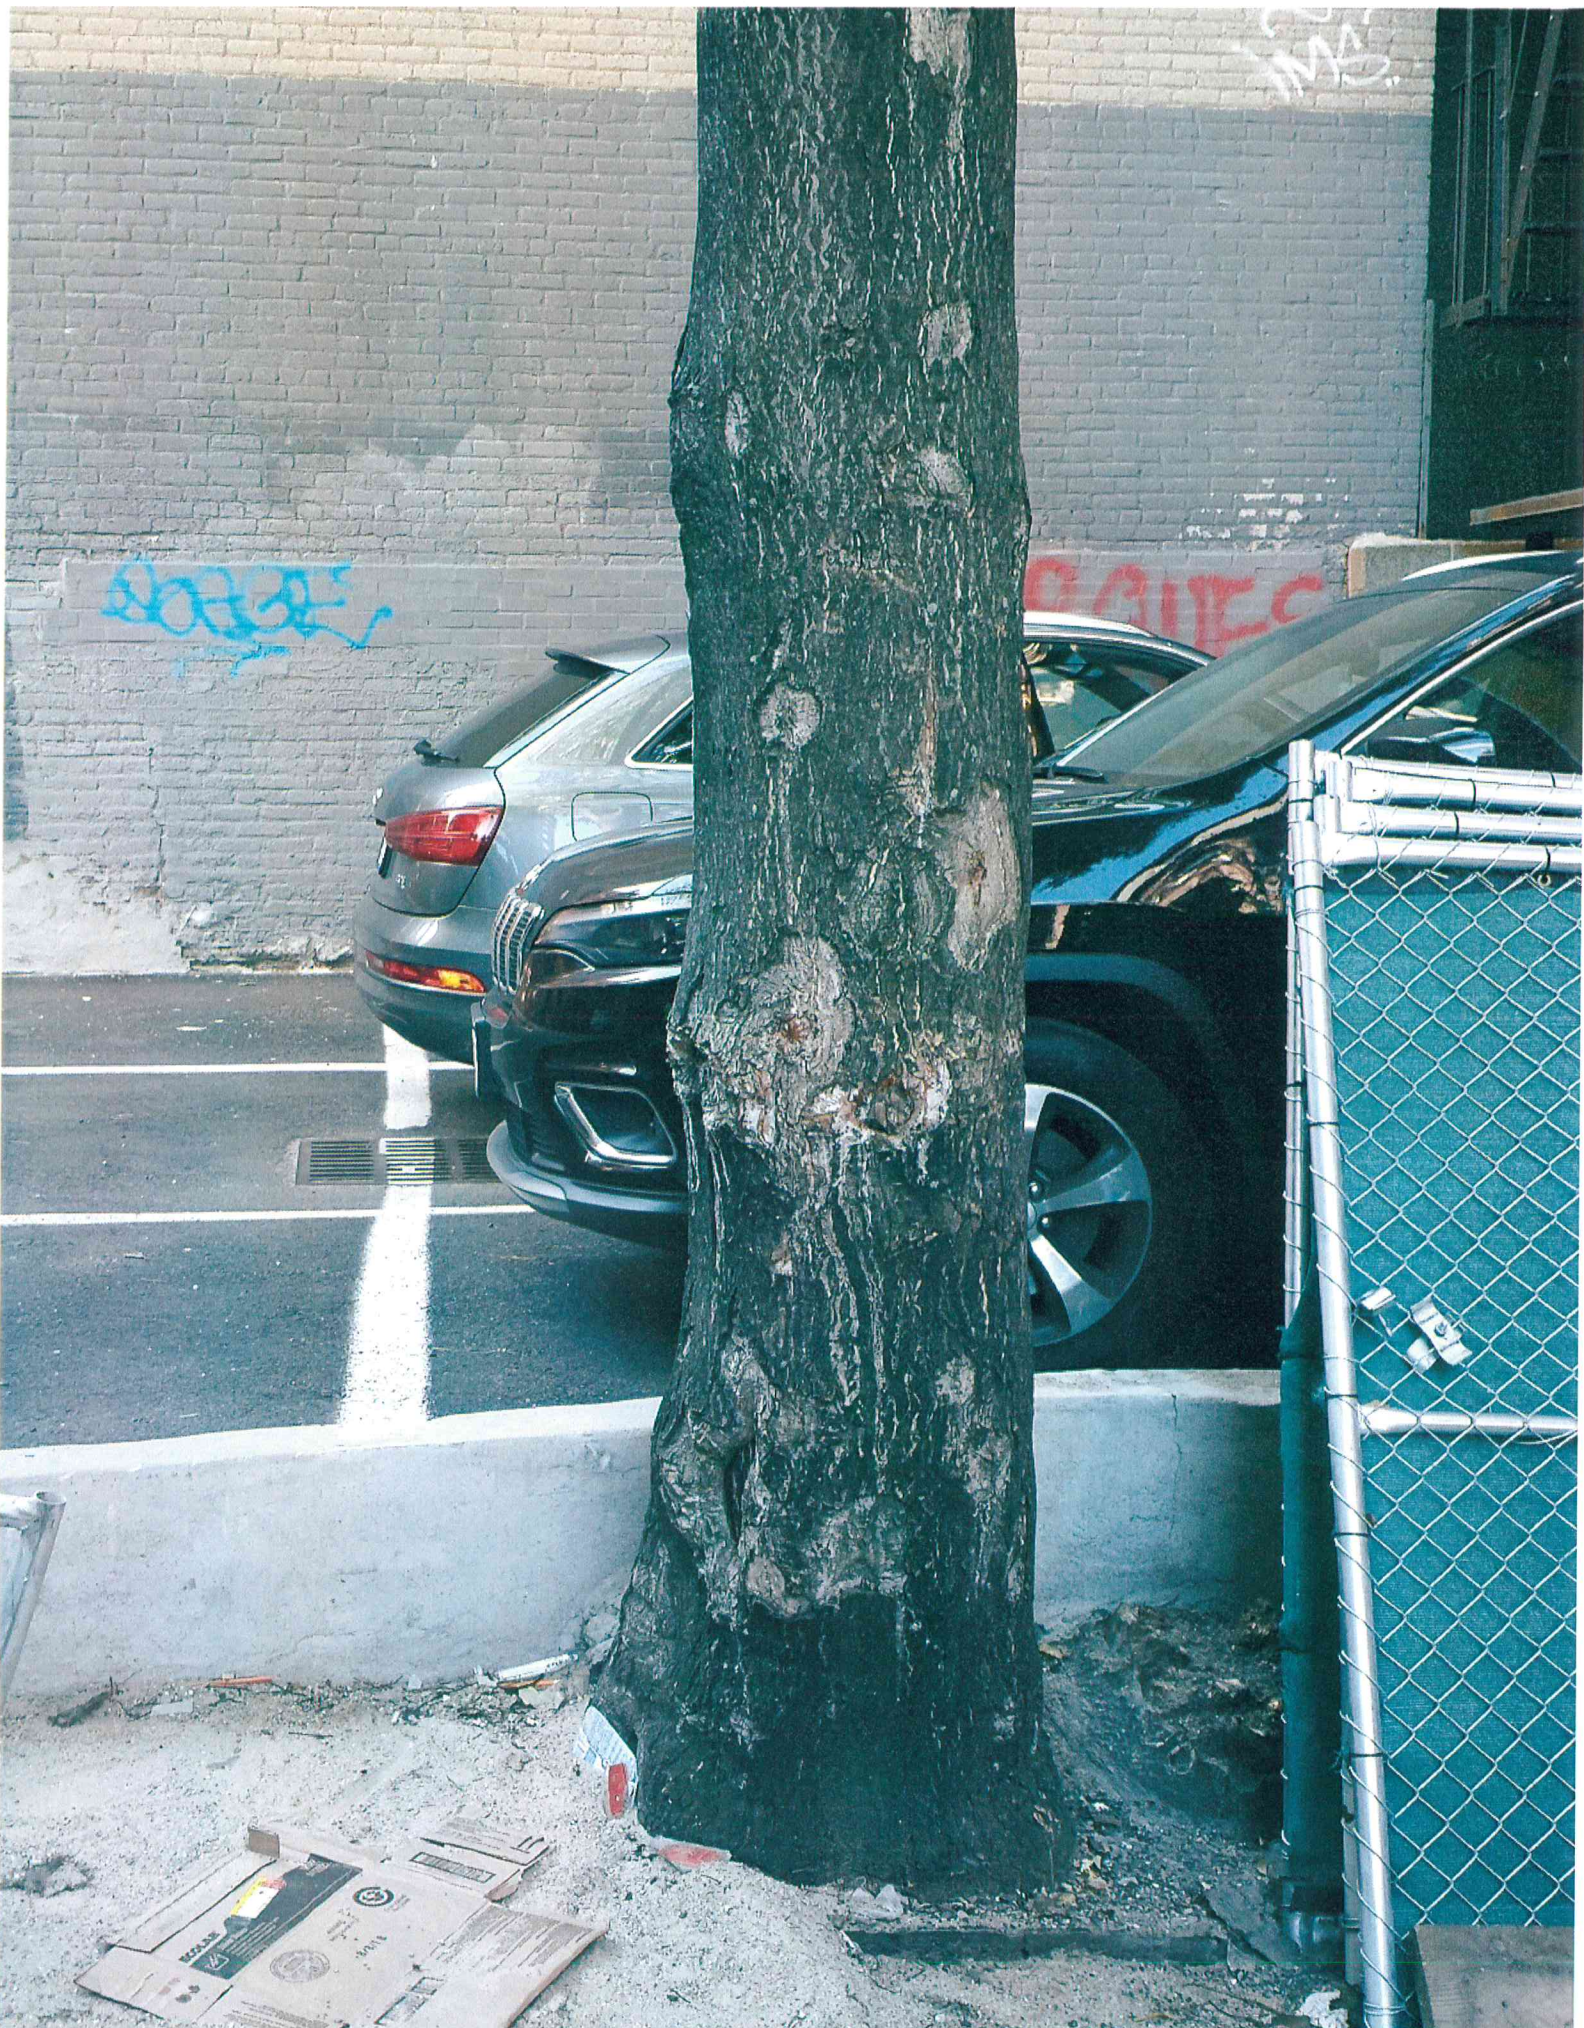
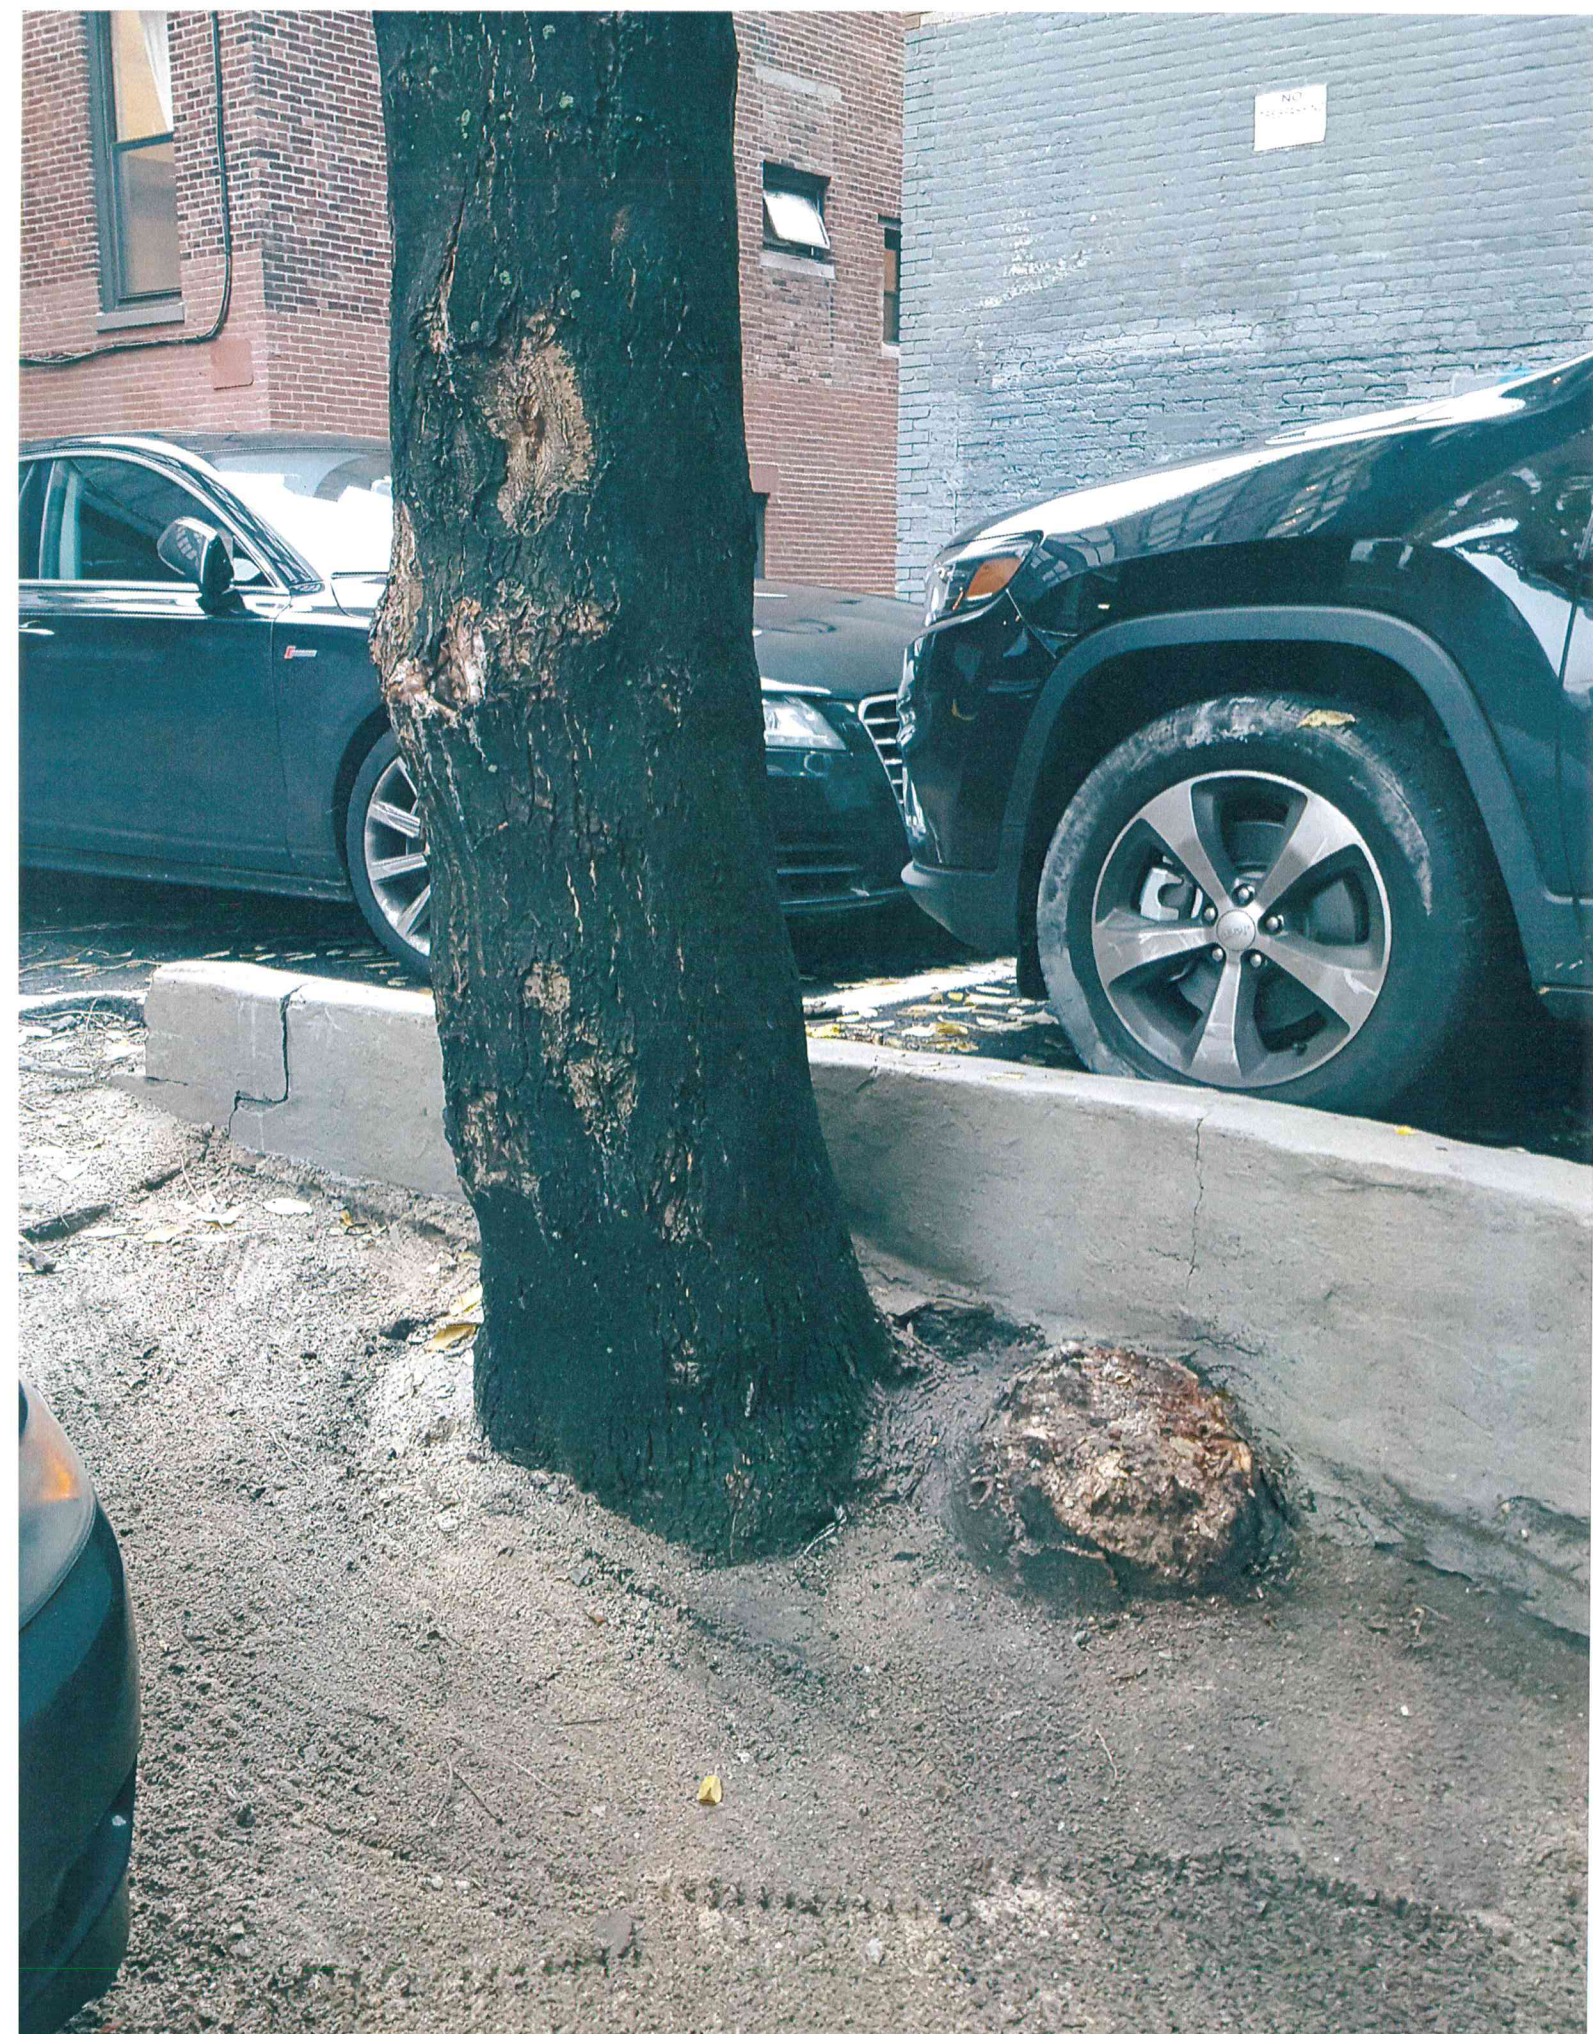
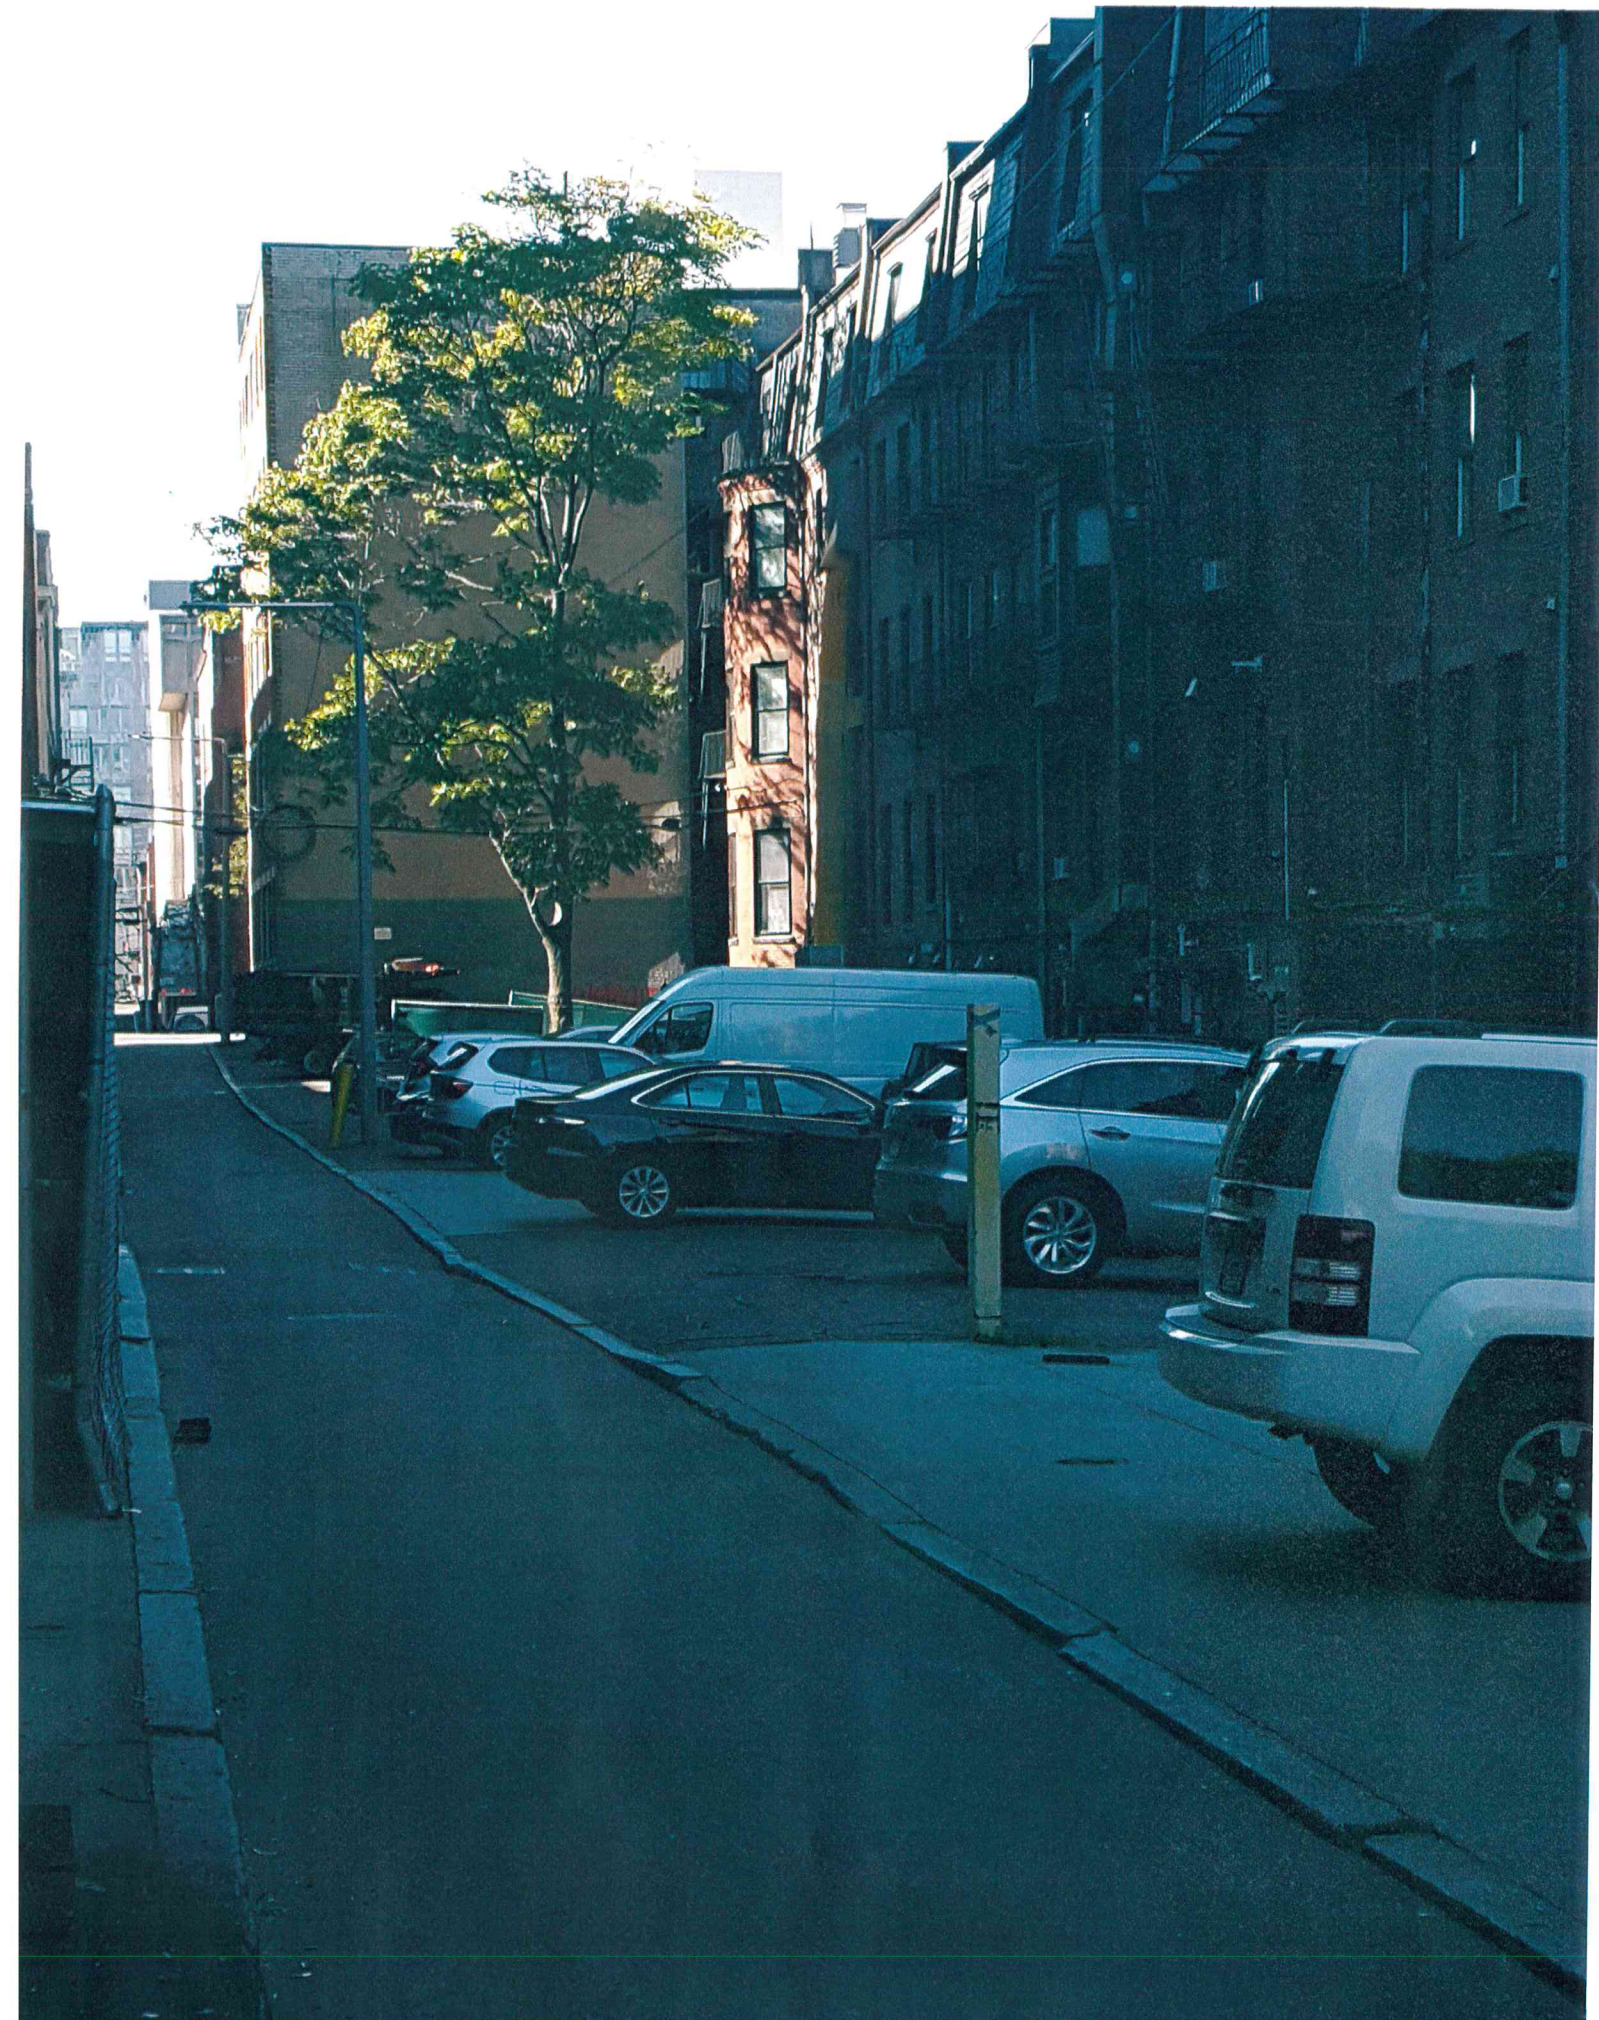
I reviewed the Ailanthus, approximately 24" in diameter, behind 276 Newbury St earlier this summer. Upon visual inspection only, I observed smaller leaves and a weak canopy. This is often an indication of stress and less than optimal health. There is decay at the base of the tree where another stem was removed at an unknown time in the past. This decay has likely spread to the trunk of the living portion of the tree and potentially the root zone.

It was stated that the construction to extend the building has been approved and will occur soon. At that time the tree will need to be pruned to clear it from the building. Unfortunately, the portion of the tree that will need to be pruned is quite significant and would result in the removal of almost half of the canopy. Not only would this be quite unappealing aesthetically it would be detrimental especially to an already stressed tree.

I would recommend that this tree be fully removed due to the proximity to the building. Not only does the tree appear to be in a state of decline but it has obvious defects including the decay at the base. There is also very limited root space due to the impermeable surfaces adjacent the trunk which have likely limited the root growth. This is a concern because there is increased likelihood of failure at the root zone that would involve the entire tree. The final reason for tree removal is since it is an invasive species that is particularly messy and not particularly strong. This is not reason alone to remove the tree, especially since trees are at a premium in the city; but considering the preexisting conditions and the likely further decline upon completion of construction I would recommend complete removal.
