Carriage House Rear Wall after Repaving of Spruce Place showing lowered pavement, exposed and damaged brick, and loss of bollards at corners

Spruce Place
Beacon Hill
DETAIL AT DOOR SILL
2/16/2015 5:28:55 PM
A005

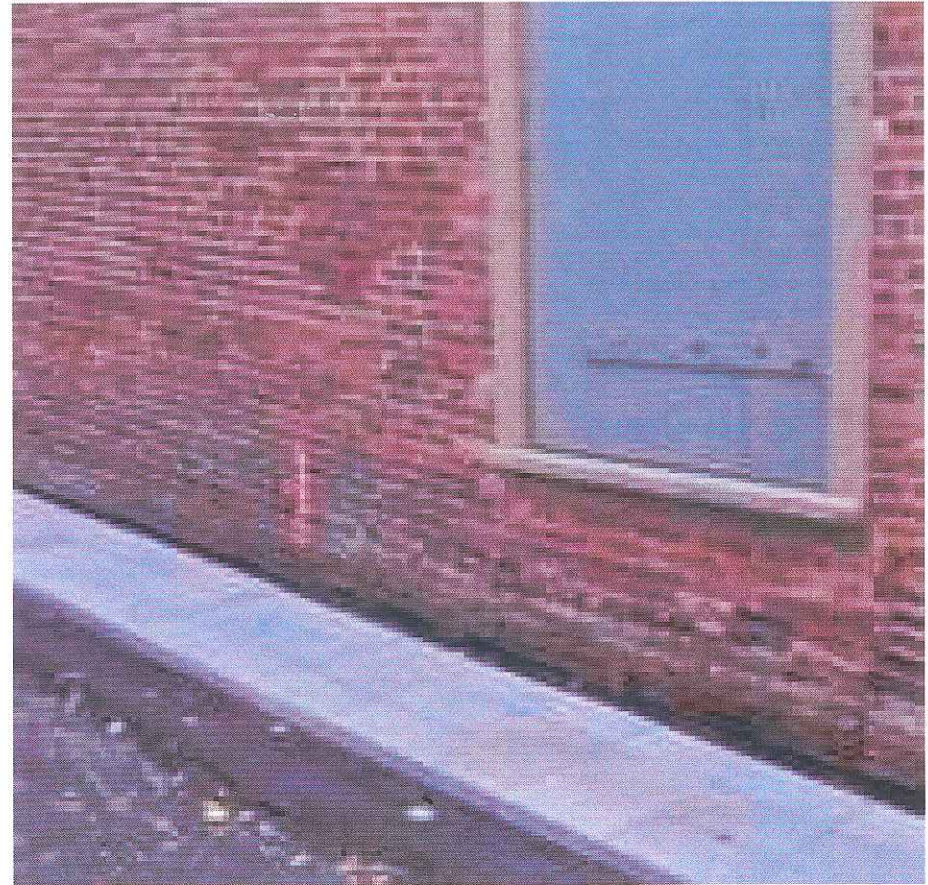
Left: Carriage House rear door before repaving project

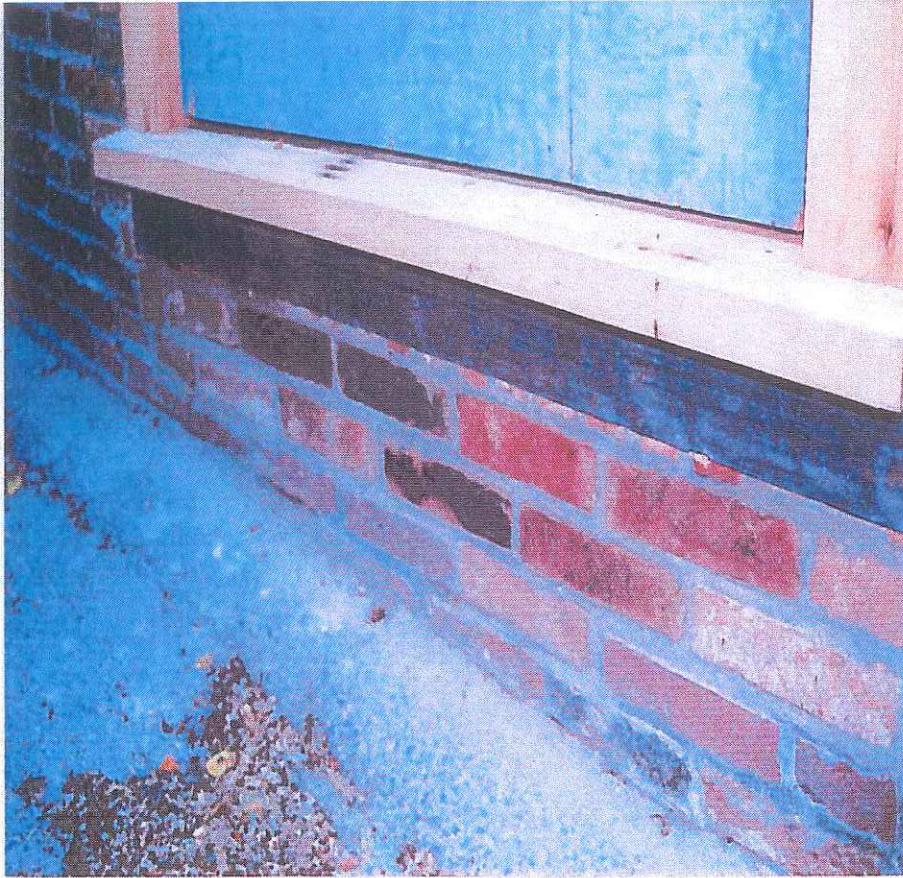
Right: Carriage House rear door after repaving lowered grade of Spruce Place, damaged wall, and removed berm

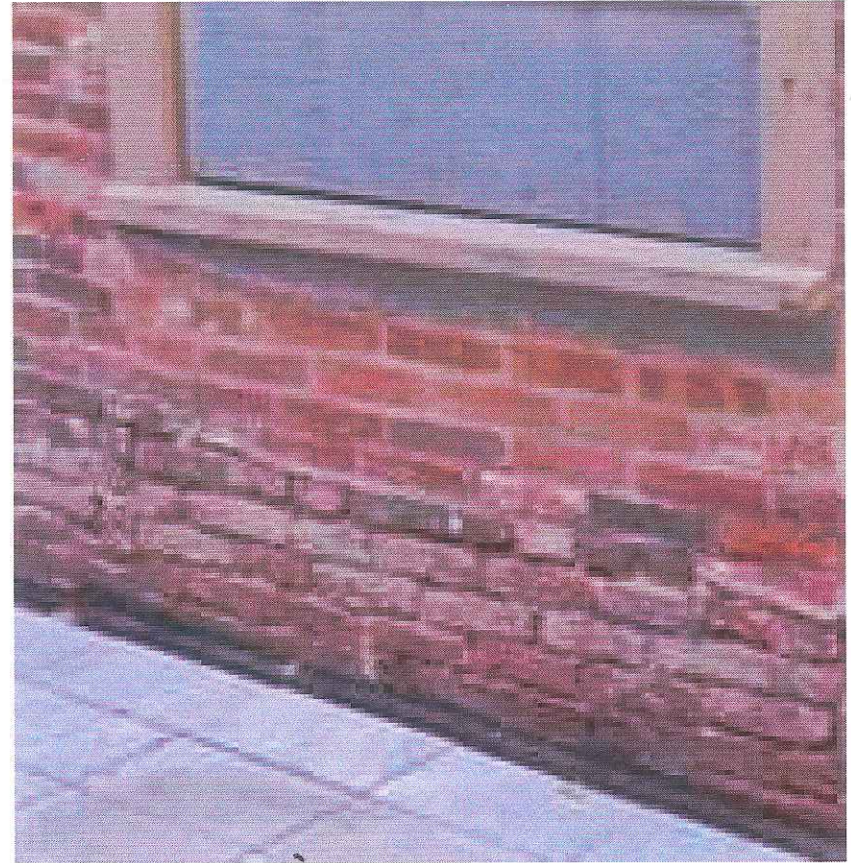
Left: Carriage House rear door before repaving project, showing berm

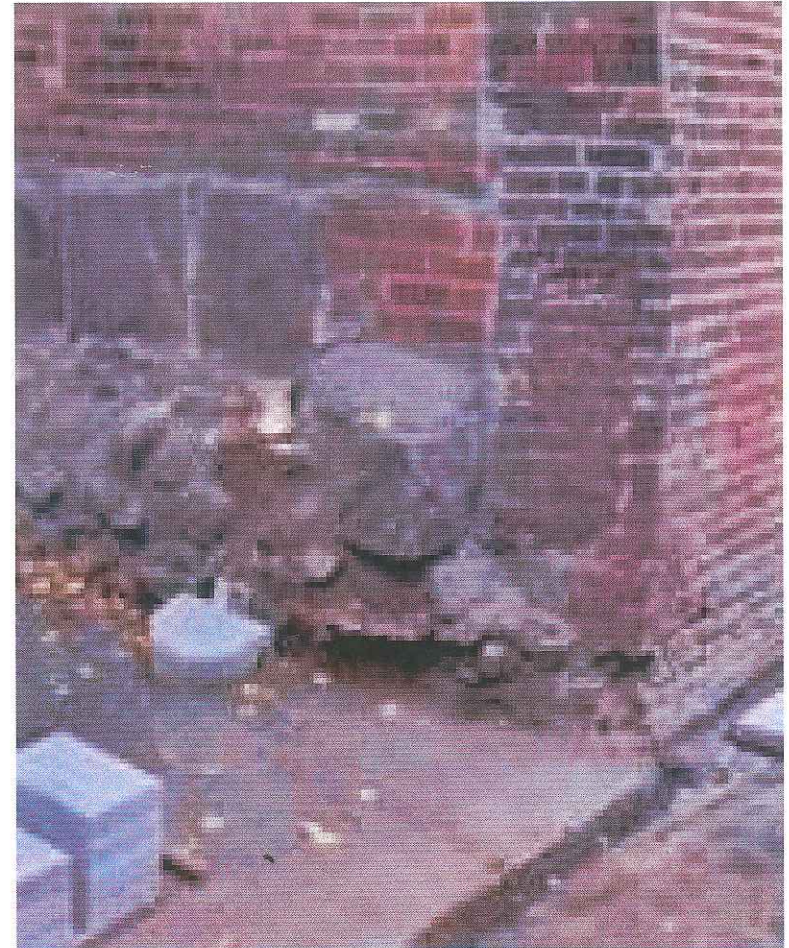
Left: Carriage House corner before repaving project showing granite bollard and berm

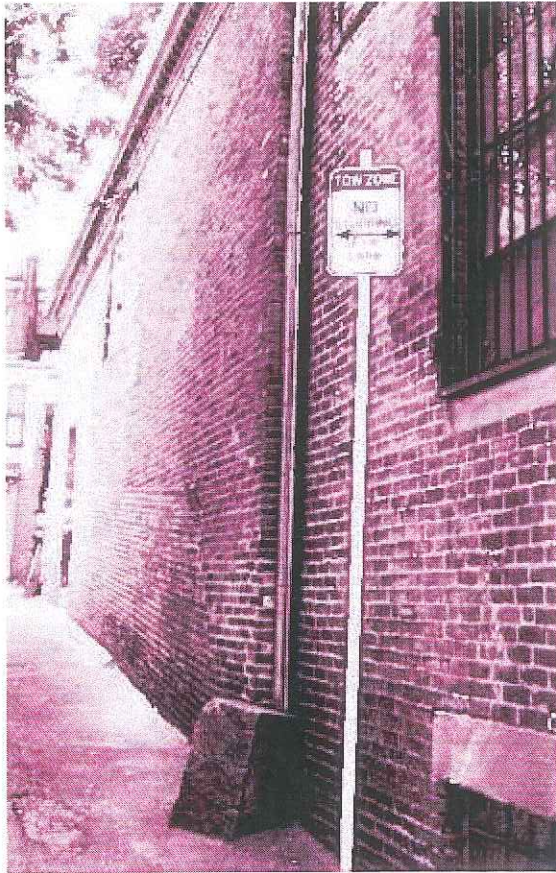
Right: Carriage House corner after repaving with granite bollard and berm missing

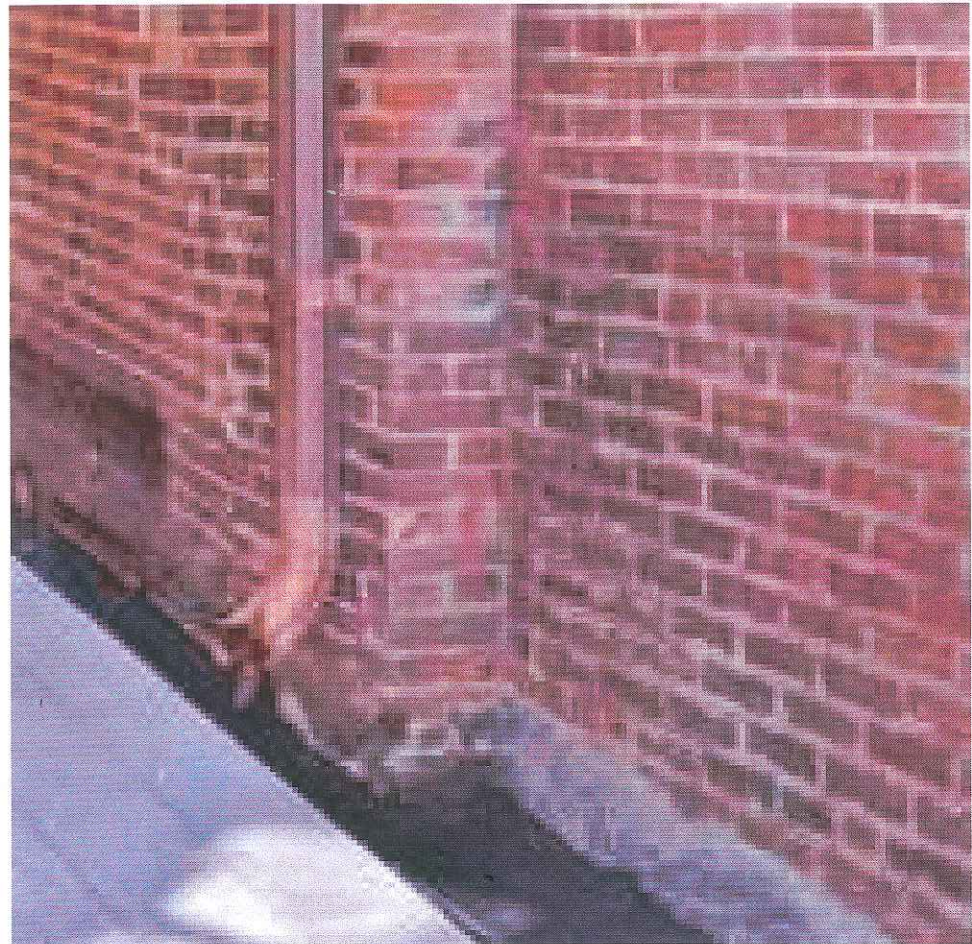
Left: Carriage House rear drainpipe before repaving project showing the end of the pipe resting on granite block

Right: Carriage House rear drainpipe after commencement of repaving with granite block removed and drainpipe left hanging
