CUSTOM HOUSE

Boston Landmark Commission Presentation

23 July 2019

SIMPSON GUMPERTZ & HEGER

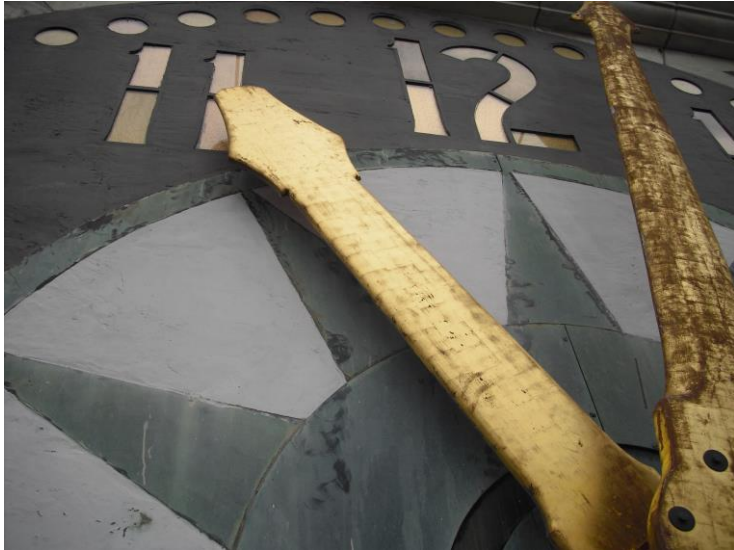
Deteriorated gold leaf finish

- Replace all hands on all elevations (8 hands total)
 - Epoxy carbon fiber composite clock hands
 - Lighter material clock hands will improve clock function and durability
 - Integral color to improve appearance
- Retain 4 original hands and display within building
- Maintain existing clock face

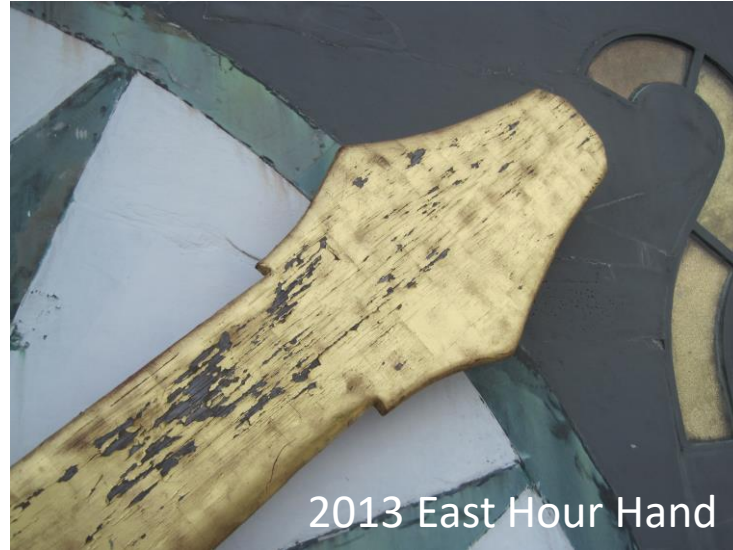
Checks/rot in wood hour hands

- Both original and replacement hands operate poorly due to weight of hands.
- Fiberglass is water logged due to cracks.

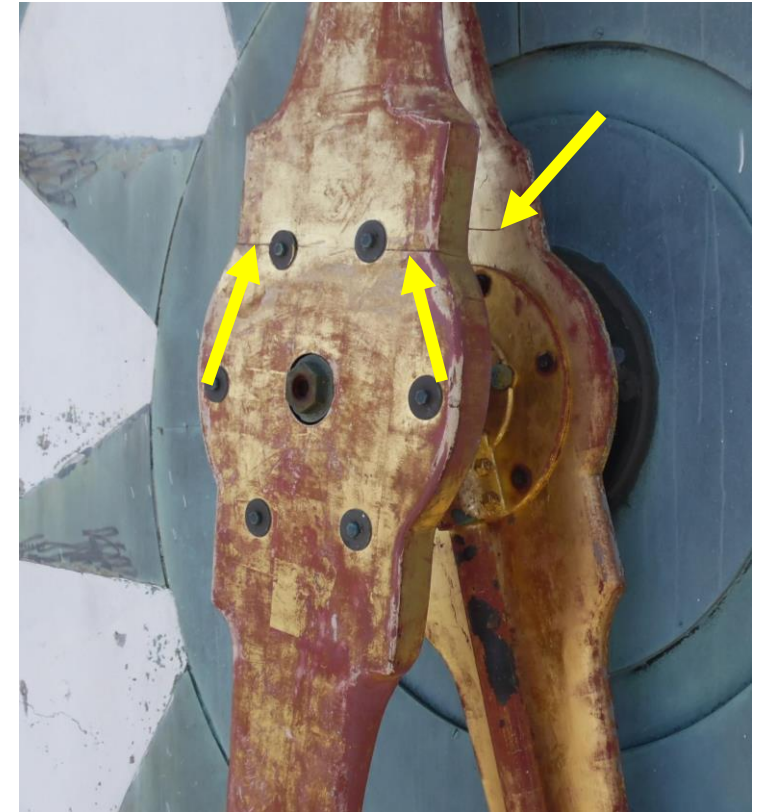
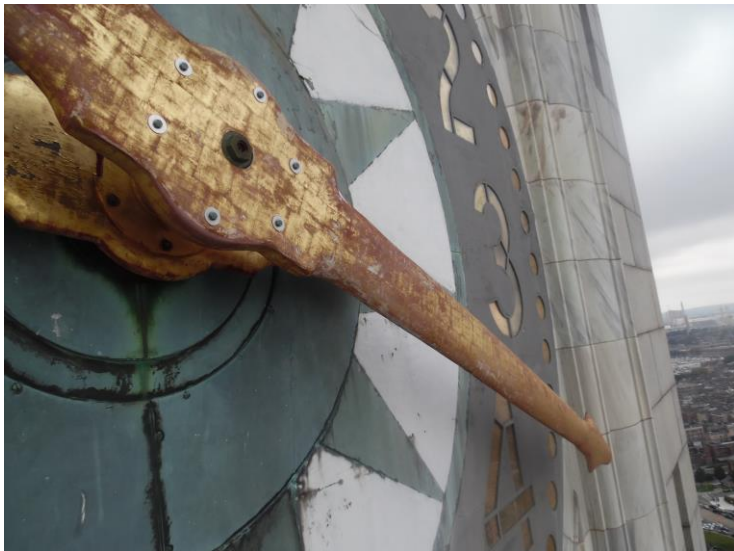
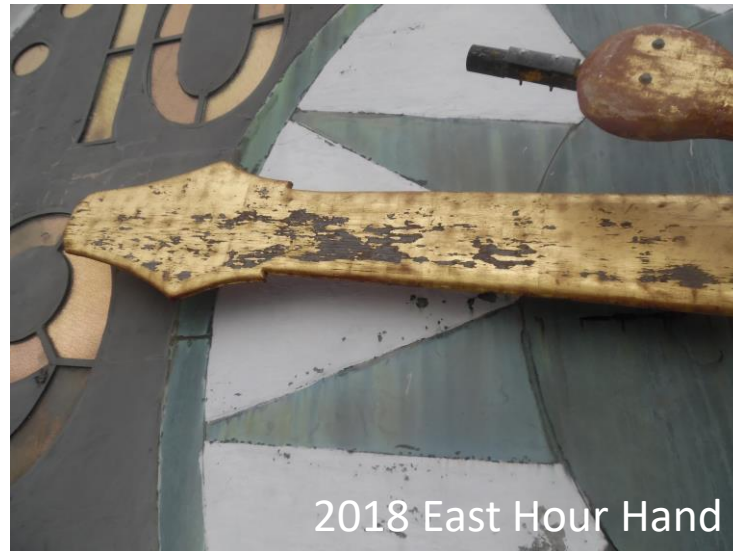
Cracks in hands at attachment
(both wood and fiberglass)
