All 4th floor
windows have
separated
aluminum
mullions

North side
Facing
Pinckney St

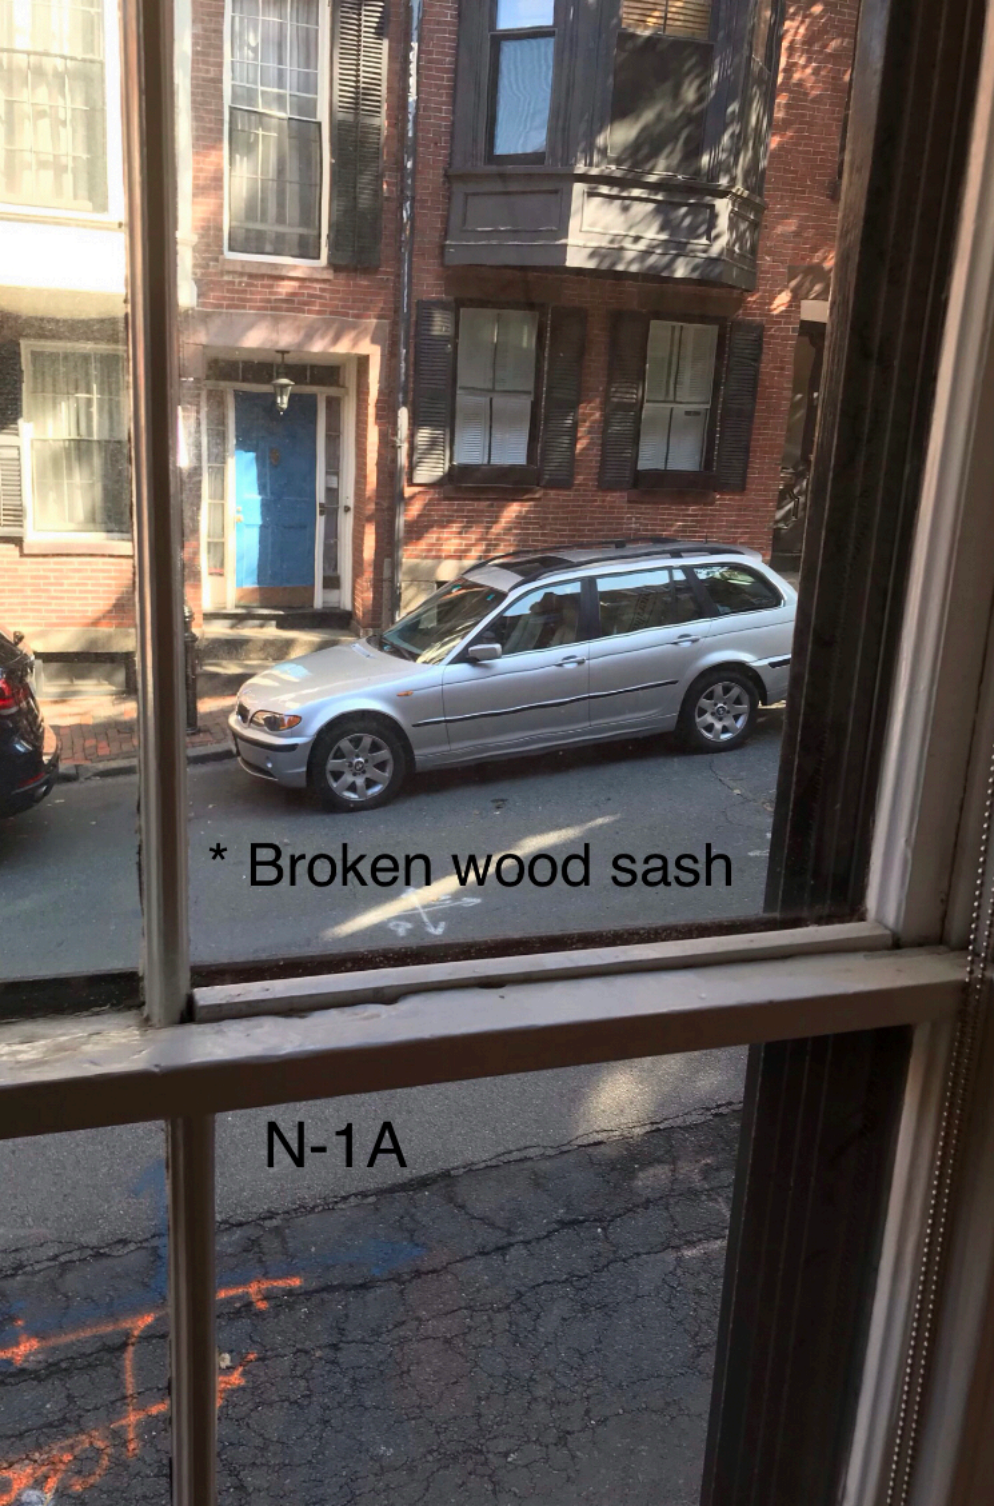
N-1A

* Broken wood sash

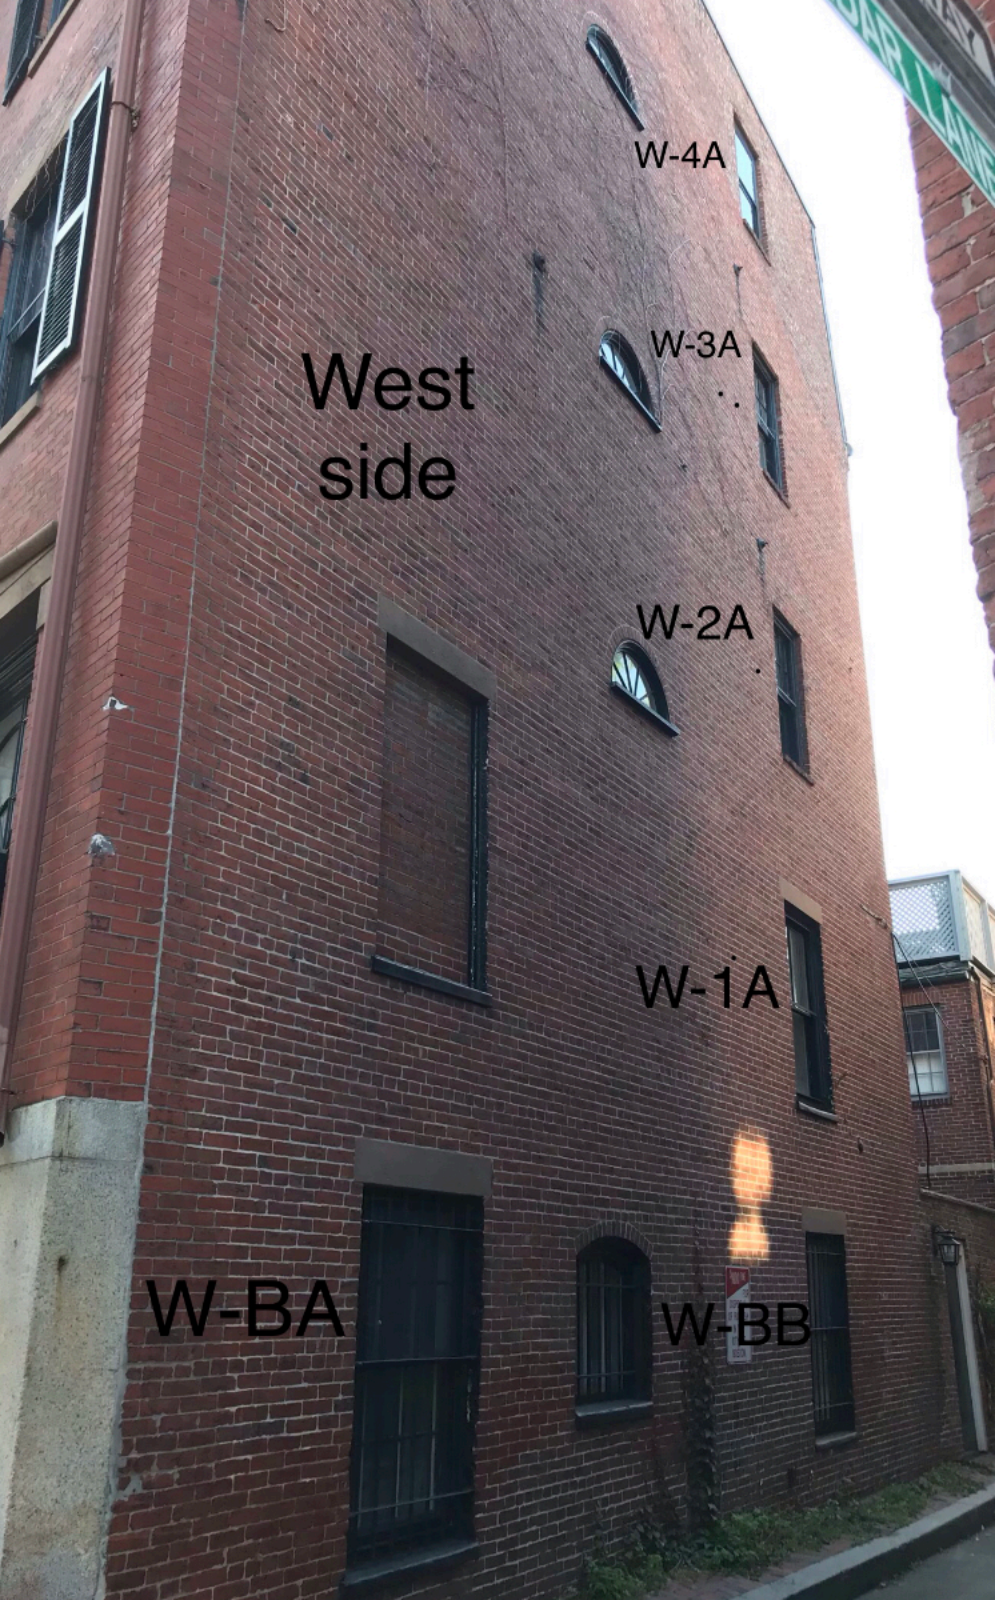
W-1A

Missing
weights
and
ropes

Sash
broken
and
wedged

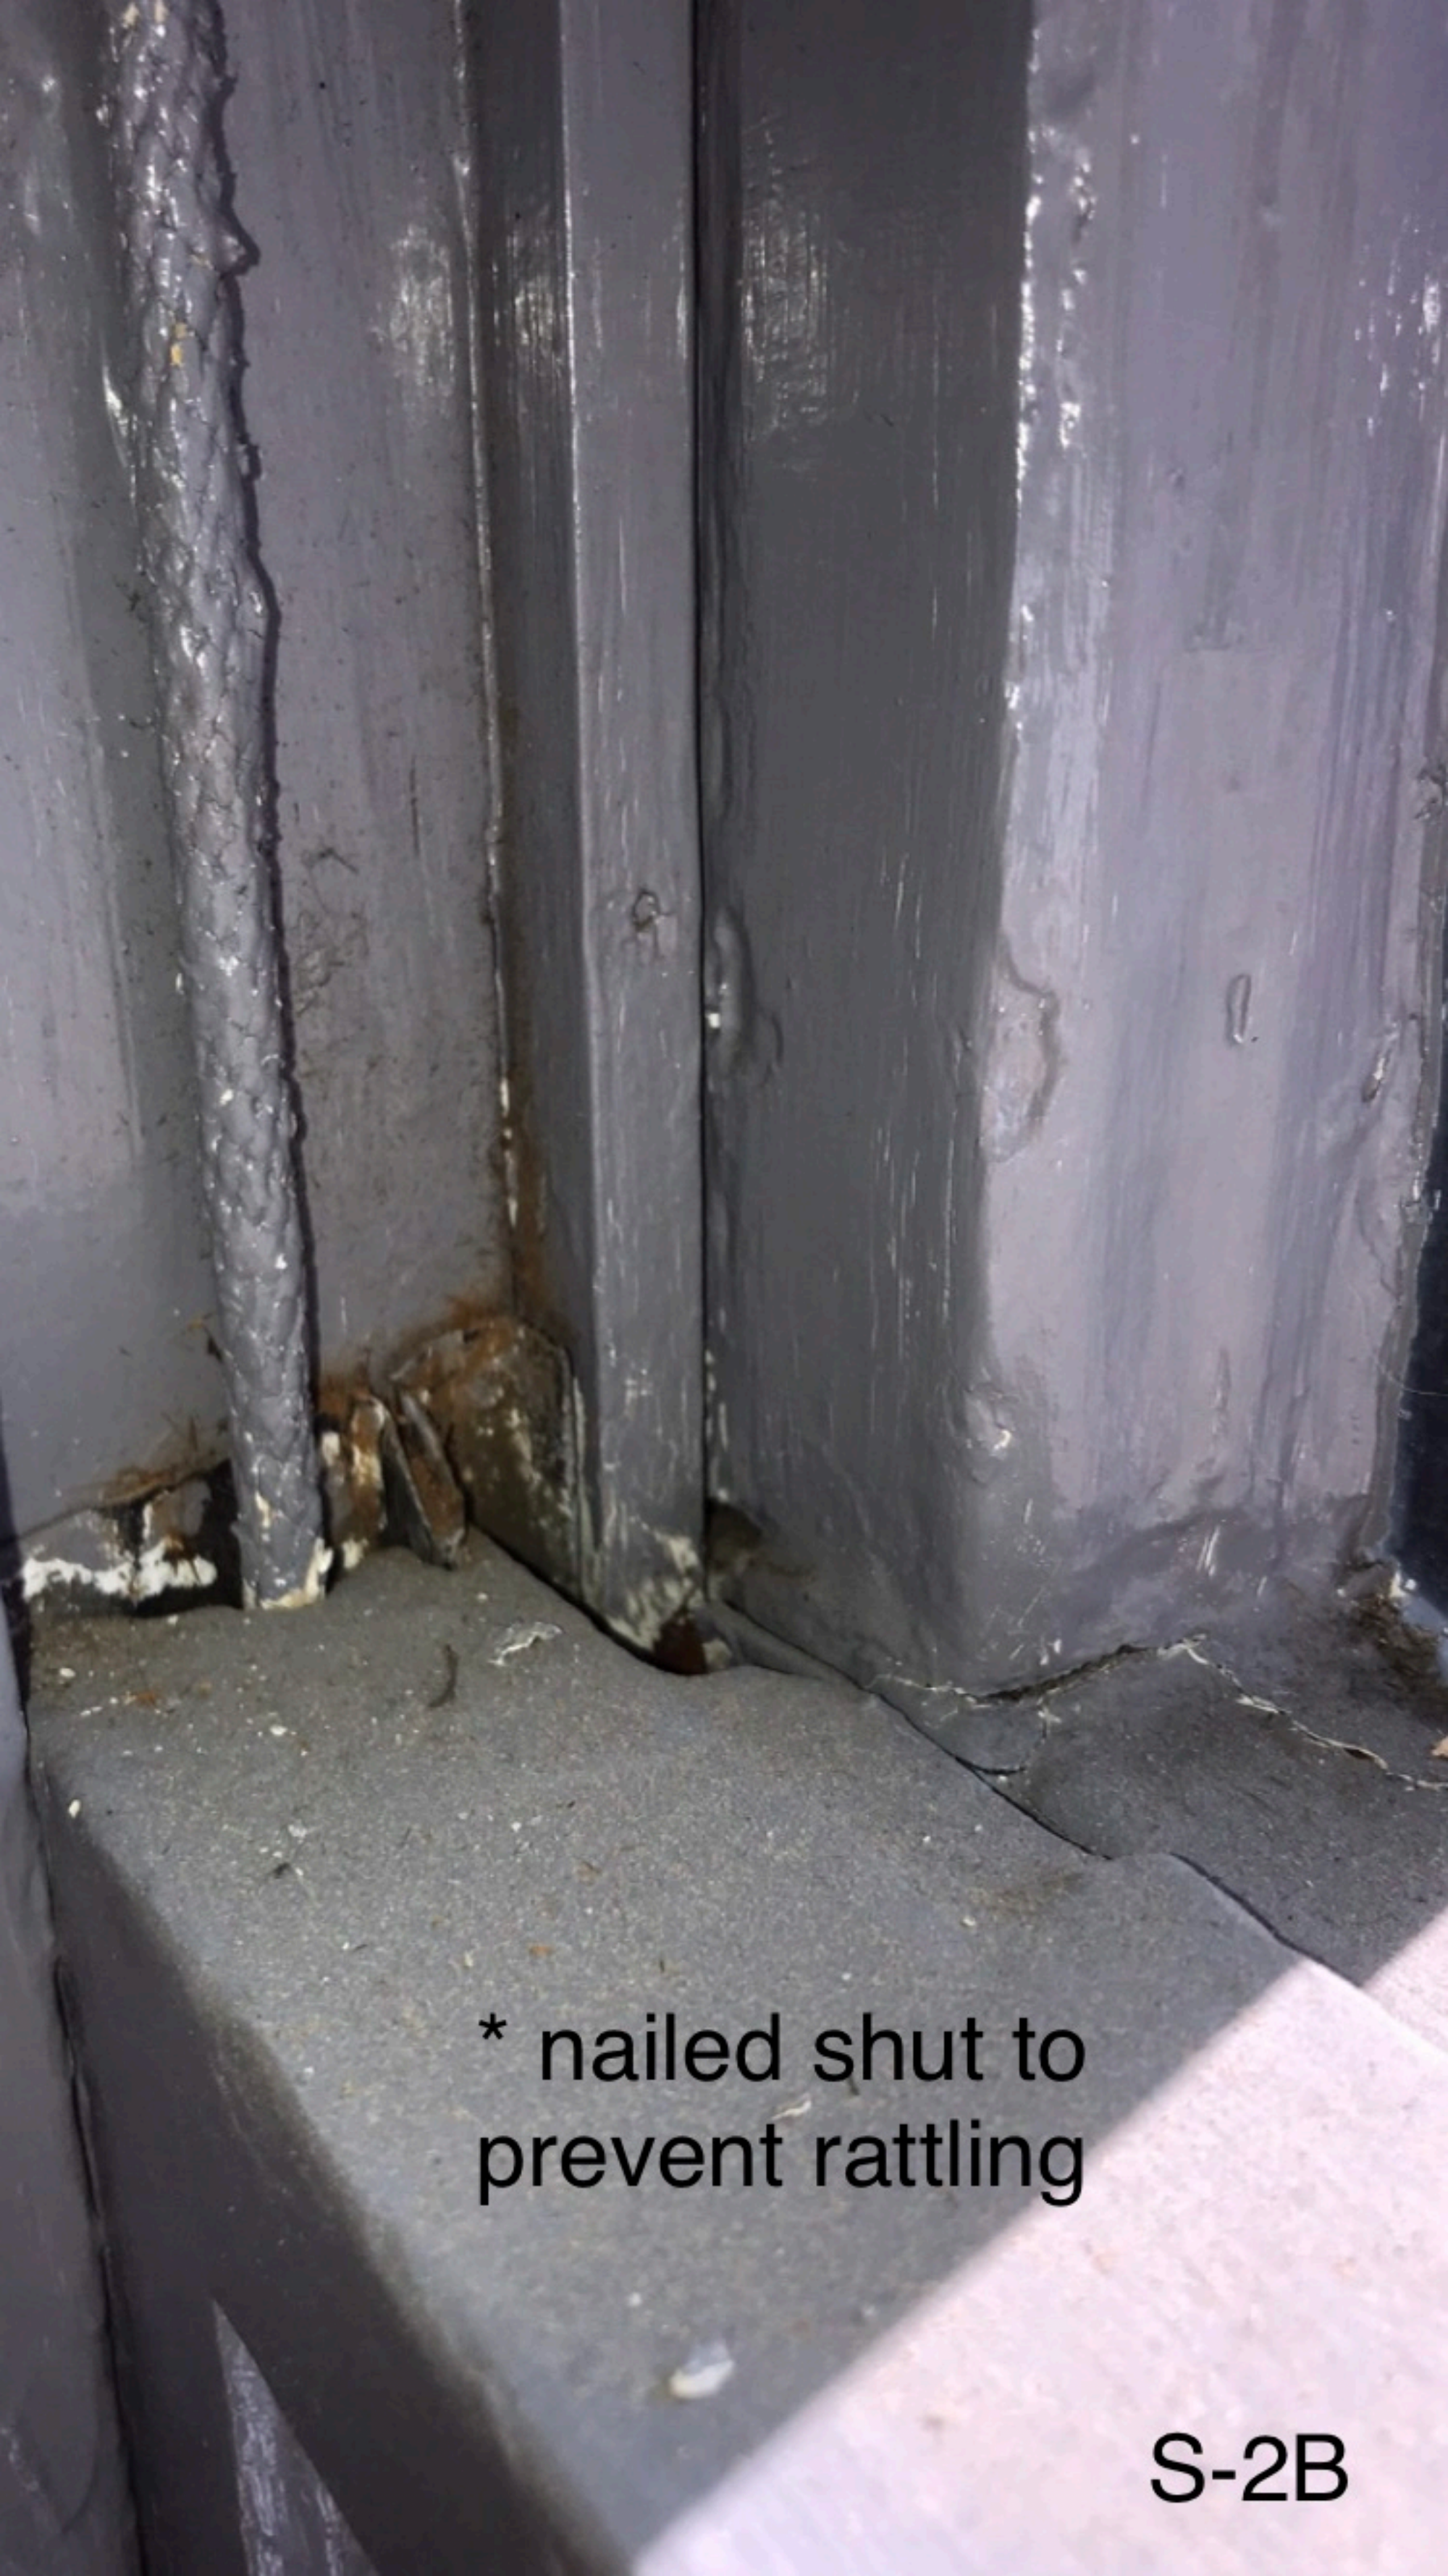
S-2B

* nailed shut to prevent rattling
