Current Conditions - Exterior

Engineer's Report

RE: Villa Victoria Center for the Arts, 85 West Newton Street, Boston – Existing Structural Conditions

Hazardous Conditions

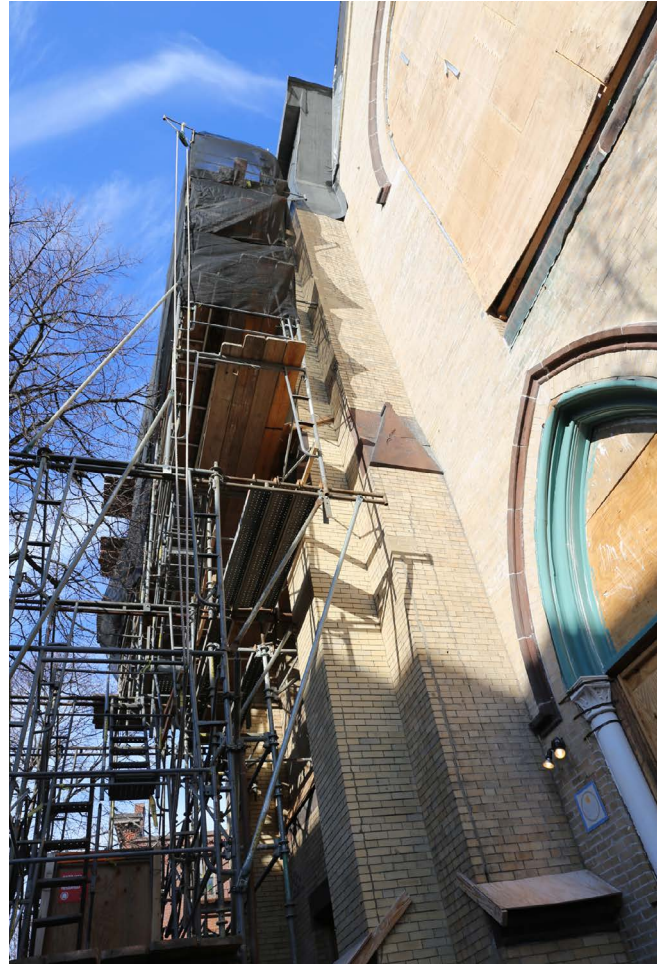
Scaffolded tower base (Spring 2019)

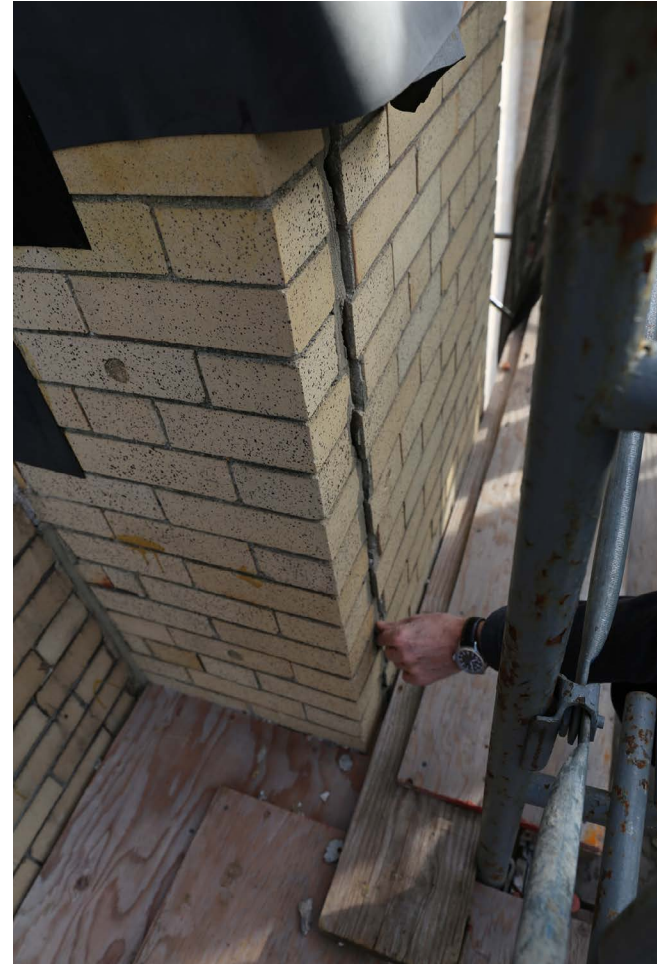
Delaminating face brick (Spring 2019)

During the period since our letter was issued, a surveying regime using tilt meters, crack monitors and vibration gauges has been undertaken to monitor the movement and behavior of the tower structure. Fortunately the monitoring has not identified any untoward movement of the tower, suggesting that with the added temporary shoring the tower remains stable (albeit during the summer months), however it did record movement of the outer bond brick which confirms that the delamination of this brickwork wythe is an ongoing issue and risk to pedestrians.

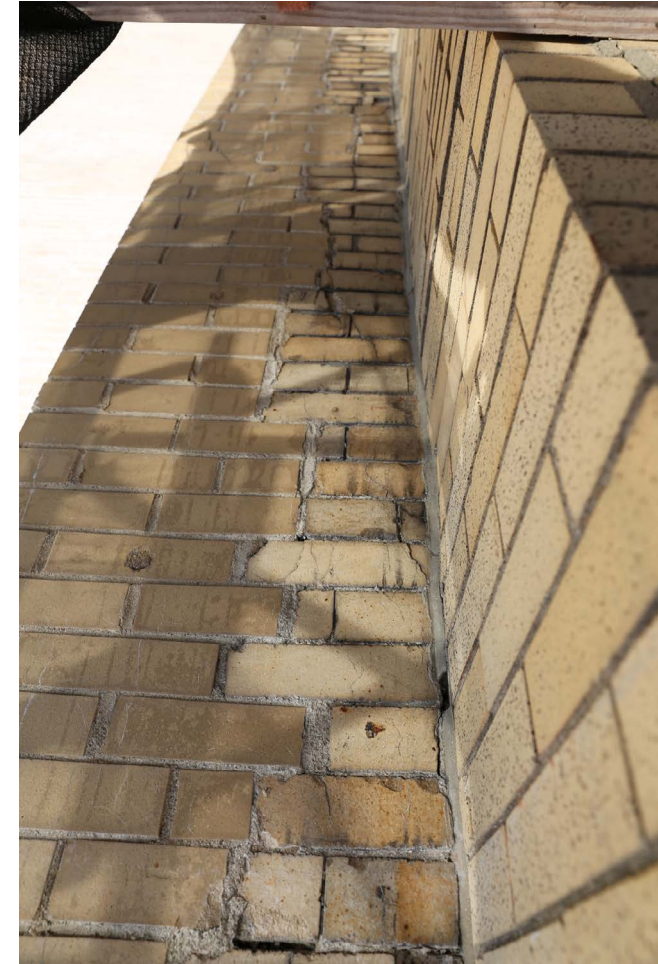
Cracks, tests and old repairs (Spring 2019)

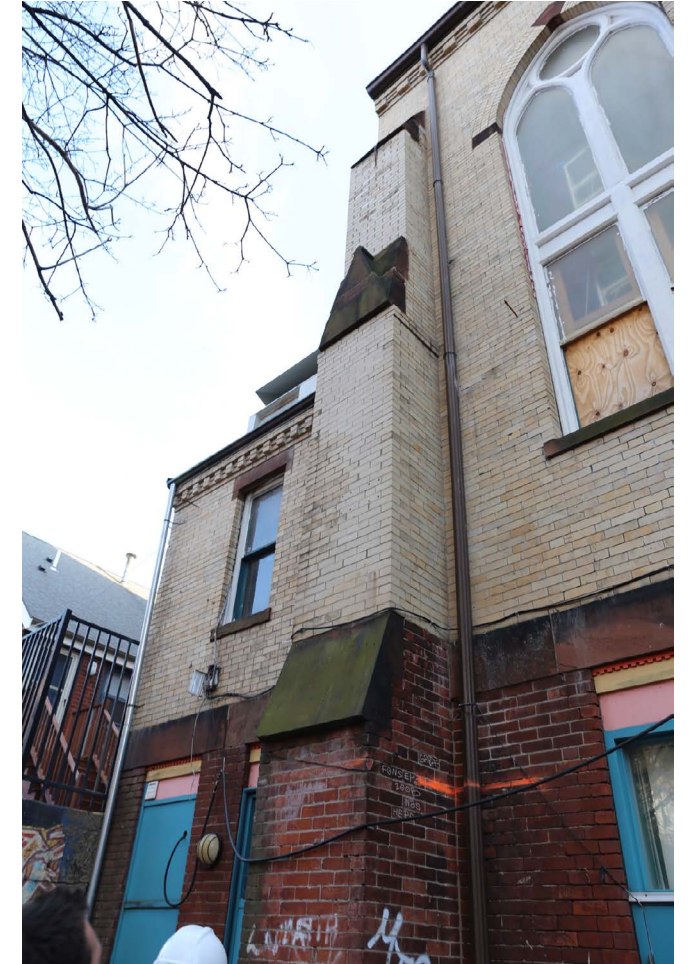
Buttress with old patches and repairs (Spring 2019)

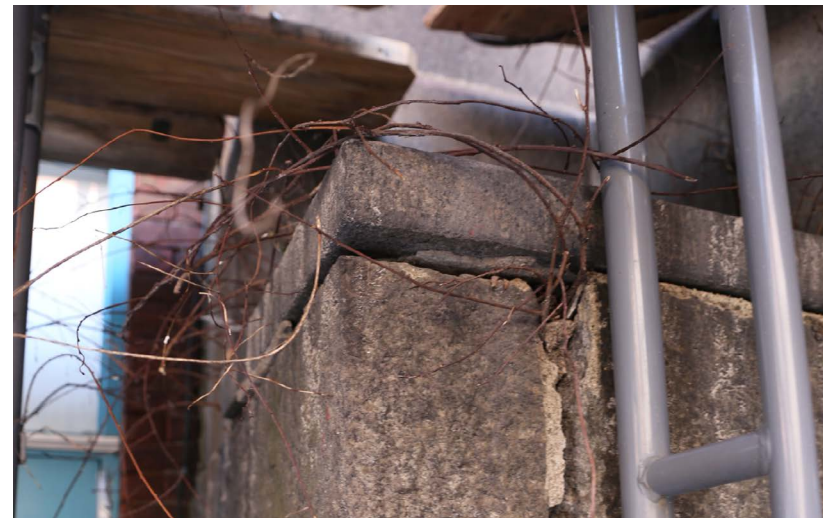
Stone displacement in granite base (Spring 2019)

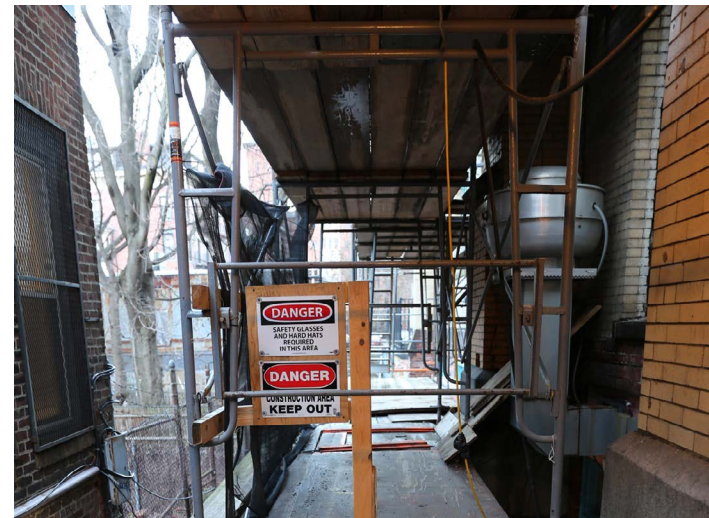
Protective scaffolding in alleyway (Spring 2019)

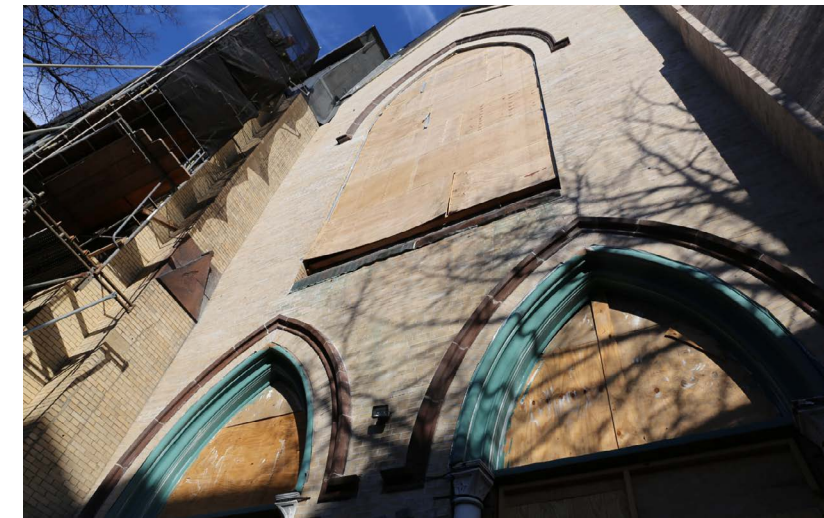
Boarded openings and mural (Spring 2019)

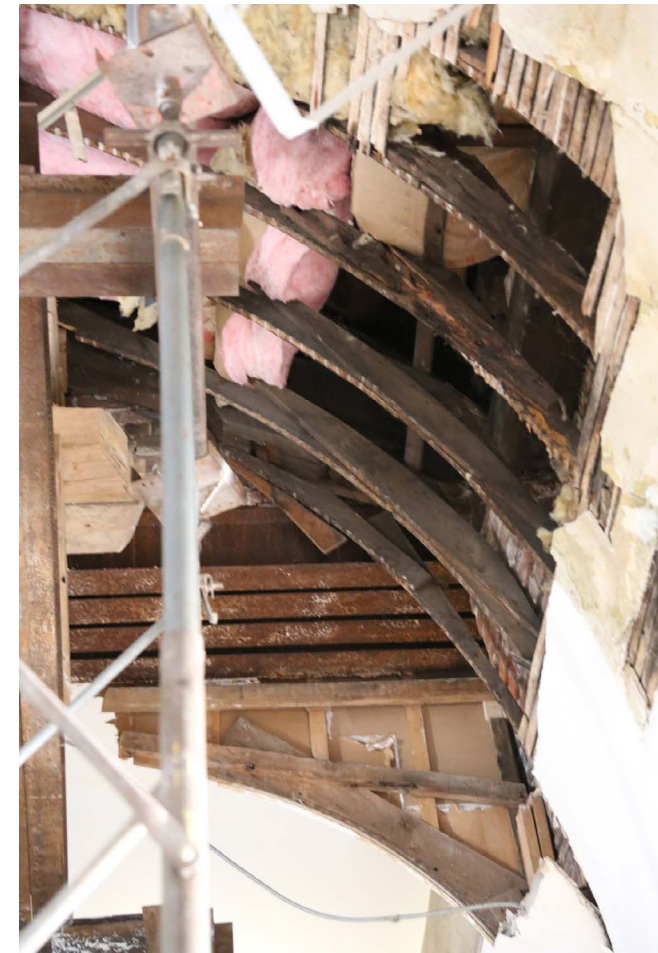
Probes and Shoring at roof framing (Spring 2019)

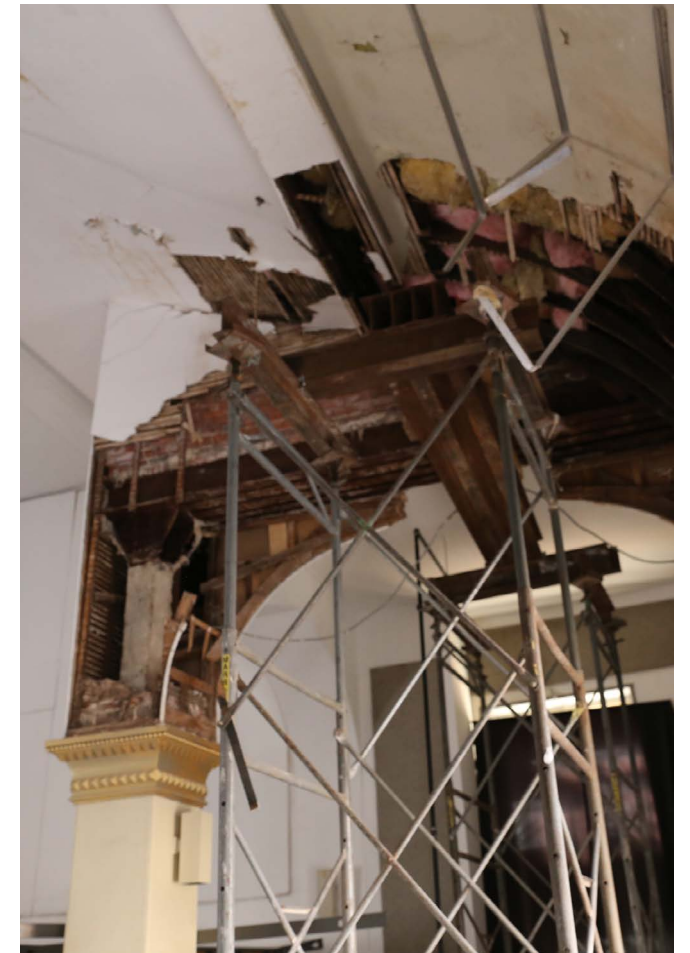
Interior tower shoring & reinforcement (Spring 2019)

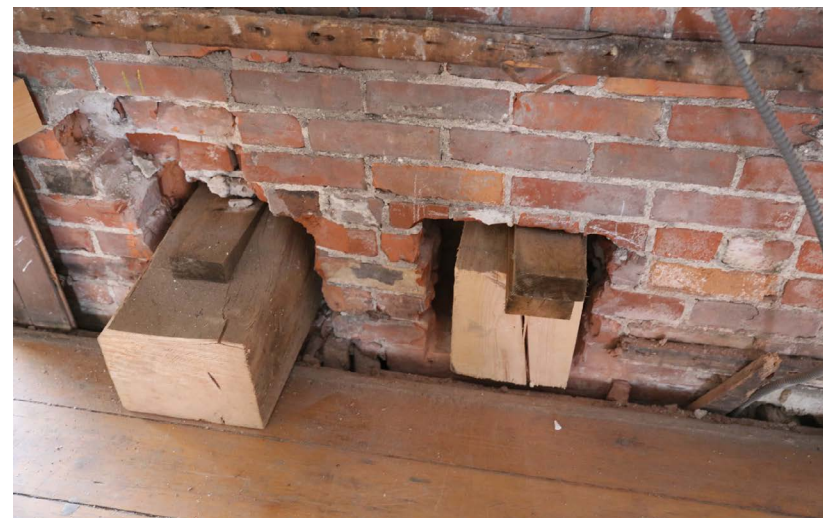
Exterior wall probes and temp support (Spring 2019)

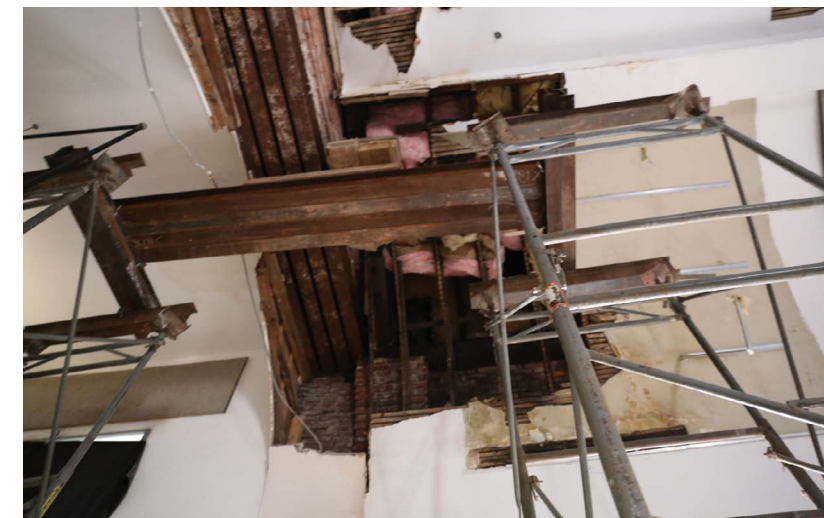
Tower and roof support shoring from below (Spring 2019)

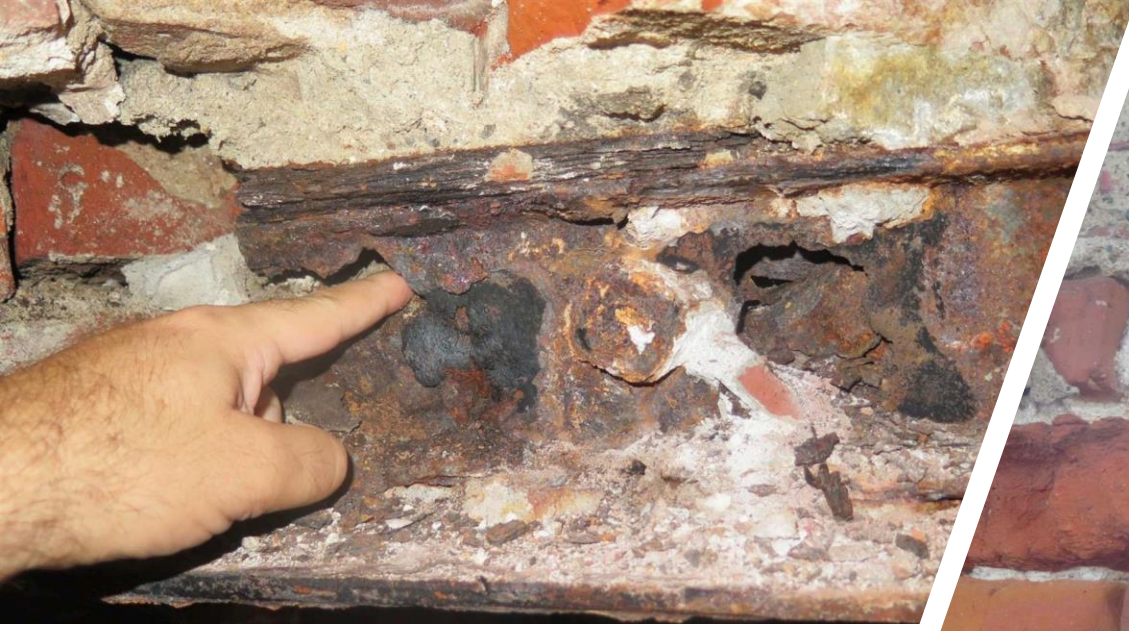
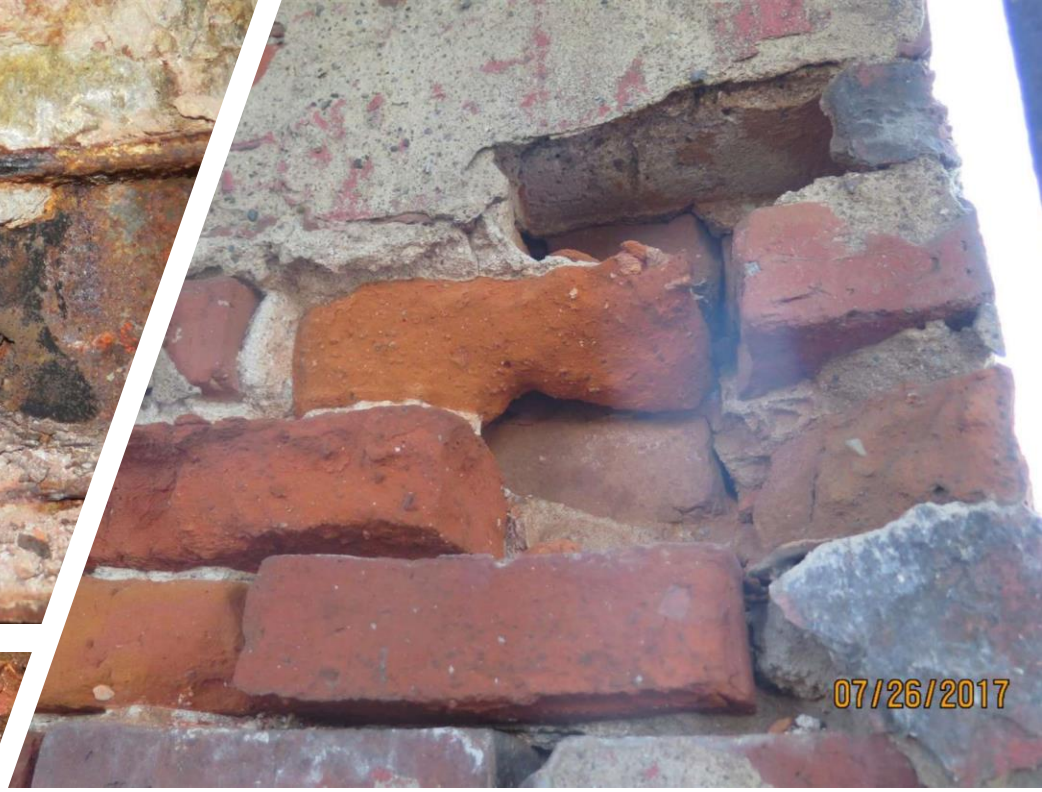
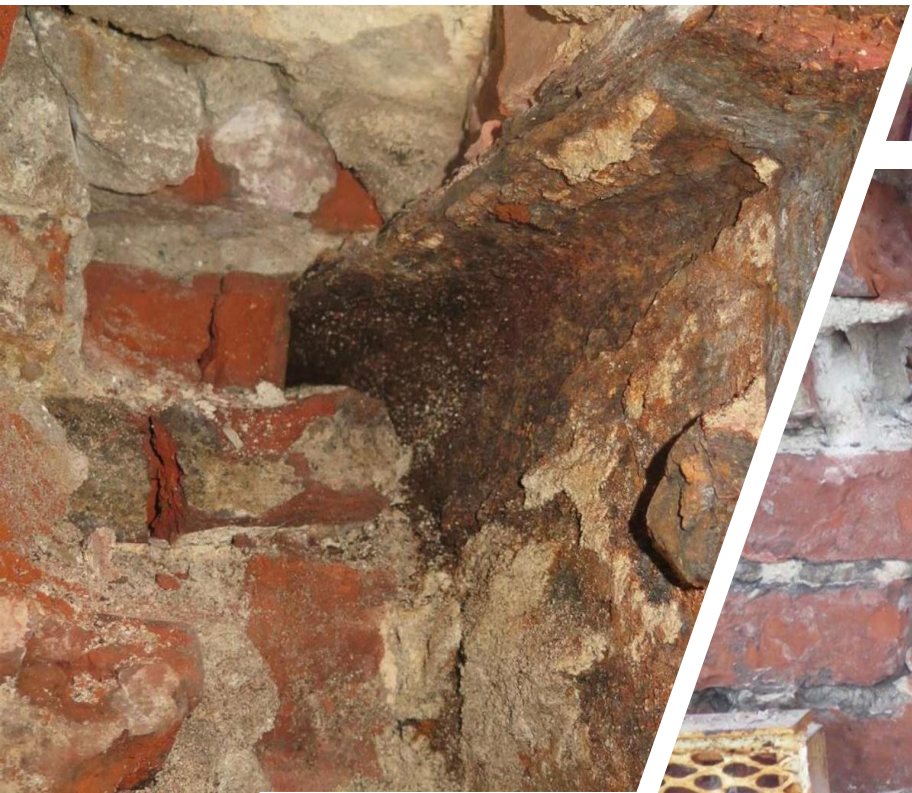
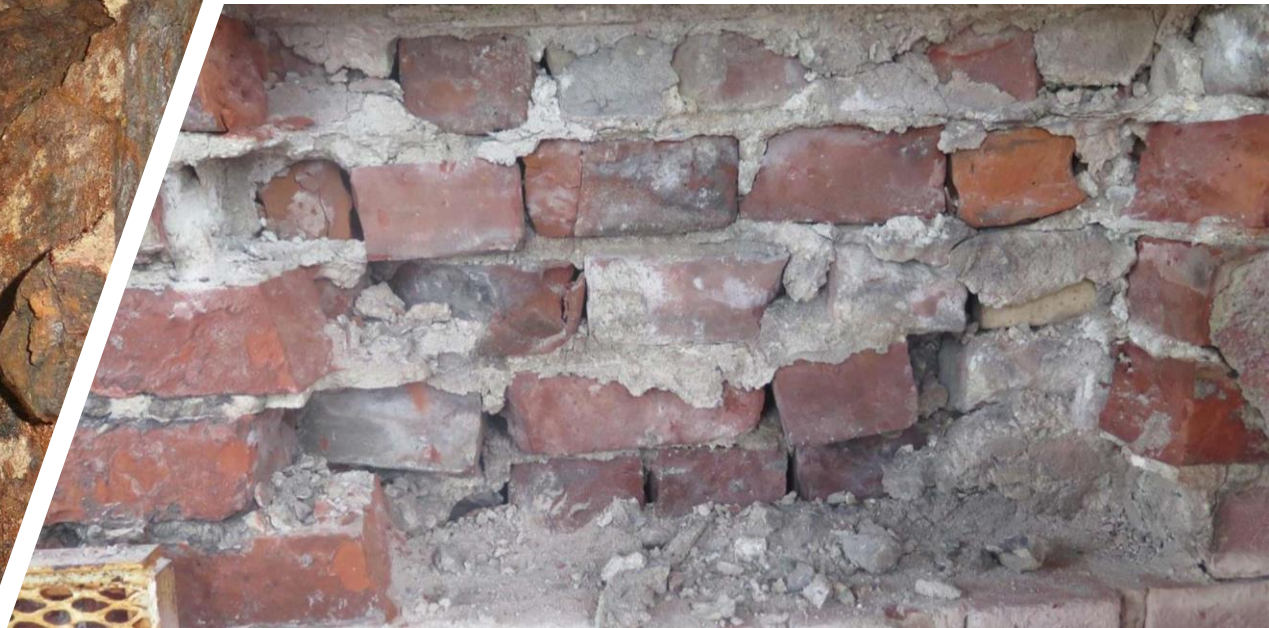
North Wall Damage Discovered

- Scaffolding installed along north elevation
 - Discovered debris clogged primary roof drain had caused extensive damage to wall below
 - Gale initiated GPR scanning followed by additional test cuts which identified separation between the inner and outer courses
 - Mortar washout and deteriorated conditions full height of wall below clogged drain
 - Rotted timber and steel lintel with deteriorated masonry above preschool egress door to alley
 - Severely corroded steel beam supporting floor joists
 - Shoring required
 - Adjacent classroom closed

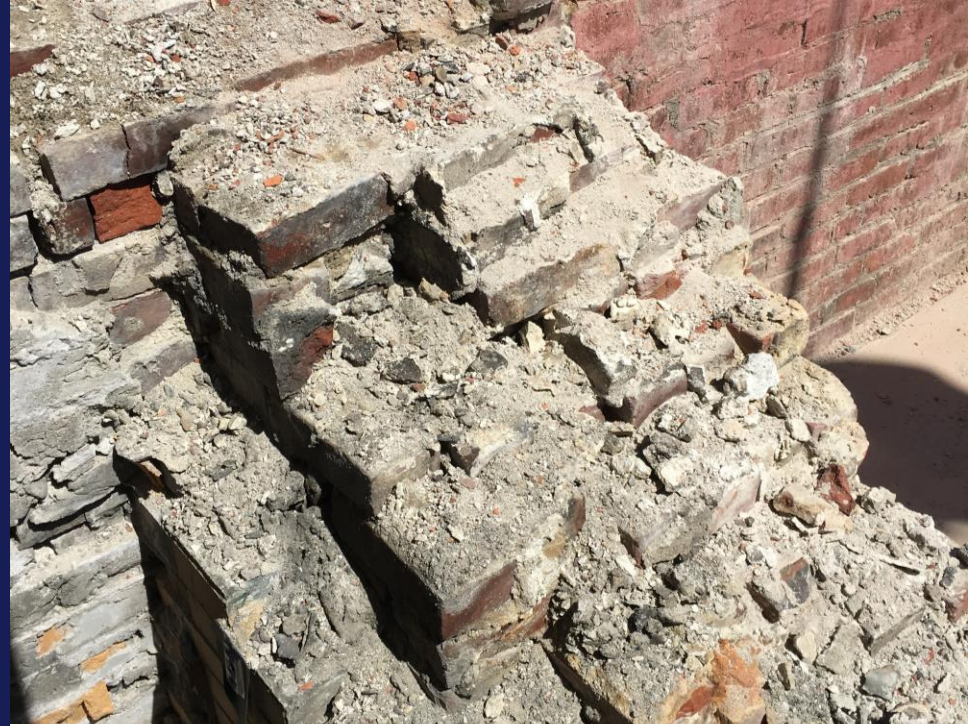
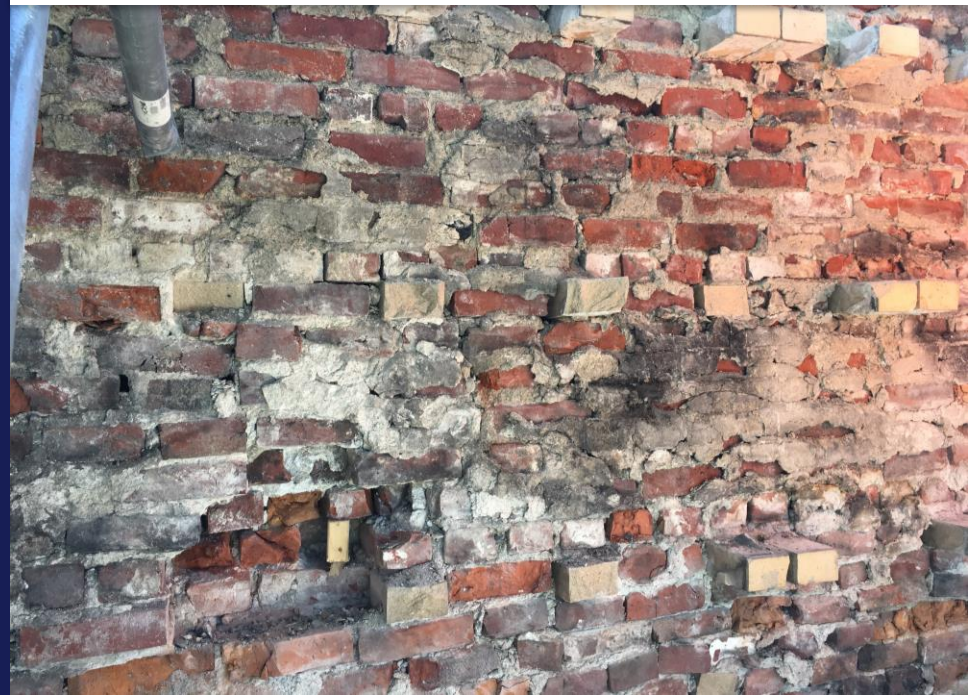
Tower Demolition

- **Poor masonry conditions still exist**
 - Demolition hammers loosen large areas of wall
 - Bricks removed easily by hand
 - Large sections of blonde brick “peeled” away with pry-bar...snapped headers
 - Severely deteriorated joint mortar
- **SGH to provide 2nd opinion on wall integrity and validate Gale’s findings:**
 - SGH agreed with Gale’s assessment that masonry deterioration too extensive to support weight of new belfry and spire

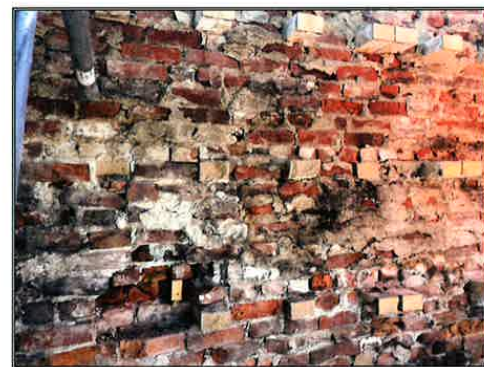
On May 8, 2018, Gale again visited the site to observe Shawmut's method of demolition using hand tool techniques and to review the underlying condition of the undisturbed inner red brick wythes. Following the removal of approximately seven feet (7') of blonde brick veneer along the north tower wall using this technique, it was revealed that more than half of the blonde brick headers were snapped or unbonded.

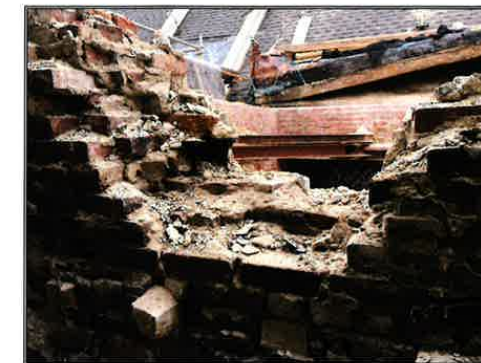
At many locations, inner red brick wythes could be removed by hand and were found to have little mortar bond between courses.

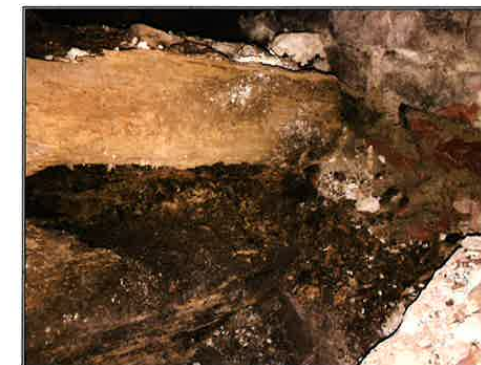
On May 9, 2018, Gale observed the truss bearing condition adjacent to the tower, at the main building roof eave, which was previously inaccessible, and discovered multiple structural deficiencies. The end of the timber roof truss appeared to be severely deteriorated, with significant section loss where the top and bottom chords meet at the truss bearing point.

Additionally, adjacent to the truss, a portion of the structural steel lintel supporting the entire weight of the remaining east tower masonry wall was observed to be severely deteriorated. The visible portion of the flanges and web of the lintel was observed to have significant section loss, including a hole through the web at its end.
