CERTIFICATE OF APPROPRIATENESS APPLICATION

Re: Minor Modifications at 3 Park Street

Park Street Church

Park Street Church requests approval for minor modifications related to in-kind glass replacement in wood windows and replacement of the door entry video intercom system.

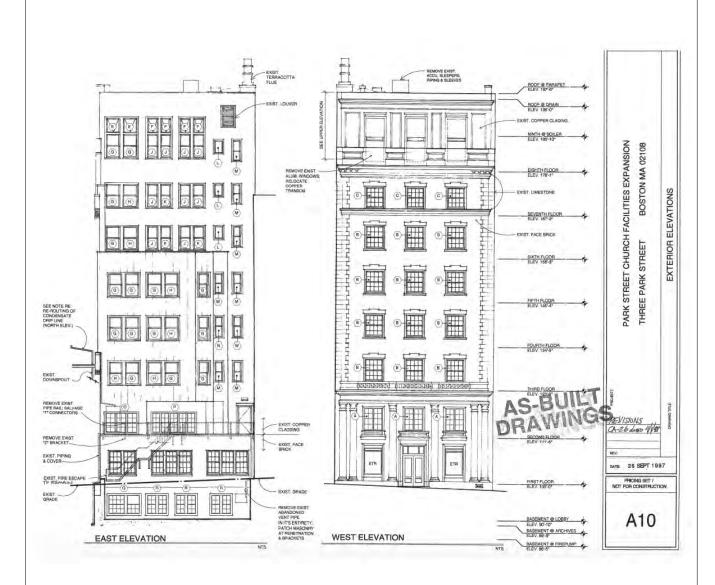
Exterior Elevations from 1997 Work Performed Under Certificate of Appropriateness #96.394BH

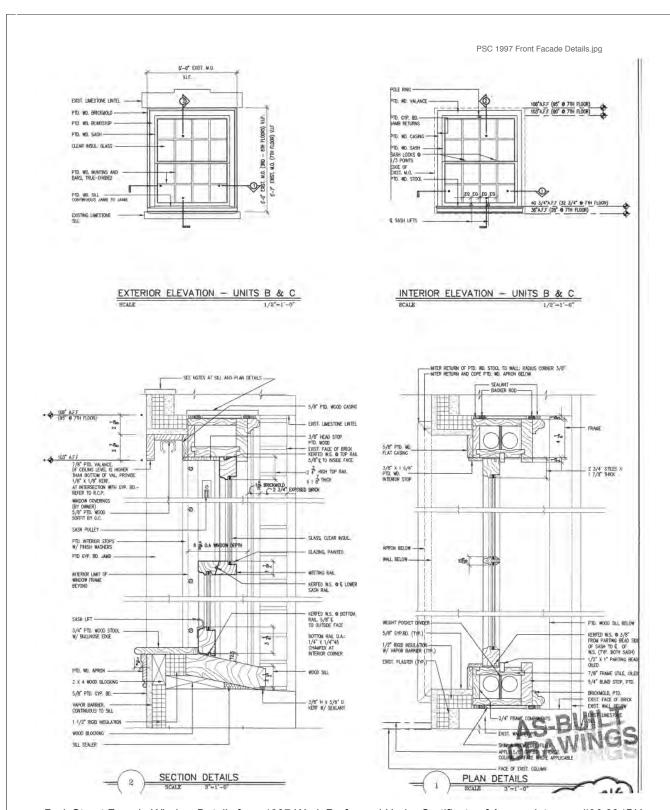
Park Street Facade Window Details from 1997 Work Performed Under Certificate of Appropriateness #96.394BH

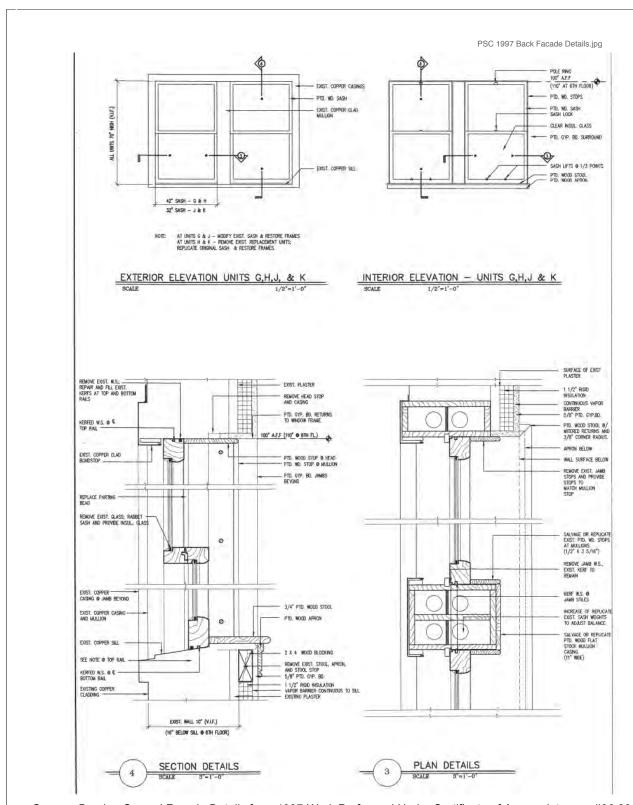
Granary Burying Ground Facade Details from 1997 Work Performed Under Certificate of Appropriateness #96.394BH

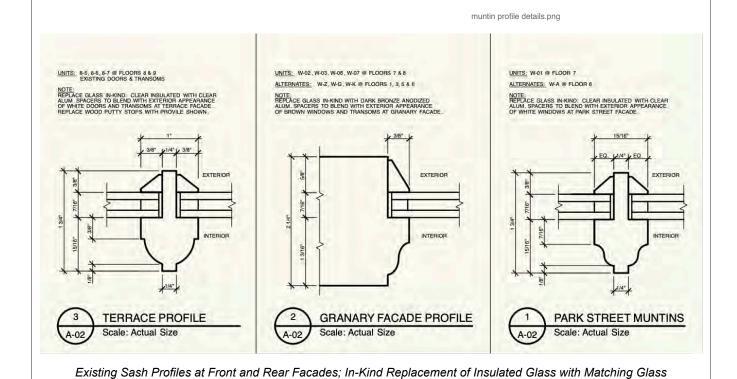
Proposed Window Schedule for Selective Replacement of Existing Insulated Glass with Matching Units

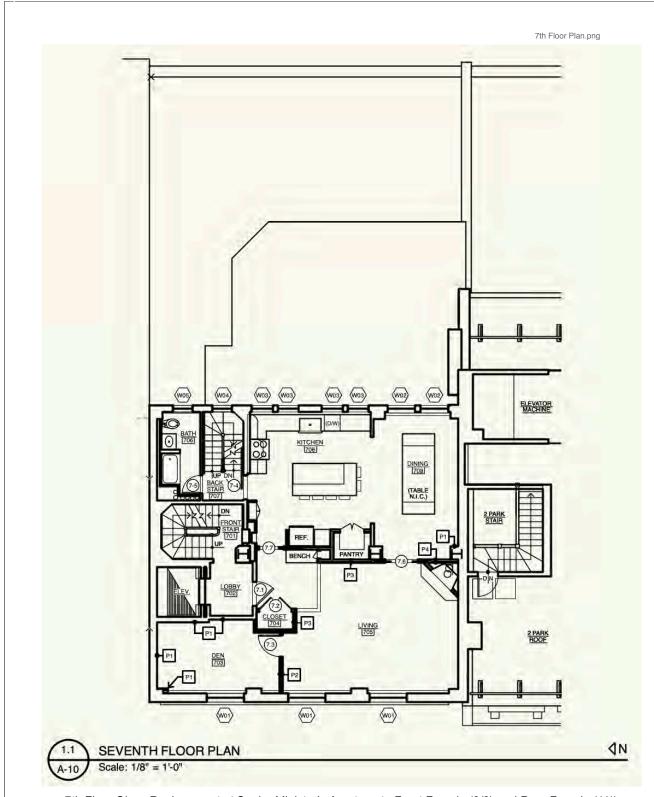
7th Floor Glass Replacement at Senior Minister's Apartment: Front Facade (8/8) and Rear Facade (1/1)

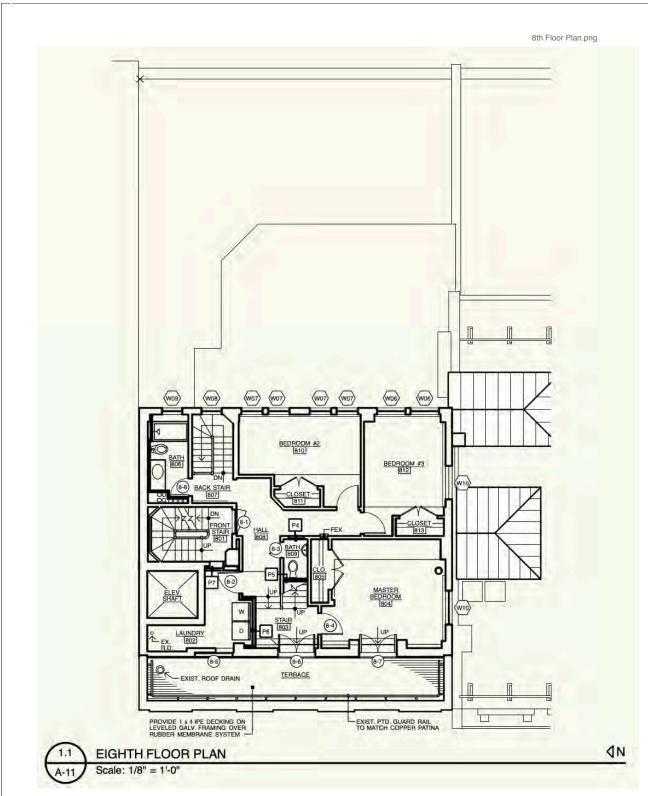
8th Floor Glass Replacement at Senior Minister's Apartment: Front Facade (Multi-Light Doors with Transoms) and Rear Facade (1/1 Double-Hung Units with Transoms)

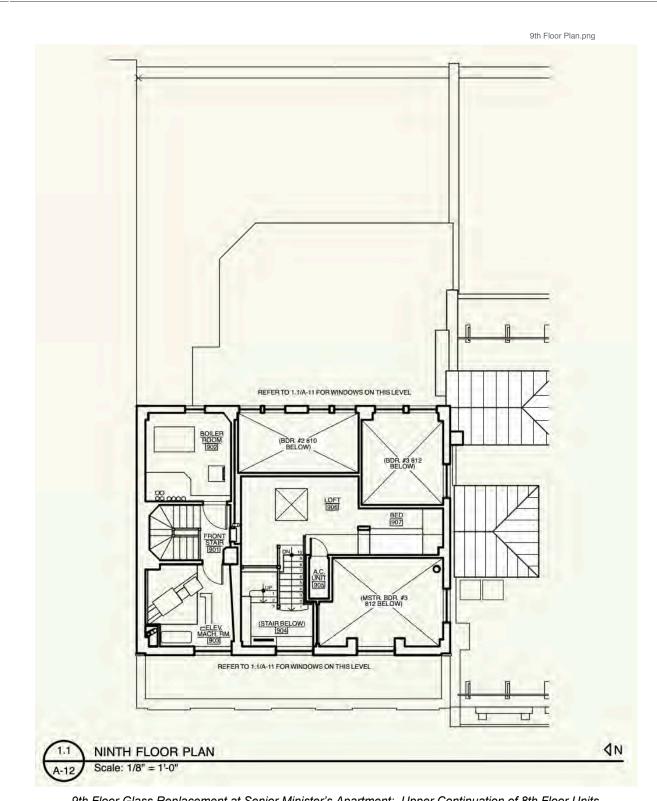
9th Floor Glass Replacement at Senior Minister's Apartment: Upper Continuation of 8th Floor Units

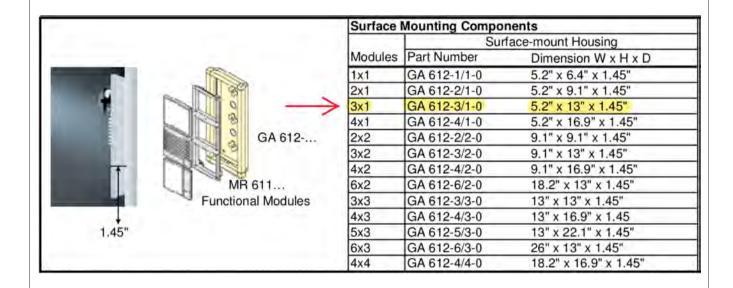
Proposed Replacement Intercom Unit is a 3-Component Assembly into a Single Surface-Mounted Device
