Historic Photos - Exterior

North Wall Damage Discovered

Tower Demolition

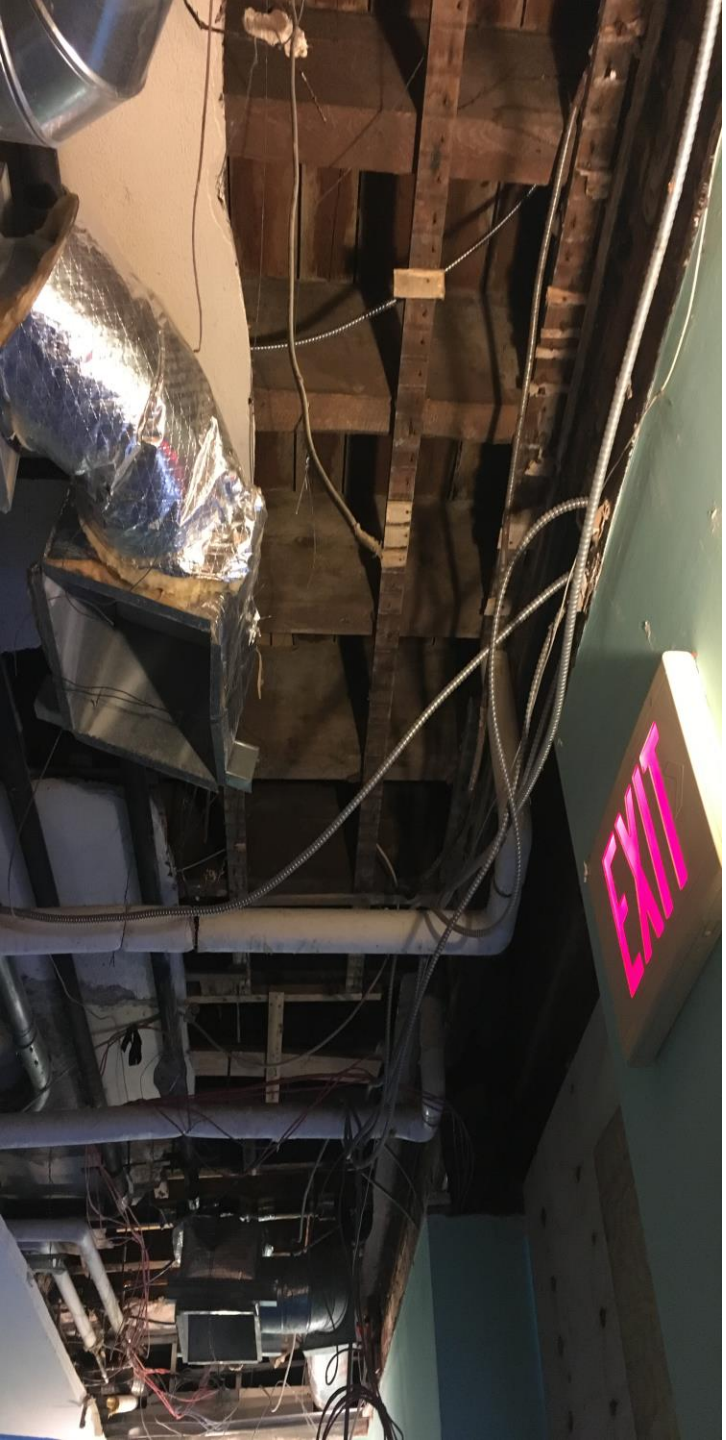
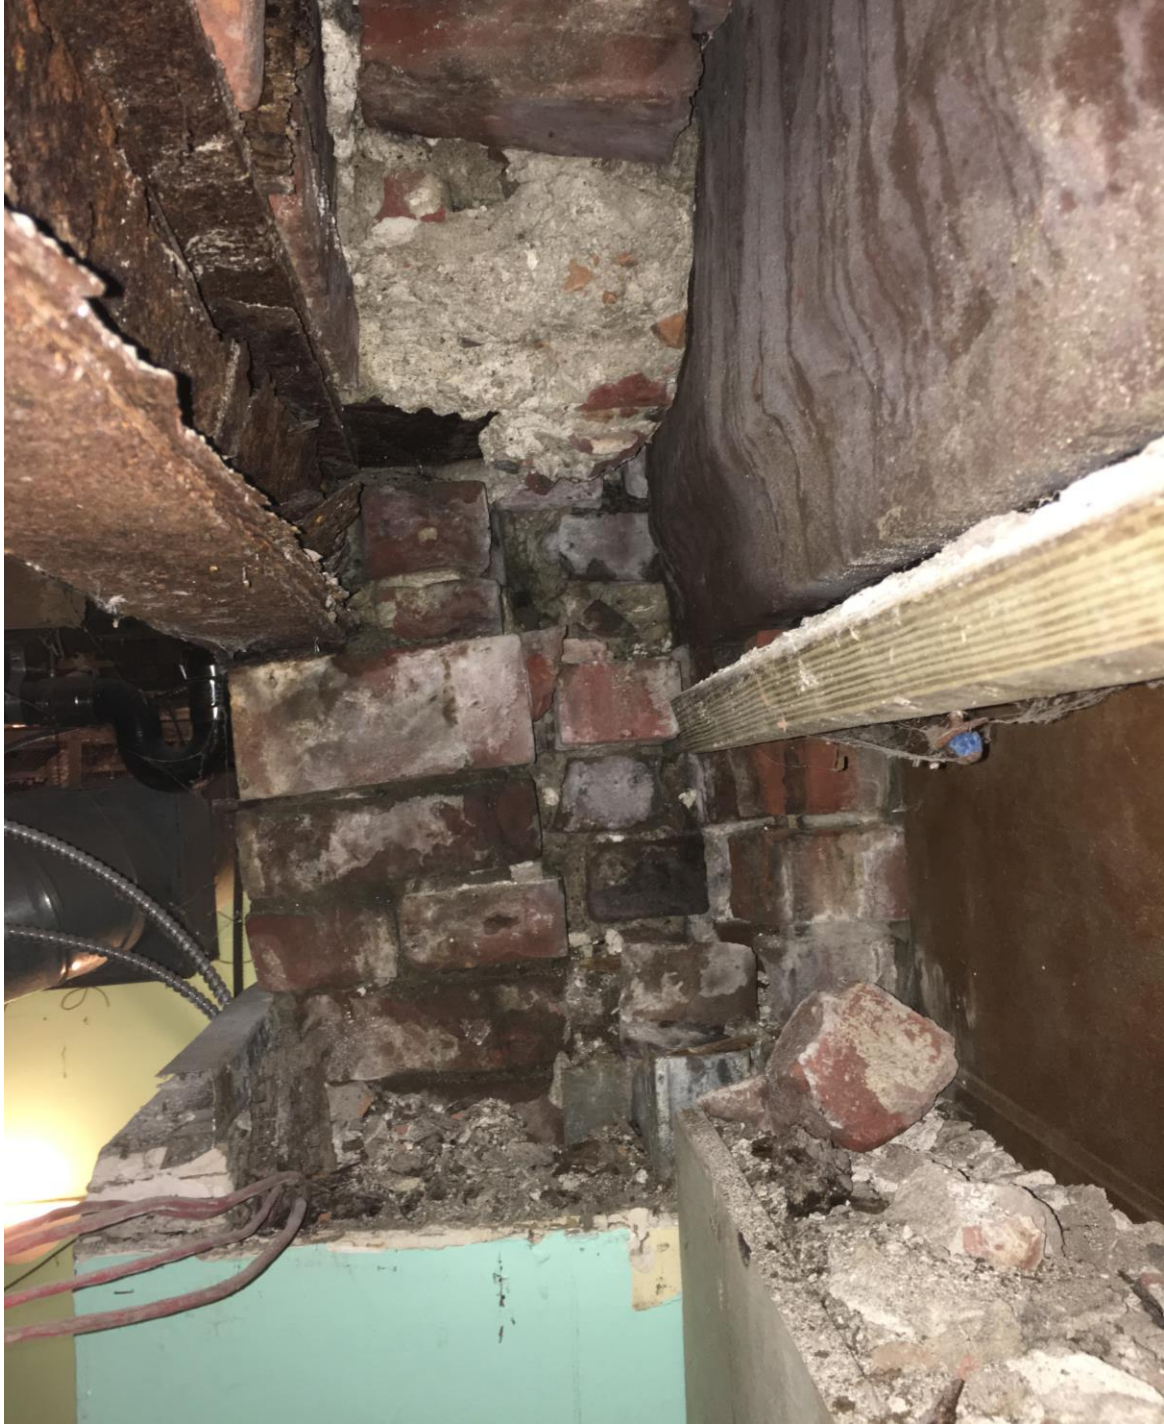
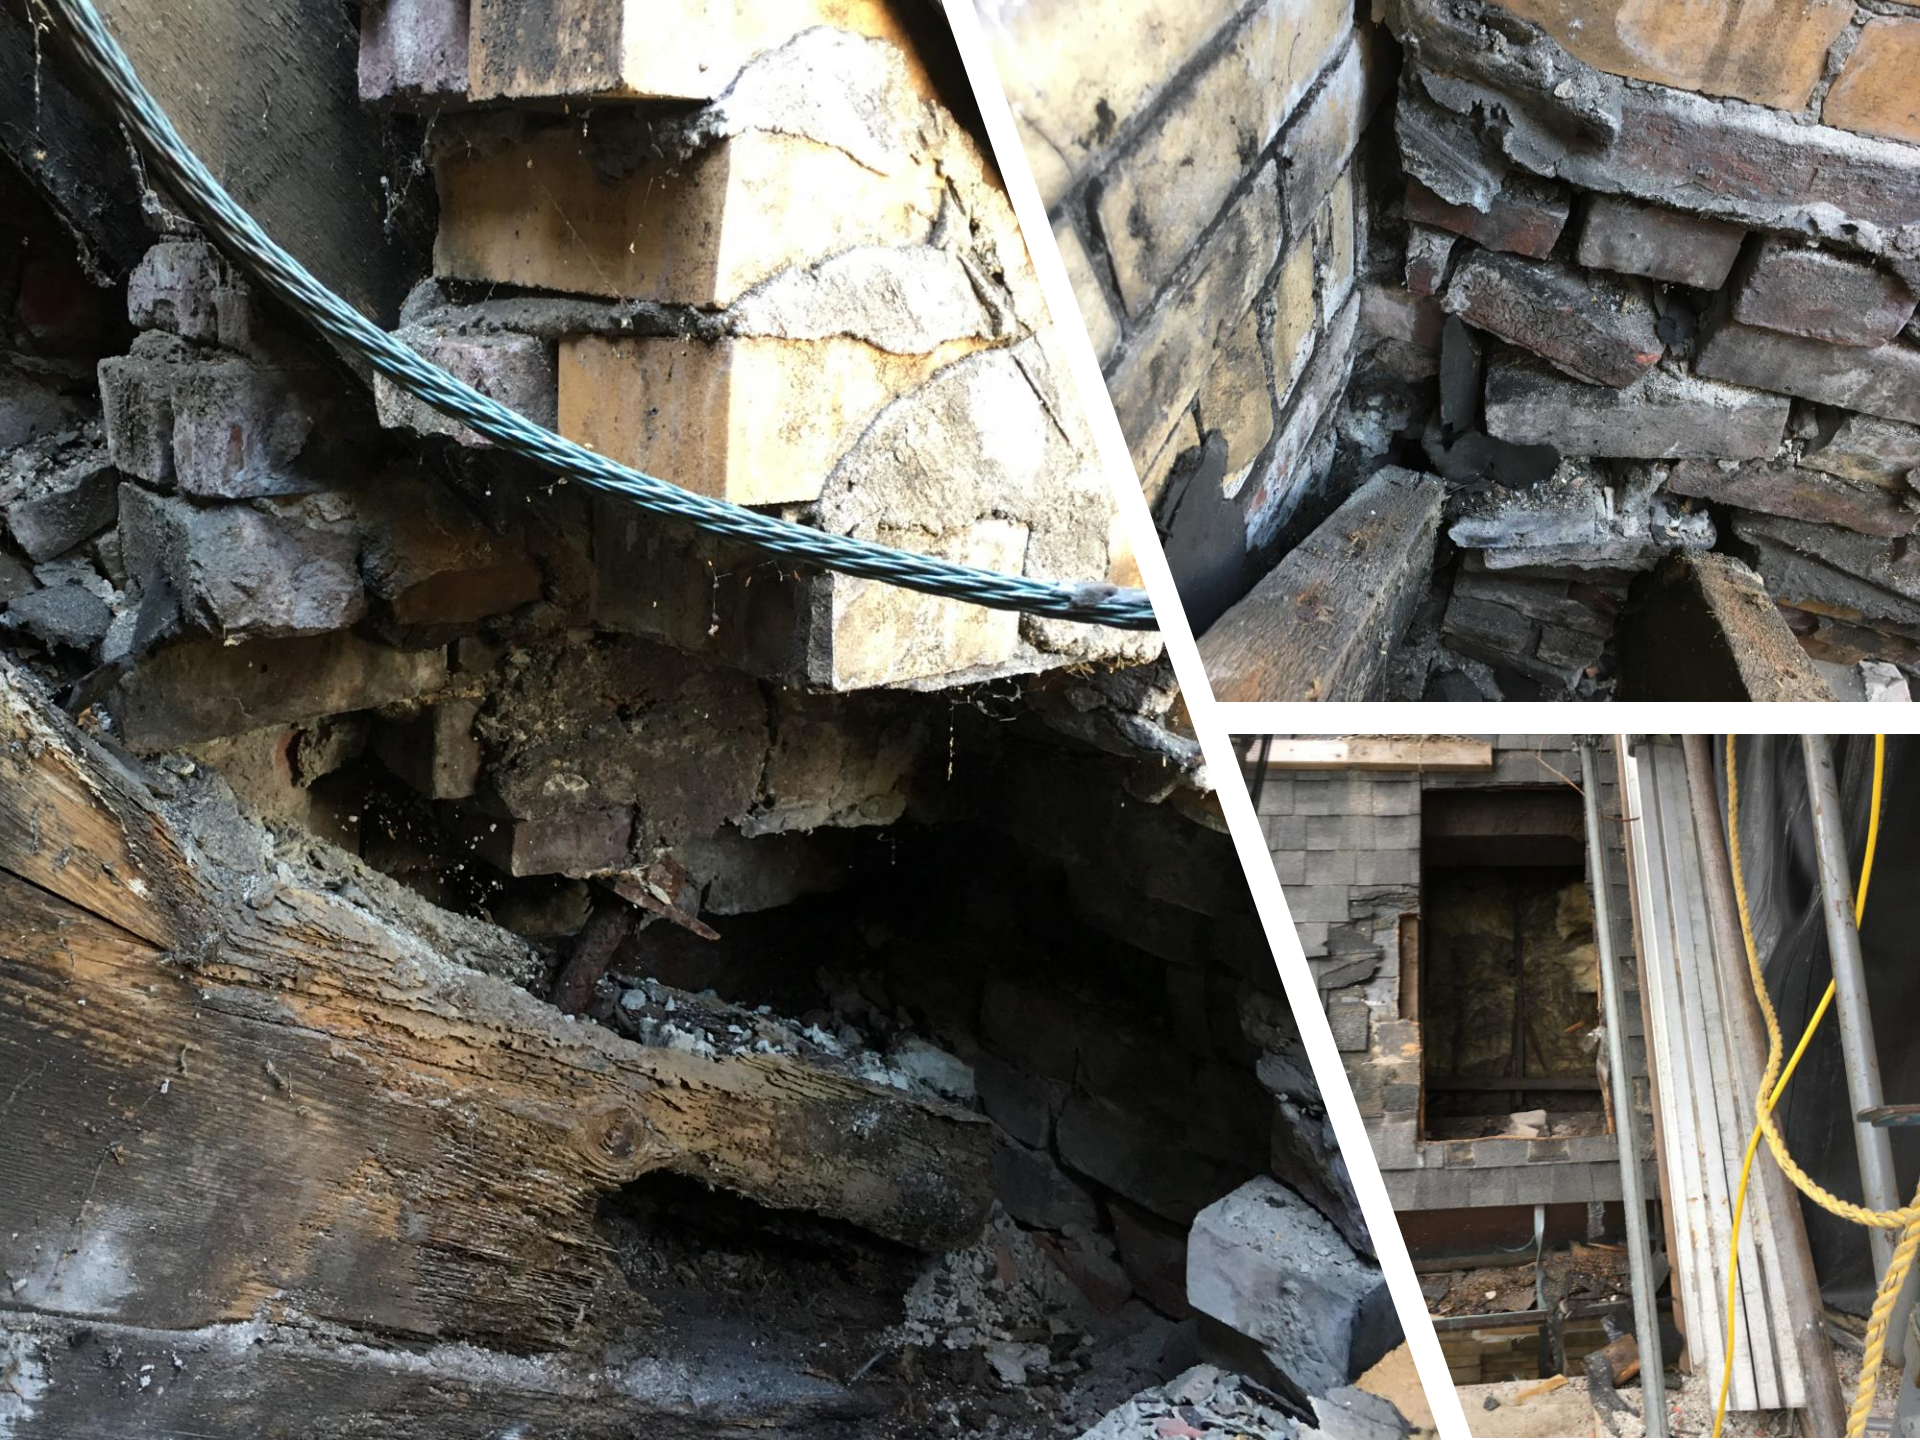
April 2018

- Scaffolding installed along north elevation
 - Discovered debris clogged primary roof drain had caused extensive damage to wall below
 - Gale initiated GPR scanning followed by additional test cuts which identified separation between the inner and outer courses
 - Mortar washout and deteriorated conditions full height of wall below clogged drain
 - Rotted timber and steel lintel with deteriorated masonry above preschool egress door to alley
 - Severely corroded steel beam supporting floor joists
 - Shoring required
 - Adjacent classroom closed
