300 A Street

south facade finish upgrade

LOCUS PLAN
EXISTING DEFICIENCIES
PROPOSED IMPROVEMENTS

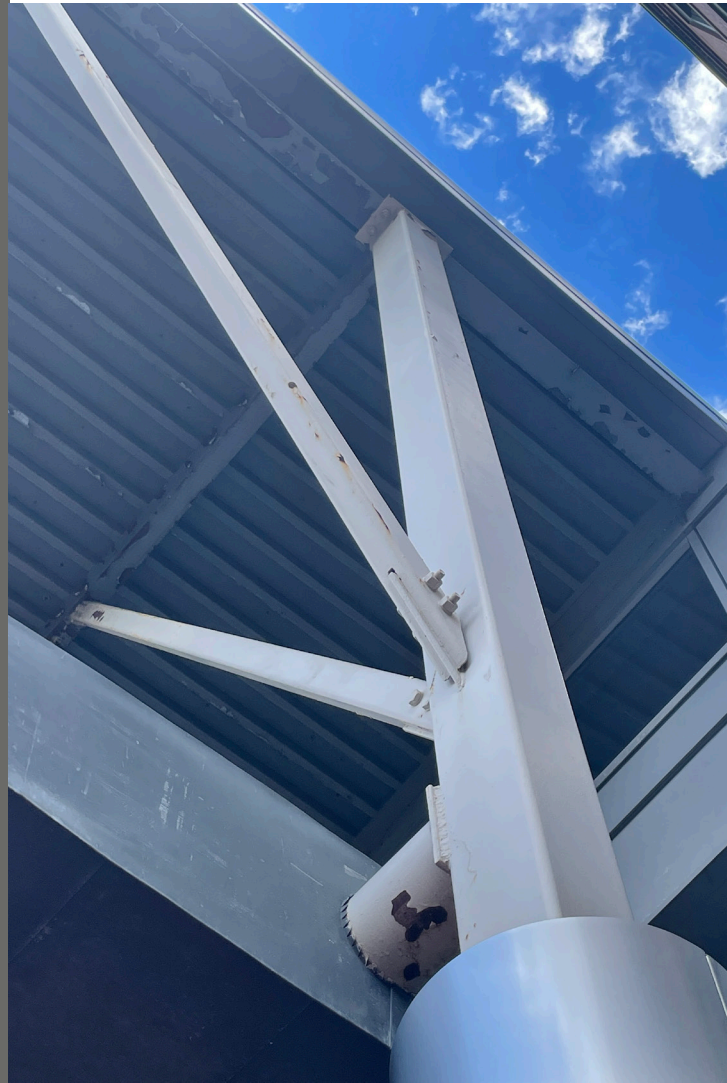
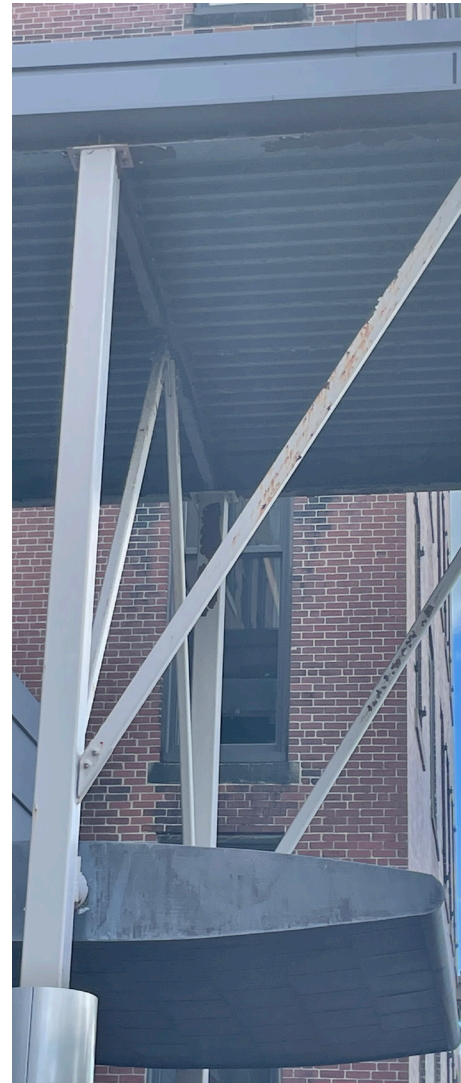
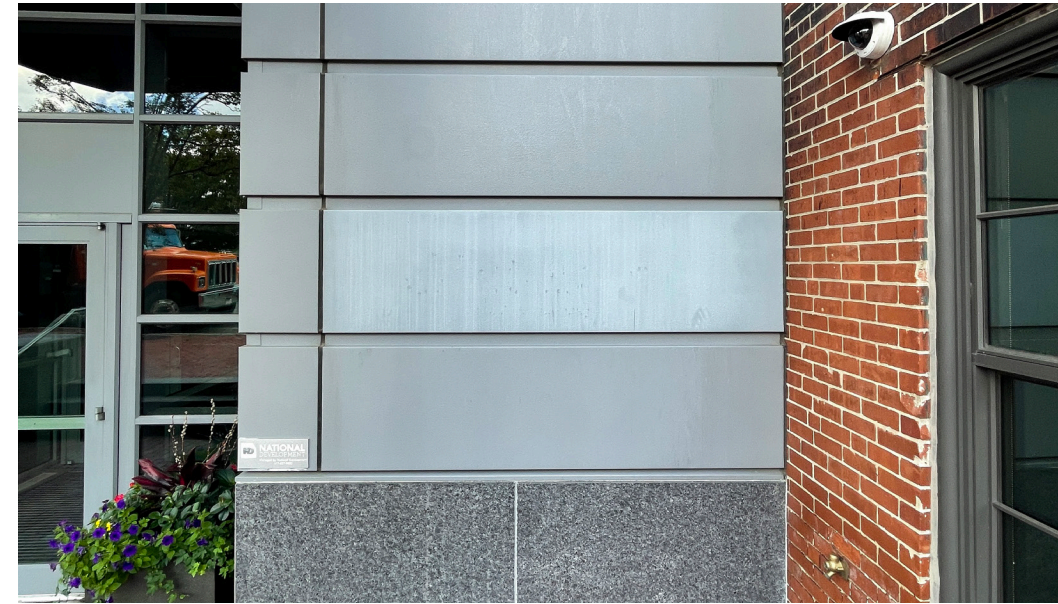
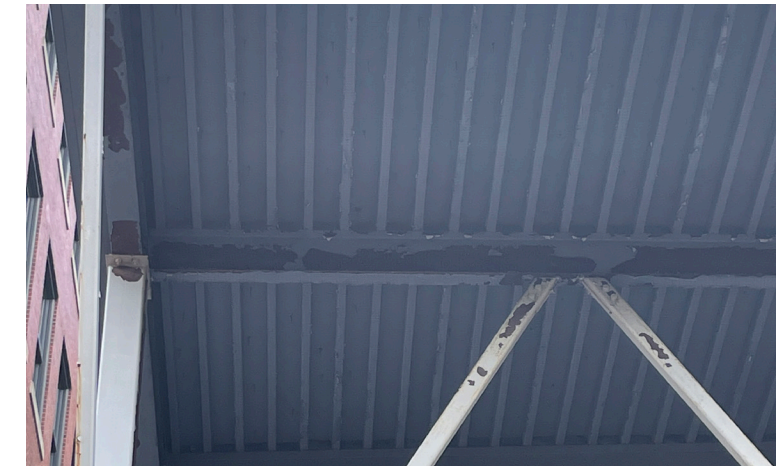
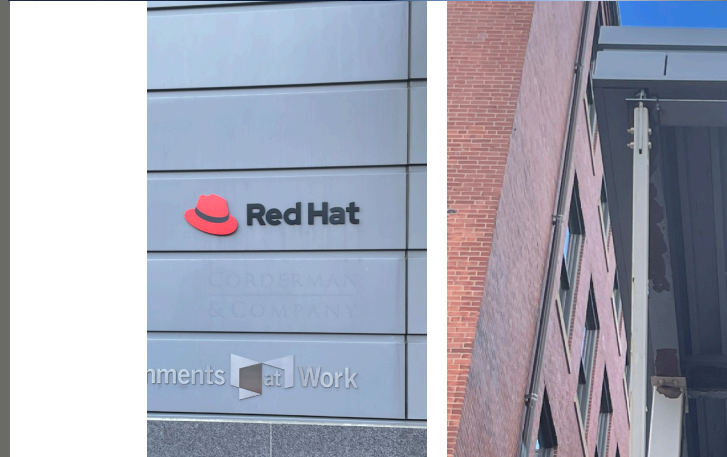
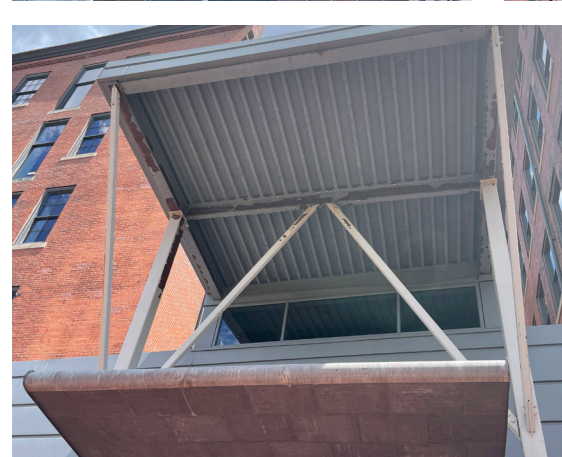
Existing Deficiencies

The existing south facade at 300 A Street is exhibiting significant finish deterioration including paint peeling, rusting and fading due to sun exposure.

The existing canopy structure and metal panels will remain in place. The existing painted steel shall have loose and spalled paint removed while well adhered paint may remain.

Entire steel members will receive a lead-free, corrosion resistant coating - Tnemec AK02 Universal Primer and (2) coats of semi-gloss, low VOC epoxy paint - Tnemec Series 104 H.S. Epoxy for salt spray and weathering protection.
