15 CHANNEL CENTER ST
BOSTON, MA

MIDWAY ARTIST STUDIOS

EXISTING CONDITION PHOTOS

Sheet Number: P-004
 Project Number: 22096
 Date: 10/6/2023

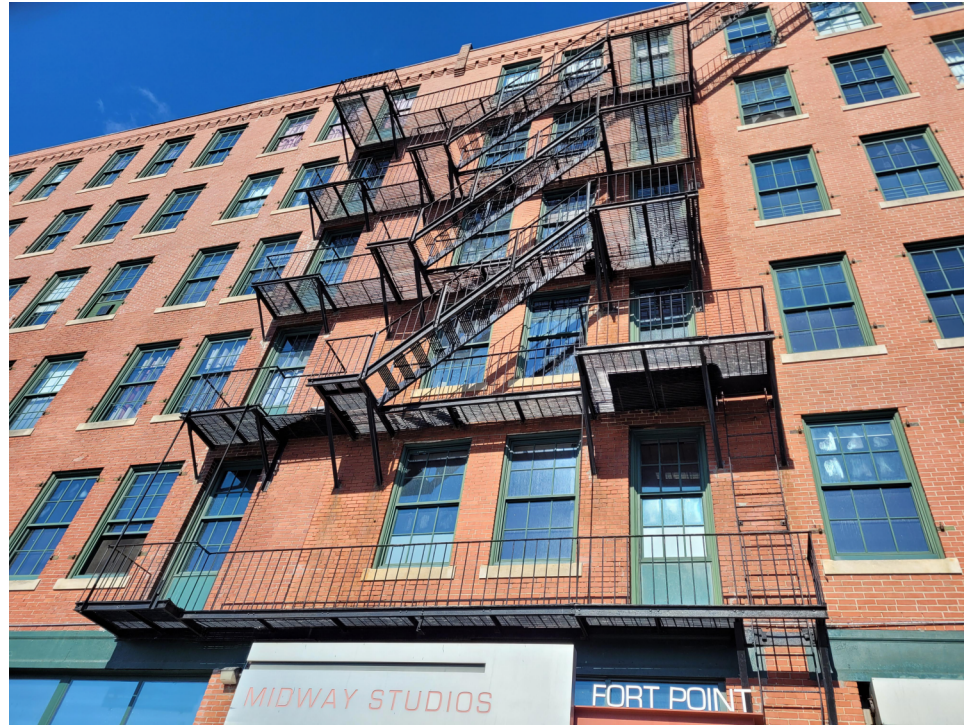
BACK ELEVATION - MEDALLION AVE
EXISTING FIRE ESCAPE A (BETWEEN COLUMN LINES 5 AND 6)
SEE SHEET A-202

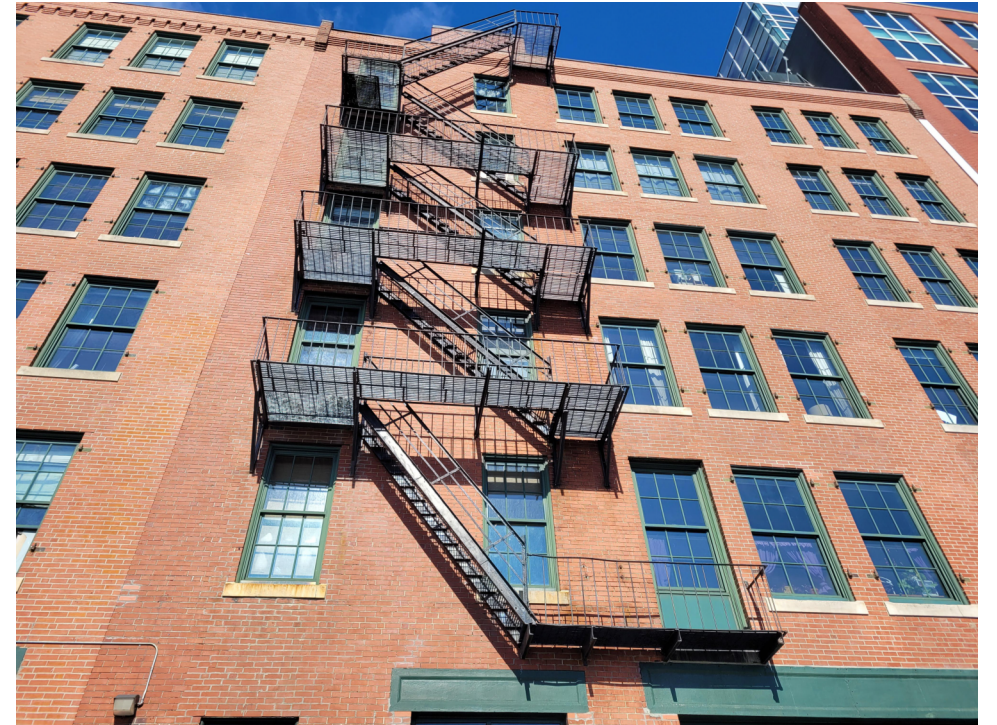
BACK ELEVATION - MEDALLION AVE
EXISTING FIRE ESCAPE B (BETWEEN COLUMN LINES 9 AND 10)
SEE SHEET A-203

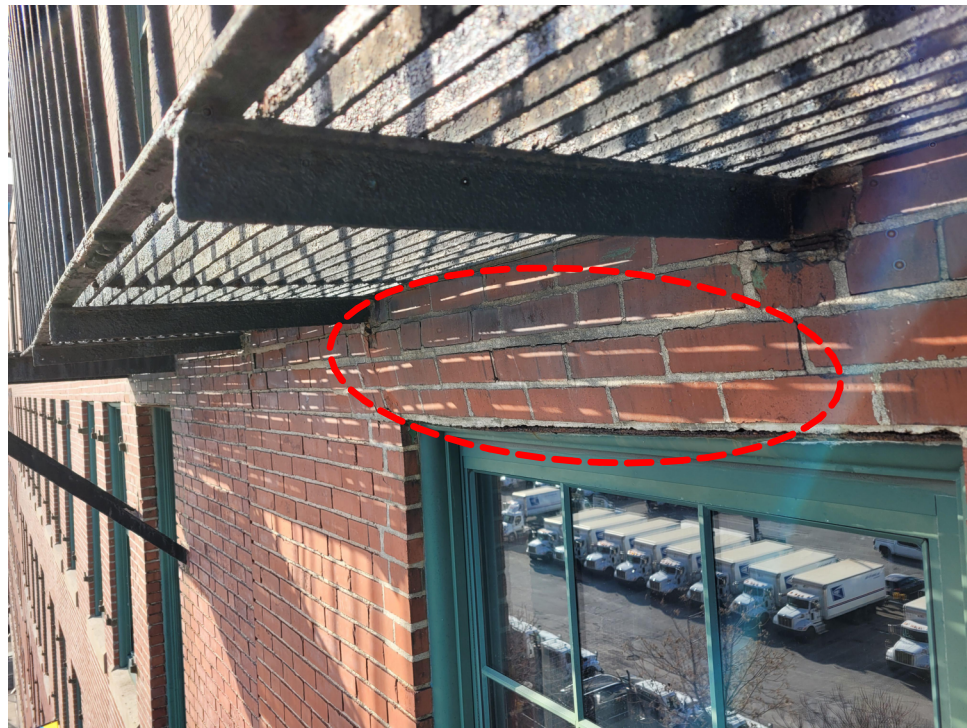
BULGING BRICK AROUND THE WINDOW LINTEL. PORTION OF THE FIRE ESCAPE LANDING IS BEING SUPPORTED BY THIS DETERIORATED SOLID MASONRY WALL AREA.

THESE REPRESENT THE MORE SEVERE DAMAGES THAT ARE OCCURRING AROUND THE FIRE ESCAPES. THERE HAS BEEN A SIGNIFICANT DISPLACEMENT OF THE OUTER BRICK WITH THE ABOVE ONE WINDOW SITUATED BENEATH ONE OF THE EXISTING FIRE ESCAPES, RESULTING IN THE DISLODGEMENT OF SIZEABLE MORTAR JOINT SECTIONS FROM THE WALL. THIS ISSUE IS MIRRORED IN THE ADJACENT TWO WINDOWS, WHERE SIMILAR MASONRY DETERIORATION AND DISPLACEMENT ARE EVIDENT.

* FOR REPAIR DETAILS AND SPECIFICATIONS ON MATERIALS, SEE CONSTRUCTION DRAWINGS AND SPECIFICATIONS.

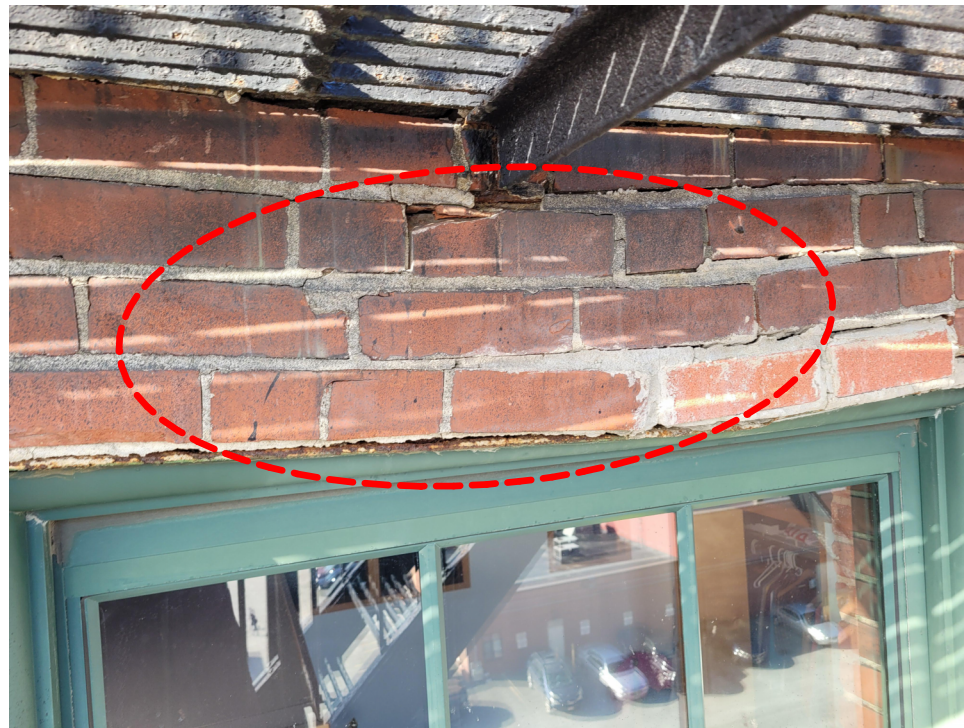
BRICK DISPLACEMENT AROUND THE WINDOW LINTEL. PORTION OF THE FIRE ESCAPE LANDING IS BEING SUPPORTED BY THIS DETERIORATED SOLID MASONRY WALL AREA.

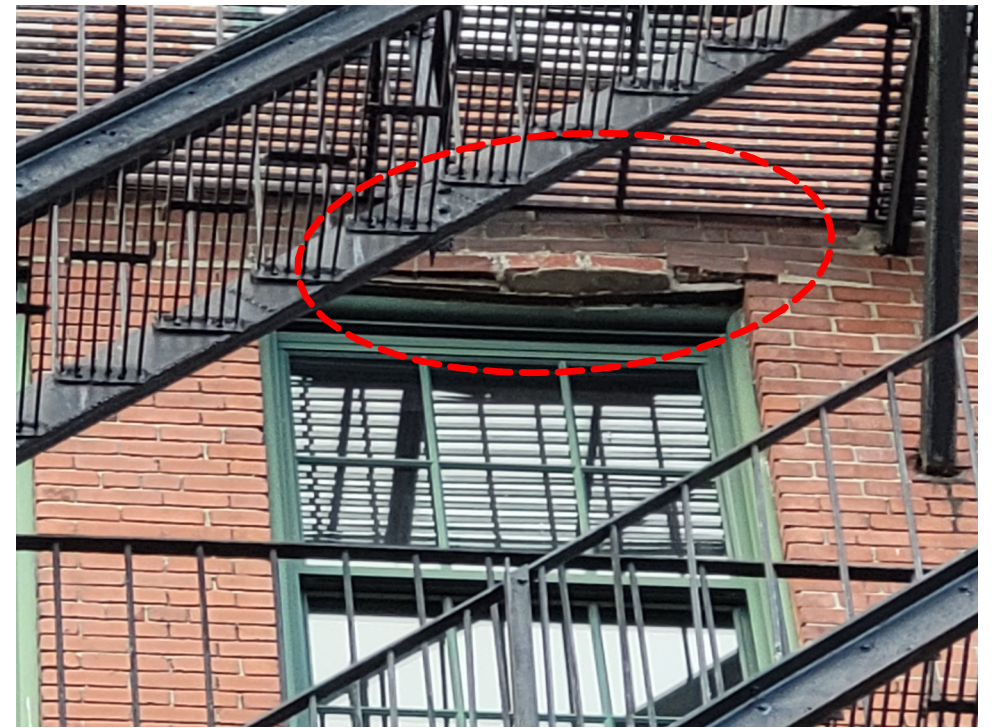
SIGNIFICANT MOVEMENT OF THE BRICK AROUND THE WINDOW LINTEL. PORTION OF THE FIRE ESCAPE LANDING IS BEING SUPPORTED BY THIS DETERIORATED SOLID MASONRY WALL AREA.

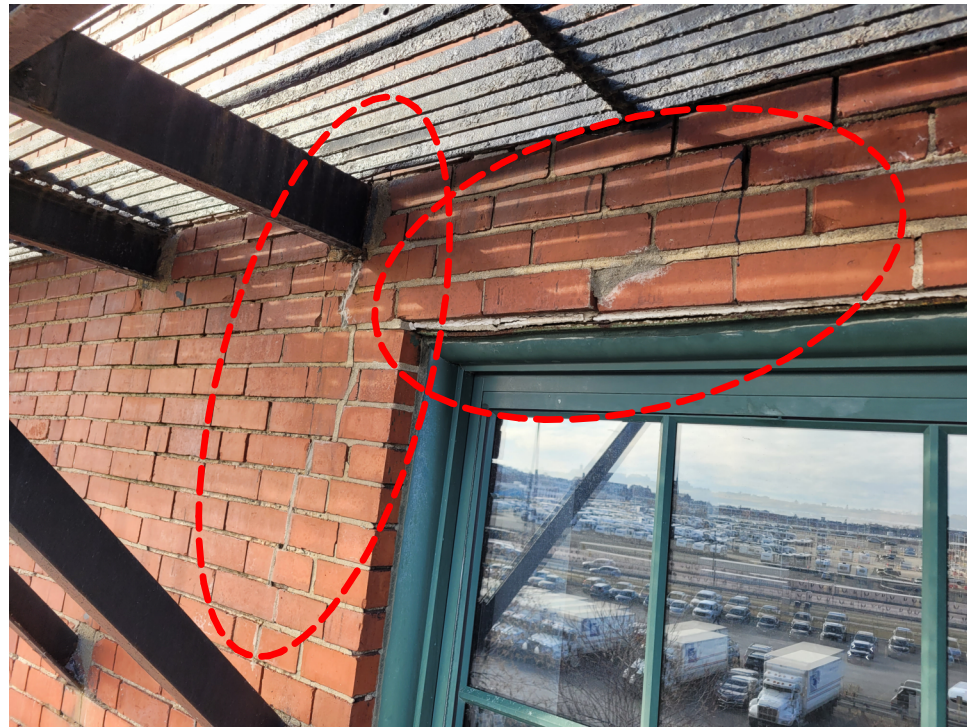
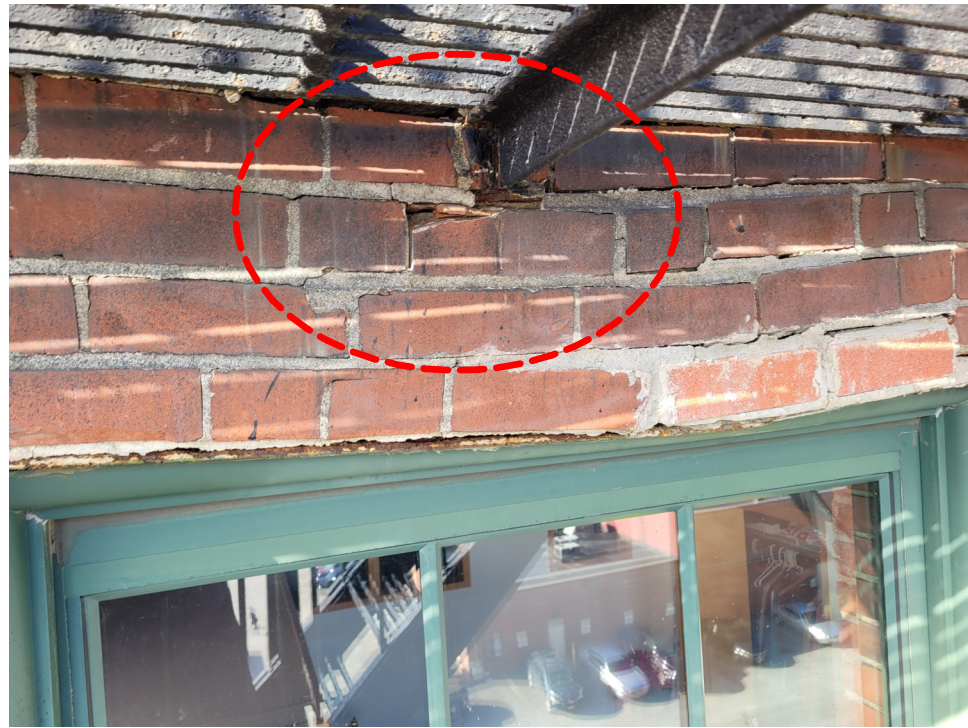
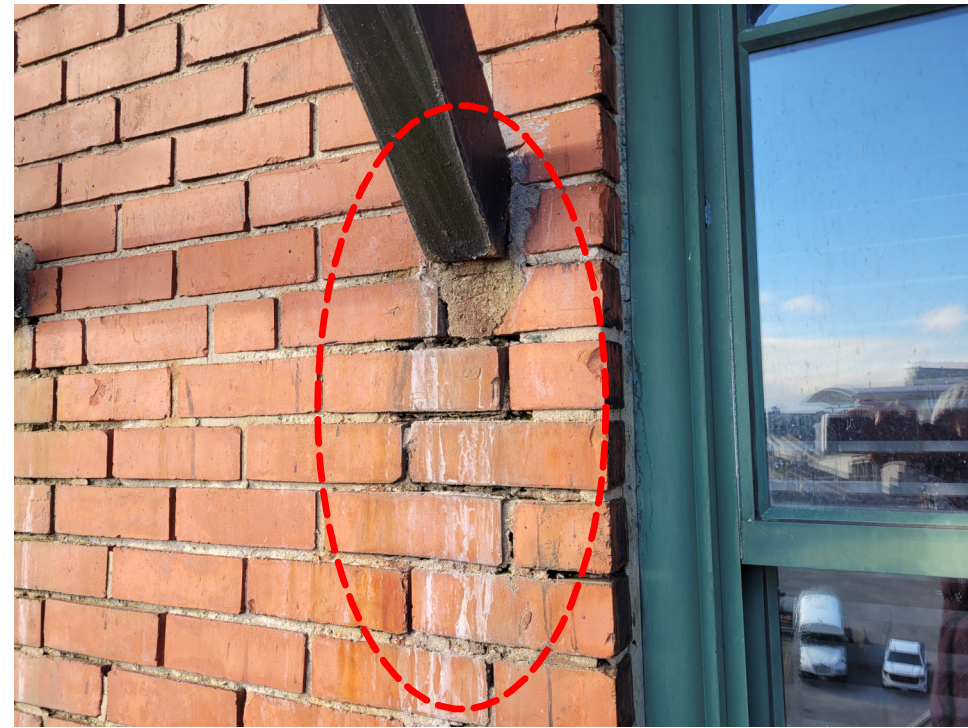
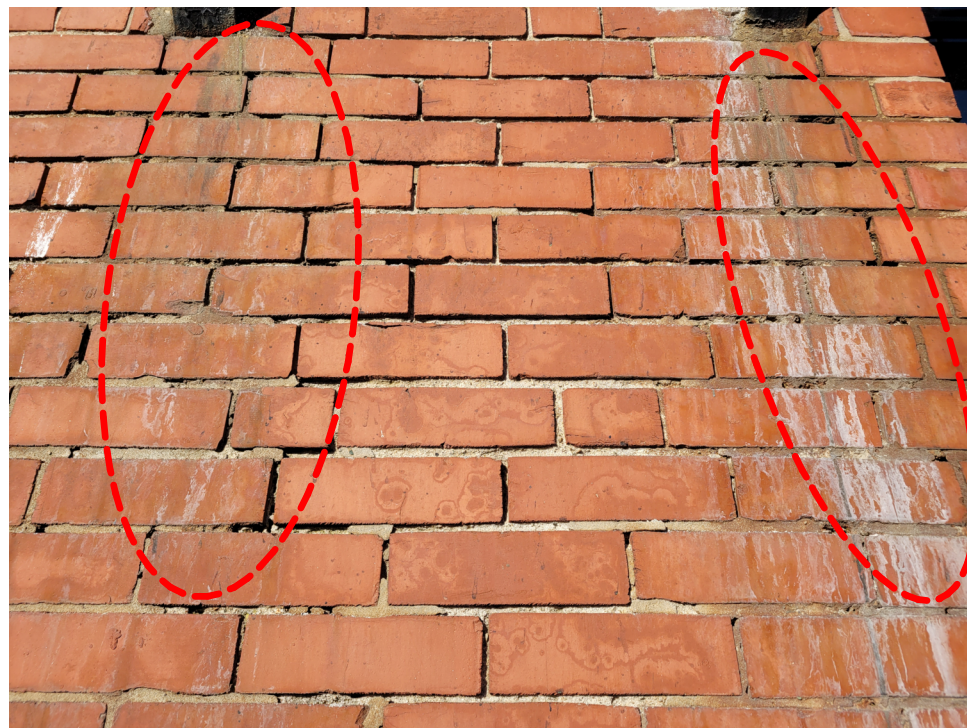
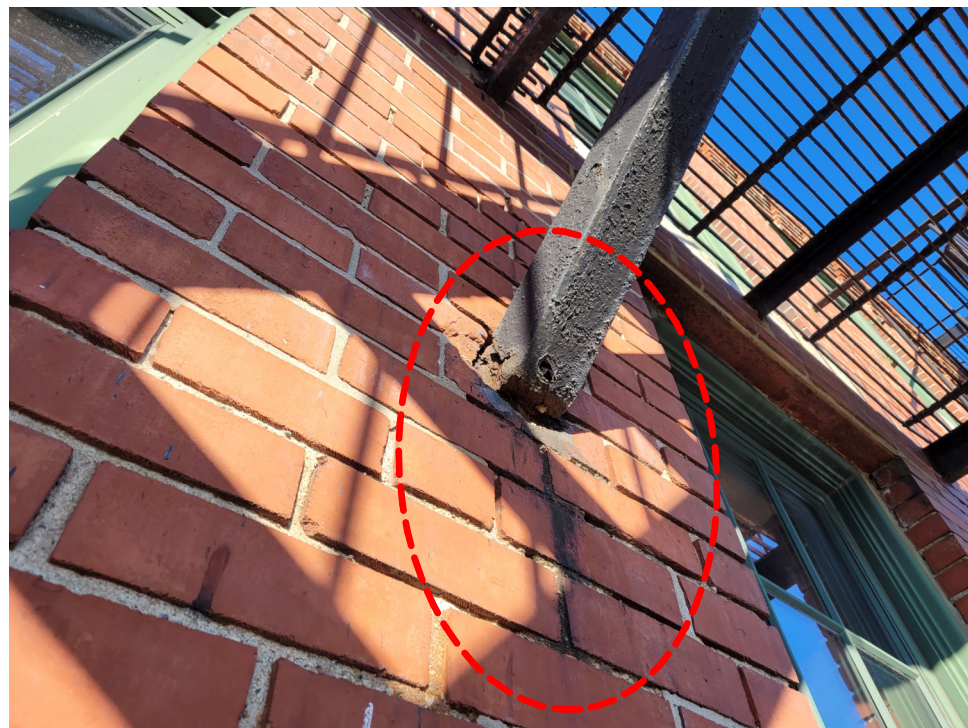
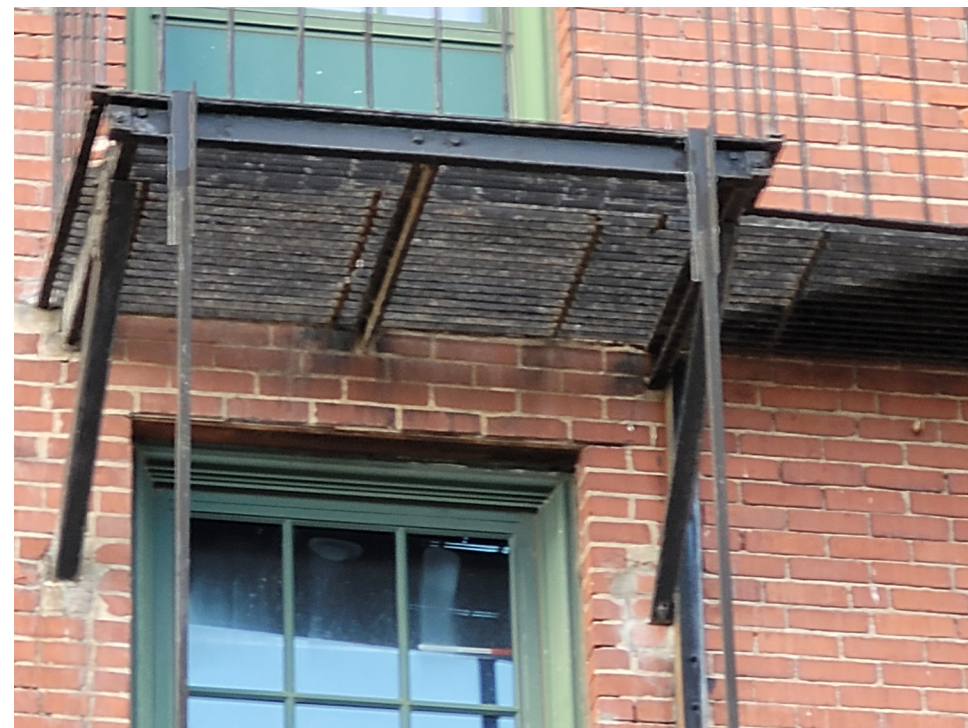
THESE PHOTOS ALSO DEPICT ADDITIONAL DAMAGES OCCURRING ON THE MASONRY WALL SURROUNDING THE FIRE ESCAPES. MULTIPLE CRACKS HAVE BEEN OBSERVED, PRIMARILY ATTRIBUTED TO THE DETERIORATED CONDITION OF THE FIRE ESCAPE COMPONENTS. THESE IMAGES ALSO REVEAL STAINS RESULTING FROM WATER RUNOFF ON THE WALLS FROM THE FIRE ESCAPES, SHOWCASING THE ADVERSE IMPACT ON THE DURABILITY OF BOTH THE MASONRY AND MORTAR JOINTS

FOR REPAIR DETAILS AND SPECIFICATIONS ON MATERIALS, SEE CONTRUTION DRAWINGS AND SPECIFICATIONS. ALL MATERIALS WILL MATCH EXISTING.
