16-18 & 22 GARDNER ST.

Structural Investigation Report

16-18 Gardner St, Boston, MA 02119

Prepared by
**SurfZone Engineering
Consultants LLC**
August 21, 2023

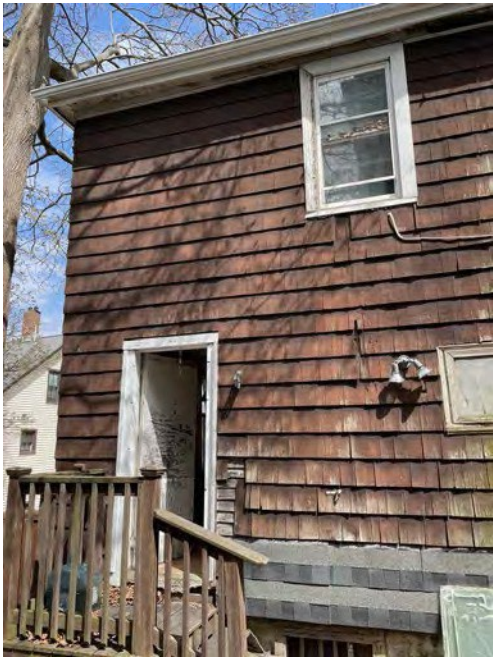
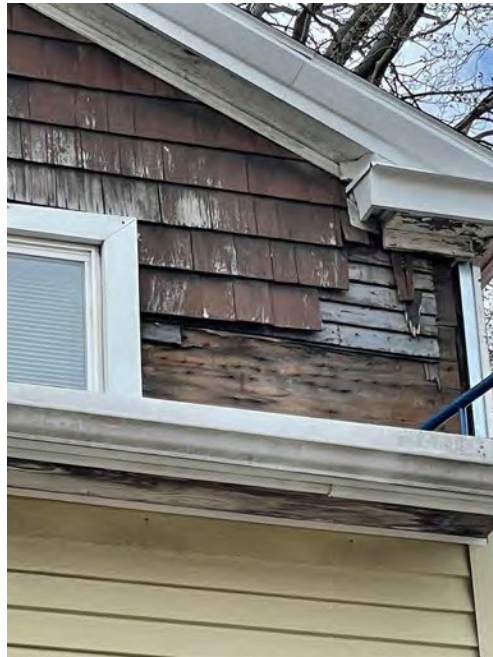
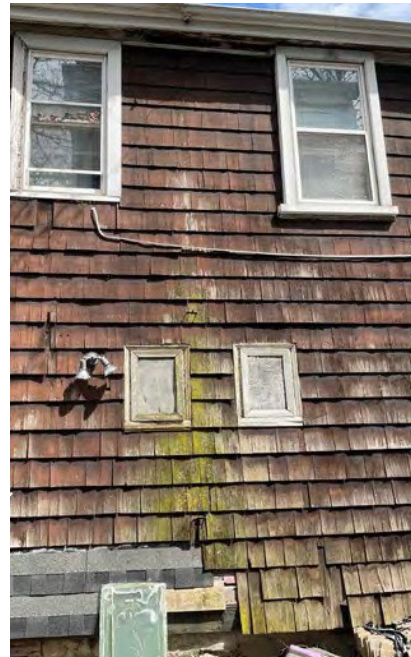
Exterior

The building's exterior conditions exhibit failing materials. The wood deck, soffits, and trims are damaged, and the masonry shows signs of water leakage.

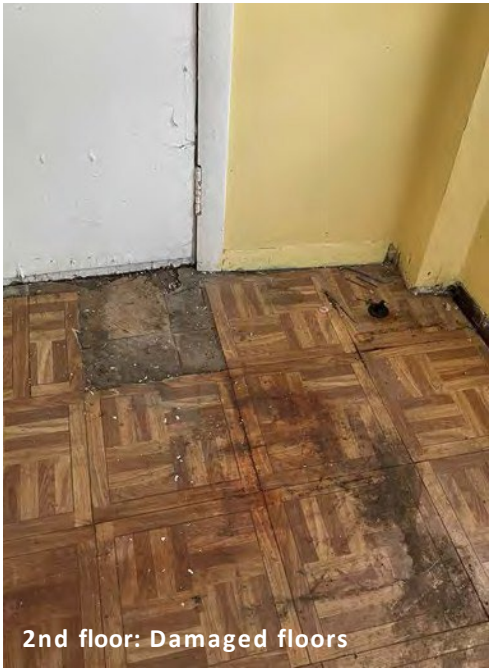
2nd floor: Damaged floors

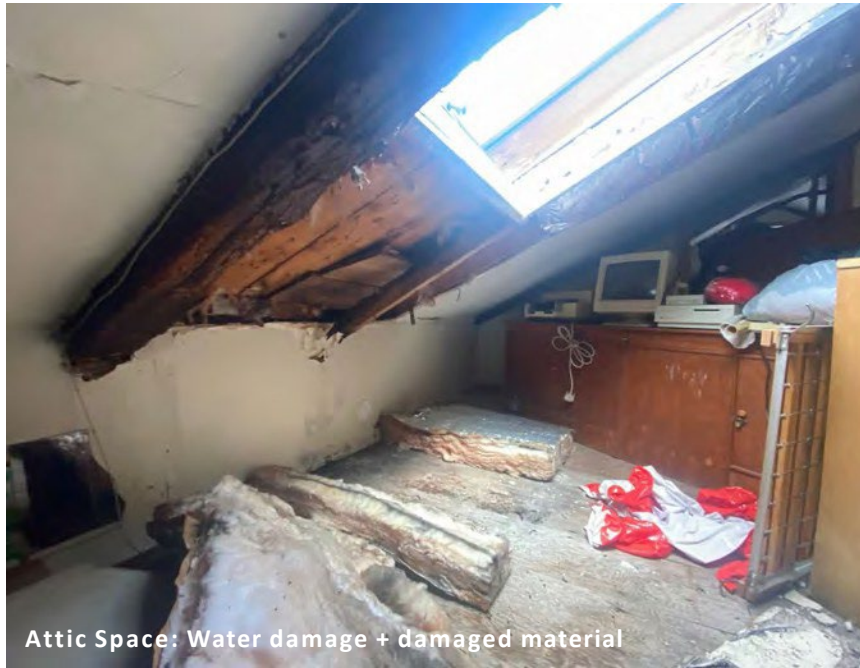
Attic Space: Water damage + damaged material

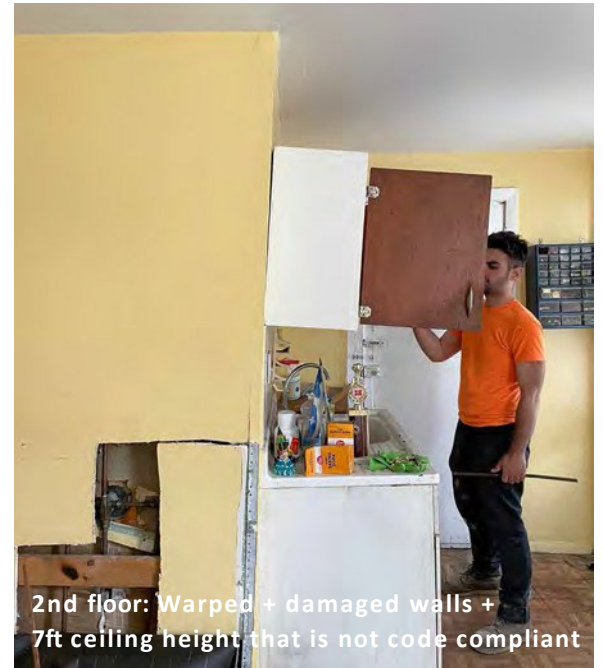
2nd floor: Warped + damaged walls + 7ft ceiling height that is not code compliant

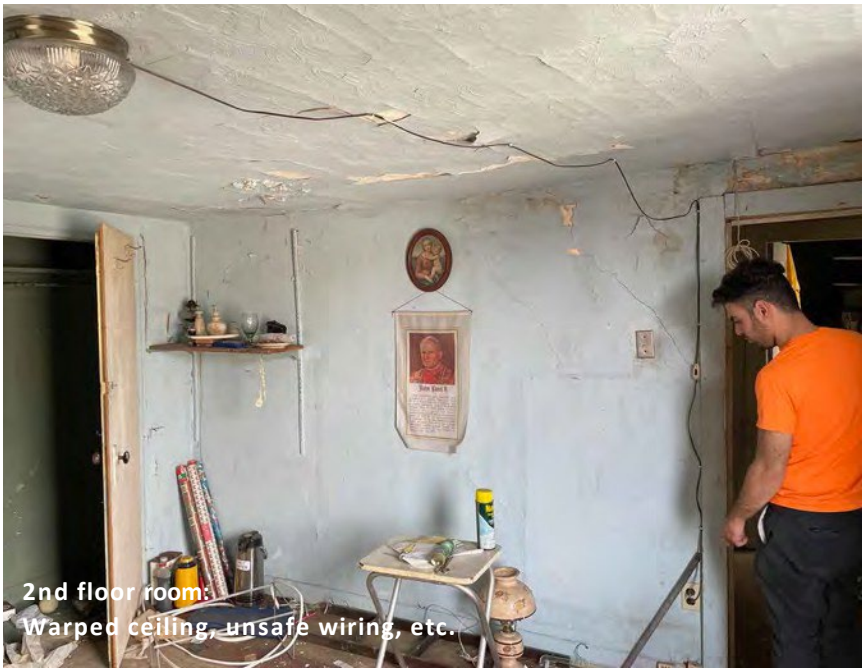
2nd floor room: Warped ceiling, unsafe wiring, etc.

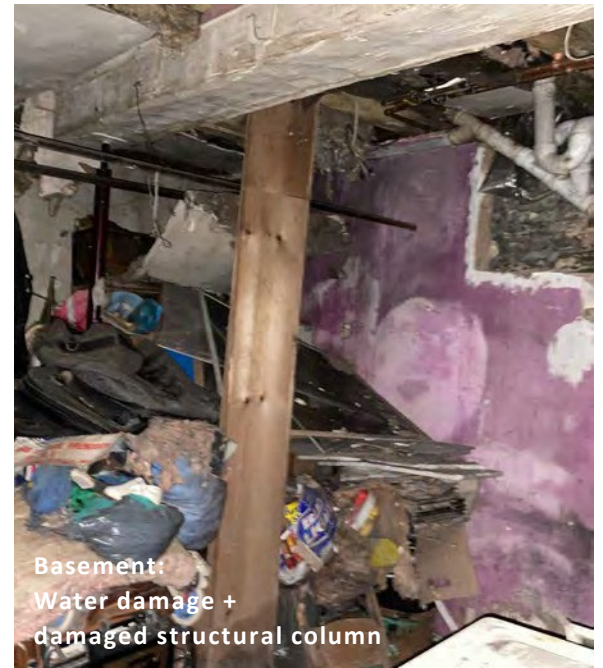
Basement: Water damage + damaged structural column

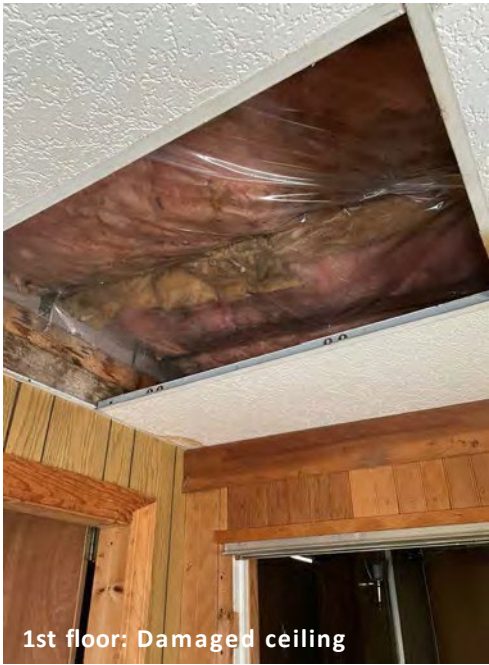
1st floor: Damaged ceiling

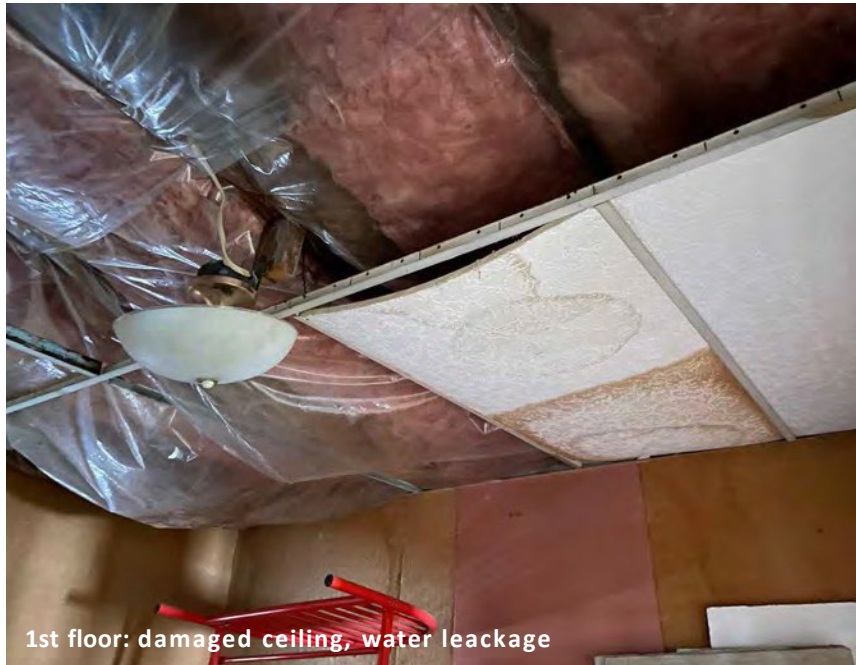
1st floor: damaged ceiling, water leakage

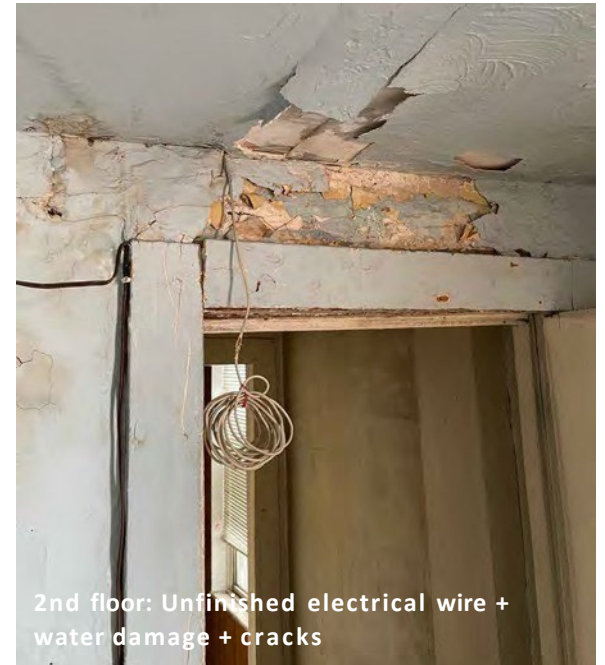
2nd floor: Unfinished electrical wire + water damage + cracks

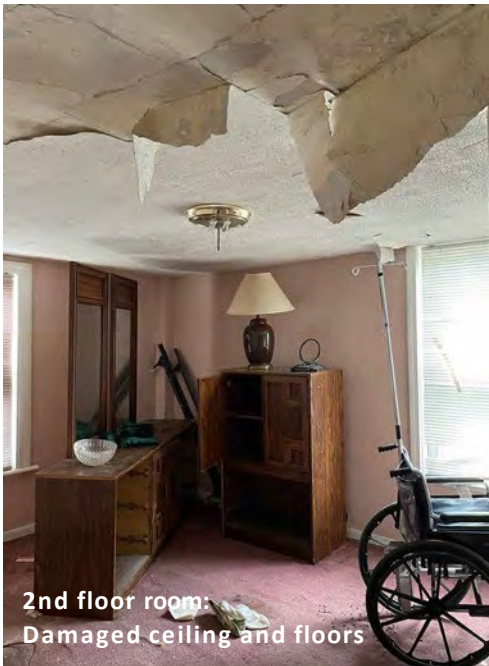
2nd floor room:
Damaged ceiling and floors

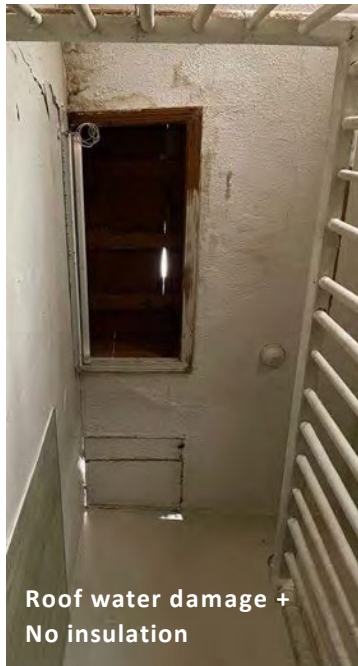
Roof water damage +
No insulation

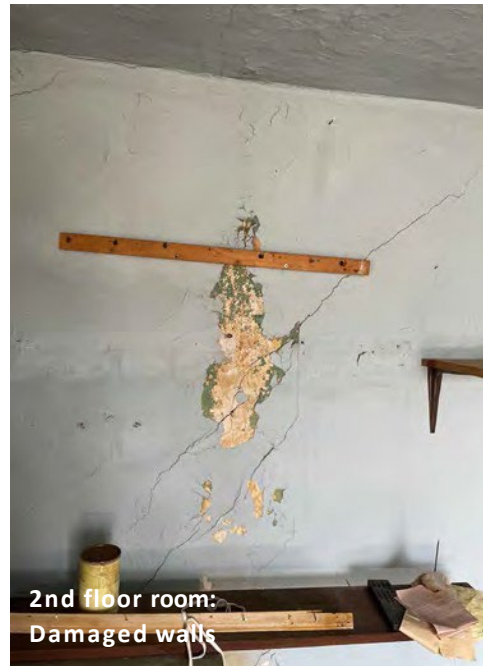
2nd floor room:
Damaged walls

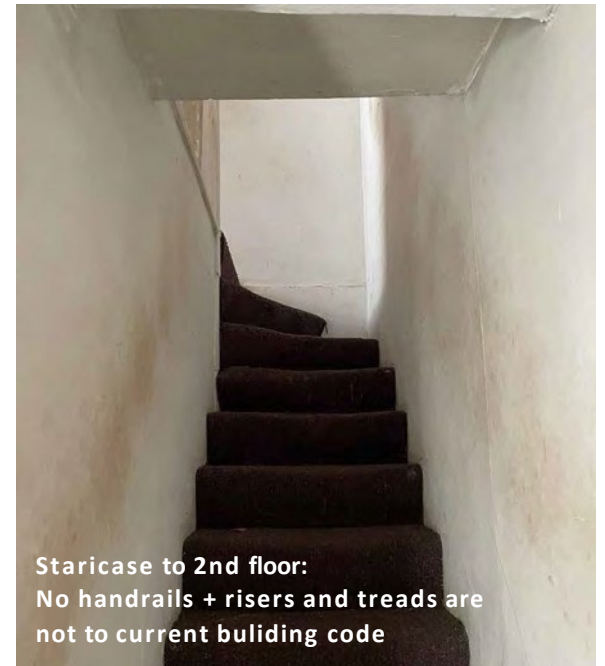
Staircase to 2nd floor:
No handrails + risers and treads are
not to current building code

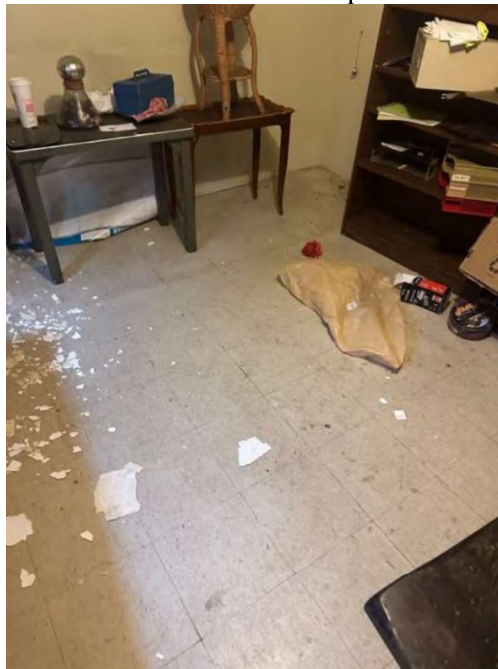
1. There is a significant slope (4-6 inches over the 10') on the first-floor living room. The ceiling height is 7' and the has a noticeable slope toward the center of the house.

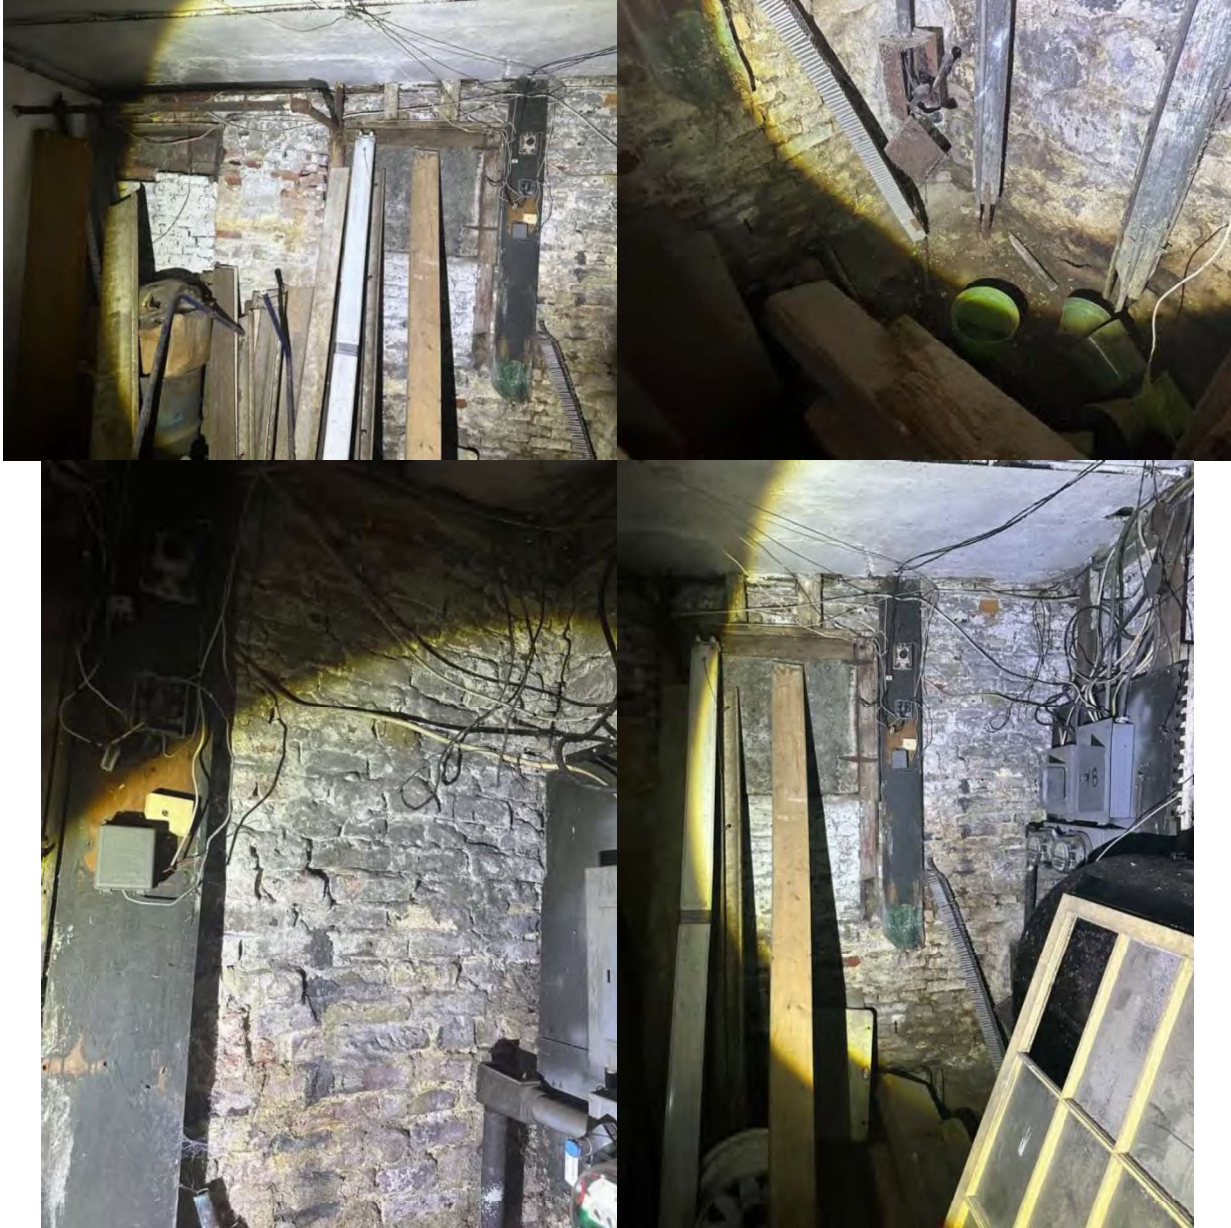
2. The stairs from the unit to the basement are not up-to-code with approximately 5' clearance and are not safe.
3. The brick foundation wall on the right side of the building is crumbling and has structural bulged, cracked, and needs to be replaced.

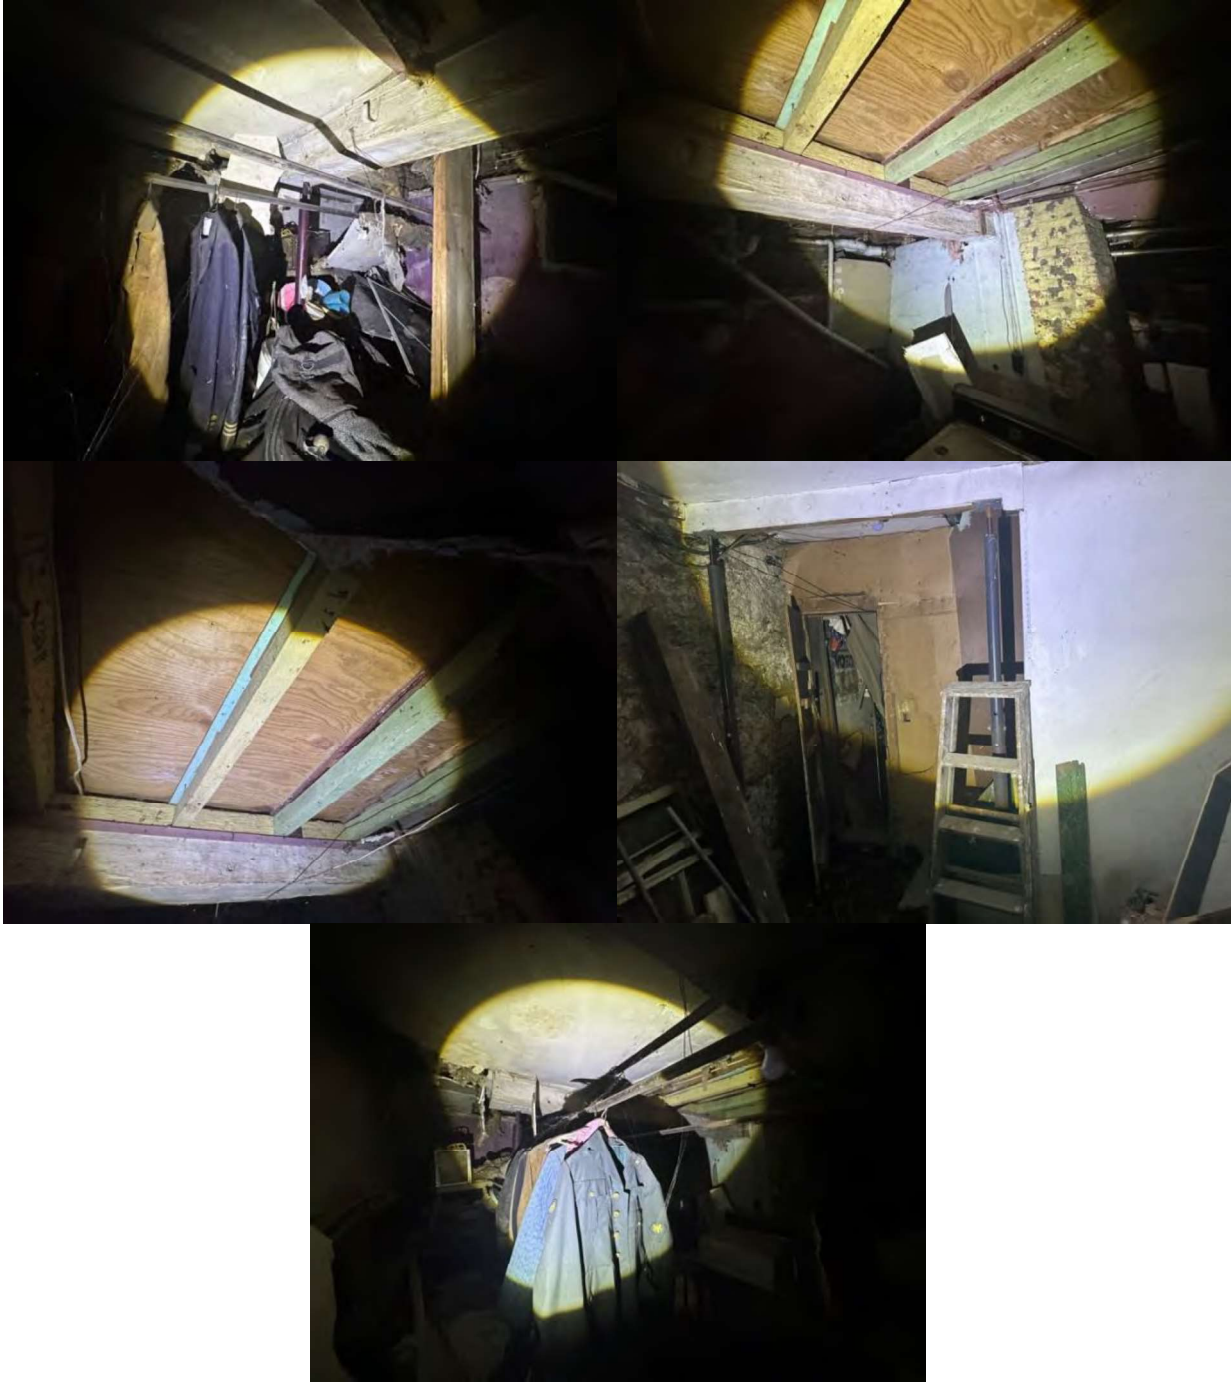
5. The main beam in the basement supporting the first-floor framing system is not properly supported and is not structurally sound. This beam is significantly slanted, cracked, and sits on a temporary screw jack. Screw jacks do not have any footing and are not permanent support. The beam end is cut at one side and floats. This beam needs to be replaced with an engineered beam to be installed on lally columns (on designed footings). The floor joists are 3x4 @ 2' spacing, are undersized for the span, and need to be reinforced.

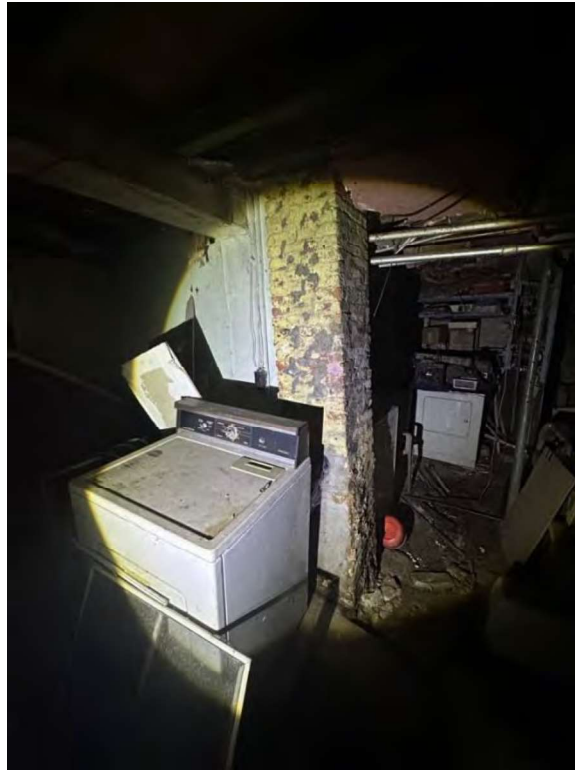
6. The chimney is significantly tilted (approximately 3" over 7 ft) and is compromised. This chimney needs to be rebuilt and is not salvageable/repairable.

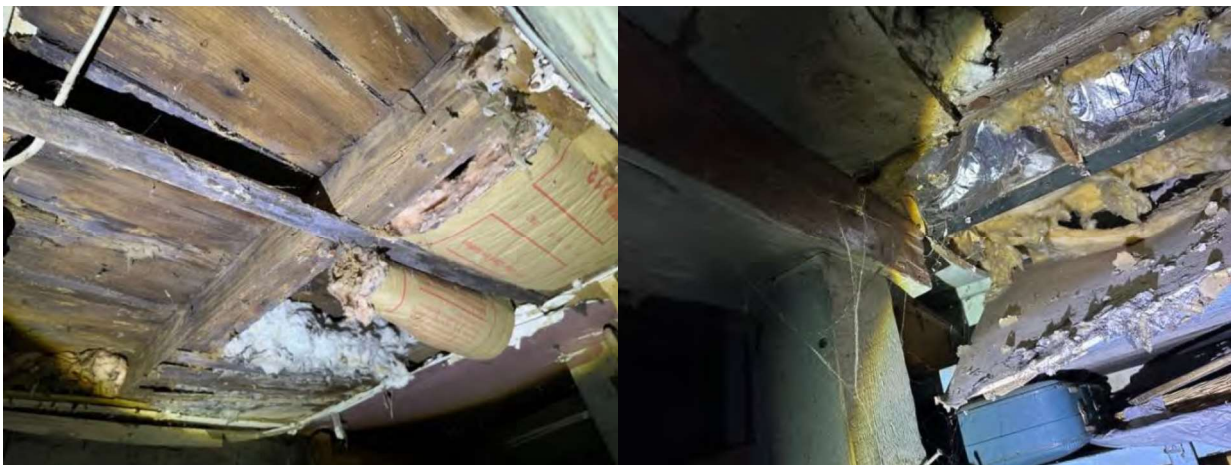
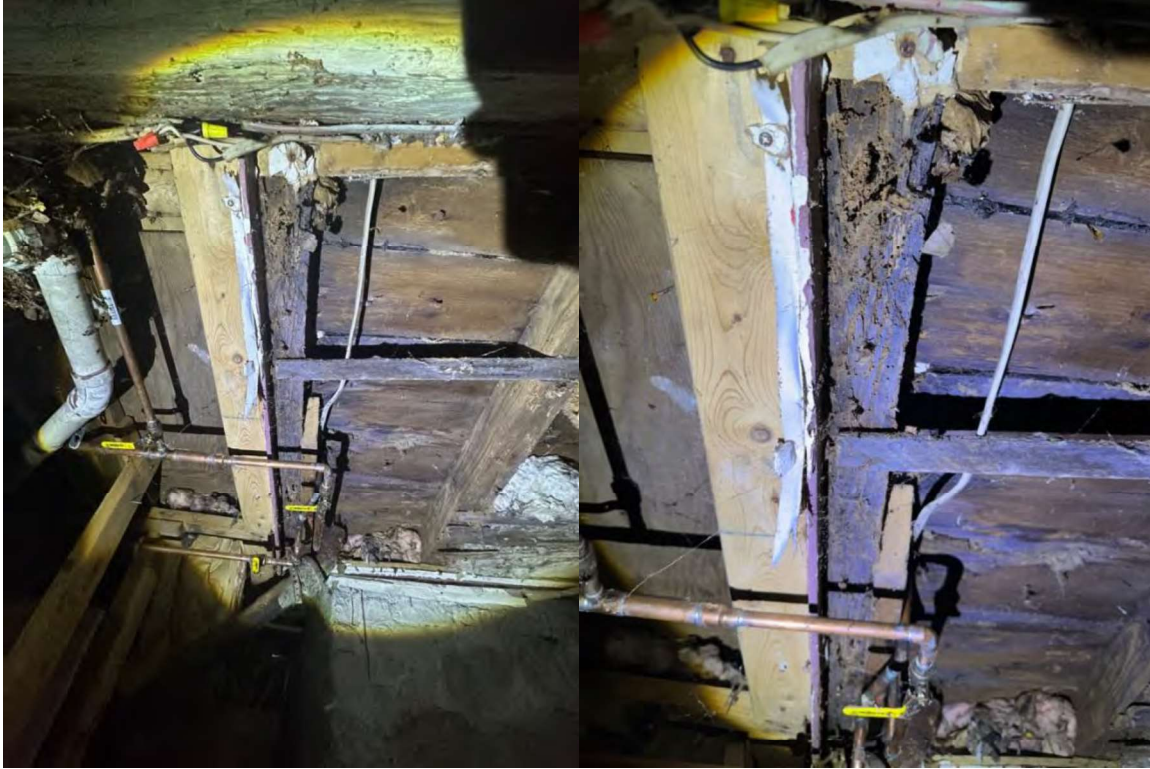
7. There are signs of severe boring insect damage on the floor framing on the southwest corner of the house. It is recommended to engage a qualified pest control contractor to inspect and treat as needed. The compromised members need to be completely replaced with designed members.

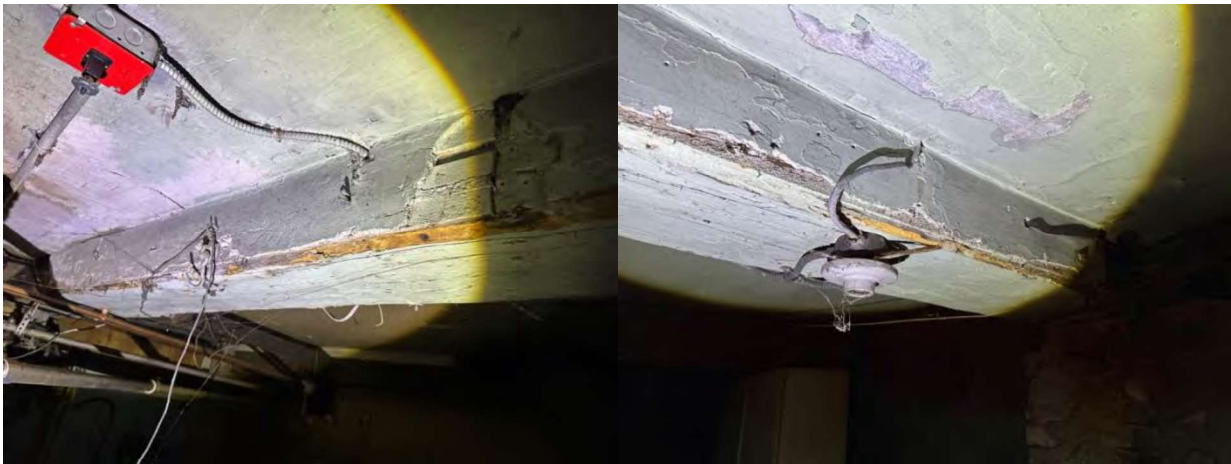
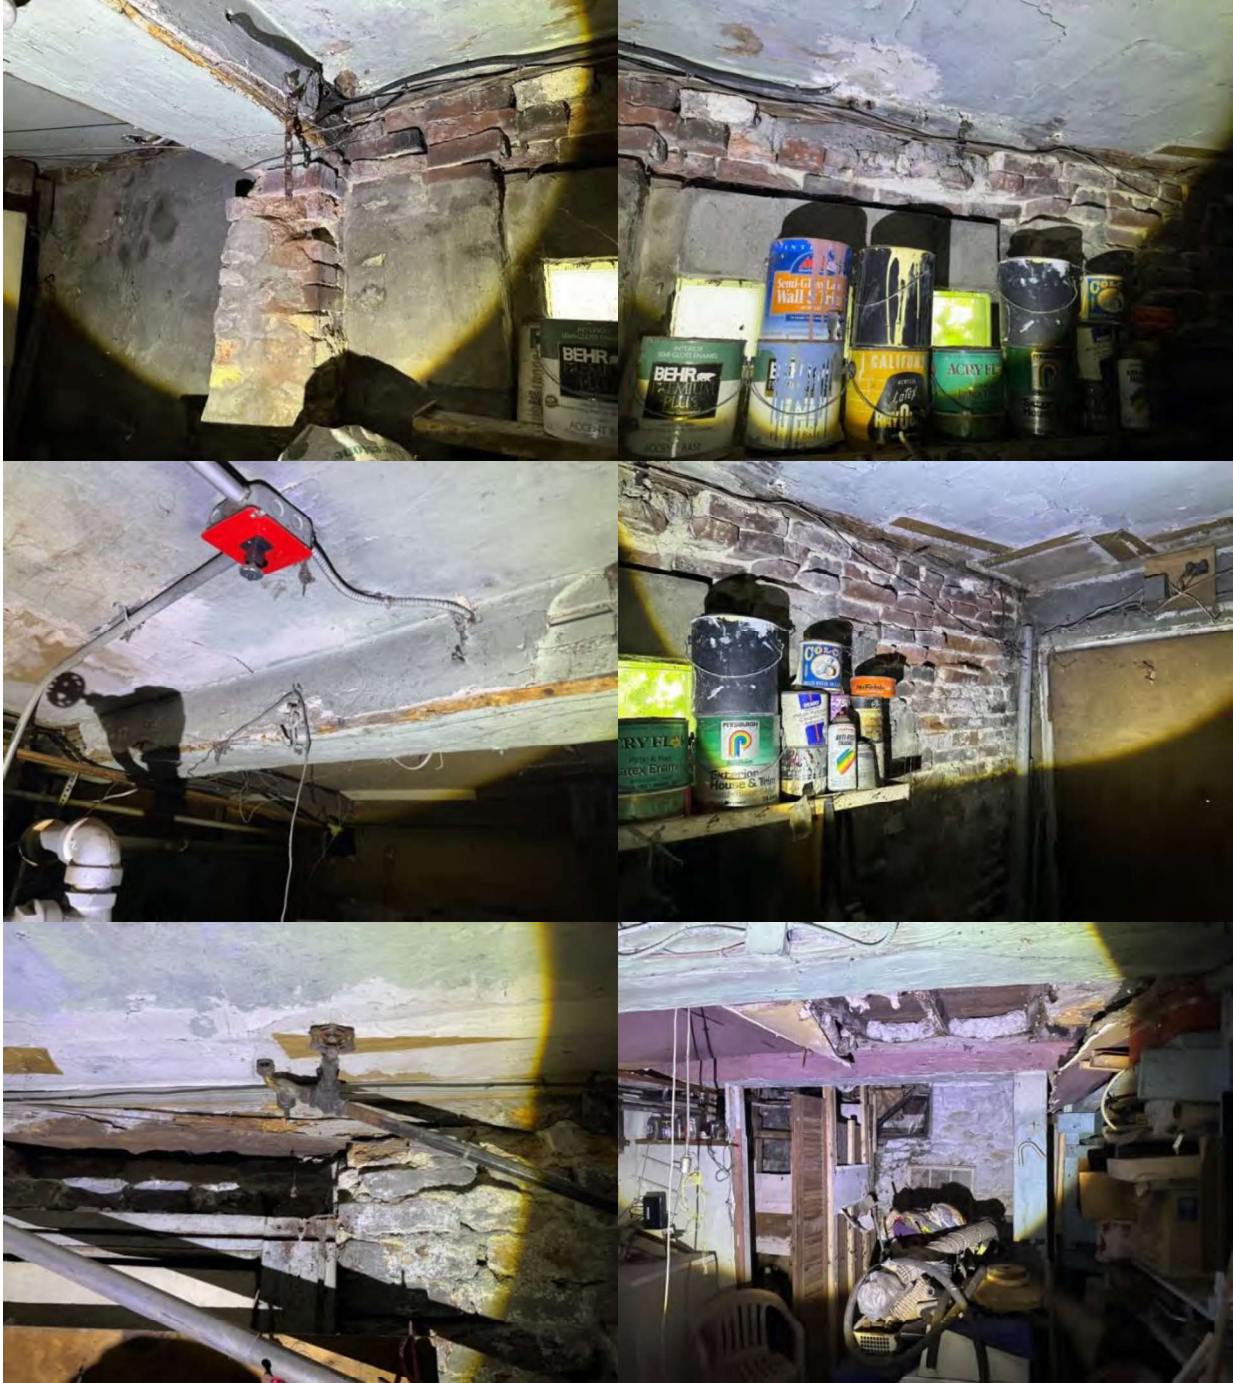
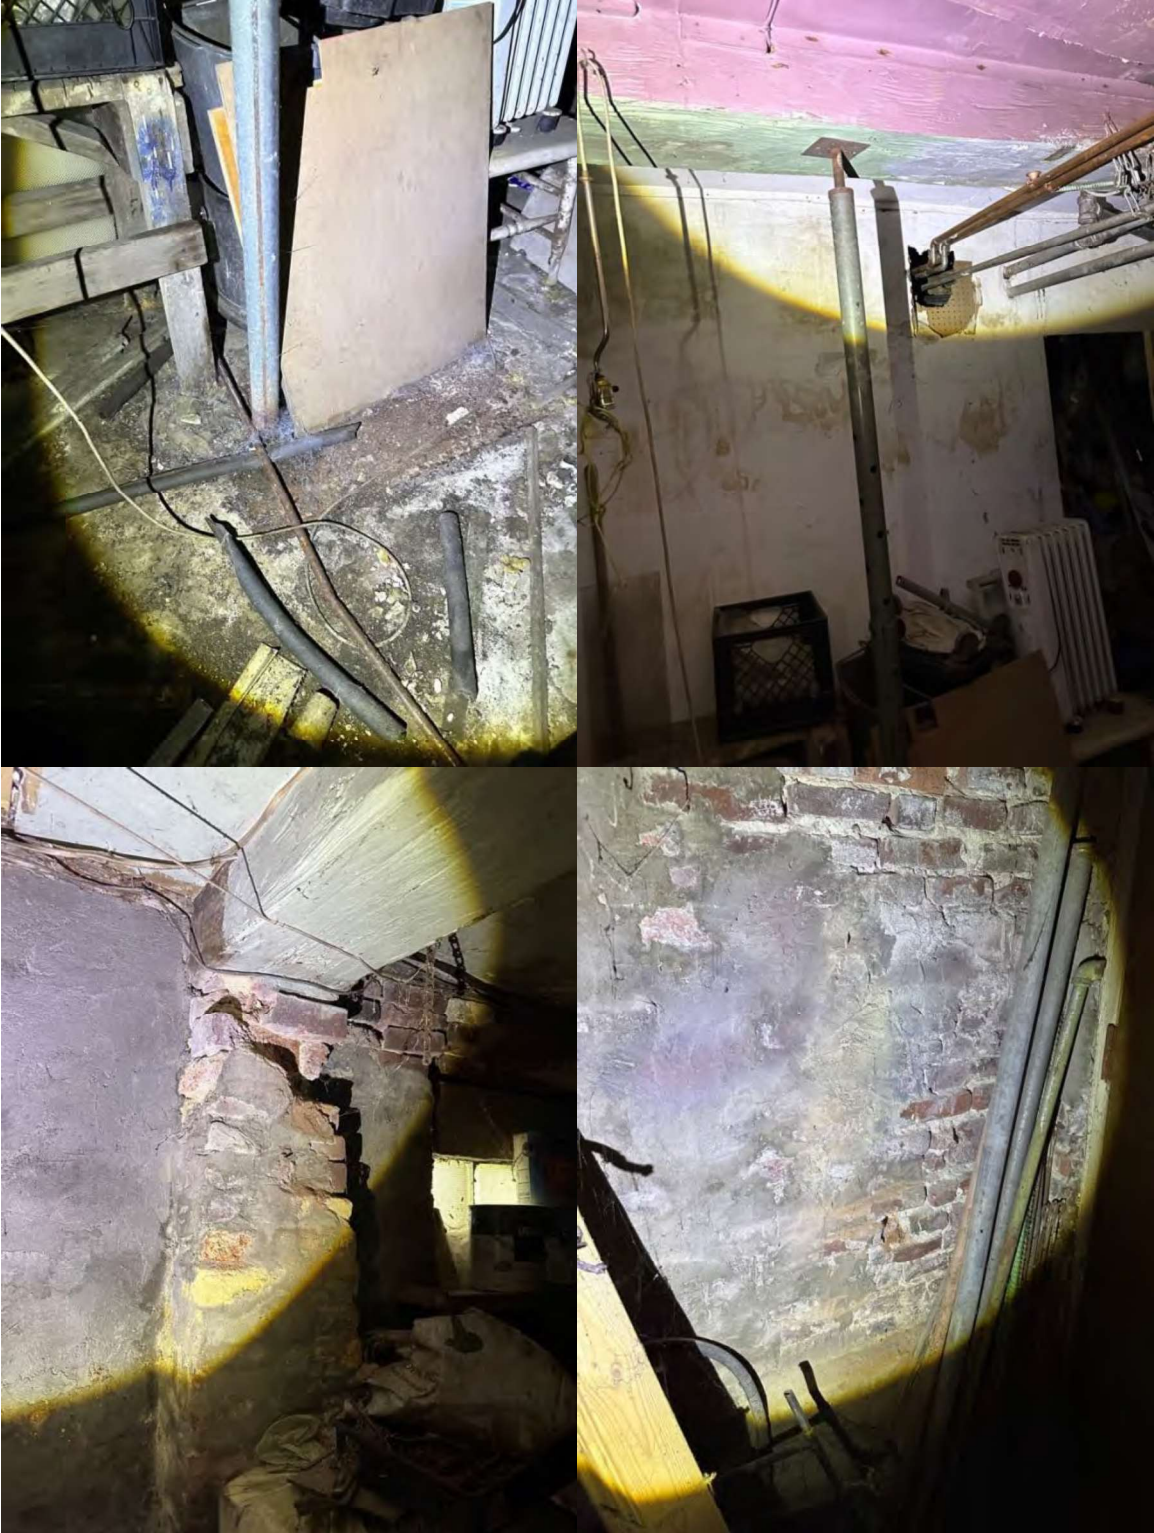
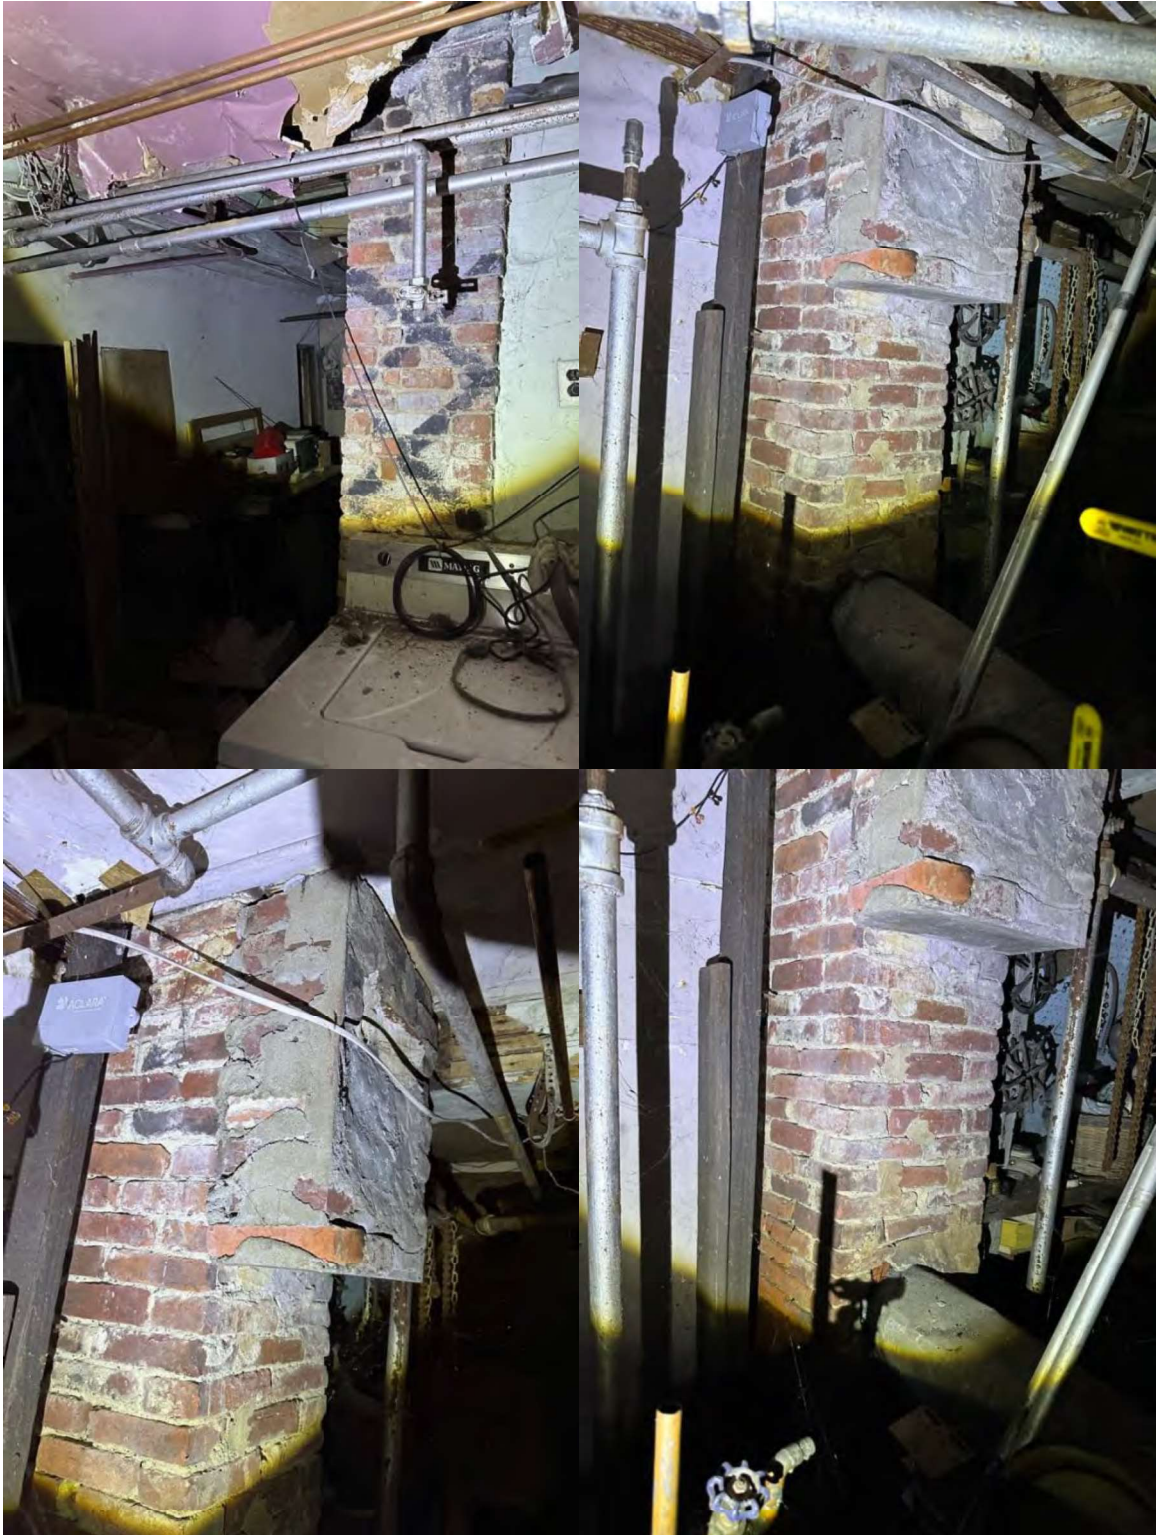
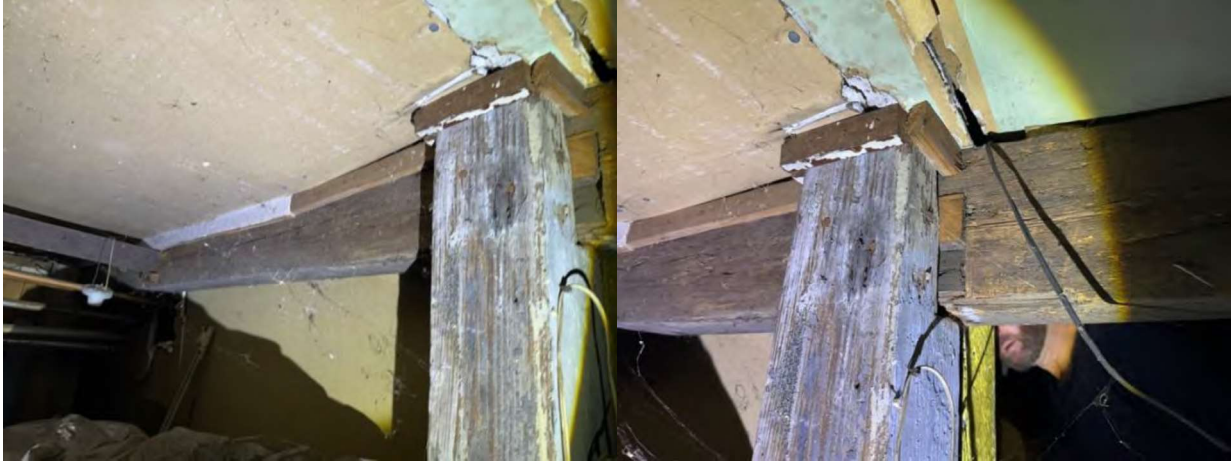
8. The two main beams supporting the other side of the house (northwest side – furnace room) are not structurally supported. One of the beams is supported by a compromised brick support at the end. This beam and the perimeter sill beam have signs of boring insect damage and need to be replaced. The existing floor framing is not safe to walk and needs temporary shoring before complete construction.

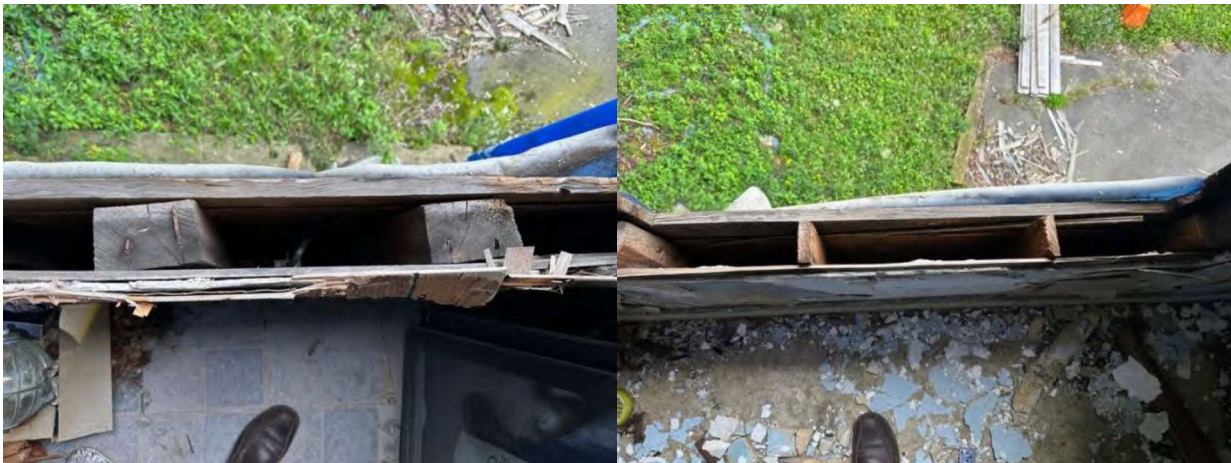
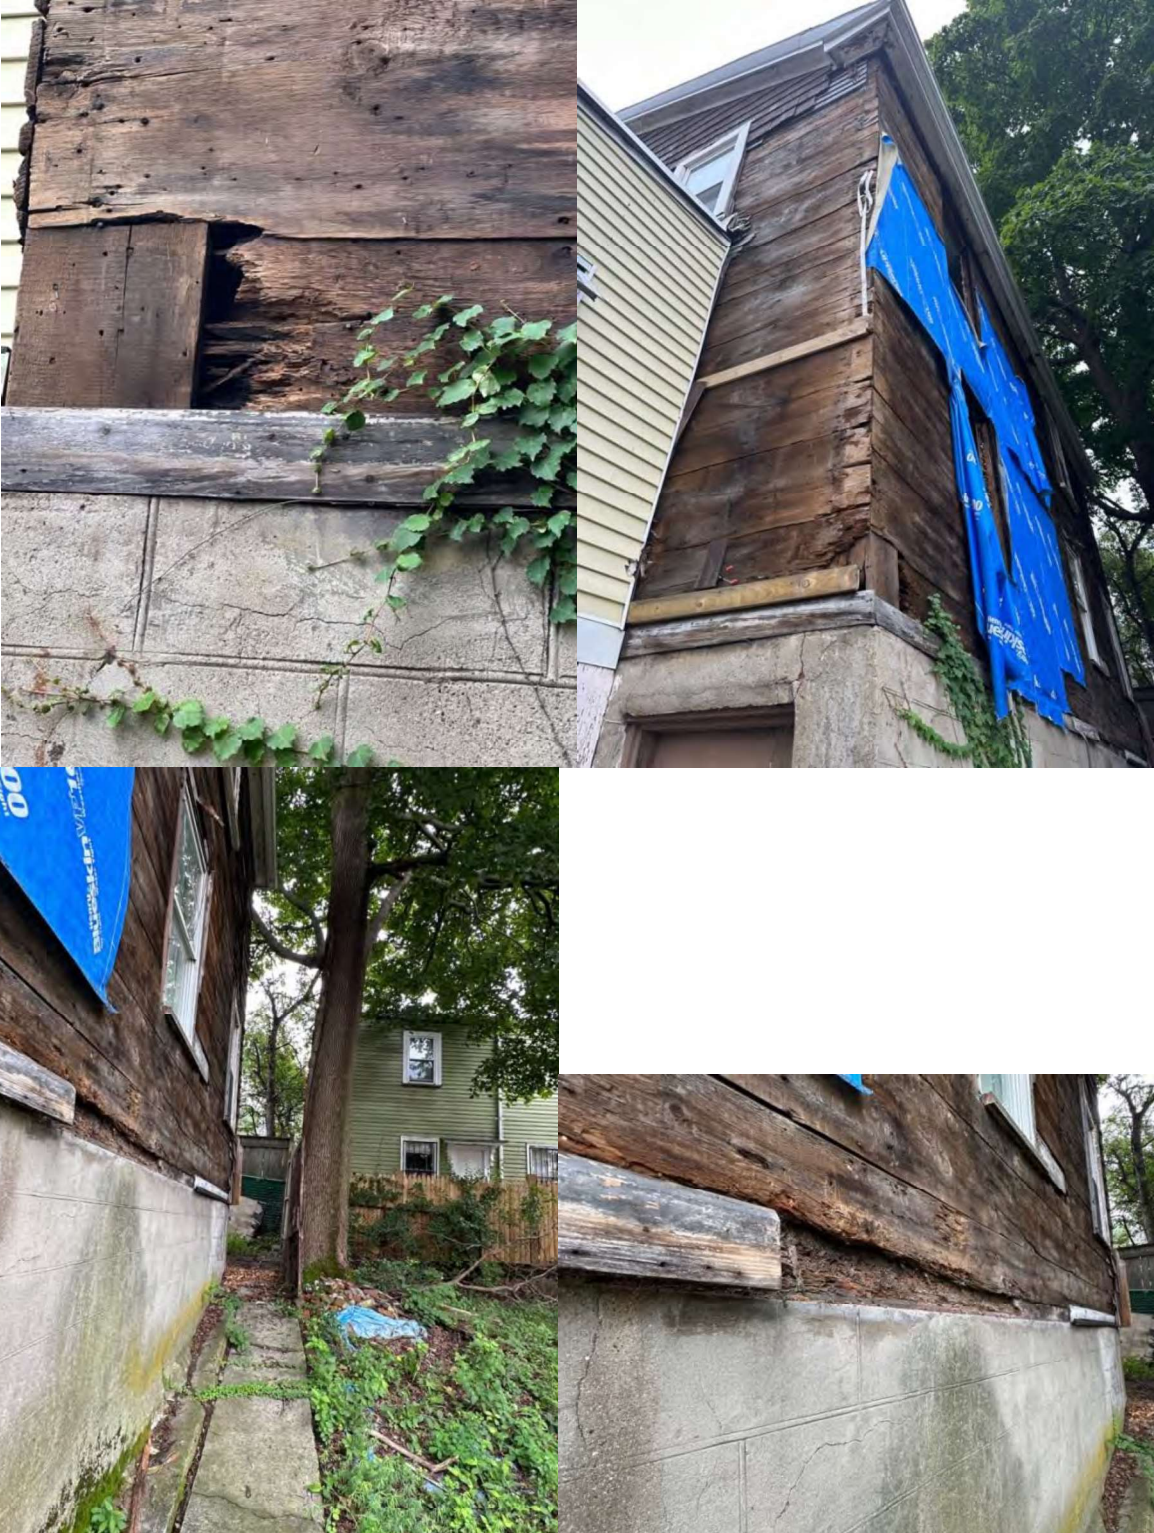
9. The Exterior wall framing exposed on the first and 2nd floor (right side looking from the front) shows a 3x4 stud on the flat. This exterior wall framing appears to be insufficient for insulation. The exterior wall studs on the 2nd floor are smaller (1" thick) and need to be reframed completely for lateral load-bearing strength. The exterior siding has signs of significant boring insects and needs to be completely redone.

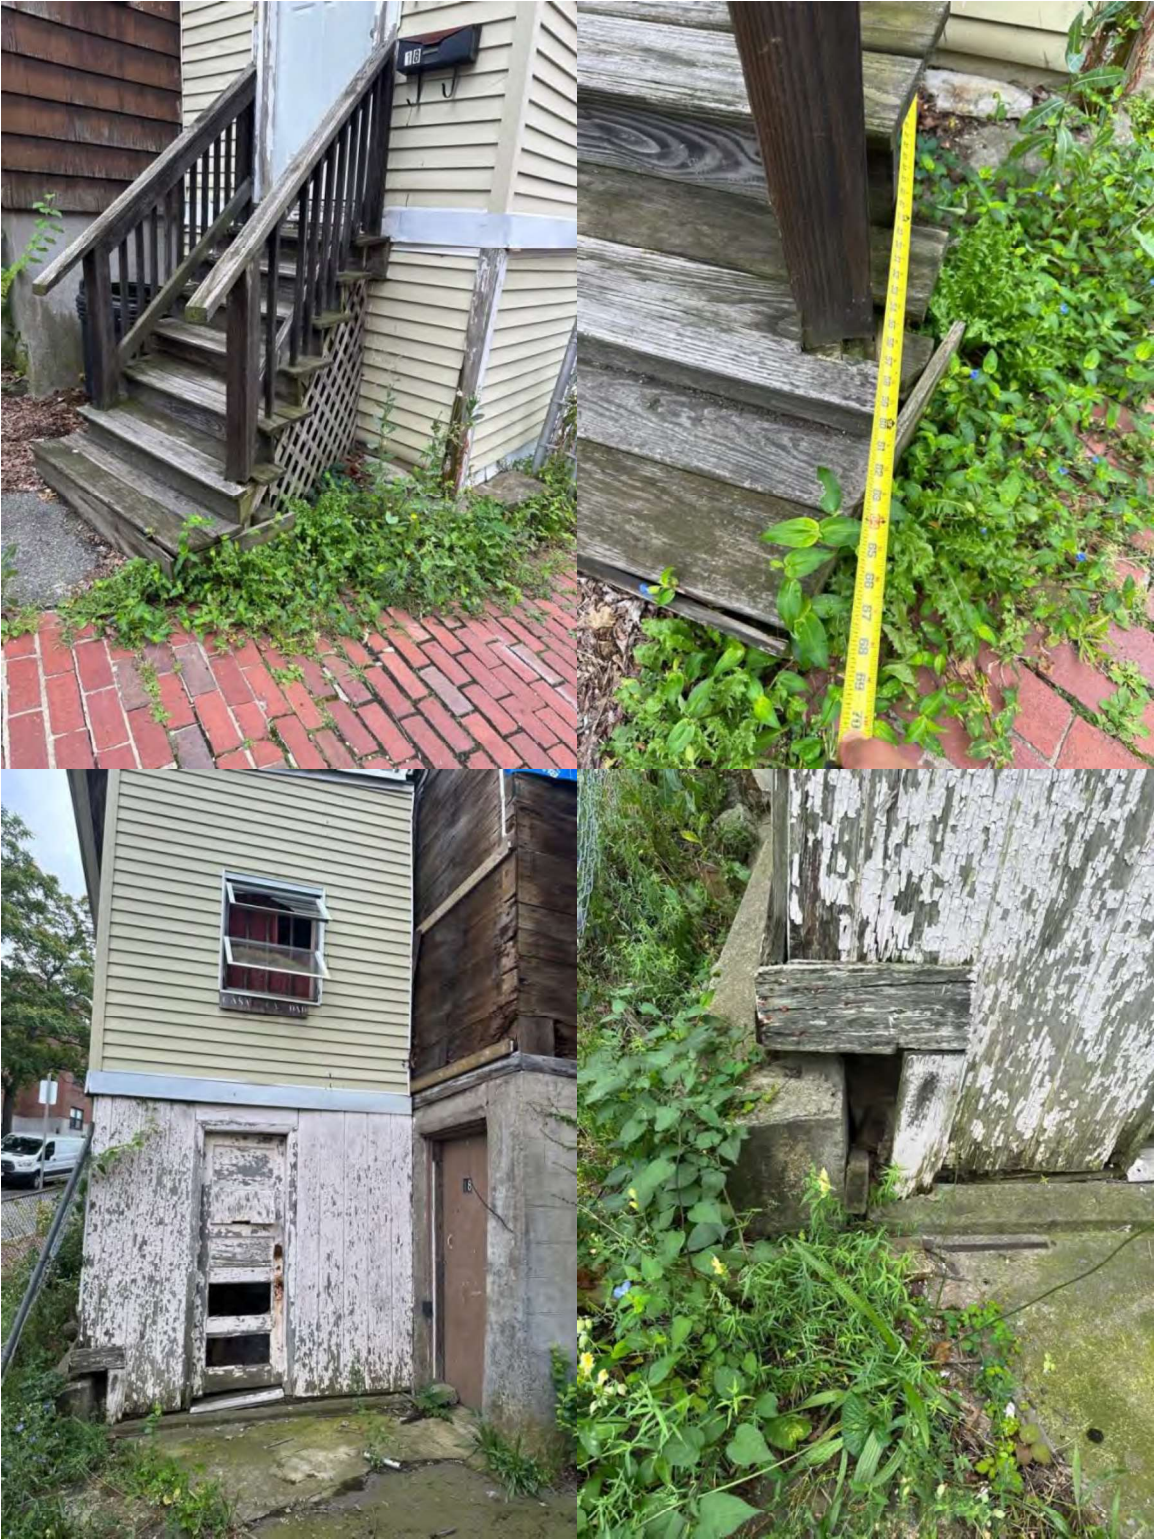
10. The attic was not safely accessible for inspection at the time of the visit.
11. The front addition appears to have not been built in a designed footing and the stairs are not up to code.
