**White Stadium
Boston, MA**

Tree Preservation Report

Andrew Balon
Arborist Representative
ISA Certified Arborist
ISA Tree Risk Assessment Qualified
50 Bear Hill Rd,
Waltham, MA 02451
(781) 622 5980

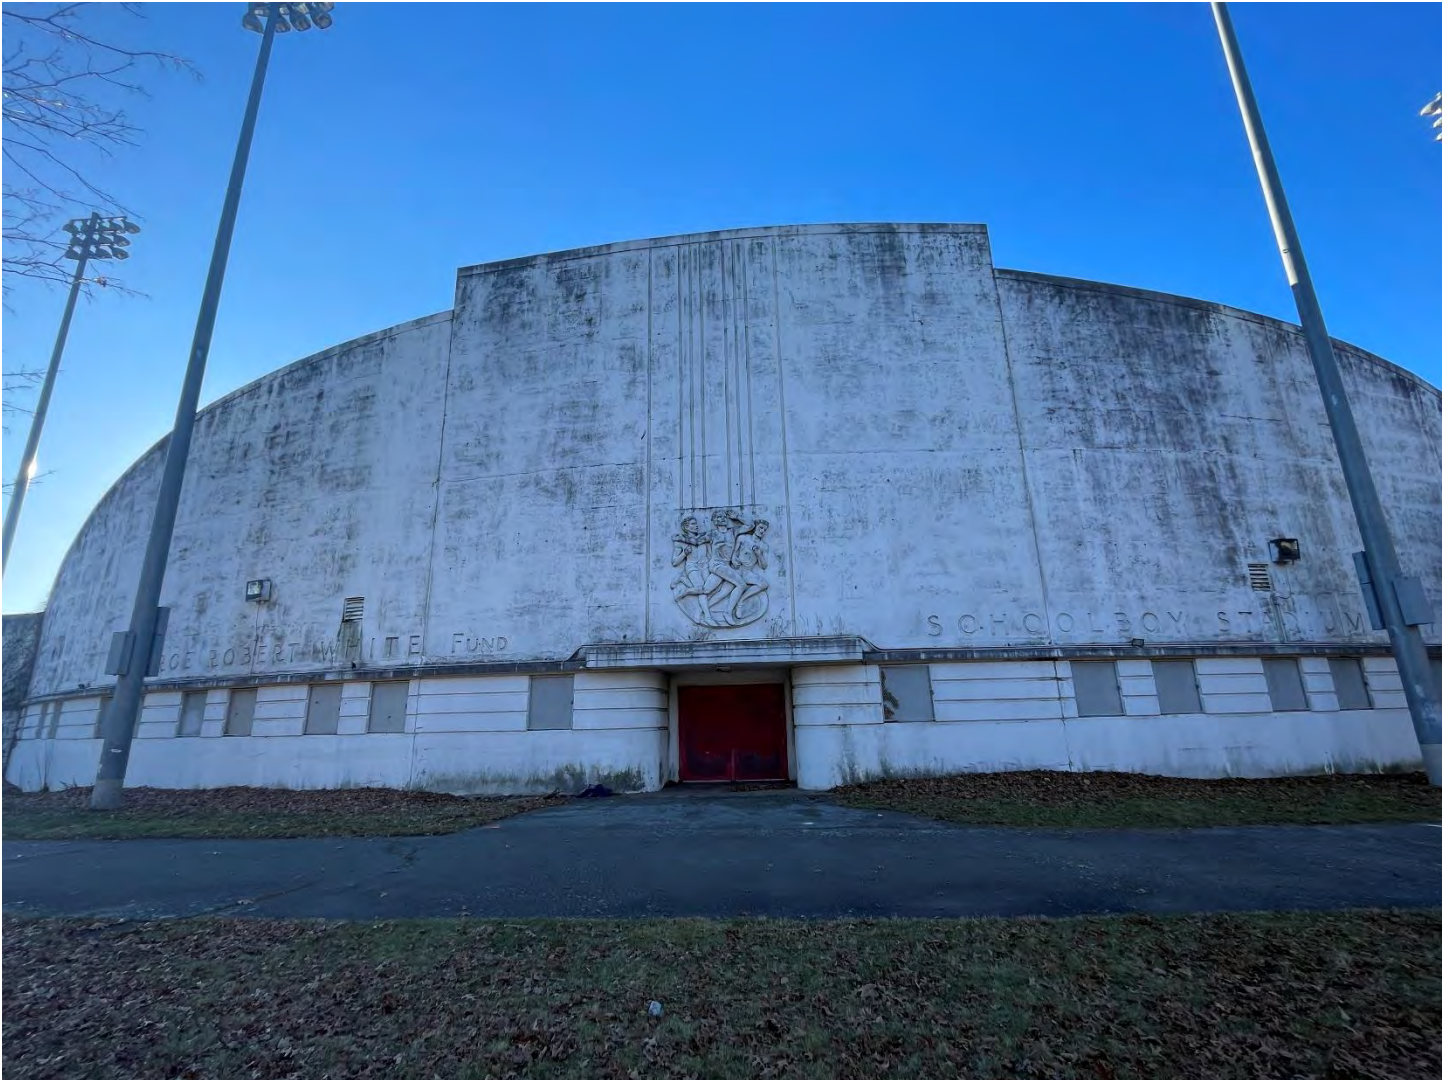
Photo 1. Image of existing stadium infrastructure on the eastern side of White Stadium.

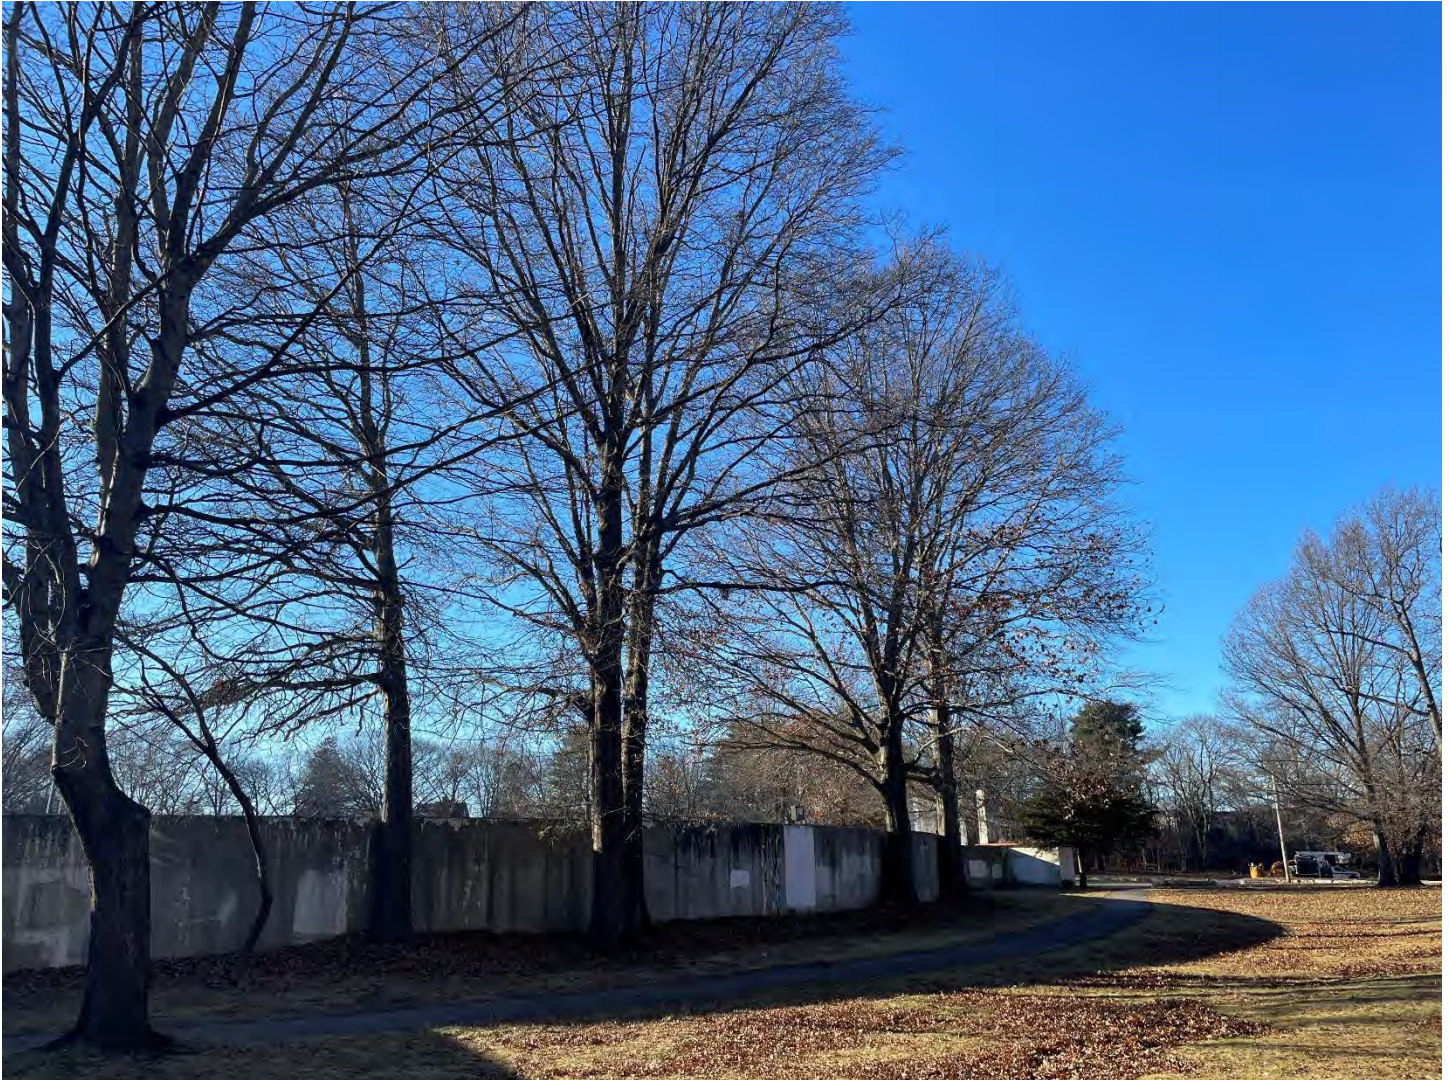
Photo 2. Image of multiple trees (Trees 7-13) growing along the existing stadium wall. These trees, though in good condition, were determined to have a low suitability for preservation. This is because, based on conversation with Crowley Cottrell, demolition was planned for the existing structure. It would be impossible to demolish the existing wall without seriously impacting the tree root zones. Even if demolition were not planned, these trees would continue to grow and will likely negatively impact the adjacent infrastructure.

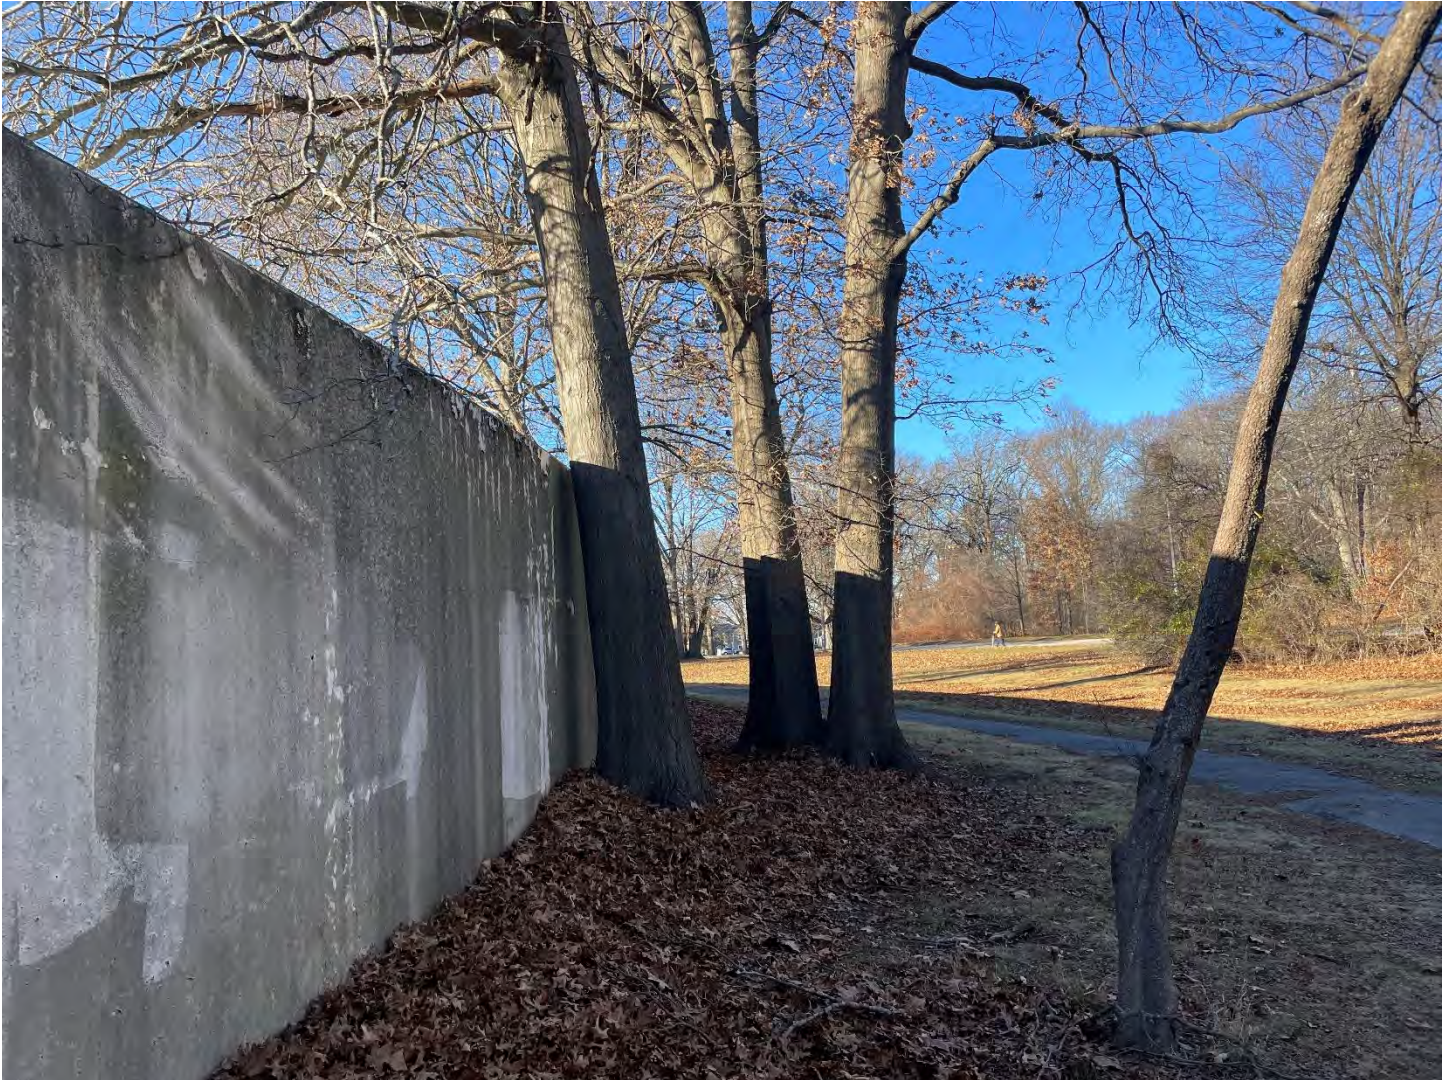
Photo 3. Image focusing on Trees 10, 11, and 12. These trees are located very close to the existing wall. Tree 12 was observed very close to touching the existing wall.

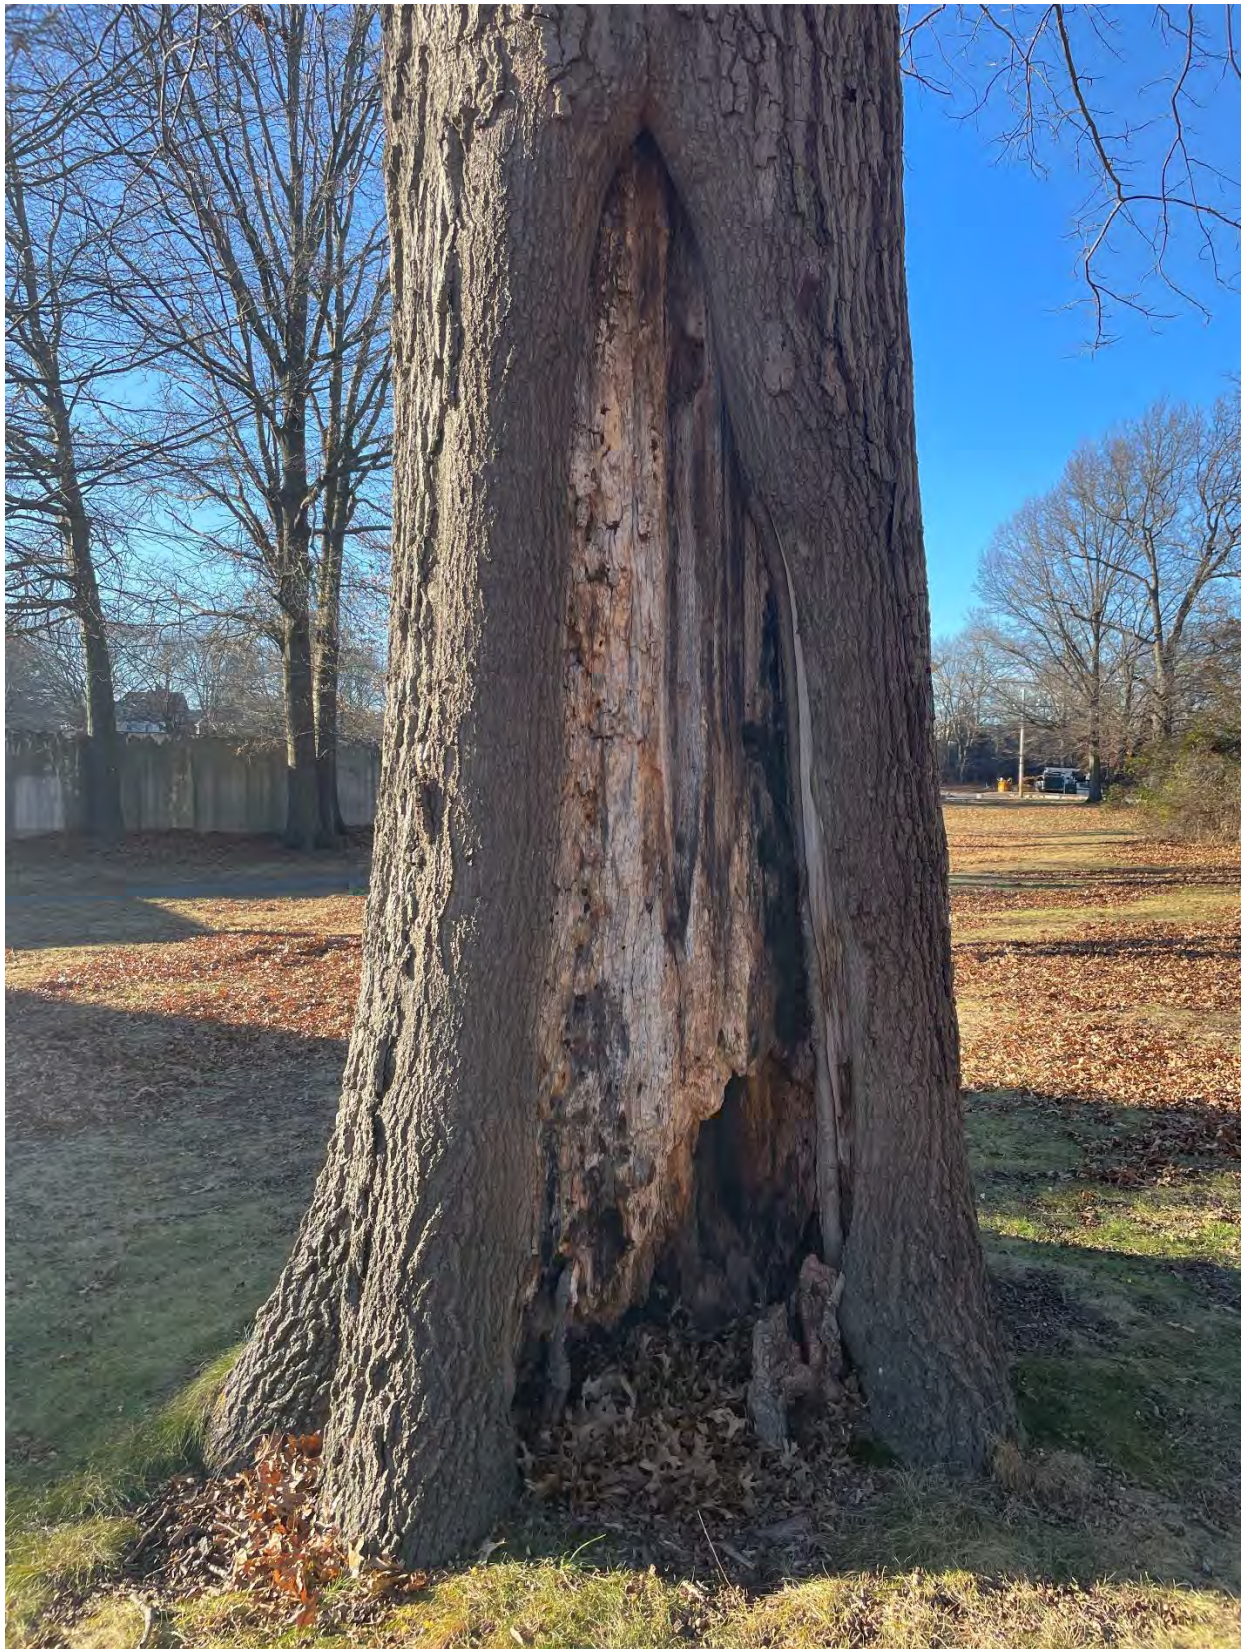
Photo 5. Image of Tree 16. This tree was the largest tree observed in the site area. It was determined that this tree has a low suitability for preservation because of extensive stem decay.

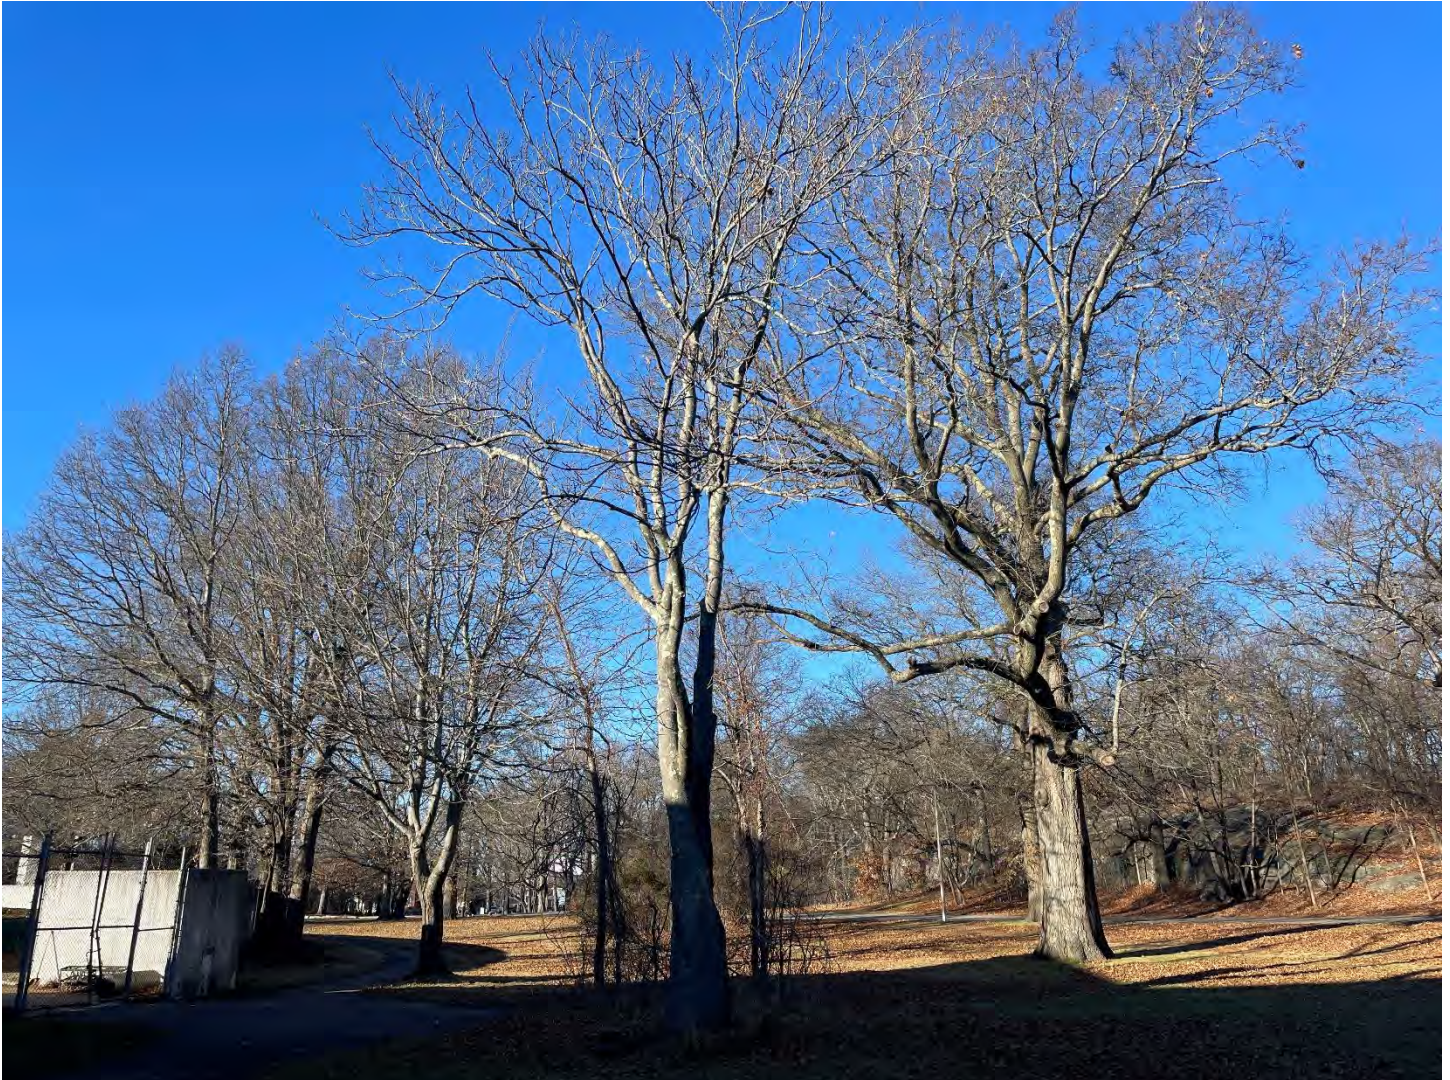
Photo 6. Image of Trees 16-18. All three of these trees were determined to have a low suitability for preservation because of significant structural issues.

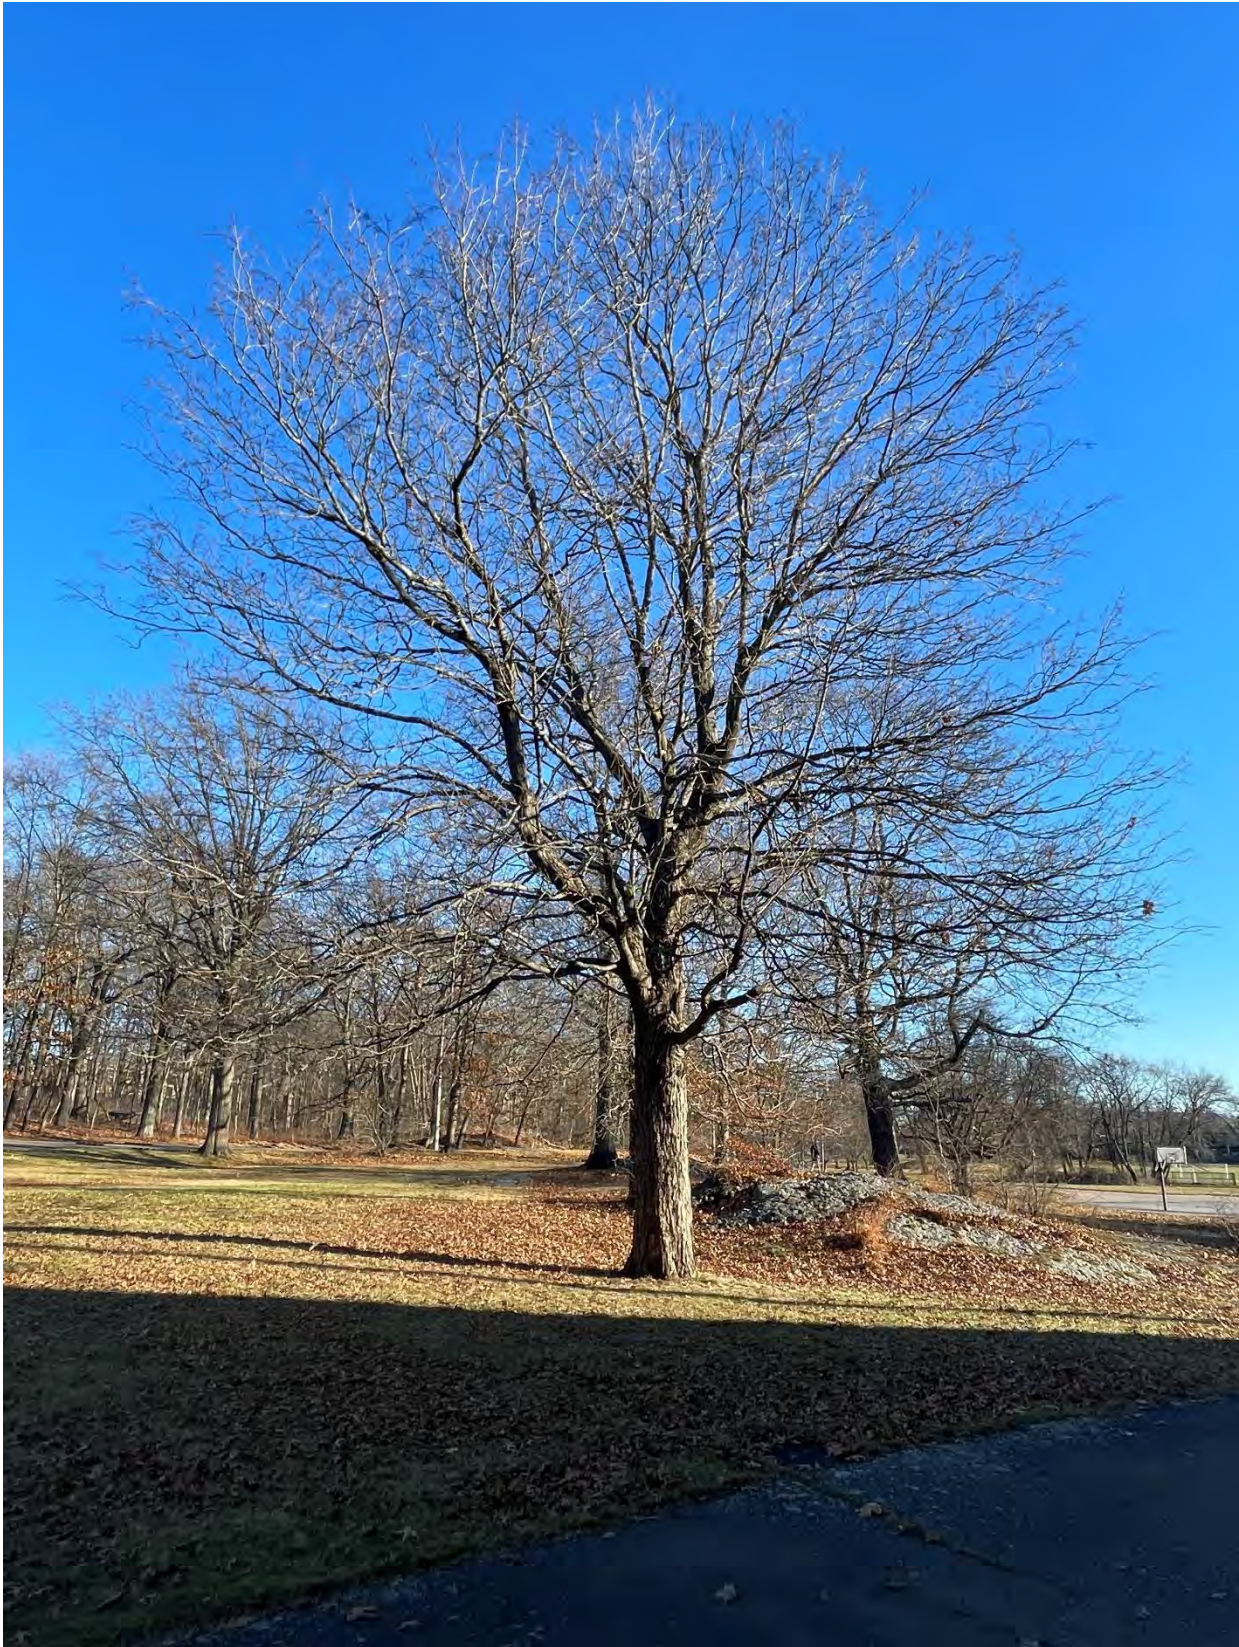
Photo 7. Image of Tree 20. This tree was determined to be in good condition at the time of the site visit. The tree was given a moderate suitability for preservation rating because it will be more difficult to retain a tree in the mature age class. Pin oaks are, generally, tolerant of construction activities but older pin oaks are less tolerant to the stresses associated with construction.

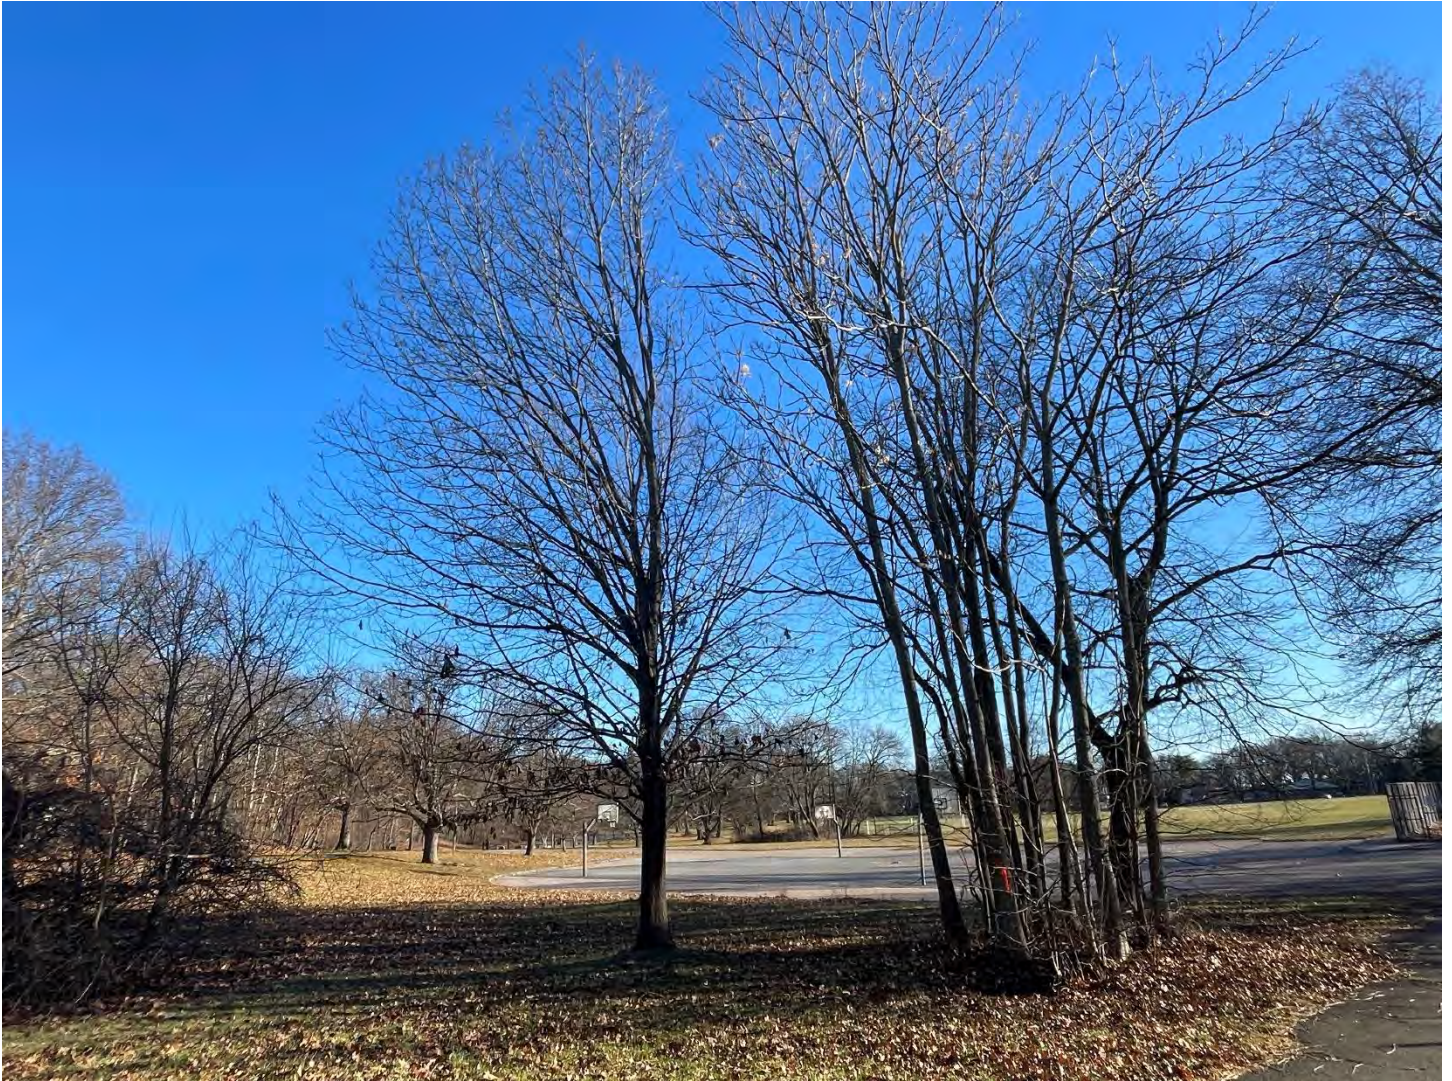
Photo 9. Image of Trees 51-53. Tree 52 was identified as one tree with multiple co-dominant stems. It is possible that these stems all sprouted from the same parent source or stump.

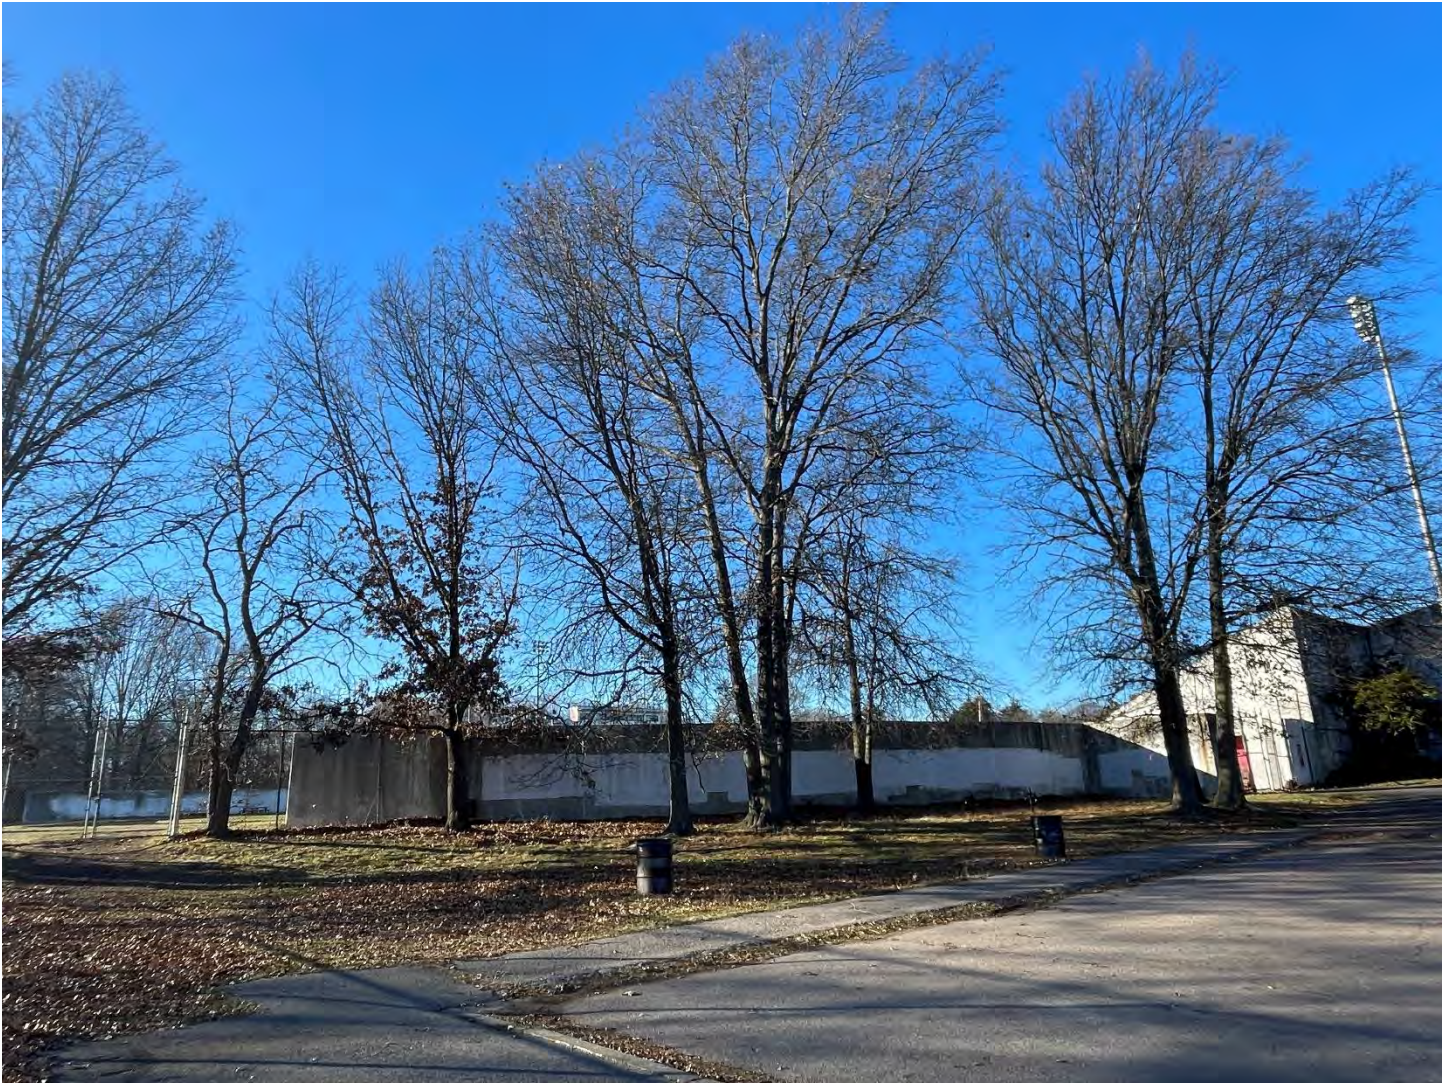
Photo 10. Image of Trees 55-61. These trees are also in close proximity to the existing infrastructure and may be unsuitable to preserve based on the means and methods of demolition. Final site plans and building activities may also cause these trees to be unsuitable to preserve for the future.

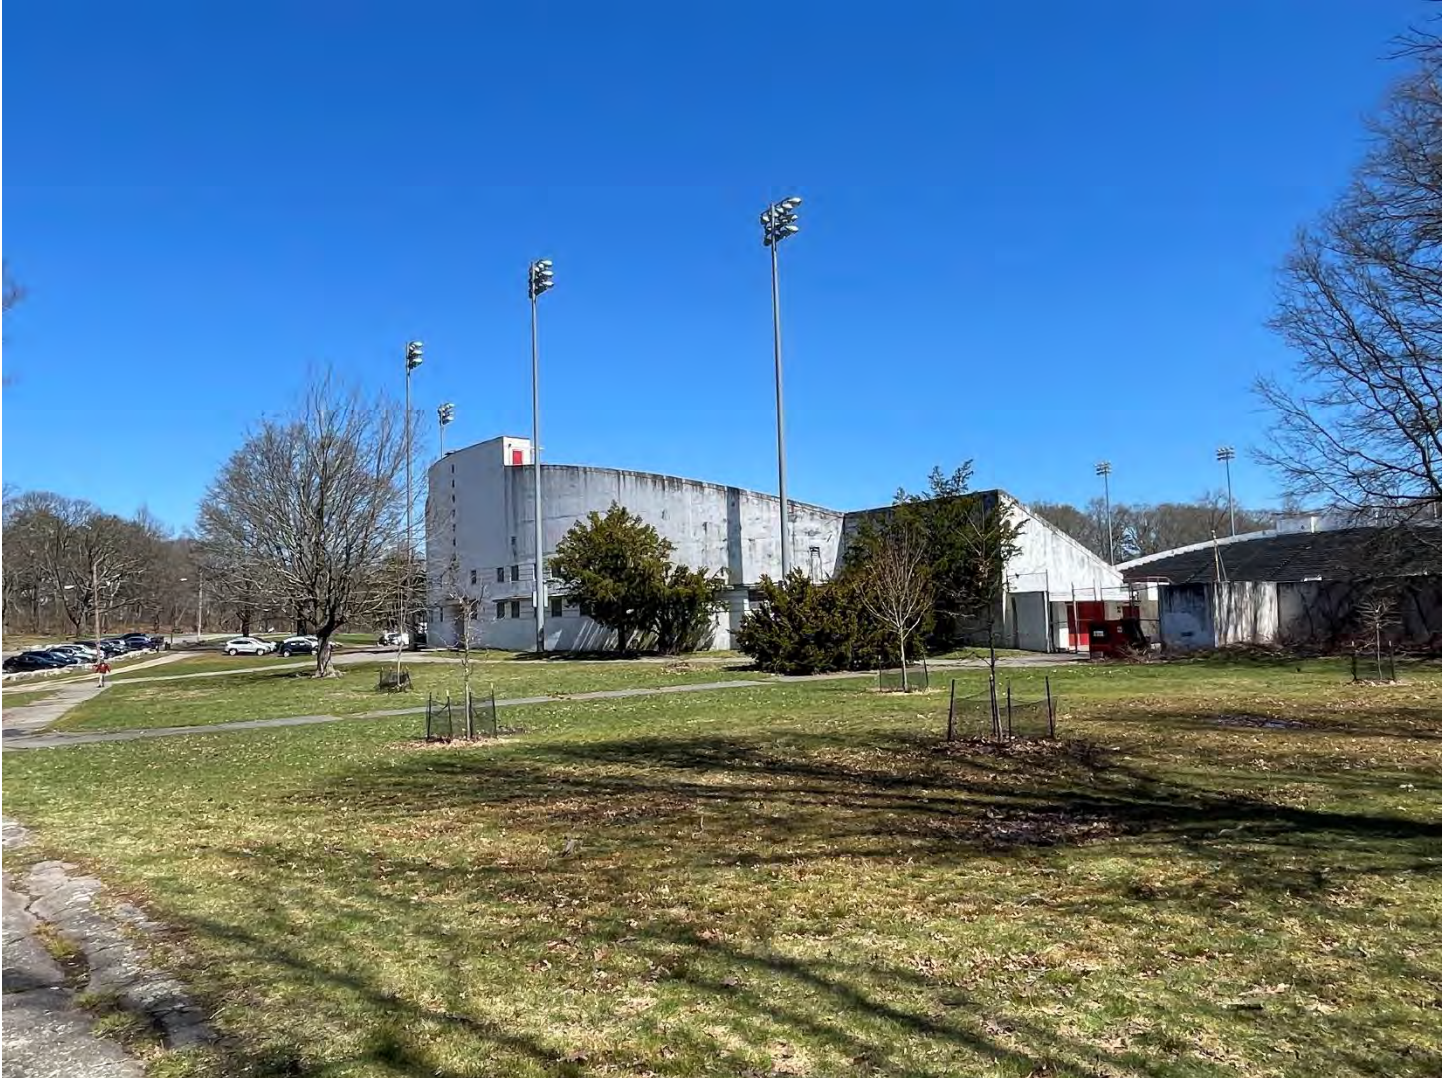
Photo 1. Image of existing stadium infrastructure on the western side of White Stadium.

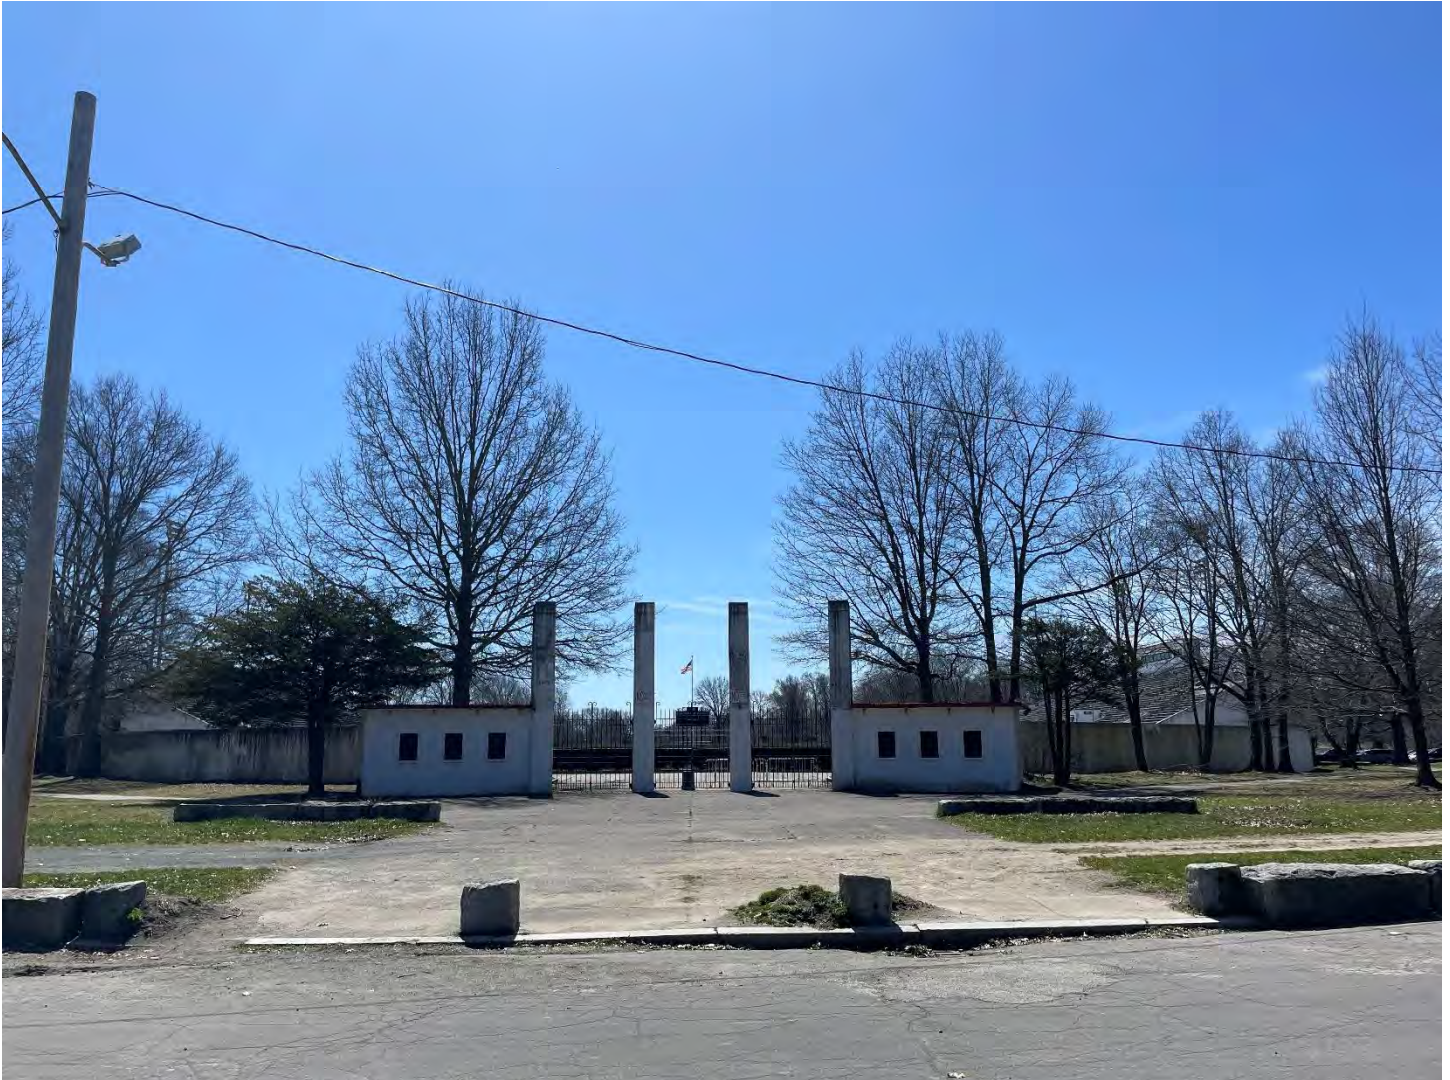
Photo 2. Image of the northern side of the existing infrastructure. Trees included in this assessment were on the right side of the entrance. Trees on the left side of this entrance were investigated in December 2023 with Crowley Cotrell.

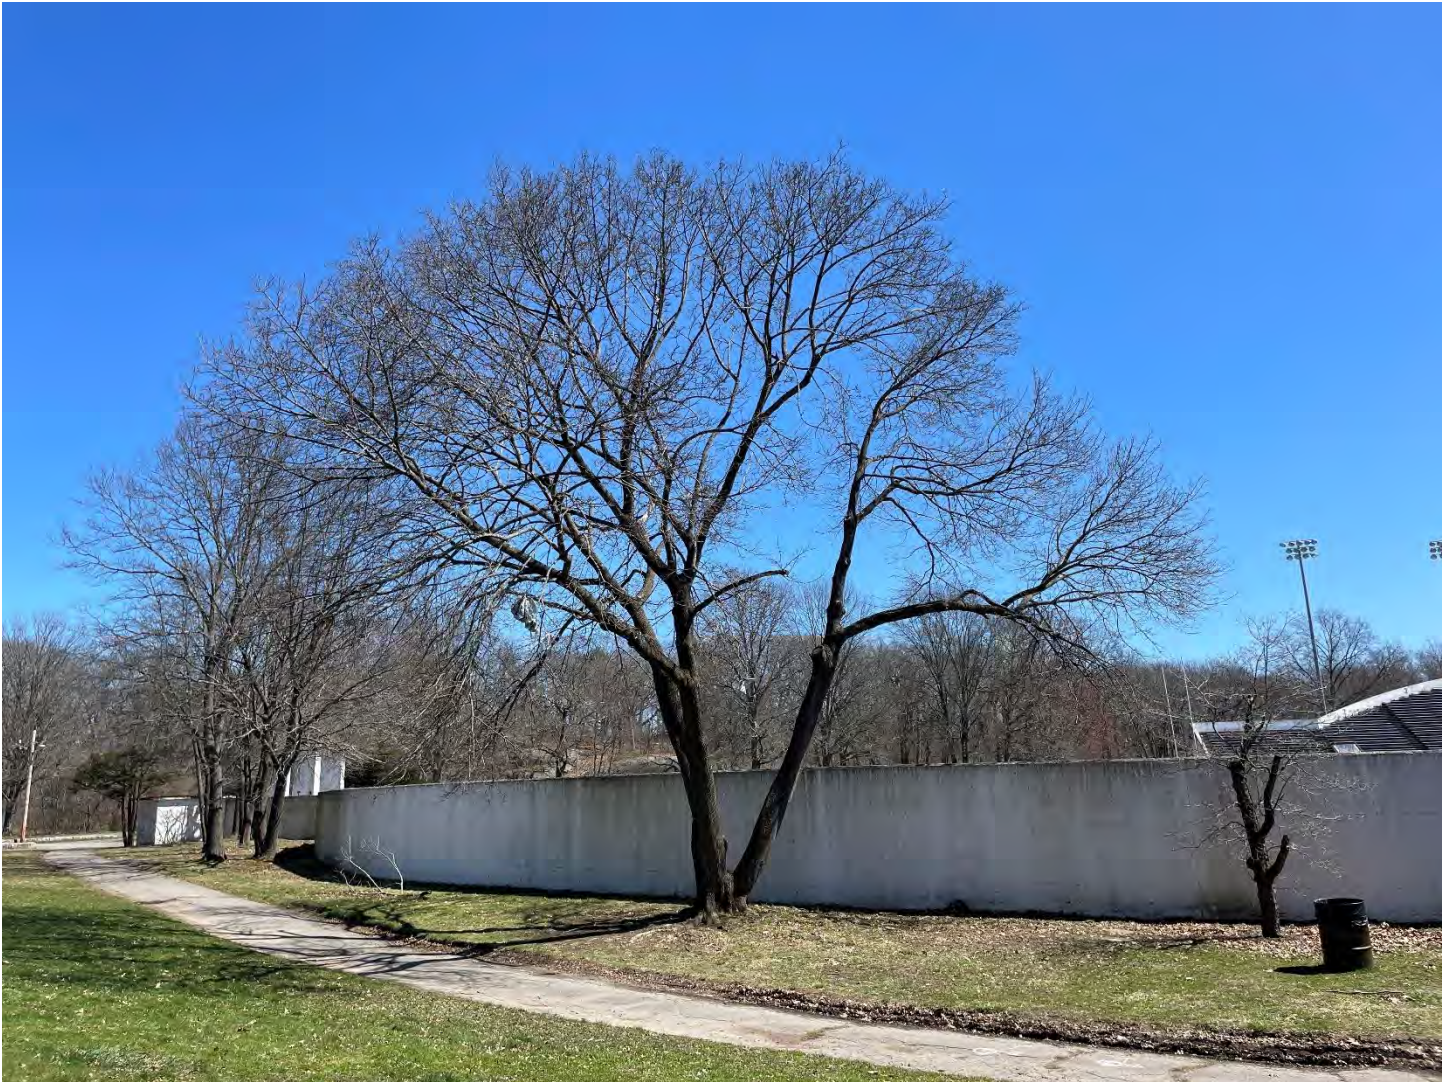
Photo 3. Image focusing on trees close to the existing stadium infrastructure. Tree 1016 is a multi-stem Norway maple with significant defects such as stem decay. This tree is in poor condition, is an undesirable species, and is located. The tree was given a low suitability for preservation rating for these reasons.

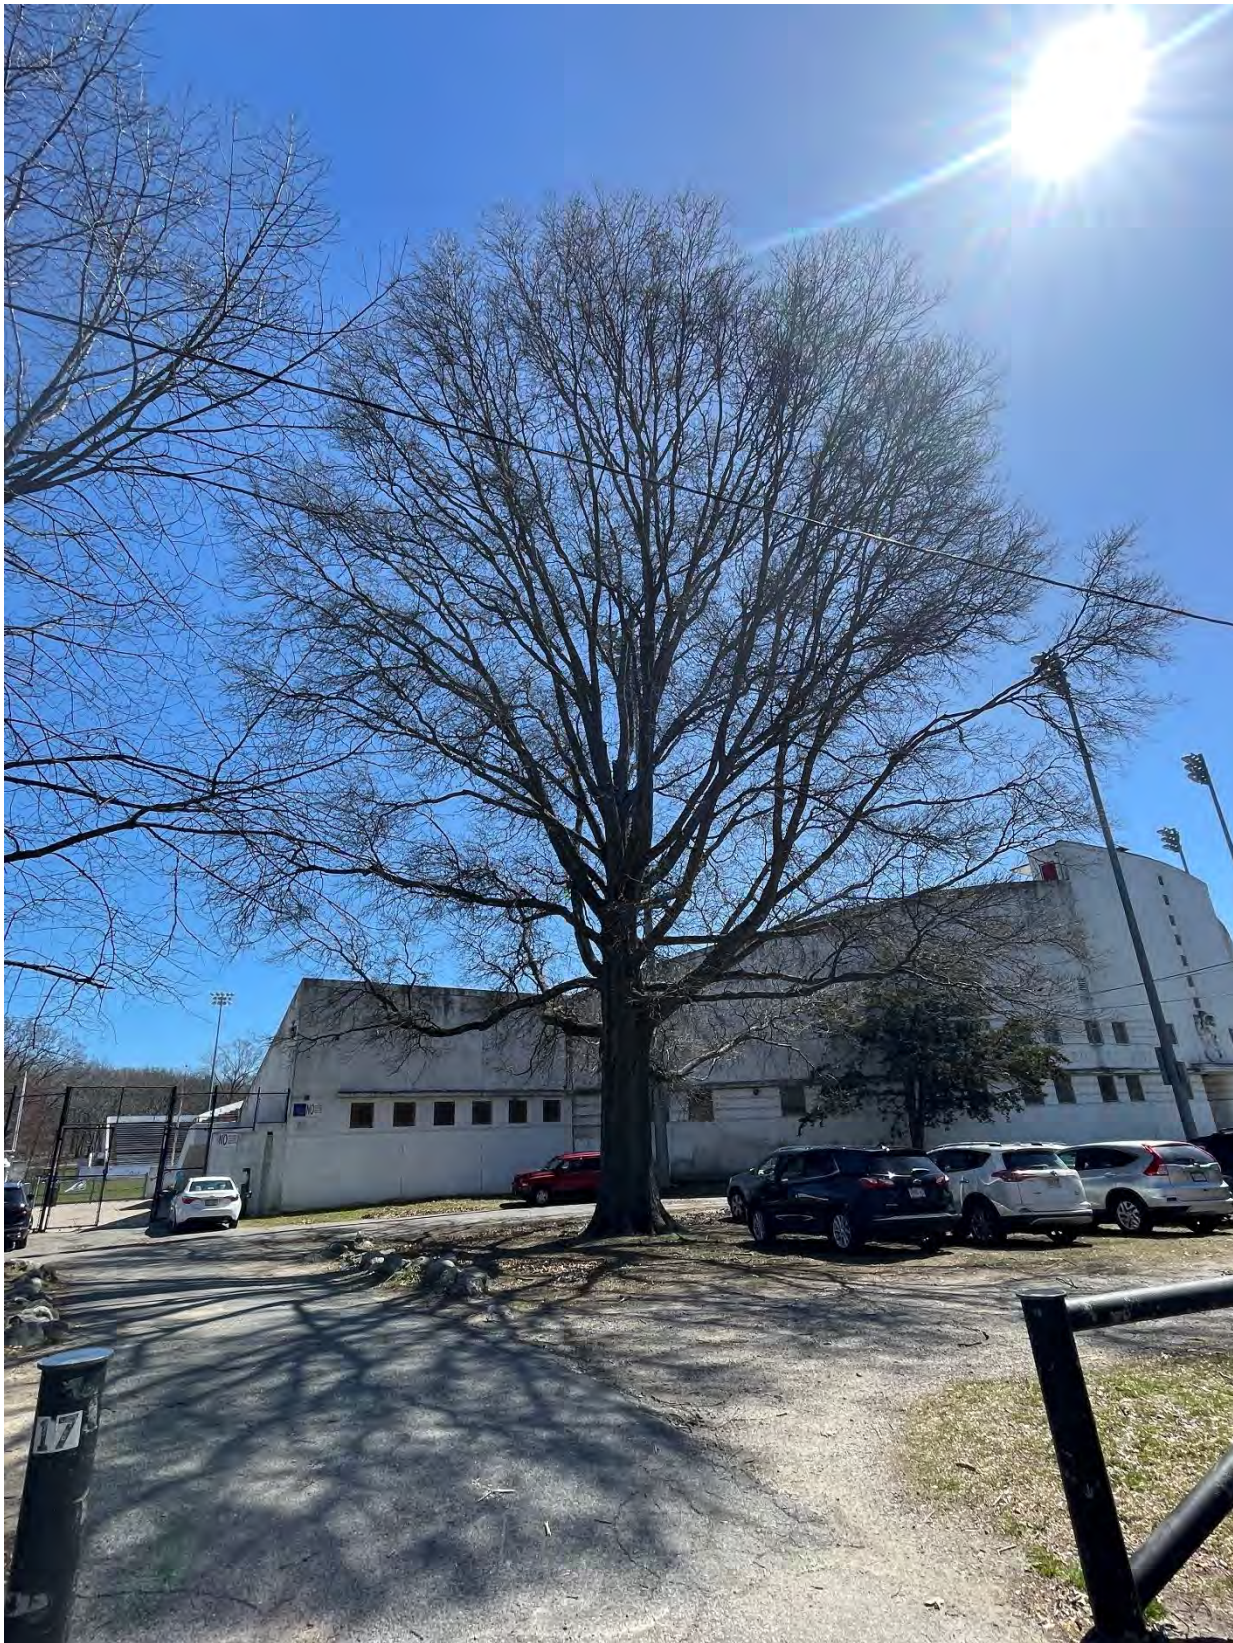
Photo 4. Image of Tree 1019 located adjacent to the existing parking area. This tree, and any other tree with observable compaction, is recommended for a Root Invigoration™.

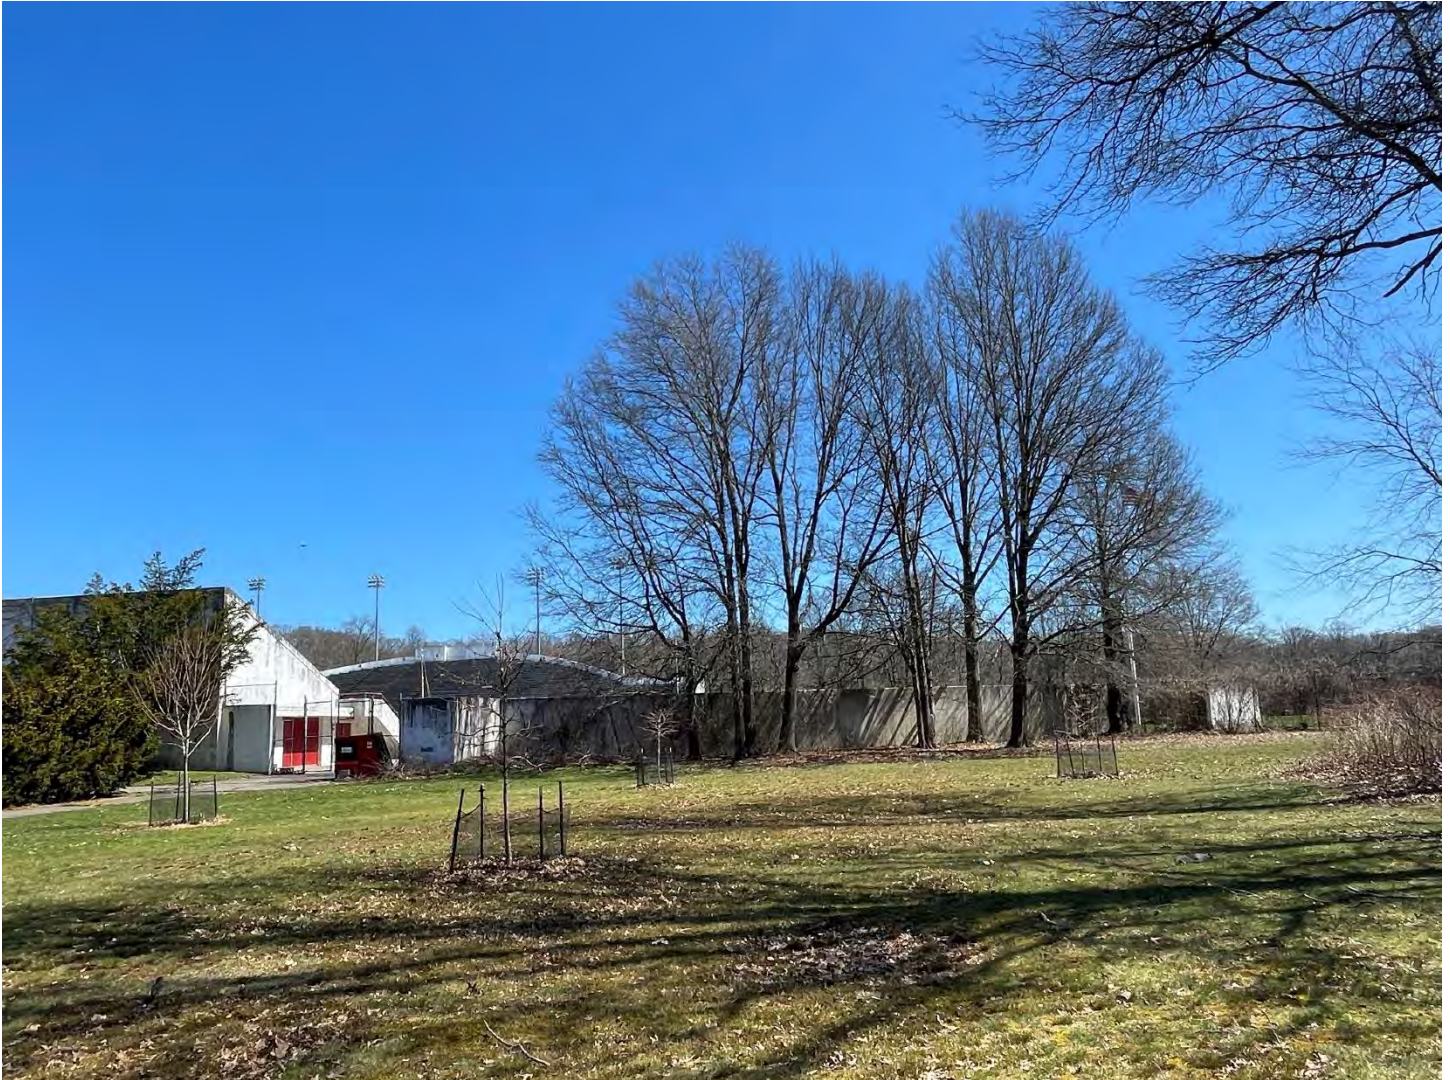
Photo 5. Image of small, newly planted trees (identified as trees 1030-1034) located in the field area. These trees were determined to be a high suitability for preservation during construction. The larger pin oaks beyond were identified as Trees 1035-1044. These trees are close to existing infrastructure and may be challenging to retain as construction is underway. These trees were determined to be moderate to low suitability for preservation.
