**White Stadium
Boston, MA**

Tree Preservation Report

Andrew Balon
Arborist Representative
ISA Certified Arborist
ISA Tree Risk Assessment Qualified
50 Bear Hill Rd,
Waltham, MA 02451
(781) 622 5980

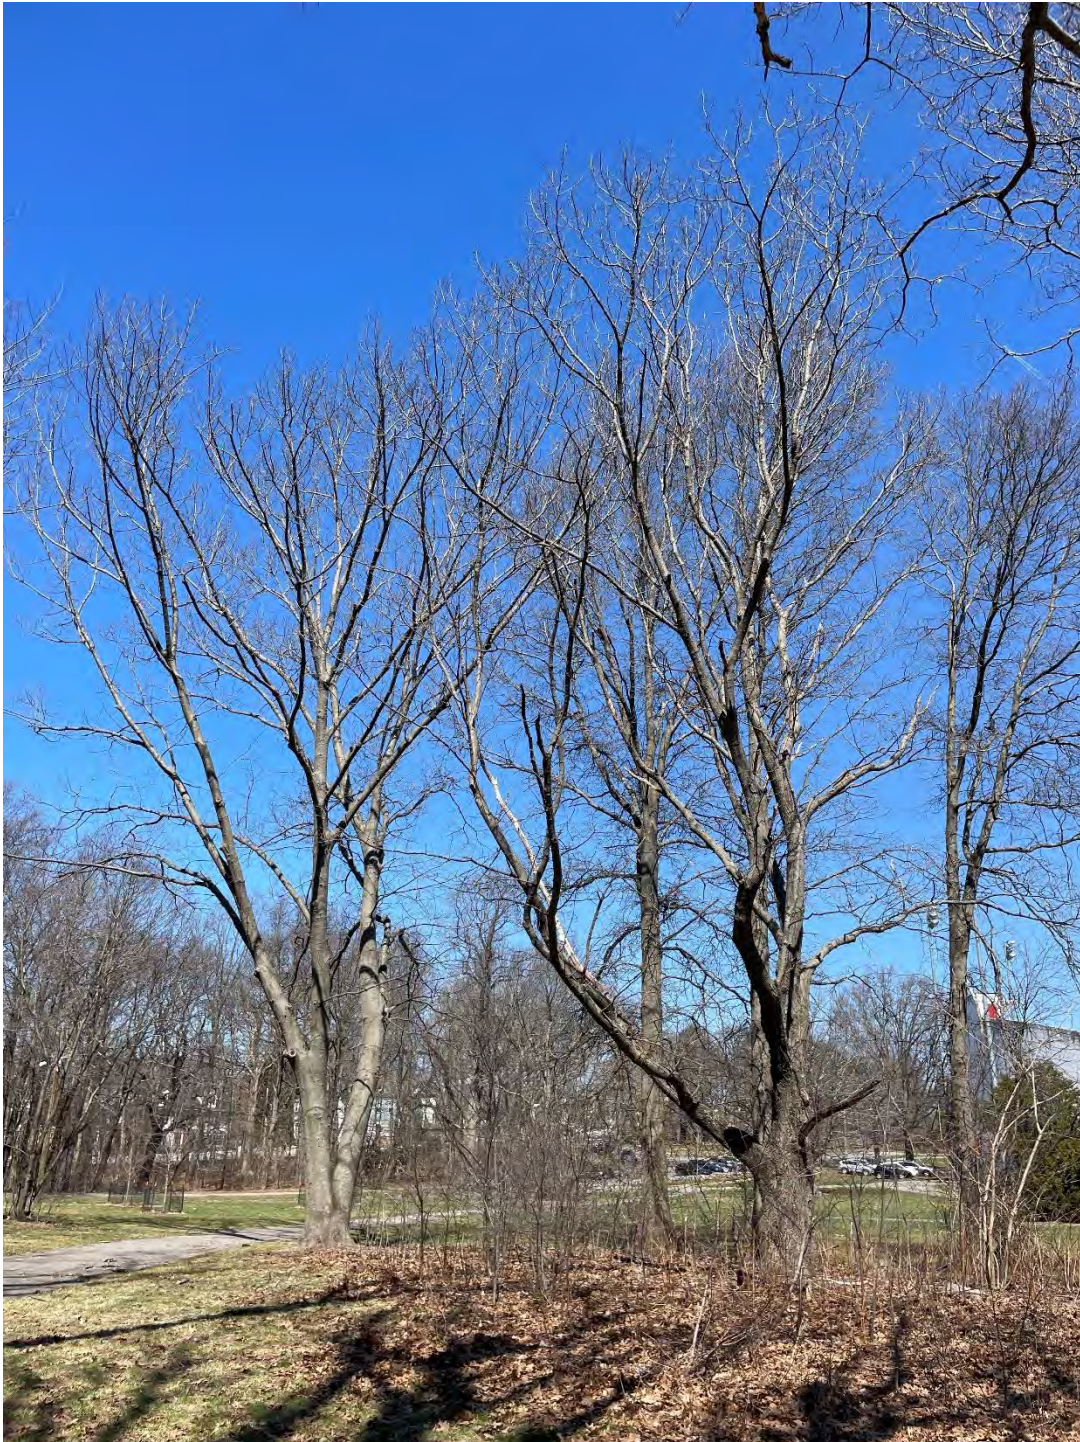
Photo 6. Image of Trees 1046-1049. These mature trees were observed to be in generally good condition. Conversation with Stantec suggested that construction impacts will be lower in this area than others closer to the stadium. If this is the case, these trees would be good examples of trees suitable for retention if tree preservation measures are followed.

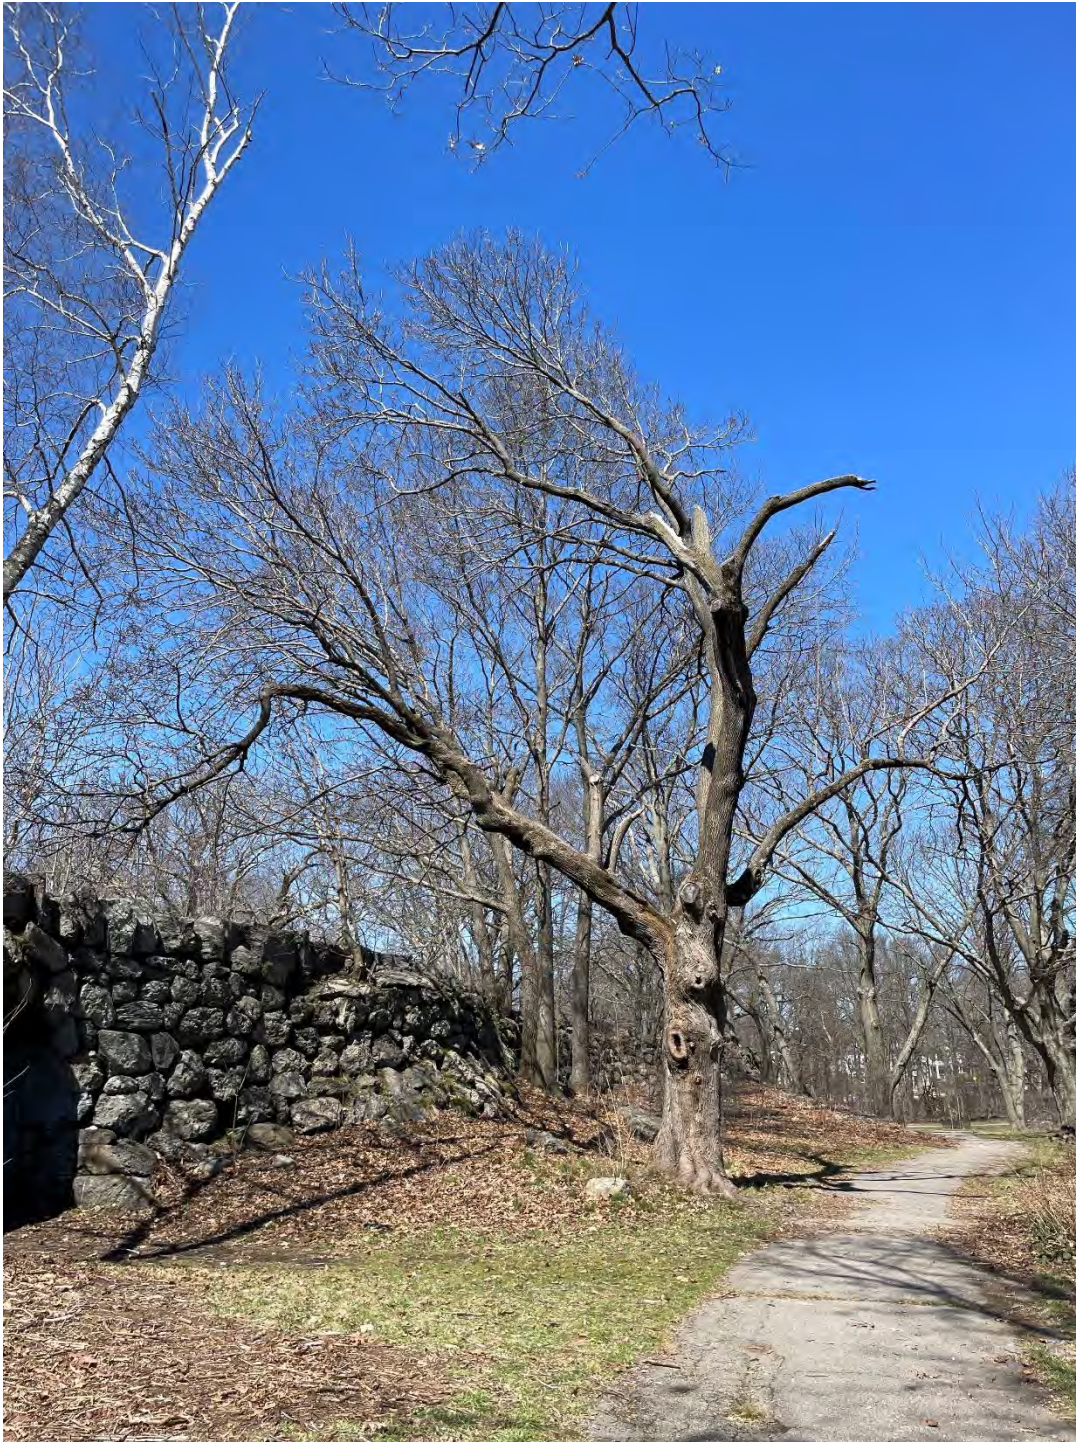
Photo 7. Image of Tree 1060. This tree was observed to be in poor condition at the time of the site visit. Significant defects included extensive storm damage, large dead branches, stem decay, and low vigor. This tree may not be suitable for retention on the property regardless of construction activities.

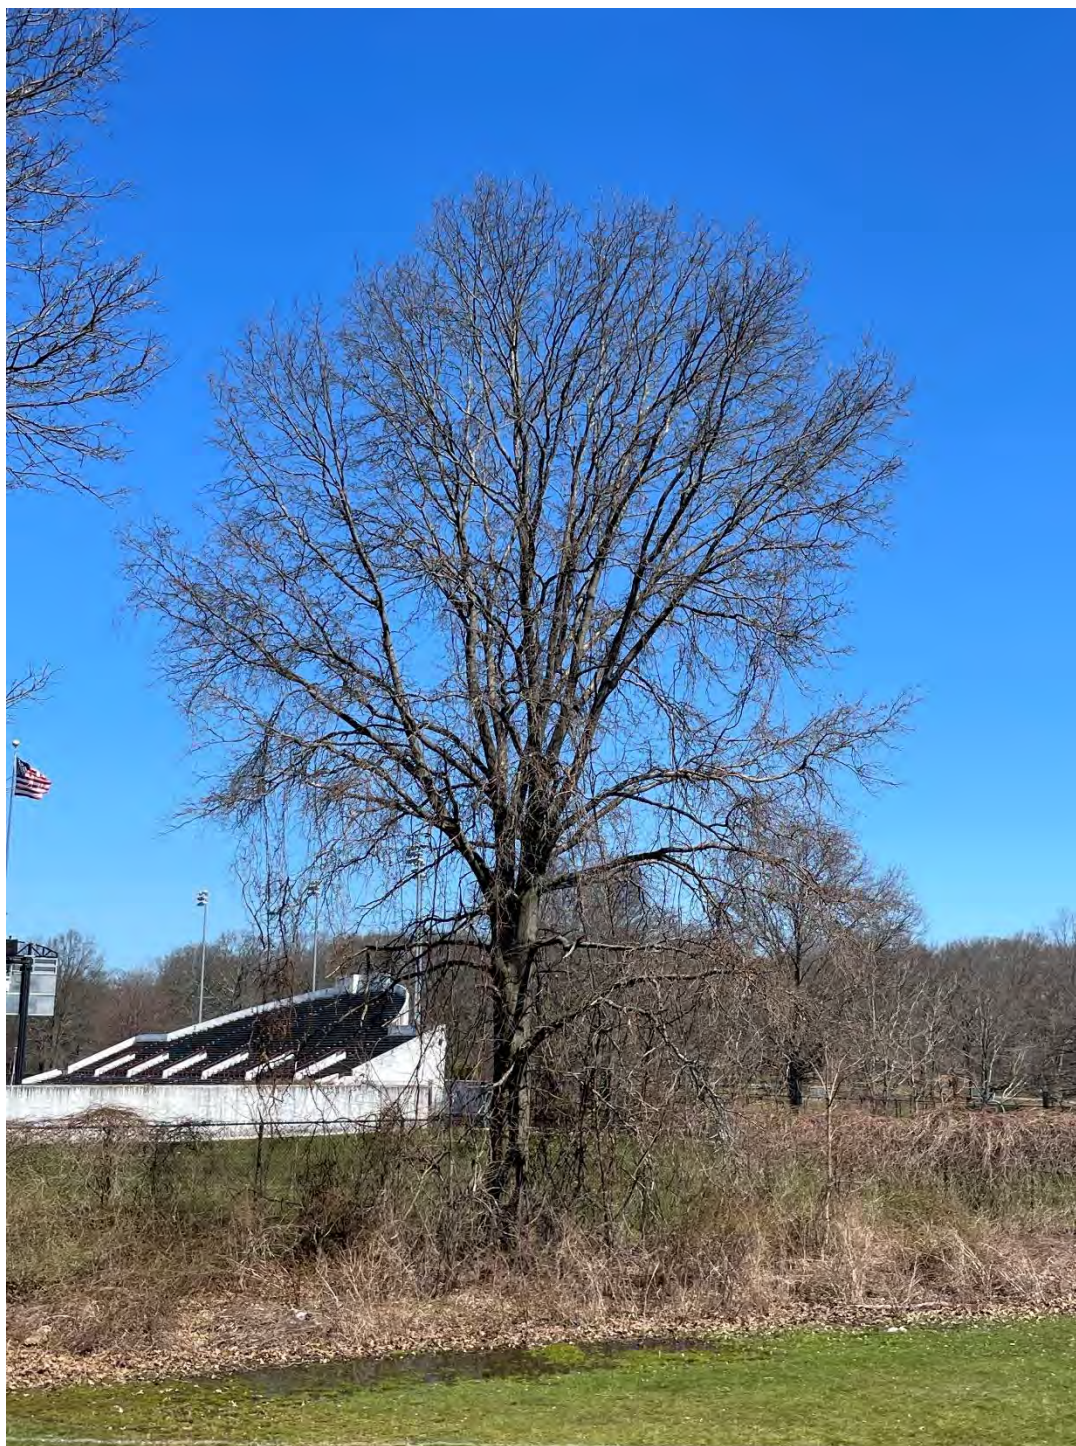
Photo 8. Image of Trees 1060 at the southern end of the existing stadium. This tree is in good condition. It is recommended to remove the vines from the canopy of this tree and others on the property. Vines can limit photosynthetic capacity in the canopy and cause stress.
