Garage Door Replacement

74 Chestnut St, Boston, MA 02108

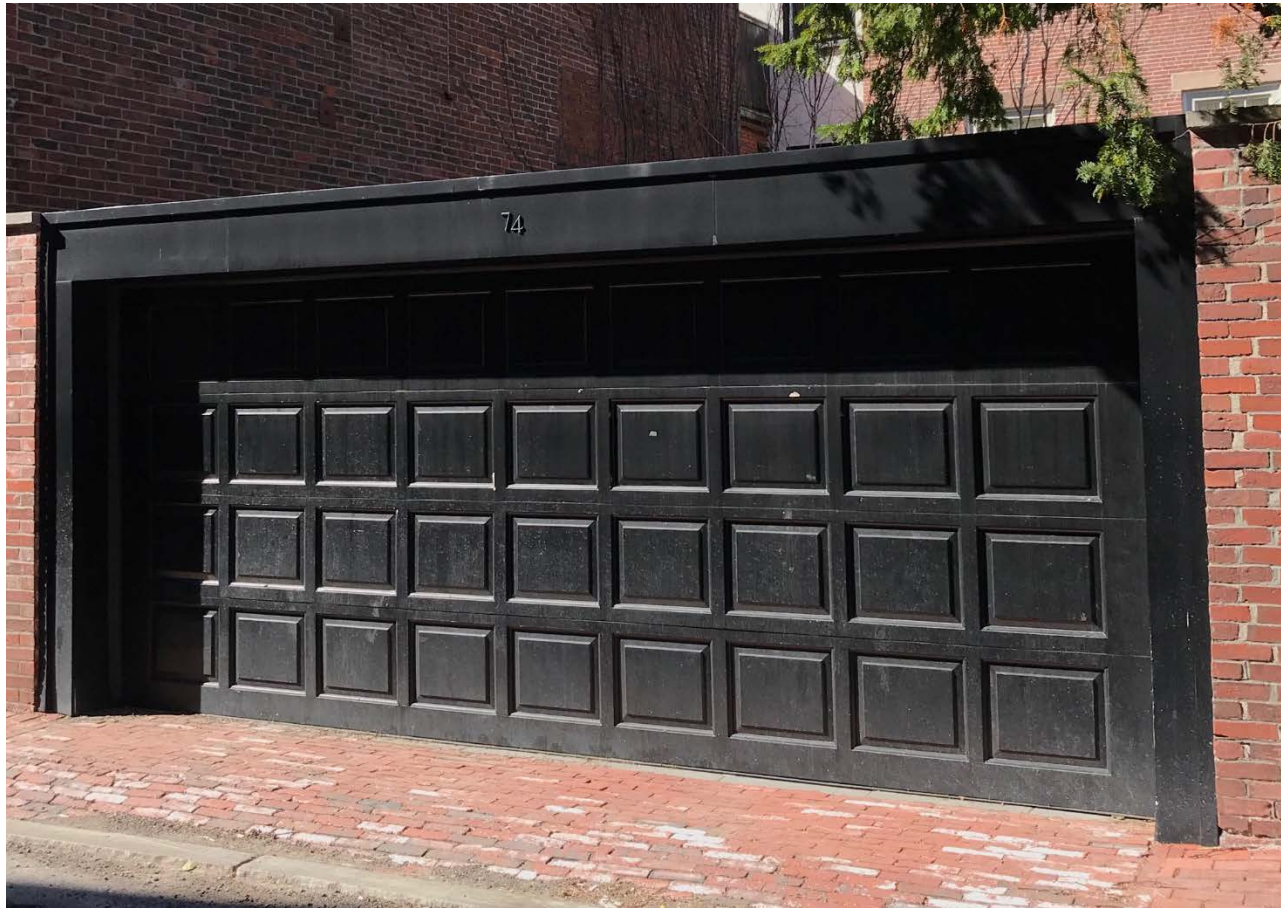
Existing Conditions

(Image taken March 2019)

- **Material**
 - Constructed of cedar
- **Design**
 - Size: 16'0" x 6'8"
 - Style: Custom raised panels / 9 panels wide x 4 panels high
 - Color: Painted semi-gloss black
- **Motor**
 - Side-mounted motor
 - Garage does not have a roof, therefore side-mount is required

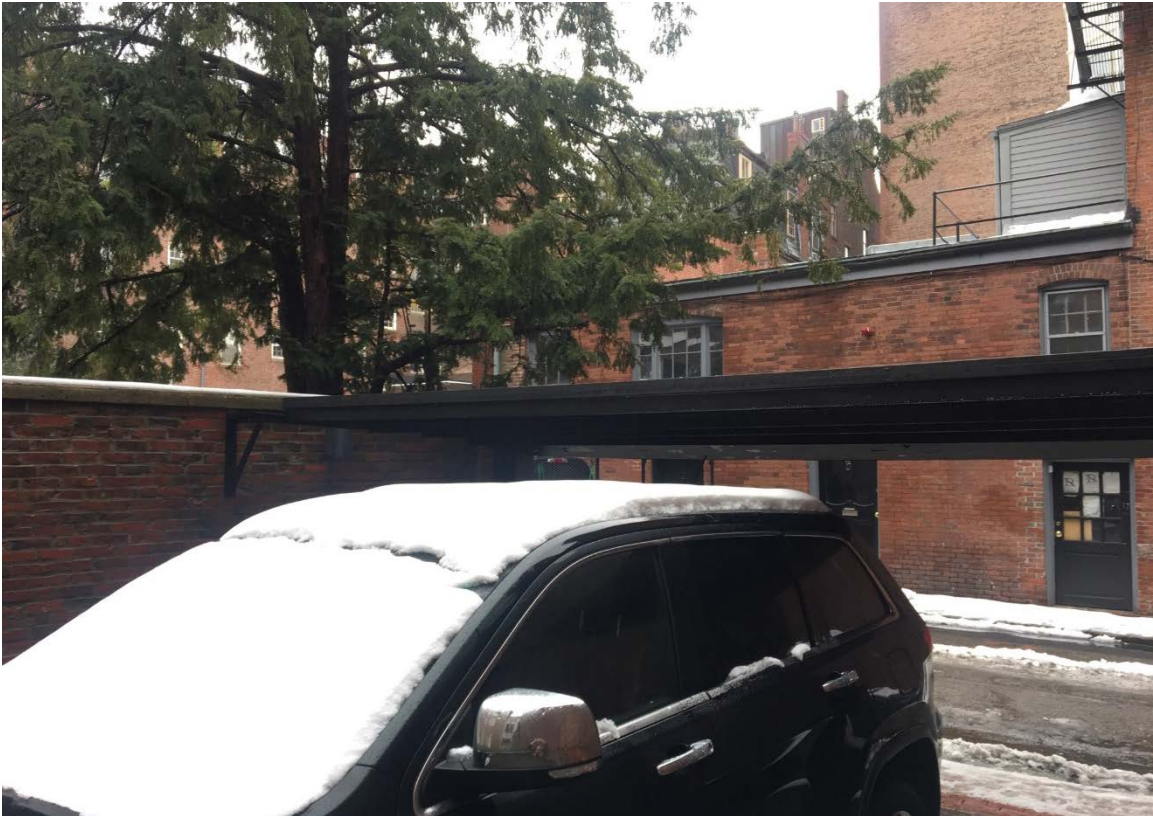
Reasons For Replacement

(Image taken Feb. 2019)

- **Motor**
 - Because the door is oversized, the existing side-mounted motor has failed and needs replacement.
 - Garage has no roof, therefore installation of overhead motor would be visible from street view. This is non-conforming to the BHAC.

- **Material**
 - Wood naturally retains & loses water. This requires 2x/year adjustments to the springs.
 - If spring adjustments are missed, the spring has potential to break.
 - This happened in Feb. 2019, and spring required replacement.
 - Strain on the spring also contributed to the above mentioned motor failure.

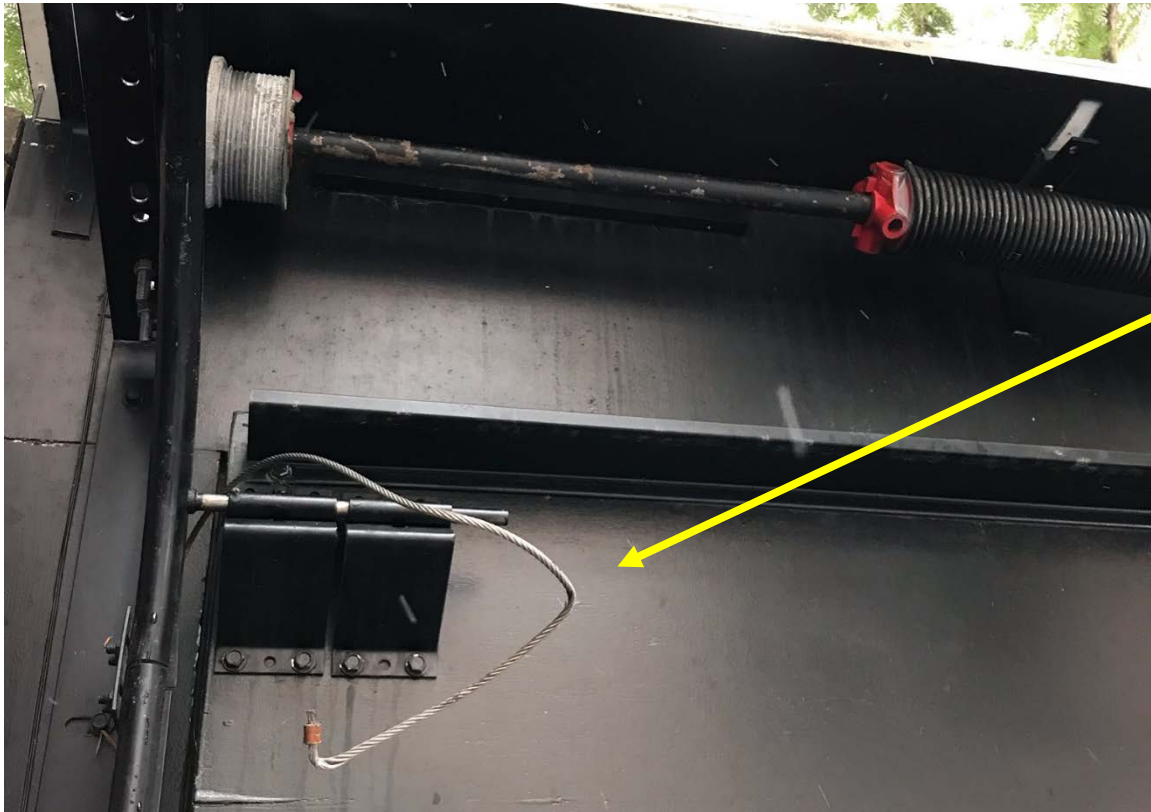
Reasons For Replacement

(Image taken Feb. 2019)

■ Safety

- The existing motor has failed due to weight limitations, and wood door is unable to be opened. This eliminates the rear egress and is a safety concern.
- In the current condition, the cables have the potential to snap. This has happened on one occasion, which had major potential to injure the operator.

■ Longevity

- Current wooden door & side-mounted motor require routine maintenance & upkeep. This has proven challenging and has significant cost implications.
- Paint is peeling and requires regular touch ups. Each gallon of paint adds more weight, further exhausting the spring & motor.
