BOSTON ATHENAEUM

SOUTH BALCONY REHABILITATION

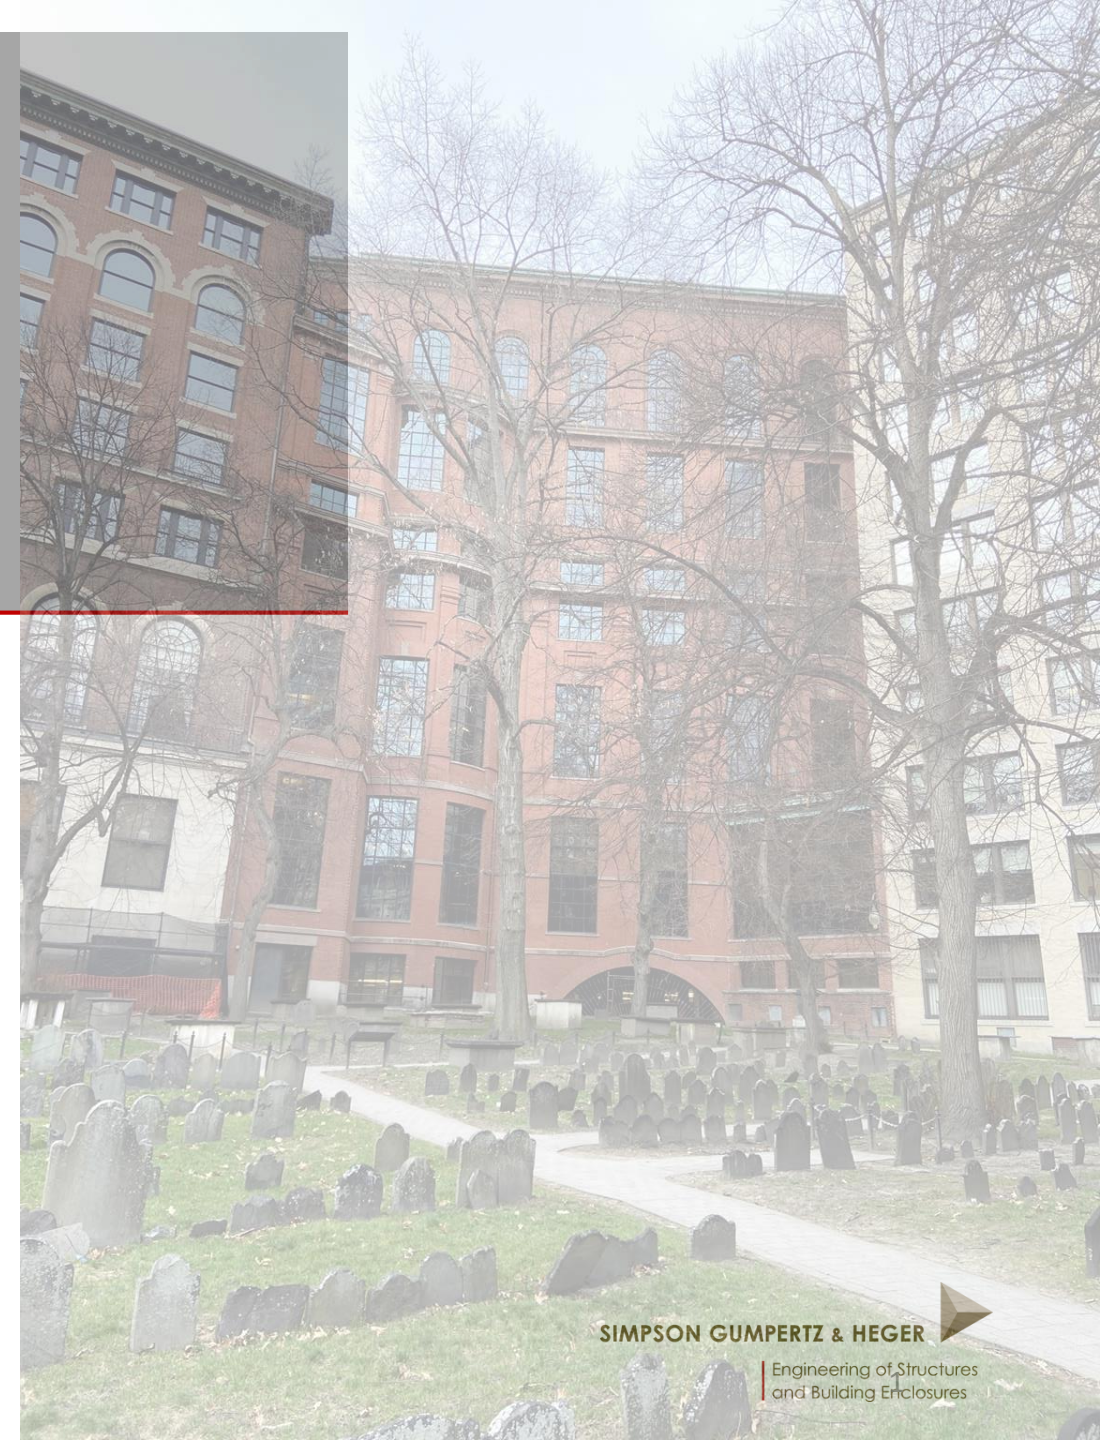
SIMPSON GUMPERTZ & HEGER

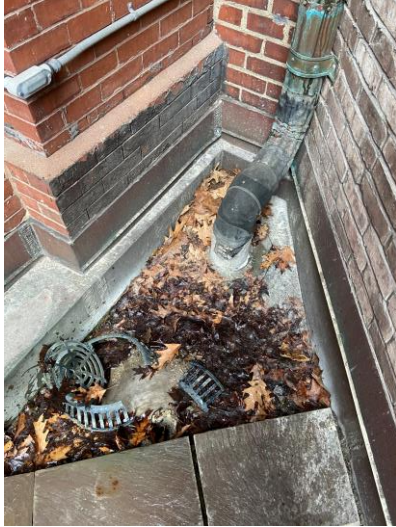
Photo 1: Clogged internal drain at second-floor balcony

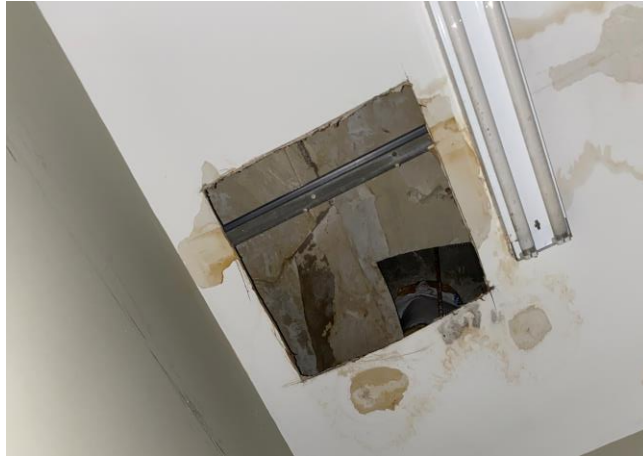
Photo 2: Interior water damage below second-floor balcony.

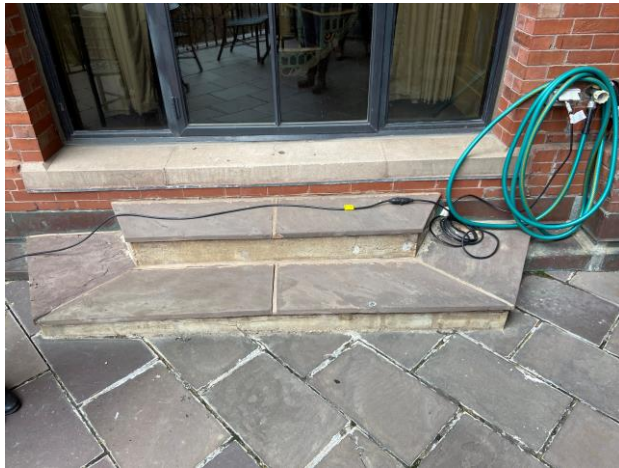
Photo 4: Slippery and loose pavers at edge and stairs pose potential tripping hazards.

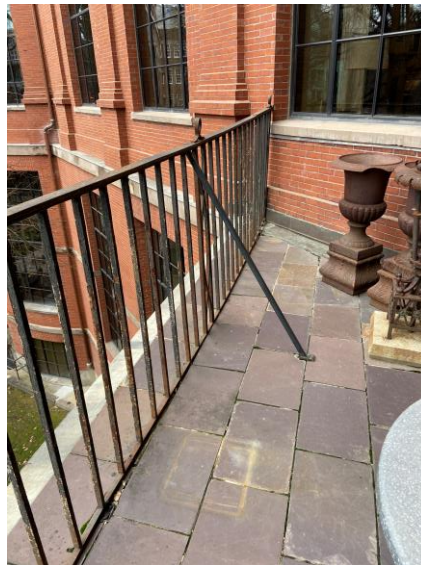
Photo 3: Non-original railing at second-floor balcony does not comply with current architectural or structural code.

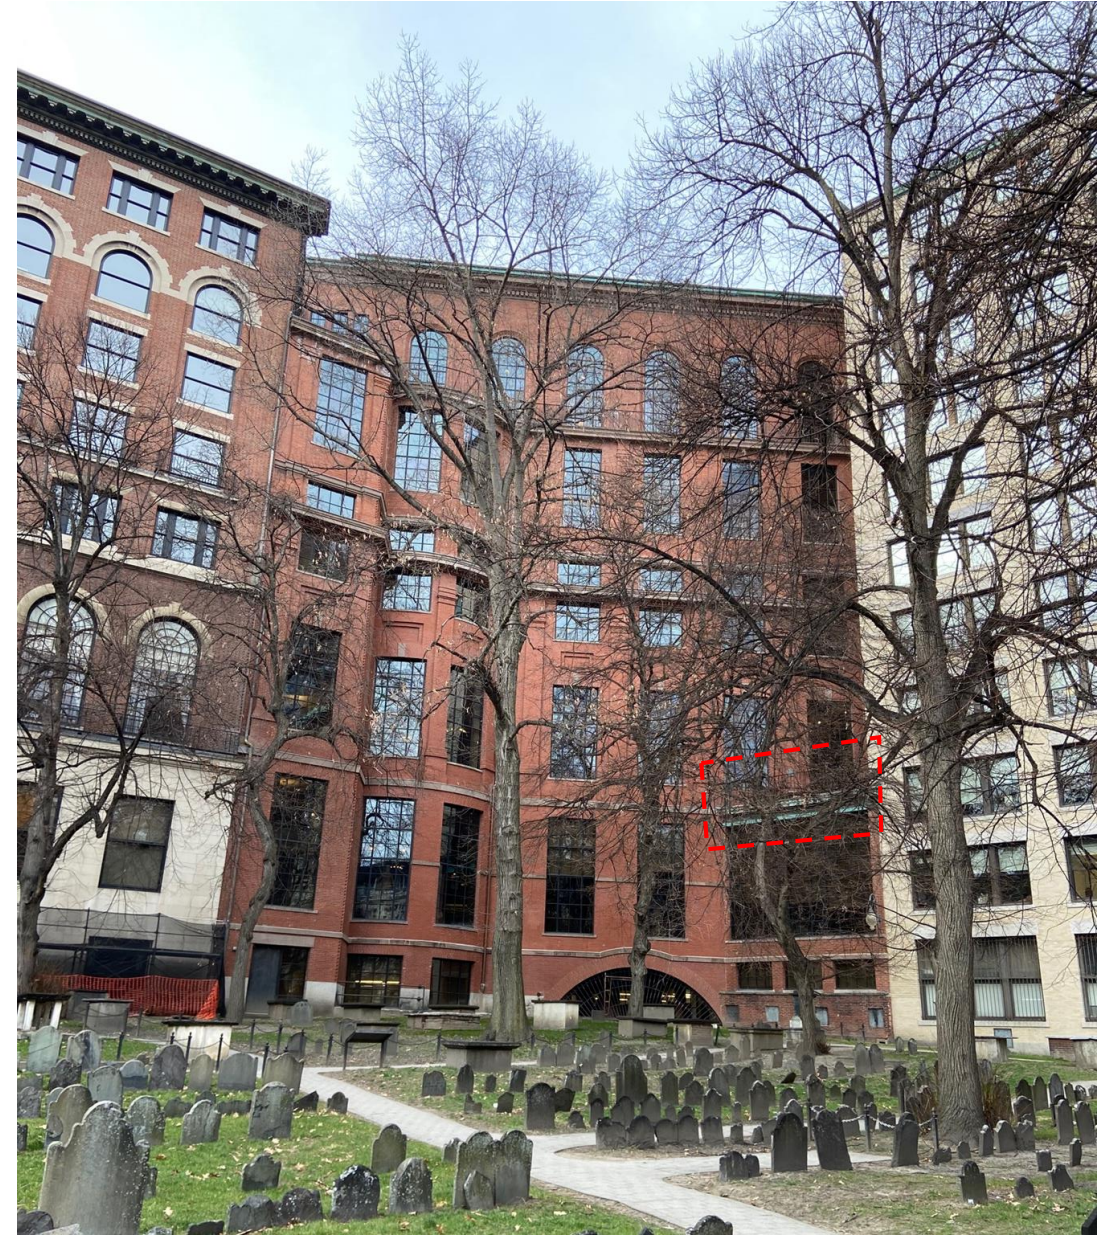
Fifth-Floor Balcony – Existing Conditions

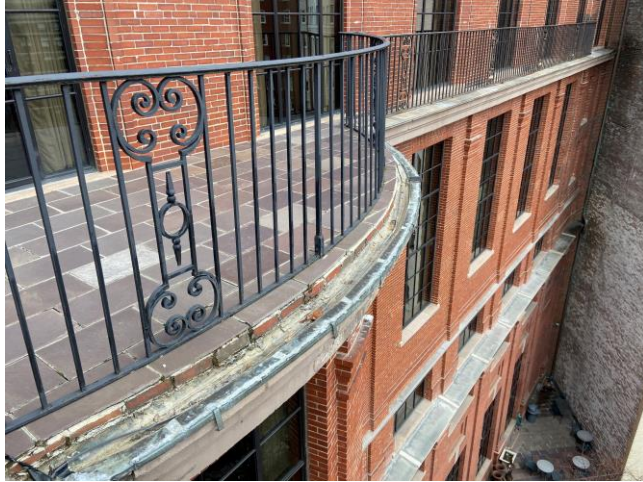
Photo 5: Slippery and loose pavers pose potential tripping hazards and non-original railing at fifth-floor does not comply with current architectural or structural code.

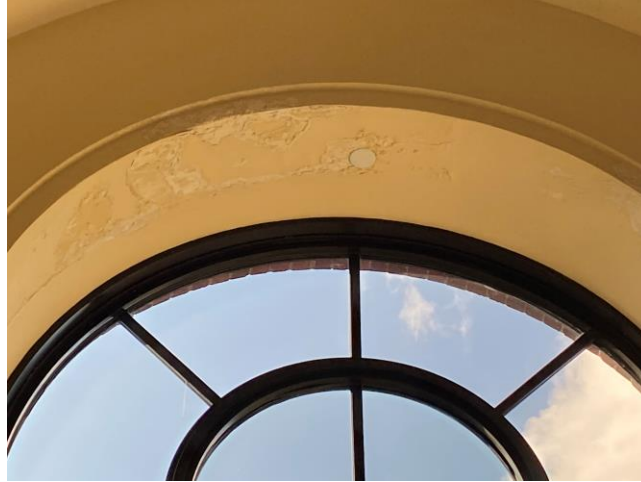
Photo 6: Damaged interior water damage below fifth-floor balcony.

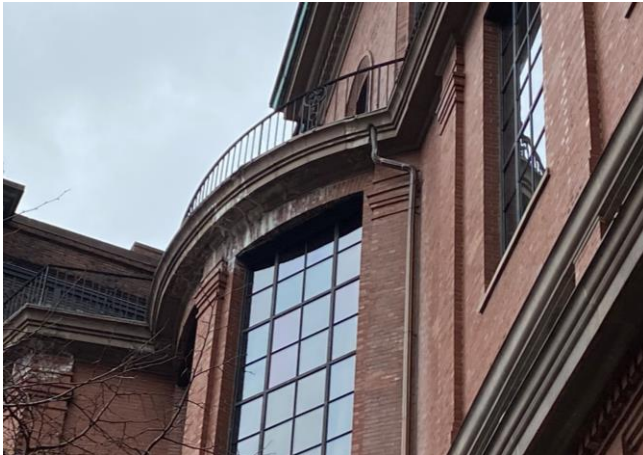
Photo 7: Mortar-set pavers and leaking gutter are contributing to masonry staining and deterioration below the fifth-floor balcony.

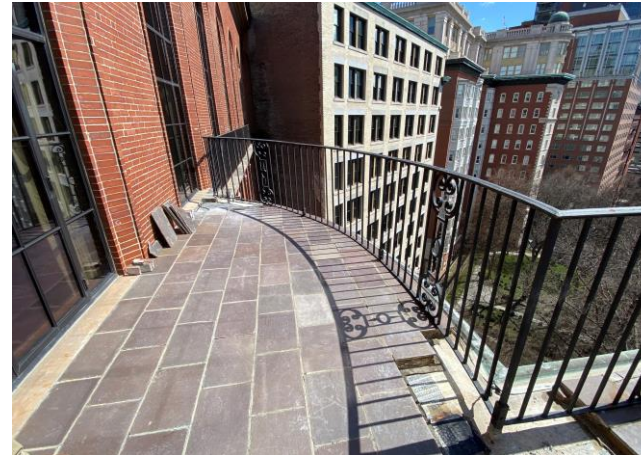
Photo 8: The fifth-floor balcony (shown) and second-floor balconies are not open due to safety concerns.

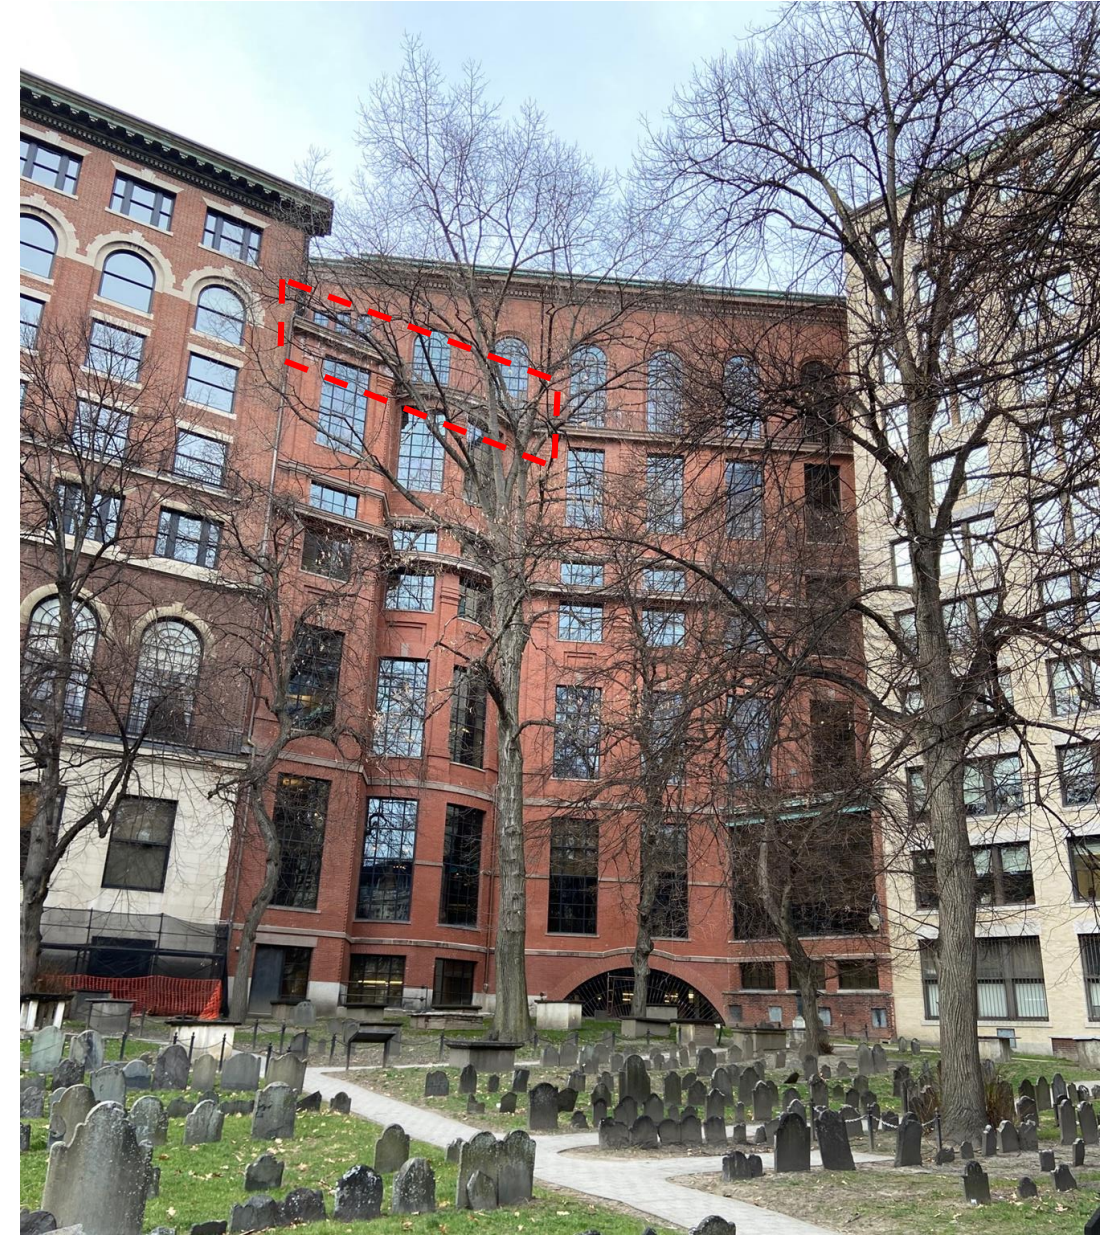
Proposed Balcony Rehabilitation - Overview

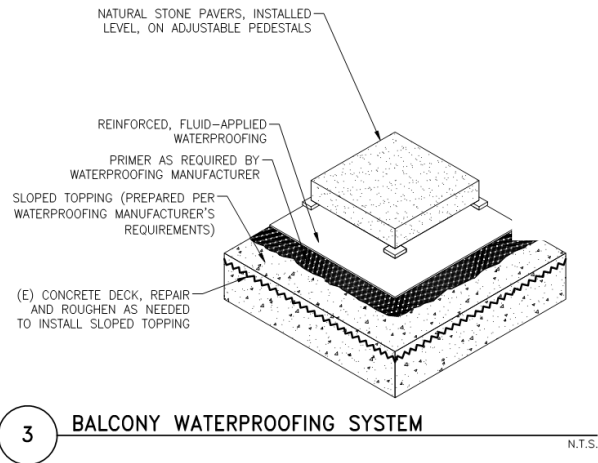
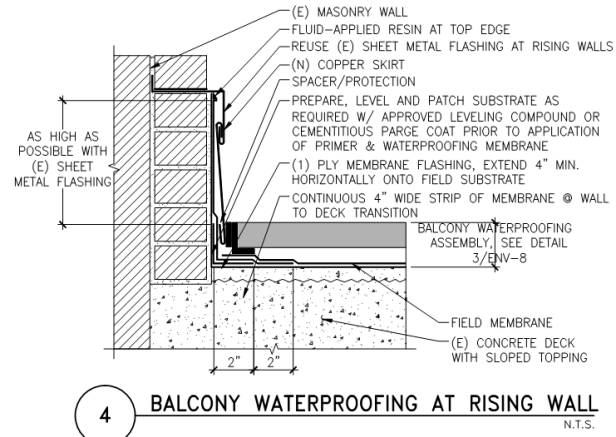
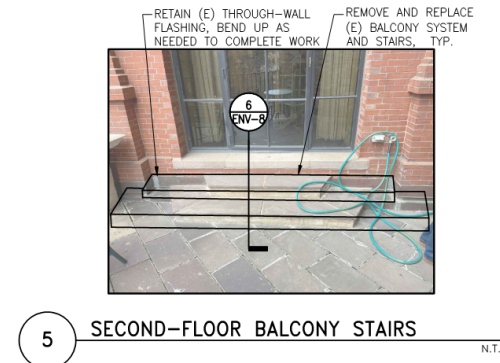
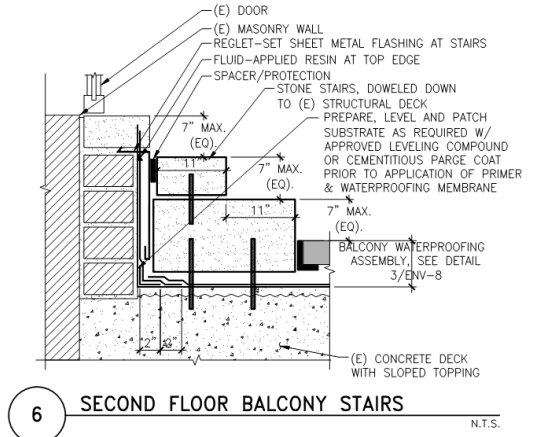
Proposed Balcony Rehabilitation - Railings

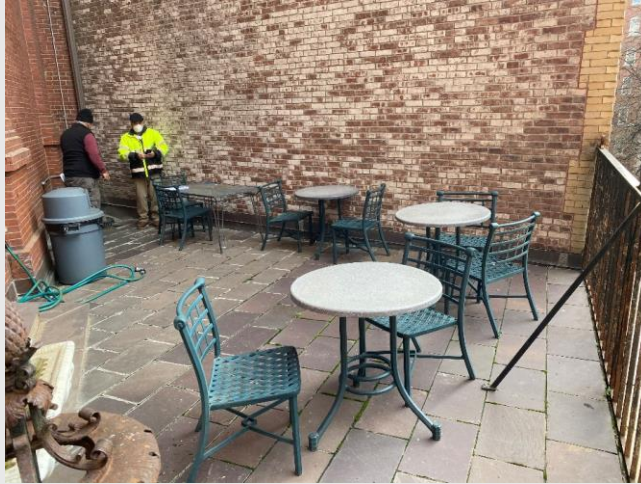
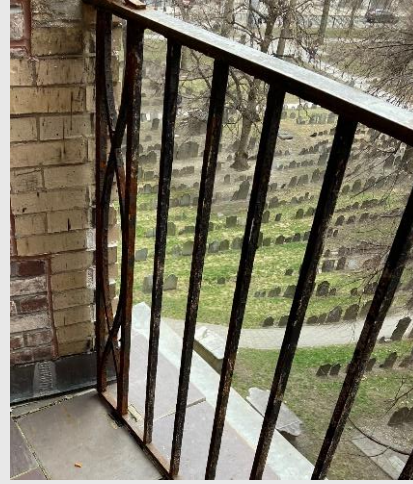
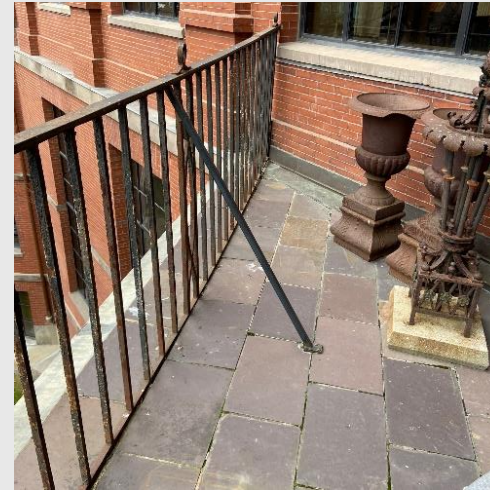
Replicate end panel at second-floor balcony

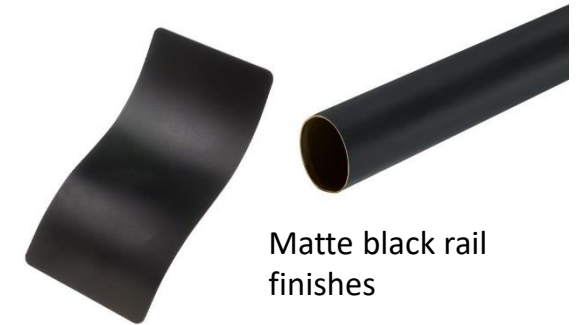
Matte black rail finishes

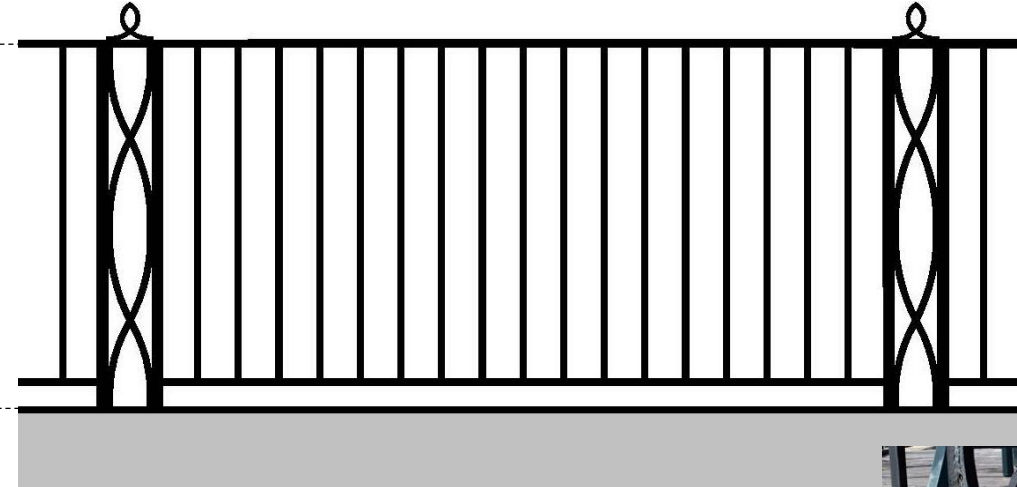
New guardrail elevation

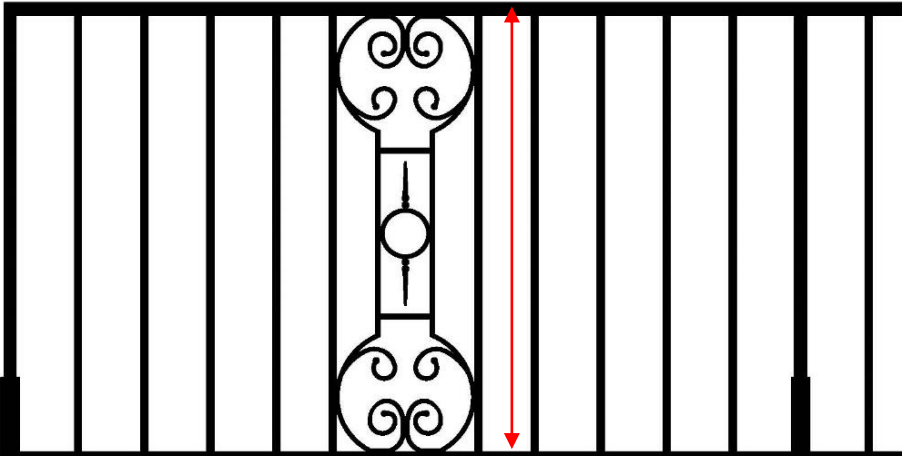
Existing guardrail elevation

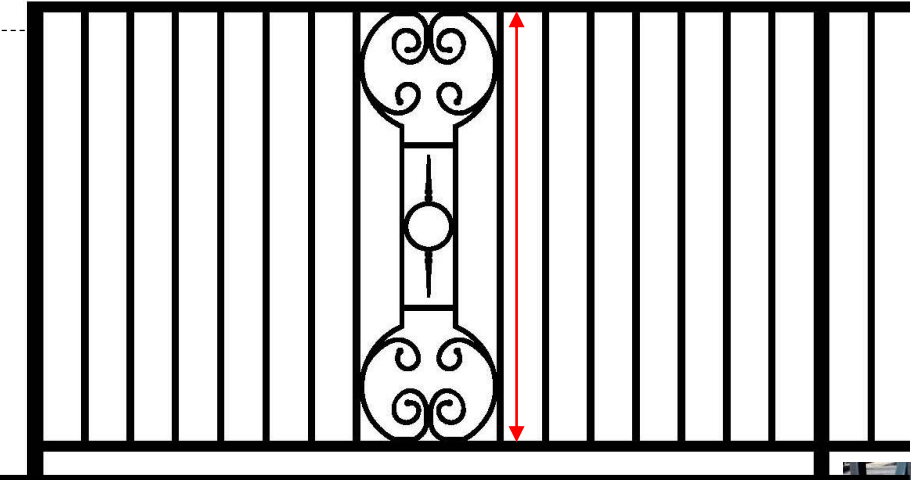
New guardrail elevation
