# **CERTIFICATE of APPROPRIATENESS / HEARING CONTINUATION of APP # 20.1067 BH**

**Re:** 2 Park Street / Fire Escape Repair  
Park Street Church

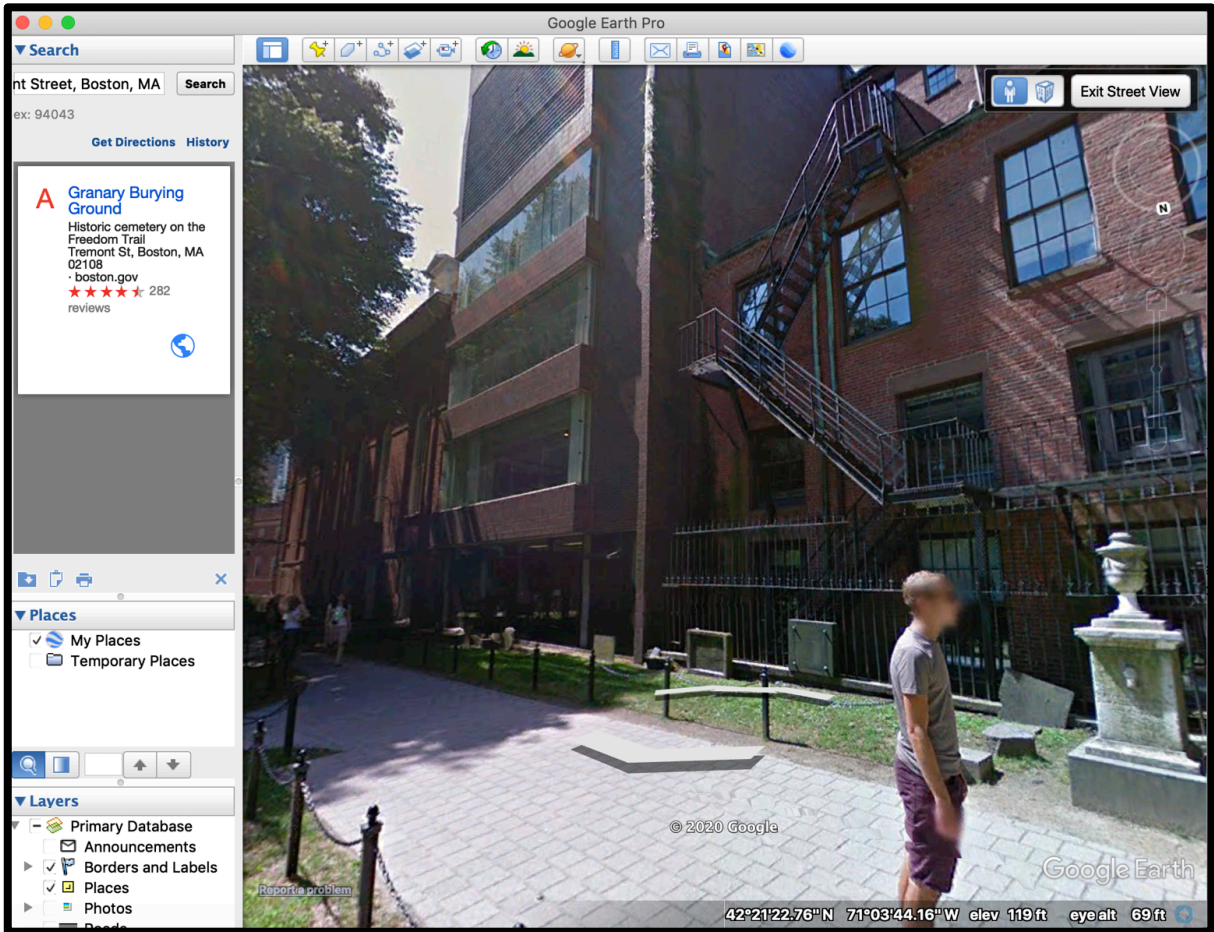
During the hearing, a view of the fire escape was shown via Google Earth (see similar image attached). The lighting in this image revealed that the vertical bracket as proposed would be quite visible since it would be in a similar plane as the leading edge of the fire escape stringers and open side guard rails. Those leading edges catch the limited light that filters through the trees, whereas the existing diagonal bracket is in shadow. Seeing this view, the Commission did not accept the proposed vertical bracket and continued the hearing so that alternates to supporting the third floor landing could be reviewed. (The Architect had never seen the façade in this particular light during site visits and agreed with the Commission's directive.)
