## Notes to accompany Beacon Hill Architectural Commission Application

## October 28, 2020

## SUBJECT: Replace broken sidewalk at 10 Walnut Street - Beacon Hill

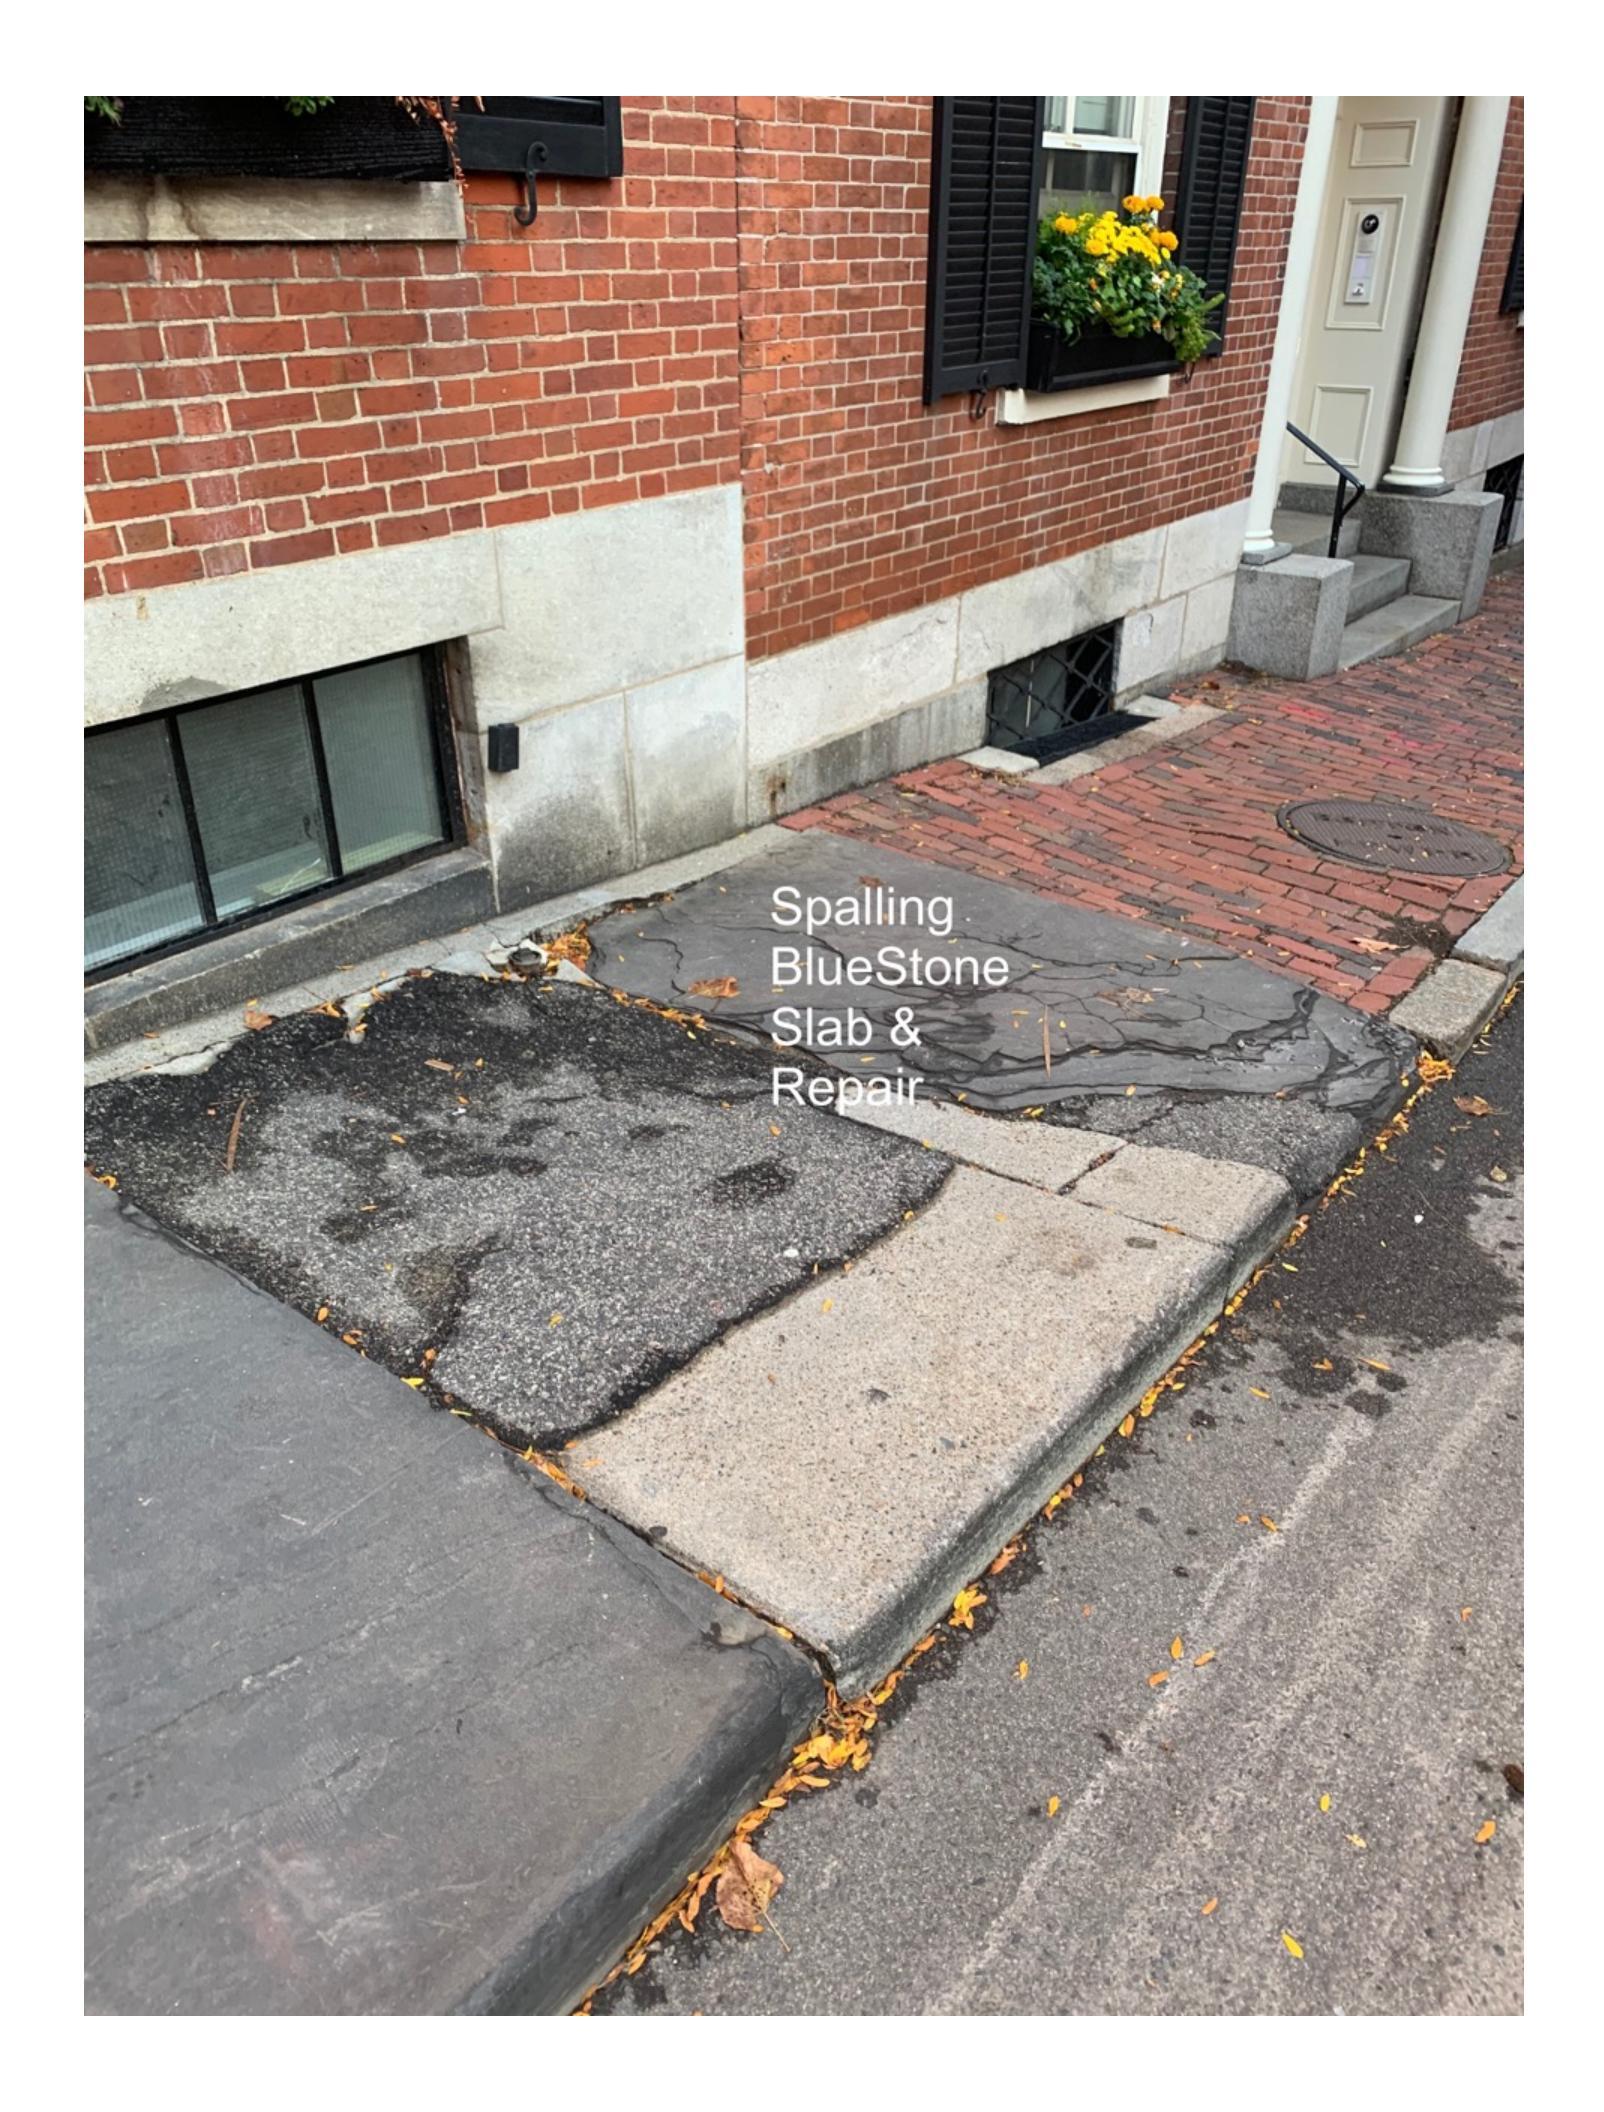
- The bluestone slabs are a liability concern for all involved. The Southerly section
  of slab closest to Beacon Street was cracked many, many years ago presumably
  due to an oil fill pipe being installed. Trucks double park on it and it fluctuates
  greatly when actively driven upon. It's a matter of time before it fails structurally
  despite being repaired (by the former owners) with concrete. <u>See attached
  photos</u>.

- The new proposed curbs will be granite to match existing in the neighborhood and set at a curb reveal of 5" which will prohibit double parking & deliveries. Contractors park there constantly requiring multiple BTD visits and causing neighbor frustrations.

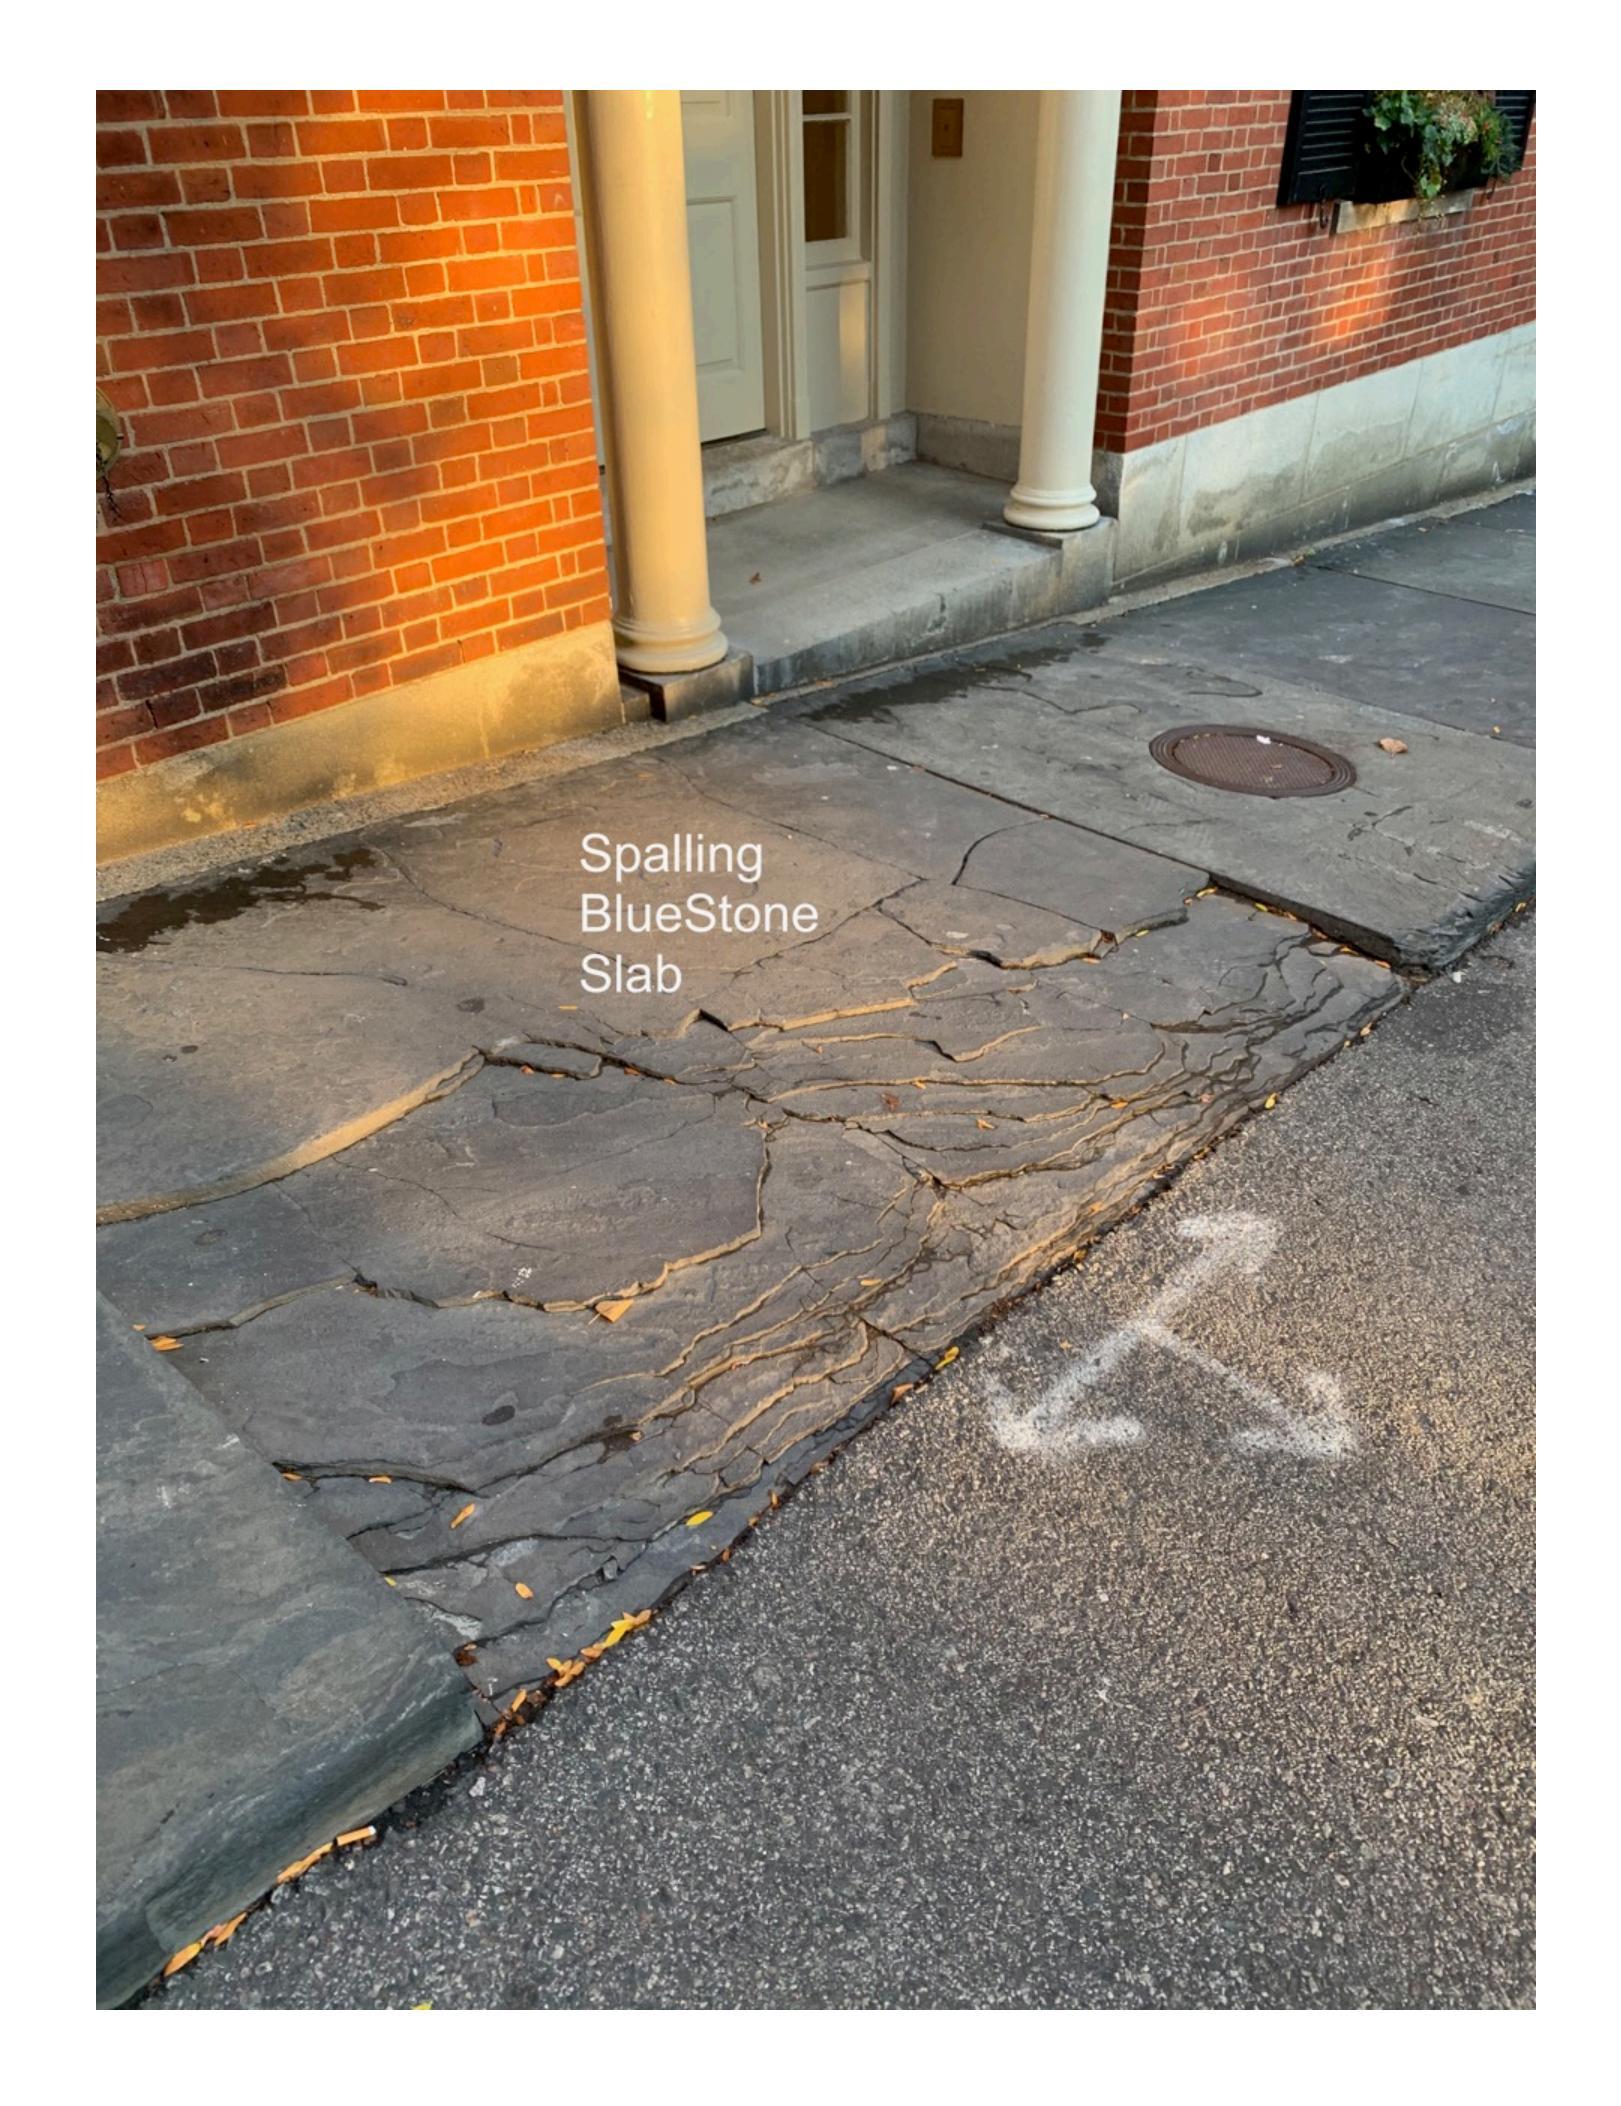
- Due to constant driving onto the sidewalk, the outside edge of the bluestone is worn down significantly to where it's only an inch or two above the street; promoting double parking of delivery trucks and area contractors on the sidewalk. There is no curbing now, just the edges of the slabs themselves worn down to an inch or two.

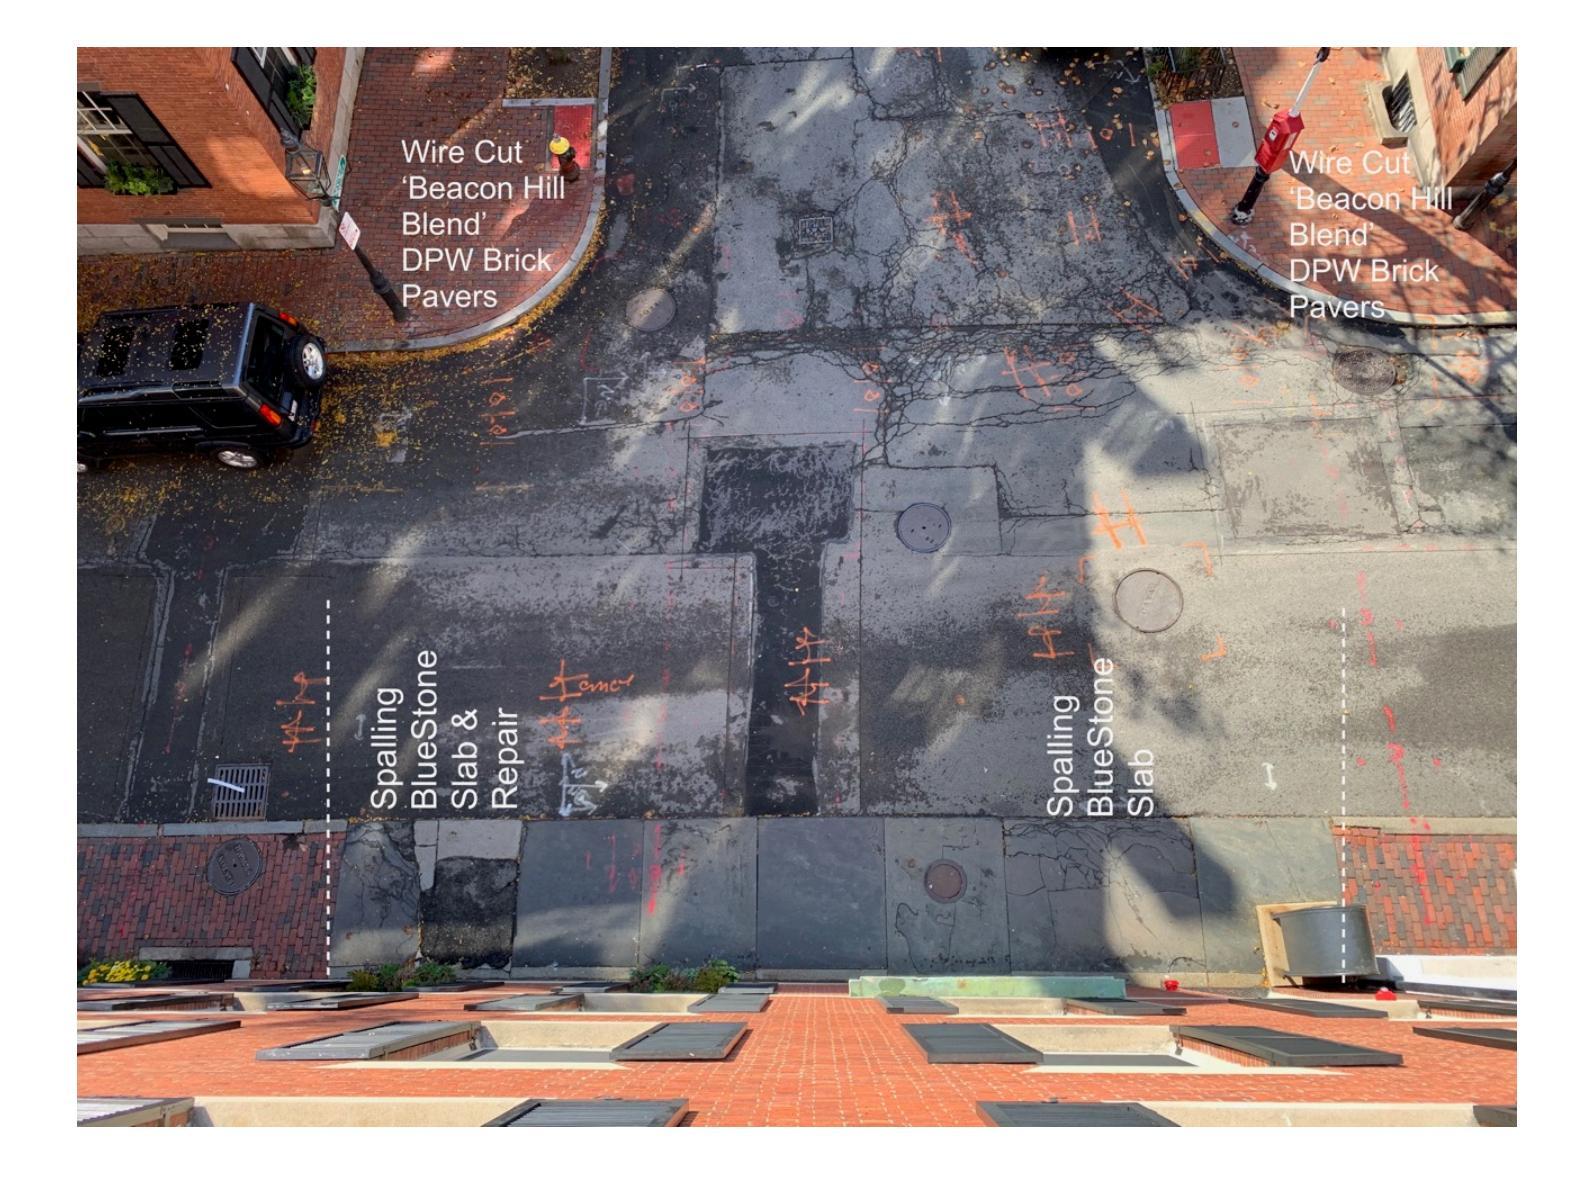
- You can see the existing 'coal hole' in the bird's eye photo. This will be retained for historic reasons.
- Both the slip resistance and un-evenness of the slabs makes it next to impossible to meet Accessibility requirements. The new DPW brick spec will comply with slip resistance and the installation will meet the Federal rule of max. 2% cross-pitch.
