256 - 260 NEWBURY STREET

CHEVRON PARTNERS

JUNE 20, 2023

FACADE RESTORATION - PUBLIC ALLEY

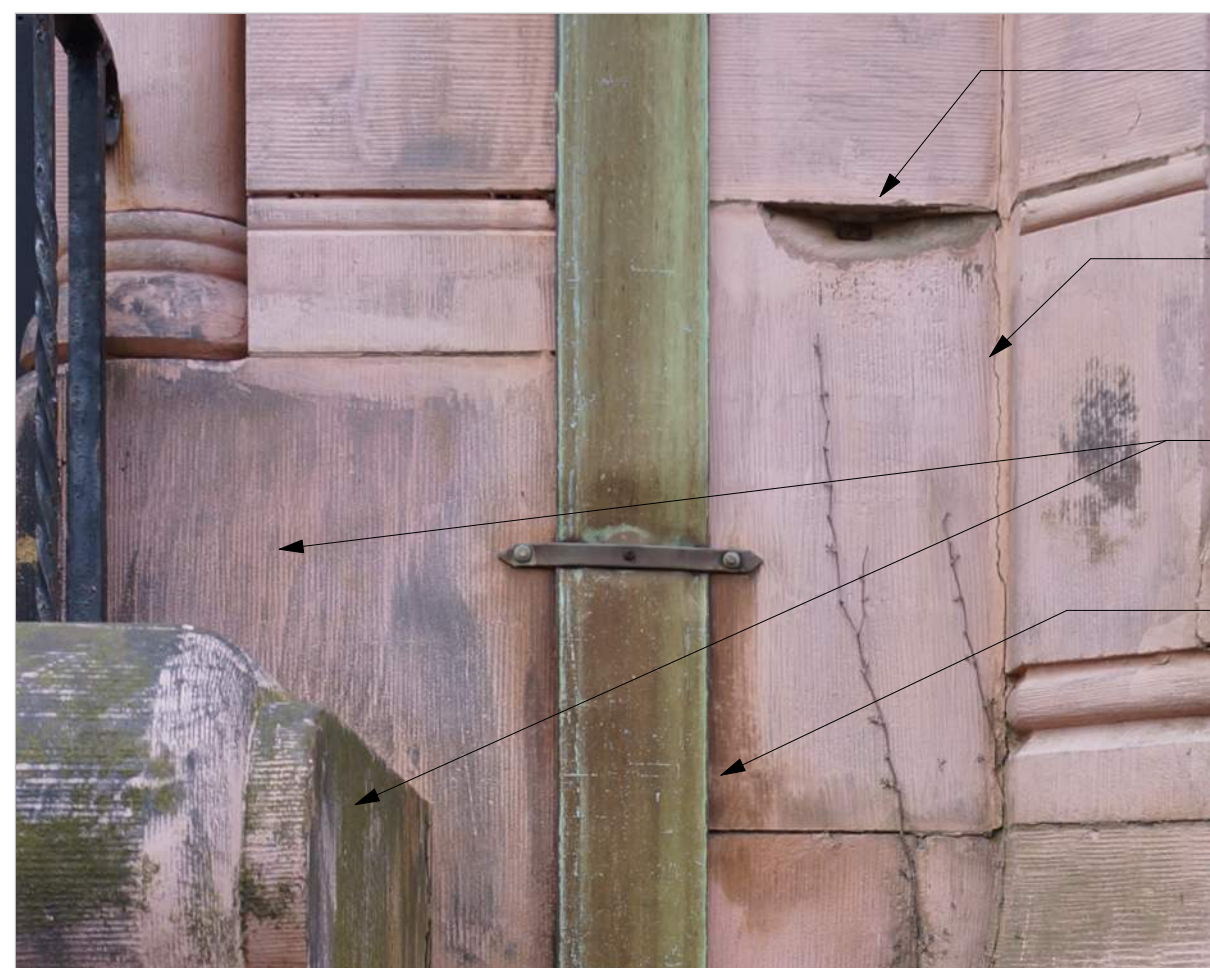
DETAIL 01

SPALLED STONE
 CRACKED STONE
 WORN PAINT FINISH
 STAINED STONE

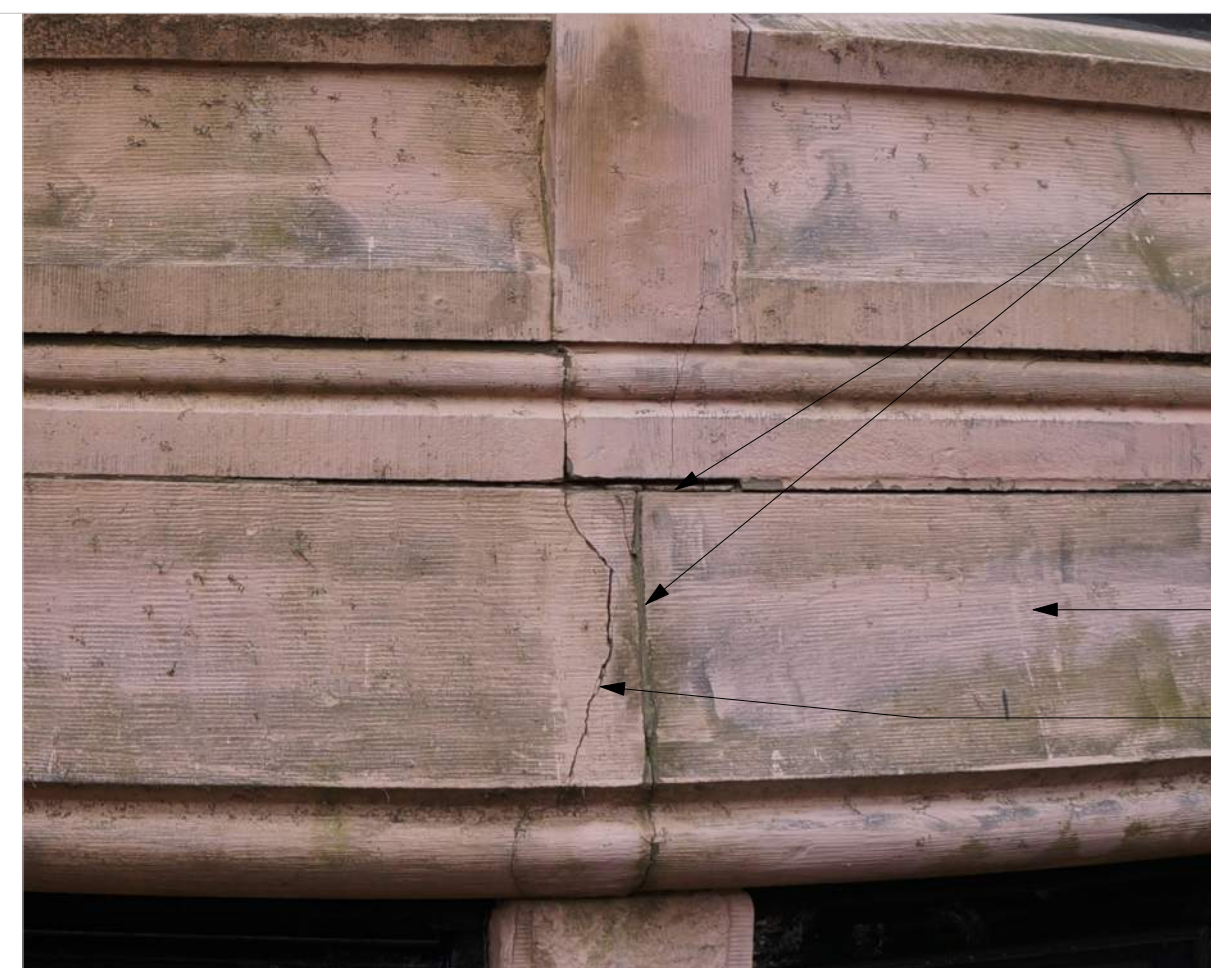
DETAIL 02

DAMAGED MORTAR, TYPICAL ENTIRE FACADE, ALL THREE ADDRESSES
 STONE DAMAGE
 WORN PAINT FINISH
 CRACKED STONE

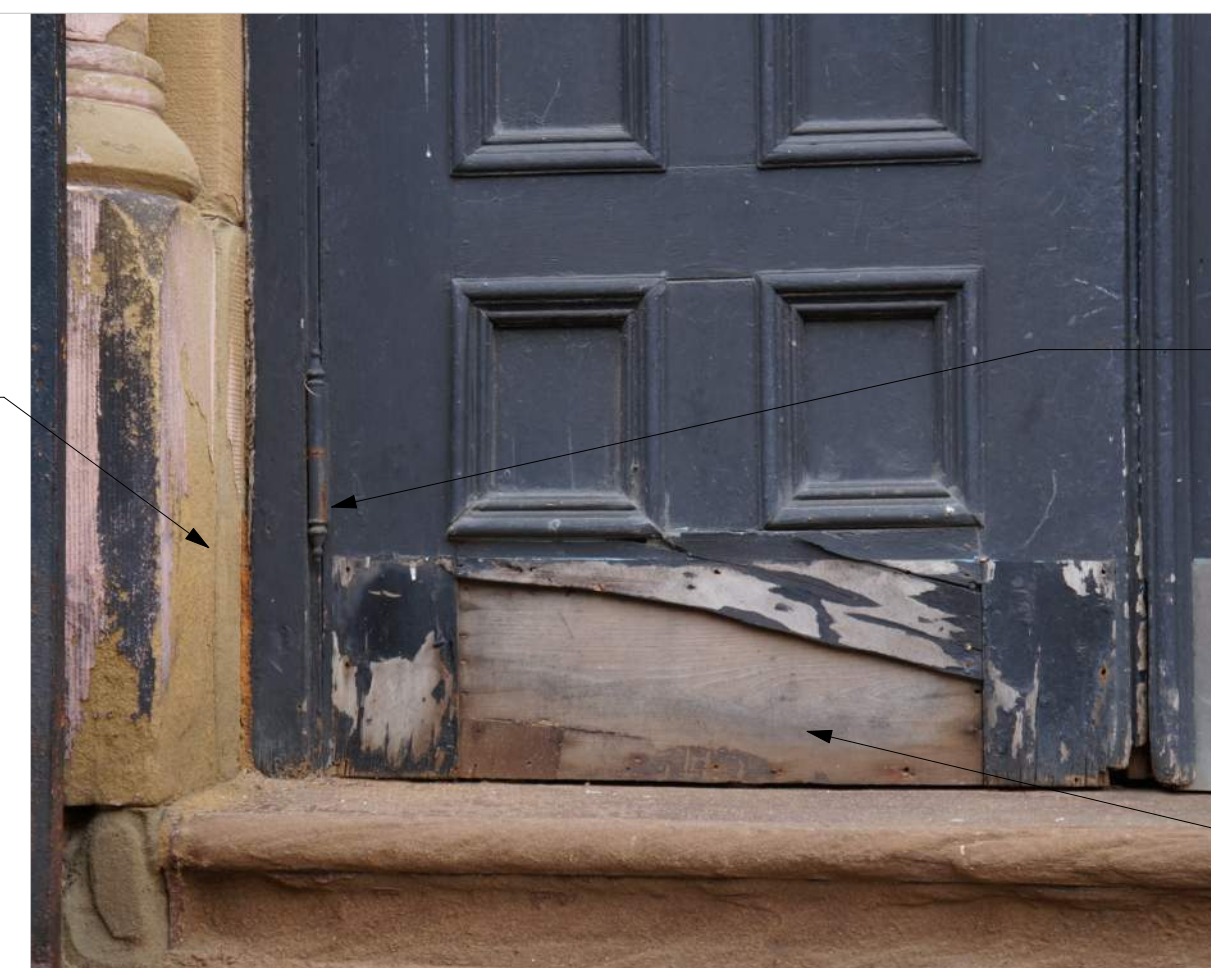
DETAIL 03

CORRODED HARDWARE
 DELAMINATED WOOD DOOR

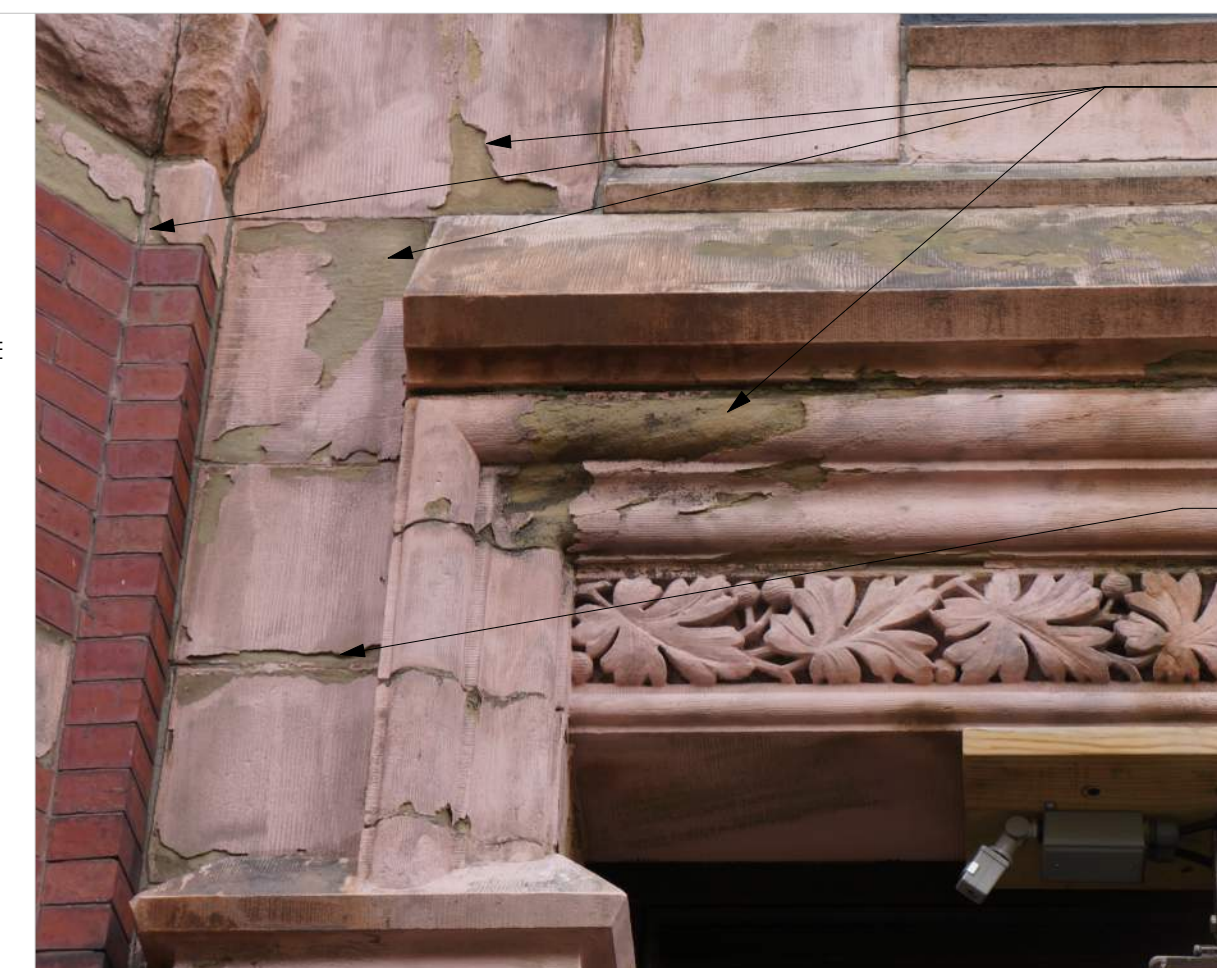
DETAIL 04

CHIPPED PAINT FINISH
 STONE DAMAGE

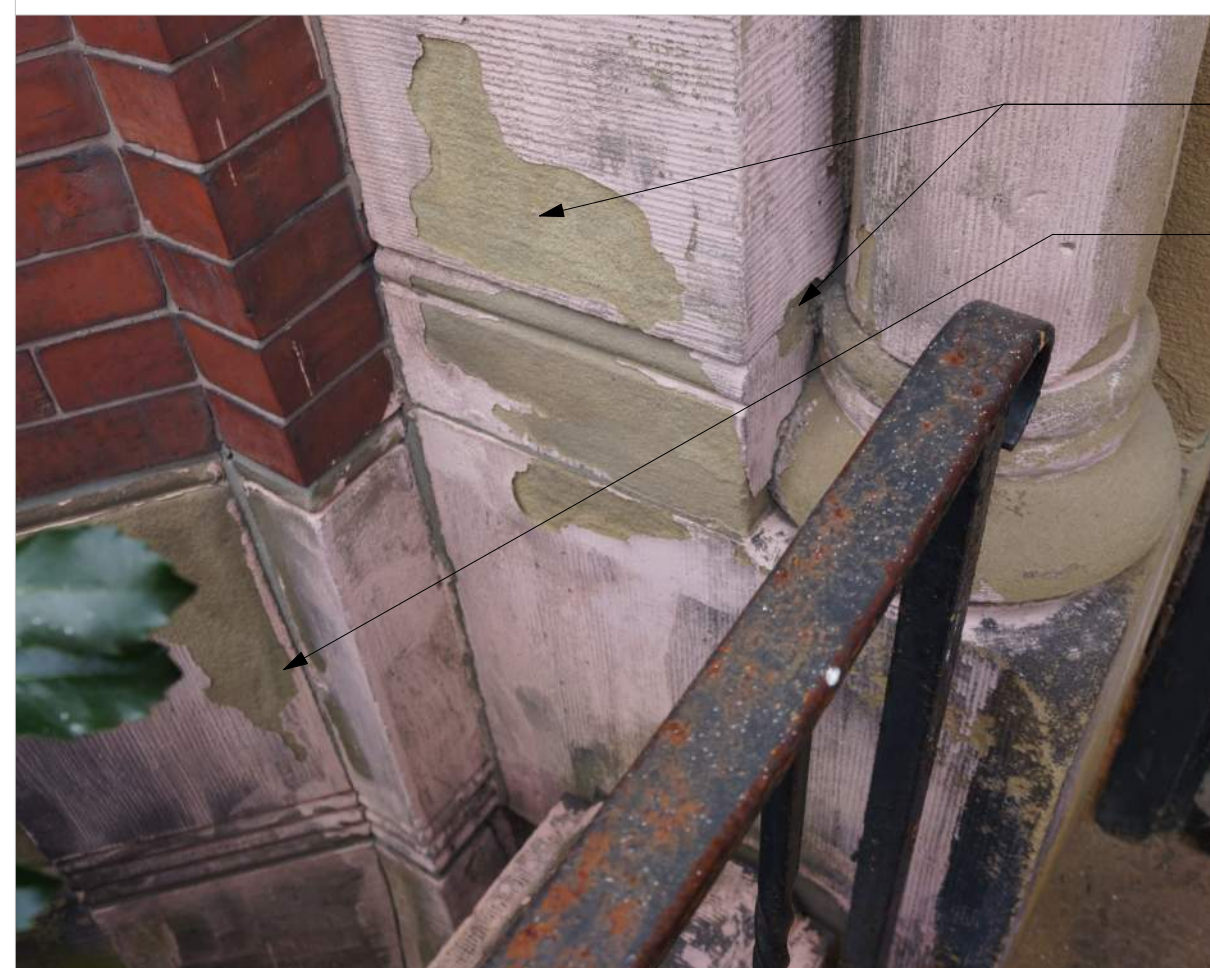
DETAIL 05

STONE DAMAGE
 CHIPPED PAINT

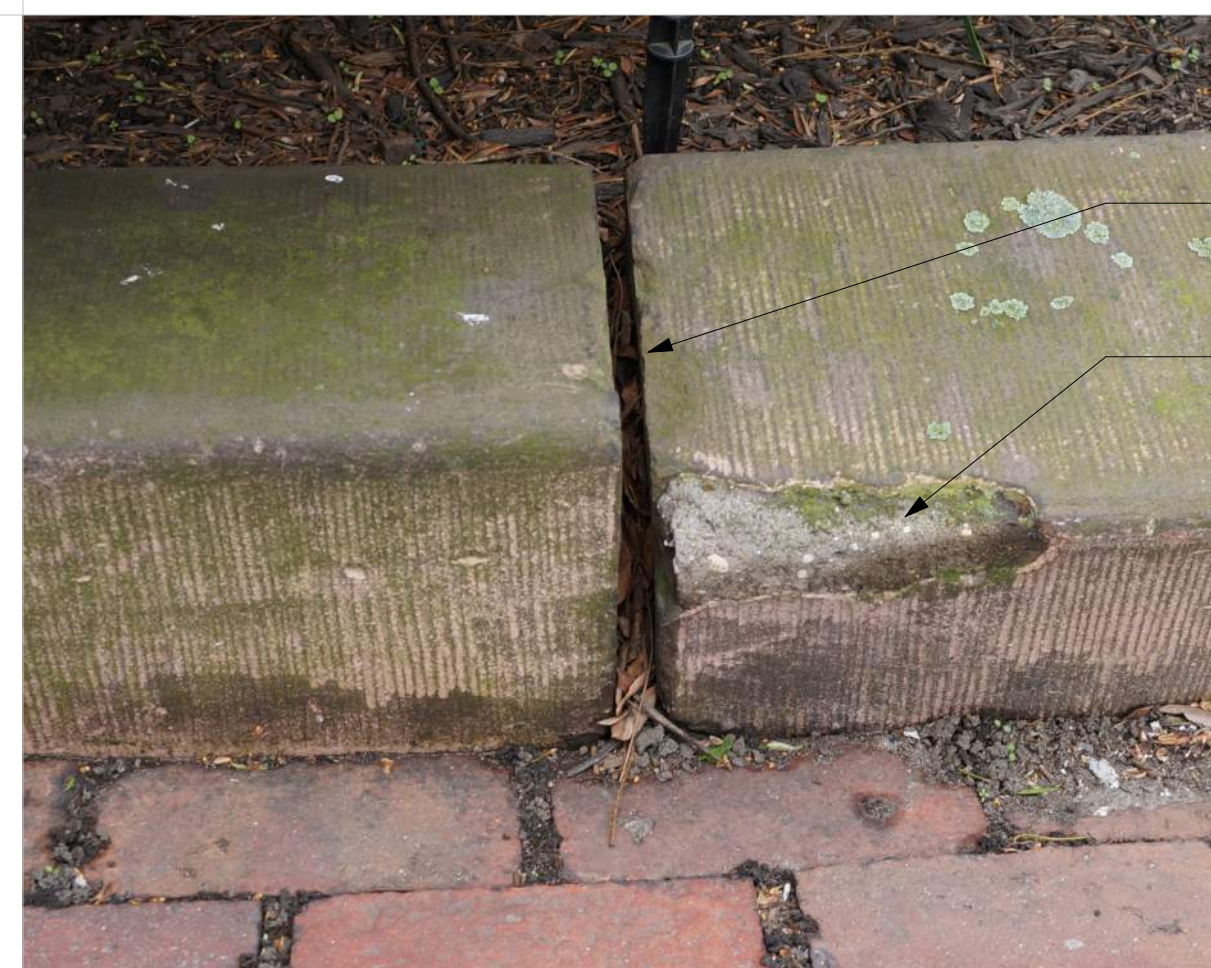
DETAIL 06

STONE MISALIGNMENT
 STONE DAMAGE

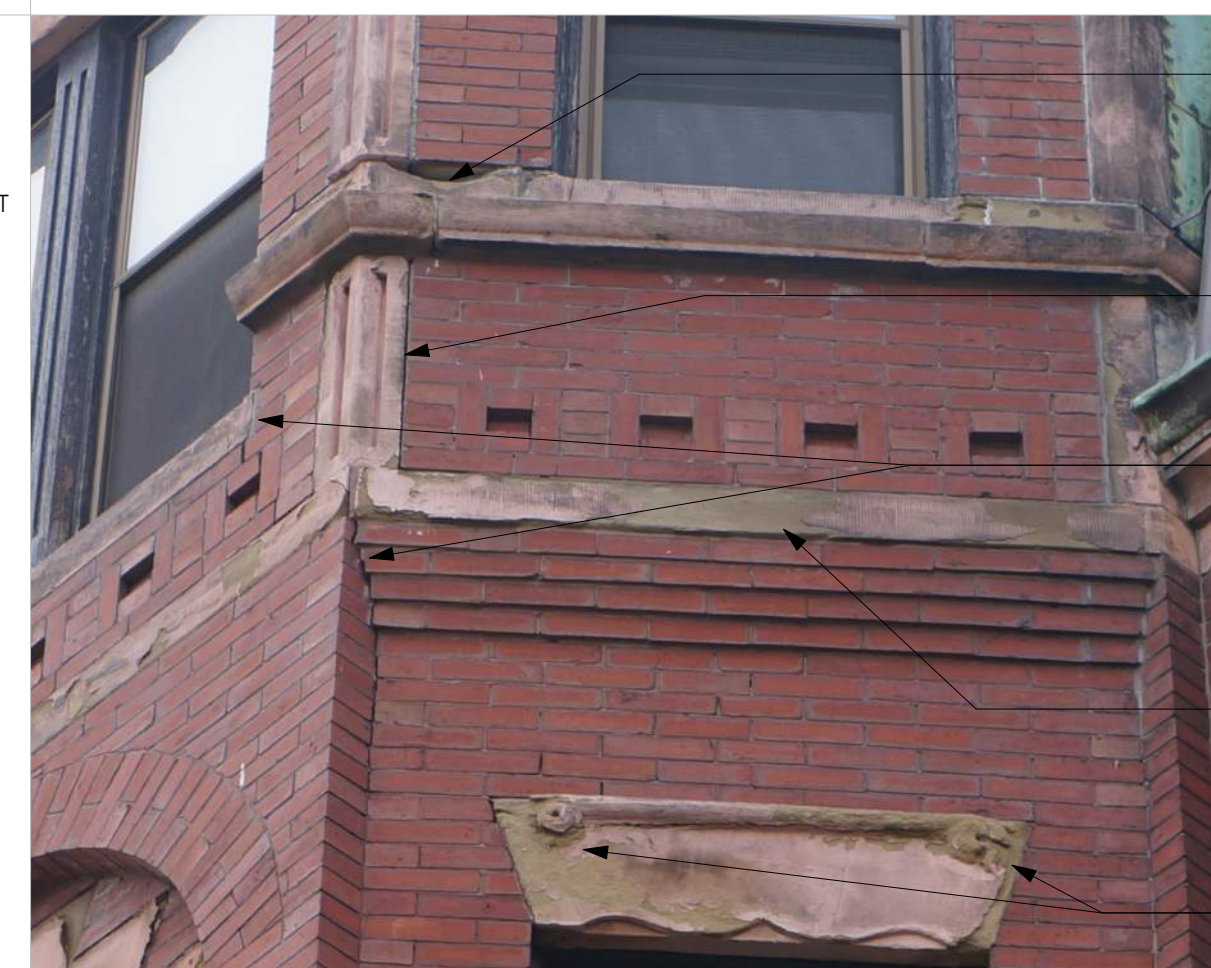
DETAIL 07

STONE SPALLING
 CRACKED MASONRY JOINT, POSSIBLE WALL DELAMINATION
 MORTAR DAMAGE
 CHIPPED AND WORN PAINT FINISH
 DAMAGED STONE

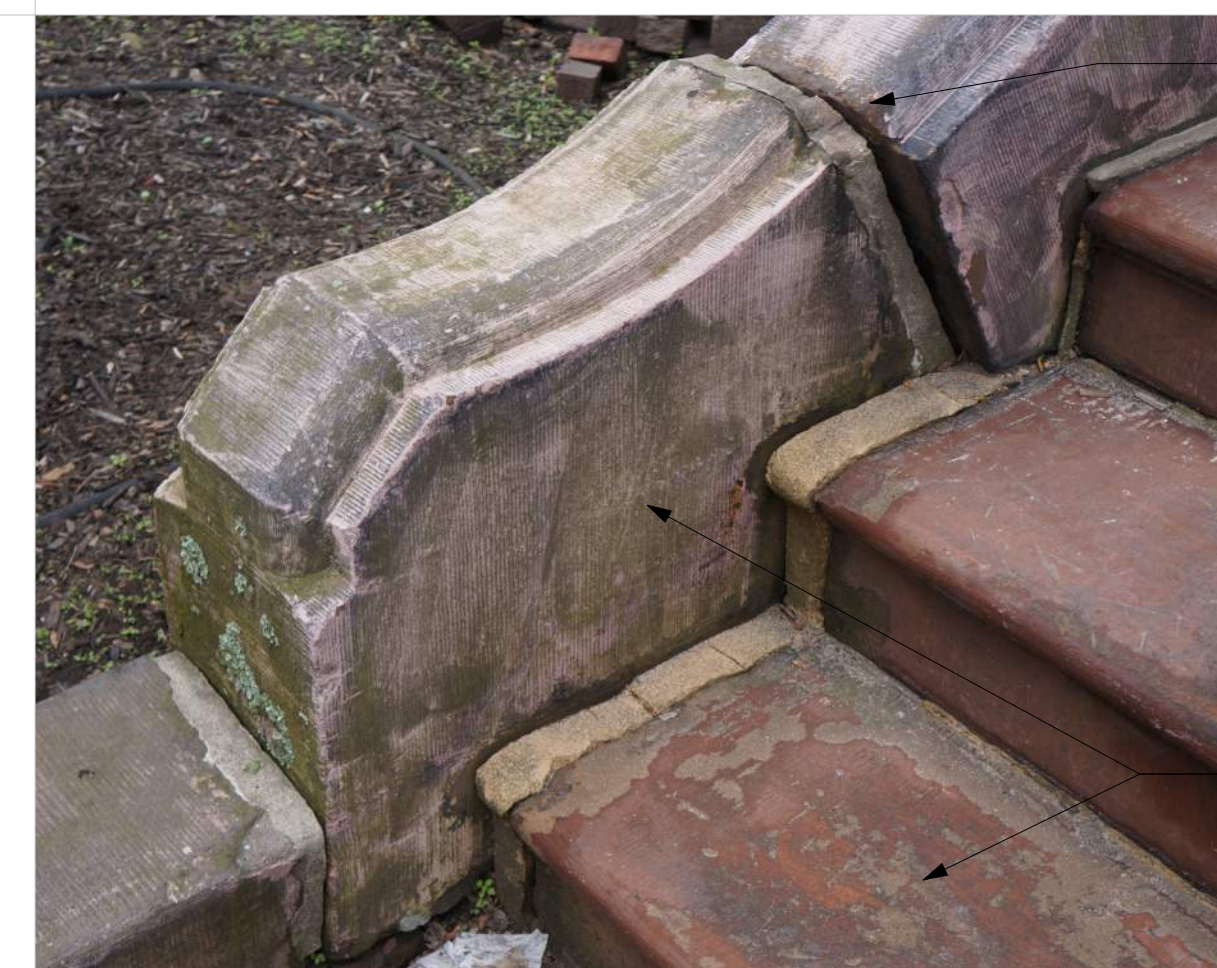
DETAIL 08

MISALIGNED STONE
 WORN PAINT

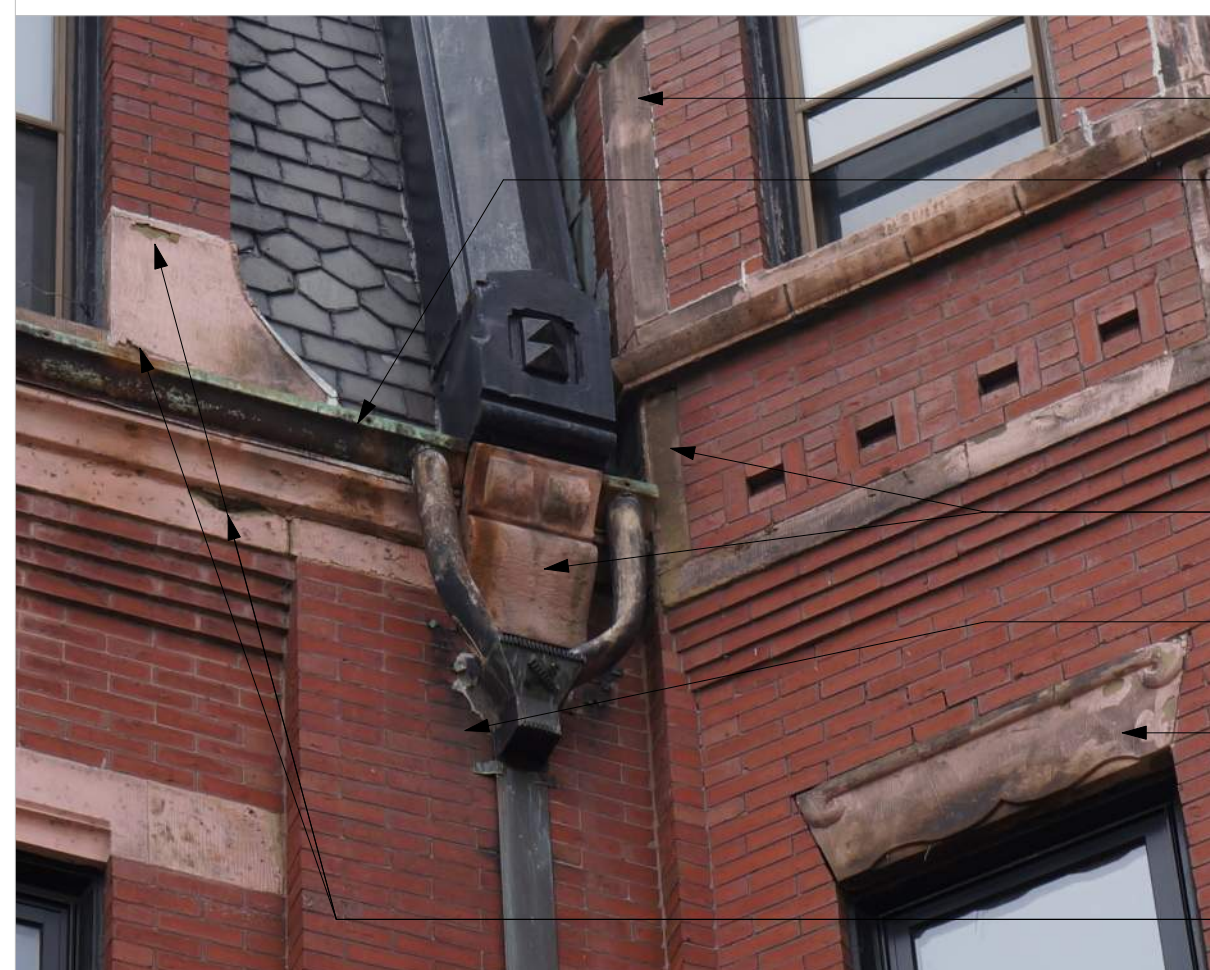
DETAIL 09

STAINED AND WORN PAINT FINISH
 CORRODED COPPER GUTTER AND DETAILS
 CORROSION STAINING
 MISSING AND DAMAGED LEADER DETAILS
 STAINING AND CHIPPED PAINT FINISH
 SPALLED STONE

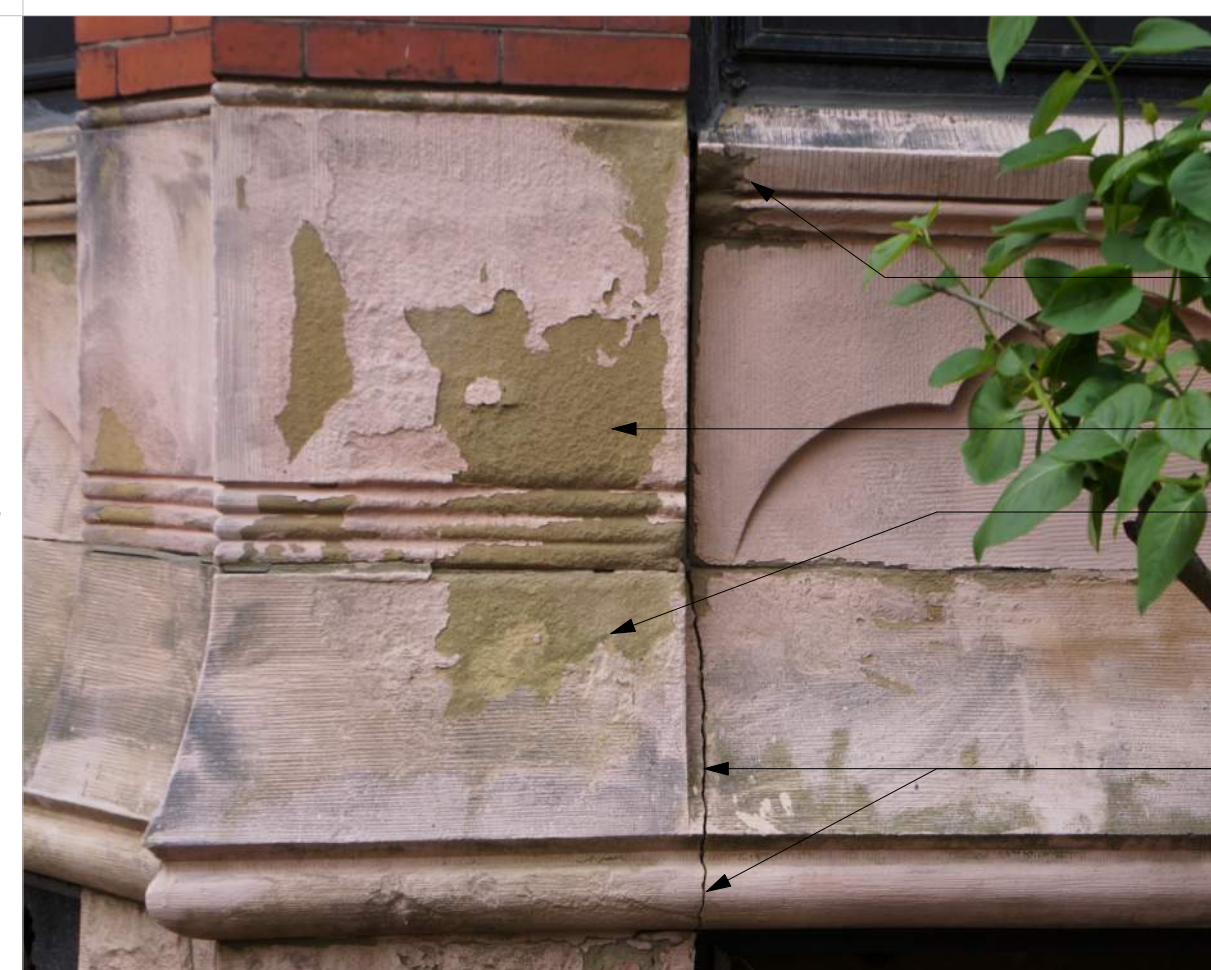
DETAIL 10

DAMAGED STONE
 CHIPPED PAINT FINISH
 DAMAGED STONE SURFACE (MISSING STRIATED FINISH) TYPICAL WHERE PAINT HAS CHIPPED OFF
 CRACKED STONE

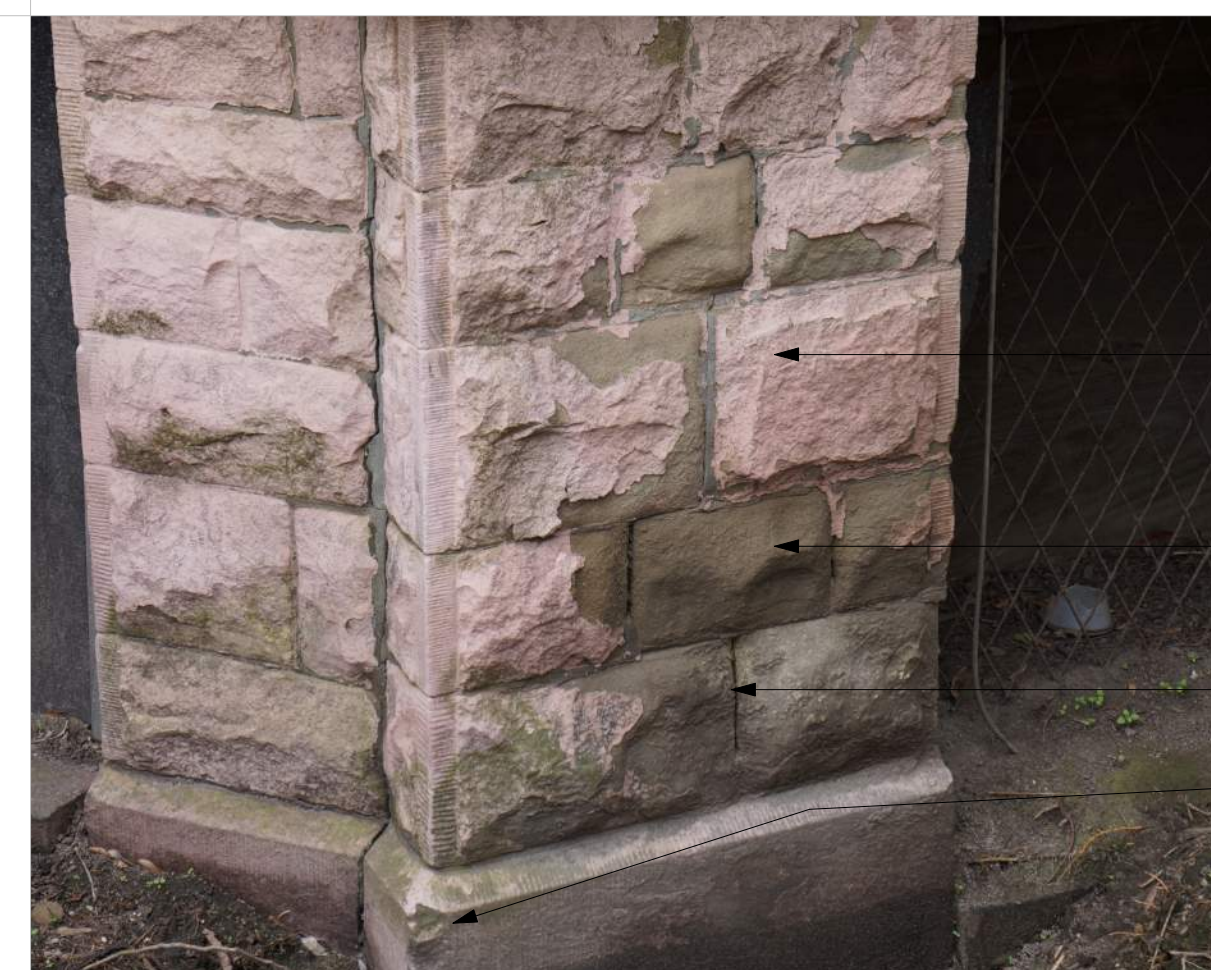
DETAIL 11

REMOVE STONE AT GROUND
 CHIPPED PAINT FINISH
 MORTAR DAMAGE
 DAMAGED STONE

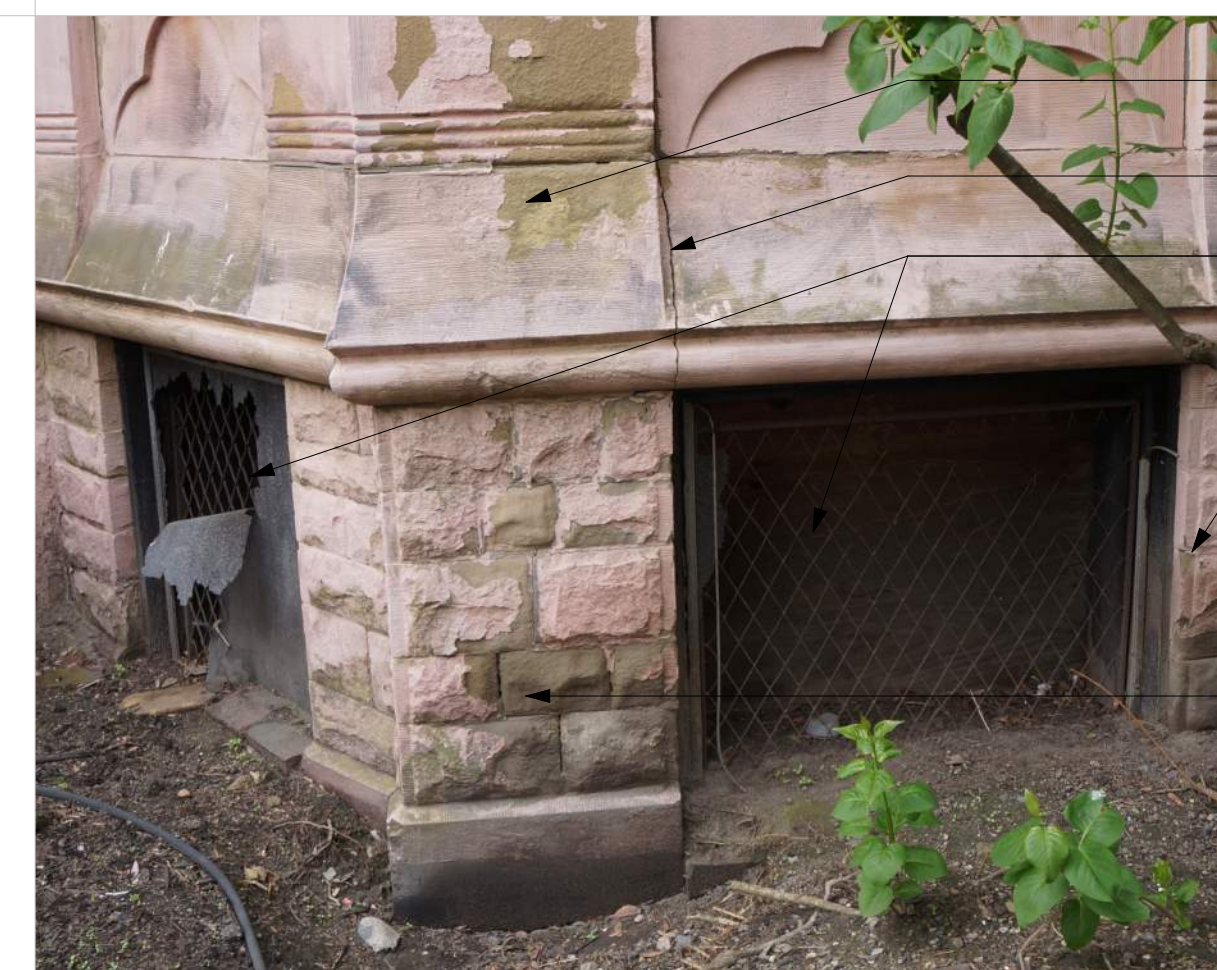
DETAIL 12

REPAIR STONE
 CRACKED STONE
 DAMAGED METAL GRILLE
 DAMAGED WOOD AND PAINT AT BRICK MOULD AND WINDOW FRAME
 REMOVE STONE AT GROUND

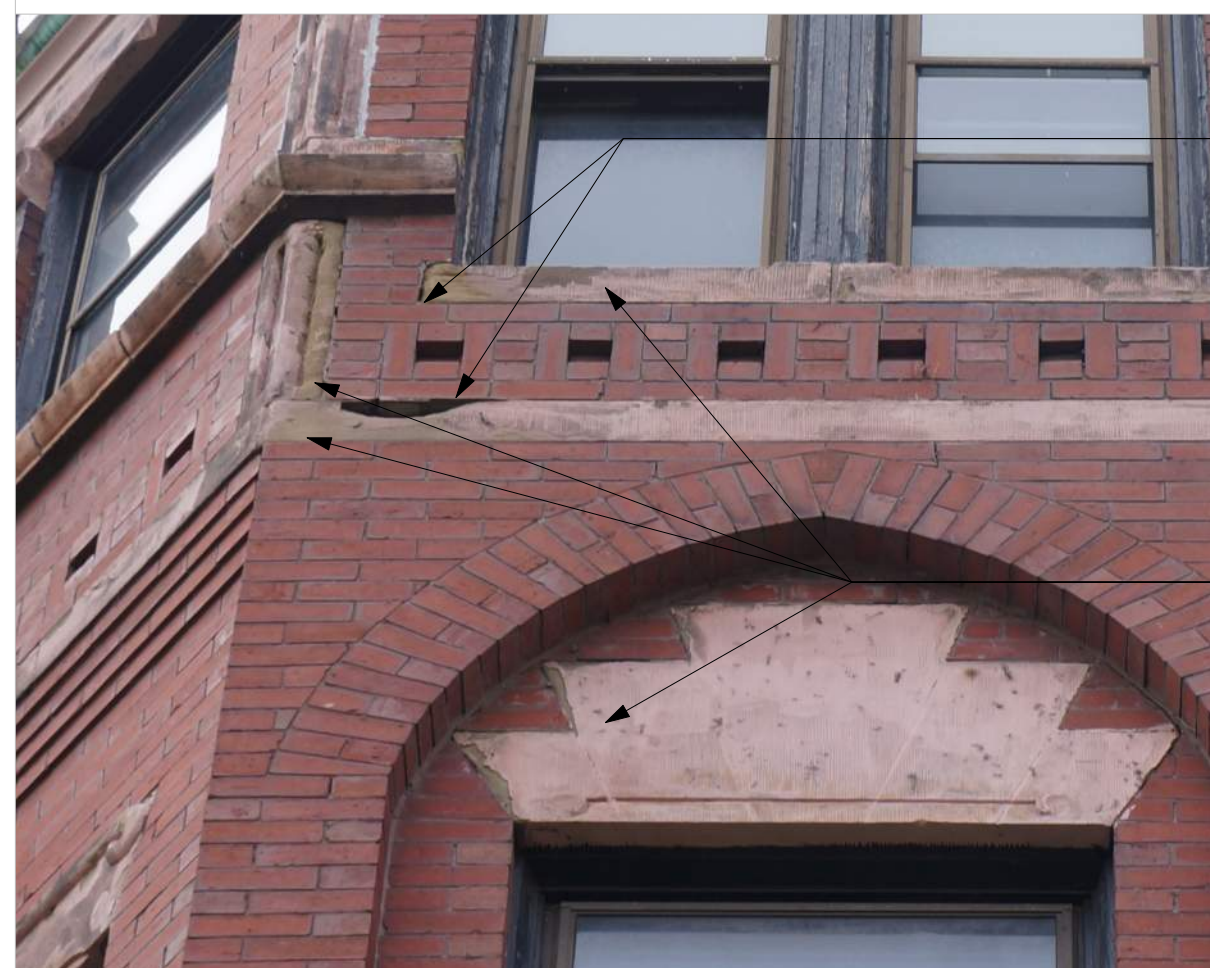
DETAIL 13

SPALLED STONE
 CHIPPED AND WORN PAINT FINISH

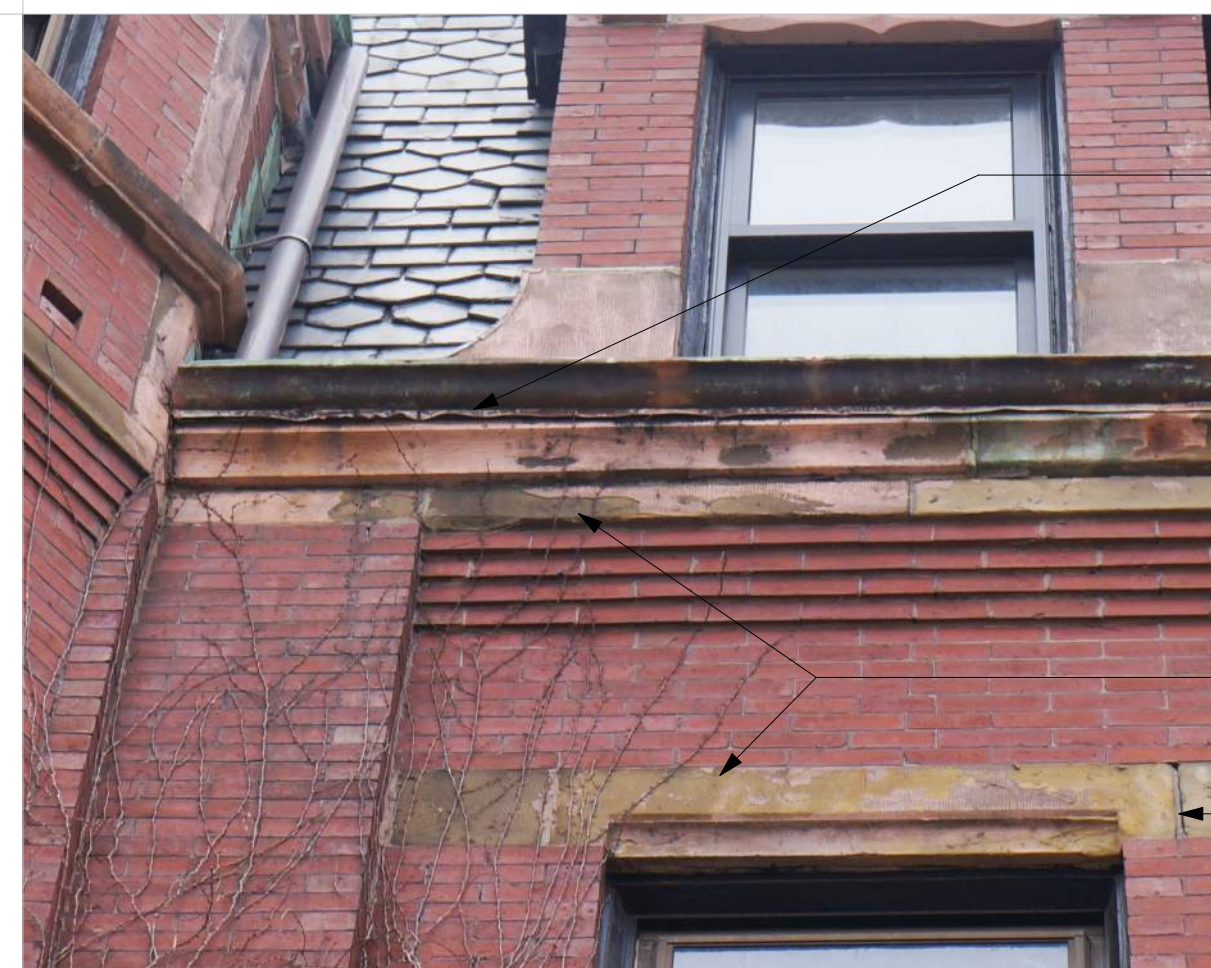
DETAIL 14

CORRODED AND DAMAGED COPPER GUTTER AND FLASHING
 CHIPPED PAINT AND DAMAGED STONE
 DAMAGED MORTAR

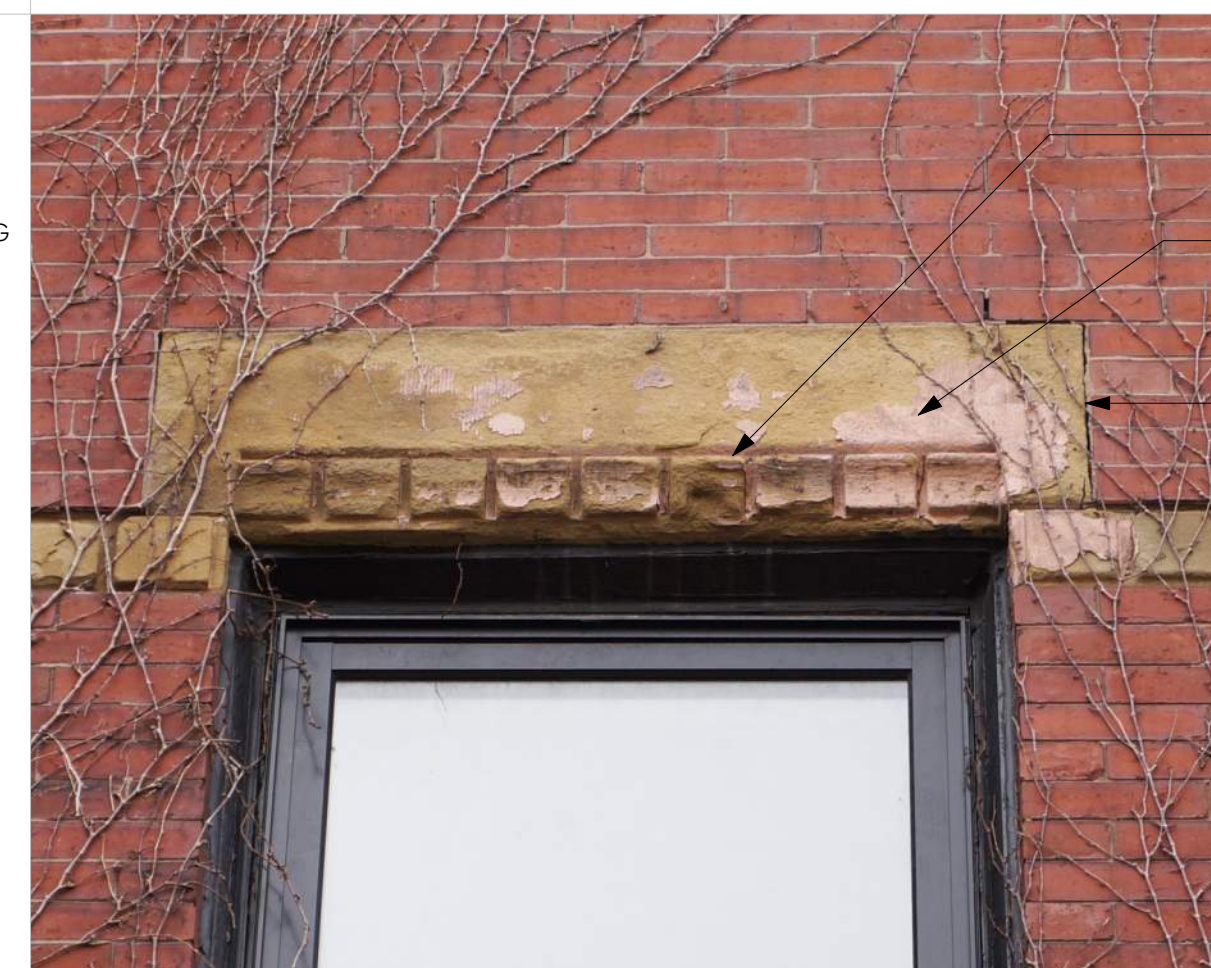
DETAIL 15

DAMAGED STONE DETAILS
 CHIPPED PAINT FINISH
 DAMAGED MORTAR

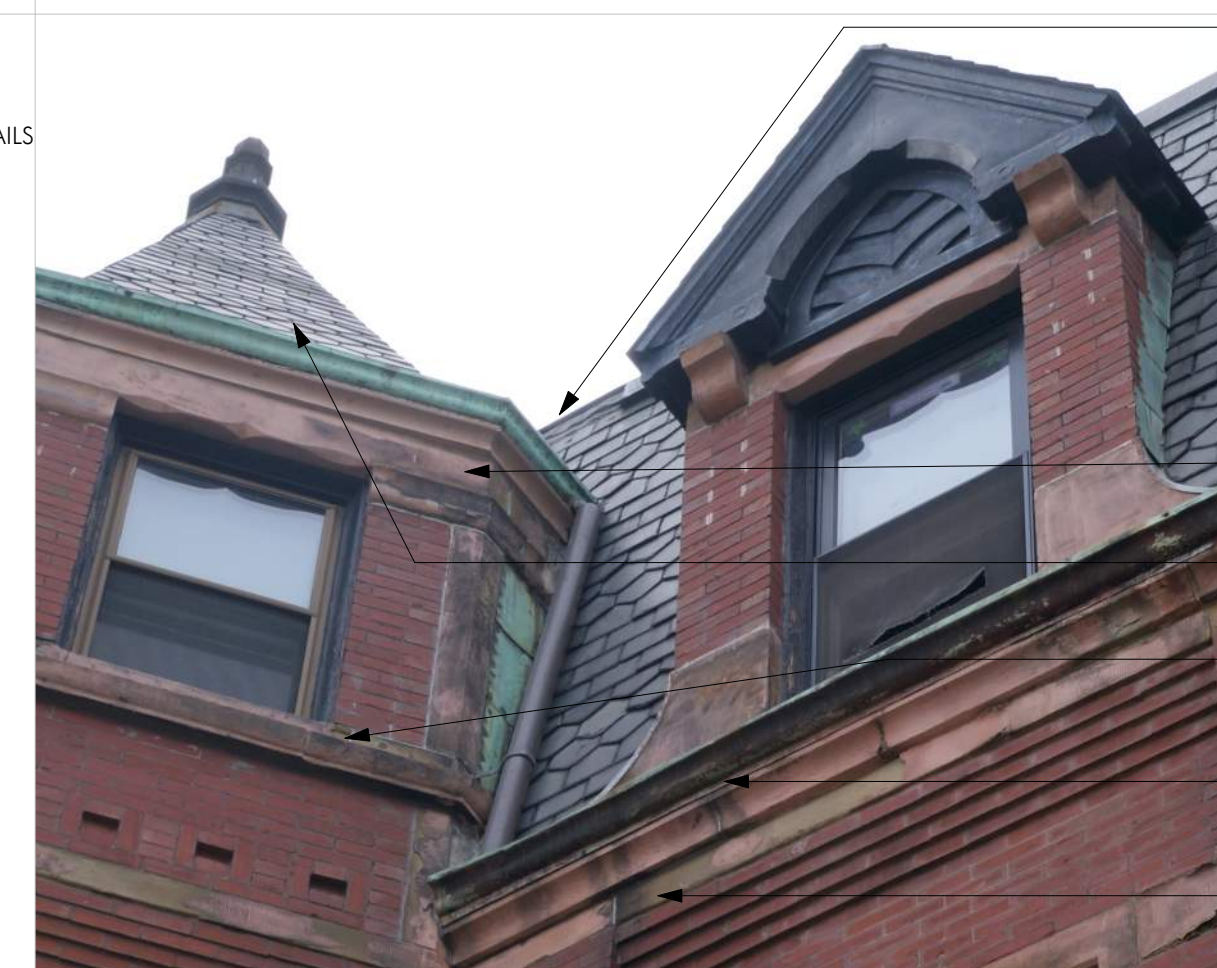
DETAIL 16

MISSING FLASHING
 STAINED AND WORN PAINT FINISH
 CRACKED SLATE ROOF SHINGLE
 DAMAGED STONE
 CORRODED AND DAMAGED COPPER GUTTER AND FLASHING
 DAMAGED STONE AND CHIPPED PAINT FINISH

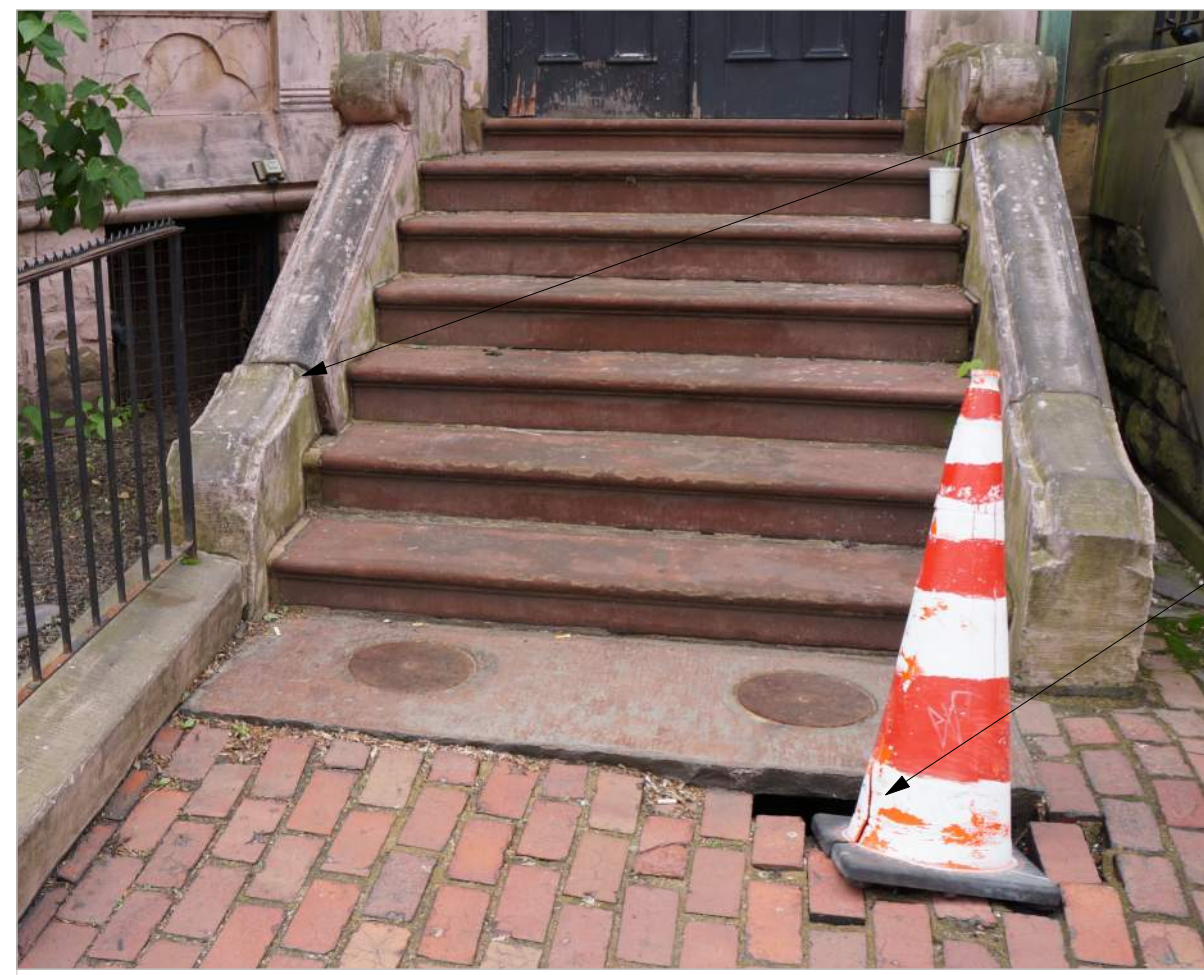
DETAIL 32

JARRED STONE

COLLAPSED SIDEWALK & STAIR BASE

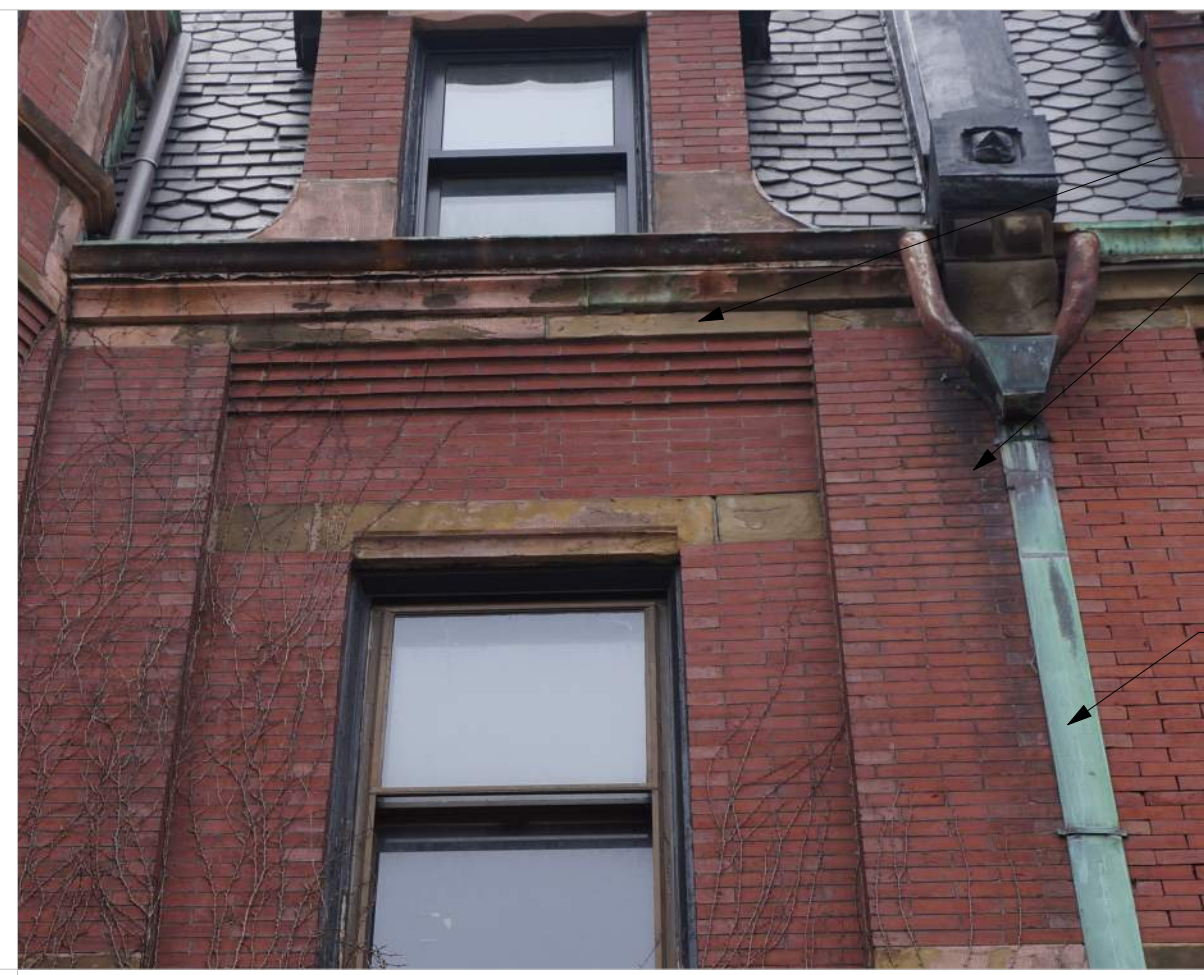
DETAIL 33

STONE DAMAGE & STAINING

STAINED BRICK

CORRODED GUTTER & DOWNSPOUTS, TYP.

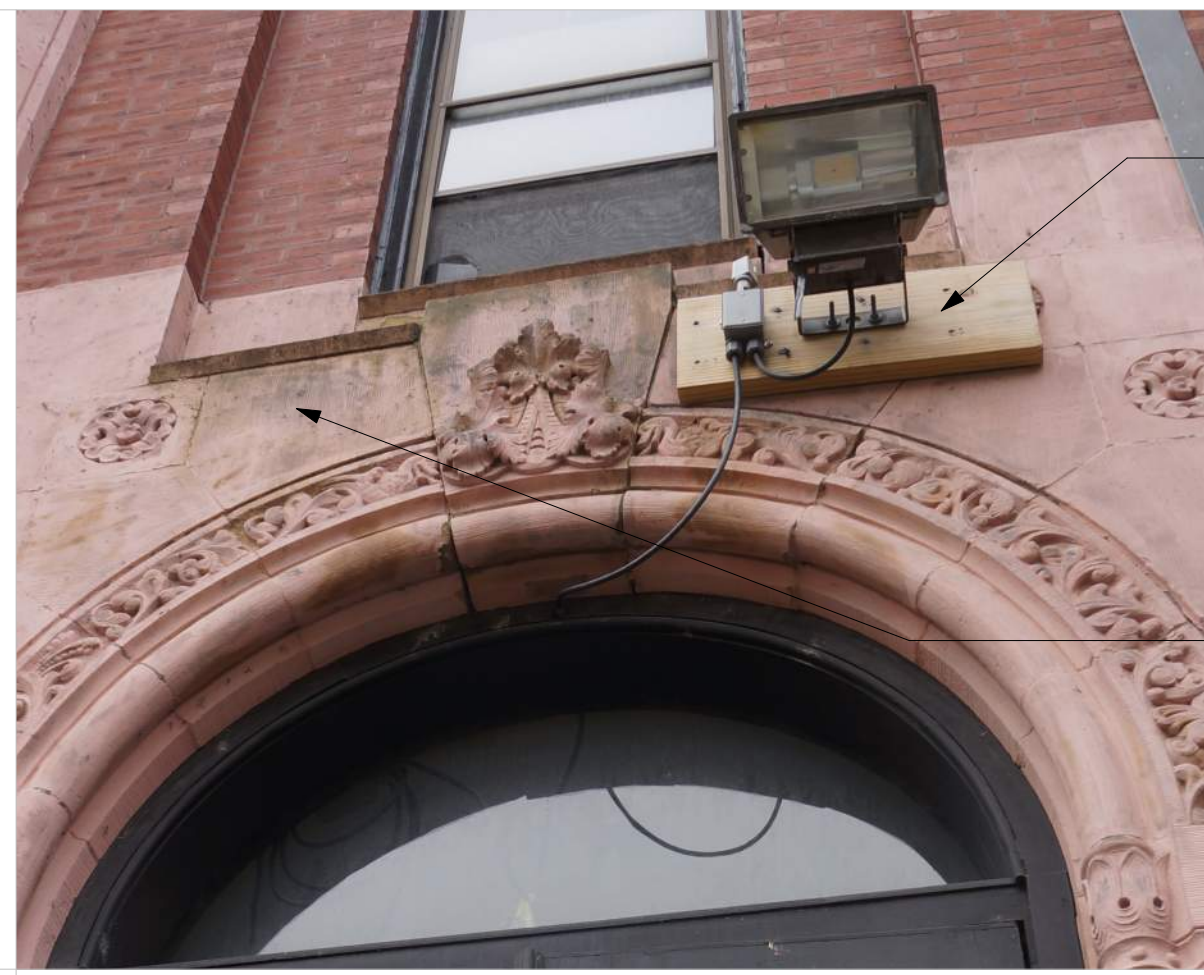
DETAIL 34

CABLES & LIGHT FIXTURE

STONE DAMAGE & STAINING
