256 - 260 NEWBURY STREET

CHEVRON PARTNERS

JUNE 20, 2023

FACADE RESTORATION - PUBLIC ALLEY

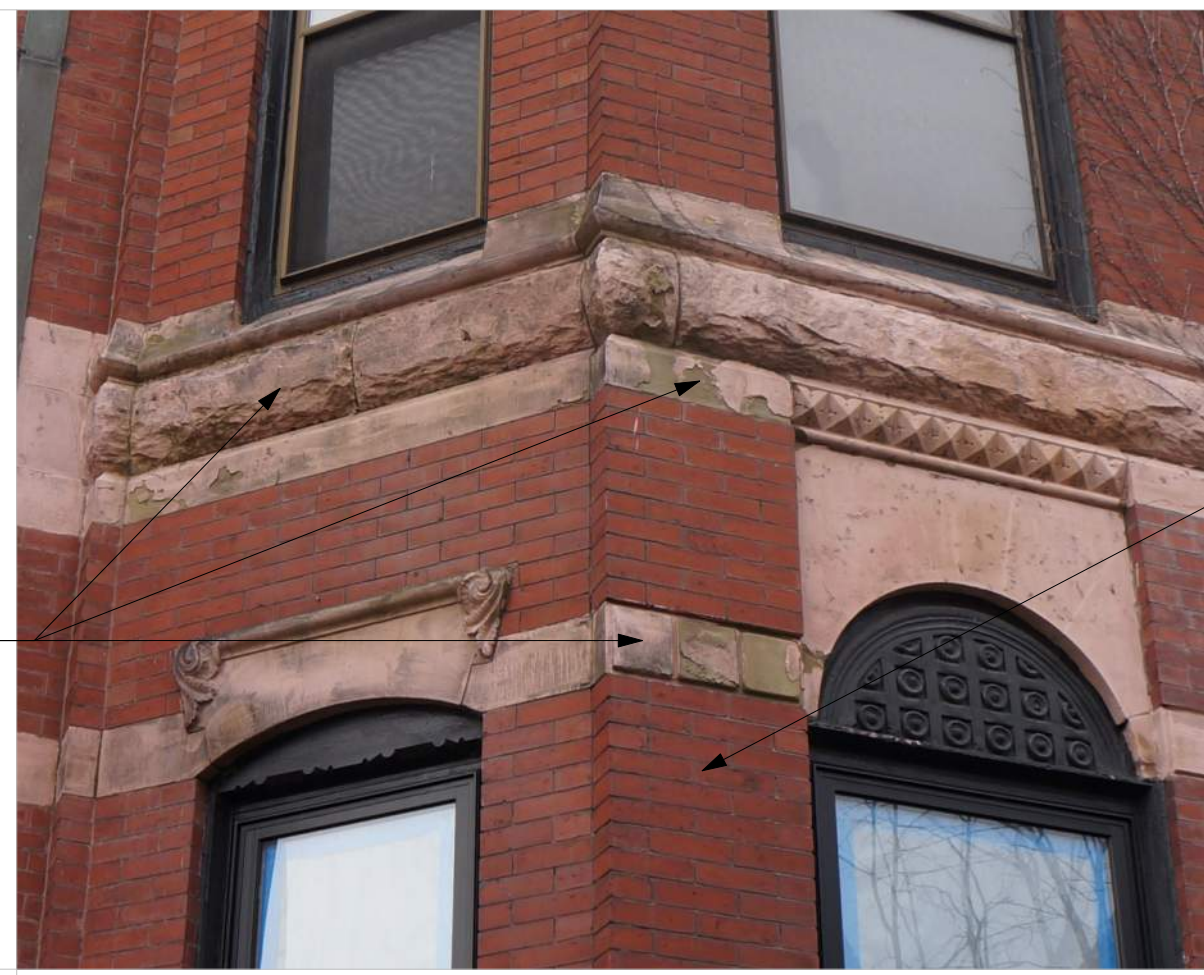
DETAIL 35

BRICK DAMAGE & STAINING

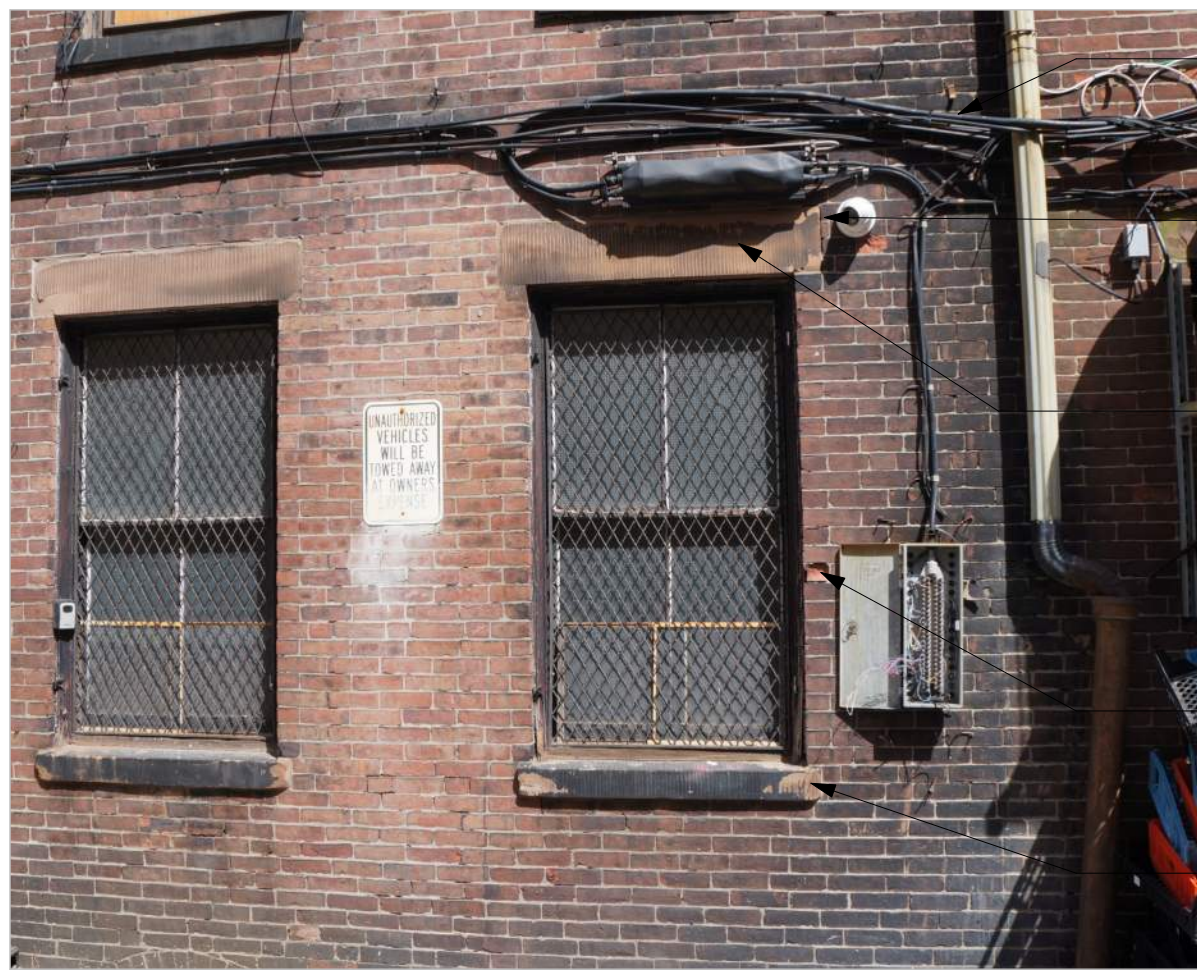
DETAIL 17

ELECTRICAL DEVICE AND CABLING
MORTAR DAMAGE
DAMAGED STONE LINTEL
DAMAGED BRICK
DAMAGED STONE SILL

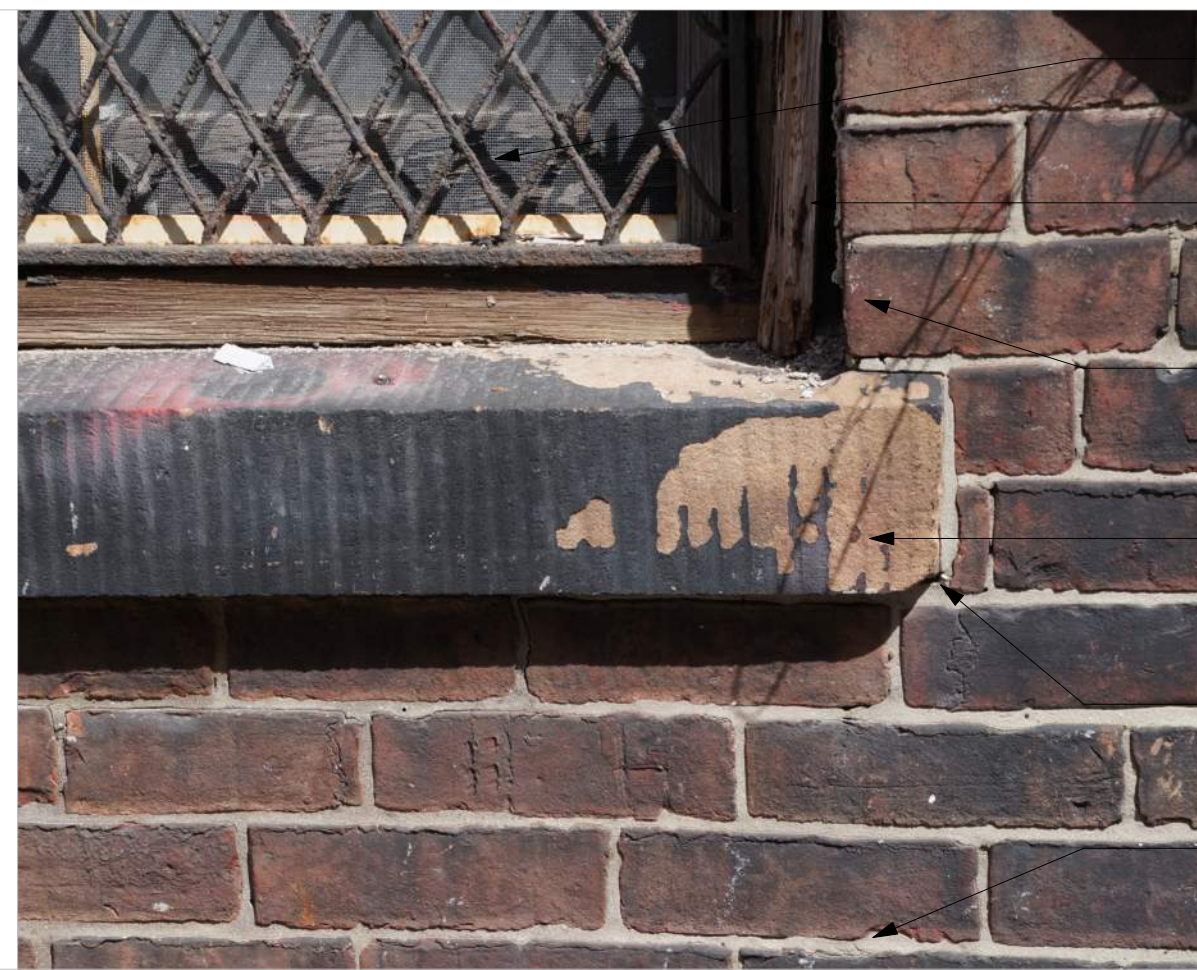
DETAIL 18

CORRODED METAL GRILLE
DAMAGED WOOD WINDOW, SUBSILL AND BRICK MOULD
DAMAGED BRICK
WORN AND CHIPPED PAINT
FINISH DAMAGED STONE SILL
MORTAR DAMAGE

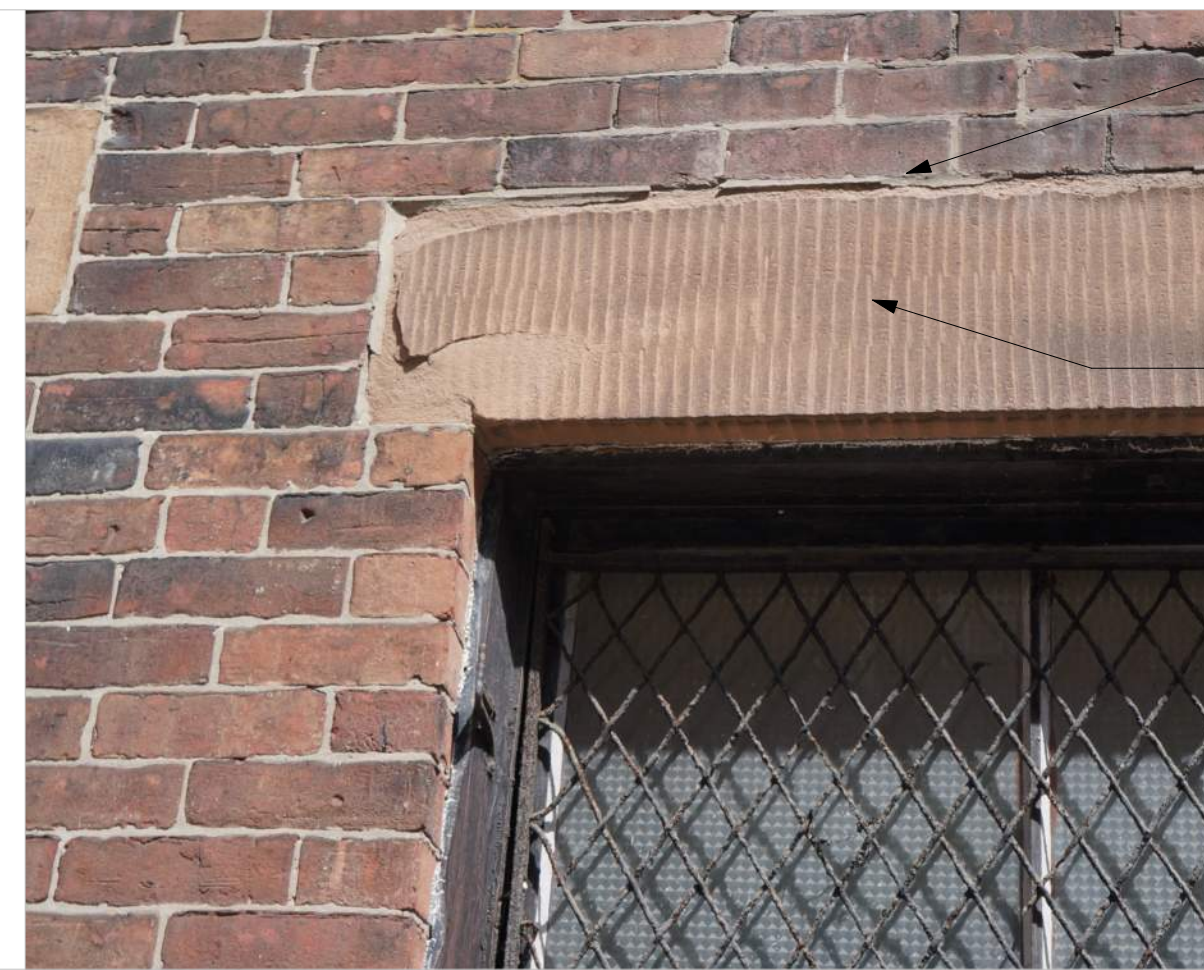
DETAIL 19

MORTAR DAMAGE
DAMAGED STONE SURFACE

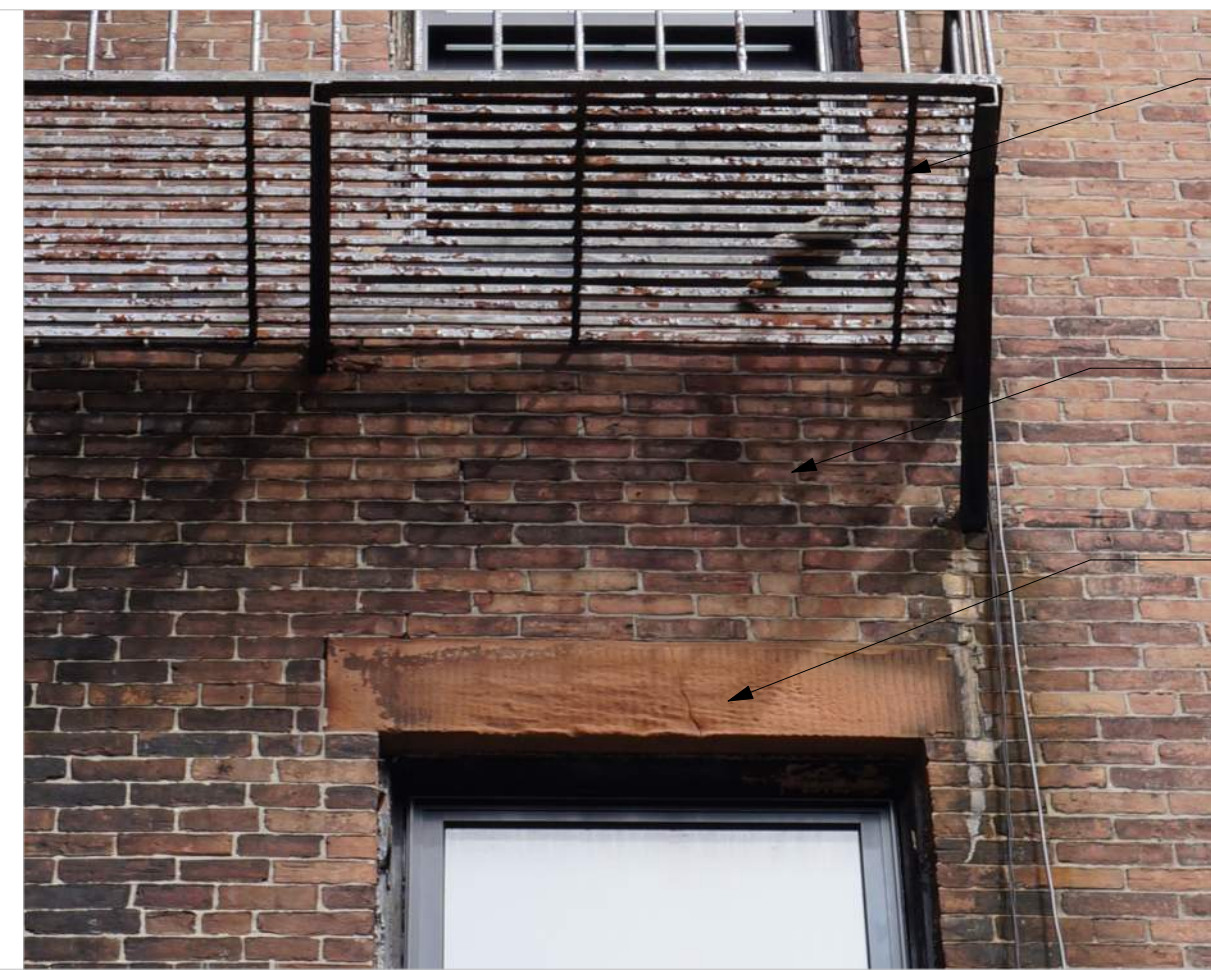
DETAIL 20

CORRODED FIRE ESCAPE
BRICK STAINING
DAMAGED STONE SURFACE

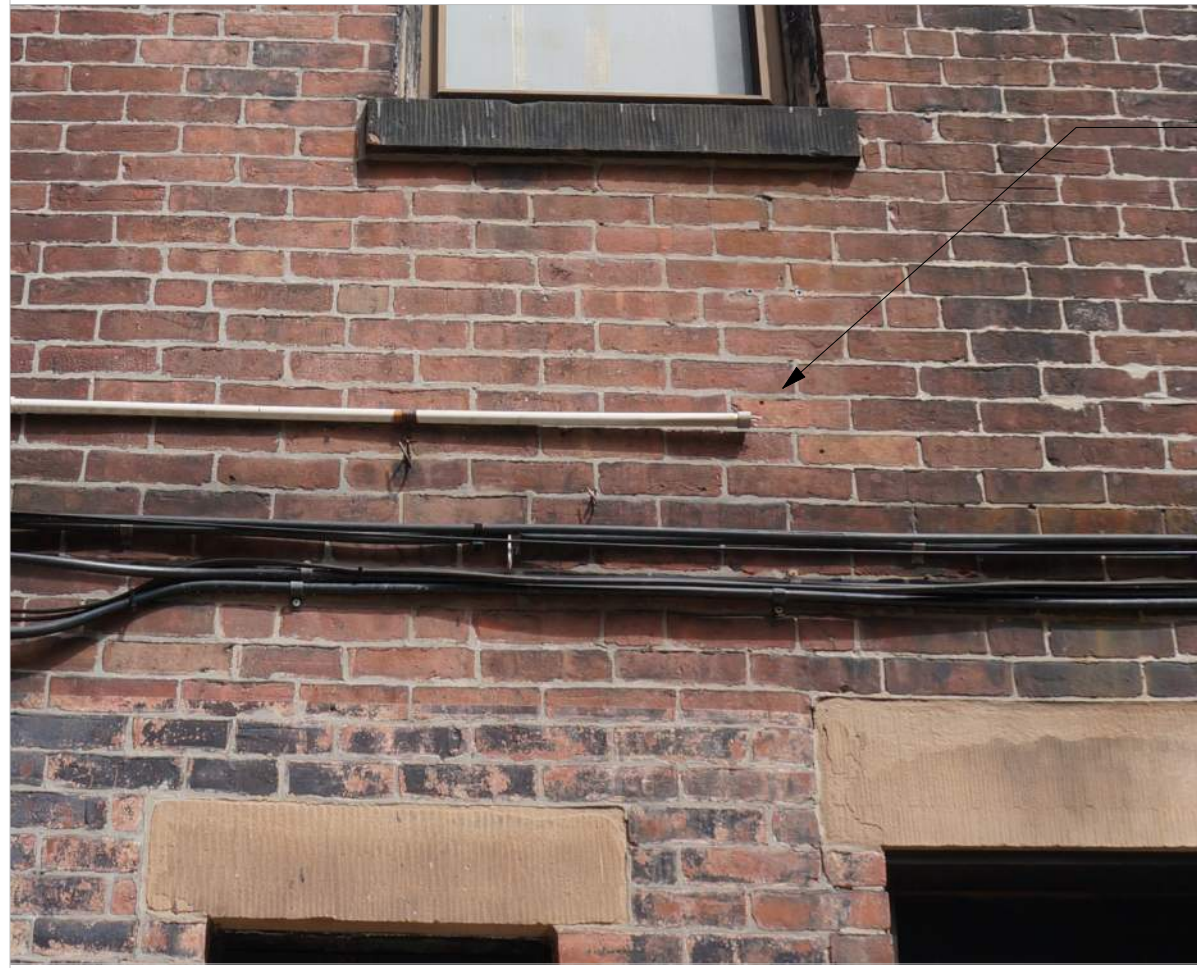
DETAIL 21

LIGHTING FIXTURE CORRODED, DISLODGED ELECTRICAL DEVICE AND CABLE

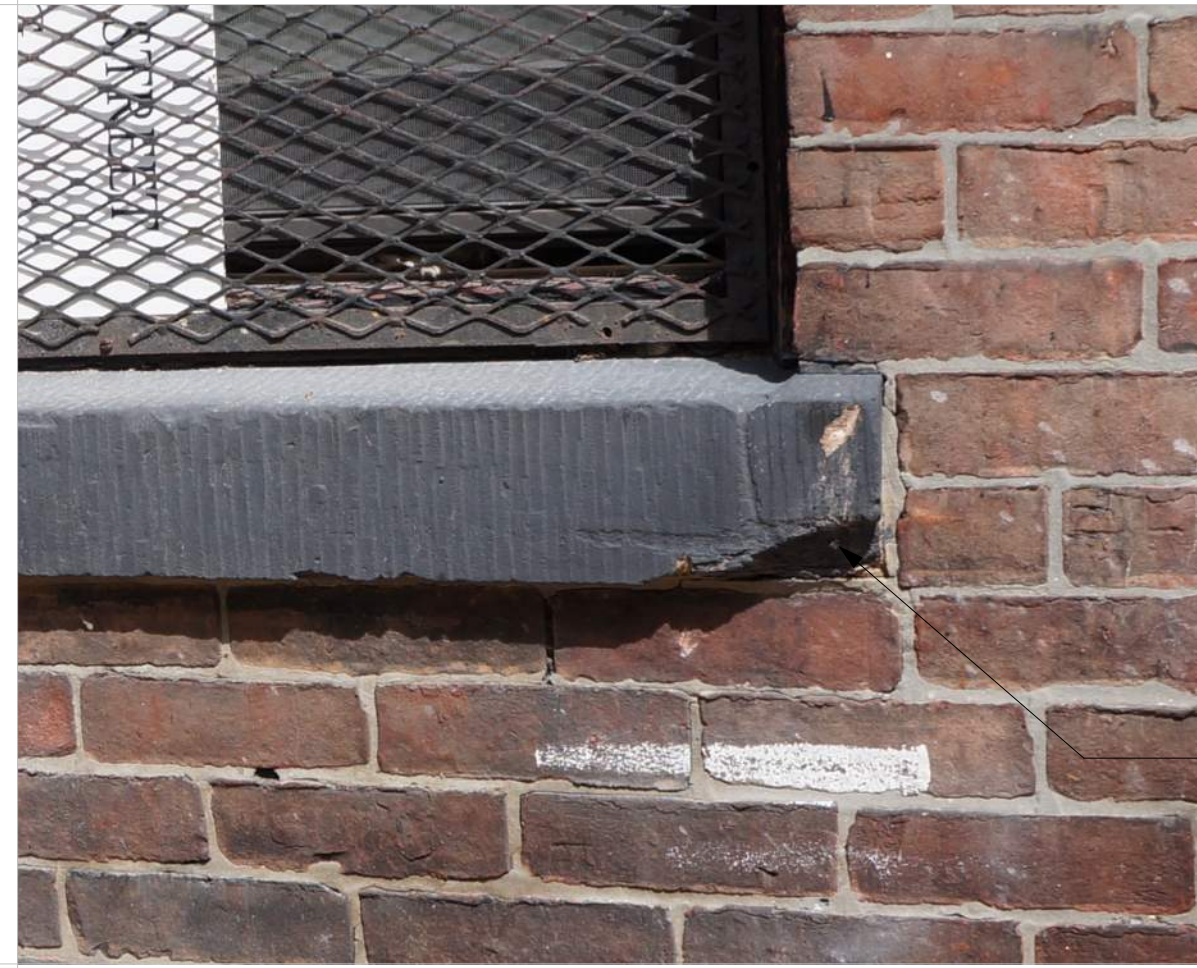
DETAIL 22

DAMAGED STONE

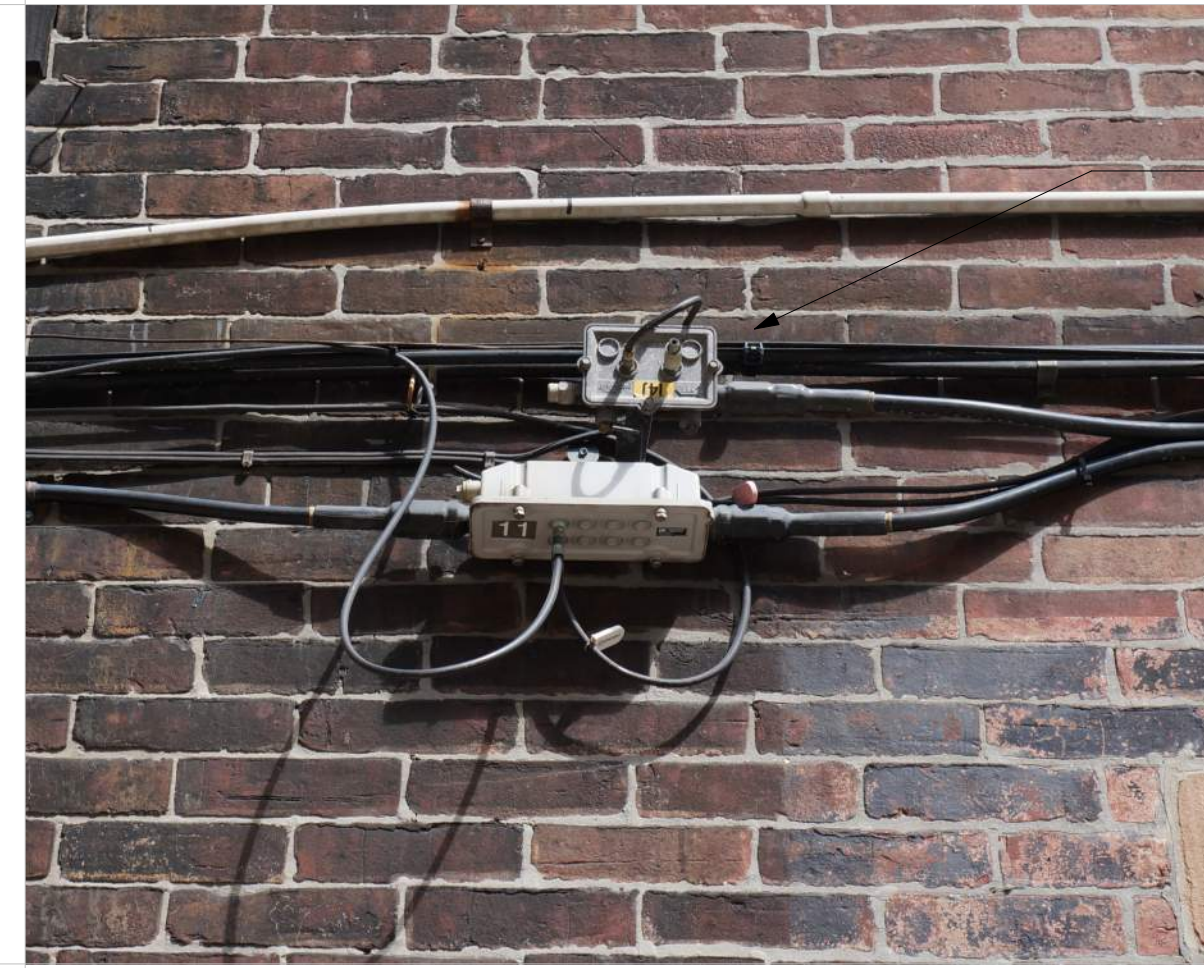
DETAIL 23

CABLE DEVICES AND CABLING

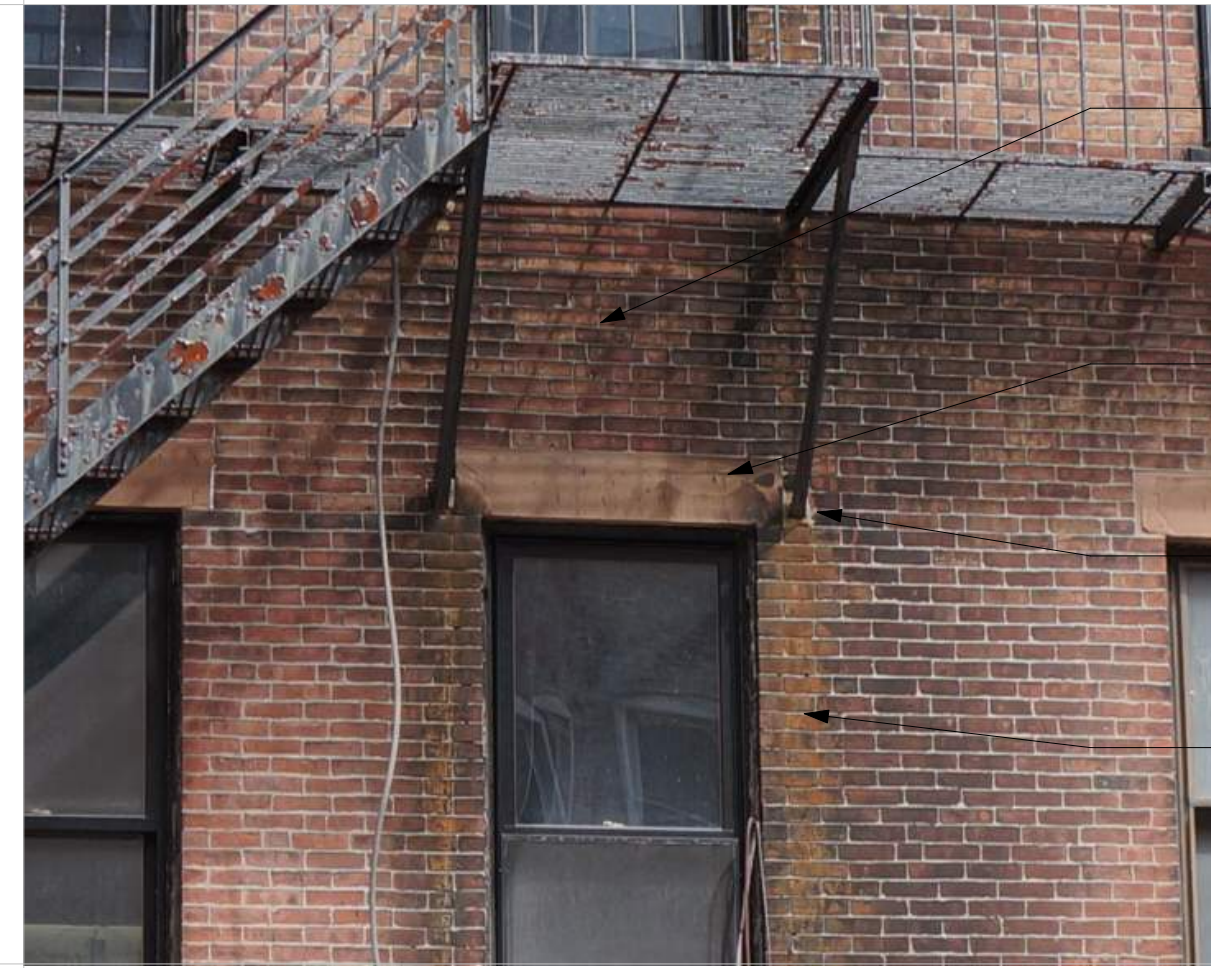
DETAIL 24

MORTAR DAMAGE
STONE DAMAGE
DAMAGED MORTAR, POSSIBLE COMPROMISED FIRE ESCAPE SUPPORT STRUCTURE.
PAINT DRIPPINGS AND BRICK STAINING

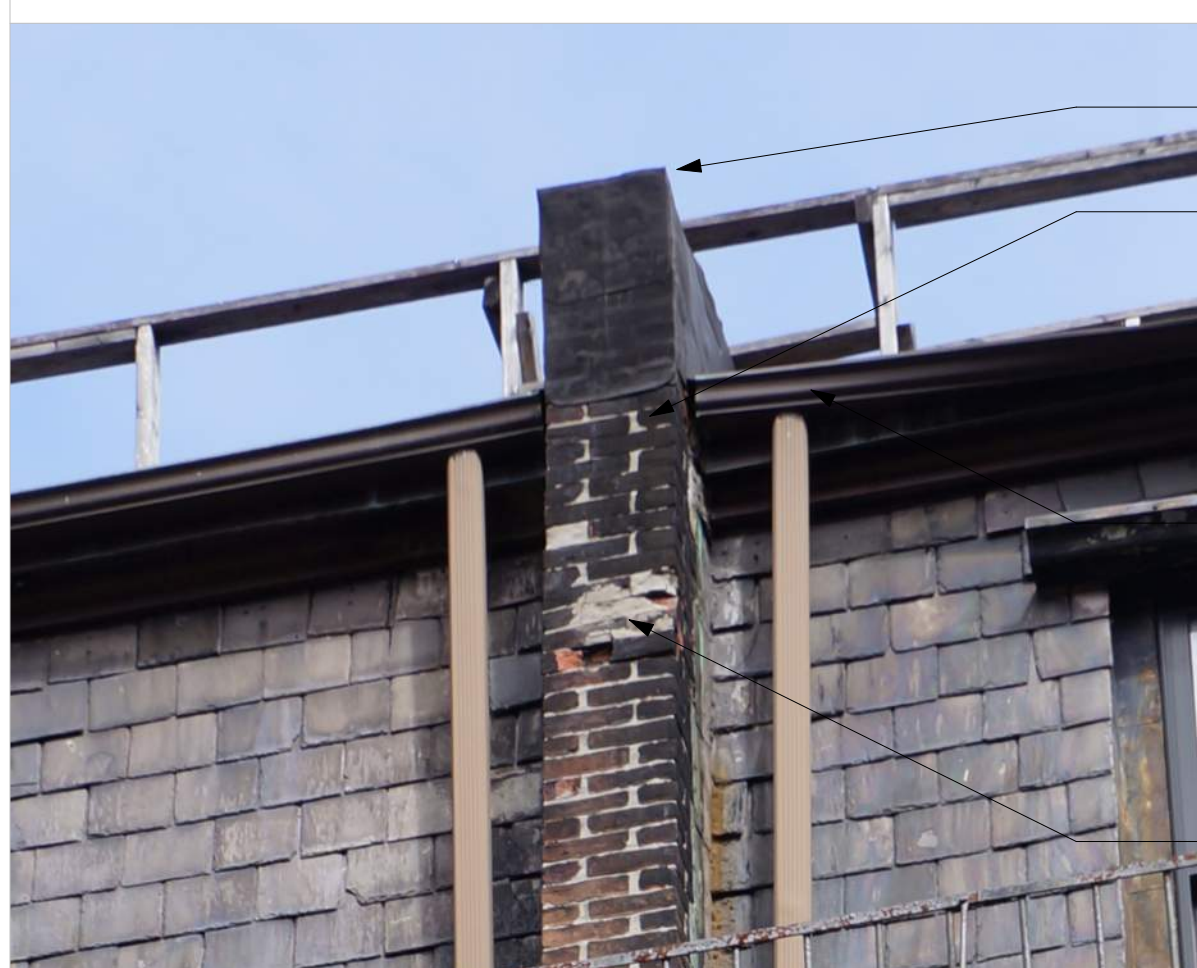
DETAIL 25

RUBBER ROOFING AT PARTY WALL PARAPET
STAINED OR PAINTED BRICK
DAMAGED ALUMINUM GUTTER
EXCESSIVE MORTAR

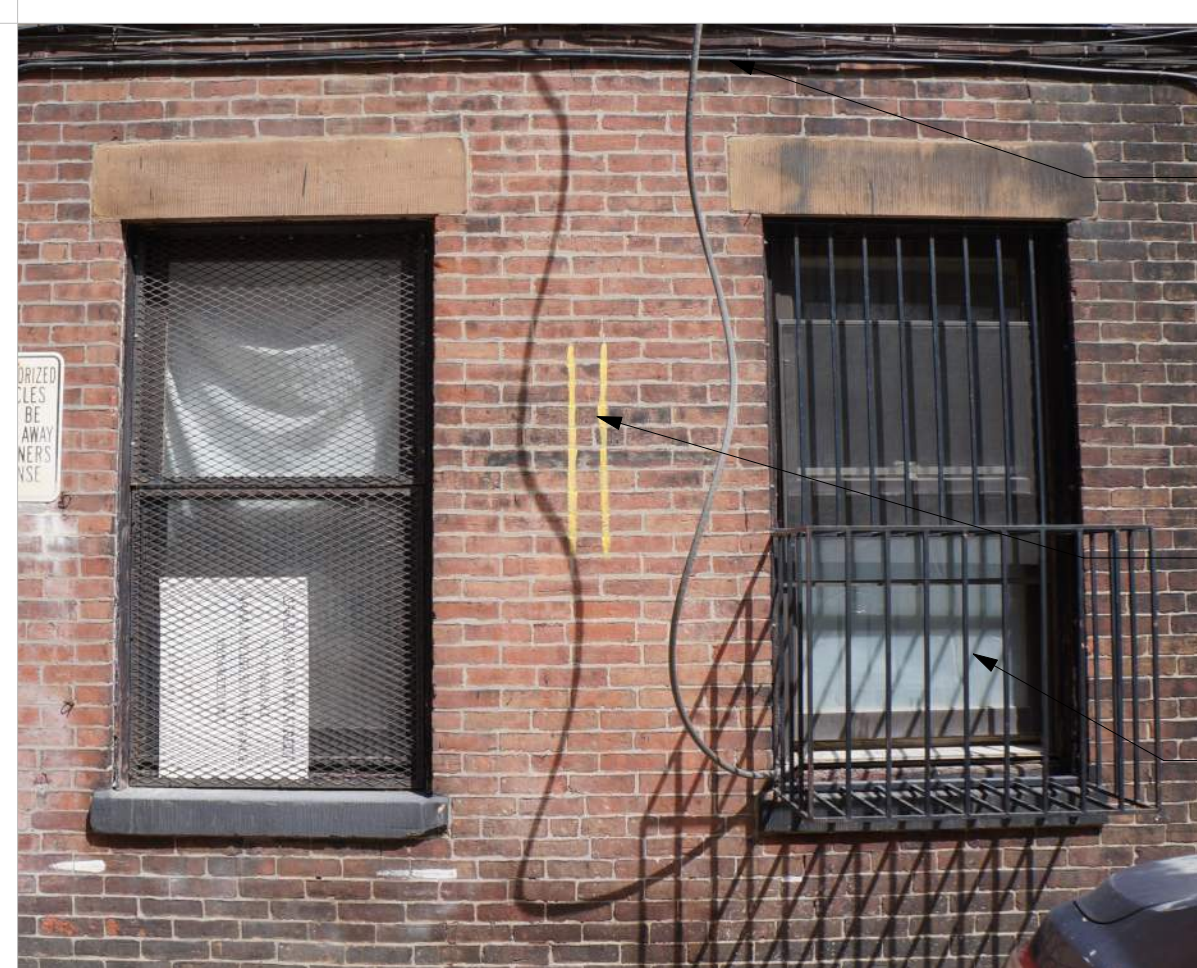
DETAIL 26

CONDUIT AND CABLING
ERRANT PAINT
AIR CONDITIONER METAL GRILLE

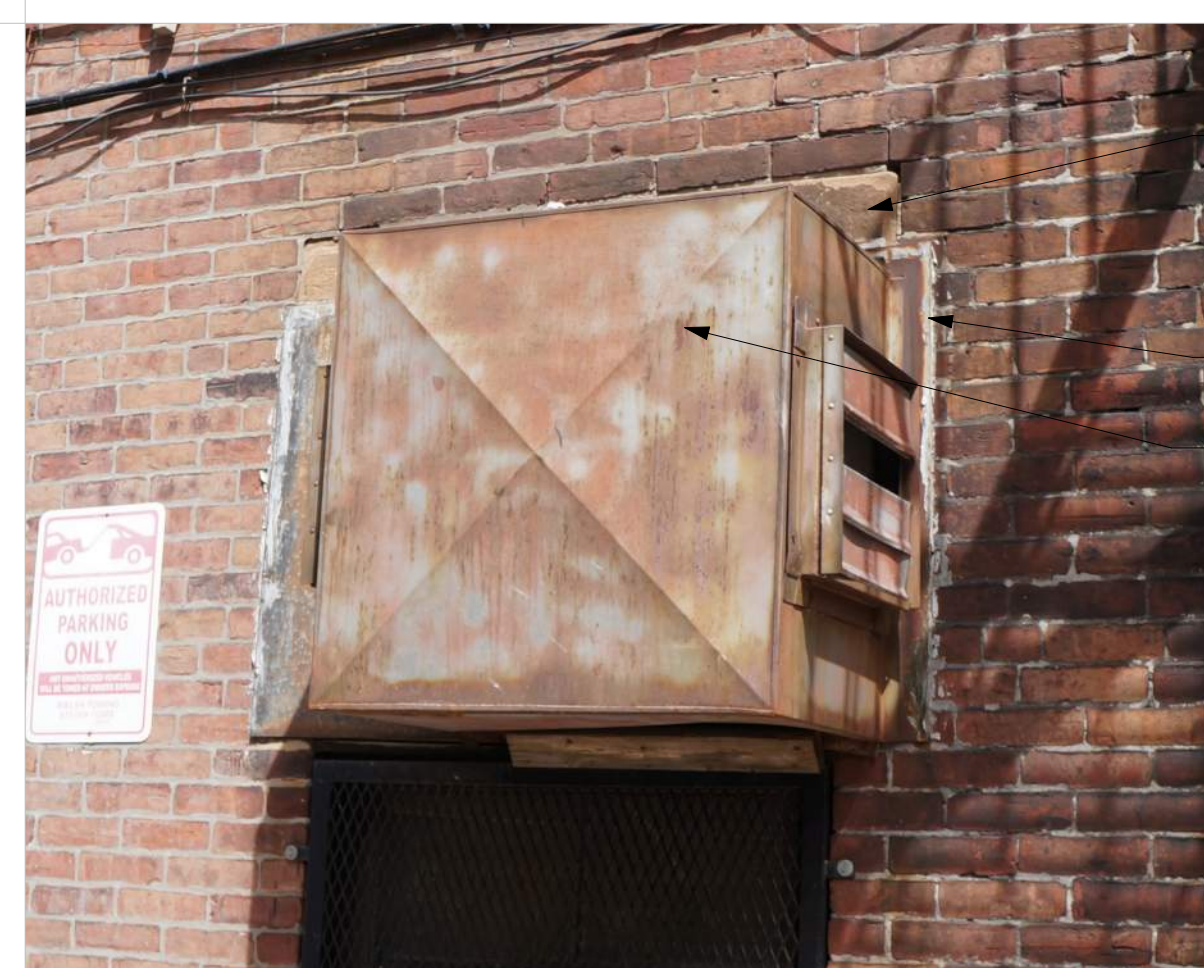
DETAIL 27

DAMAGED STONE
MORTAR DAMAGE
EXPOSED AND CORRODED MECHANICAL EQUIPMENT

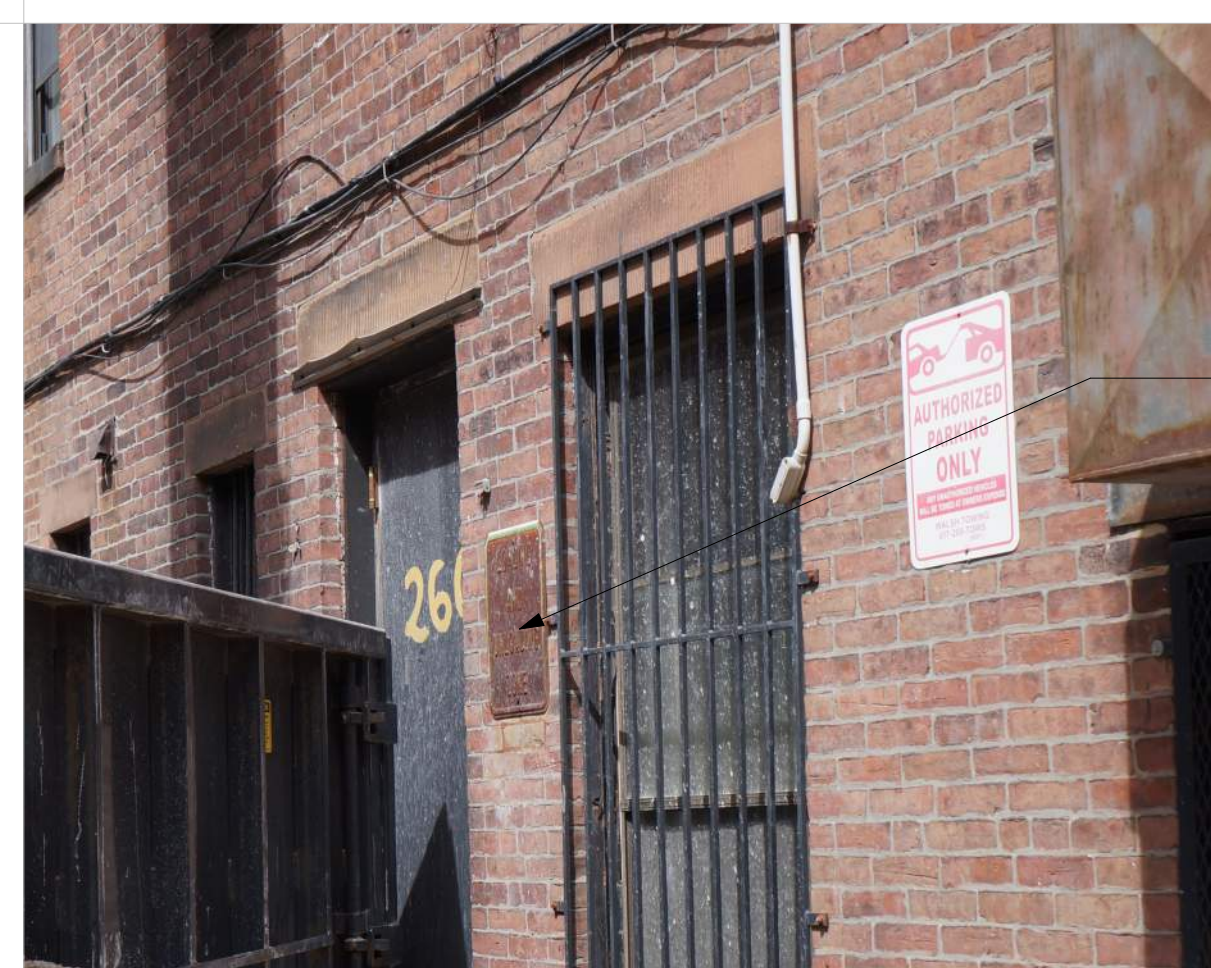
DETAIL 31

CORRODED AND OBSOLETE SIGNAGE

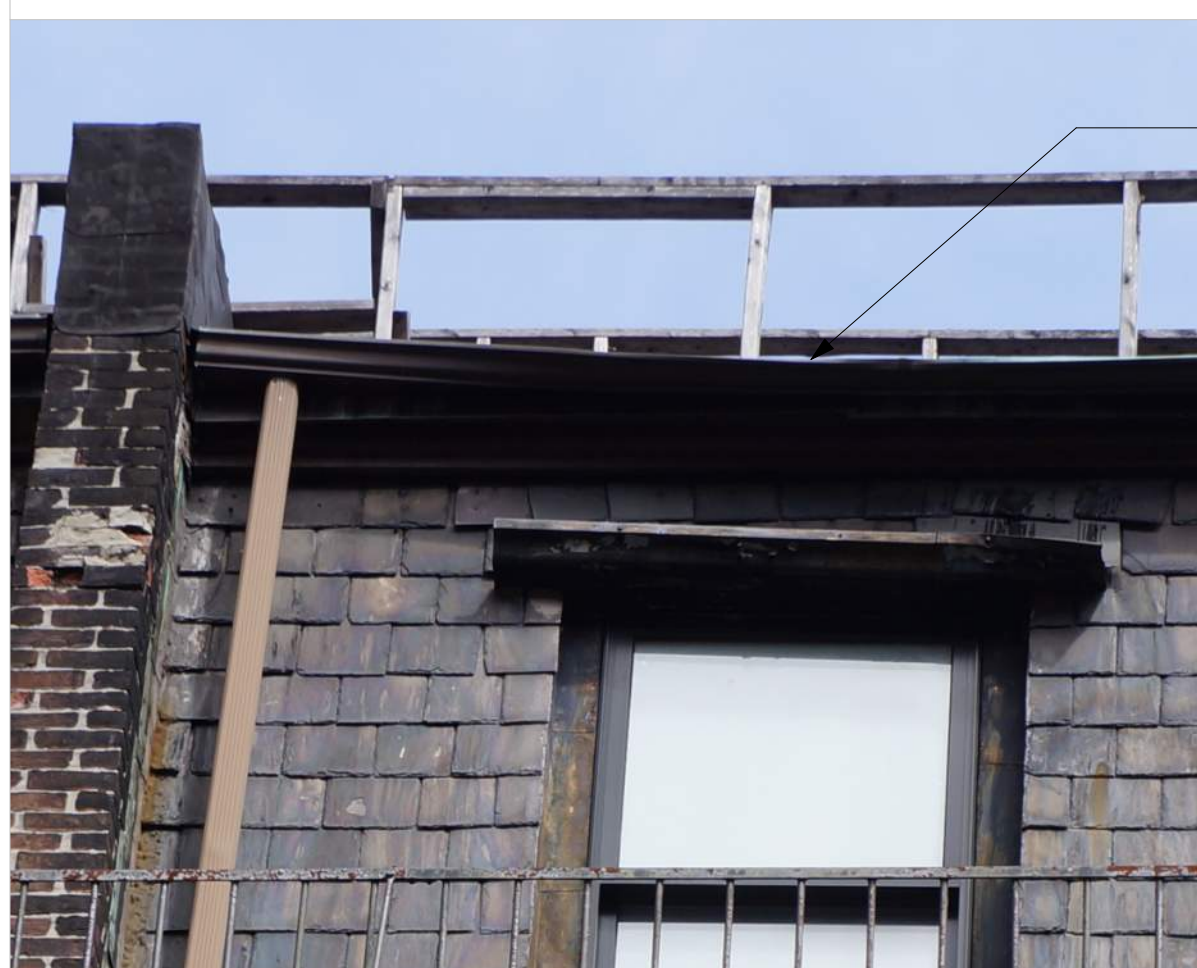
DETAIL 28

ROTTED WOOD AND DEGRADED PAINT AT MANSARD WINDOWS

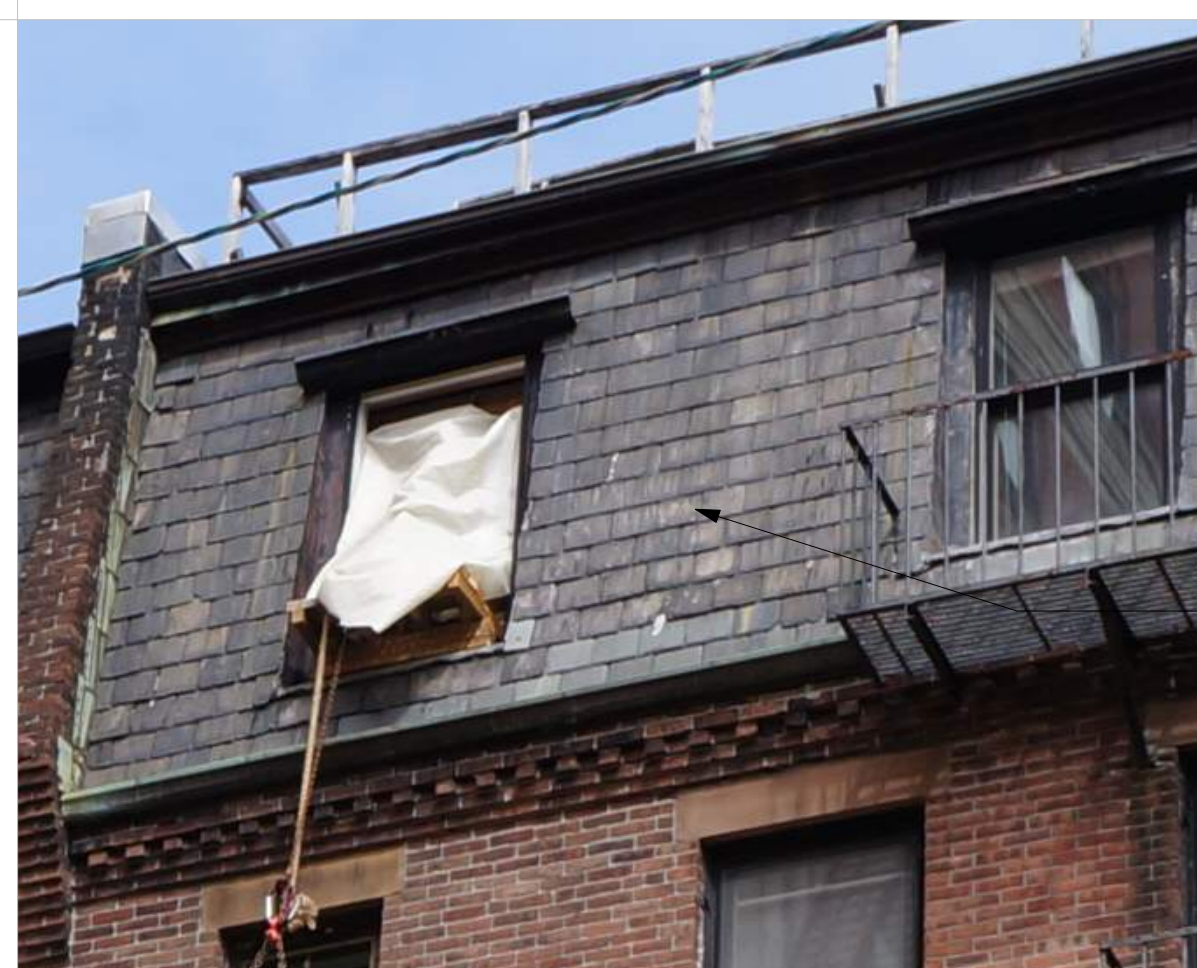
DETAIL 29

MISMATCHED AND DAMAGED SLATE SHINGLES

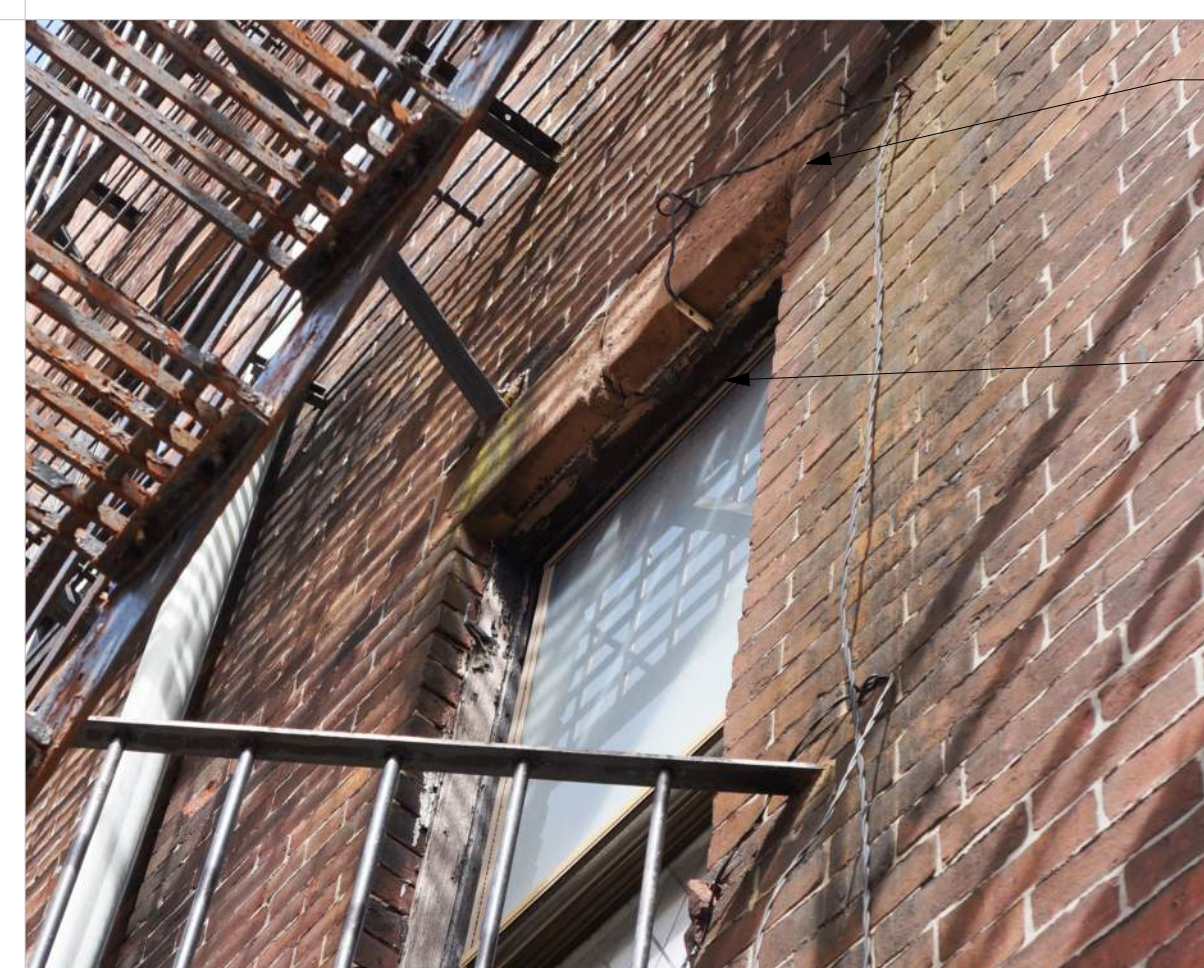
DETAIL 30

CRACKED STONE AND STAINED LINTEL
ROTTED WOOD BRICK MOULD
