CHABAD CENTER FOR MISSION HILL

1615-1617 Tremont Street

Architectural Conservation District Commission

Advisory Review Application

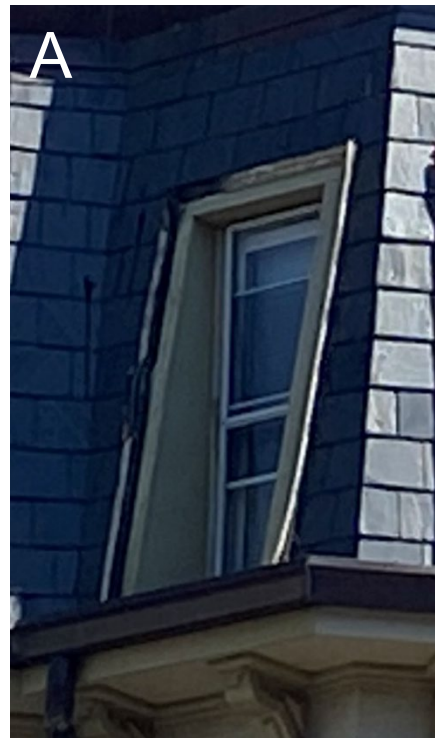
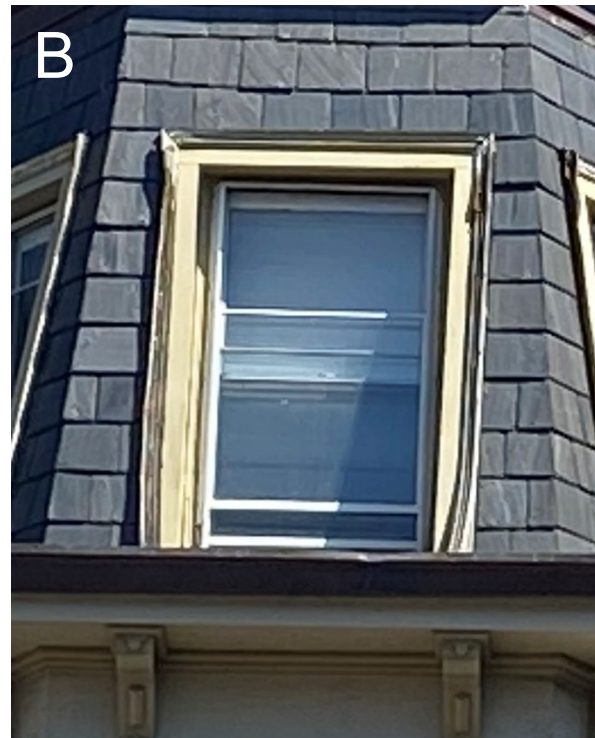
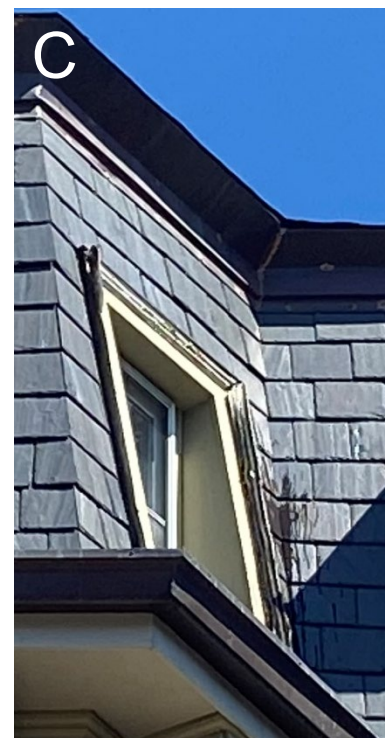
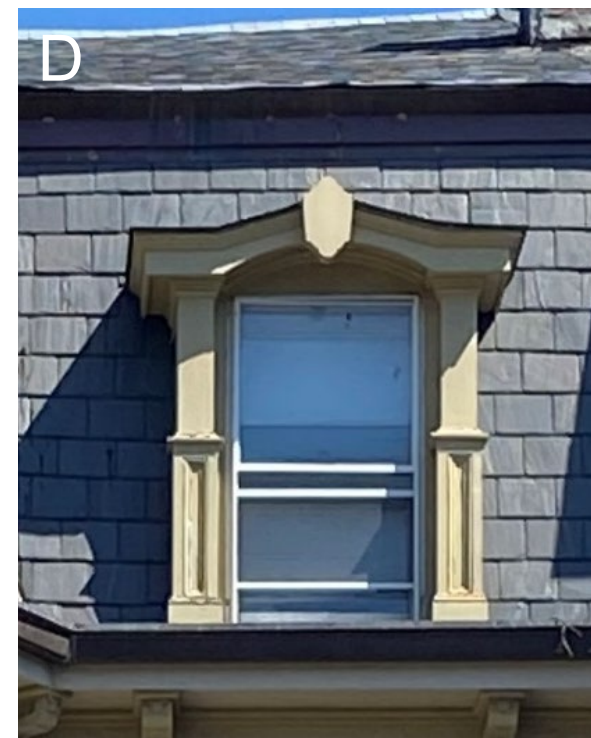
Mansard Level Windows

| No. | Feature | Current Condition | Treatment |
|---|---|---|---|
| | Window Sash | Poor condition | Reconstruct to match historic double hung two over two windows |
| | Sill | Poor condition | Reconstruction |
| | Window surrounds | Poor condition | A,B,C to be reconstructed |

| No. | Feature | Current Condition | Treatment |
|---|---|---|---|
| | | | D to be reconstructed based on historic design to incorporate the decorative molding and medallion |

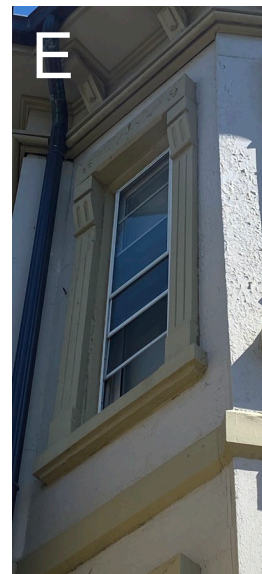
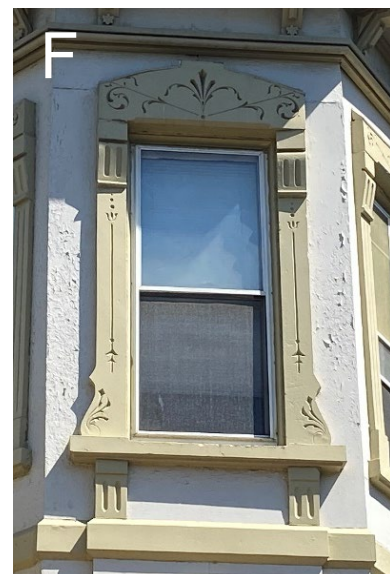
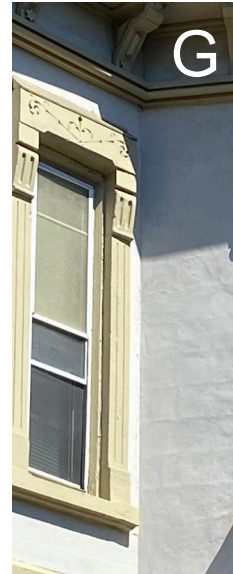
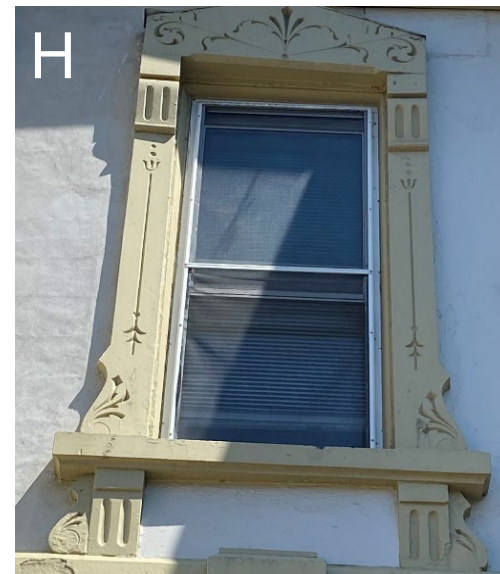
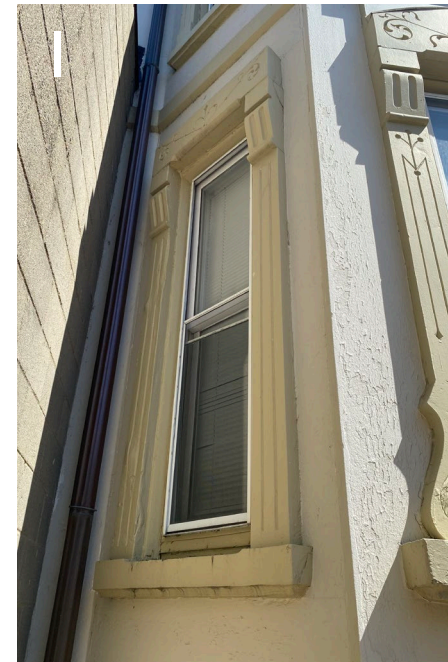
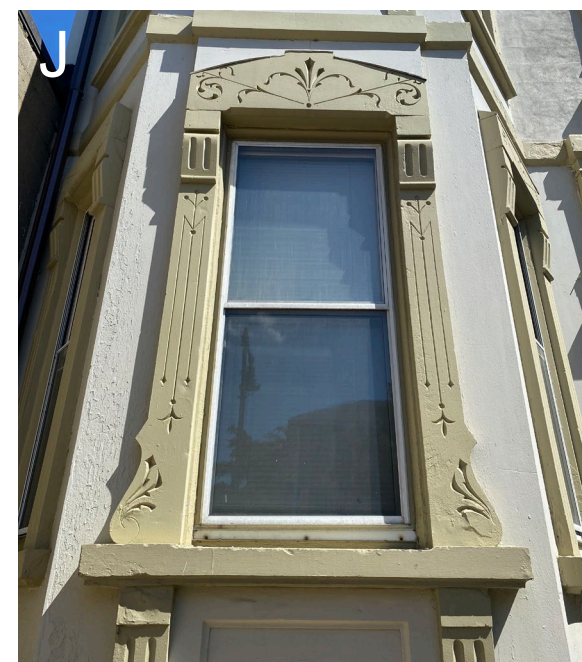
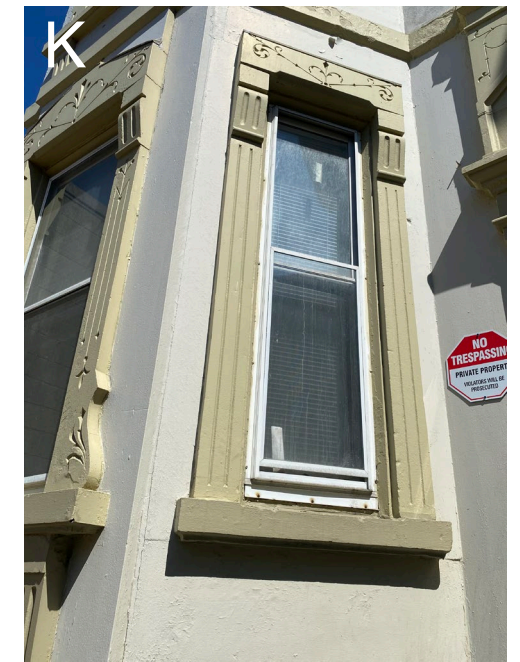
Second Floor Windows

| No. | Feature | Current Condition | Treatment |
|---|---|---|---|
| | Window Sash | Poor condition | Reconstruct all. F, H, J match historic double hung two over two windows |
| | Sill | Poor condition | Reconstruction |
| | Window surrounds | Finish appears to be in sound condition | Remove flashing over F, G, H, J, K and replace if needed. Strip stucco/paint and leave sandstone exposed on all. |

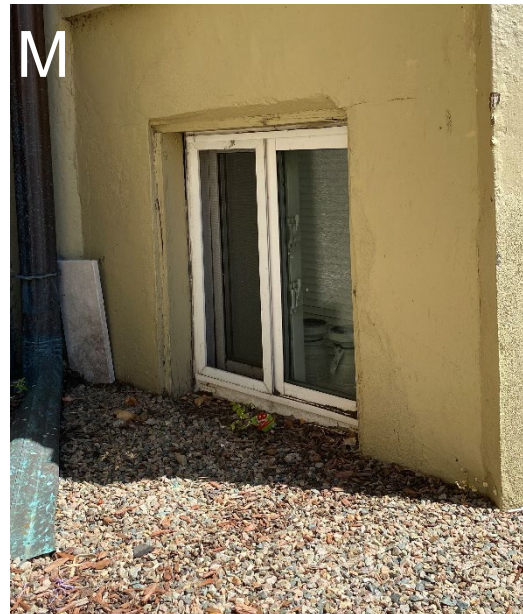
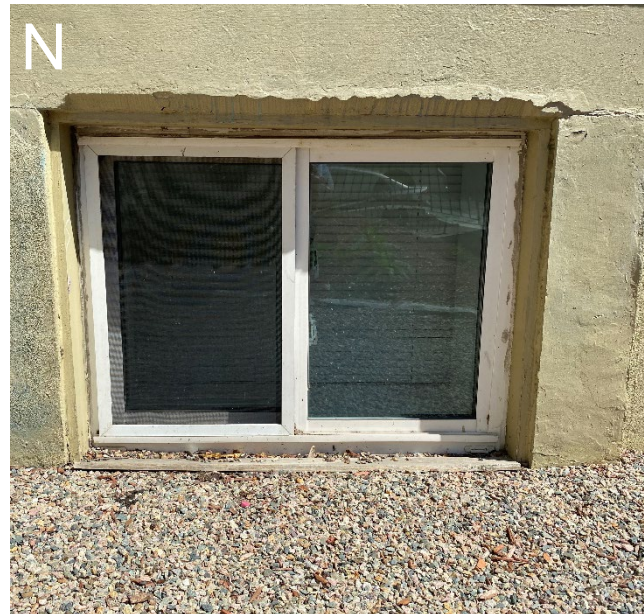
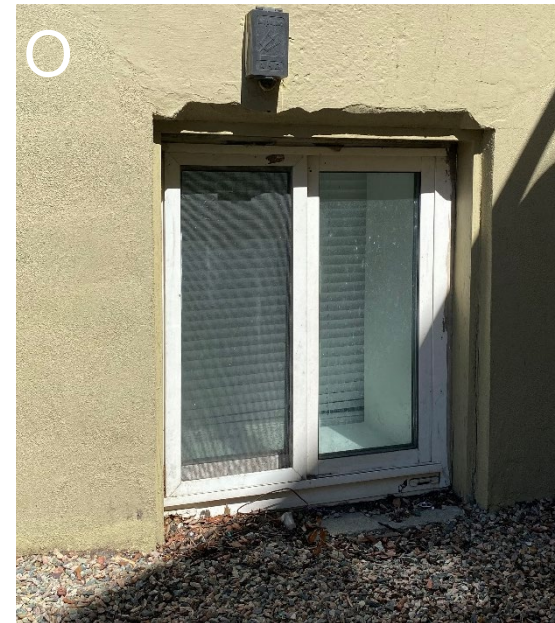
Basement Level Windows

| No. | Feature | Current Condition | Treatment |
|---|---|---|---|
| | Window Sash | Poor condition | Replace |
| | Sill | Poor condition | Replace |

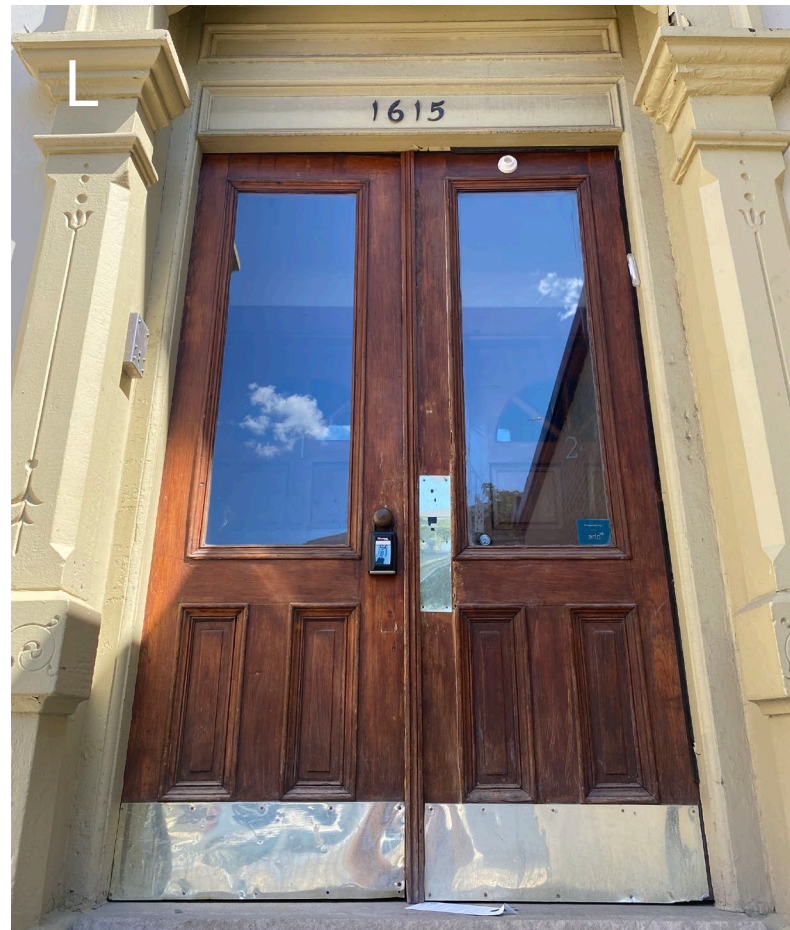
| No. | Feature | Current Condition | Treatment |
|---|---|---|---|
| | Paneling | Hardwood with metal kick plates | Door can be retained with all hardware replaced |
| | Vestibule Sidewalls | One side plastered; one side exposed brick | |

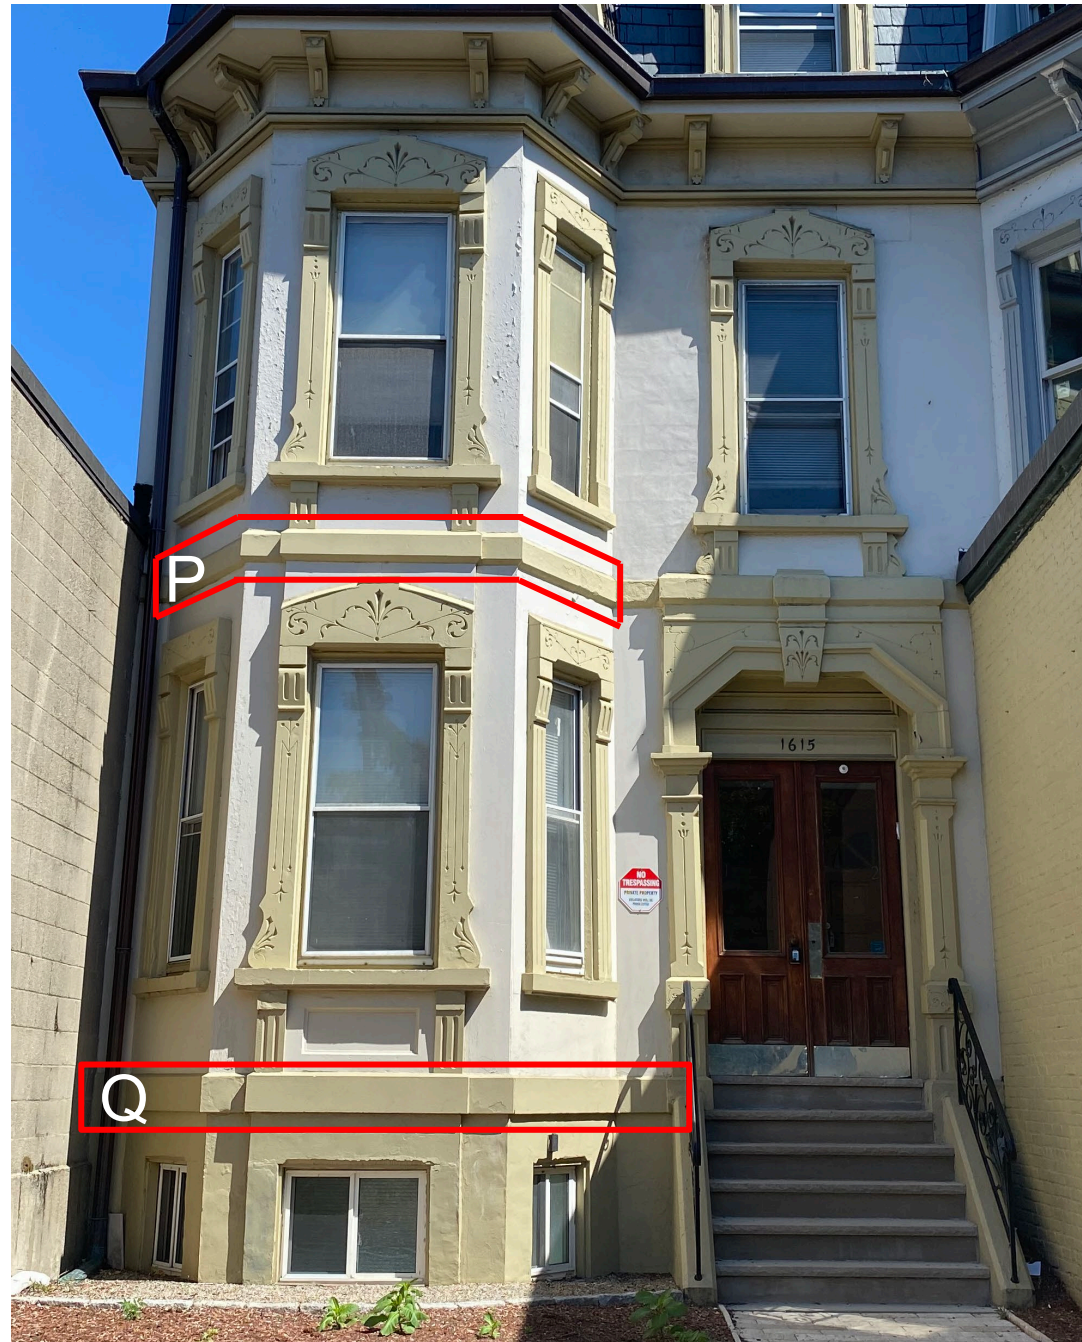
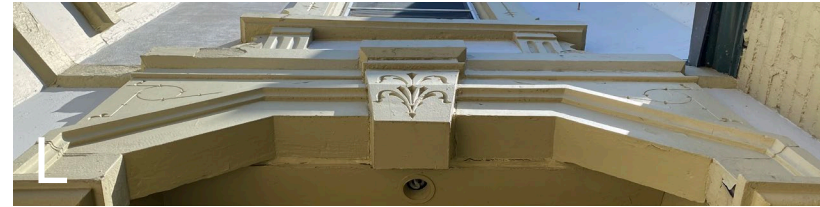
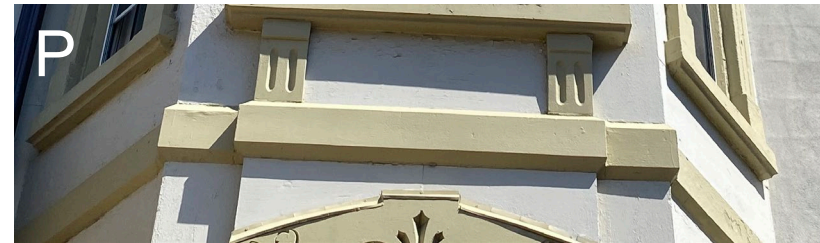
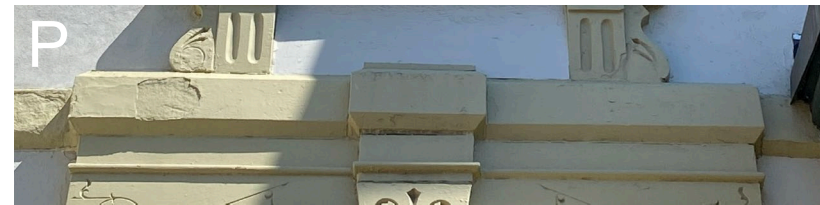
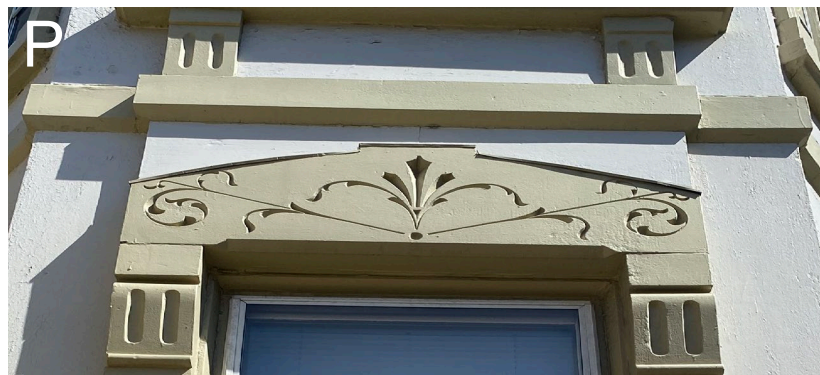
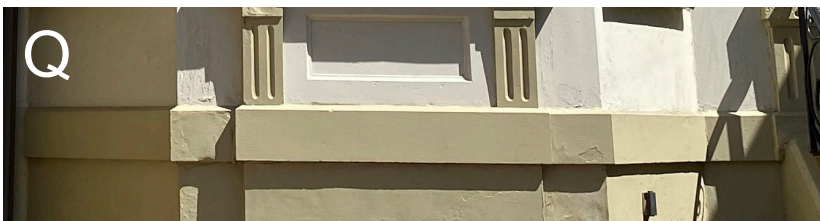
| No. | Feature | Current Condition | Treatment |
|---|---|---|---|
| 3 | Stucco over stone trim on facade | good condition | Stucco/paint to be stripped and left as exposed stone if exploratory work reveals suitable condition |

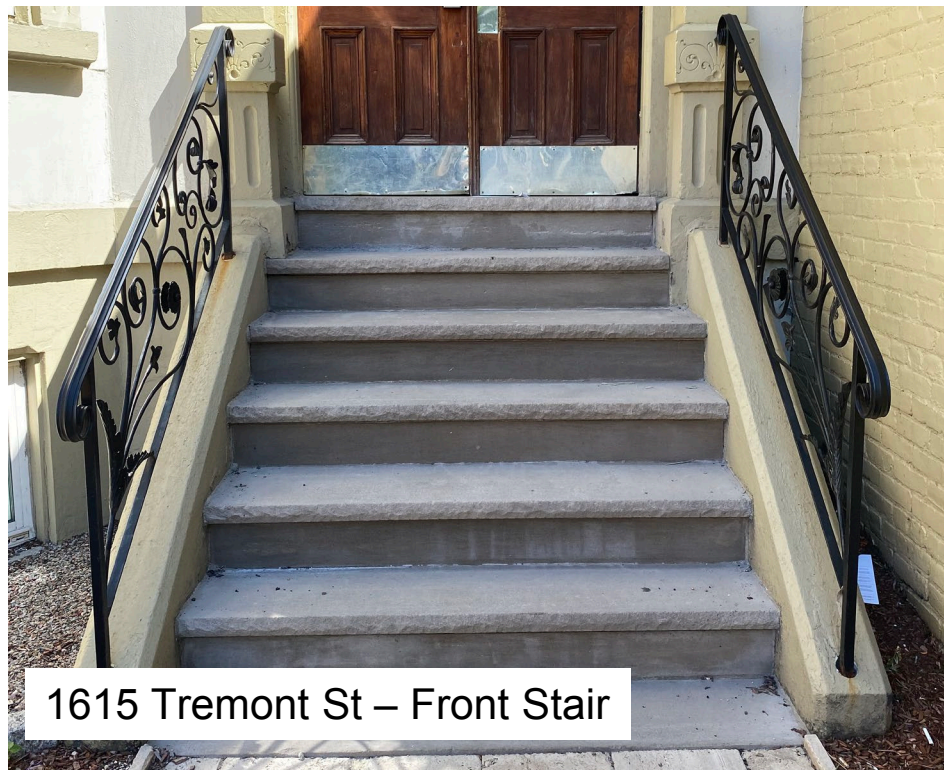
1615 Tremont St – Front Stair

| No. | Feature | Current Condition | Treatment |
|---|---|---|---|
| 1 | Stringer | Possibly original sound condition | Exploratory work to reveal stringer material. If stone in good condition, leave exposed. If not, repaint, color TBD |
| 4 | Railing | Recent steel, insecure Ornamental design out of character | Remove and replace with period appropriate balustrade/handrail Relocate from stringer to treads and separate from ornamental door surround |

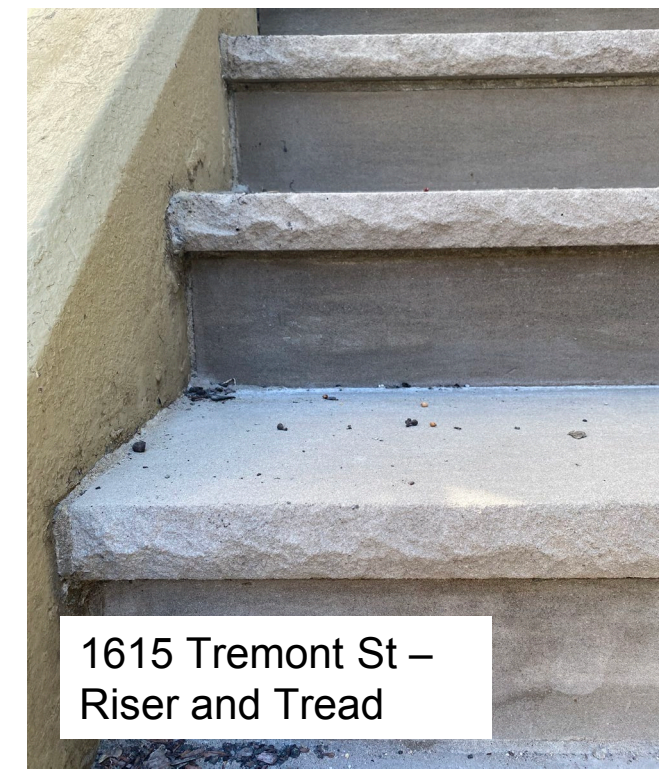
1615 Tremont St –
Riser and Tread

| No. | Feature | Current Condition | Treatment |
|---|---|---|---|
| 2 | Riser | Stone replacement (not original) Limestone sound condition | Remove and reinstall |
| 3 | Tread | Limestone sound condition | Remove and reinstall |

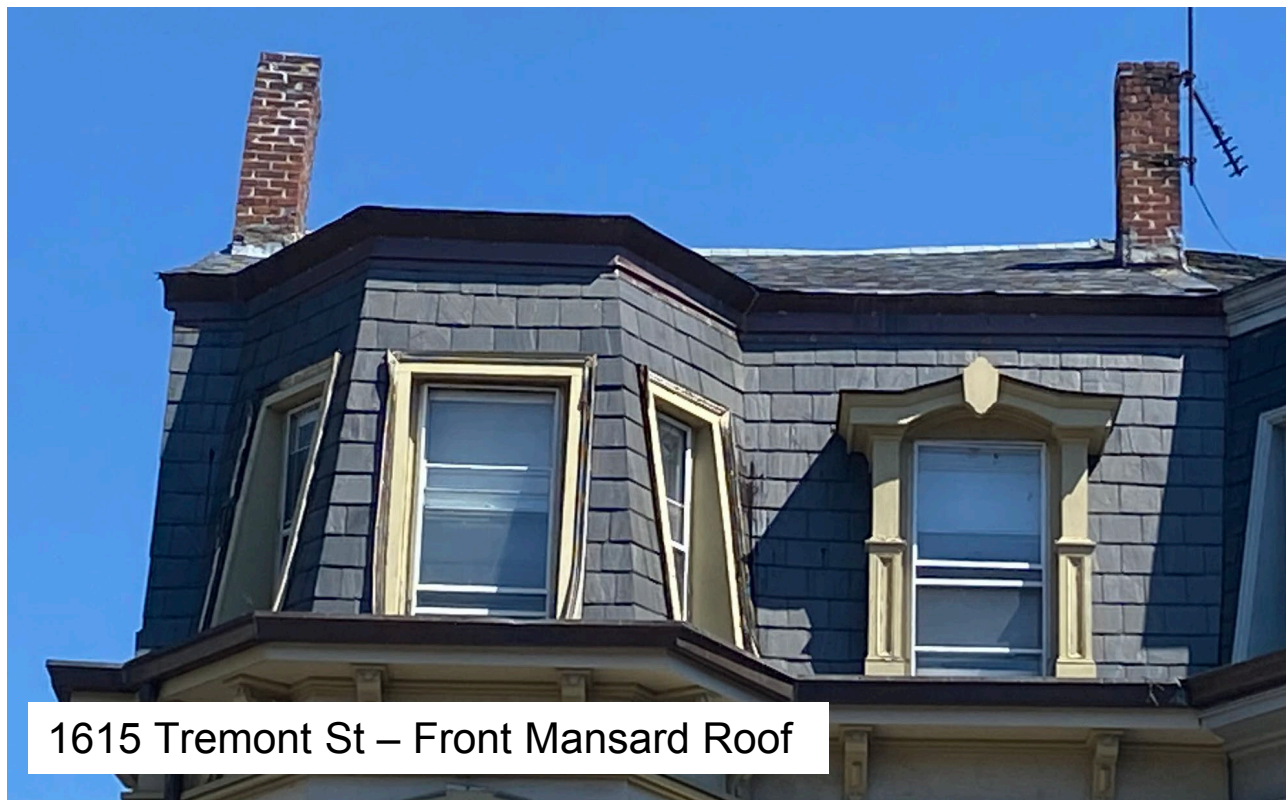
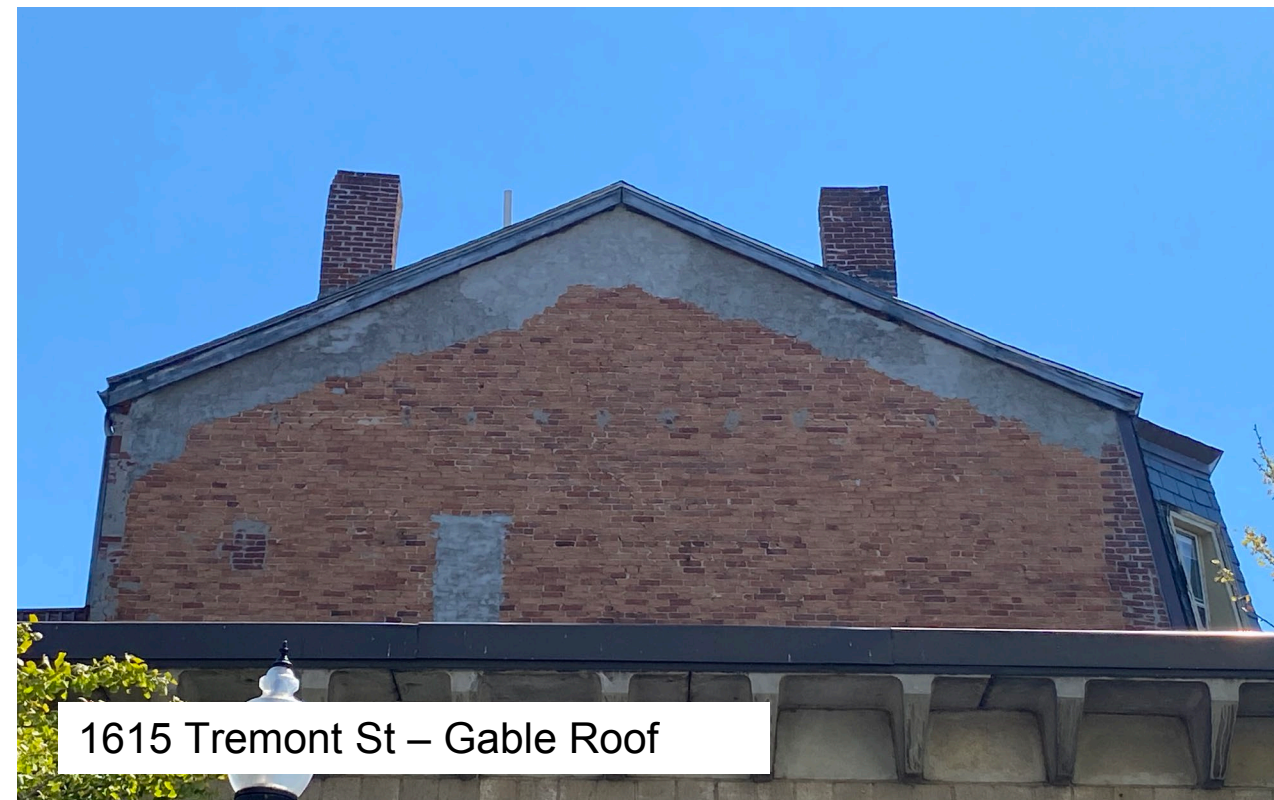
| No | Feature | Current Condition | Treatment |
|---|---|---|---|
| | Exterior | Slate appears to be in good condition Eave copper in poor condition | To be assumed that some damage will occur during demolition and new construction – reuse salvaged slate shingles or replace slate to match Replace copper trim with wood moldings |
| 2 | Chimney | Poor condition | Rear chimney to be demolished; front chimney to be repaired |
| 3 | Gable Roof | To be evaluated | Front roof replacement as required to match existing |

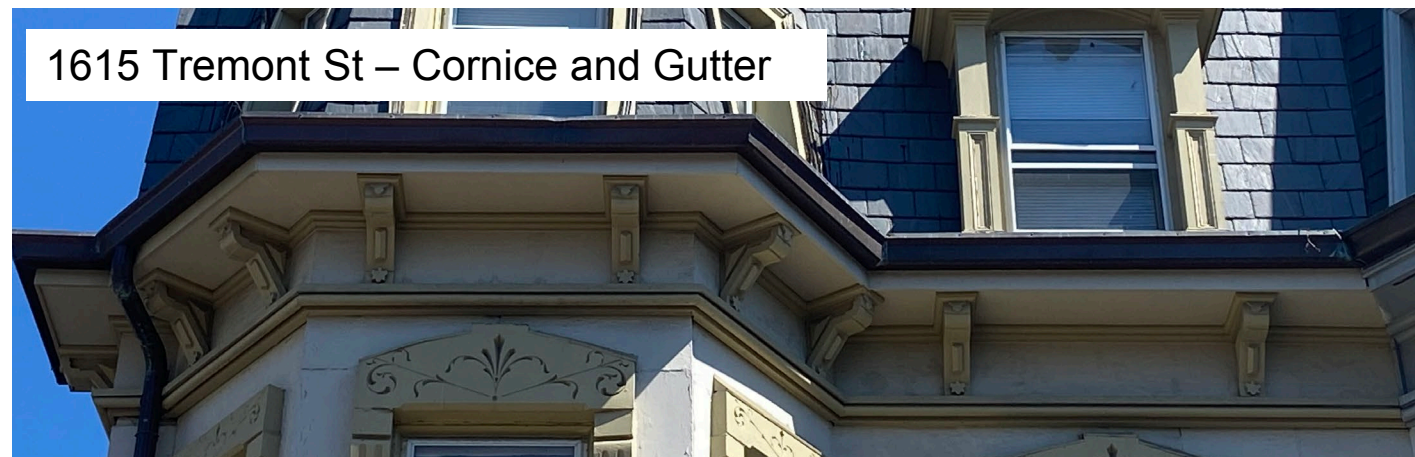
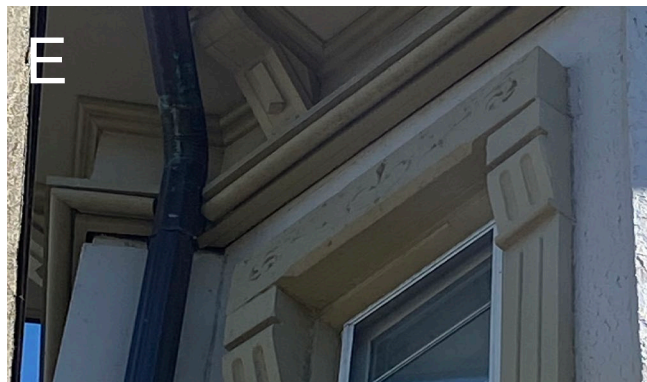
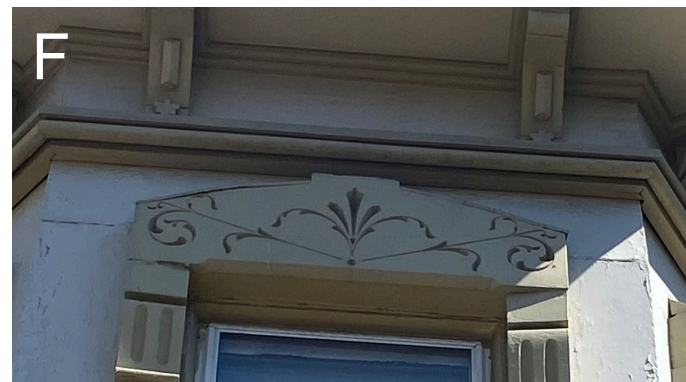
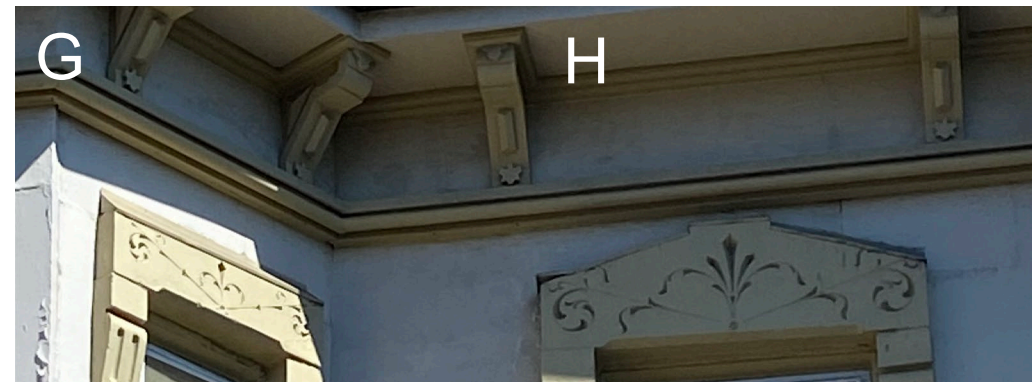
Second Floor

| No. | Feature | Current Condition | Treatment |
|---|---|---|---|
| U | Cornice | Decent condition Woodwork intact | Remove return at new construction |
| T | Gutter and Flashing | Poor condition Water problem above parlor and second floor window surrounds to be investigated | Change gutter profile – similar to adjacent rowhouse Existing flashing over window surrounds to be removed and sealed |
| T | Downspout | Poor condition | Change profile |

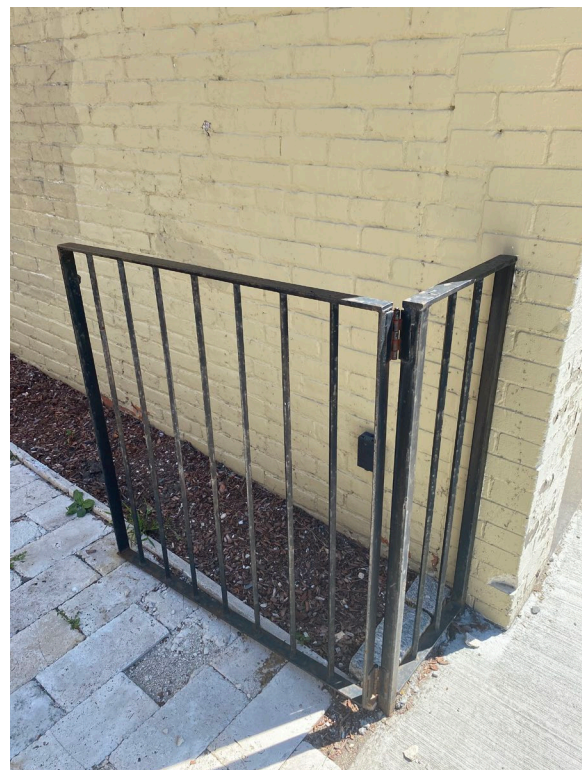
1615 Tremont St – Front Fence & Gate 1.1

| No. | Feature | Current Condition | Treatment |
|---|---|---|---|
| | 1.1 | Recent Steel Insecure Out of historic character | Remove fence gate and replace in kind |

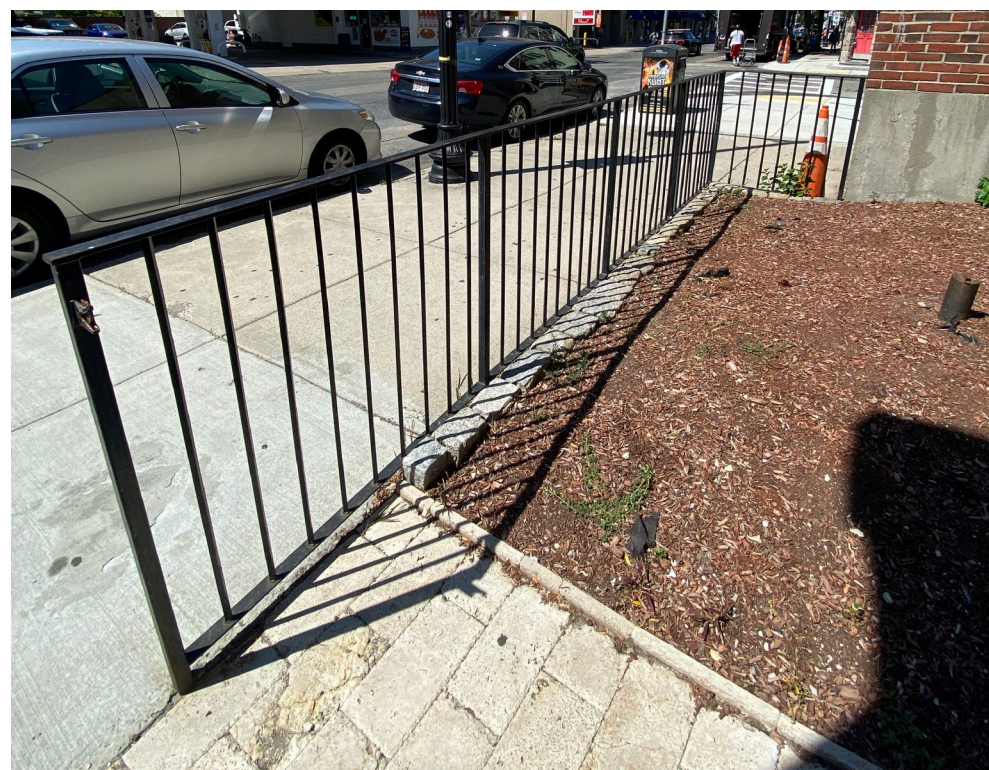
1615 Tremont St – Front Fence 1.2

| No. | Feature | Current Condition | Treatment |
|---|---|---|---|
| | 1.2 | Recent Steel Insecure Out of historic character | Remove fence and replace in kind |

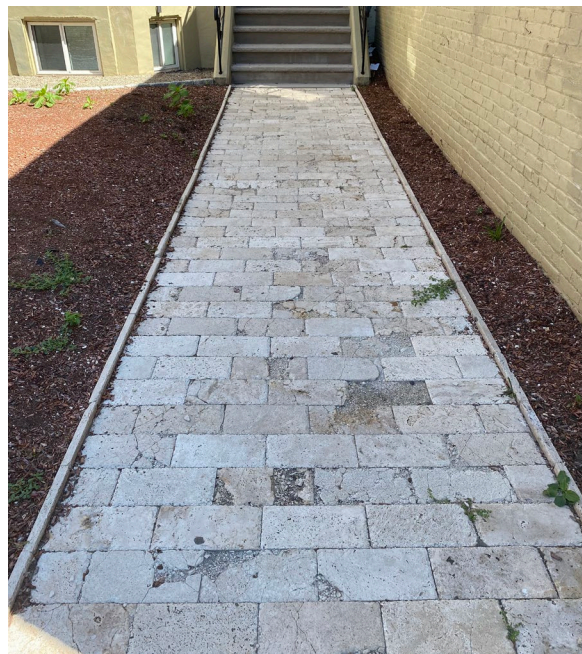
1615 Tremont St – Front Walkway

| No. | Feature | Current Condition | Treatment |
|---|---|---|---|
| 2 | Front Walkway | Stone is poor condition Stone spalling due to freeze and thaw | Install new walkway pavers |
