# CHABAD CENTER FOR MISSION HILL

1615-1617 Tremont Street

Architectural Conservation District Commission

Advisory Review Application

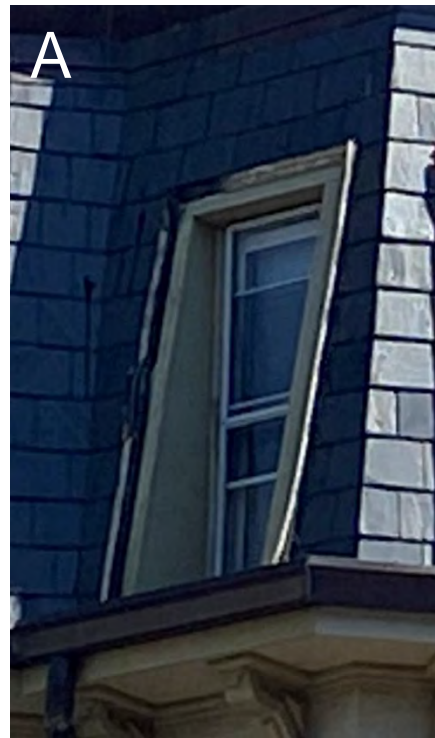
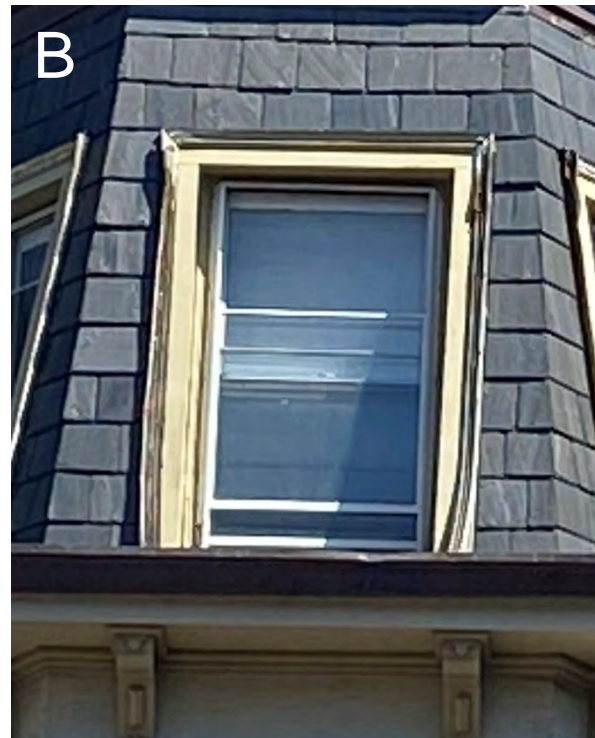
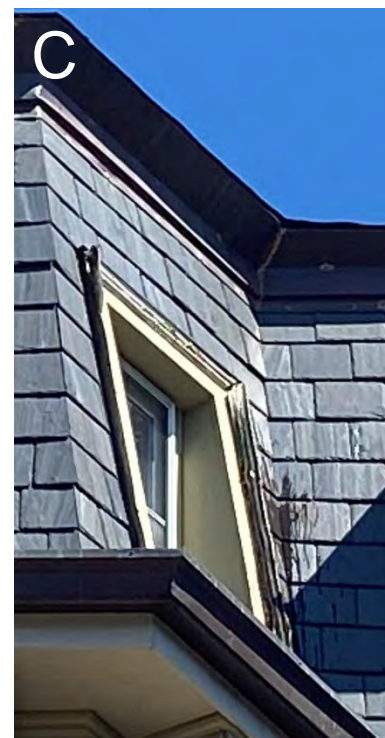
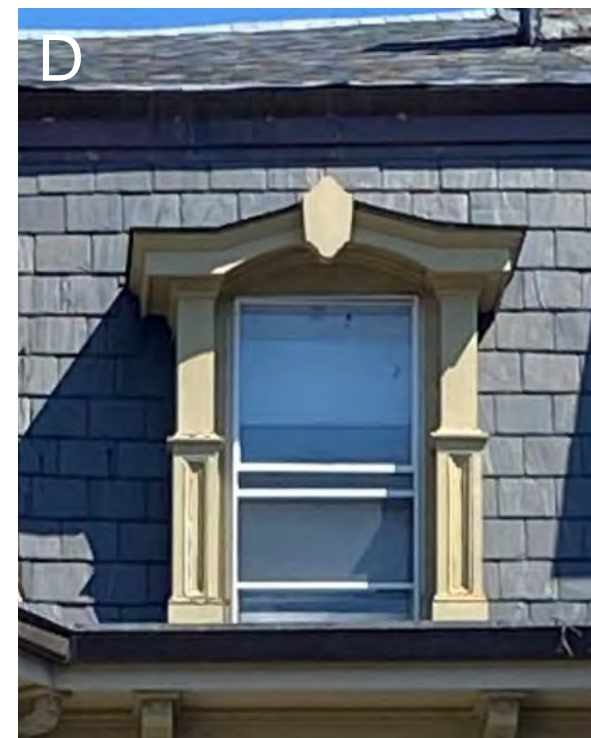
Mansard Level Windows

No.	Feature	Current Condition	Treatment
<b>1</b>	<b>Windows</b> <b>Mansard Windows</b>	<b>Exterior</b>	<b>Exterior</b>
	Window Sash	Poor condition	Reconstruct to match historic double hung two over two windows
	Sill	Poor condition	Reconstruction
	Lintel		
	Window surrounds	Poor condition	A,B,C to be reconstructed
			D to be reconstructed based on historic design to incorporate the decorative molding and medallion

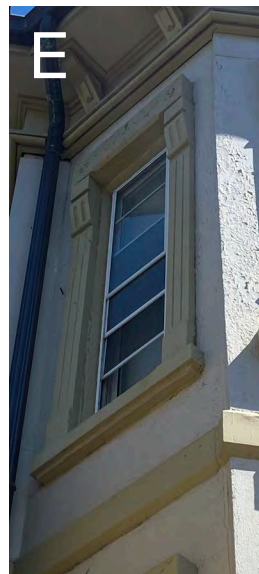
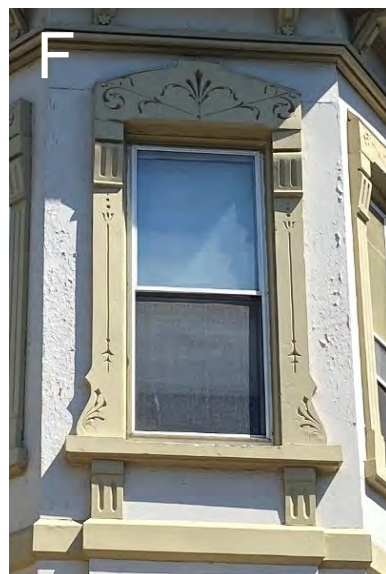
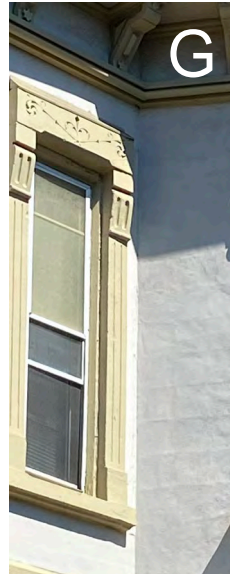
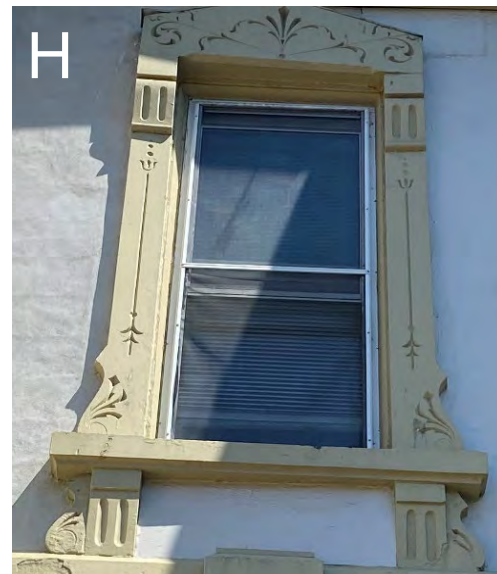
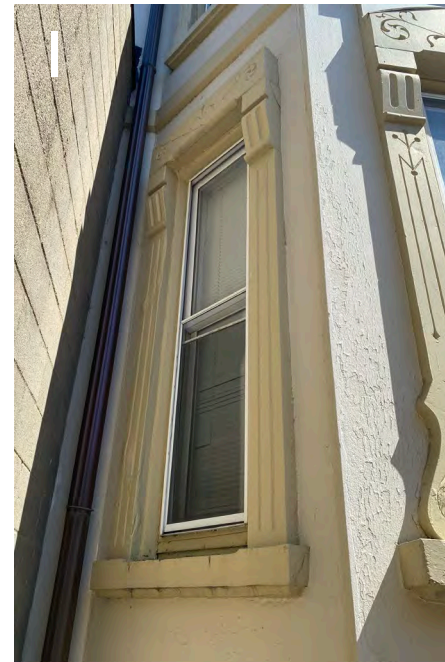
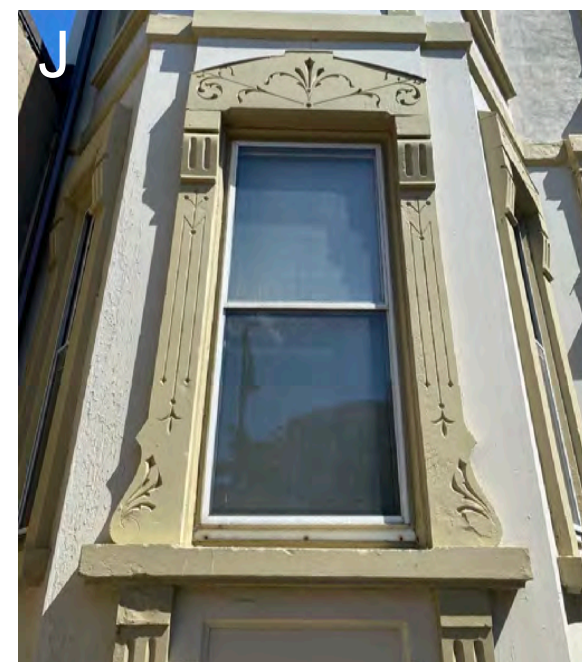
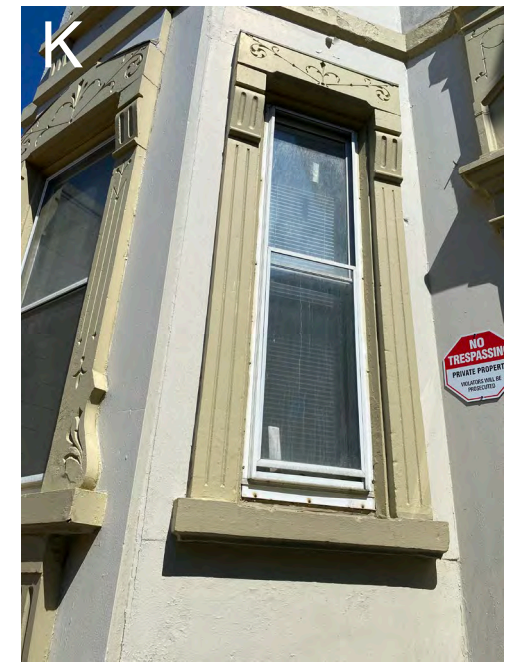
Second Floor Windows

No.	Feature	Current Condition	Treatment
<b>1</b>	<b>Windows</b> <b>Second Floor and Parlor Windows</b>	<b>Exterior</b>	<b>Exterior</b>
	Window Sash	Poor condition	Reconstruct all. F, H, J match historic double hung two over two windows
	Sill	Poor condition	Reconstruction
	Lintel		
	Window surrounds	Finish appears to be in sound condition	Remove flashing over F, G, H, J, K and replace if needed. Strip stucco/paint and leave sandstone exposed on all.

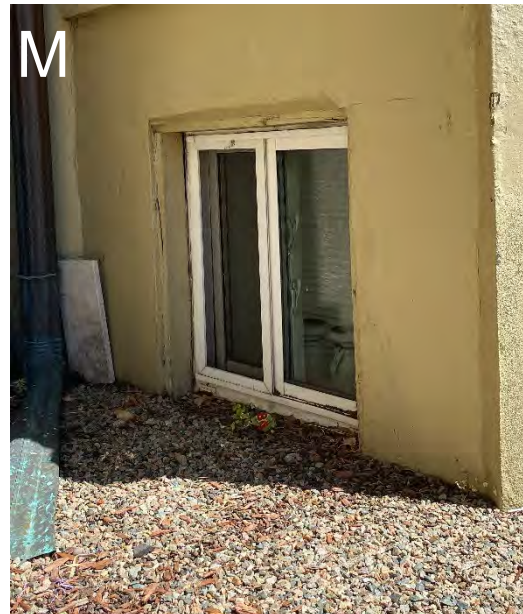
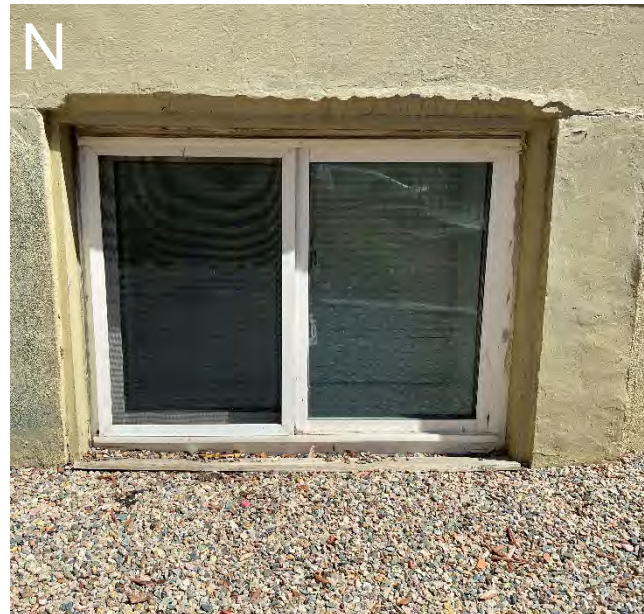
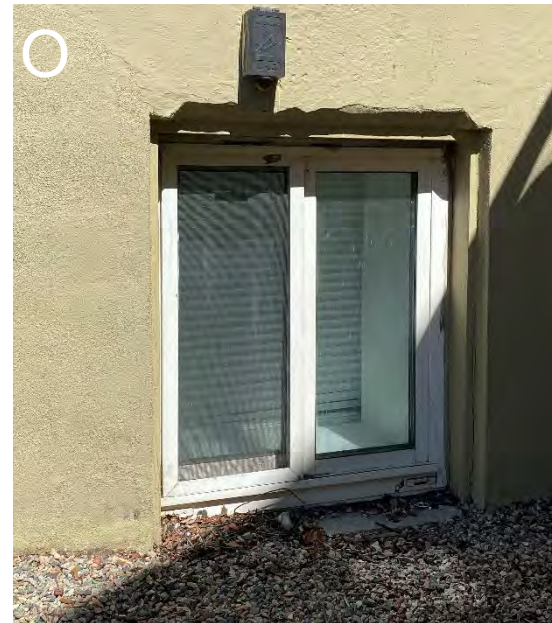
Basement Level Windows

No.	Feature	Current Condition	Treatment
<b>1</b>	<b>Windows</b> <b>Basement Windows</b>	<b>Exterior</b>	<b>Exterior</b>
	Window Sash	Poor condition	Replace
	Sill	Poor condition	Replace
	Lintel

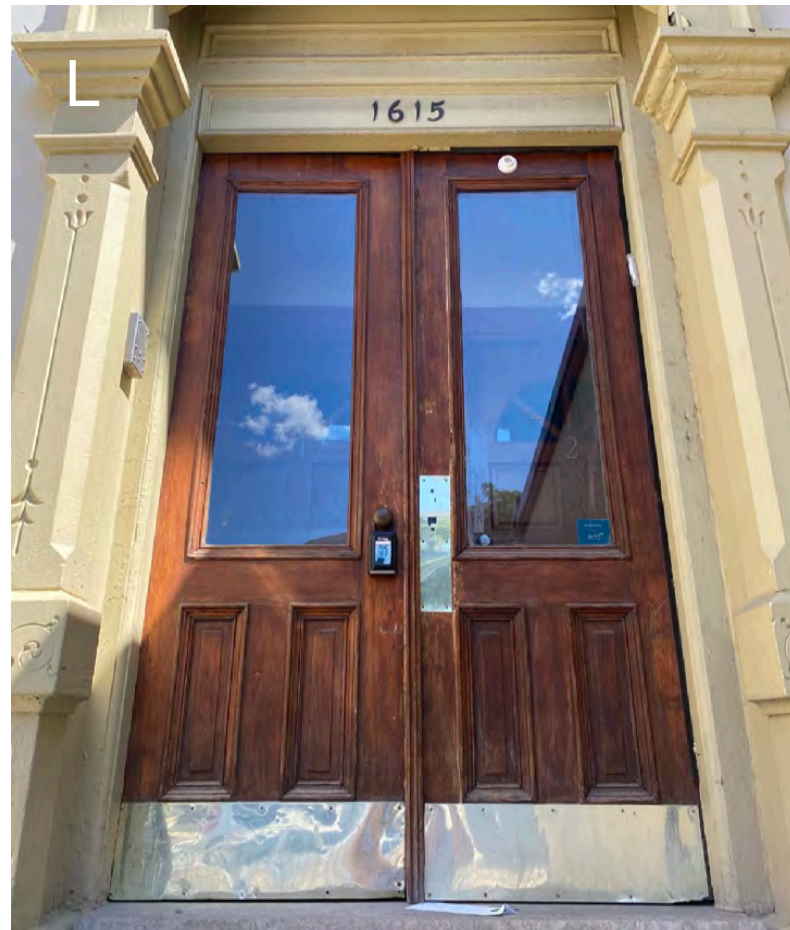
No.	Feature	Current Condition	Treatment
<b>2</b>	<b>Door</b>	<b>Exterior</b>	<b>Exterior</b>
	Paneling	Hardwood with metal kick plates	Door can be retained with all hardware replaced
	Transom		
	Vestibule Sidewalls	One side plastered; one side exposed brick

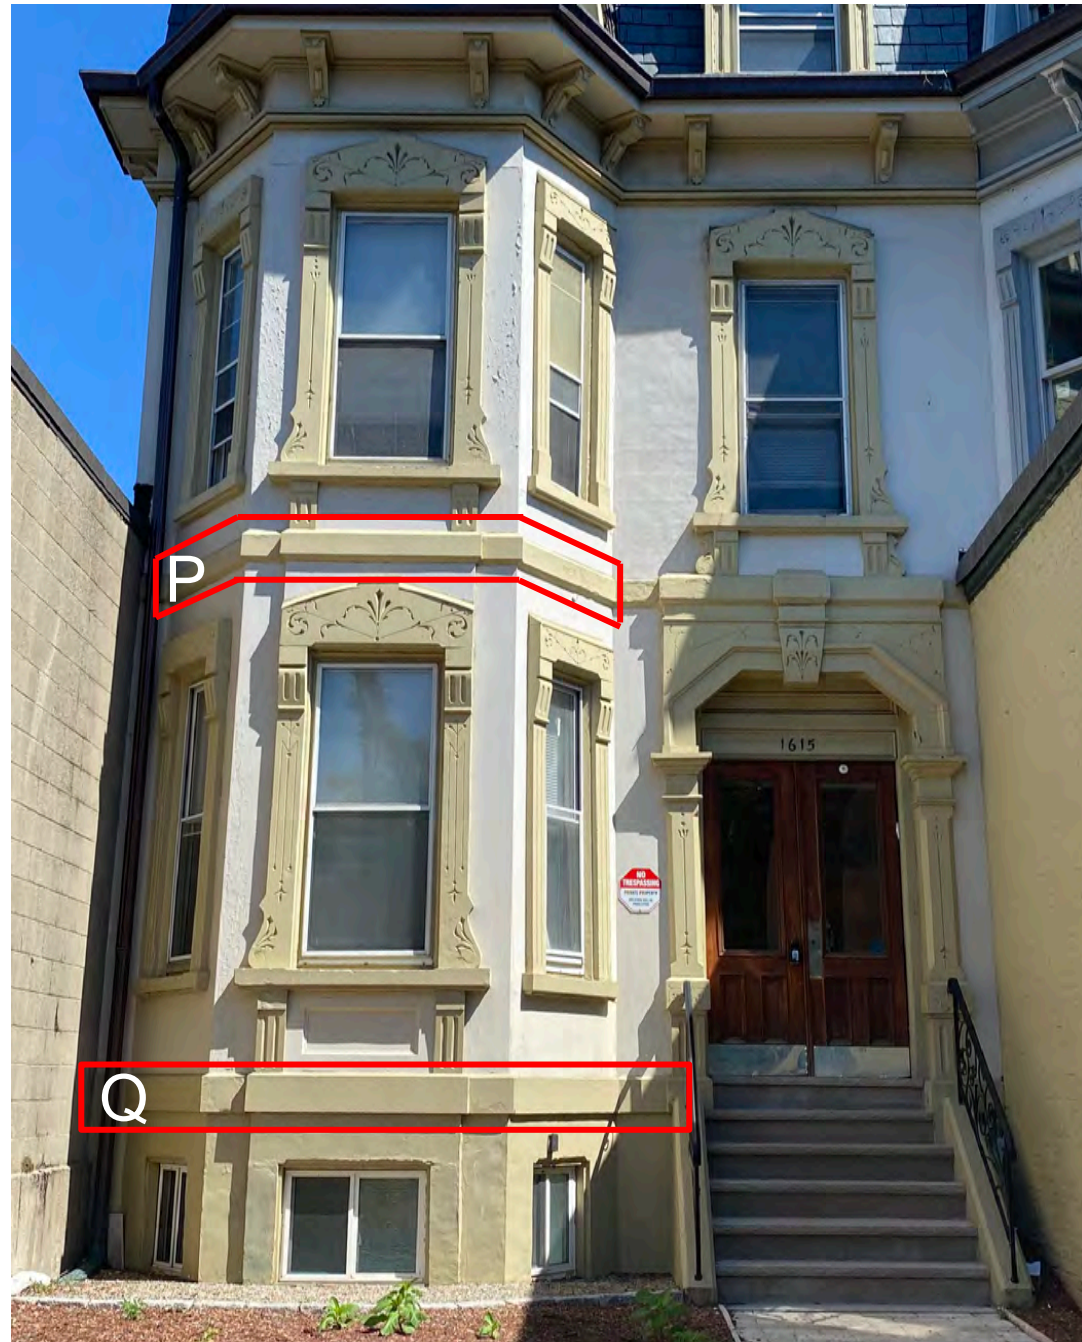
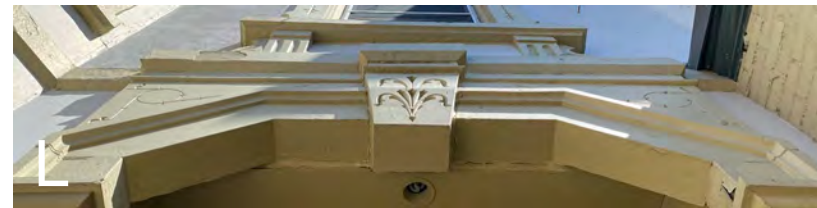
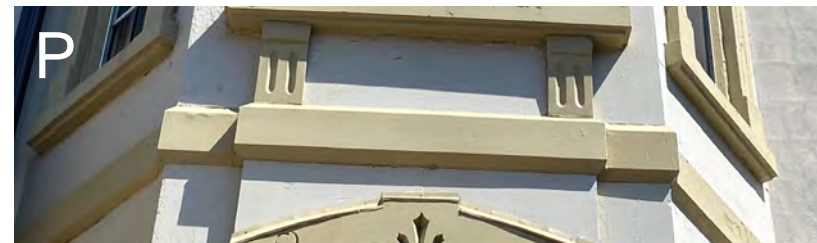
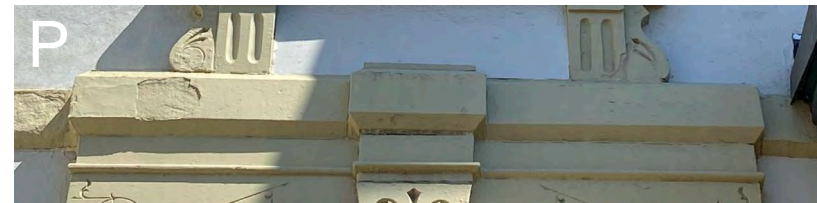
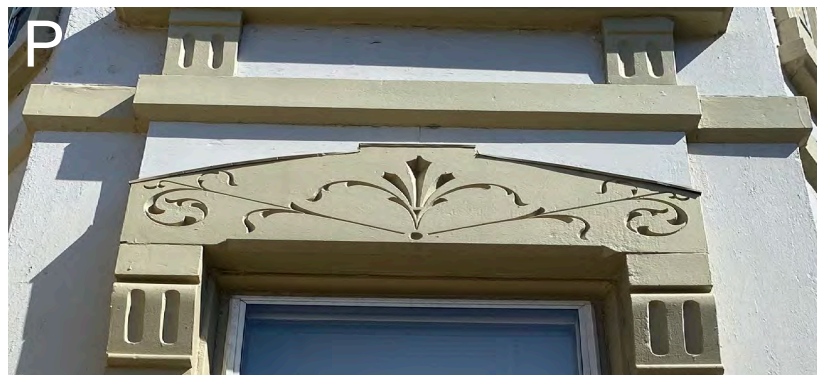
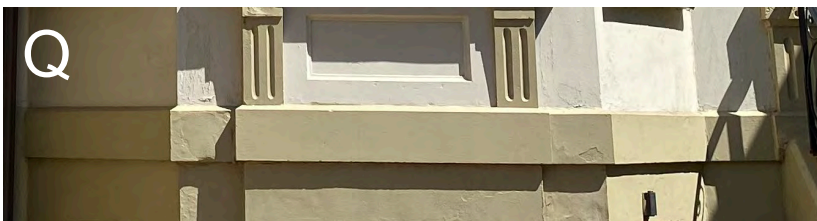
No.	Feature	Current Condition	Treatment
3	Stucco over stone trim on facade	good condition	Stucco/paint to be stripped and left as exposed stone if exploratory work reveals suitable condition

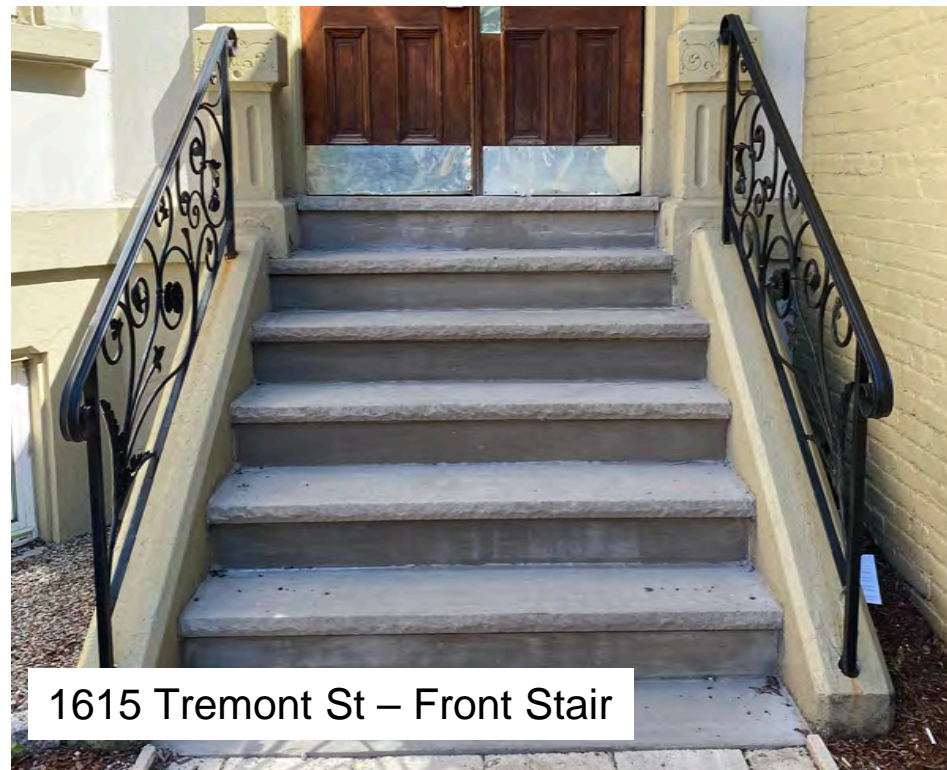
1615 Tremont St – Front Stair

No.	Feature	Current Condition	Treatment
1	Stringer	Possibly original sound condition	Exploratory work to reveal stringer material. If stone in good condition, leave exposed. If not, repaint, color TBD
2	Riser	Stone replacement (not original) Limestone sound condition	Remove and reinstall
3	Tread	Limestone sound condition	Remove and reinstall
4	Railing	Recent steel, insecure Ornamental design out of character	Remove and replace with period appropriate balustrade/handrail Relocate from stringer to treads and separate from ornamental door surround

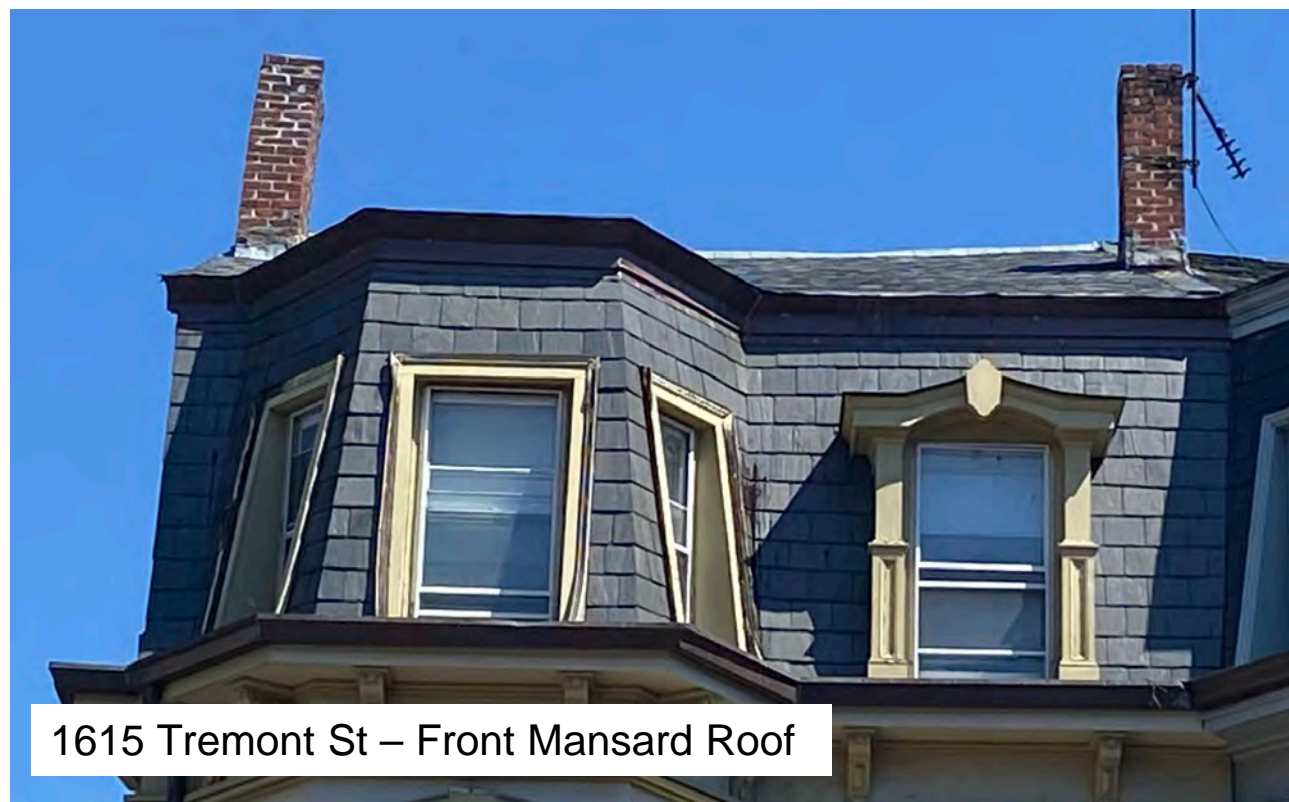
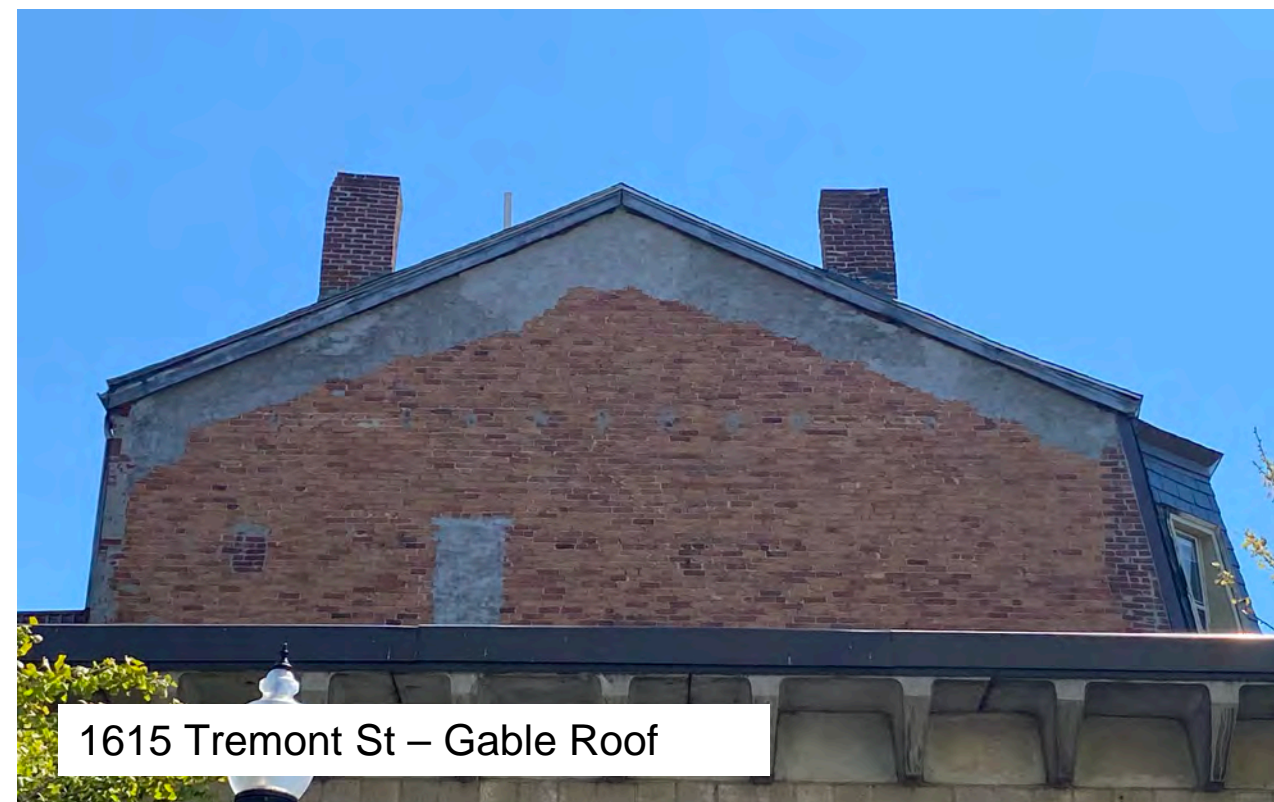
No	Feature	Current Condition	Treatment
1	<b>Mansard Roof</b>		
	Exterior	Slate appears to be in good condition Eave copper in poor condition	To be assumed that some damage will occur during demolition and new construction – reuse salvaged slate shingles or replace slate to match Replace copper trim with wood moldings
	Interior	Boarded and plastered on the inside	
2	<b>Chimney</b>	Poor condition	Rear chimney to be demolished; front chimney to be repaired
3	<b>Gable Roof</b>	To be evaluated	Front roof replacement as required to match existing

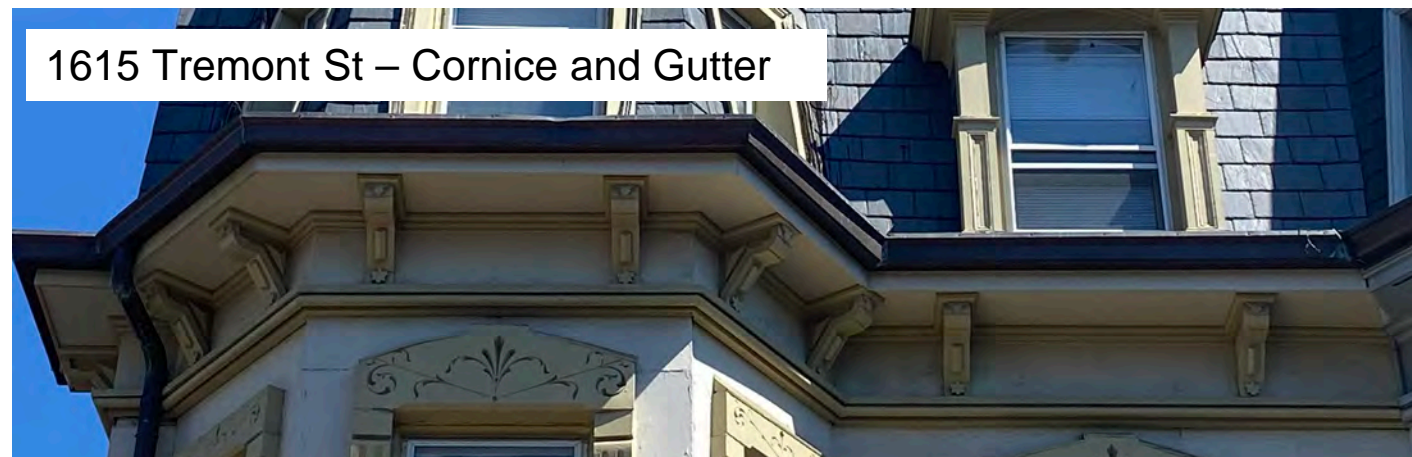
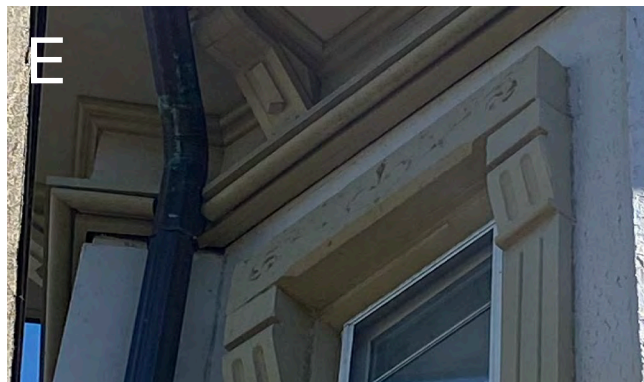
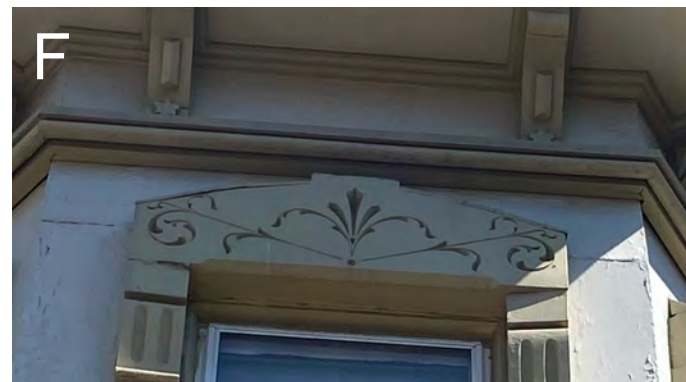
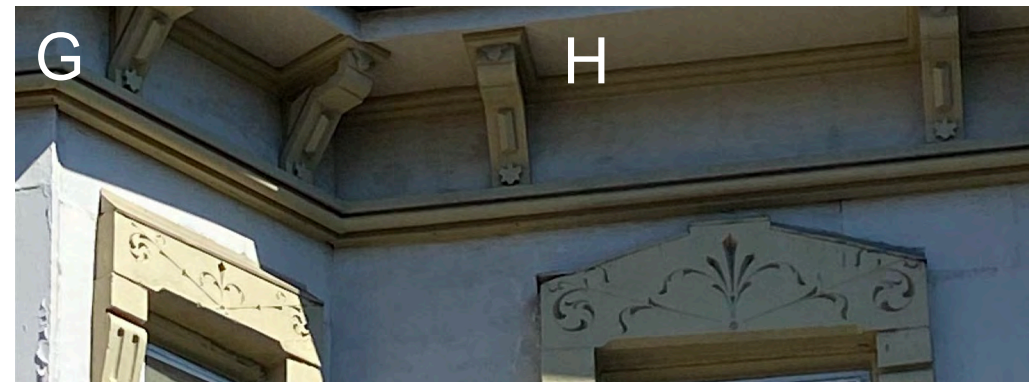
Second Floor

No.	Feature	Current Condition	Treatment
U	<b>Cornice</b>	Decent condition Woodwork intact	Remove return at new construction
T	<b>Gutter and Flashing</b>	Poor condition Water problem above parlor and second floor window surrounds to be investigated	Change gutter profile – similar to adjacent rowhouse Existing flashing over window surrounds to be removed and sealed
T	<b>Downspout</b>	Poor condition	Change profile

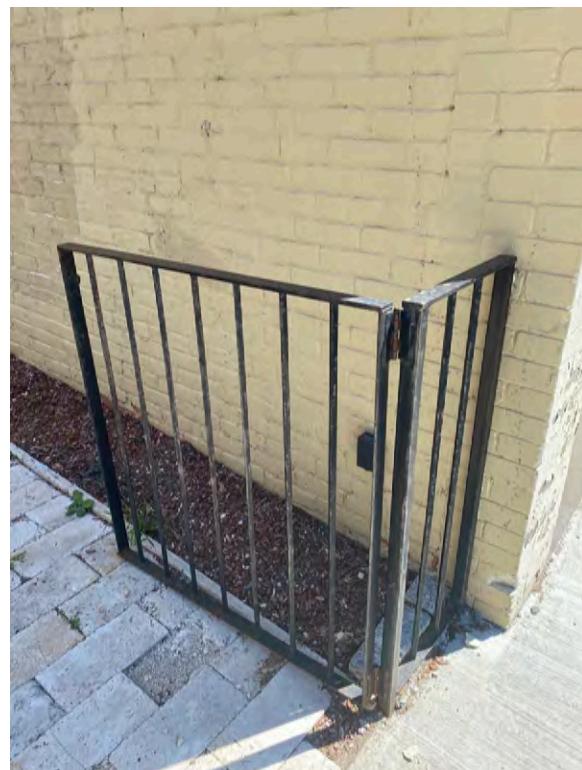
1615 Tremont St – Front  
Fence & Gate 1.1

No.	Feature	Current Condition	Treatment
<b>V</b>	<b>Front Fence &amp; Gate</b>		
	1.1	Recent Steel Insecure Out of historic character	Remove fence gate and replace in kind
	1.2	Recent Steel Insecure Out of historic character	Remove fence and replace in kind

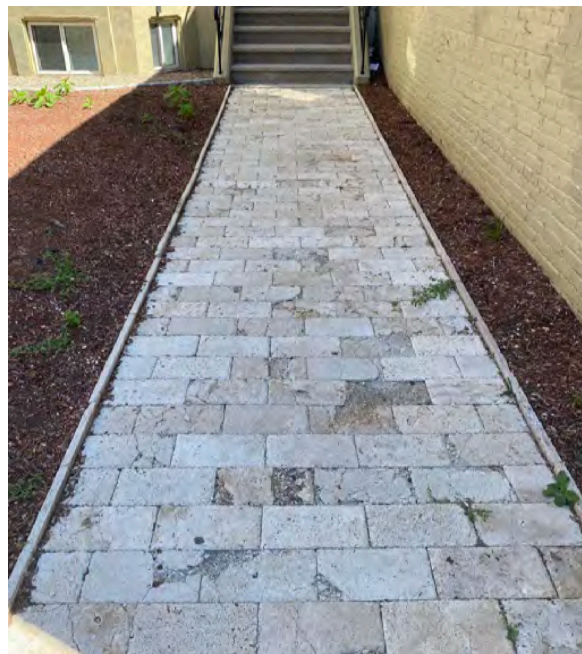
1615 Tremont St – Front Walkway

No.	Feature	Current Condition	Treatment
2	<b>Front Walkway</b>	Stone is poor condition Stone spalling due to freeze and thaw	Install new walkway pavers
3	<b>Front Yard</b>	Recent Addition – mulch and gravel	Install new green landscape planting
