PERENNIAL GARDENS LLC
DESIGN | BUILD | MAINTAIN
WWW.PERENNIALGARDENS.NET

191 COMMONWEALTH AVENUE

GARDEN RESTORATION PROJECT

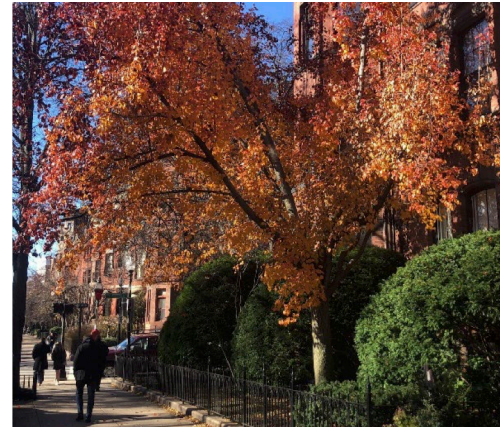
The tree was 14.5 inches in diameter. The tree was observed to be in good health showing rapid growth evidenced by 6-8 inches of twig elongation. The tree was growing up against the structure, and limbs were drooping down near the sidewalk on Commonwealth Ave. The removal of a large leader from the center of the canopy resulted in several other poorly attached leaders competing for dominance.

This type of branch structure is very common for callery pear trees, as is the failure of a codominant stem. Structural pruning is unlikely to achieve a reduced likelihood of failure as the central leader has been removed. Similarly, The installation of structural support cables is not likely to be sufficient to reduce the likelihood of failure. Aggressive pruning to reduce the branch weight and therefore reduce the likelihood of failure would result in an unsightly form of the canopy comprised by multiple topping cuts.

Photo 1. Pear tree located at the front garden of the 191 Commonwealth Ave property.

I recommend to remove the tree and replant with a species that can be maintained in this location.

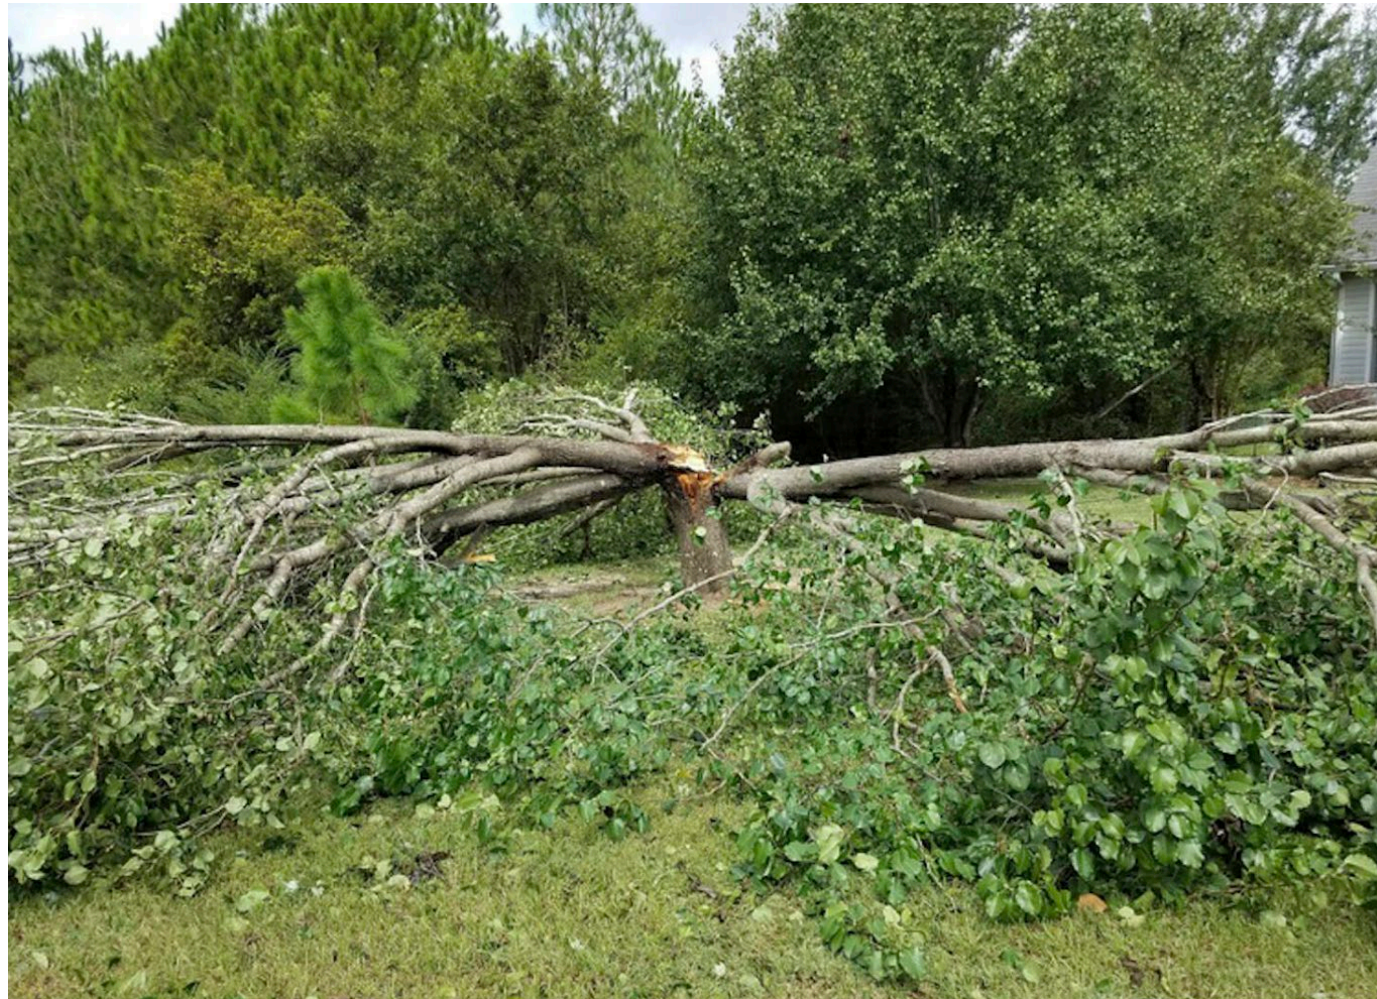
CALLERY PEAR TREE ISSUES

PEAR CROTCH: Characteristic V-crotch branch structure > susceptible to splitting

WITCHES' BROOMS: Abnormal proliferations of twigs and branches
