CITY REALTY

SOUTH END LANDMARKS COMMISSION

# 587 ALBANY STREET

**RE: 587 Albany St. Boston, MA**  
**Conceptual Structural Pricing Narrative**  
**H+O Project #24-022**

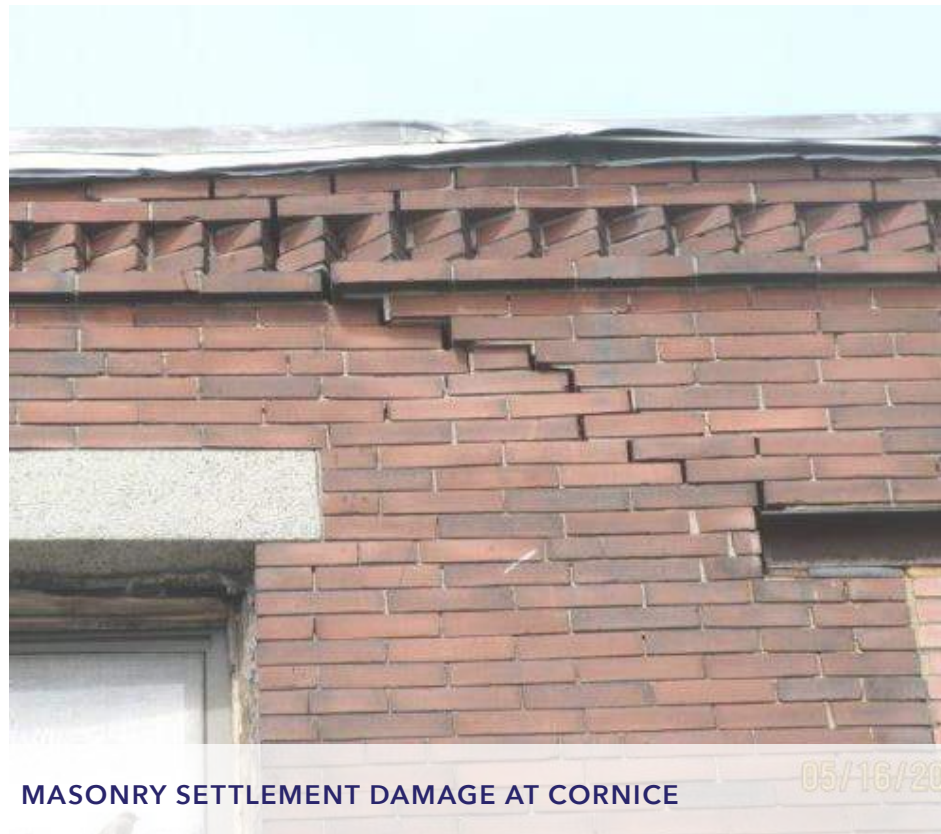
05/16/2018

MASONRY SETTLEMENT DAMAGE AT CORNICE

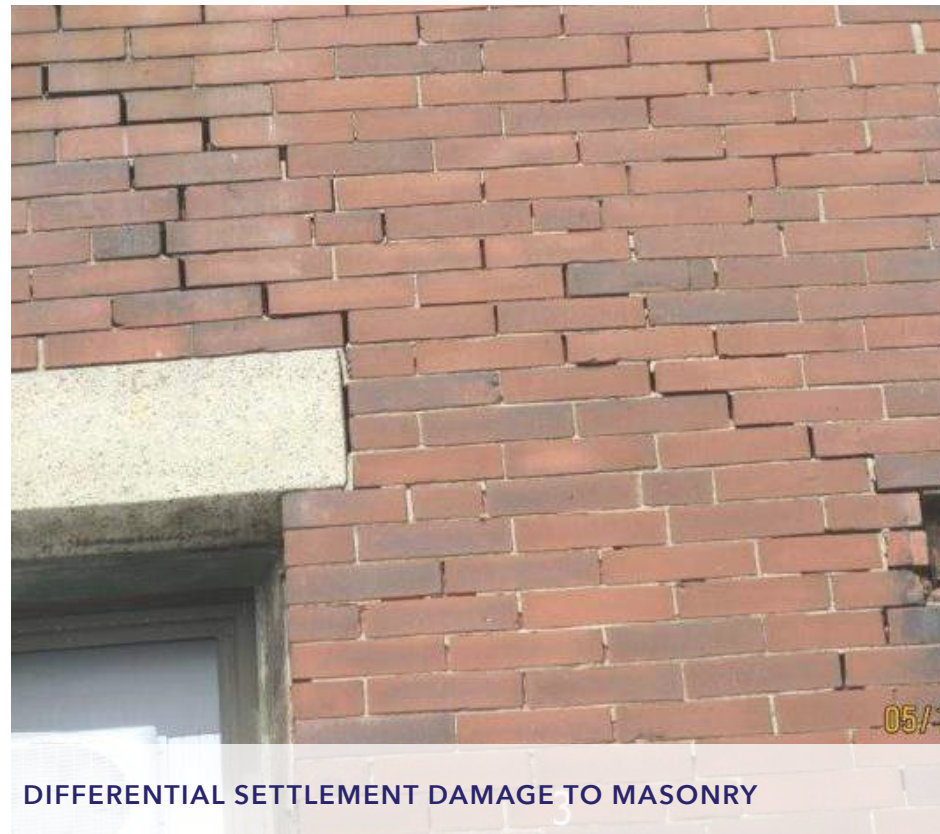
05/16/2018

DIFFERENTIAL SETTLEMENT DAMAGE TO MASONRY

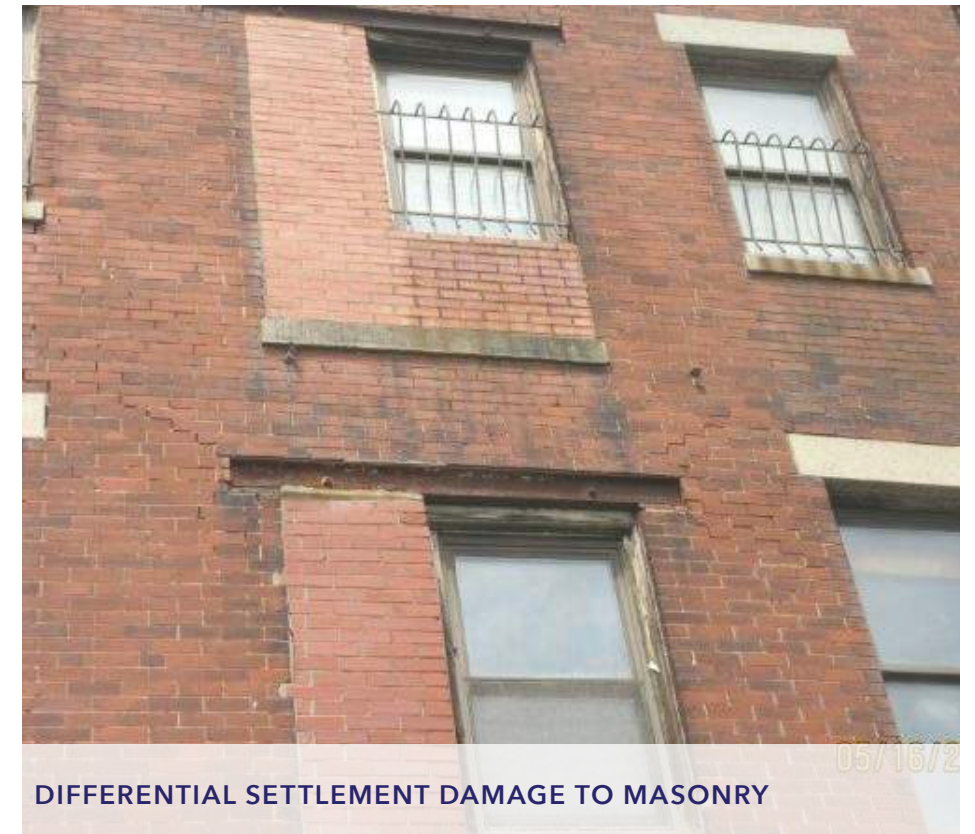
05/16/2018

DIFFERENTIAL SETTLEMENT DAMAGE TO MASONRY

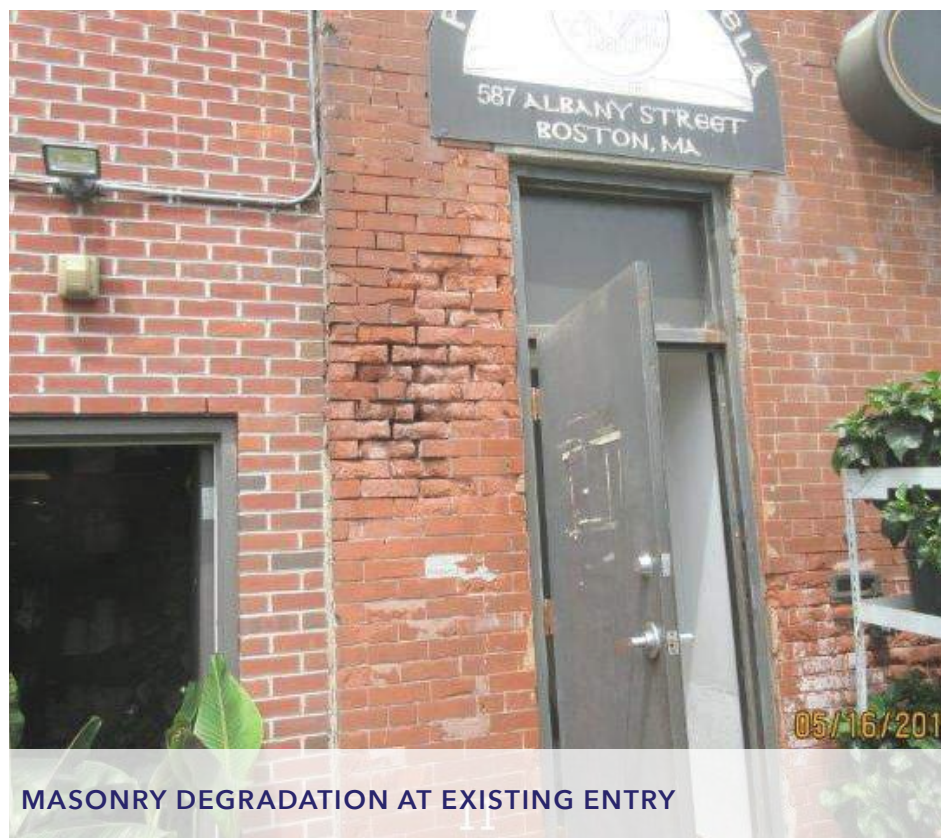
05/16/2018

MASONRY DEGRADATION AT EXISTING ENTRY

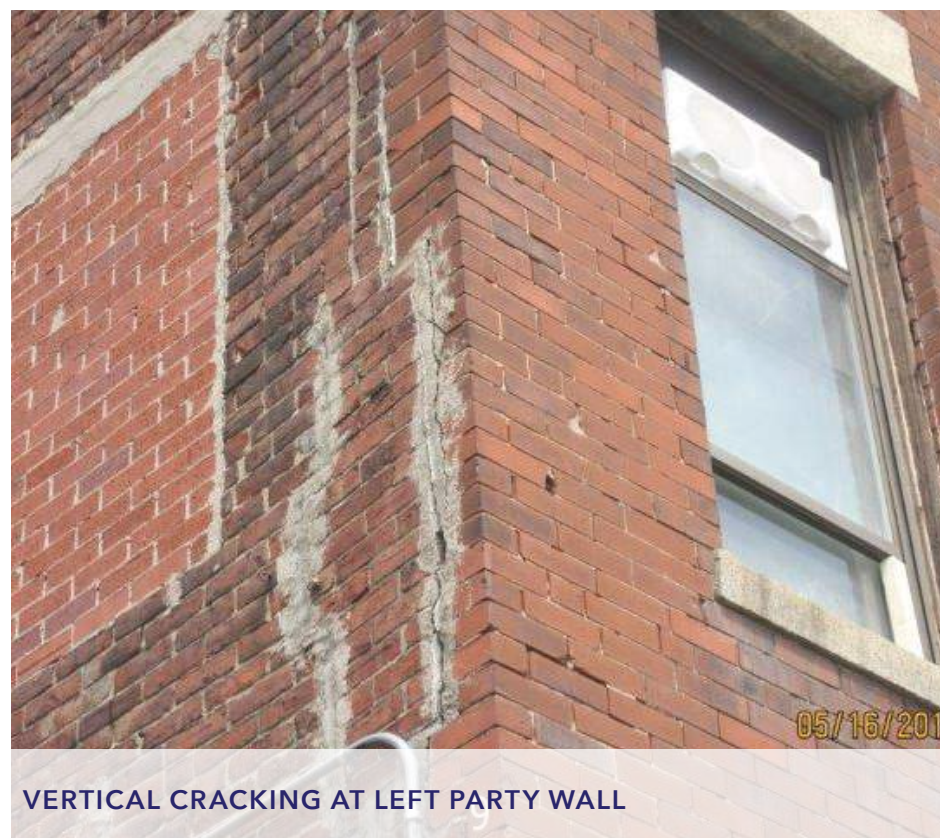
05/16/2018

VERTICAL CRACKING AT LEFT PARTY WALL

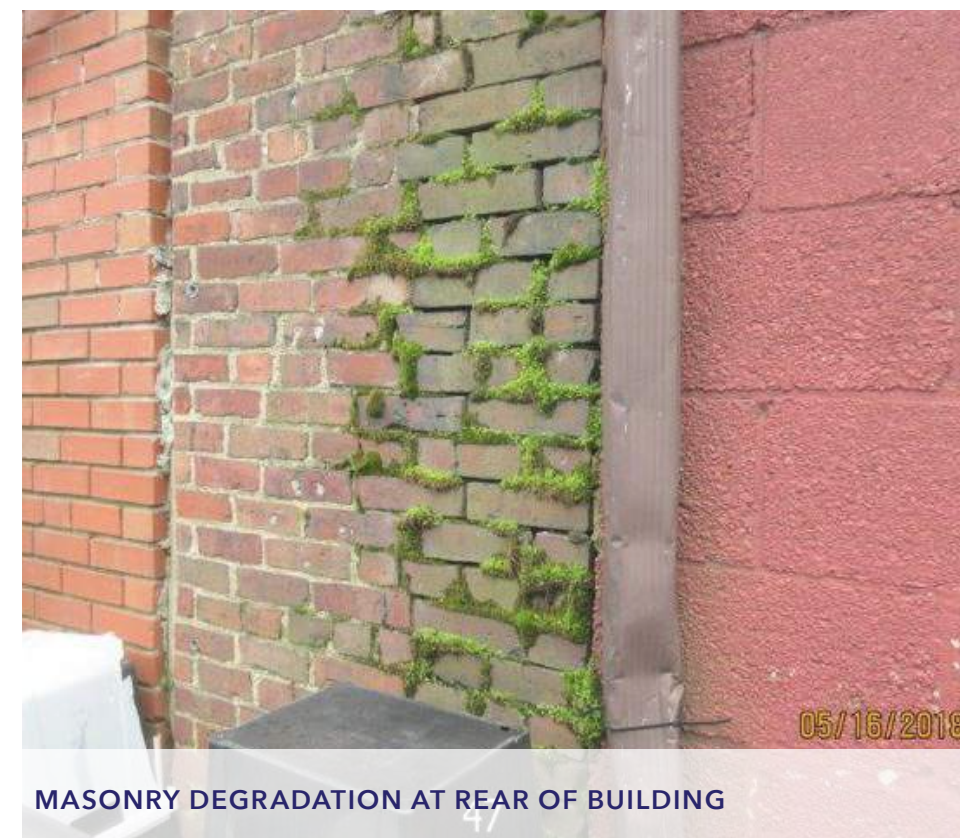
05/16/2018

MASONRY DEGRADATION AT REAR OF BUILDING

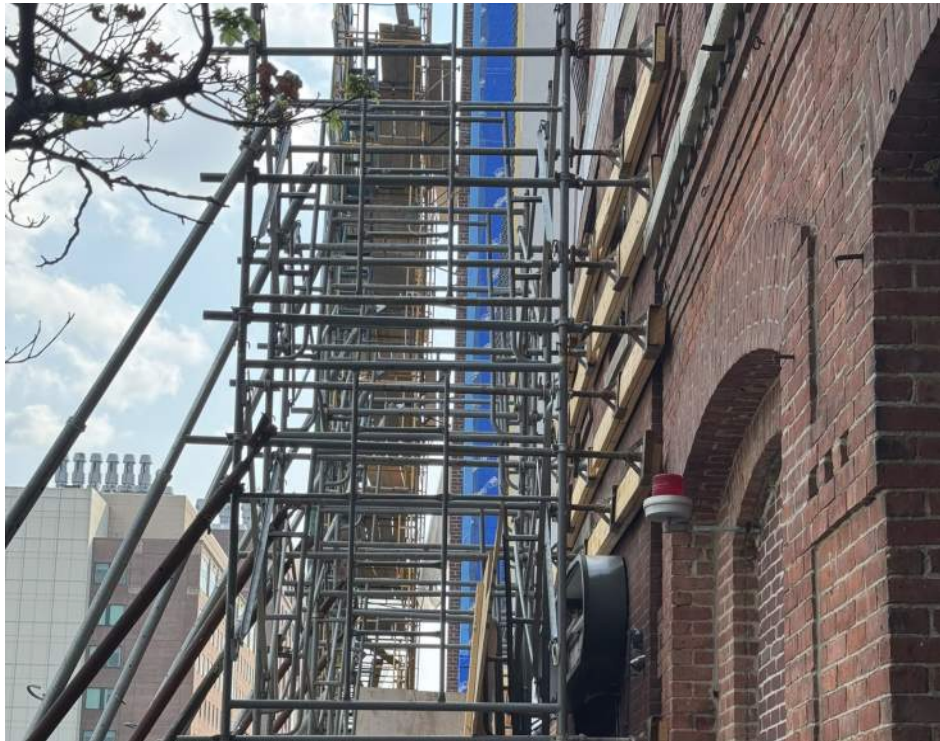
BRACING IN PLACE AGAINST BOWED MASONRY WALL

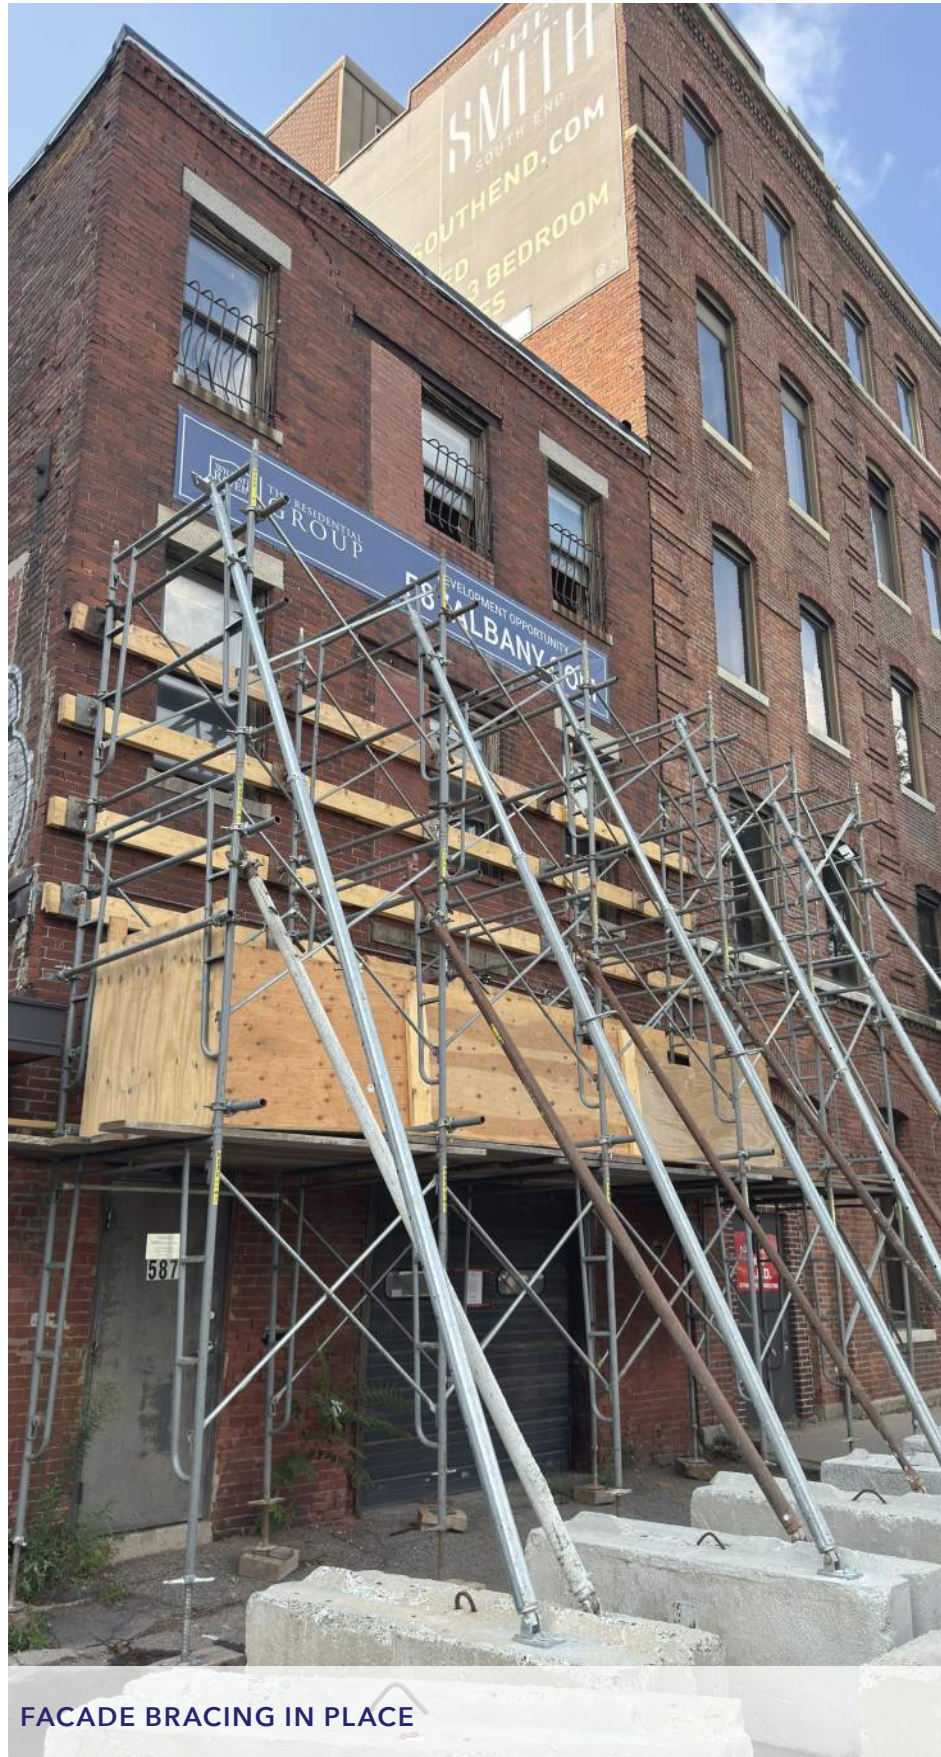
FACADE BRACING IN PLACE

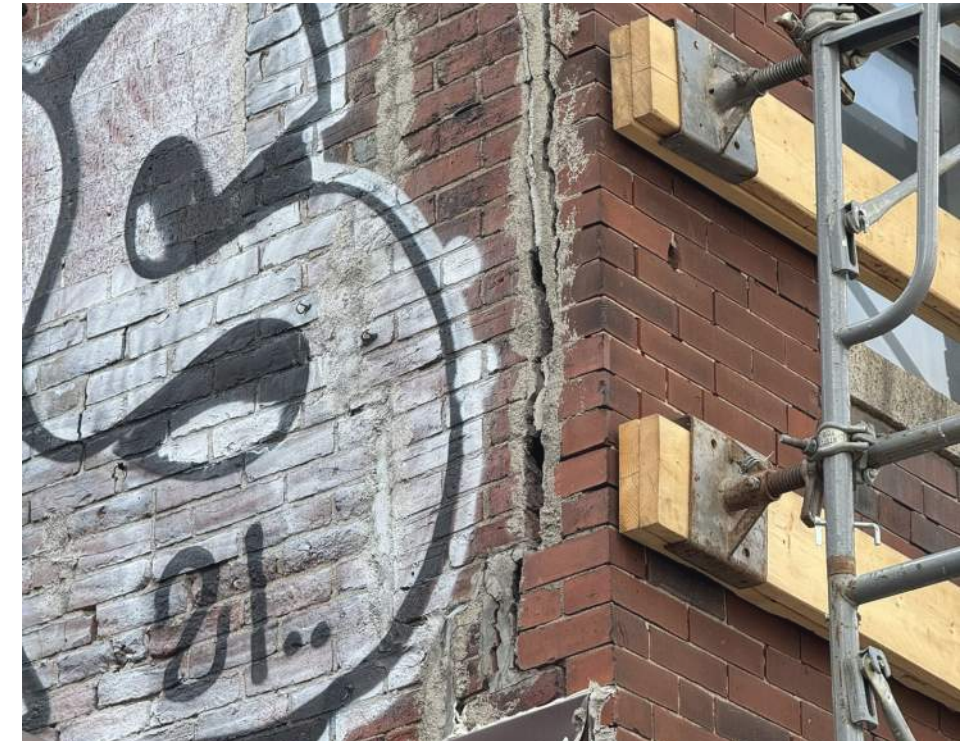
SEPARATION OF MASONRY WALLS

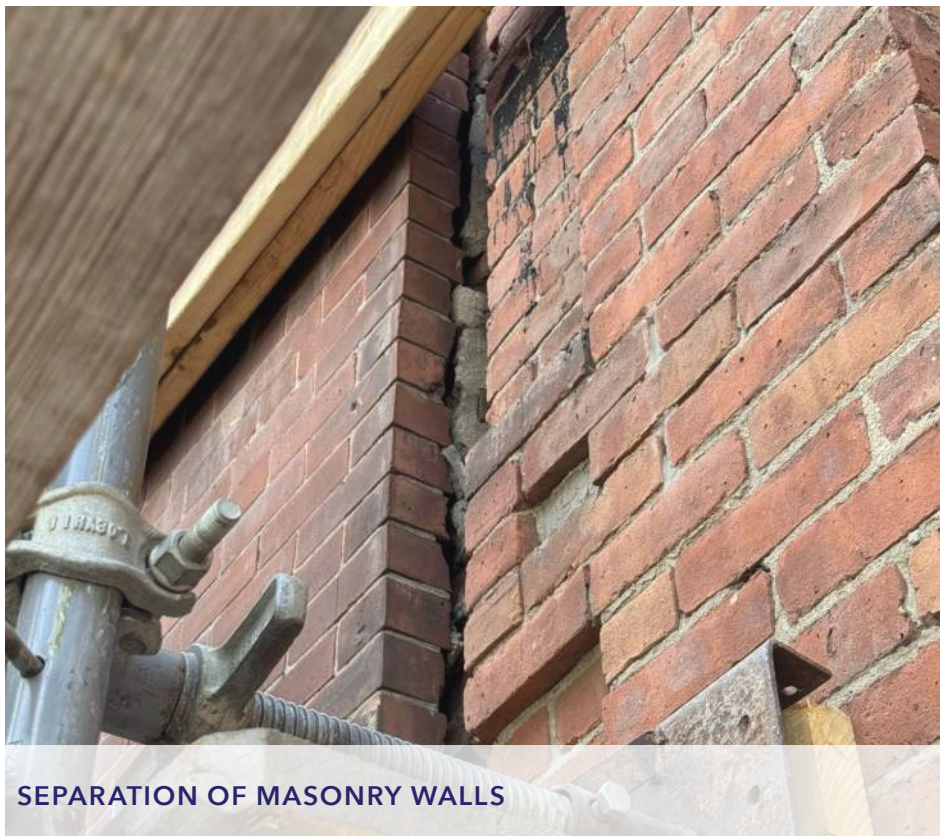
SEPARATION OF MASONRY WALLS

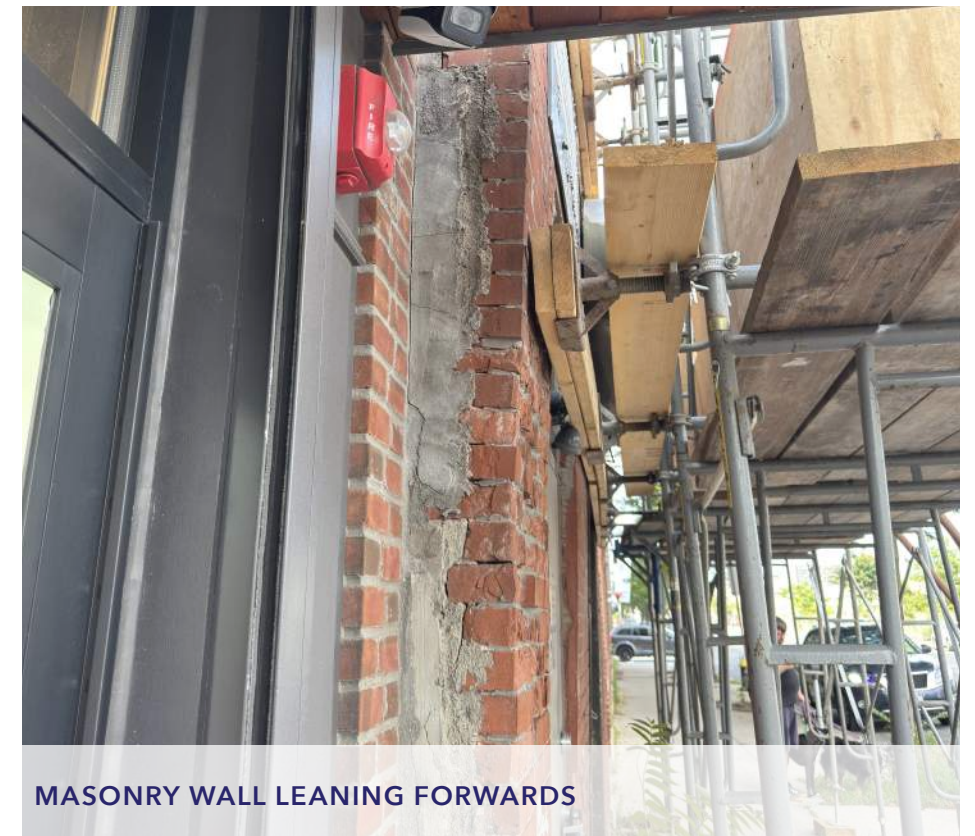
MASONRY WALL LEANING FORWARDS

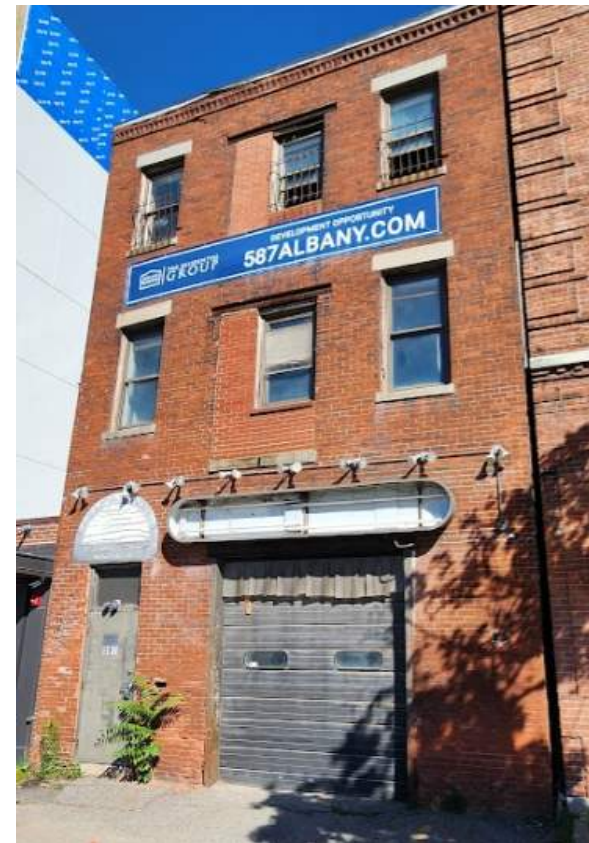
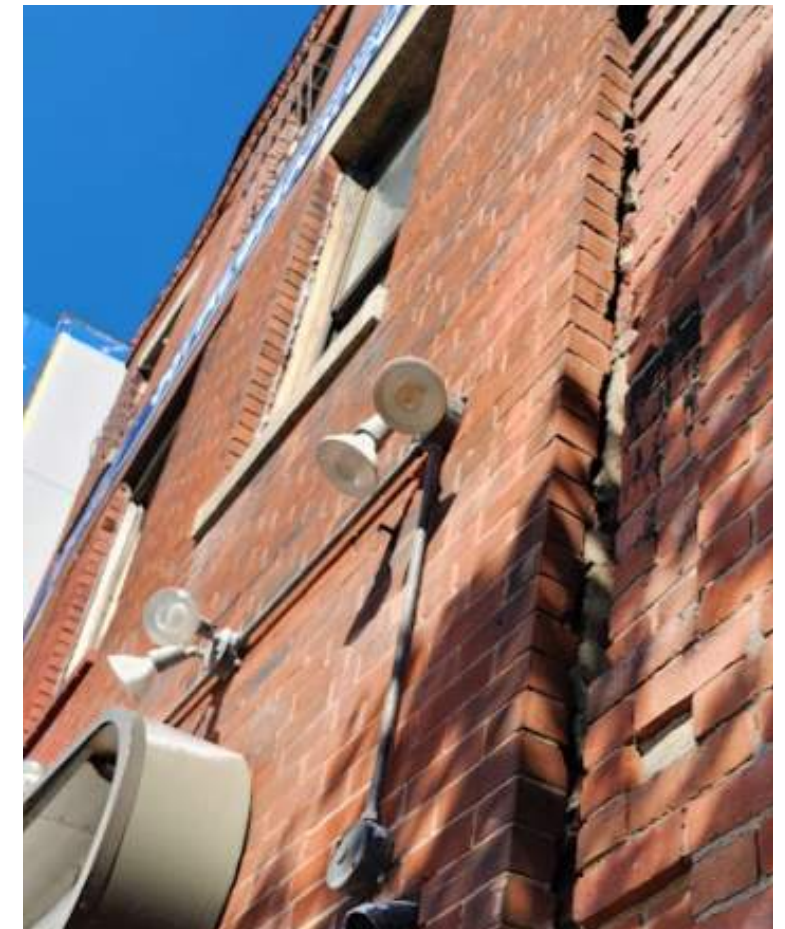
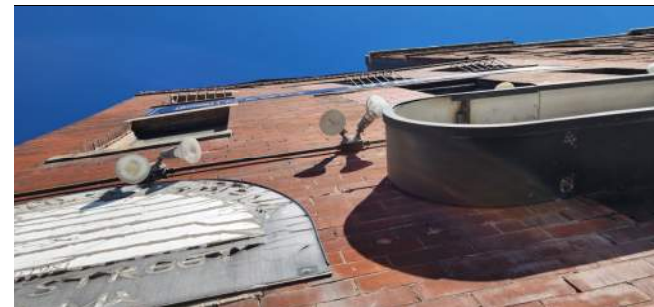
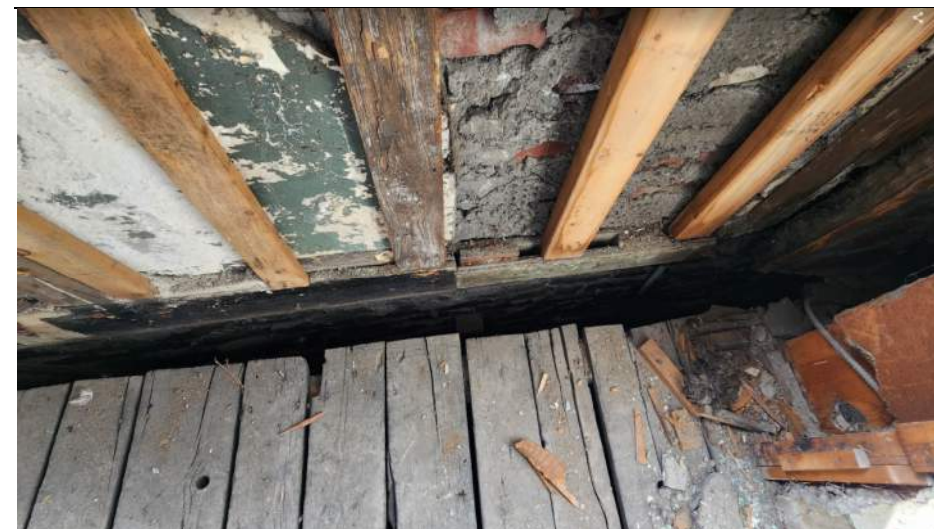
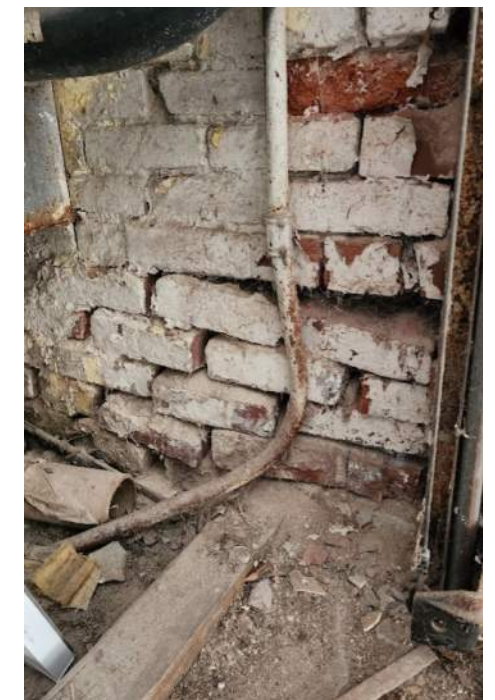
The existing structure is a 3-story unreinforced brick masonry building, a common construction type from this time period. The attached photos show several deficiencies observed during our visit. There was extensive loss of mortar, step cracking, and loose and missing bricks. At approximately the elevation of the second level, the outer wythe of masonry has pulled away and delaminated from the inner wythes. All of the above have created paths for water to enter the façade and further degrade it over time.

Of most concern, the back of the façade has pulled away from the framed second floor by about 3-5 inches. This is substantial movement, and we did not observe any floor ties, which suggests the façade currently has no bracing to prevent further movement.

There is planned redevelopment for this parcel that was intended to brace, restore, and reattach the façade to the new building. In our opinion, this façade cannot be safely braced and repaired in that manner given its out-of-plumbness and deteriorated condition. We suggest the full demolition of this wall and rebuilding or reincorporating it as a brick veneer in the new project.

This matter must be addressed promptly, as the current condition is unsafe. We recommend engaging a demolition and shoring contractor familiar with this type of work and installing appropriate sidewalk protection immediately.
