599 Tremont St. Apt 2
Owner: Kimberly Vermeer

South End Landmarks Commission Meeting December 4,
2018

1. Replace Windows
2. Install Ventilation Grille

599 Tremont Street Apt #2 Condo Unit #7 Boston MA 02118
November 6, 2018

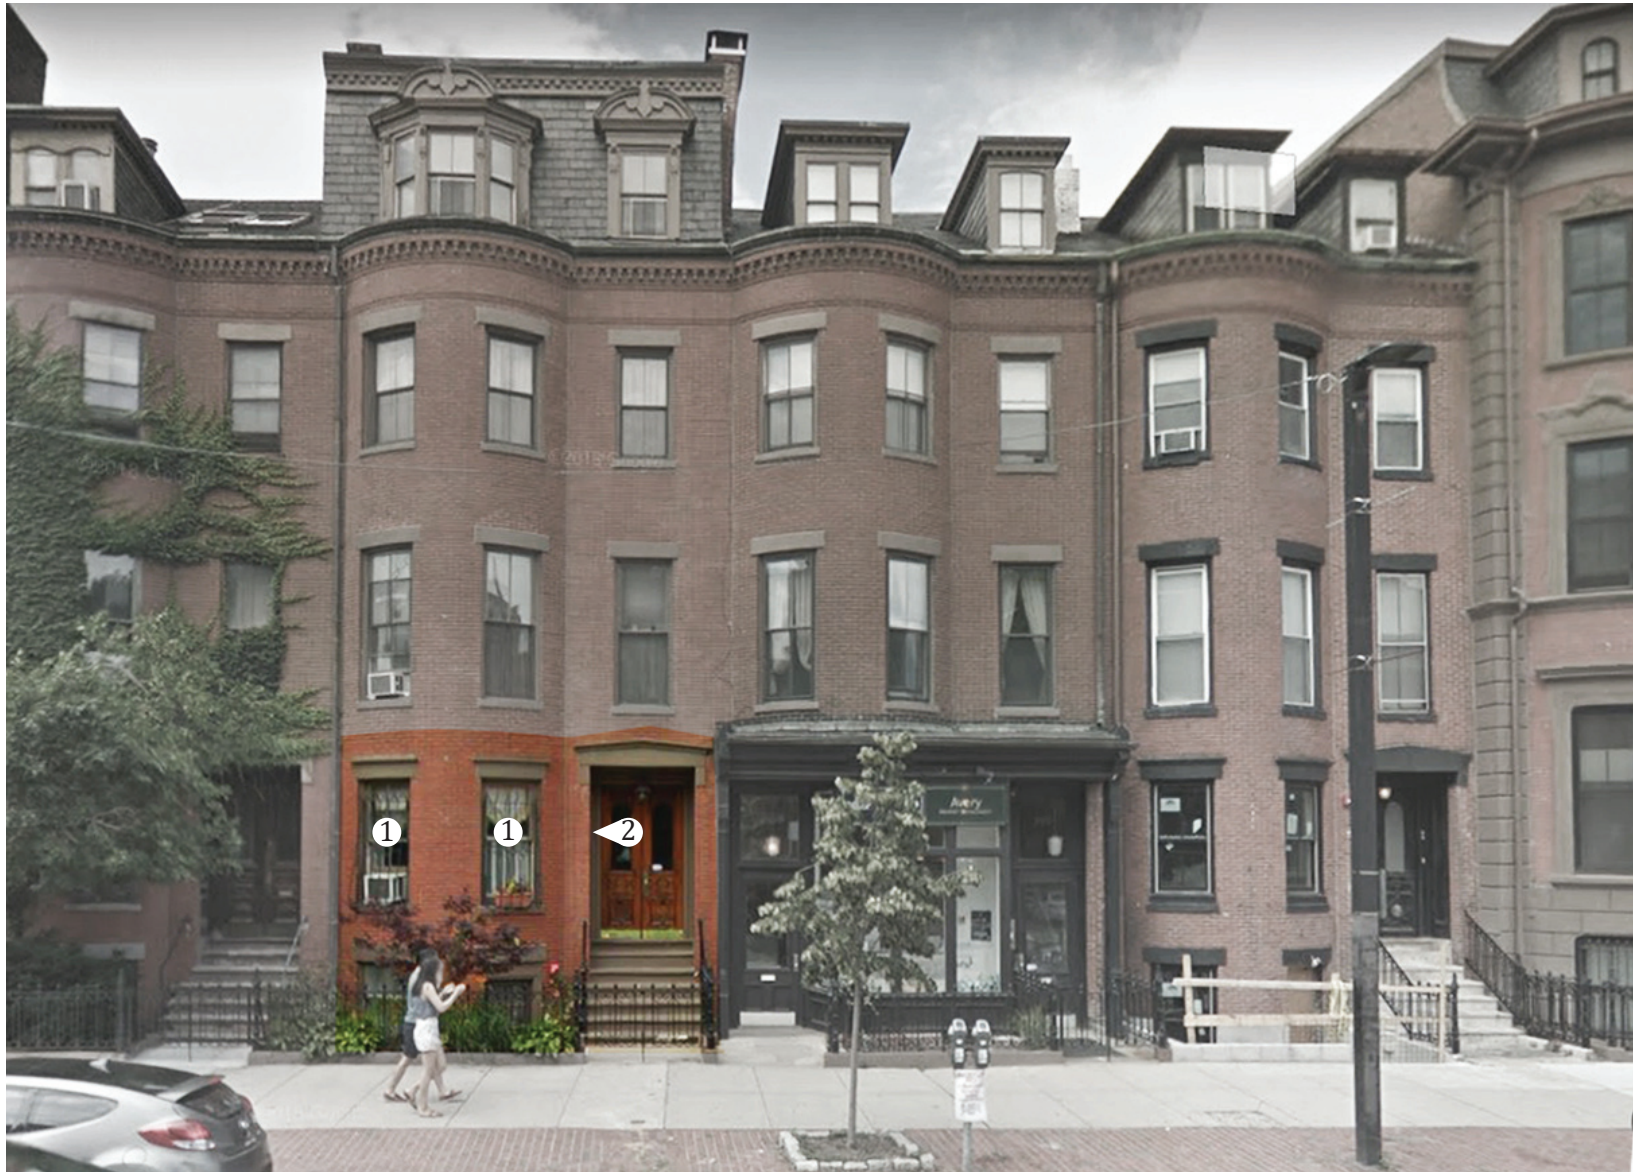
View of existing conditions, 599 Tremont Street. Affected area shown in color.

- 1 - Replace existing window in kind. Wood double hung with center mullions.
- 2- Proposed round ventilation port, painted to match existing entry panel, see detail.

- Existing Windows are replacements installed in the mid-1990s—double-hung, 2-over-2.
- Windows were not installed well originally and are now failing:
 - They are not weathertight—significant air leakage
 - Due to window failure moisture builds up between the double panes of the glazing
 - They allow significant dust, dirt and noise to intrude into the unit

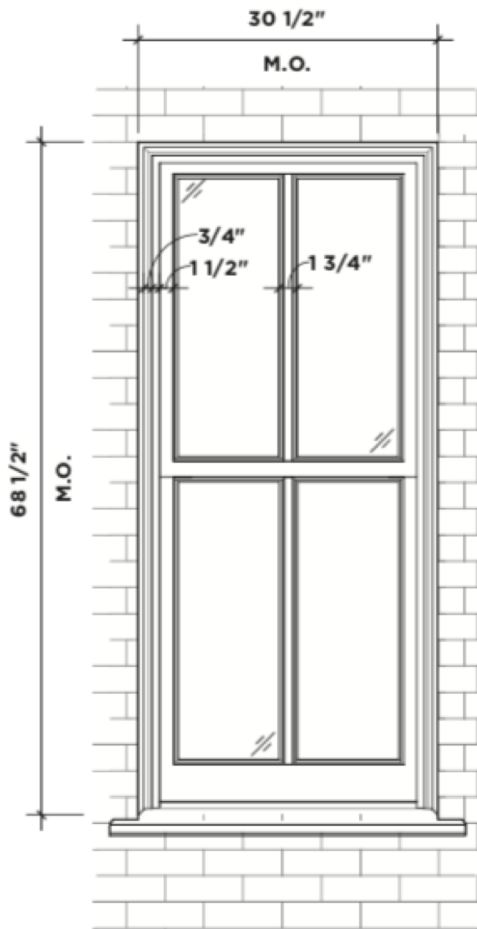
- Wood
- Two-over-Two with divided lights
- Curved sash to match radius of the bow
- Double-paned

Proposed All Wood Window

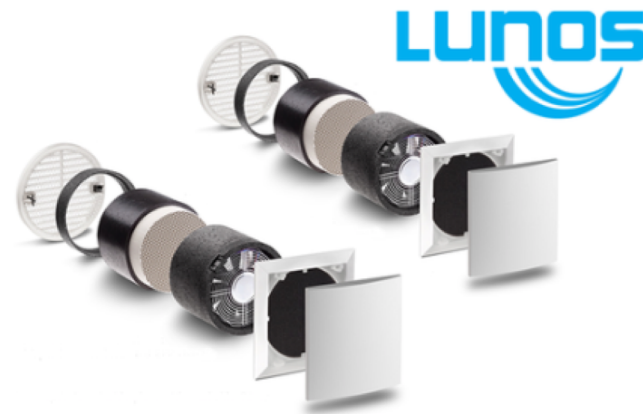
2. Proposed Ventilation Grille

- Intention: Install a Heat Recovery Ventilation (HRV) system to provide controlled fresh air to the unit
- Proposed 2-part system requires a portal at the front and back of the unit

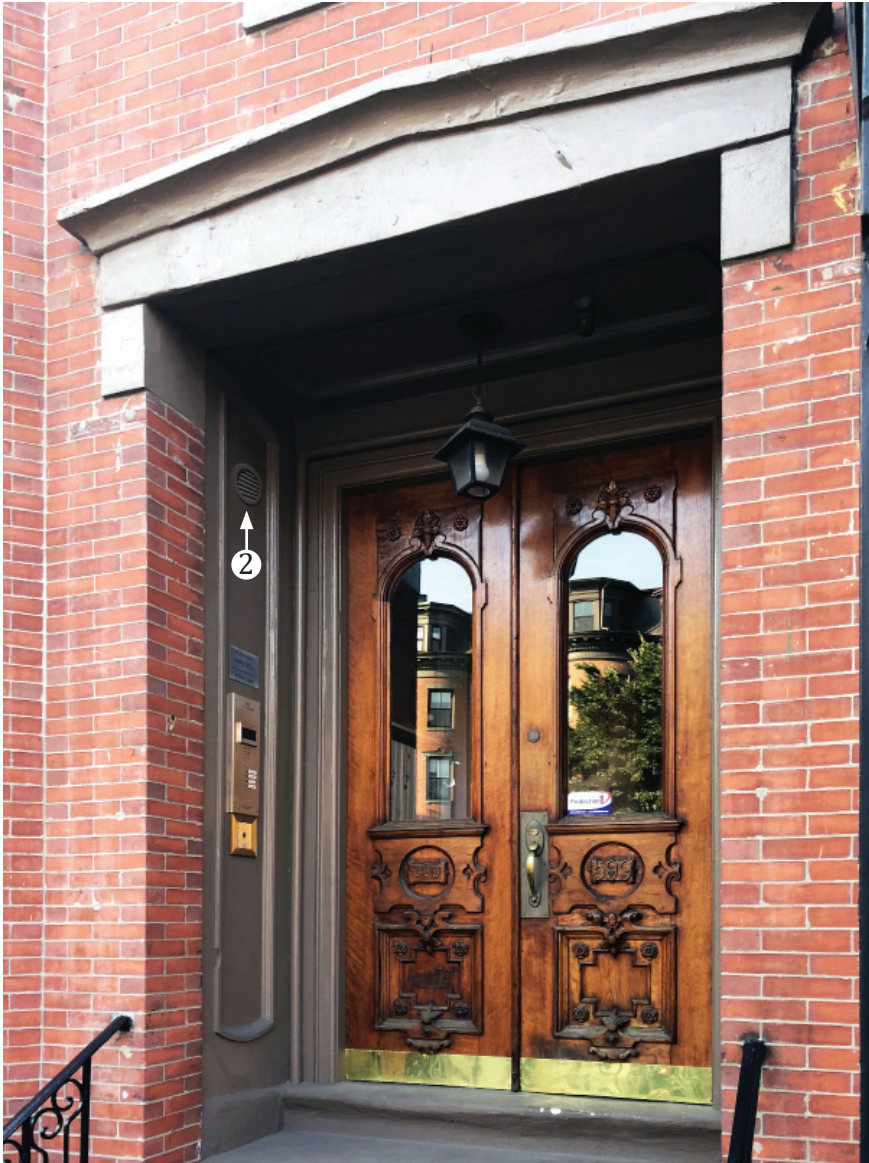
View of proposed ventilation port at Entry.

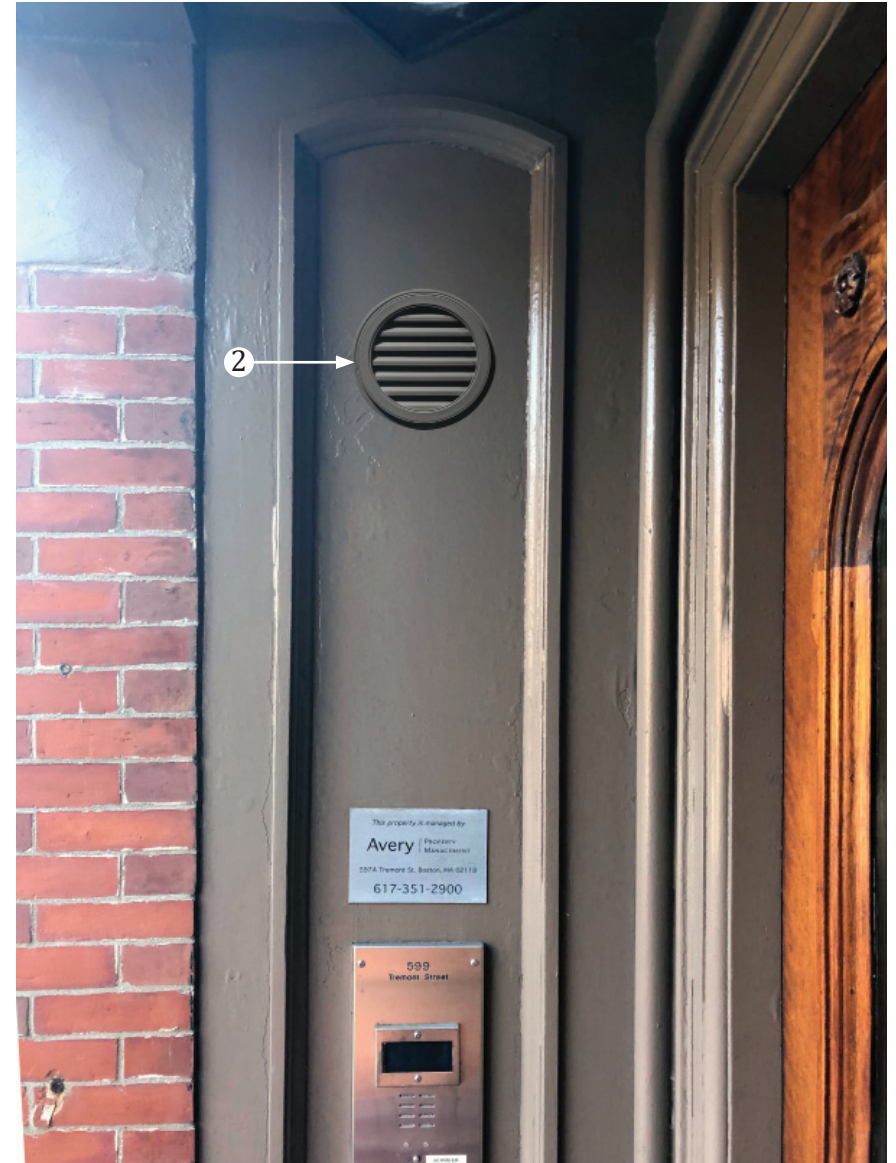
Detail of proposed round ventilation port.

- 1 - Replace existing window in kind. Wood double hung with center mullions.
- 2- Proposed round ventilation port, painted to match existing entry panel, see detail.
