## Publishing House Facade & Entries Project Narrative

## CHRISTIAN SCIENCE PUBLISHING HOUSE

### ENTRANCE UPGRADE

BOSTON LANDMARKS COMMISSION REVIEW

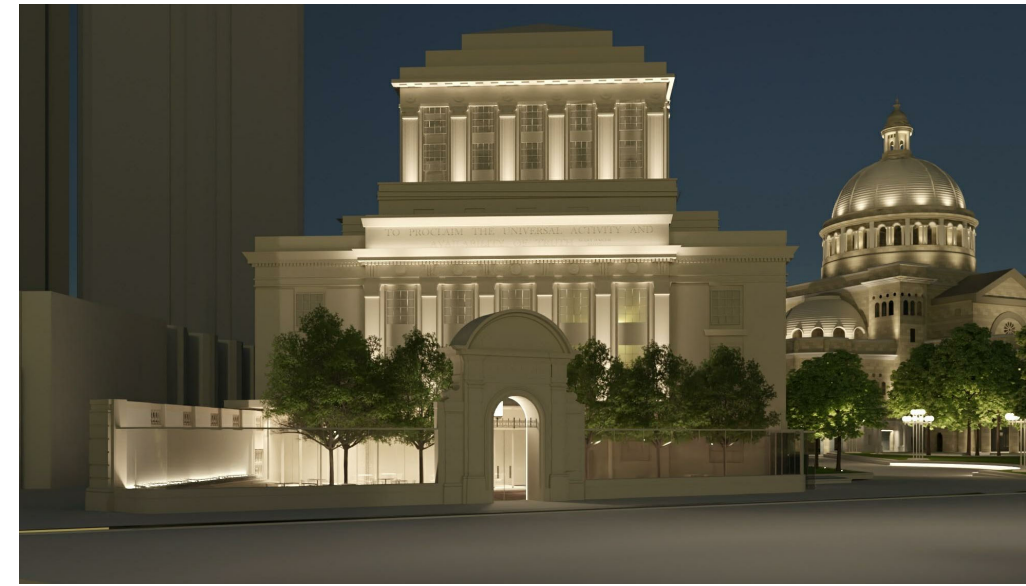
PROPOSED PUBLISHING HOUSE MASS AVE

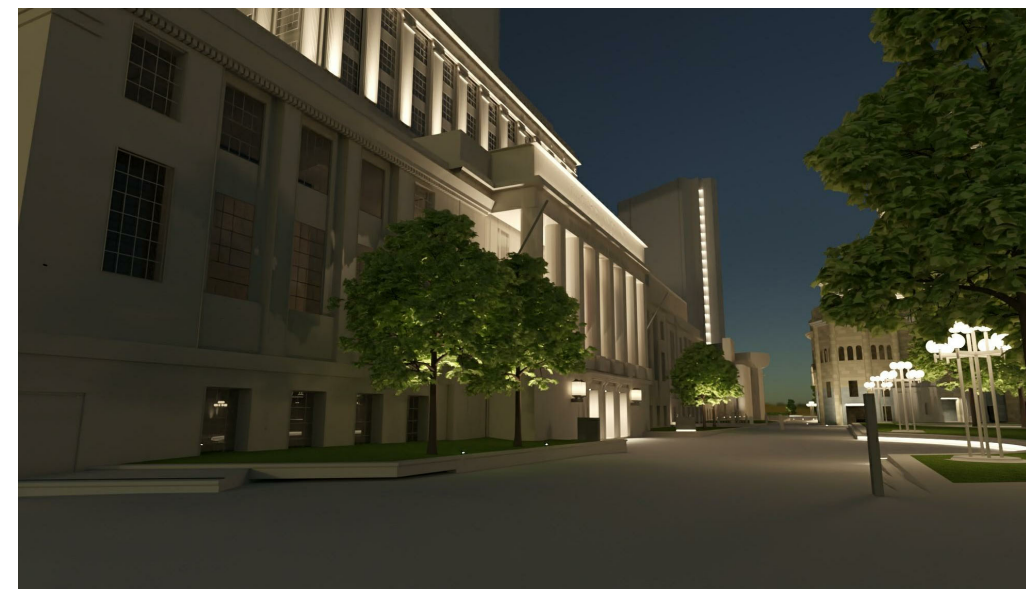
PROPOSED PUBLISHING HOUSE GROUND VIEW

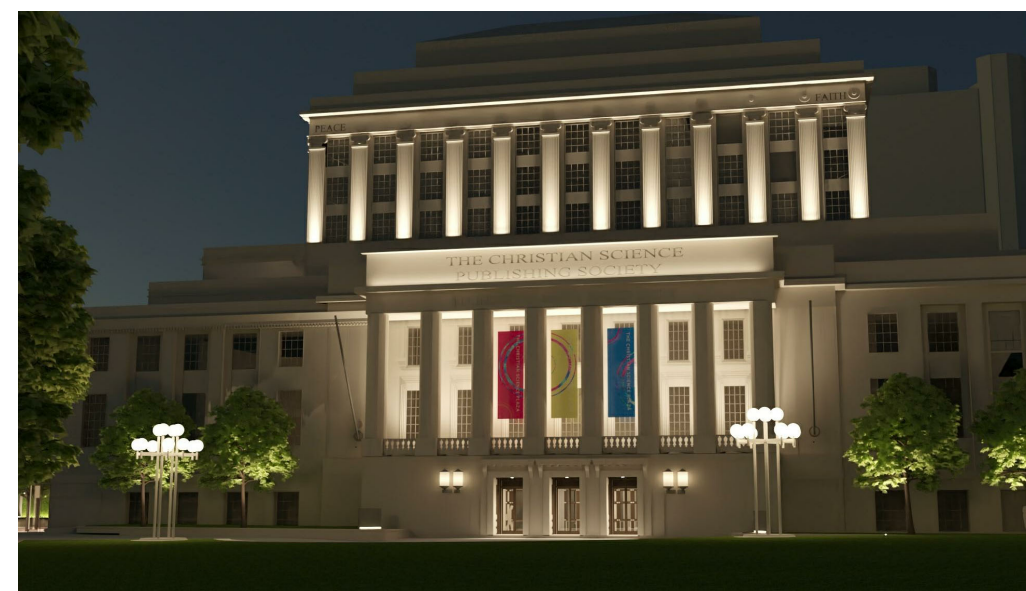
PROPOSED PUBLISHING HOUSE ENTRY

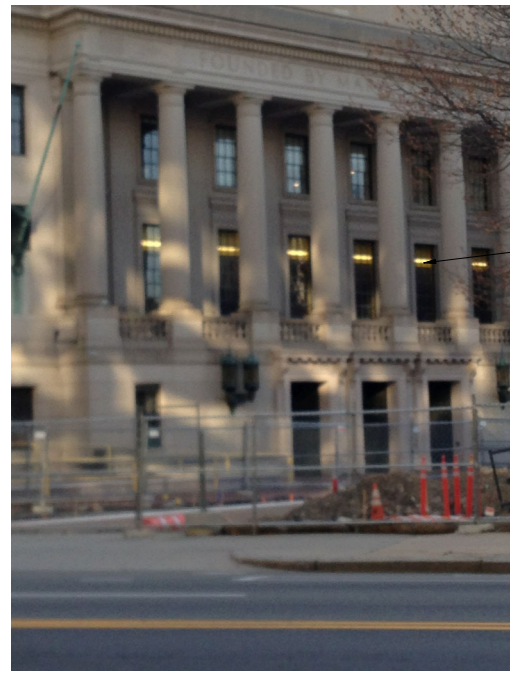
REMOVE INTERIOR STRIP LIGHTING BEHIND WINDOWS

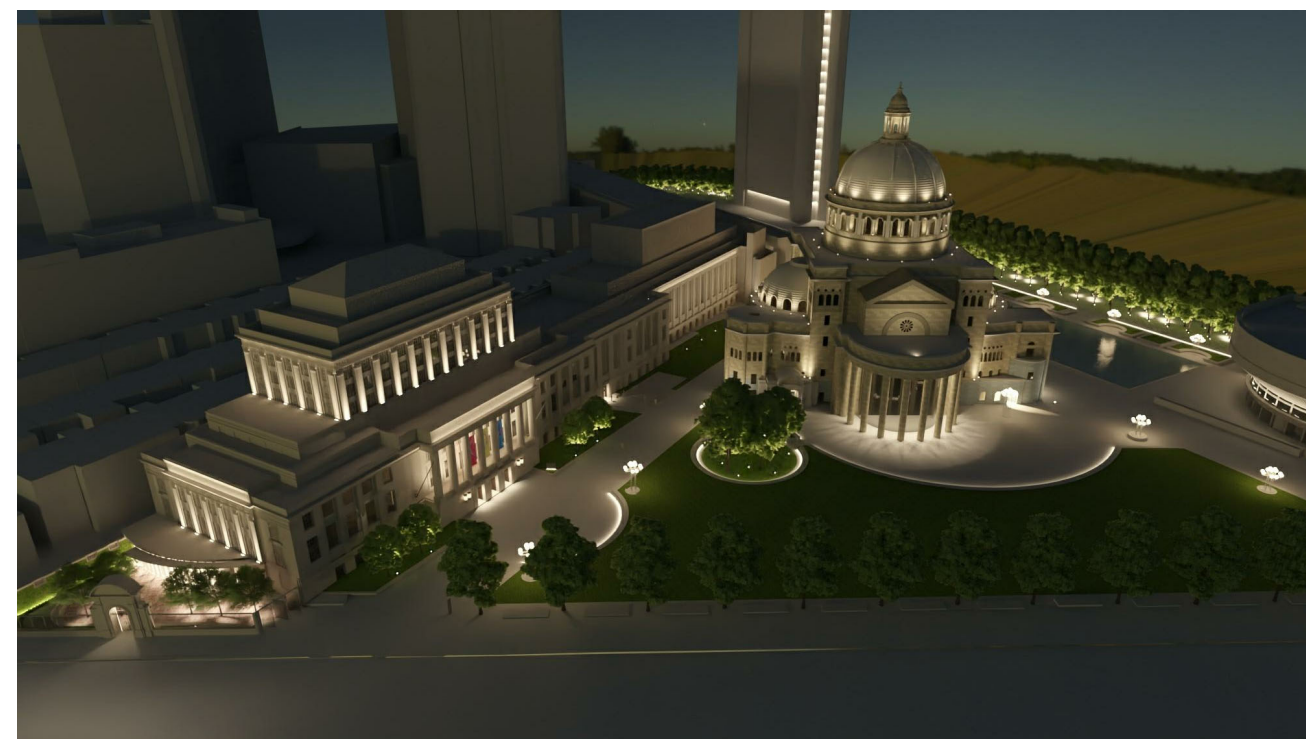
PROPOSED PLAZA LIGHTING

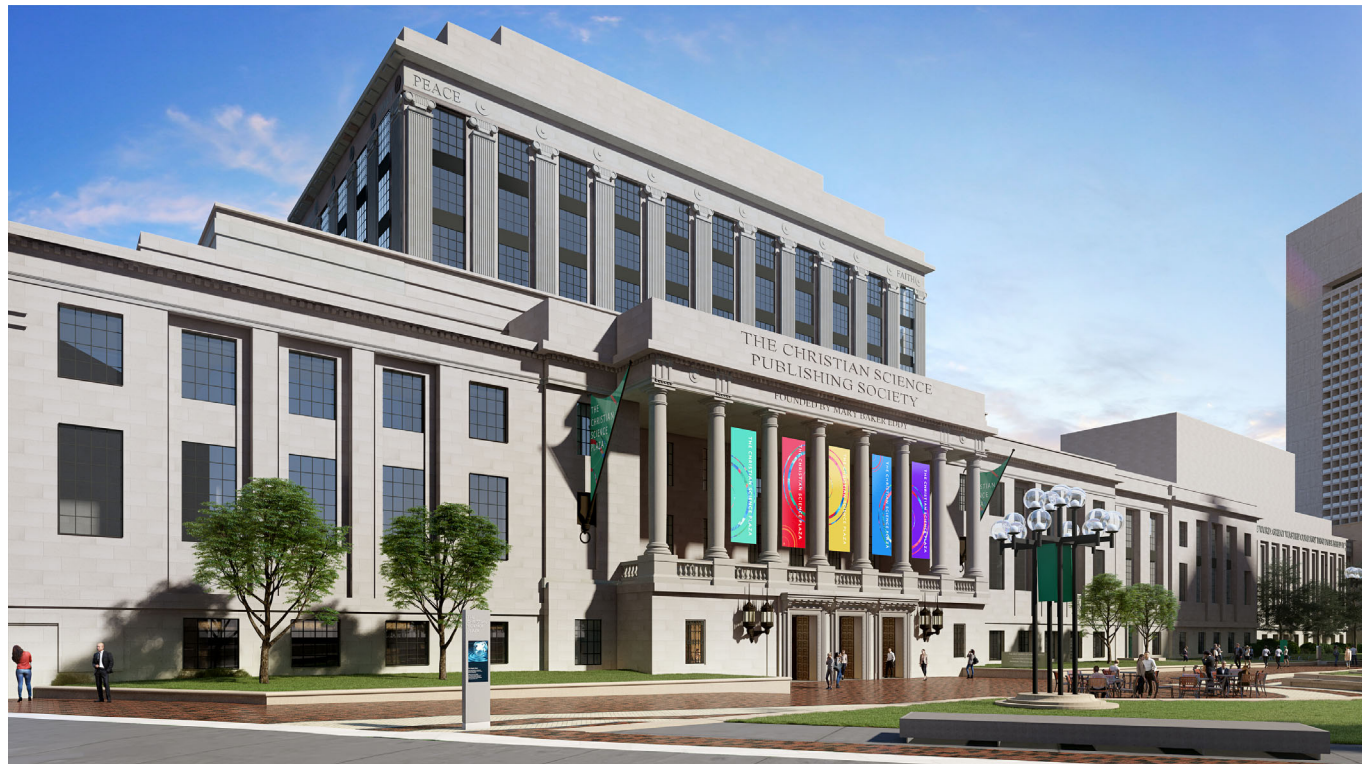
**VIEW A: FROM MASSACHUSETTS AVENUE**  
ILLUSTRATING BANNERS, SITE SIGNAGE AND MAIN ENTRANCE

As in most views the doors are hidden in the shadow of the deeply recessed portals, a number of graphic cues are proposed to clarify the prominence of the Publishing House and primary institutional entry.

The projecting banners mounted on existing flag poles provide a visible link to the building which is approached obliquely from Massachusetts Avenue. The site mounted sign within the planted landscape is oriented for pedestrians approaching from Massachusetts Avenue.

The restored decorative bronze panels within the entry portal are just visible in this view; the new glass doors are recessed in the existing stone portal and are not visible in this view.

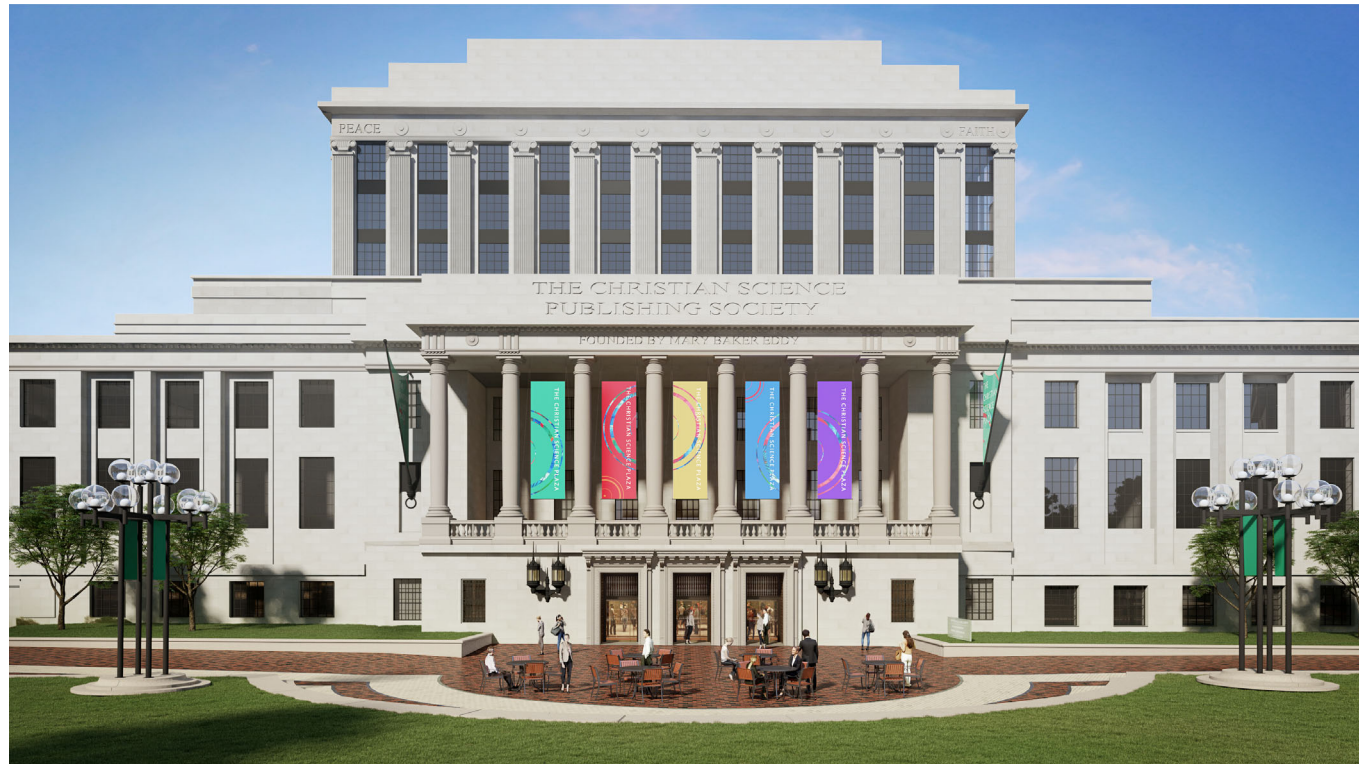
**VIEW B: FROM THE LAWN**  
ILLUSTRATING BANNERS, SITE SIGNAGE AND PROPOSED NEW DOORS AT MAIN ENTRANCE

The banners mounted between the columns at the portico mark the main public entrance to the building as seen from a distance across the lawn and plaza.

The new glass doors are visible in this view, and provide a more welcoming view into the interior vestibule and great hall beyond. The decorative bronze metal work of the sconces and window grilles flanking the main entrance are also visible in this view.

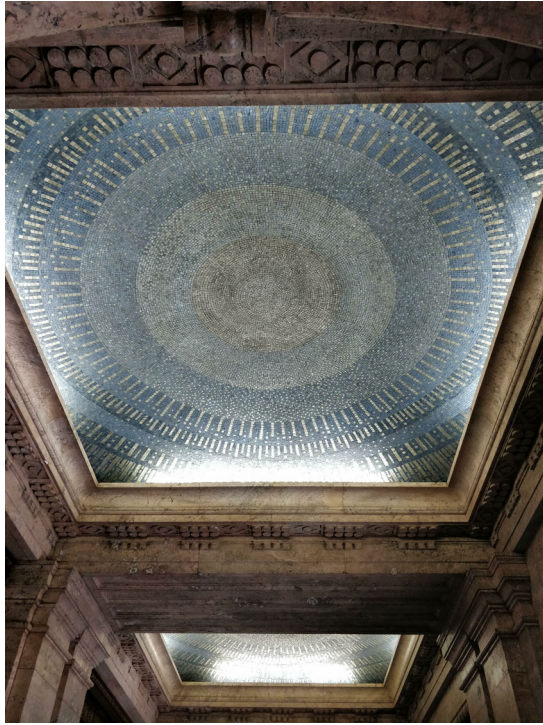
MAIN ENTRY VESTIBULE CEILING

EXISTING STONE, BRONZE AND MOSAIC TILE CEILING FINISHES WILL BE CLEANED AND REPAIRED AS REQUIRED.

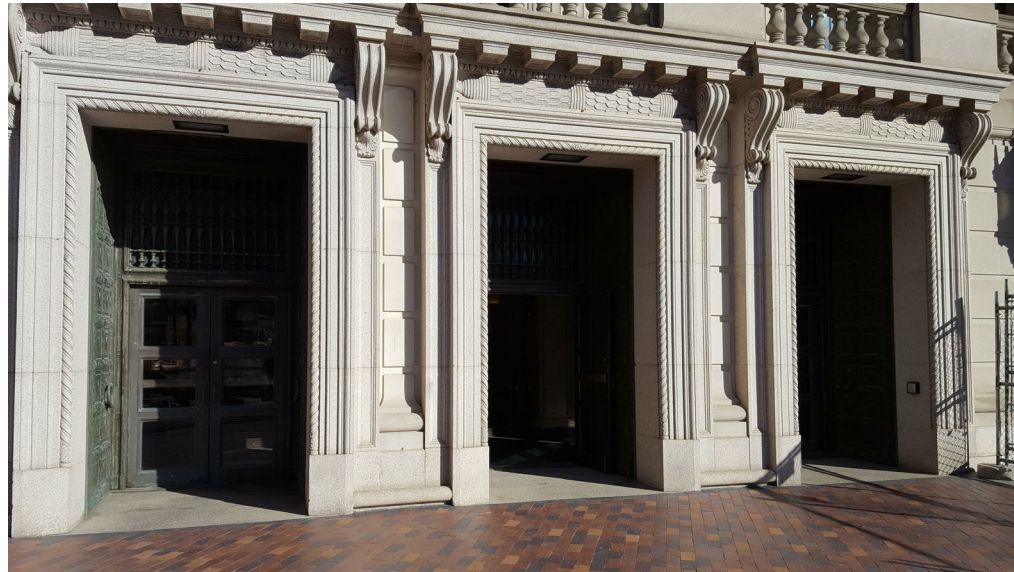
## EXISTING DOORS

- THREE PAIRS OF DOORS IN RECESSED STONE PORTALS AT MAIN ENTRANCE (PLAZA)
- SINGLE PAIR OF DOORS IN RECESSED STONE PORTAL TENANT ENTRY (PLAZA)
- SINGLE PAIR OF DOORS IN RECESSED STONE PORTAL CLEARWAY STREET
- **EXISTING DOORS ARE TOO NARROW AND DO NOT COMPLY (EXISTING LEAF +/- 30 5/8") 32" CLEAR OPENING REQUIRED**
- SURFACE MOUNTED AUTOMATIC OPERATOR INSTALLED ONE PAIR EXTERIOR DOORS AT MAIN ENTRANCE, TENANT ENTRY AND STAFF ENTRY CLEARWAY STREET

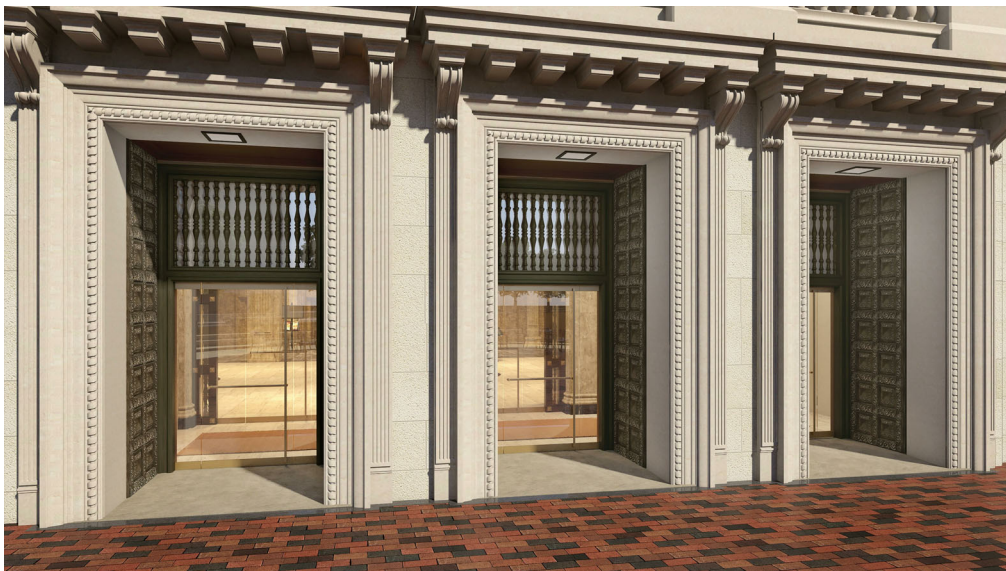
## PROPOSED SINGLE DOOR WITH SIDELIGHTS

- **SINGLE 38" DOOR LEAF EXCEEDS 32" CLEAR OPENING REQUIREMENT**
- NEW SINGLE LEAF DOOR 3'-2" X 7'-0 1/2" PROVIDES GENEROUS ACCESS
- NEW DOOR AND SIDELIGHT CONFIGURATION PROVIDE IMPROVED TRANSPARENCY AND VISIBILITY; MEET ACCESSIBILITY GUIDELINES
- NEW BRONZE HARDWARE TO MATCH RESTORED BRONZE PANELS
- NEW BACK-PAINTED GLASS TRANSON PANEL BEHIND EXISTING BRONZE GRILLE

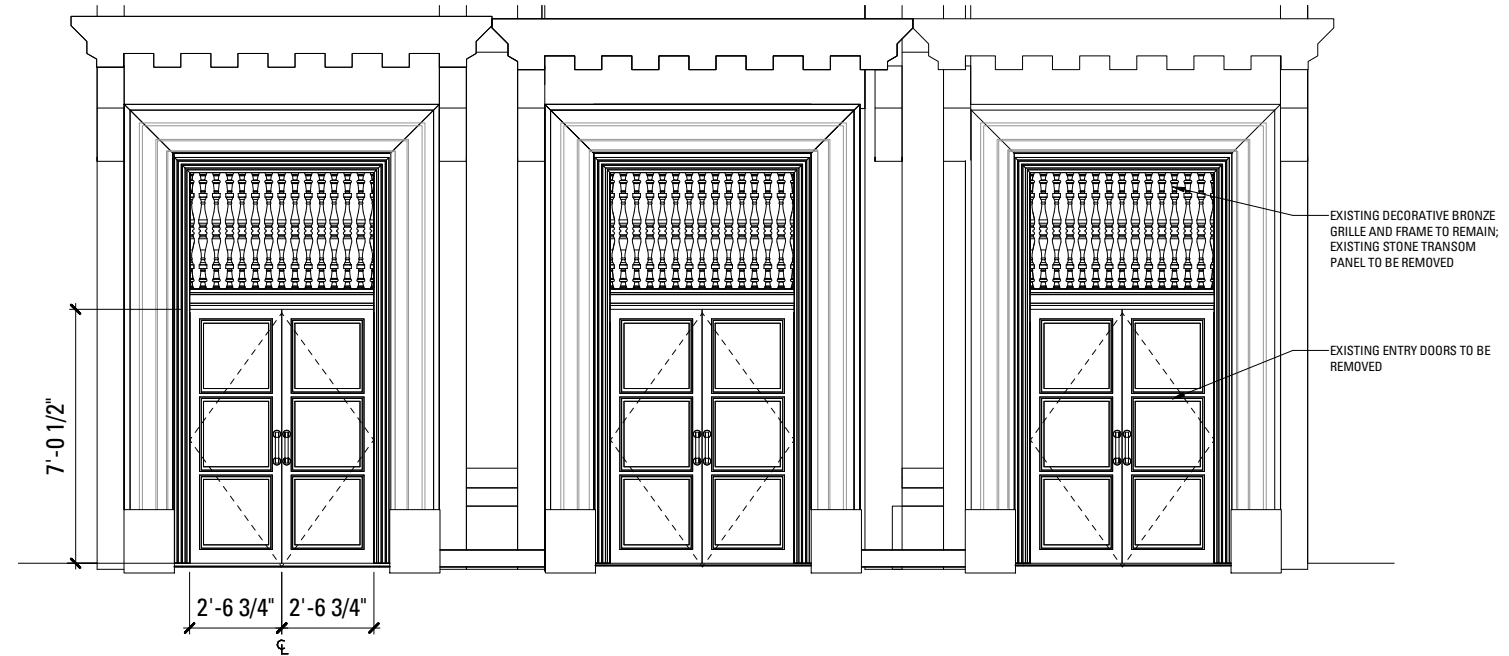
1 MAIN ENTRY PLAZA DOORS - EXISTING ELEVATION  
SCALE: 3/8" = 1'-0"

EXISTING DOORS DO NOT MEET CODE FOR ENTRY WIDTH

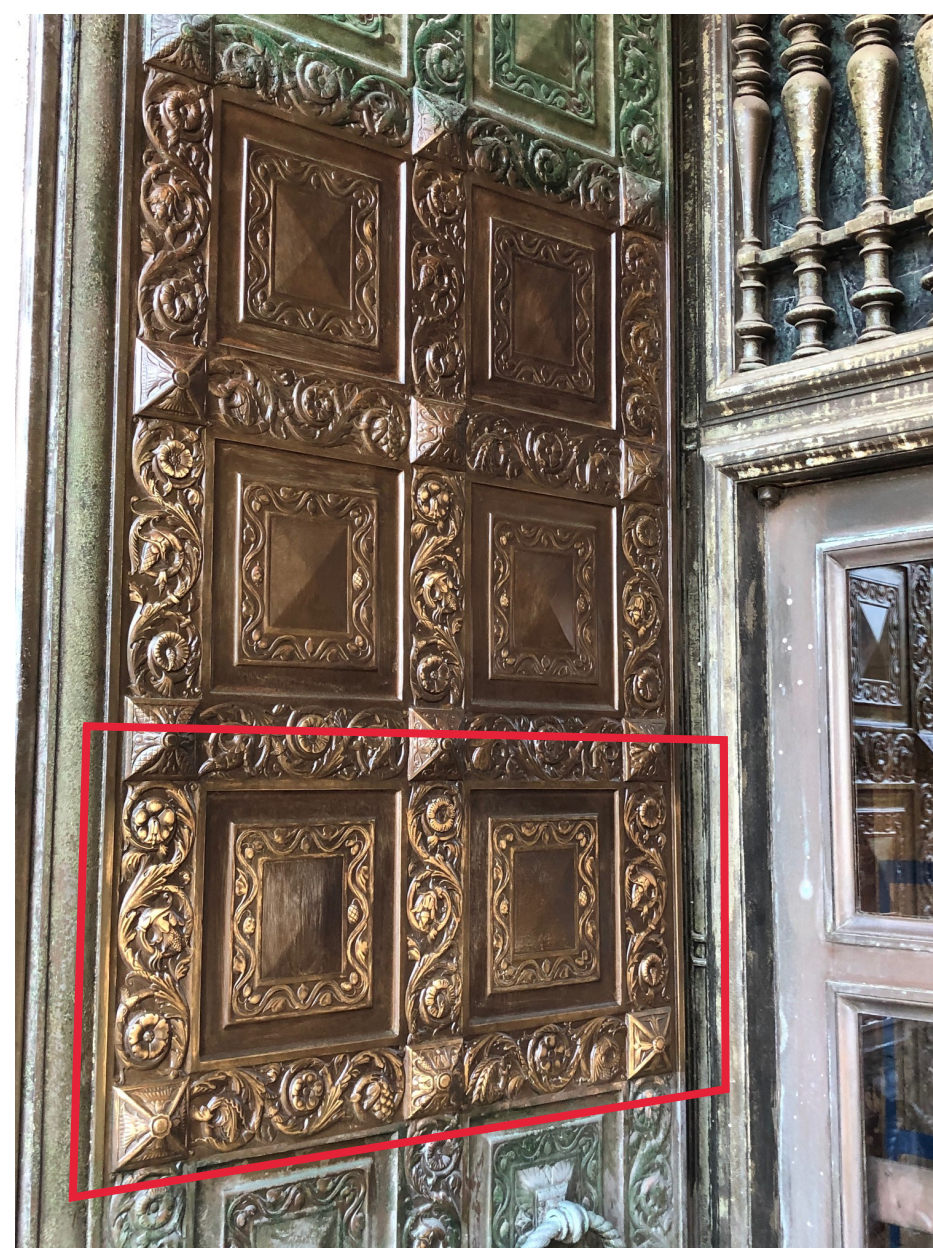
METAL RESTORATION - PREFERRED SHOWN OUTLINED IN RED

B1 Remove old coating (wax/oil) and corrosion. Patina and coat doors to match lower mockup panel (brightest mockup).

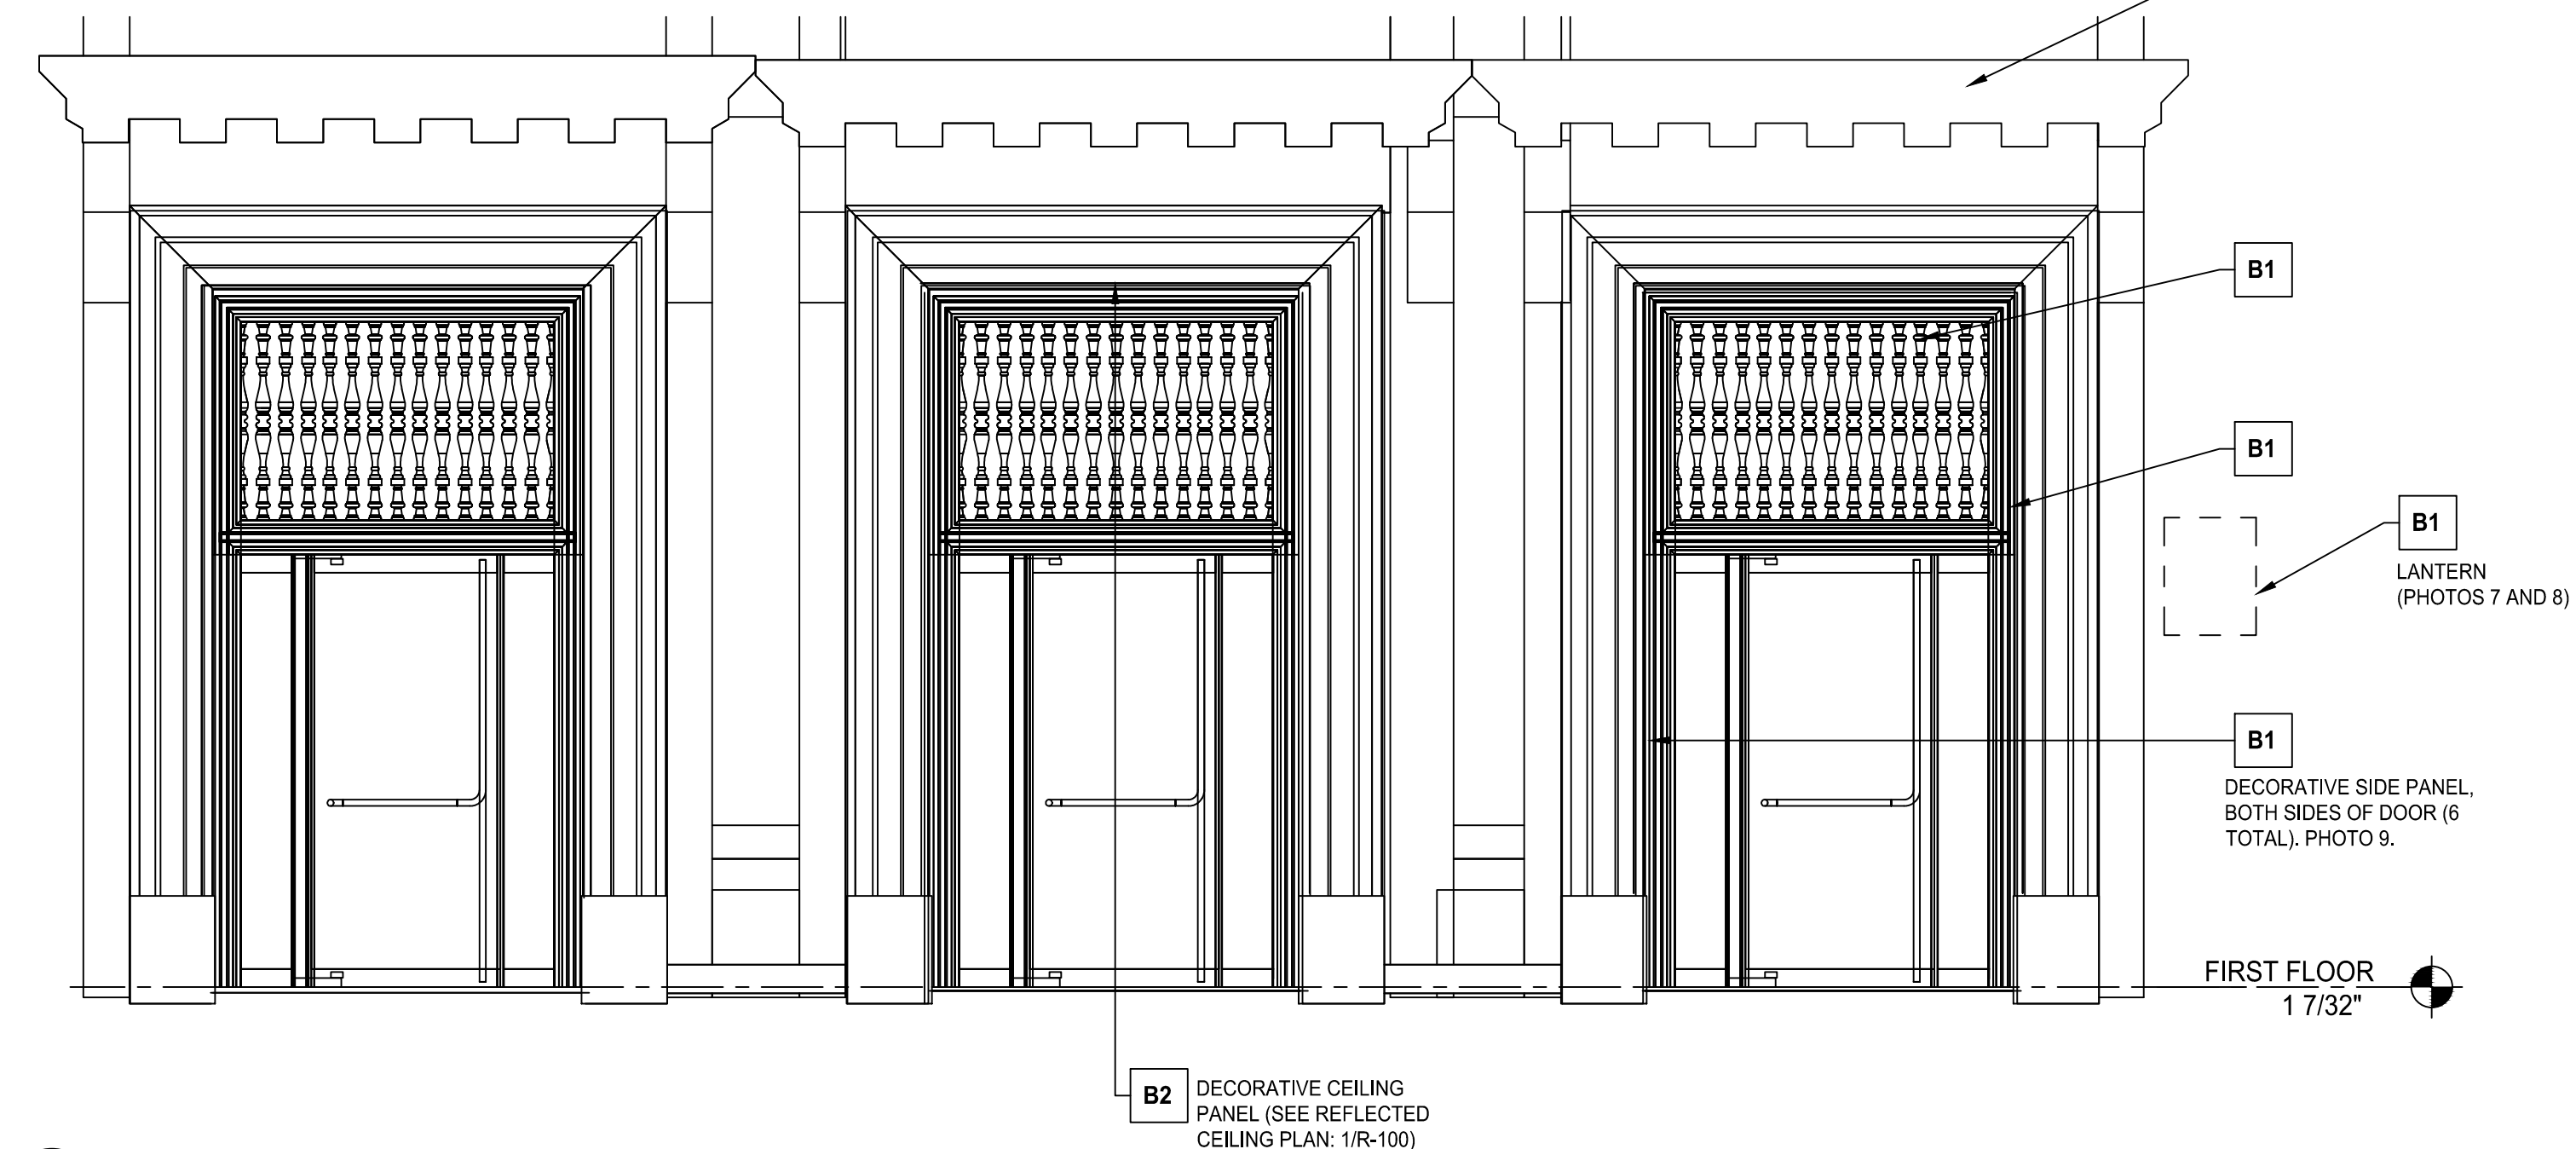
**2 MAIN ENTRY PLAZA - PROPOSED ELEVATION PLAZA**

SCALE: 3/8" = 1'-0"  
THERE ARE PRECEDENTS FOR GLASS DOORS IN LOCAL HISTORICAL LANDMARKS; SEE APPENDIX
