# 103 W. Springfield Street - Window and Trim Replacement

# 103 W. Springfield Street - Mishmash of Window Types

# 103 W. Springfield Street - Top Floor - Replace with Pella Architect Series

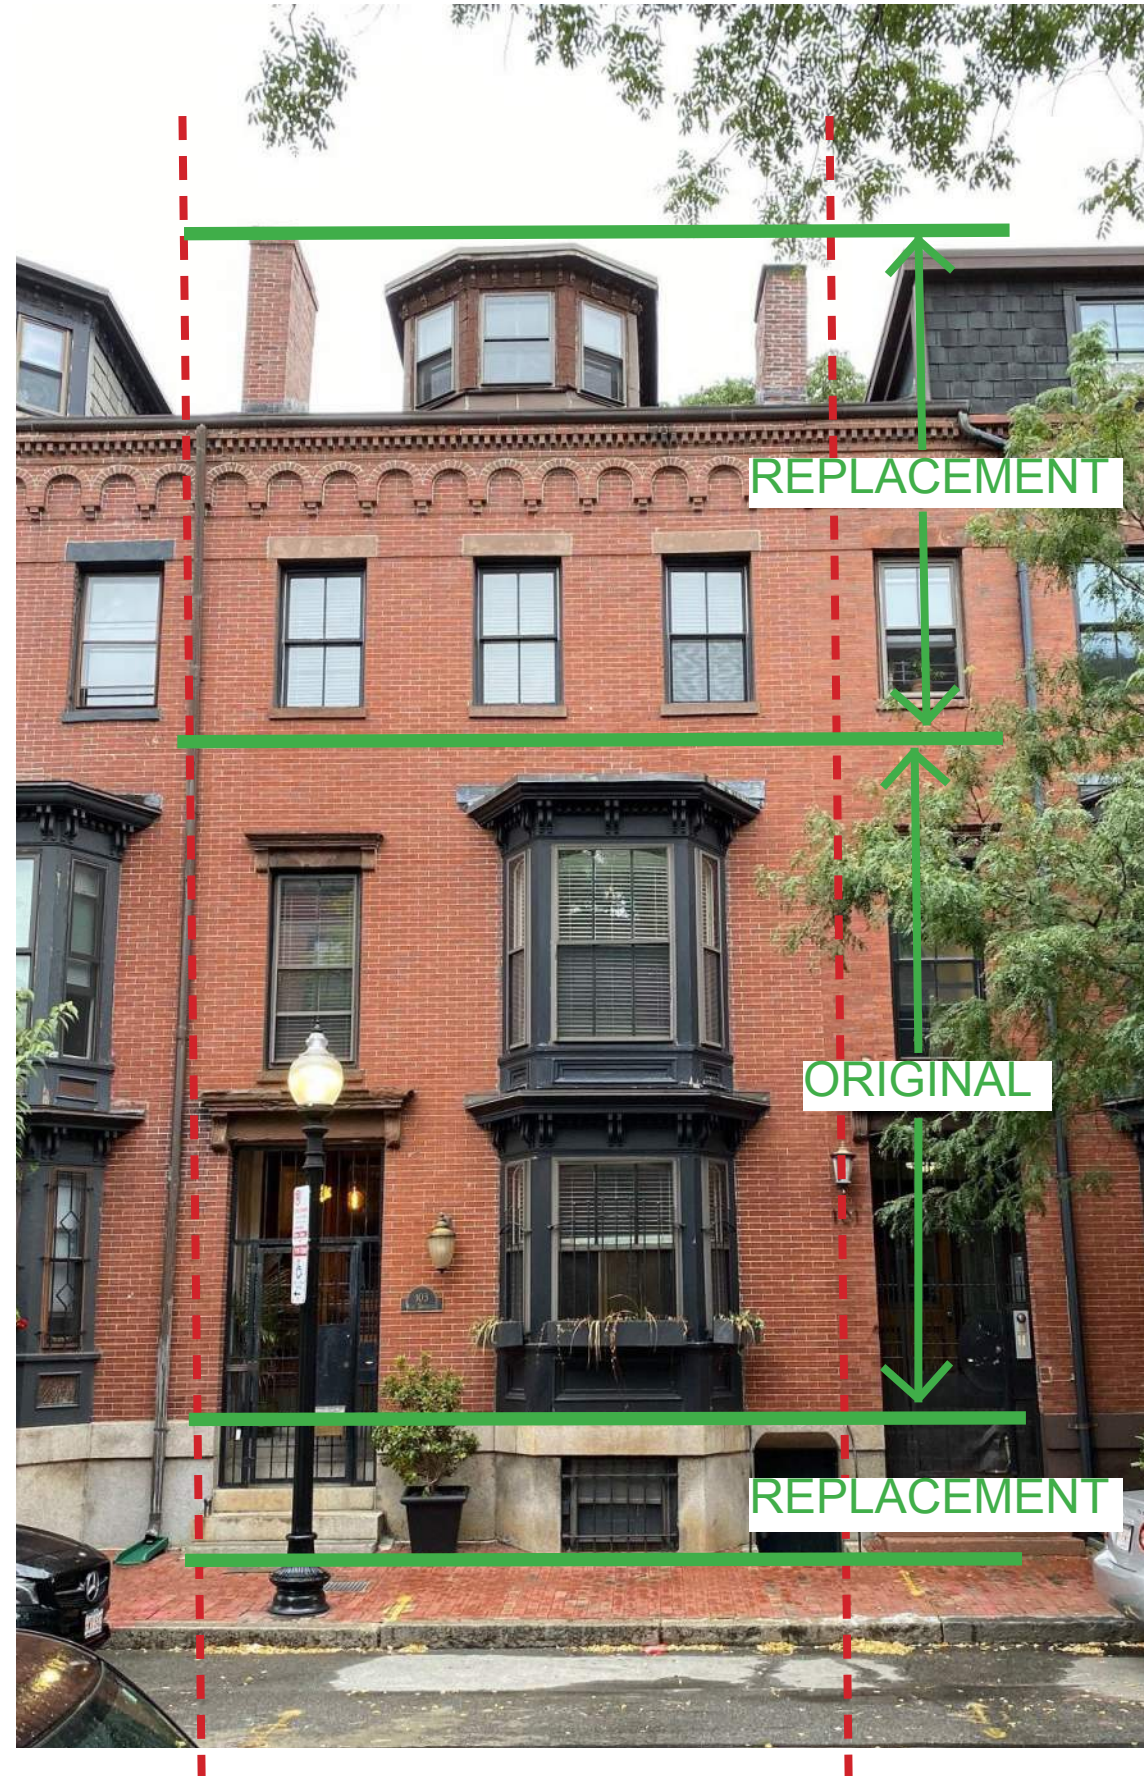
## Windows by Floor:

Top Floor: (1- 3)  
Single pane replacement sashes w/ storms (not original)

Third Floor: (4-6)  
Double pane insulated wood replacement windows w/o storms (not original)

Second Floor: (7-10)  
Single pane original windows w/ storms

First Floor: (11-13)  
Single pane original windows w/ storms

Basement (14)  
Single pane 6 over 6 salvaged window w/ storms

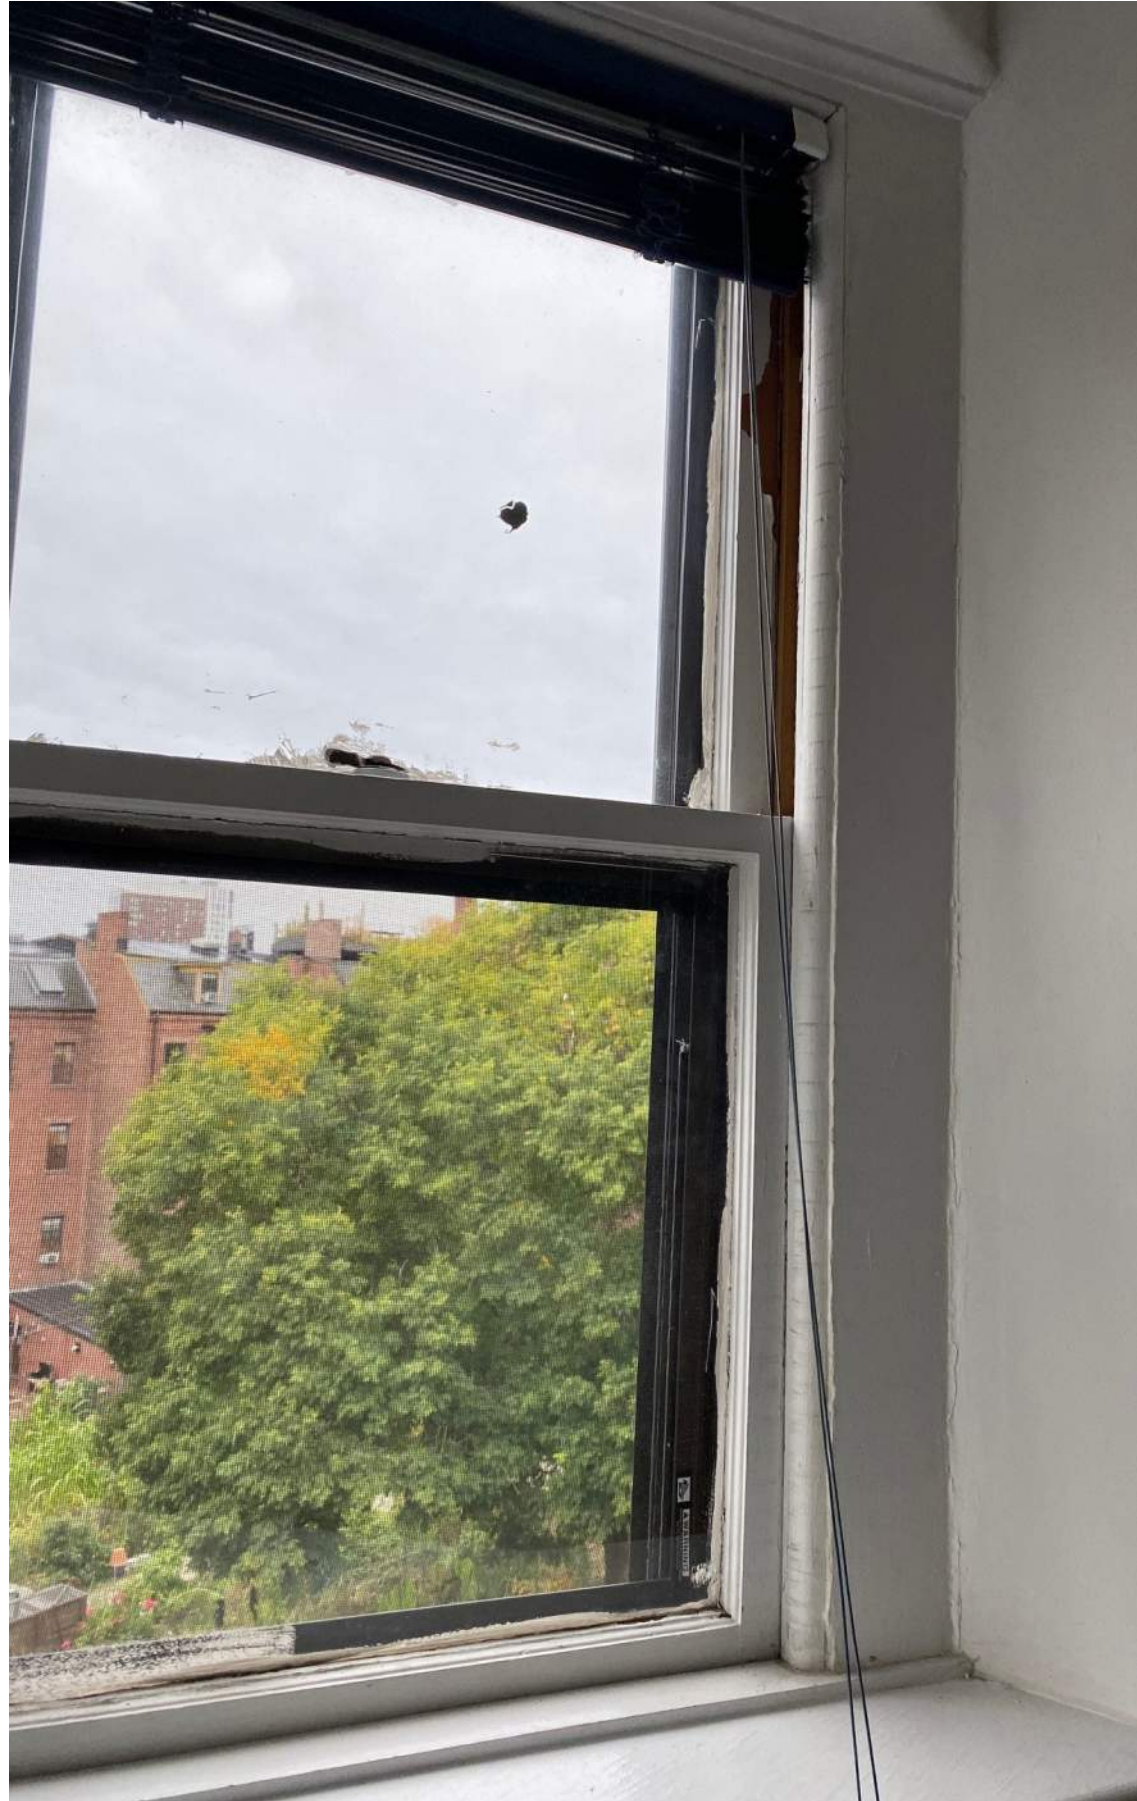
Top Floor: (1- 3)  
Single pane replacement  
sashes w/ storms (not original)  
- 7/8" ogee  
- Replacement pine frame  
- Sill and frame rot

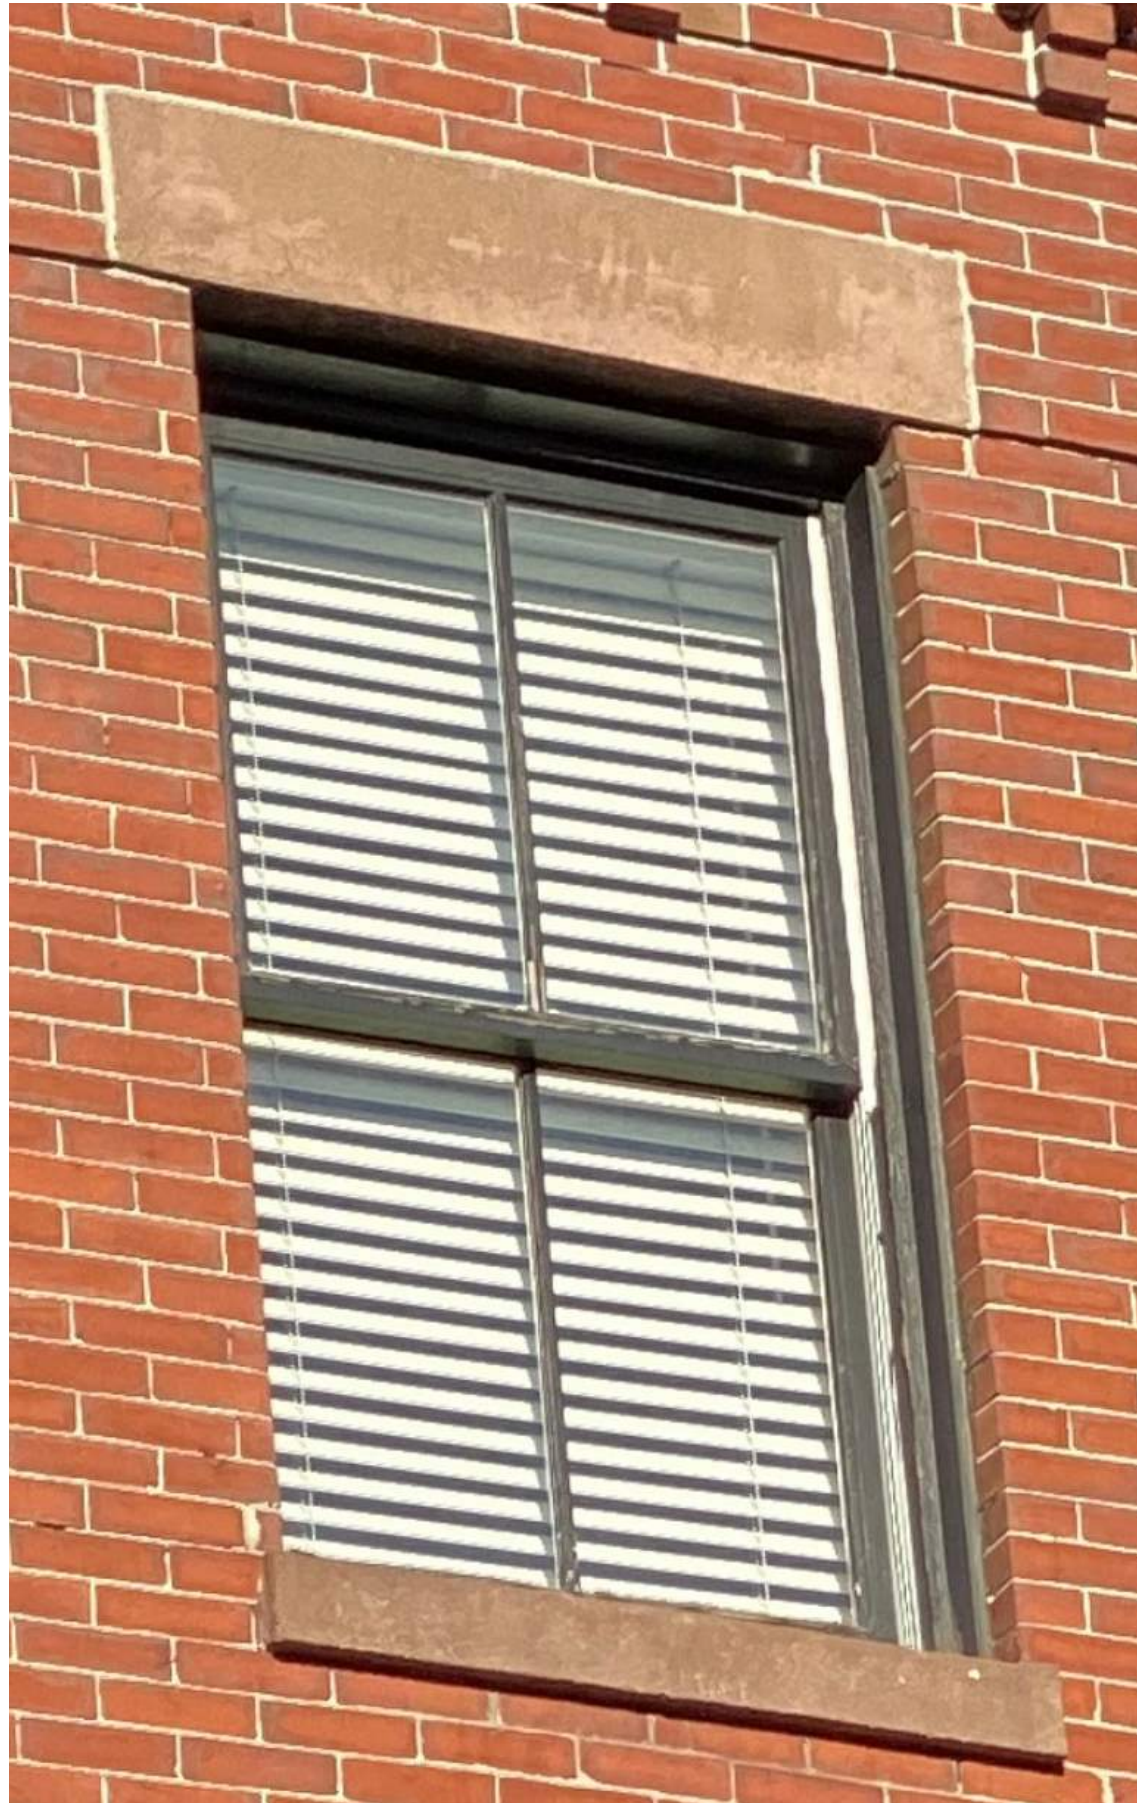
103 W. Springfield Street - Third Floor - Replace with Pella Architect Series

Third Floor: (4-6)  
Double pane insulated wood  
replacement windows w/o  
storms (not original)  
- 5/8" ogee  
- Paint peel / deterioration

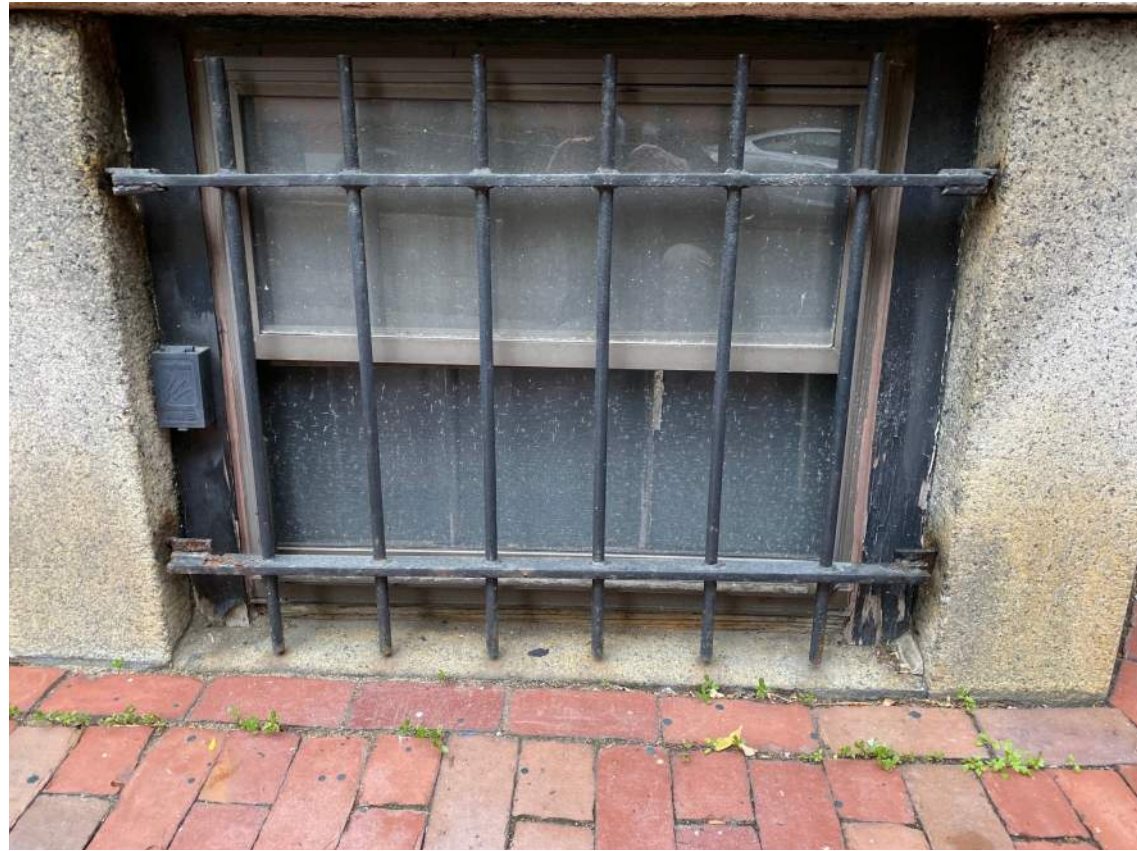
# 103 W. Springfield Street - Basement - Replace with Pella Architect Series

- Basement (14)  
Single pane salvaged awning window w/ storms
- 7/8" ogee
  - Repurposed 6 over 6 sash
  - Frame and sill rot
  - Nonexistent in 1972

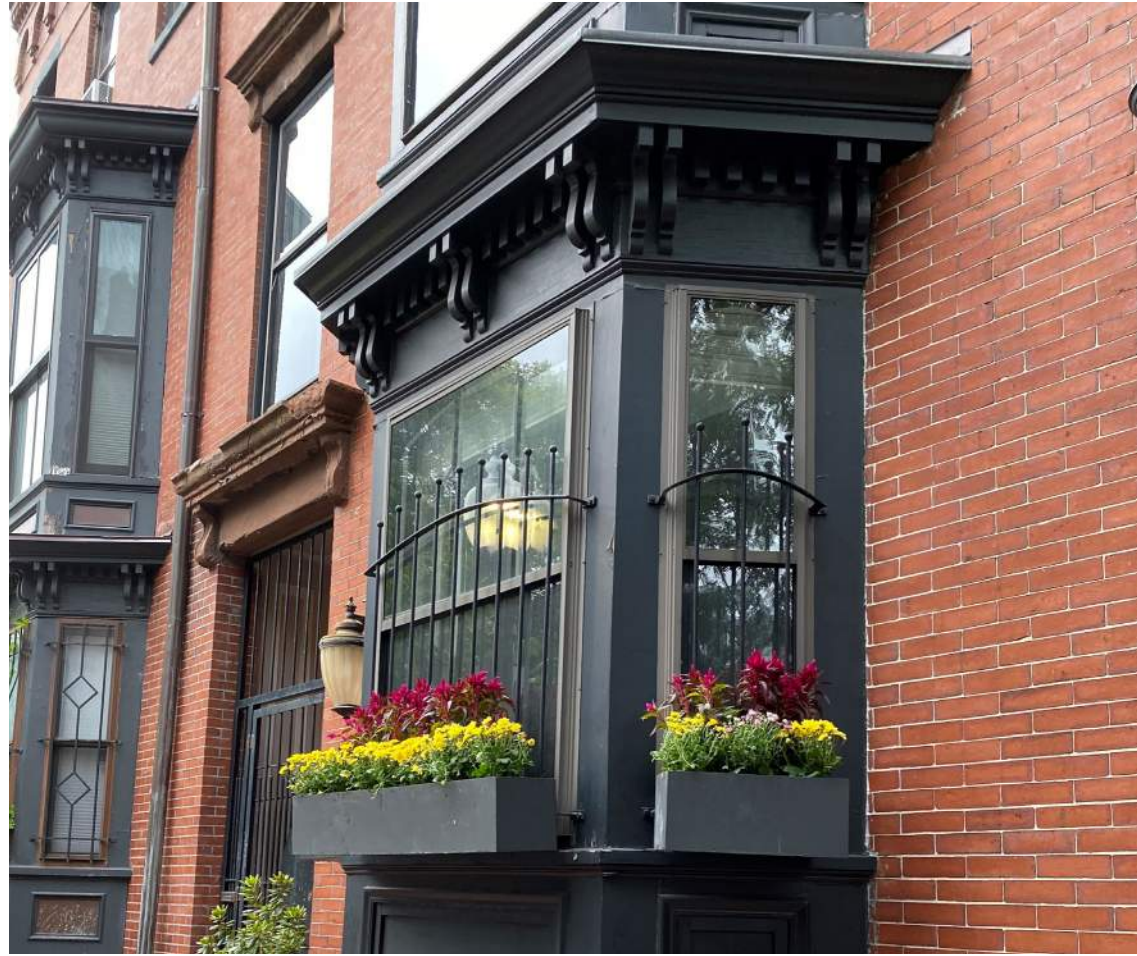
# 103 W. Springfield Street - First and Second Floors

First and Second Floor: (7-13)  
Single pane original windows  
w/ storms

- 1" ogee
- Obscured by storms

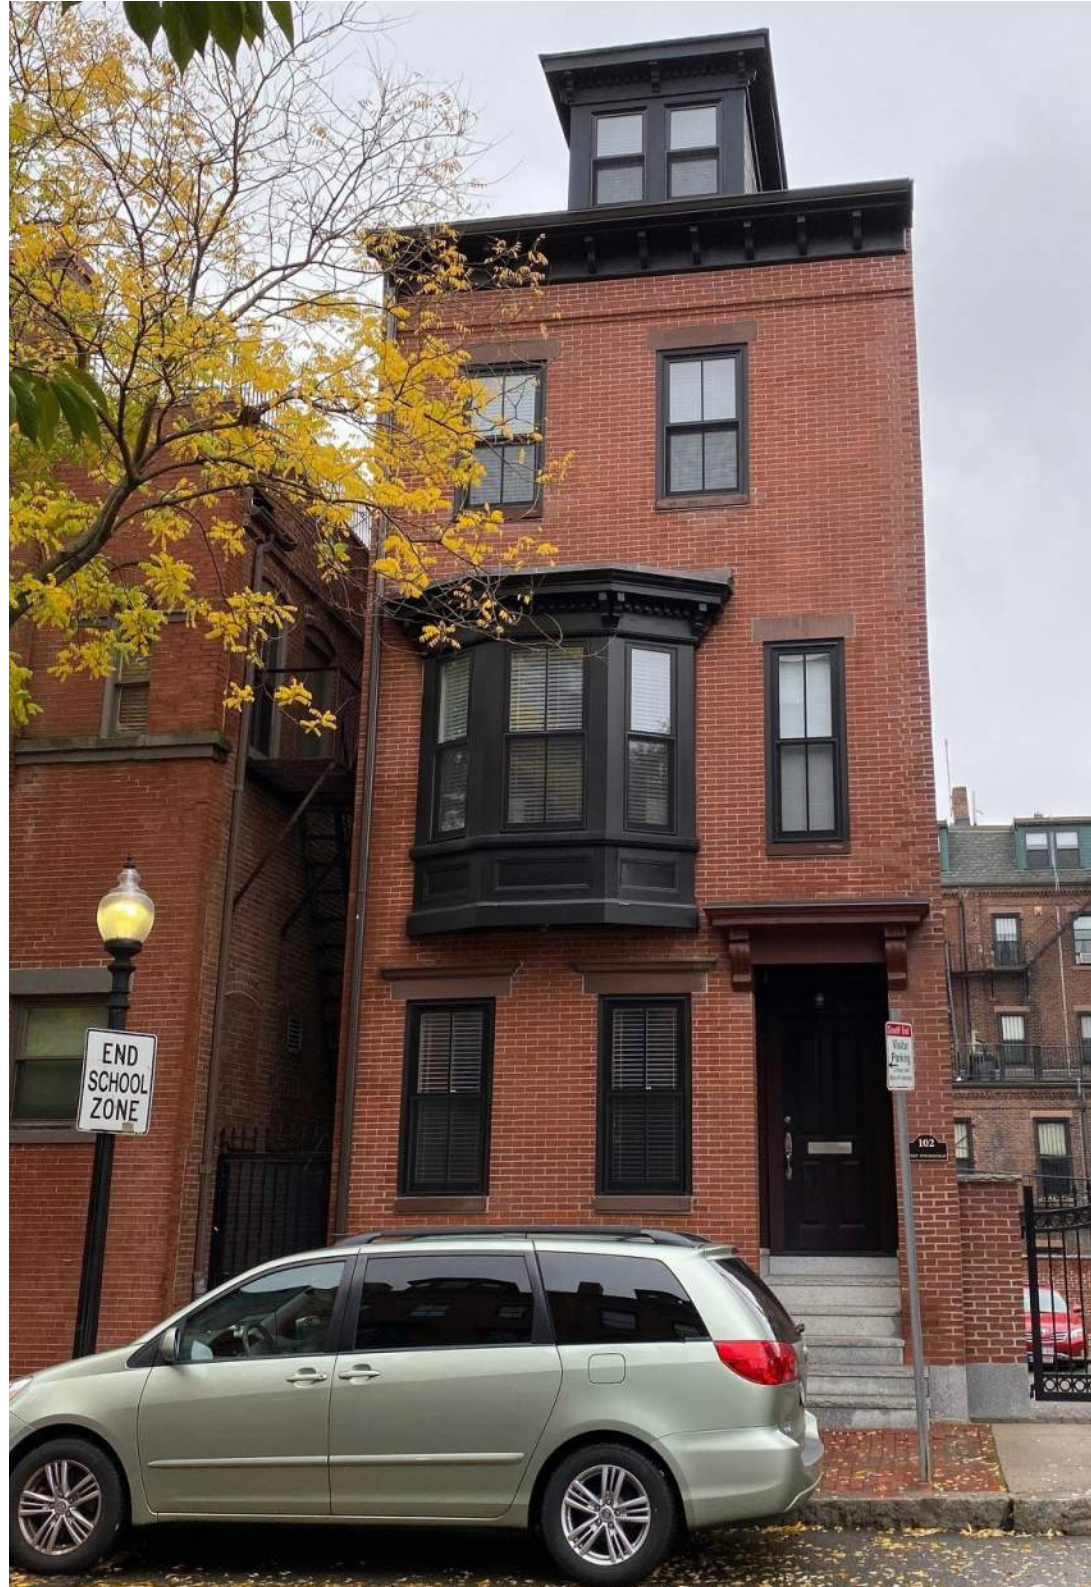
102 W. Springfield St. - In 2012 replaced original Chain and Pulley windows with new aluminum clad insulated glass windows with city approval

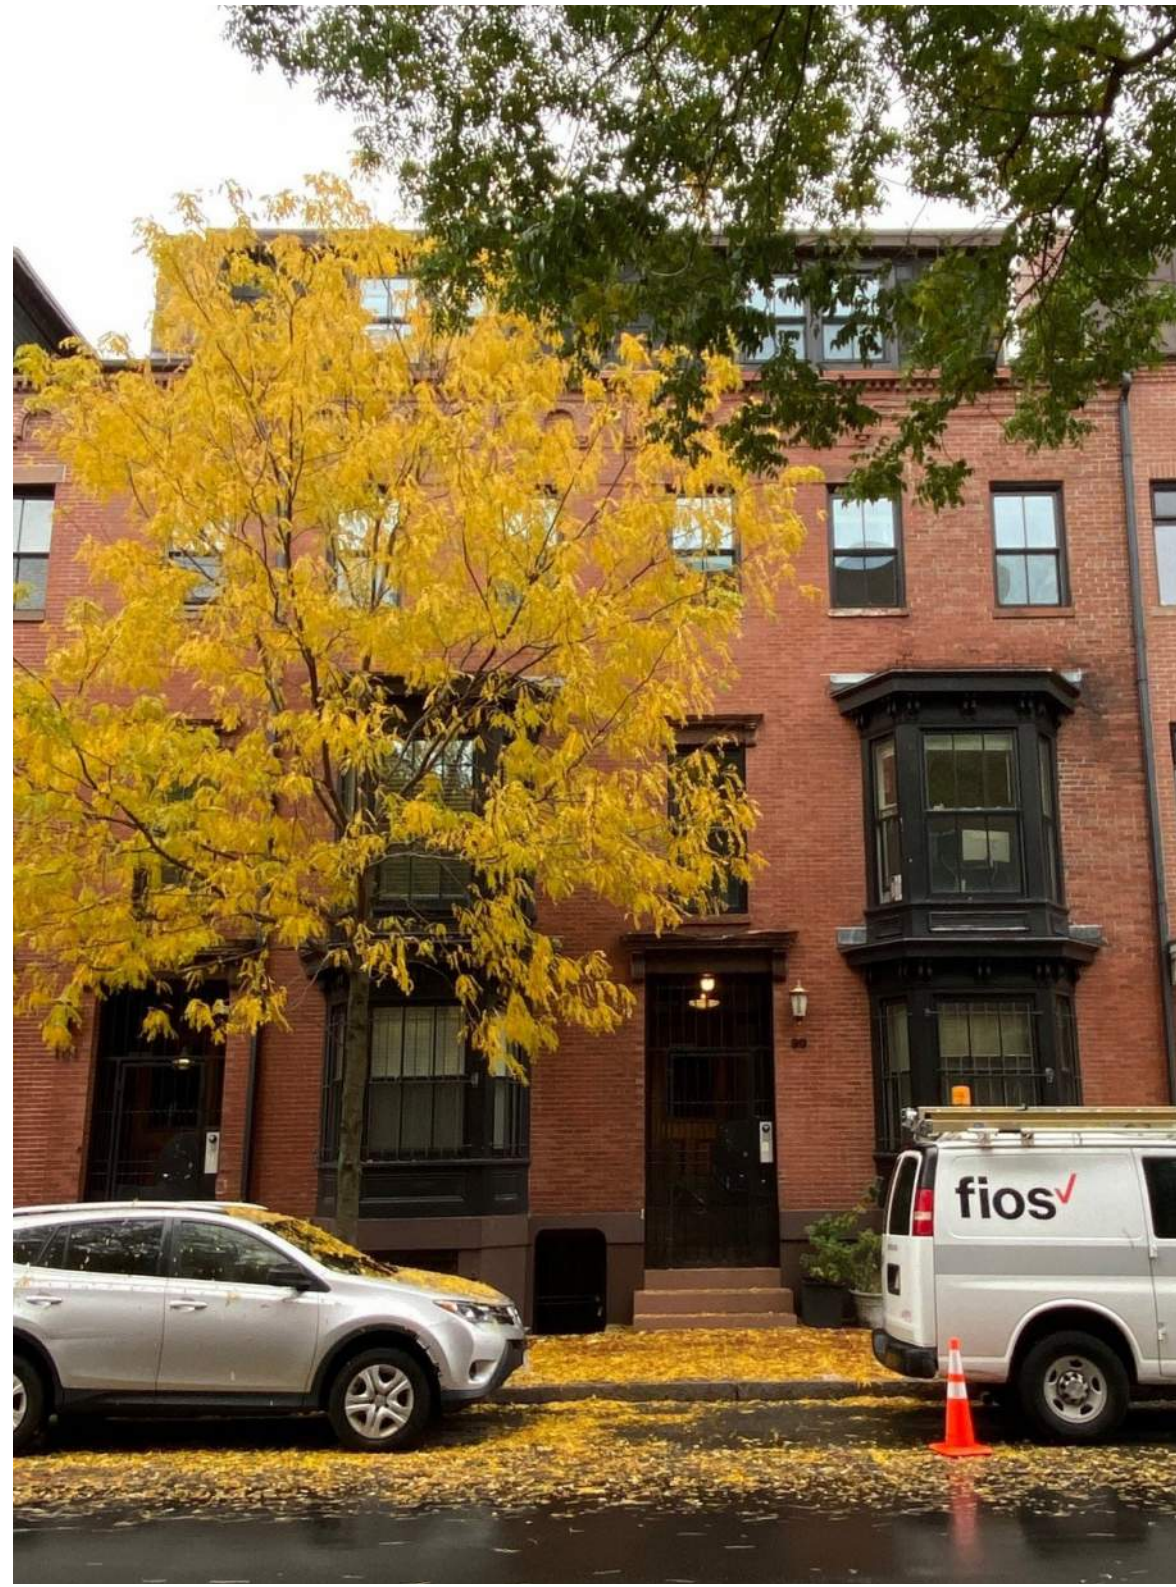
99 & 101 W. Springfield St. - In April 2012 replaced original windows and storms with new Jeld-Wen insulated glass windows with city approval
