Boston Landmarks Commission
Design Review Hearing

20.800.4 Boston Common – Boston Common Garage and Parade Ground

Massachusetts Convention Center Authority
Simpson Gumpertz & Heger
25 February 2020

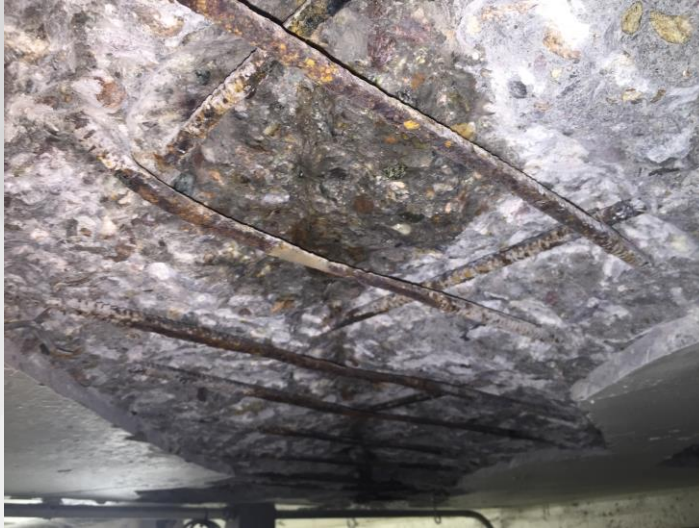
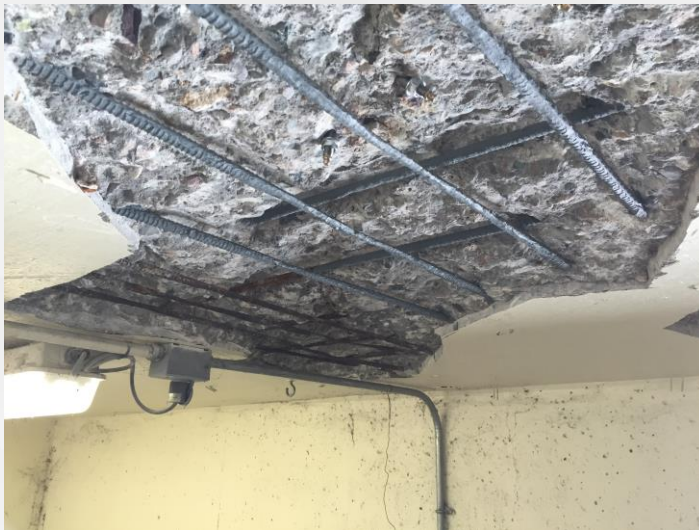
Proposed Work – Low Roof Structure

- Repair deteriorated concrete on underside of garage roof (on-going maintenance item and safety concern).
- Replace original waterproofing from 1960 construction, including flashing at Stair Kiosk No. 1 and perimeter walls.
- Install new drains as needed to improve drainage at topside of garage roof.

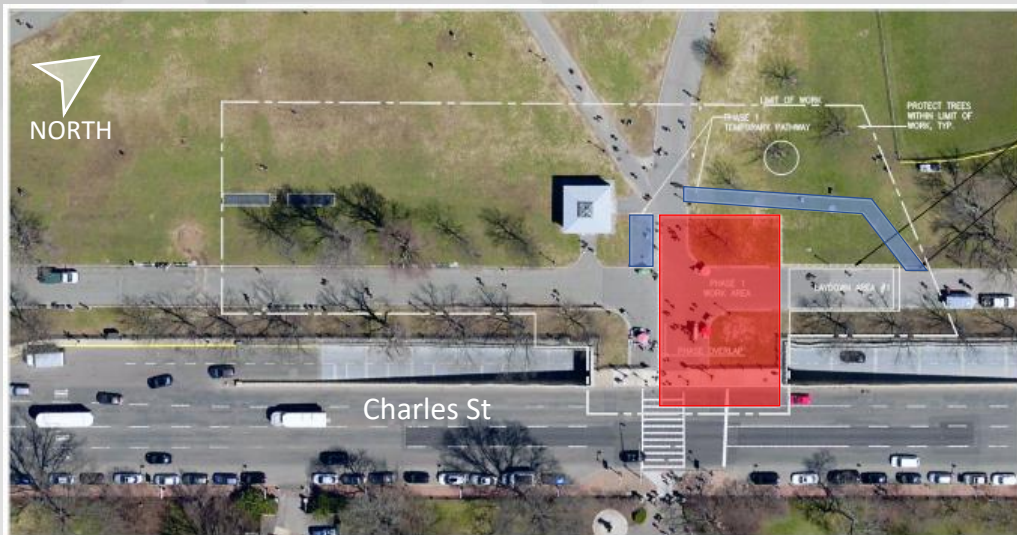
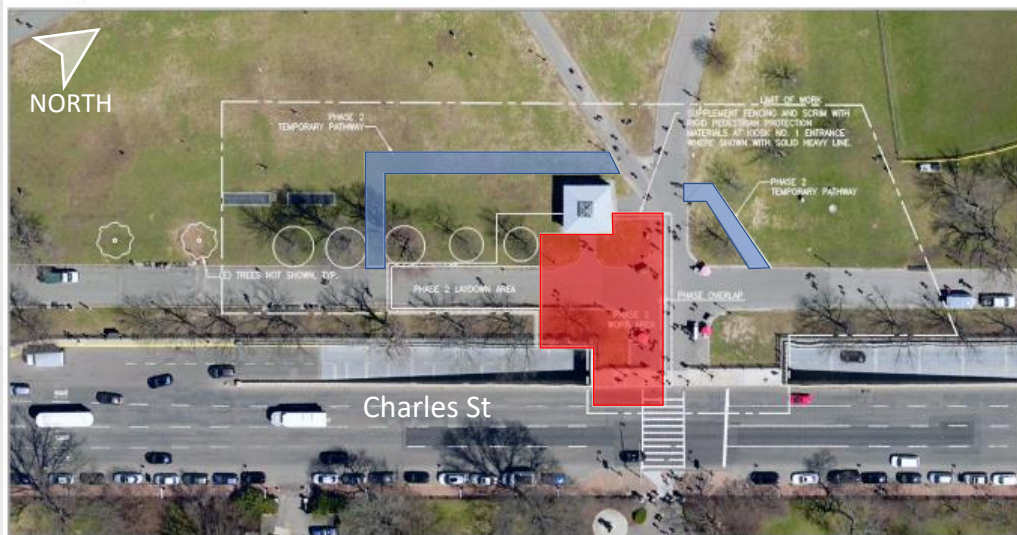
Proposed Work – Boston Common

- Repair to below ground garage structure to prevent water infiltration and further structural deterioration.
- Work includes the following:
 - Removal of and replacement of grass, top soil and sub-grade materials with limited asphalt walk path removal.
 - Repair of sub surface structures and roof drain bodies and piping.
 - Protection of tree and root structures and Pope John Paul II Monument.
 - Installation of temporary walk paths.
