JOHNSON GATES BASIN COVERING

Back Bay Fens

01.26.21
BPRD

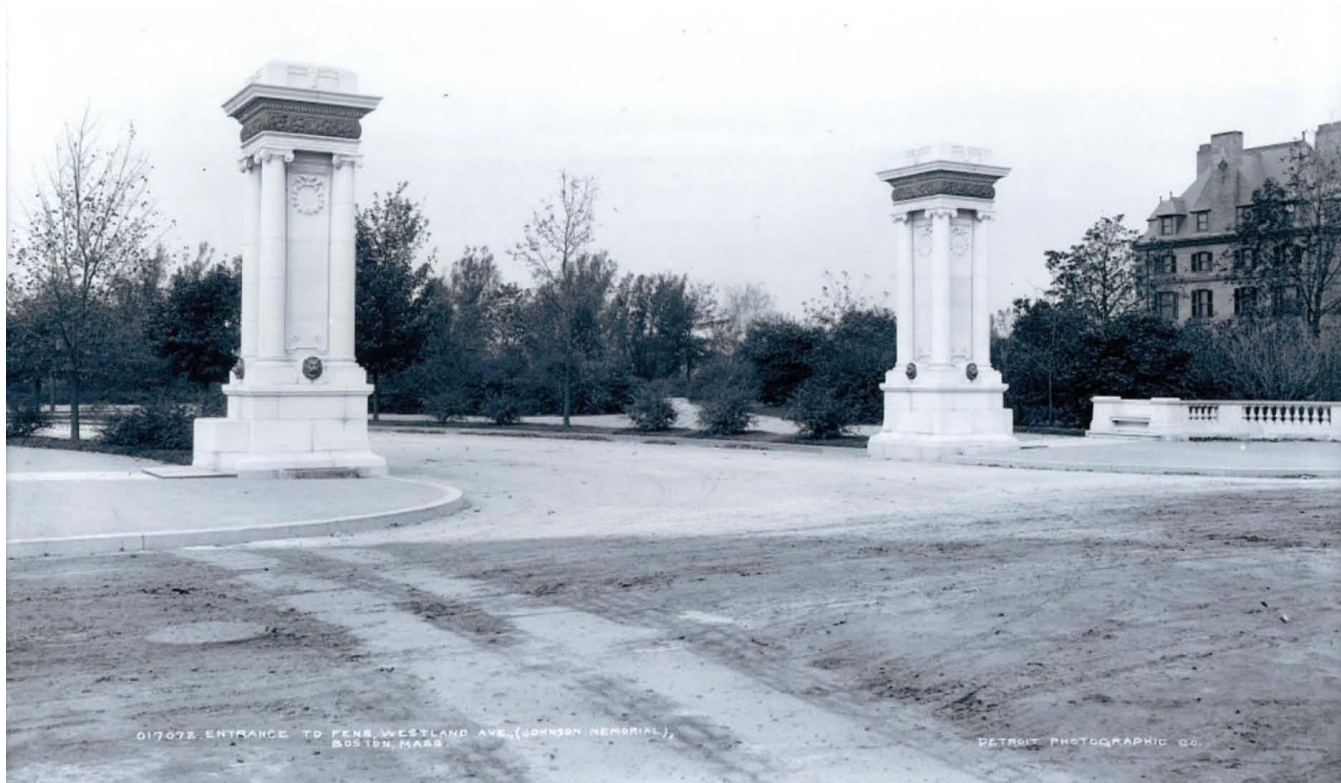
HISTORIC PHOTOS (pre-1920)

THE JOHNSON MEMORIAL GATES WERE GIFTED TO THE CITY OF BOSTON AT THE BEQUEST OF ELLEN C. JOHNSON IN 1902. THEY COMMEMORATE HER HUSBAND, JESSE JOHNSON. ALTHOUGH THE JOHNSON GATES ARE NOT IN THE PERIOD OF PRIMARY SIGNIFICANCE FOR THE EMERALD NECKLACE, THE MONUMENTS ARE HISTORICALLY SIGNIFICANT.

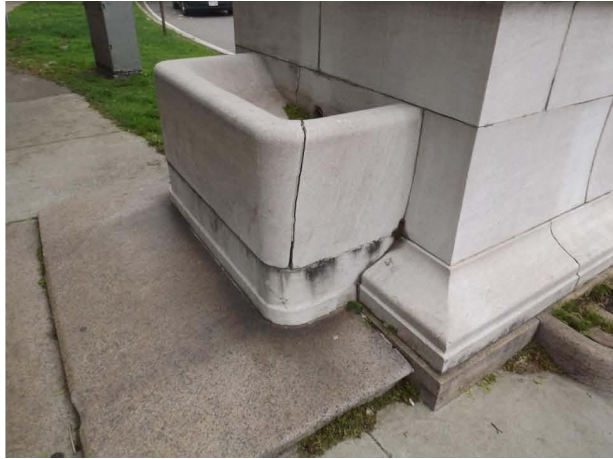
PHOTO SHOWING CRACK IN SOUTH BASIN (PRE 2017 CONDITION)

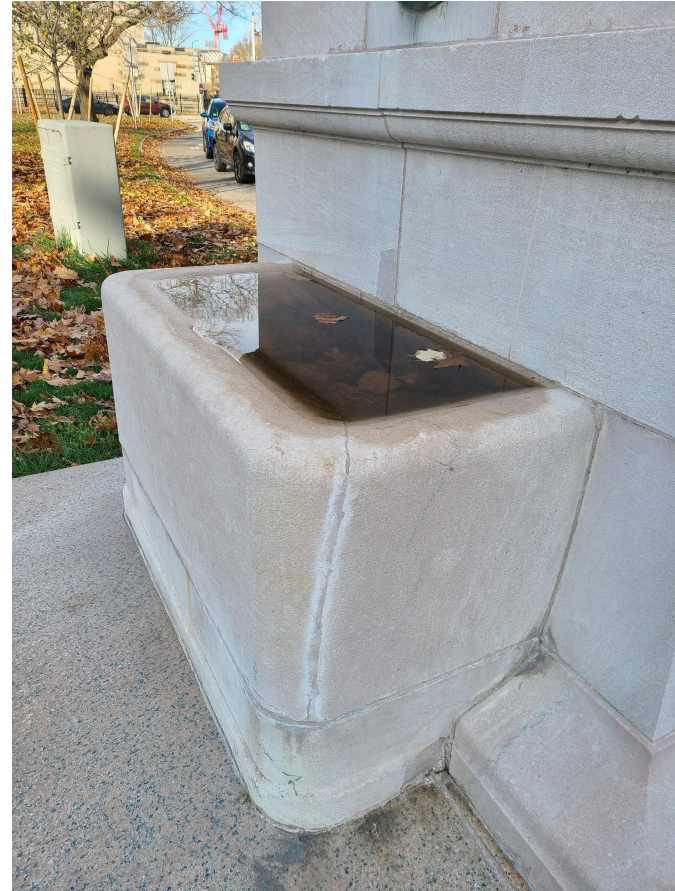
FALL 2020 PHOTO SHOWING COMPLETED CRACK REPAIR. BASIN FILLED WITH RAIN WATER HAS THE POTENTIAL TO RE-OPEN CRACK OR CREATE NEW ONE.

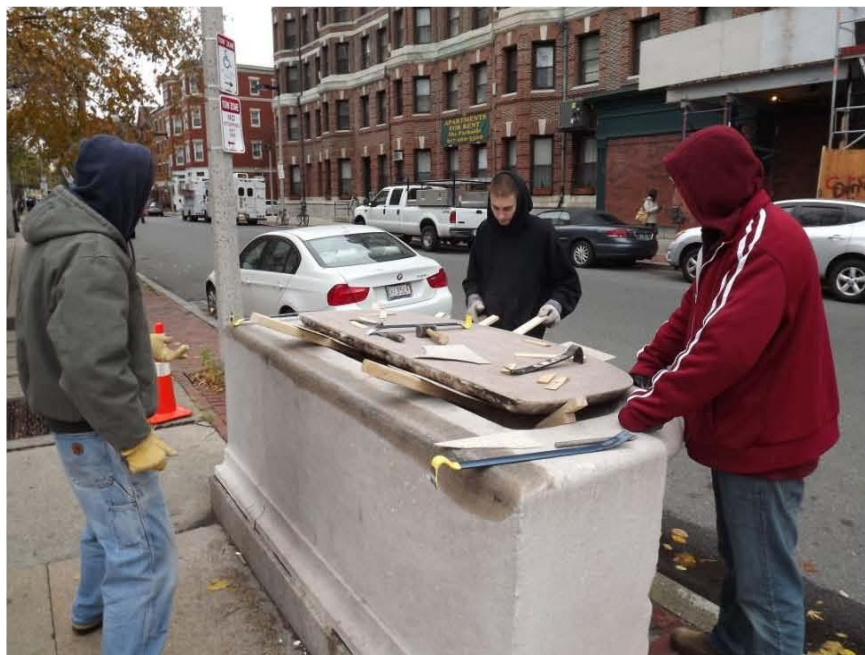
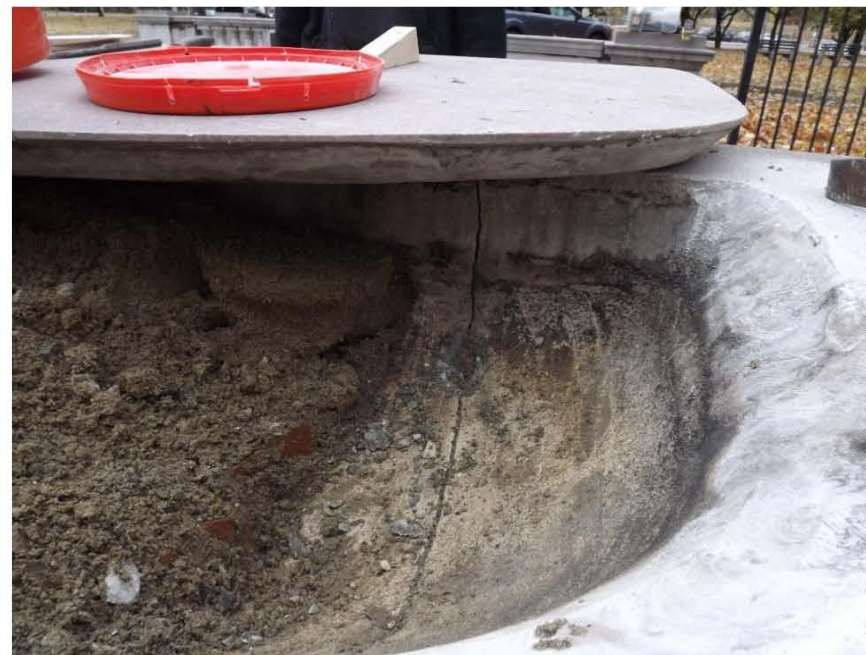
HORSE TROUGH BASINS

2013: CONSERVATORS REMOVED THE EXISTING GRANITE COVER OF THE HORSE TROUGHS AND RESEALED THE JOINTS.
