View of 33-41 Farnsworth Street alley elevation where fire shutter pin work is being proposed.

The intent of the restoration would to only remove the fire shutter pins where absolutely necessary due to one of the following conditions:

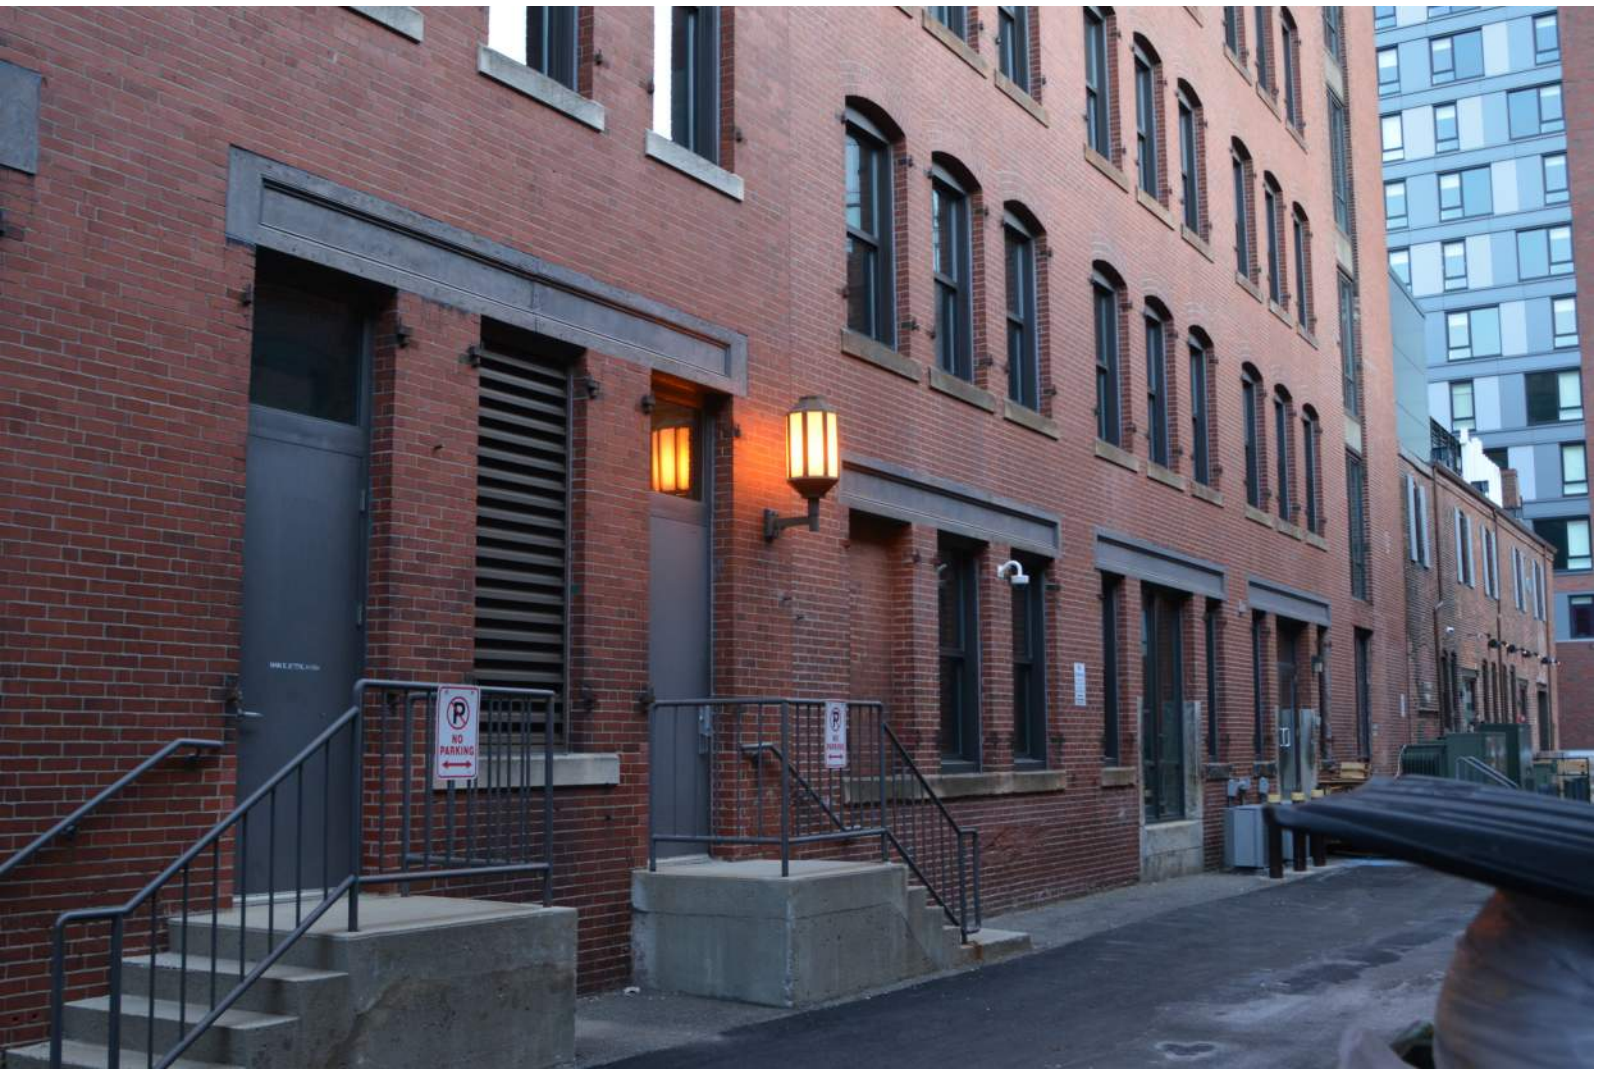
2/22/2020
DSC_5588.JPG

View of 33-41 Farnsworth Street alley elevation where fire shutter pin work is being proposed.

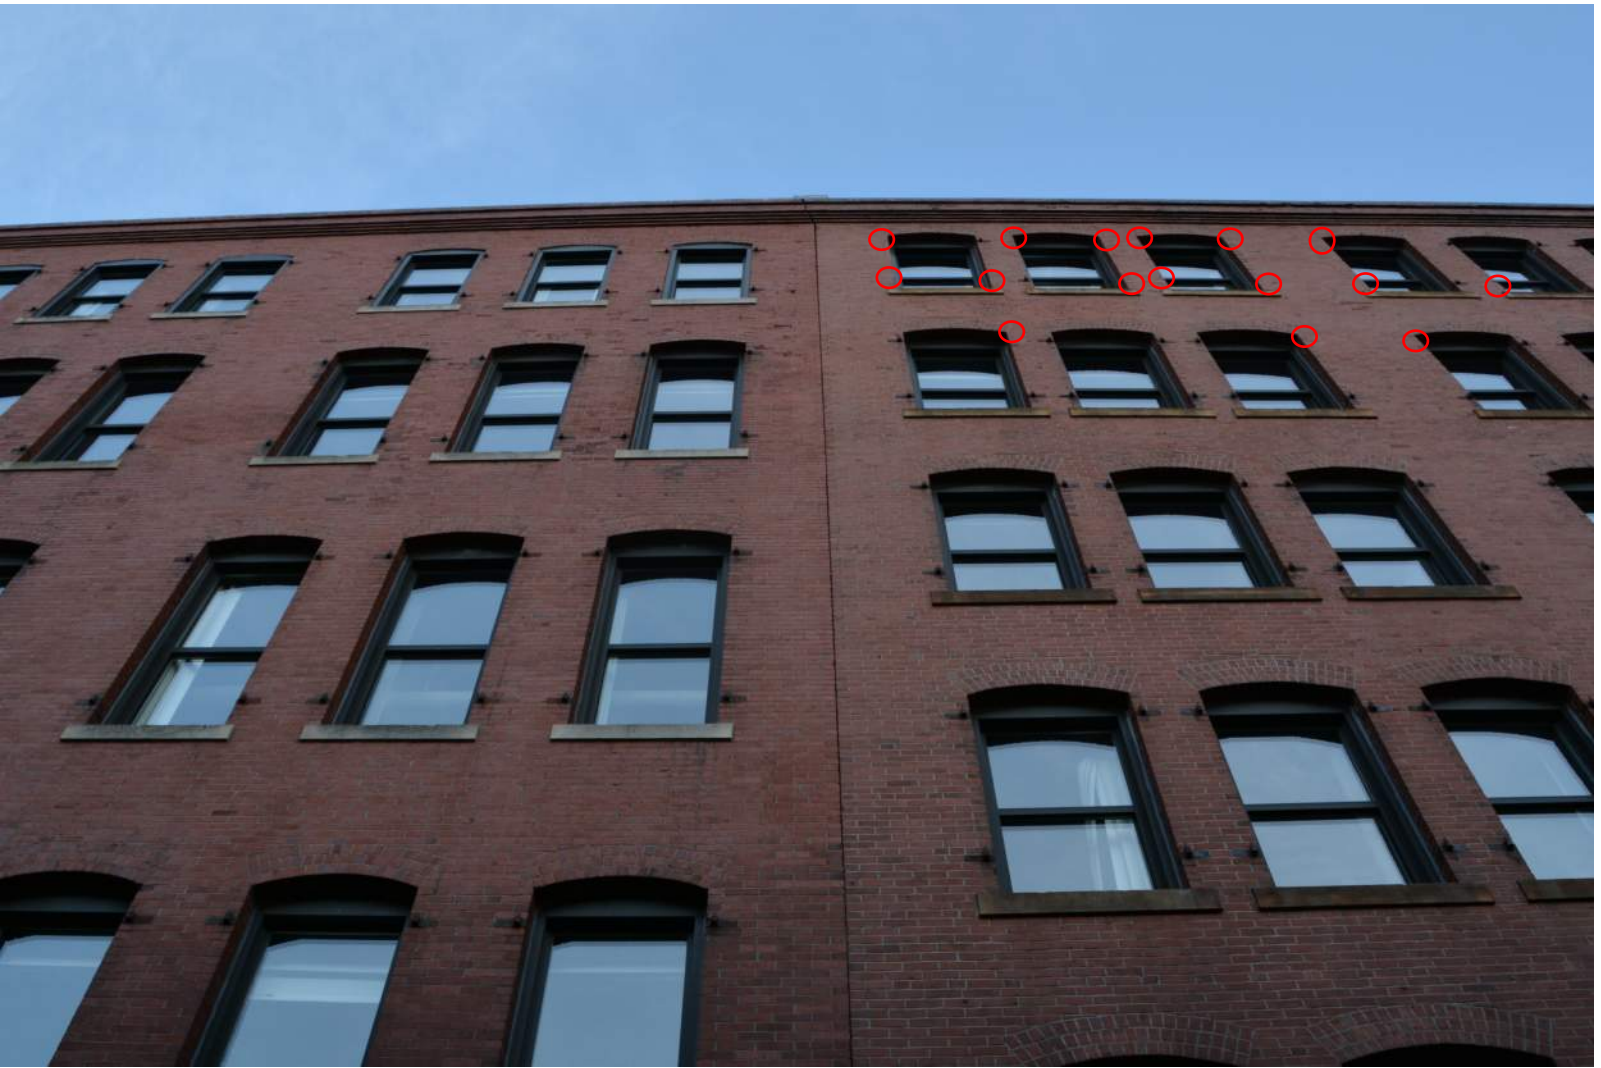
2/22/2020
DSC_5591.JPG

View of 33-41 Farnsworth Street alley elevation where fire shutter pin work is being proposed. Circled areas are an example of locations of fire shutter pin removal prior to our involvement on site.

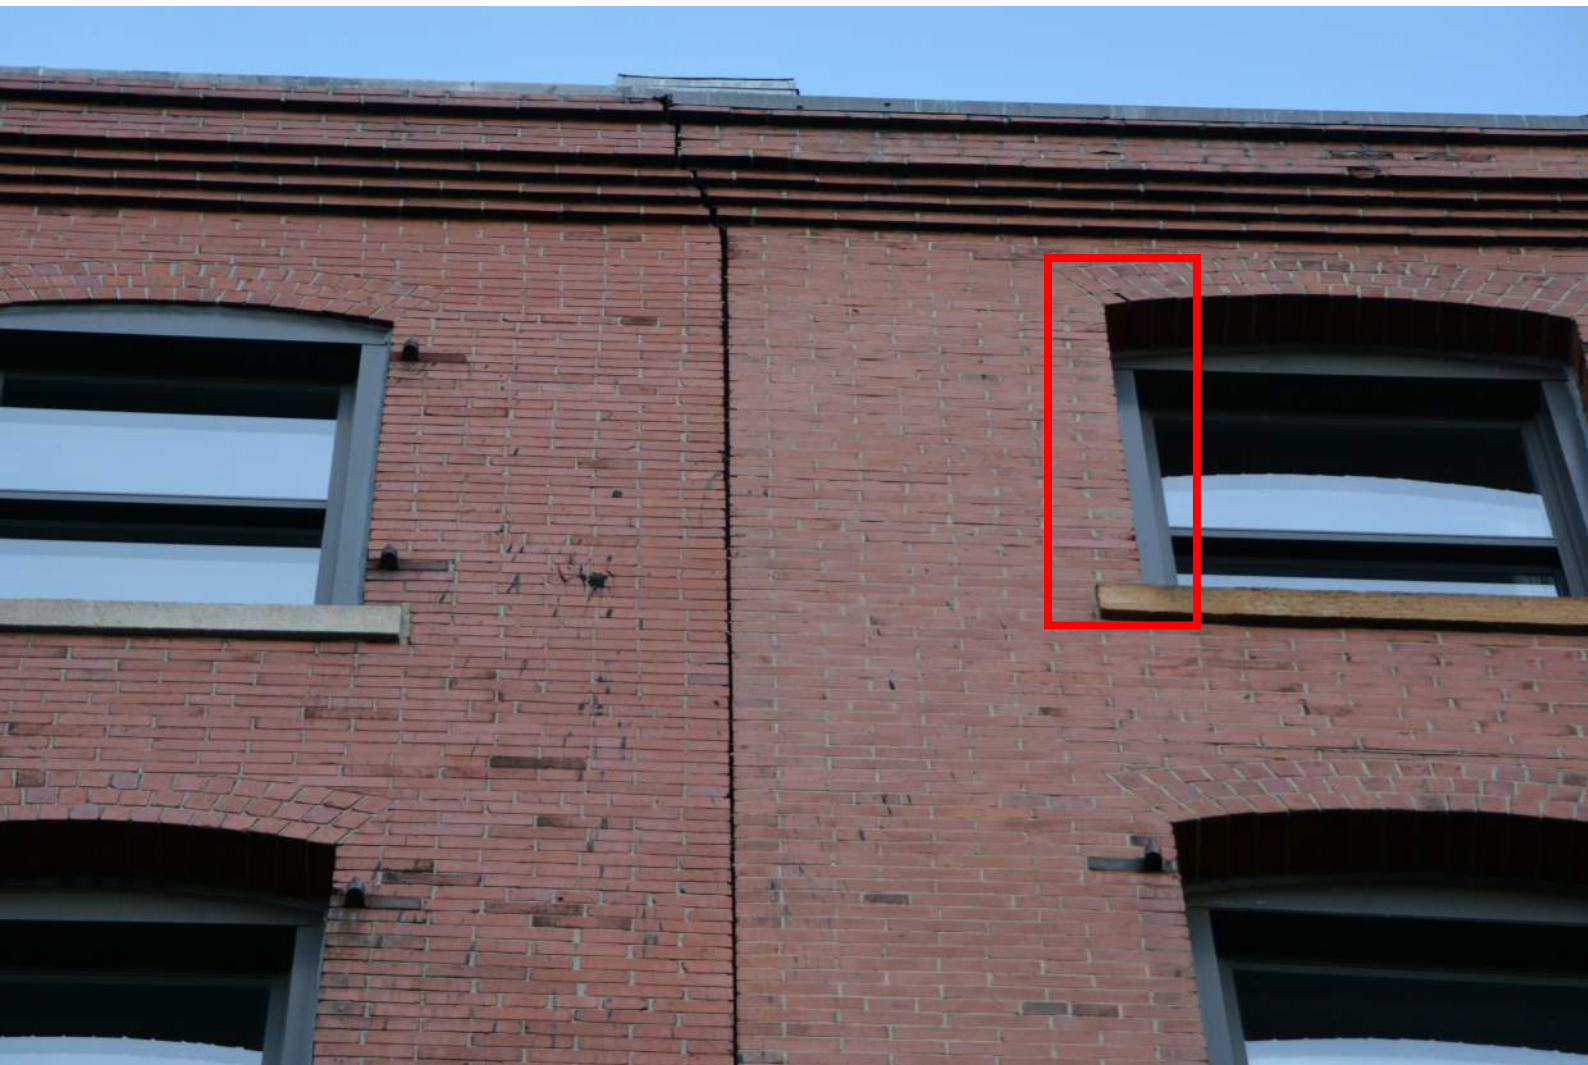
2/22/2020
DSC_5592.JPG

Close up of previous removals and brick infill at fire shutter pin locations.

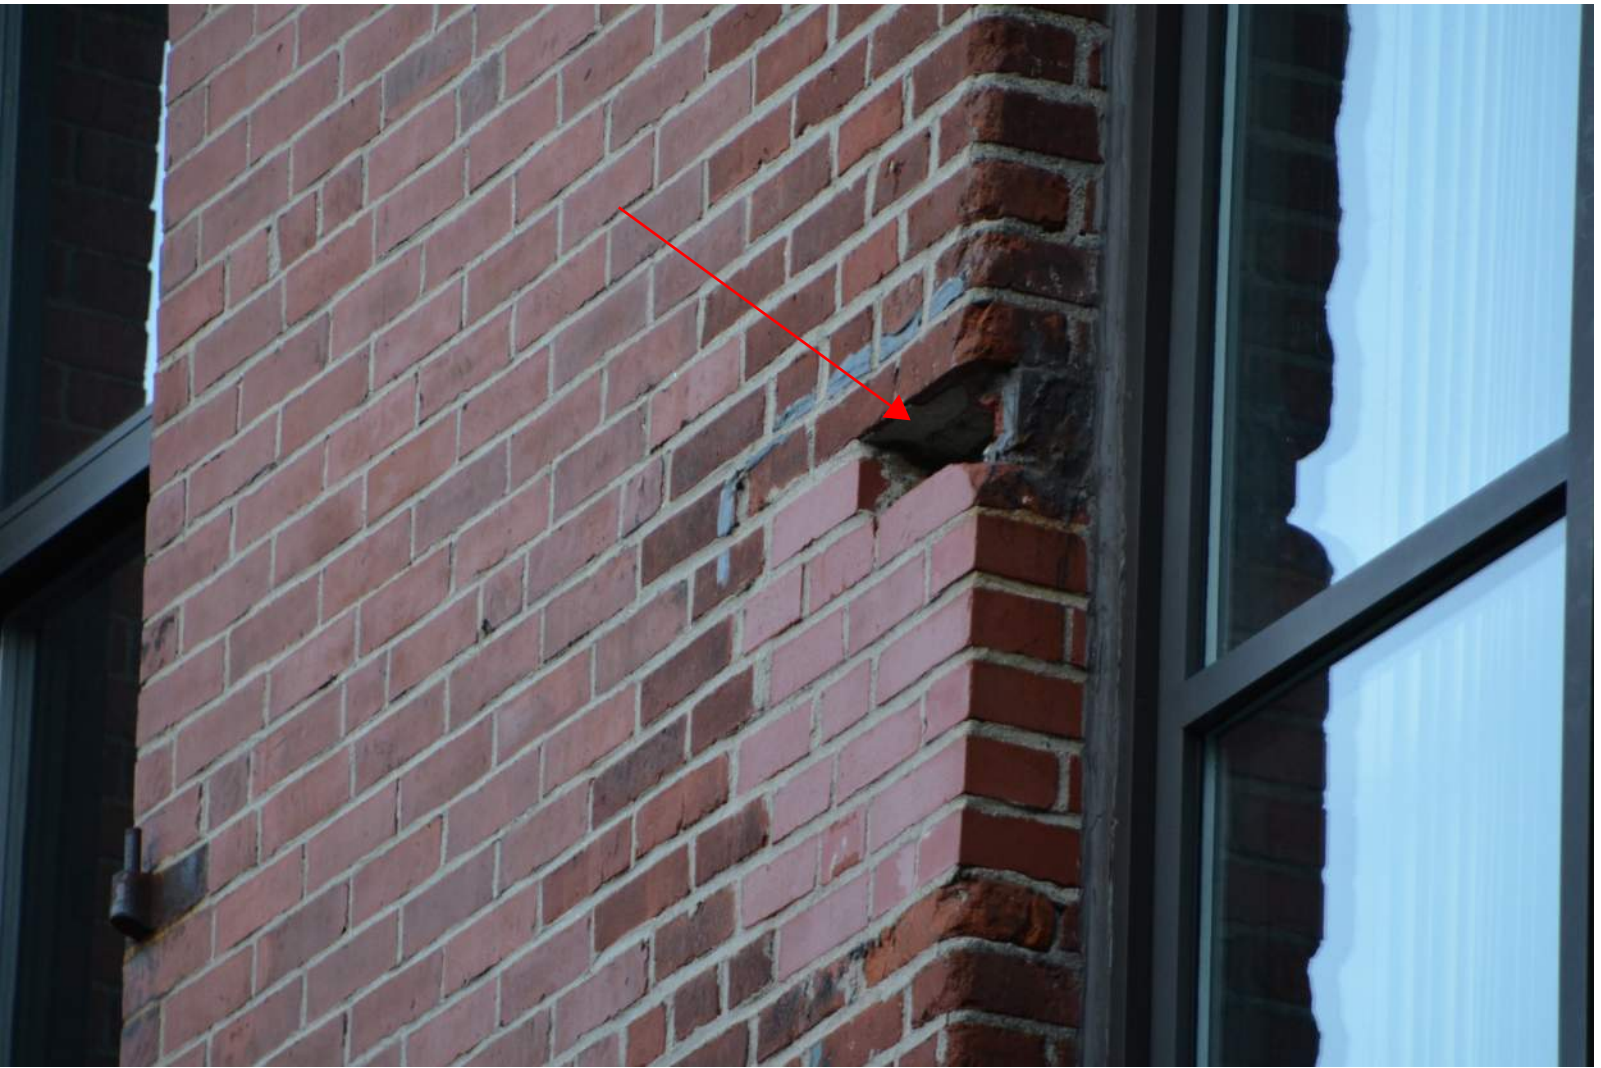
2/22/2020
DSC_5599.JPG

Example of conditions on site with partial removal of fire shutter pin that is now causing more masonry damage. This is an example of where we would like to remove the embedded steel and replace with brick and mortar.

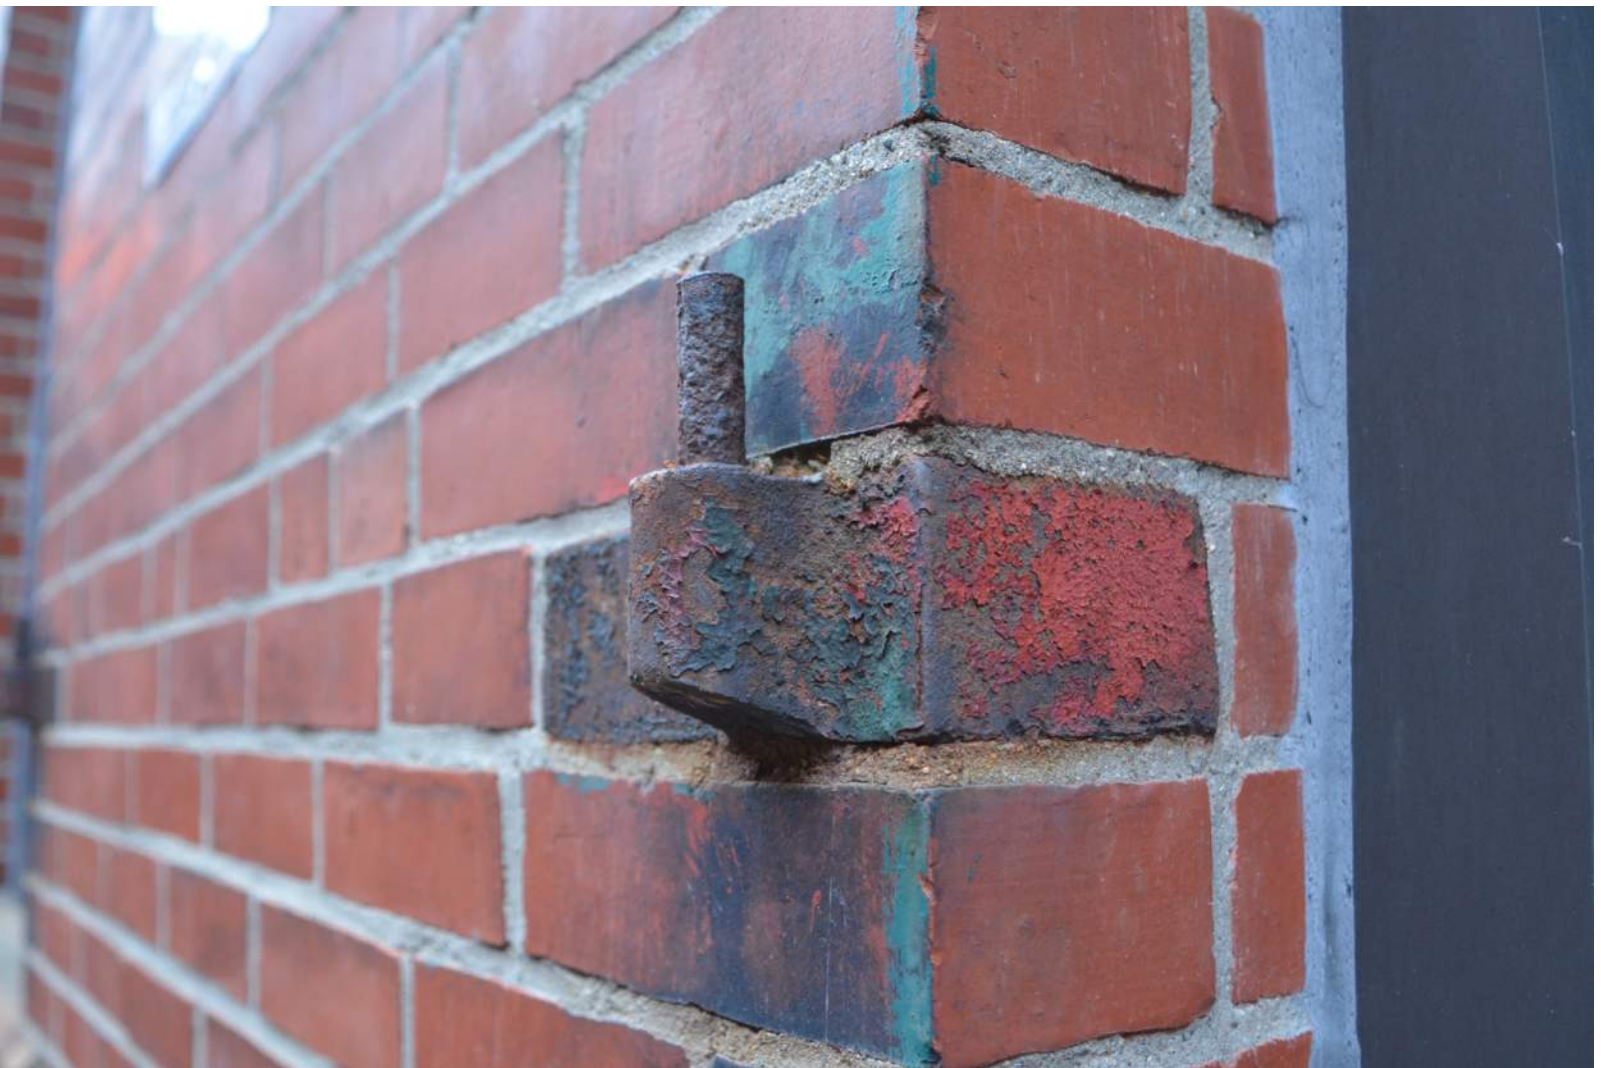
2/22/2020
DSC_5611.JPG

This is an example of a fire shutter pin that we would propose leaving in place because it is not damaged and is not causing damage to the surrounding masonry. The joints surrounding this pin would be restored to assist with preserving the masonry.

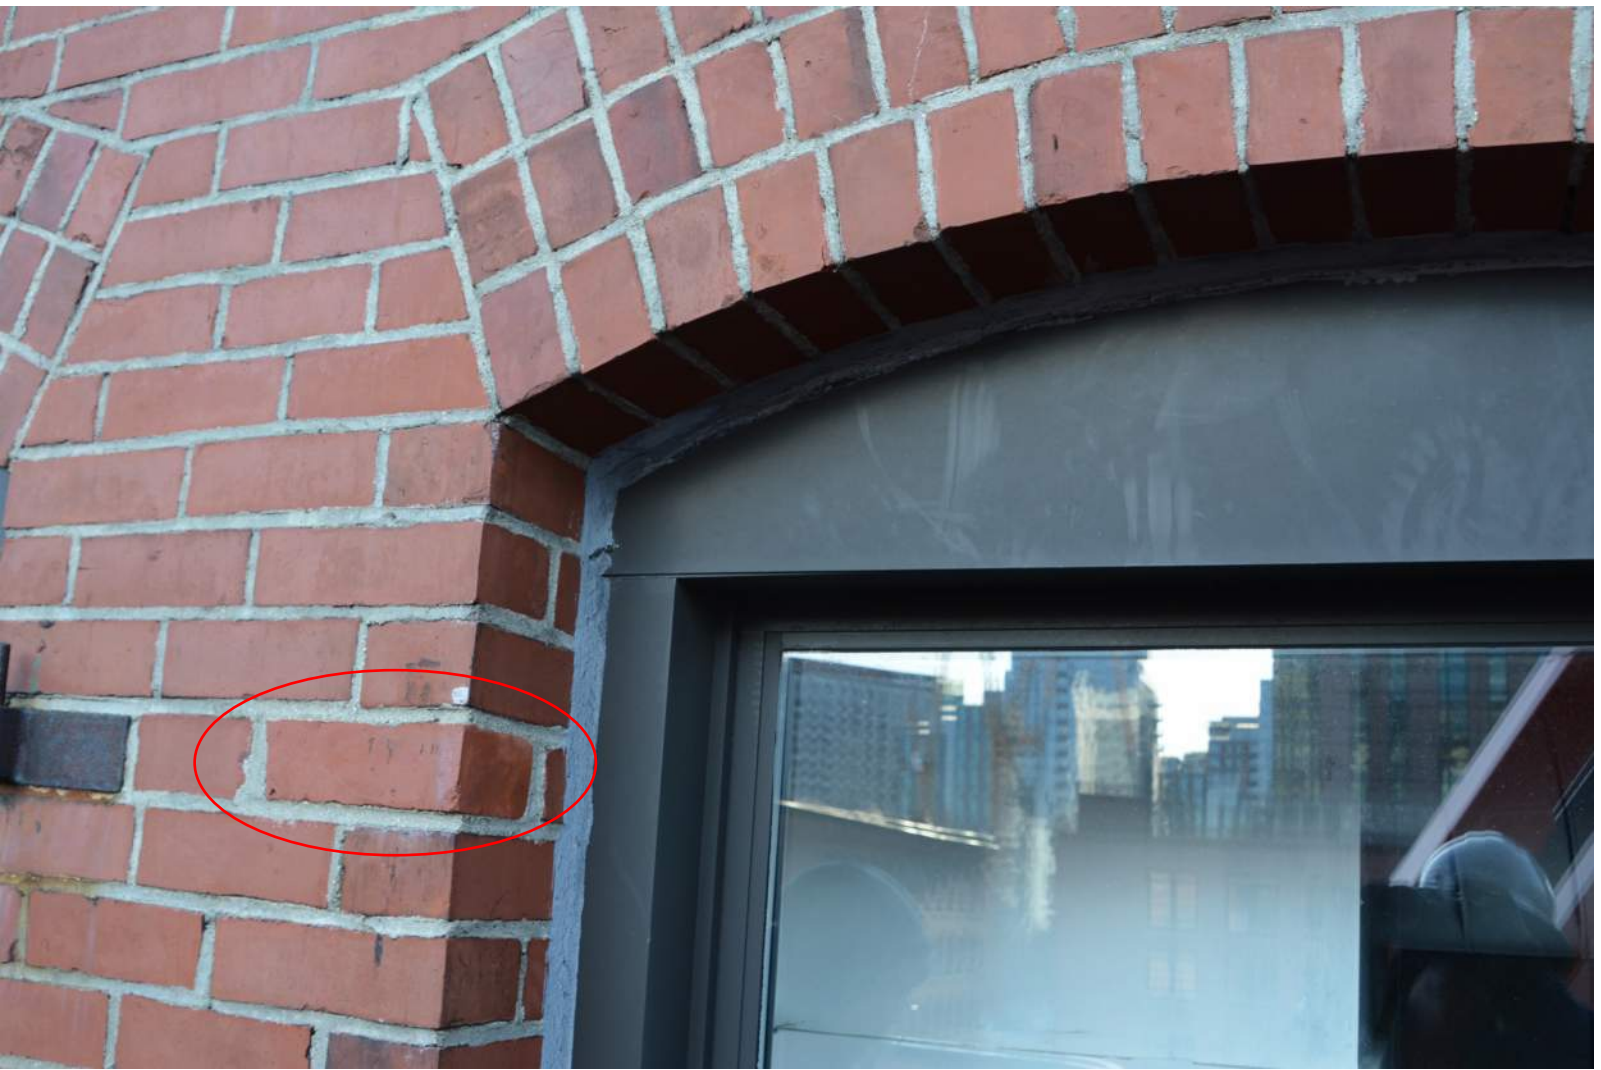
2/22/2020
DSC_5630.JPG

Example of fire shutter pin previously removed with brick infill.
This is what we are proposing to complete at the locations where
the pins are a safety hazard, partially removed, or damaging the
masonry.

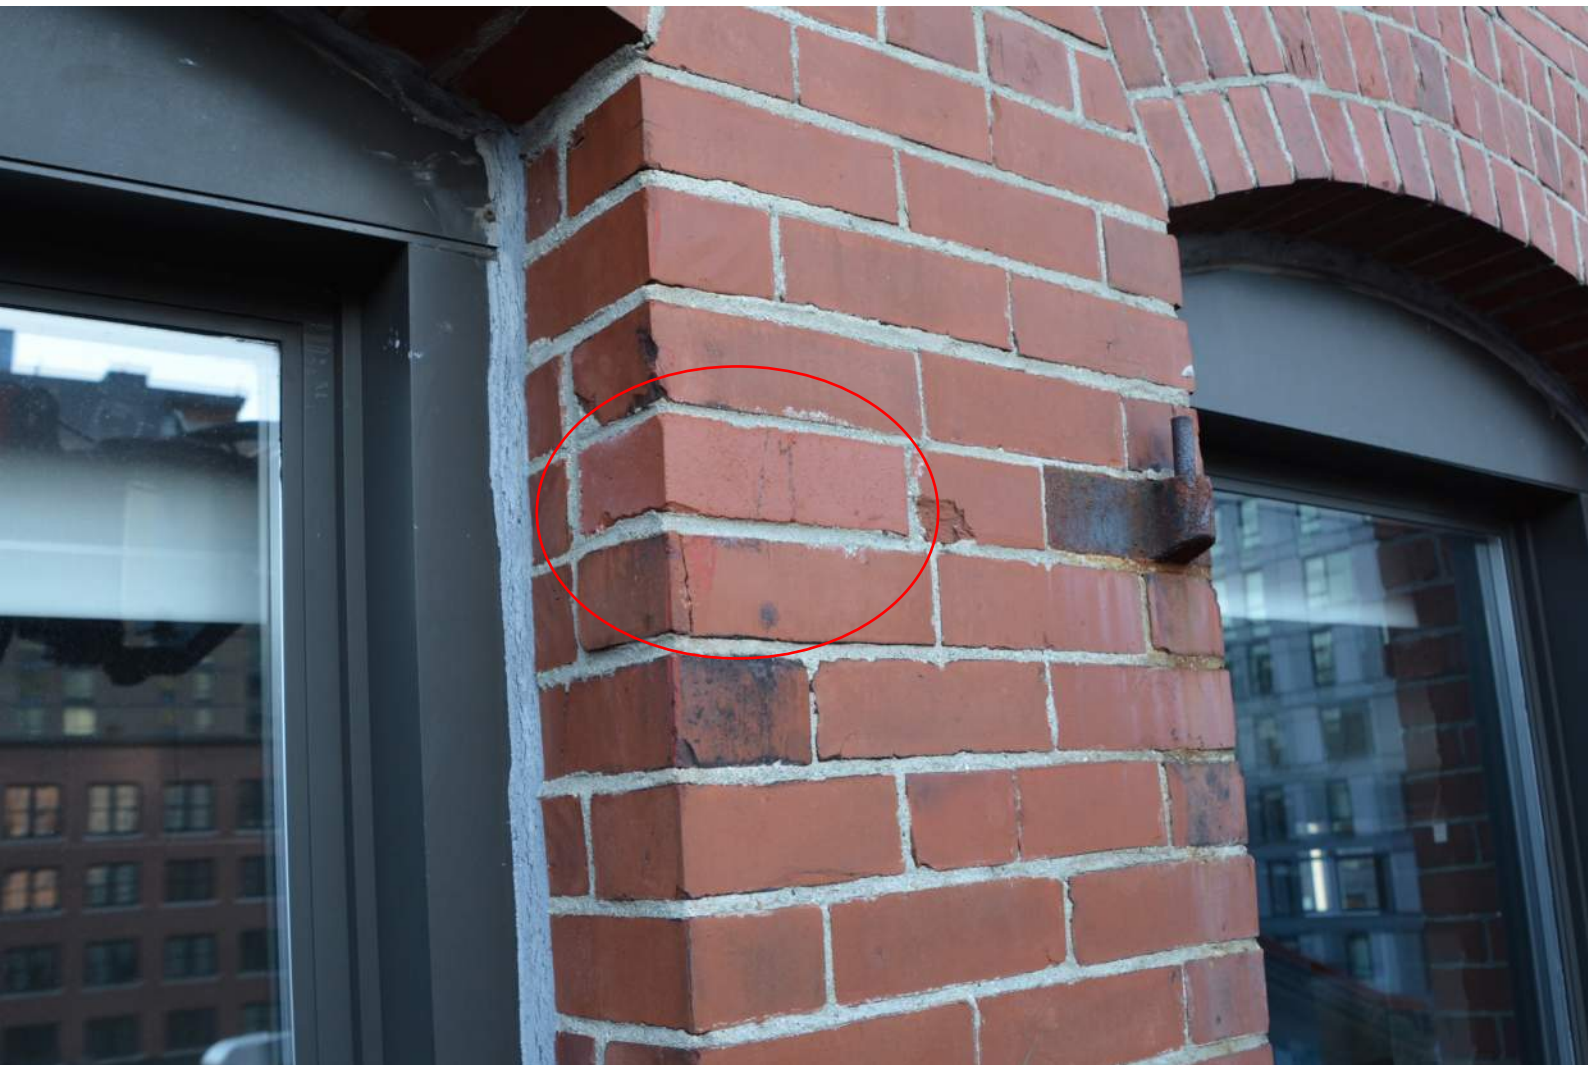
2/22/2020
DSC_5633.JPG

Example of fire shutter pin previously removed with brick infill. This is what we are proposing to complete at the locations where the pins are a safety hazard, partially removed, or damaging the masonry.

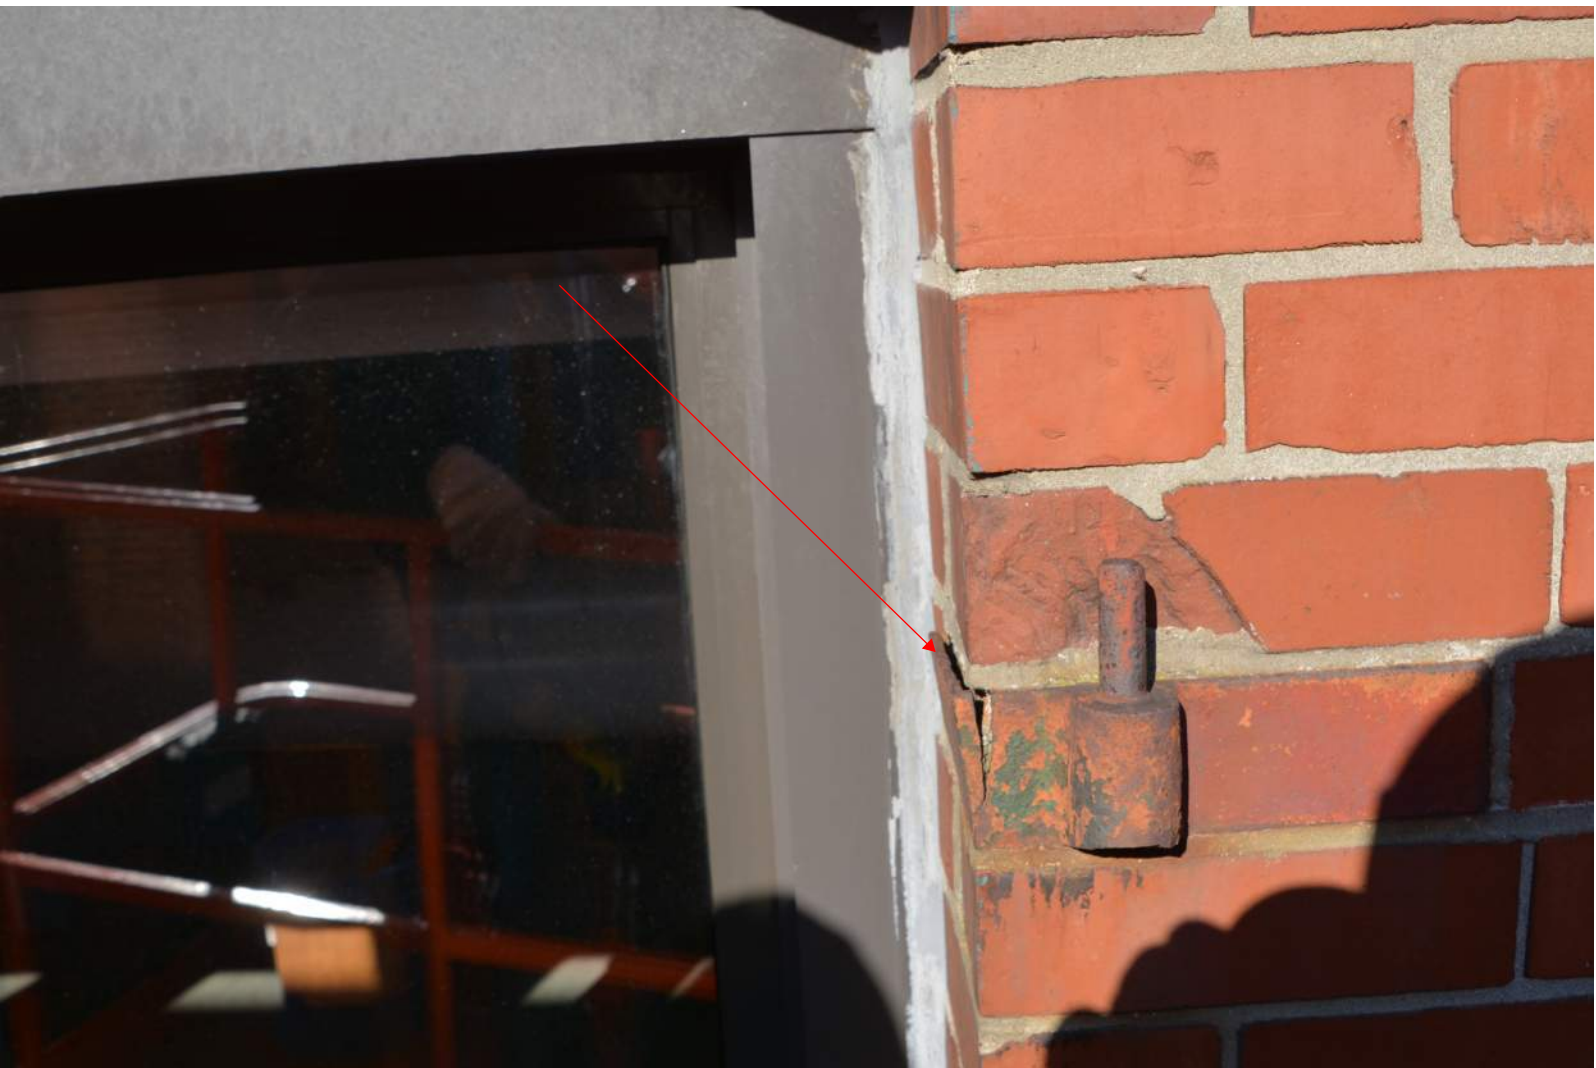
2/22/2020
DSC_5792.JPG

This is an example of a fire shutter pin we would like to remove due to safety concerns if or when it falls off the building. The fire shutter pin would be removed and replaced with brick and mortar.

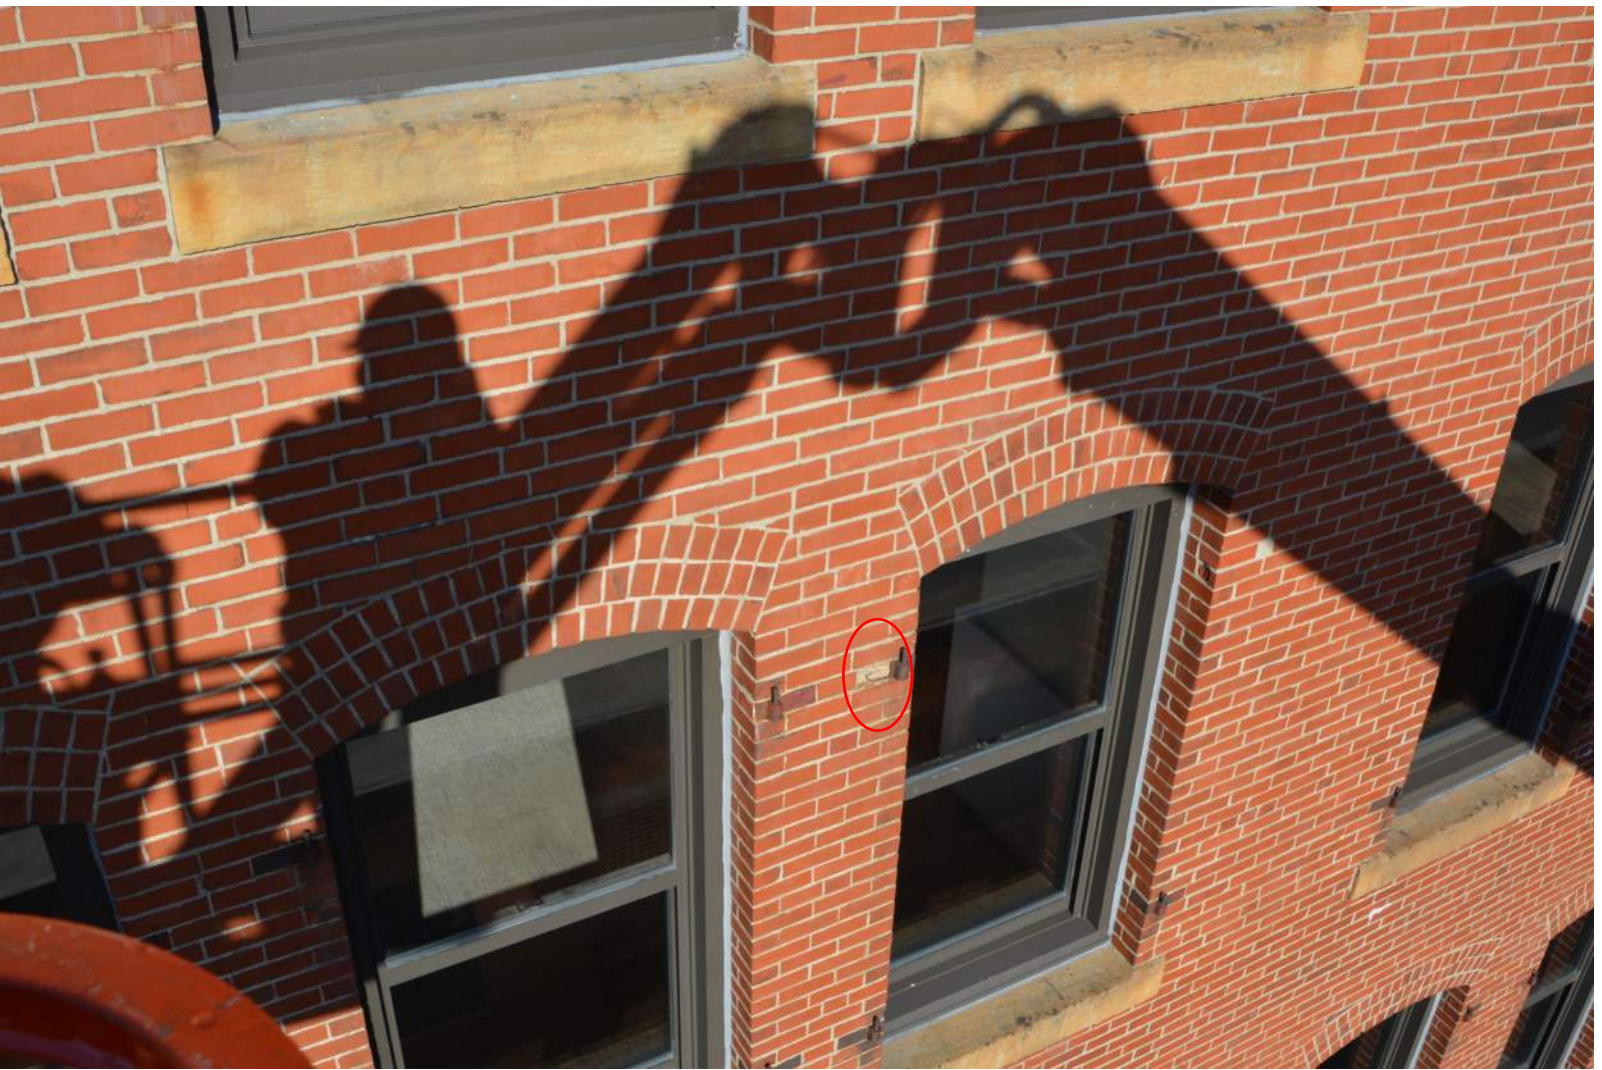
2/22/2020
DSC_5755.JPG

Example of location where the face of the fire shutter pin had fallen off the building prior to our review in 2020 and what we would like to prevent from happening in the future.

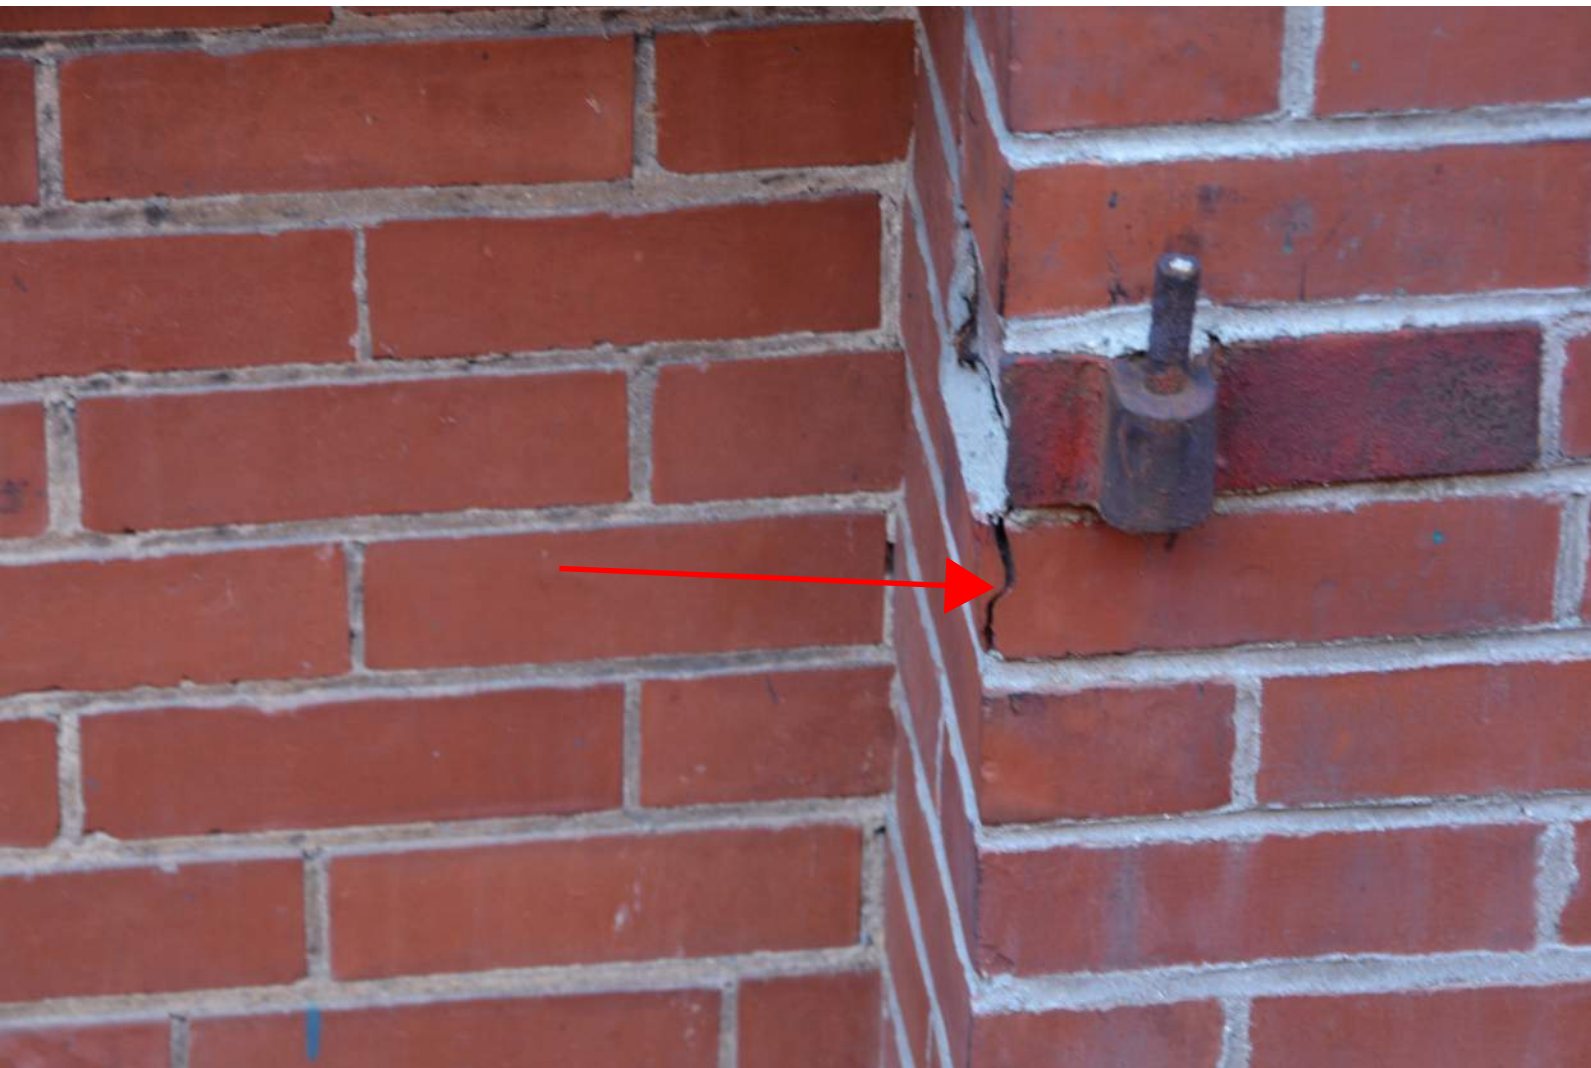
2/22/2020
DSC_5764.JPG

Example of masonry damage due to deteriorating fire shutter pin.

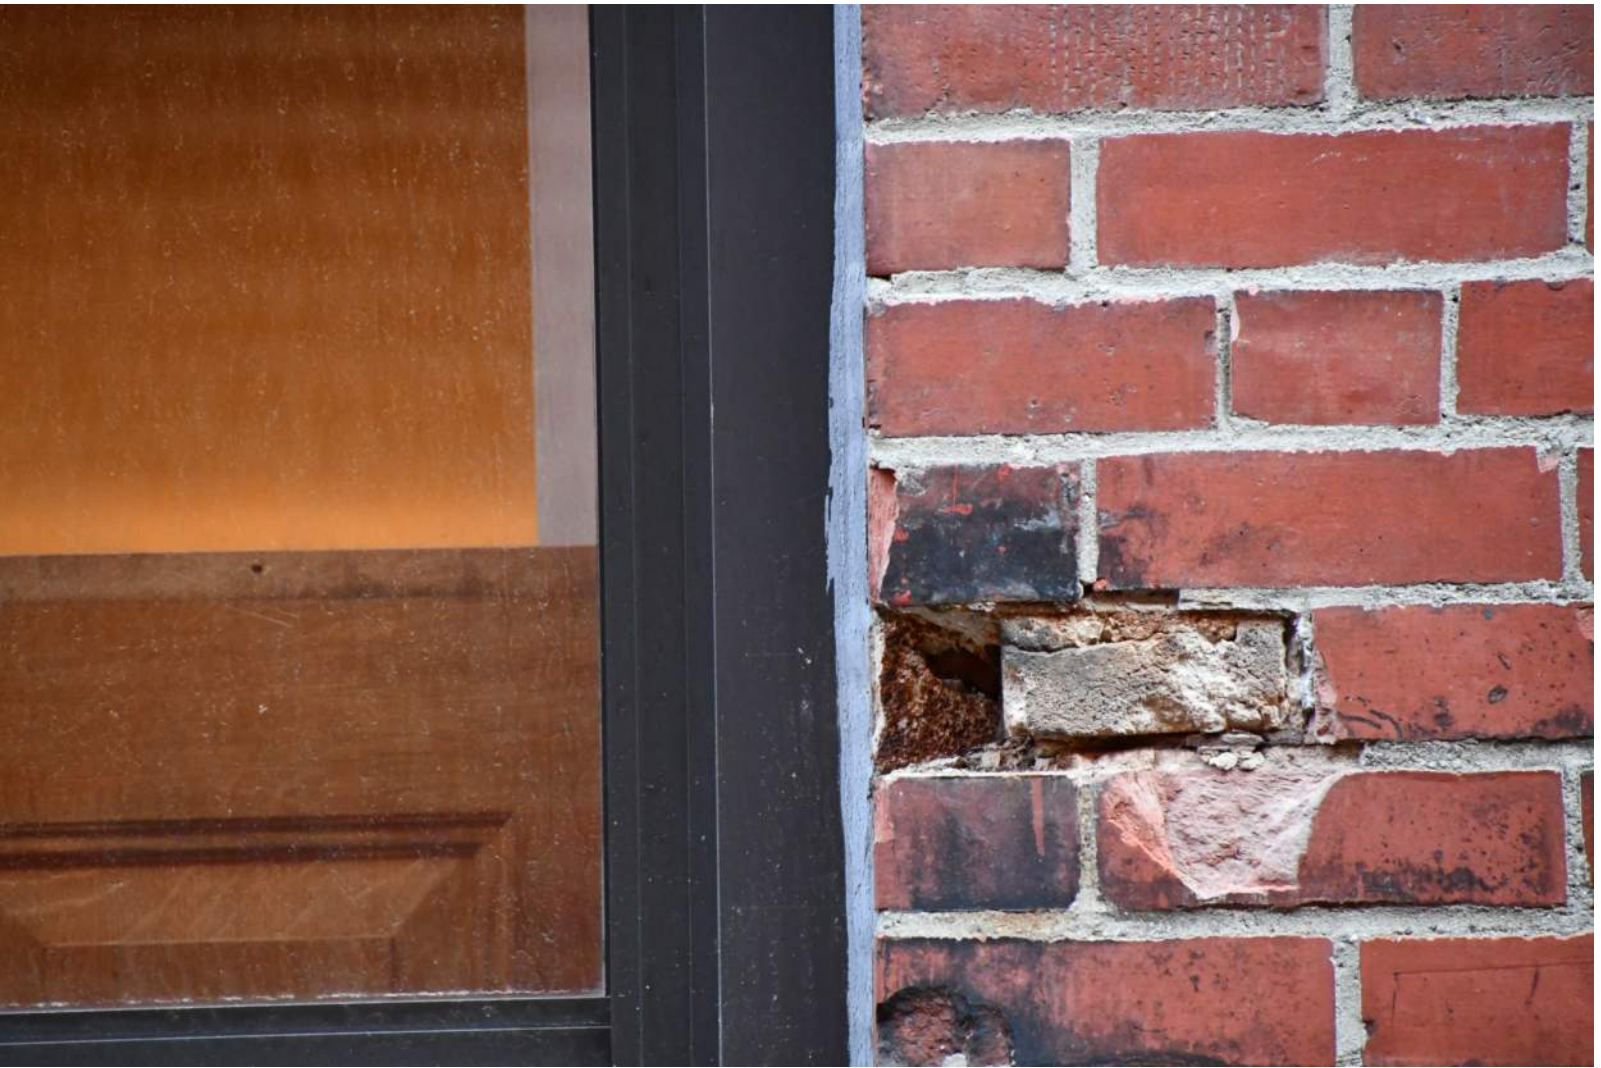
8/5/2020
DSC_6782.JPG

Example of a location with the face of the fire shutter pin removed but remaining steel is still embedded in masonry. We are proposing to remove the embedded steel that is causing masonry damage and replacing with brick and mortar at these locations.
