**RE: Tree Removal for Safety of Pedestrians on Sidewalk**

85 & 95 Sutherland Road (the "Site")  
Boston, MA 02135

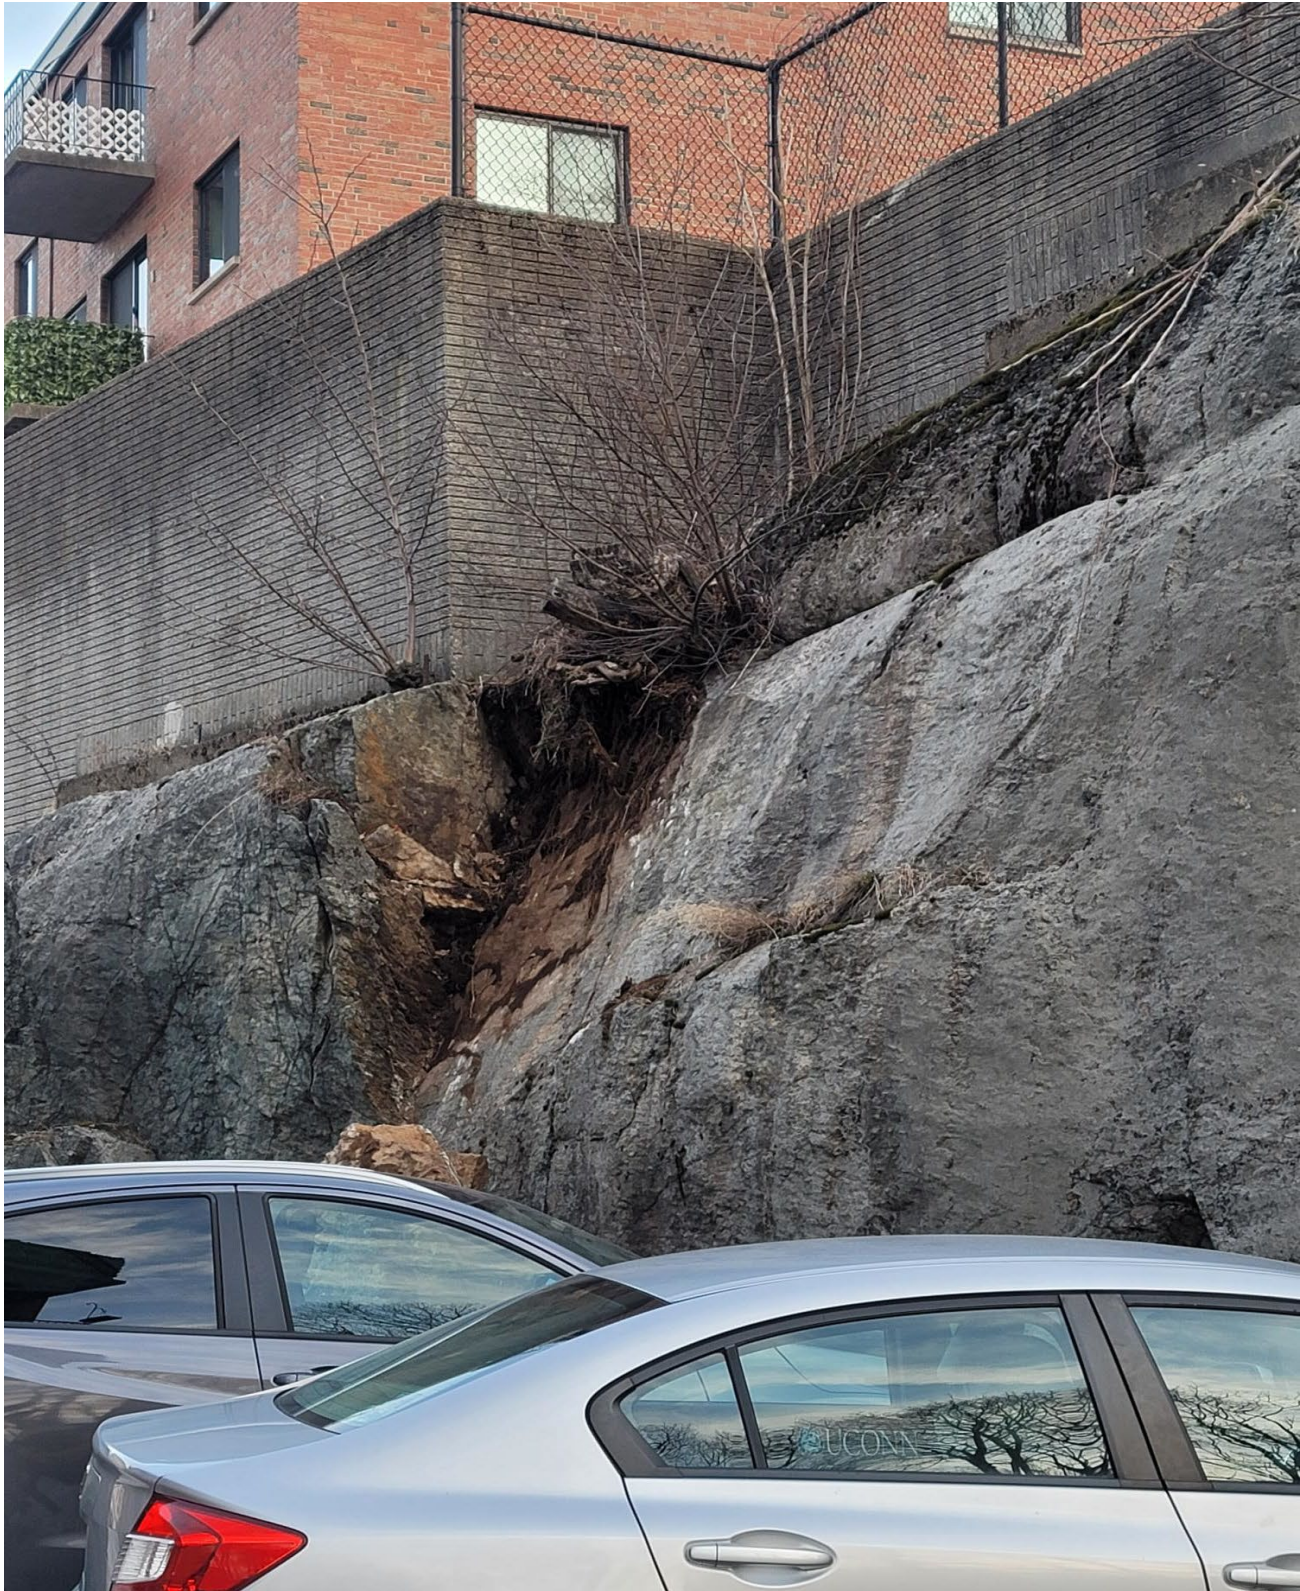
Photo #1 – March 15, 2022  
Collapse Area

On March 15, 2022, FSL was informed by the Site Owner that there was a sudden "partial collapse of a ledge wall where a massive boulder fell on a couple of cars" at 85 Sutherland Road (See Photos #1-#4). The Site Owner requested FSL mobilize to the Site to verify the condition of the remainder of the ledge outcrop and determine possible solutions to reduce chances of future collapses.

On March 16, 2022, FSL mobilized to the Site. Upon entry to Site parking lot, FSL identified an area that was fenced off with large boulders located in the fenced in area. The large boulders appeared to fall from approximately 10-15 above grade from the adjacent ledge outcrop, beneath the footing of a masonry wall on 95 Sutherland Road, adjacent to the north of the subject Site (see enclosed Figure 1). In the collapse area, there was a stump of a tree that had been cut in the past (see Photos #1 and #4).

Therefore, based on the observations at both 85 Sutherland Road and 95 Sutherland Road, FSL highly advises that the trees and small brush be removed as soon as possible in order to reduce the chances of ledge outcrop fractures collapsing into the sidewalk and Sutherland Road to avoid physical damage and possible bodily harm.

1. Remove loose ledge fractures from the outcrop to reduce chances of future collapse
2. Underpin and stabilize the masonry wall on top of the ledge outcrop where necessary once all vegetation and loose ledge fractures are removed.

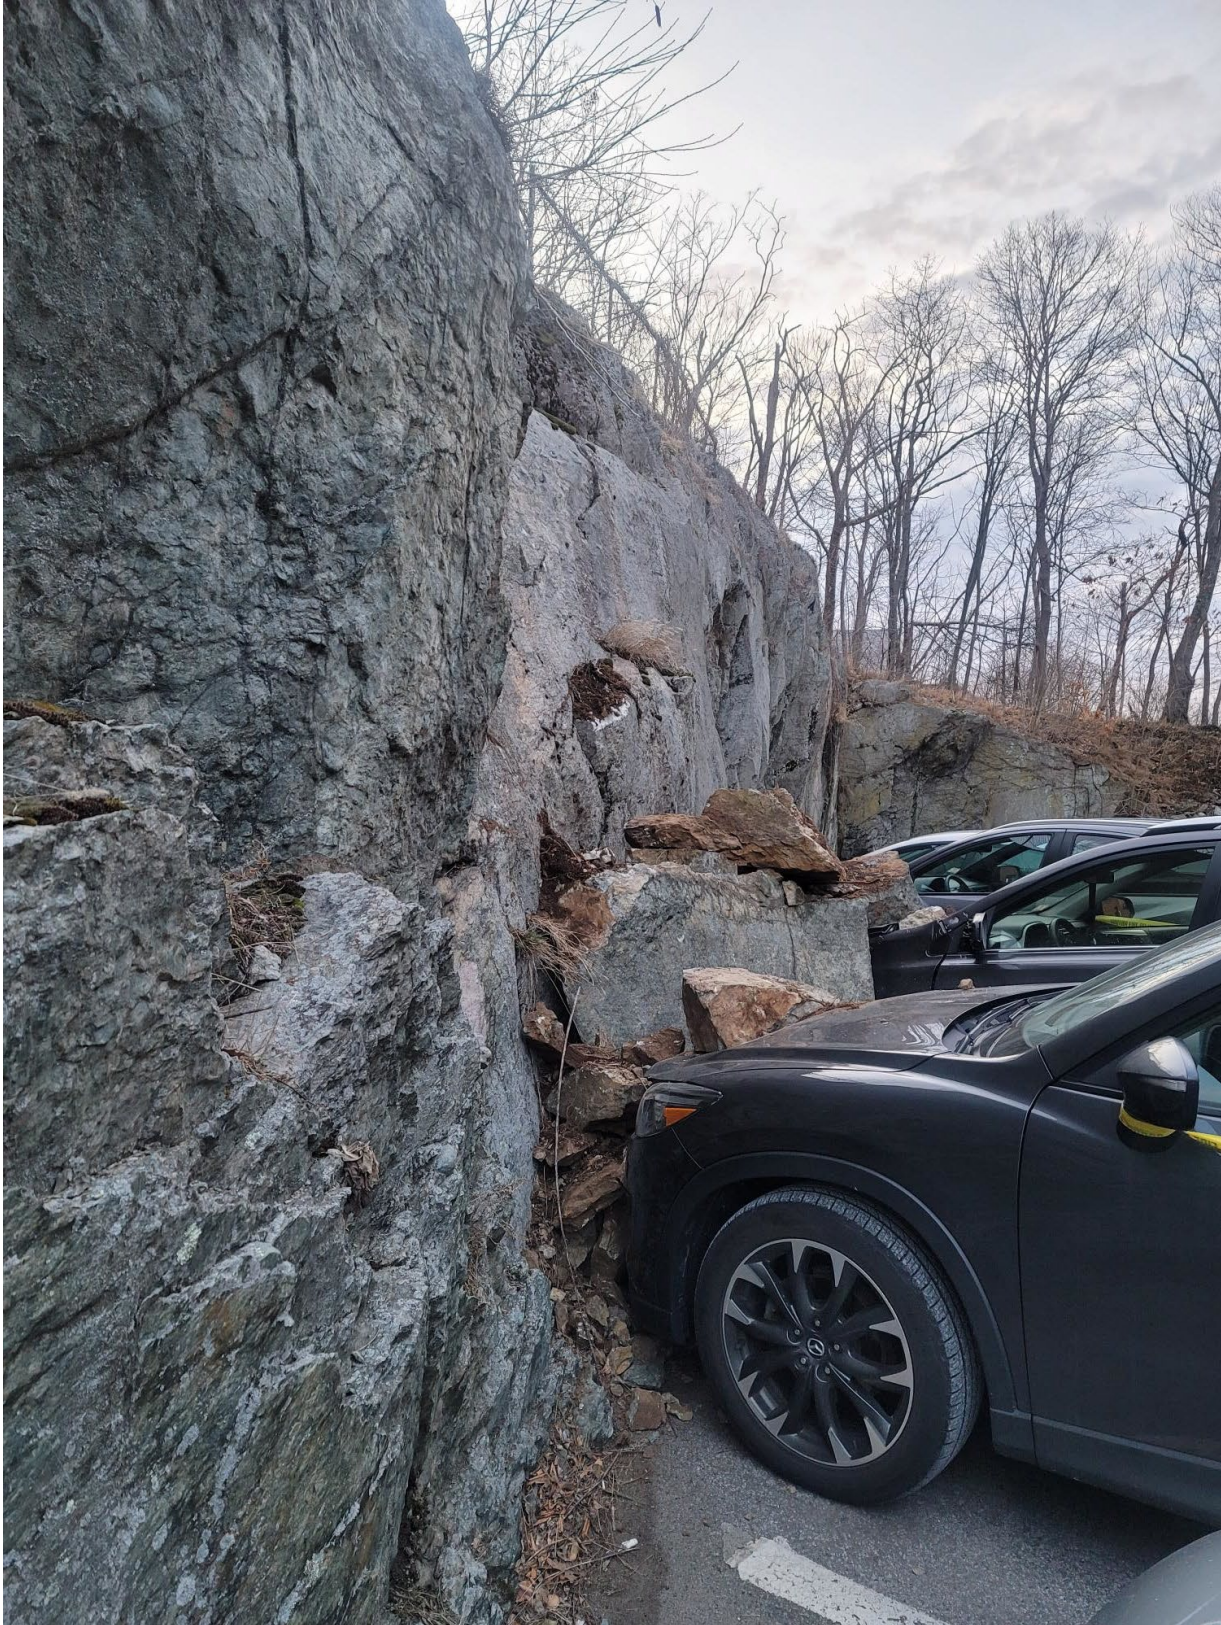
Photo

#2 – March 15, 2022  
Collapse Area and Impact to Cars Beneath

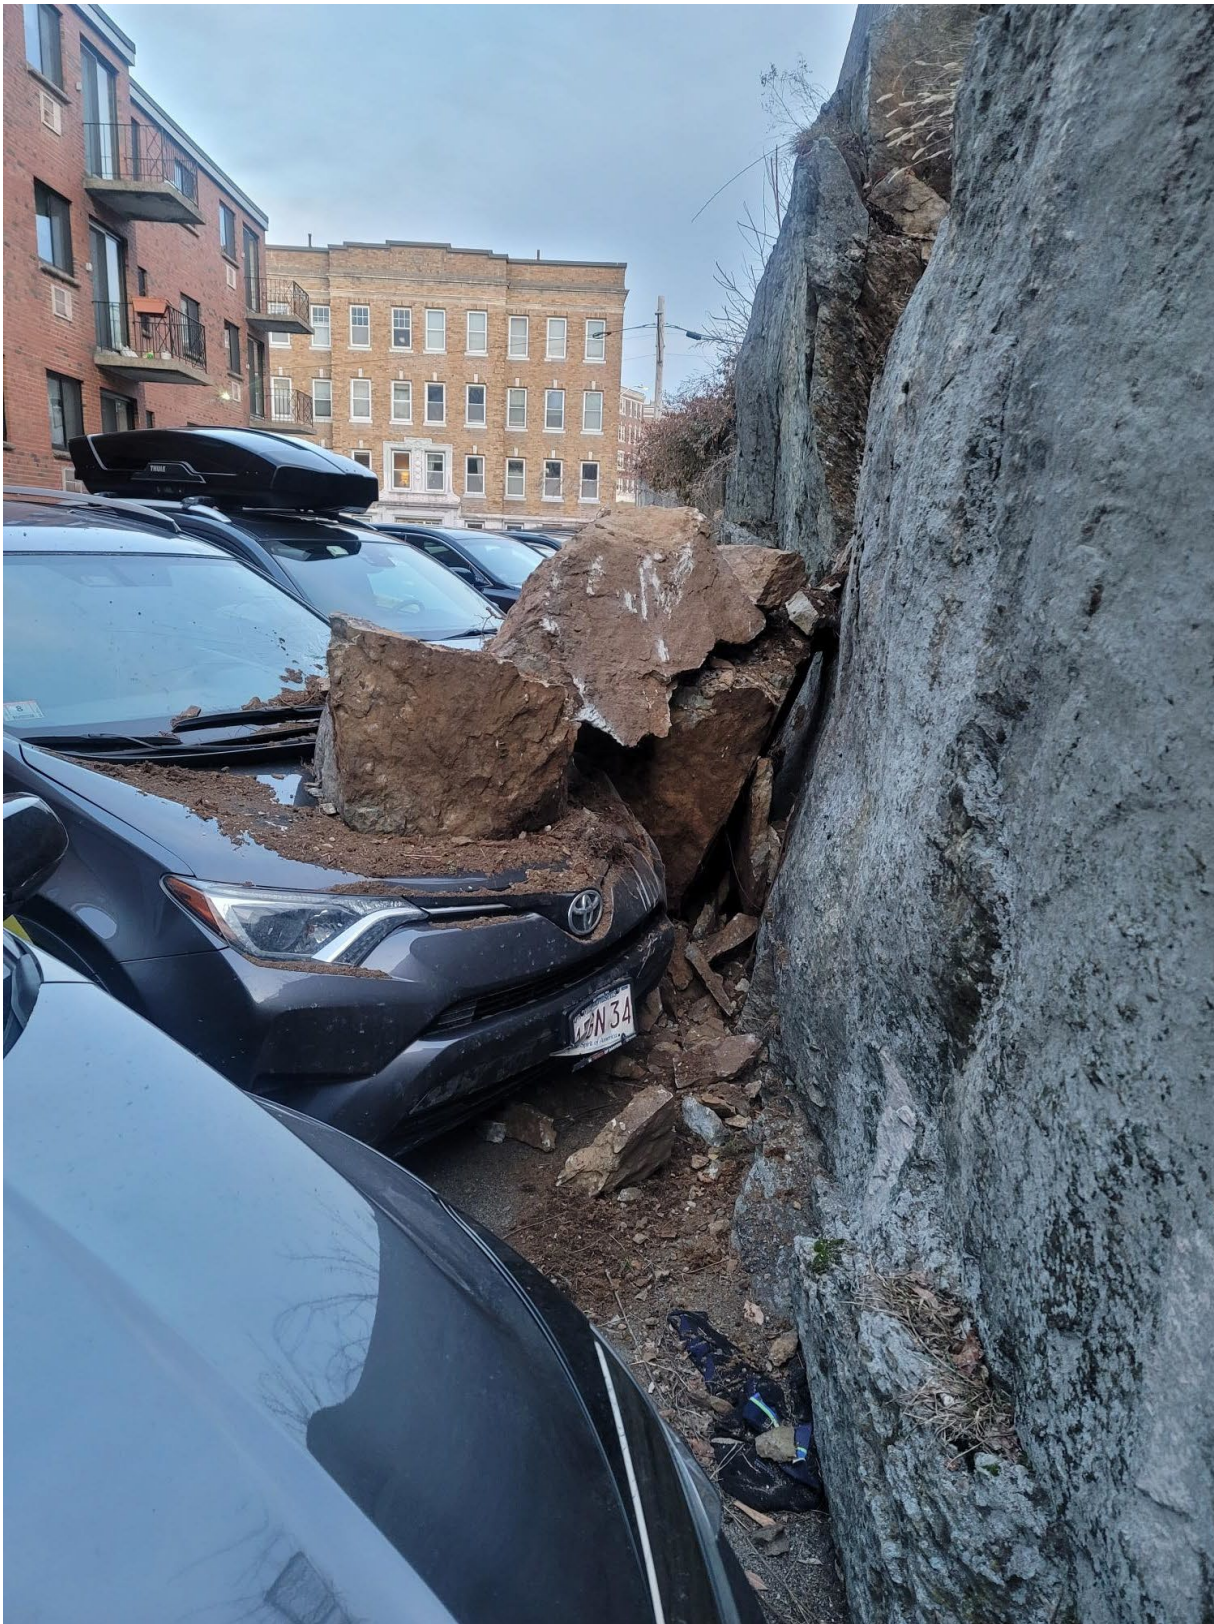
Photo #3 – March 15, 2022  
Collapse Area and Impact to Cars Beneath

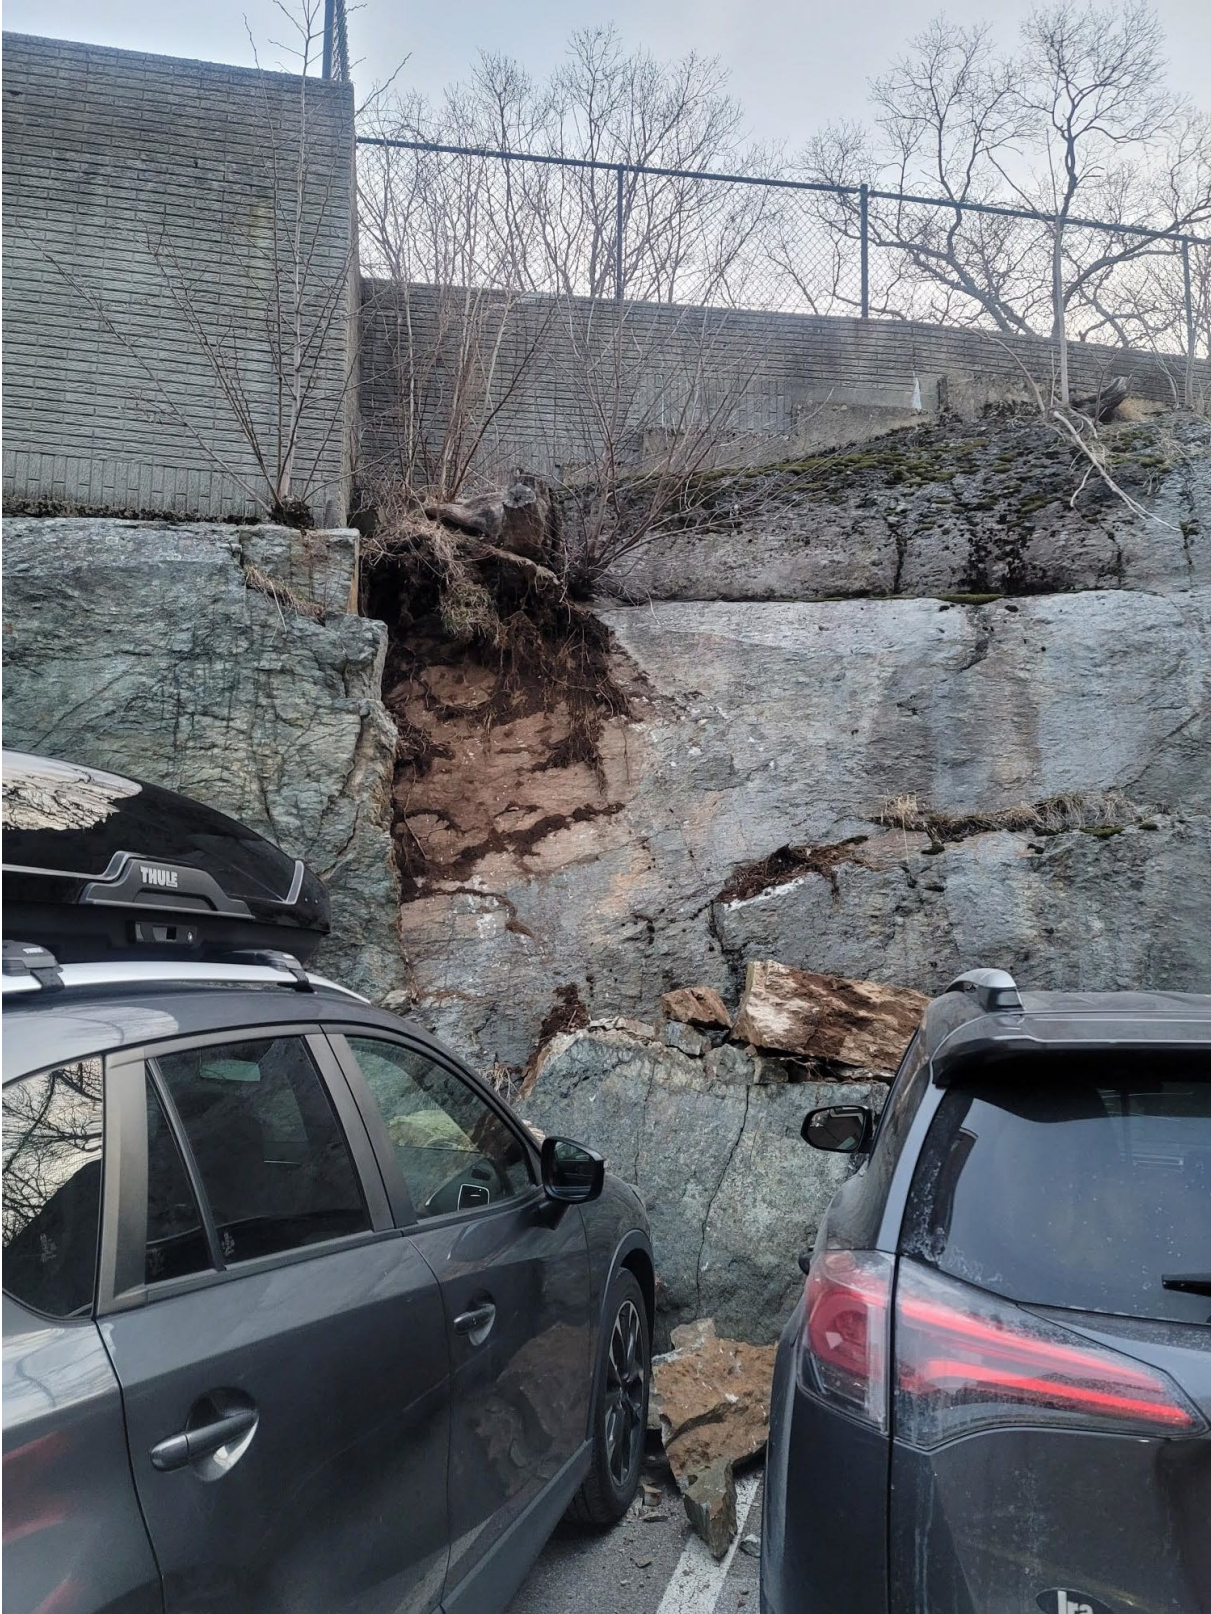
Photo #4 – March 15, 2022  
Collapse Area and Impact to Cars Beneath

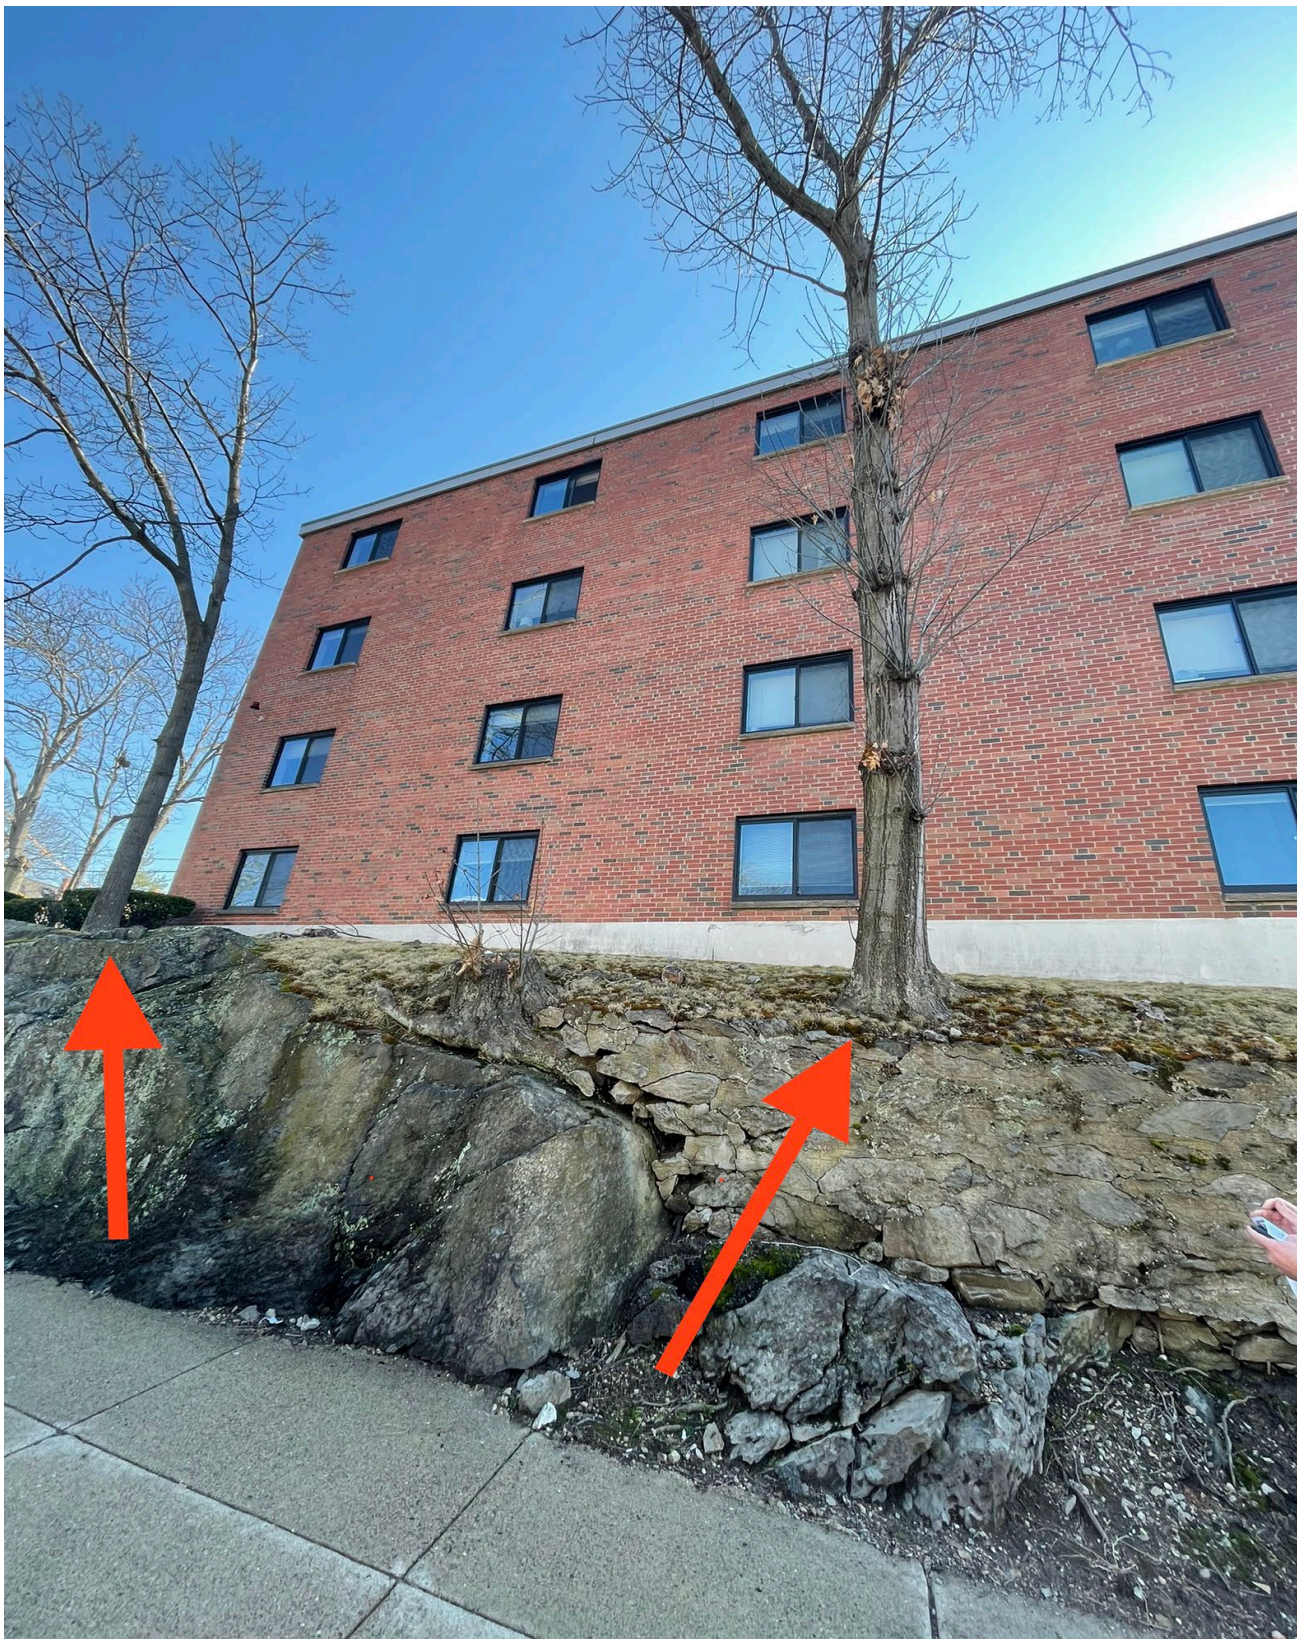
Photo #5 – March 16, 2022

FSL continued inspecting the ledge outcrop, which continued along the 95 Sutherland Road property boundary along Sutherland Road. Again, FSL identified several sections of deeply cracked ledge from various heights above the municipal sidewalk, with certain areas that could be removed by basic hand pressure. FSL also identified both trees and small brush on top of the ledge outcrop (see Photo #5).

Trees and other vegetation can cause fractures in ledge through growth while seeking water sources, and through decay with creation of void spaces for freeze/thaw seasonal activities. As previously seen at 85 Sutherland, fractures have been shown to suddenly collapse to the ground, with the potential to cause damage to property, and even possible bodily harm.

Based on the current conditions at the Site, FSL believes that continuing to allow trees and other vegetation to grow within and on-top of the fractured ledge outcrop, including areas along the Sutherland Road sidewalk that is owned by the City of Boston, could cause ledge outcrops to collapse into the sidewalk and Sutherland Road, causing physical damage, and could possibly cause bodily harm should pedestrians be in the areas during the collapse.

Trees that must be removed to prevent collapse into sidewalk and Sutherland Road. Evidence of previous sealing of past ledge void areas.
