Proposal for 1 Taylor Street Apt A

Description of work:

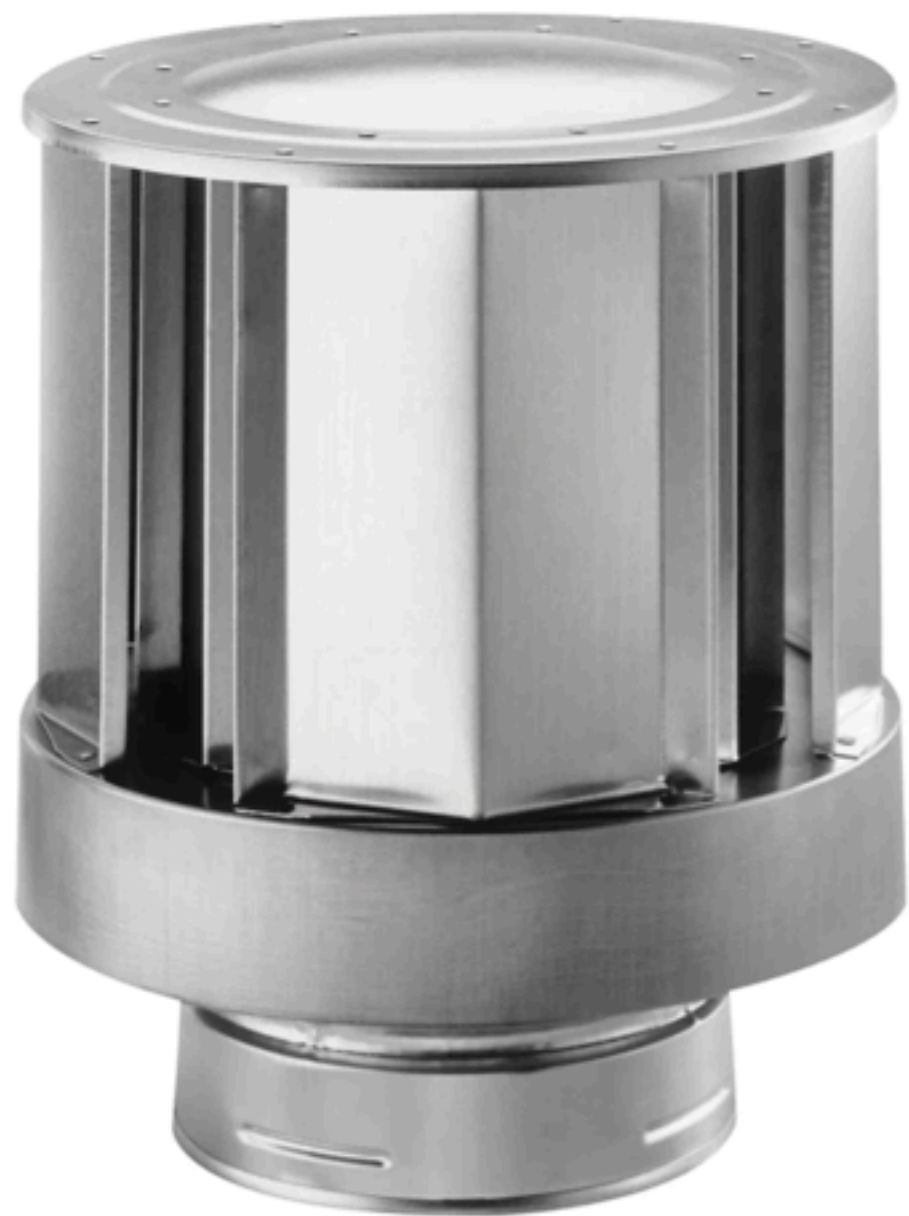
Copper (painted) Cap

***Actual cap will be copper in color**

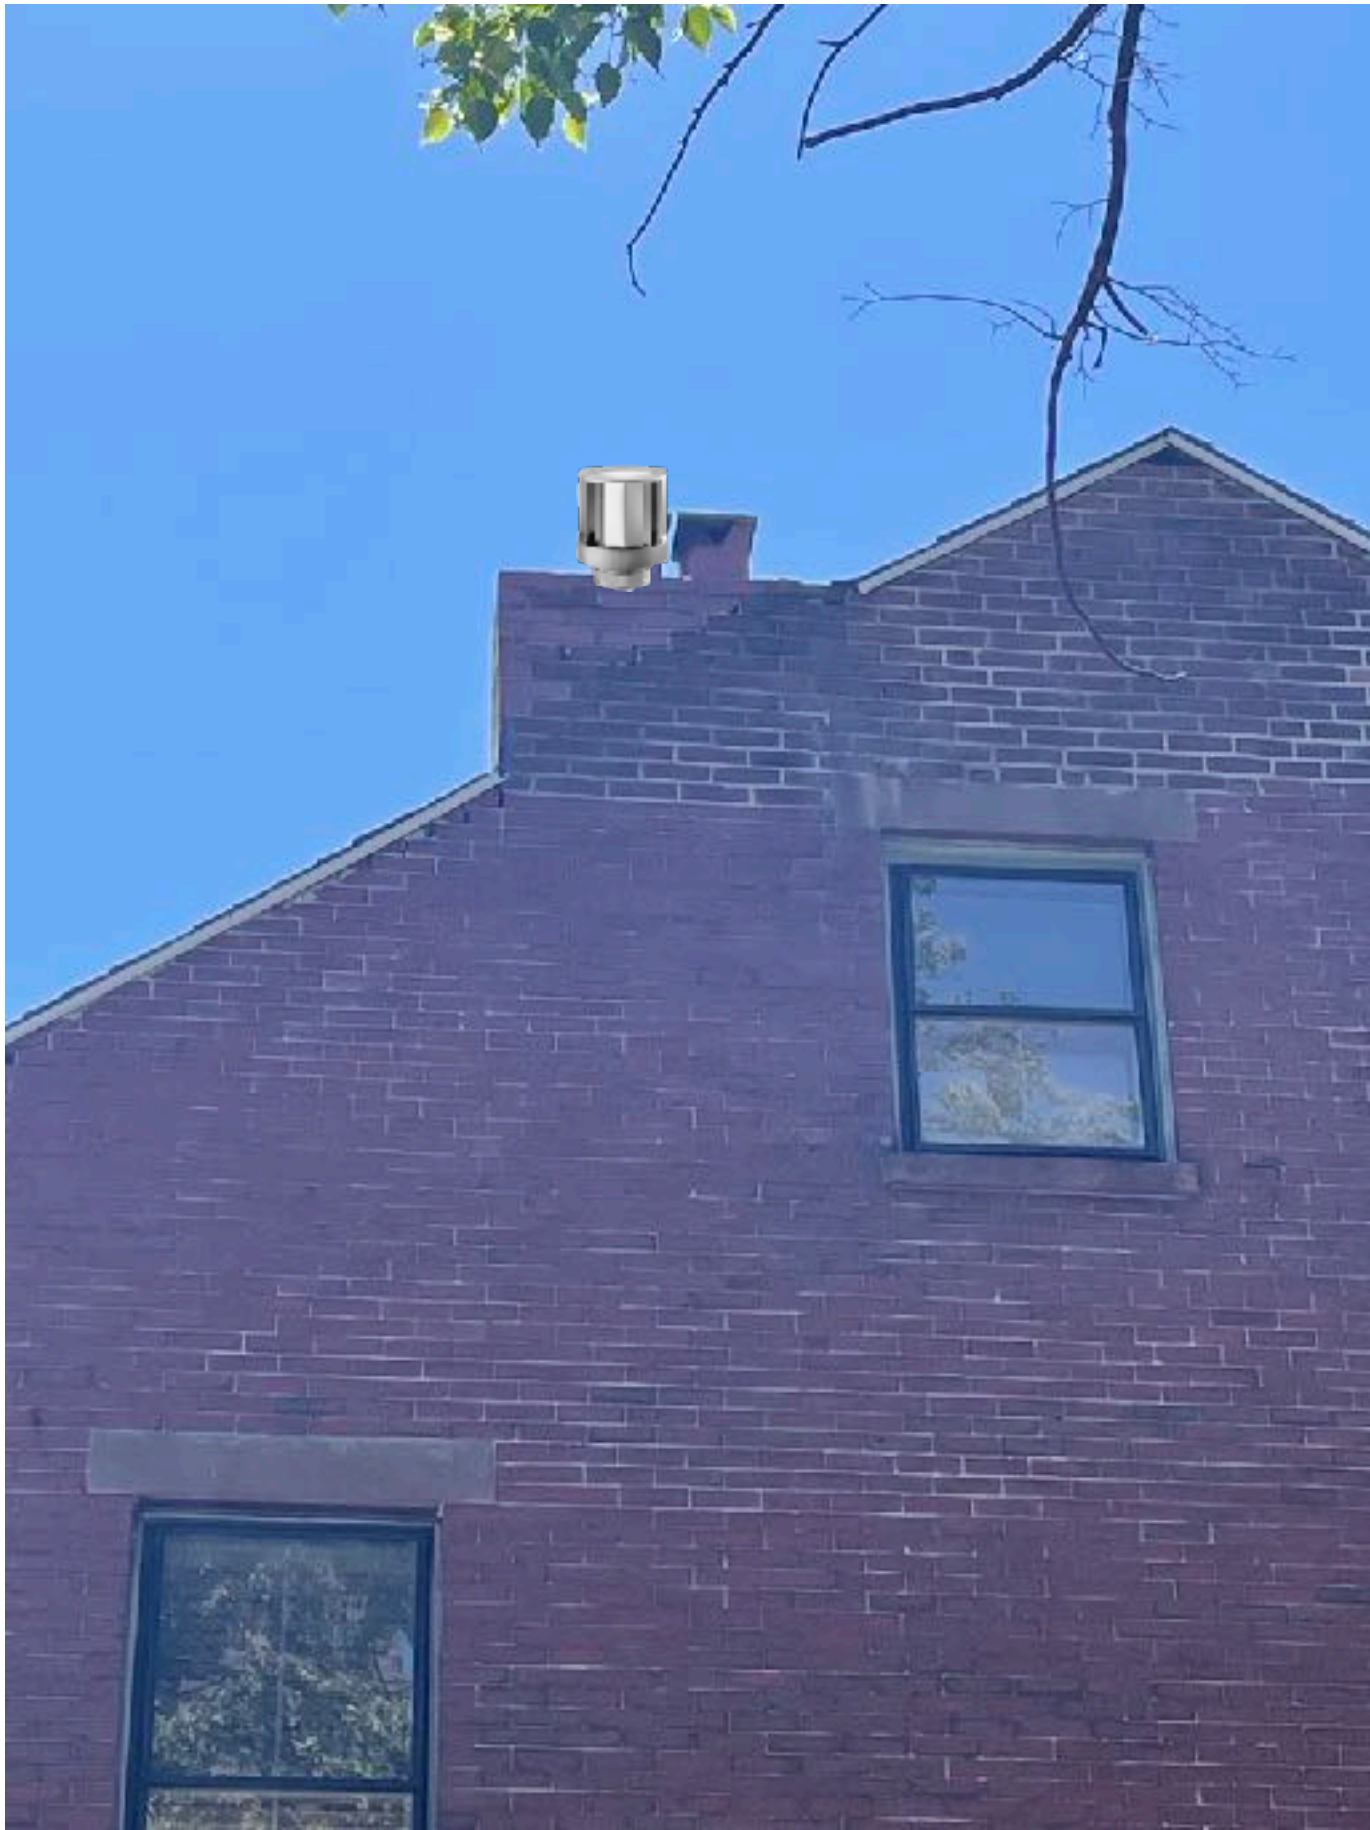
No additional holes will be made in the unit, original chimney hole will be used

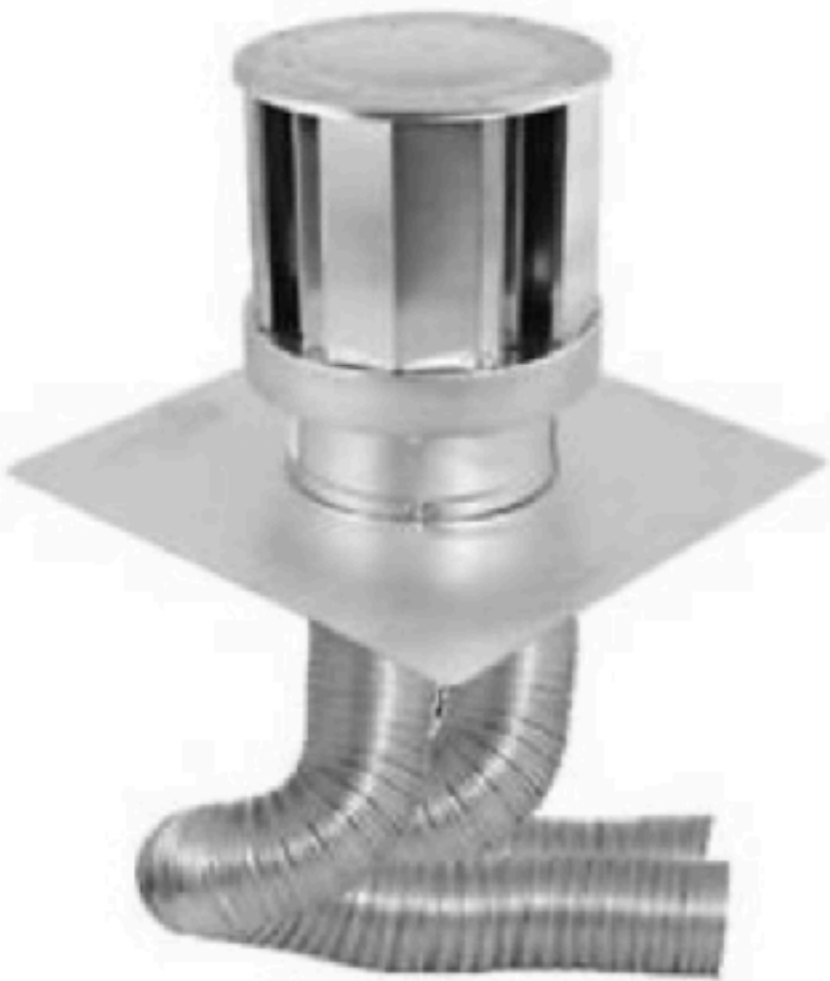
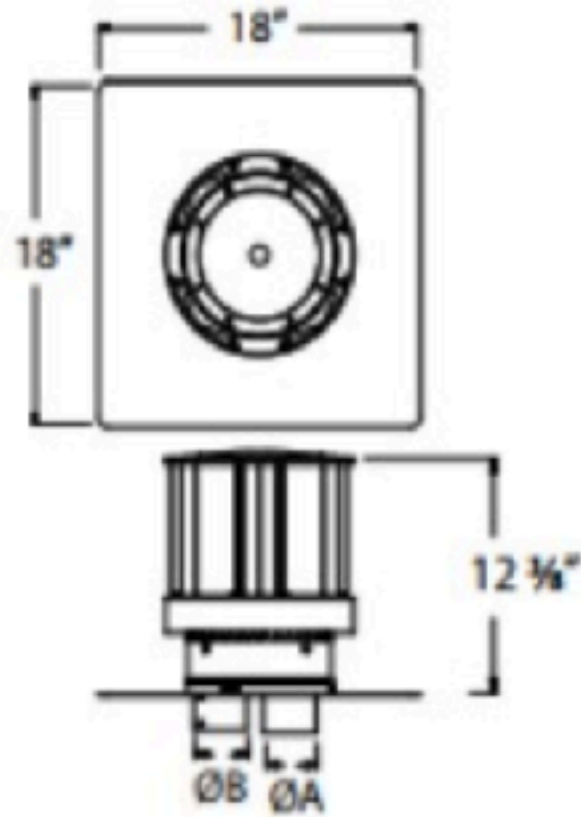
In depth view of vent, piping will be inserted into existing chimney opening

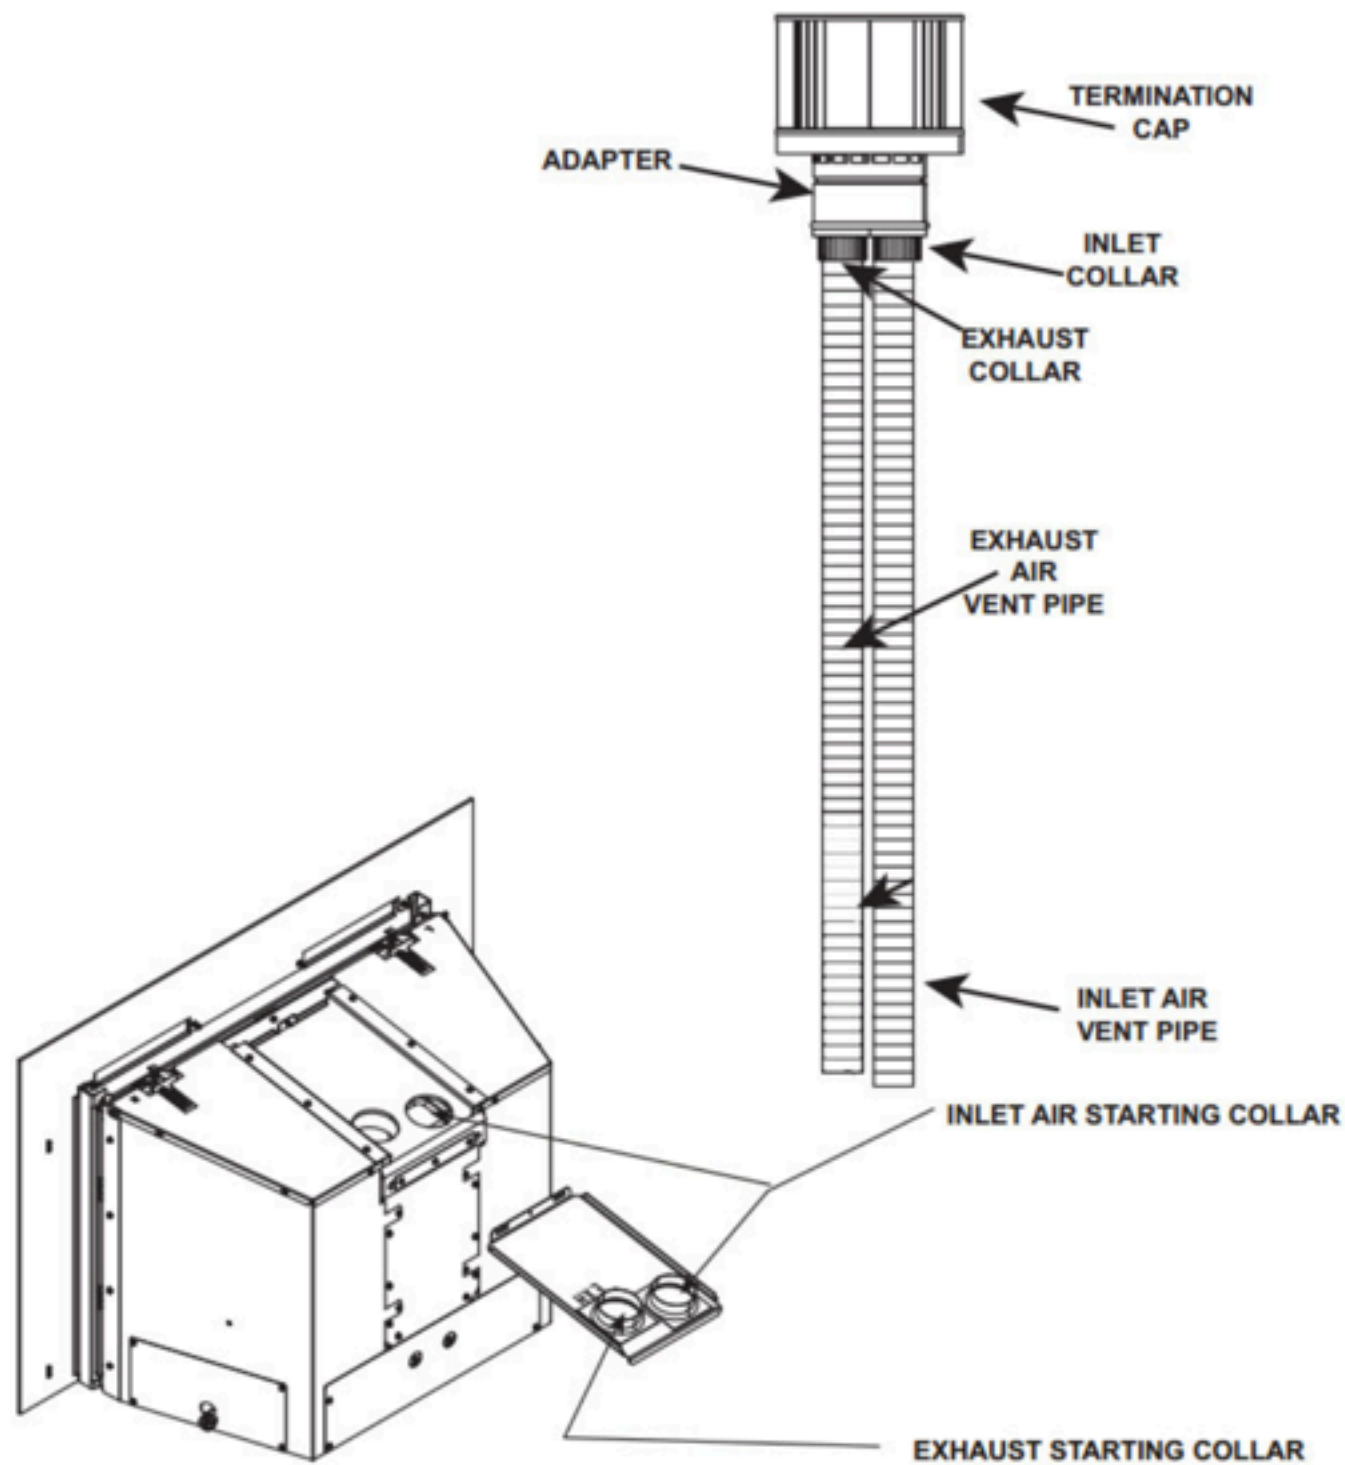
Diagram of interior pipe and connection to stove

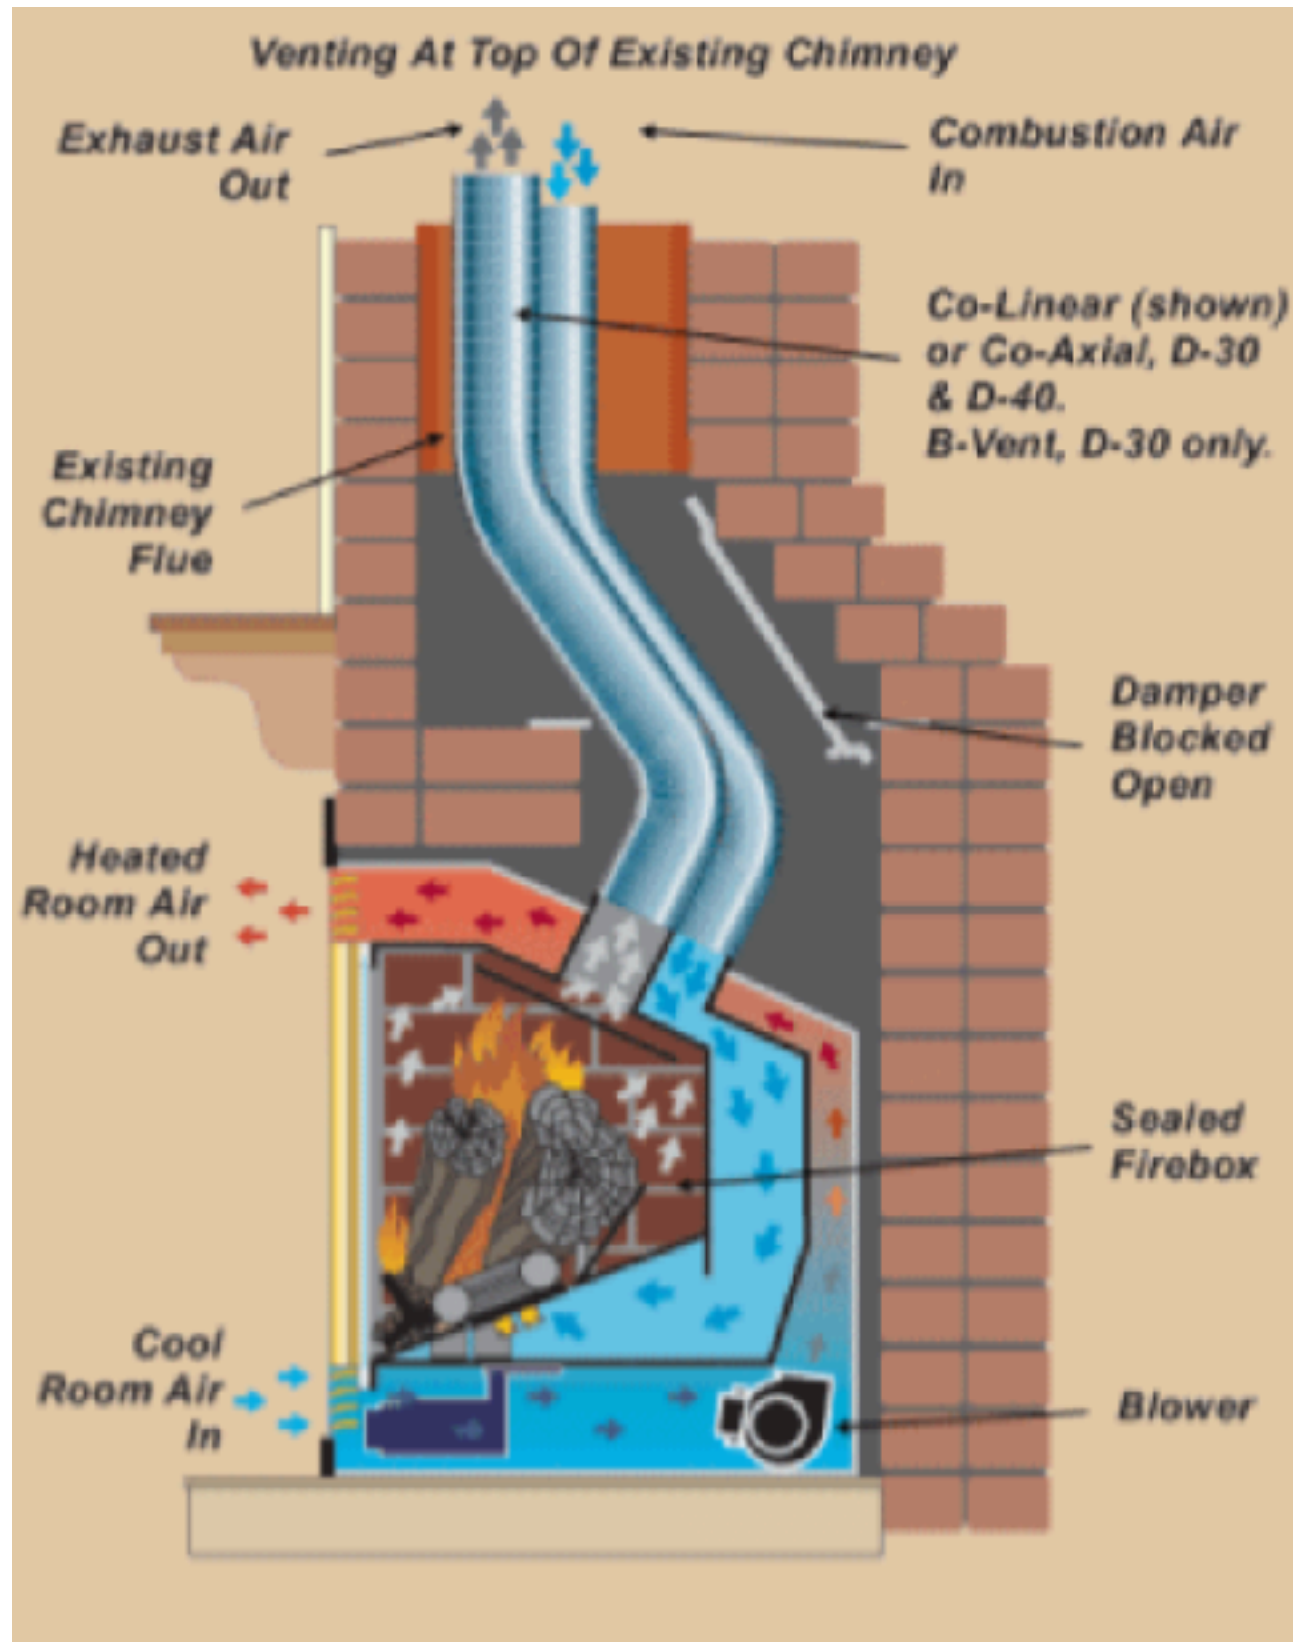
Side view of chimney and highly efficient working stove
