City of Boston Public Works Department
Long Island Bridge over Boston Harbor Bridge Superstructure Replacement

Navigation Impact Study Supplement

Revised May 2022

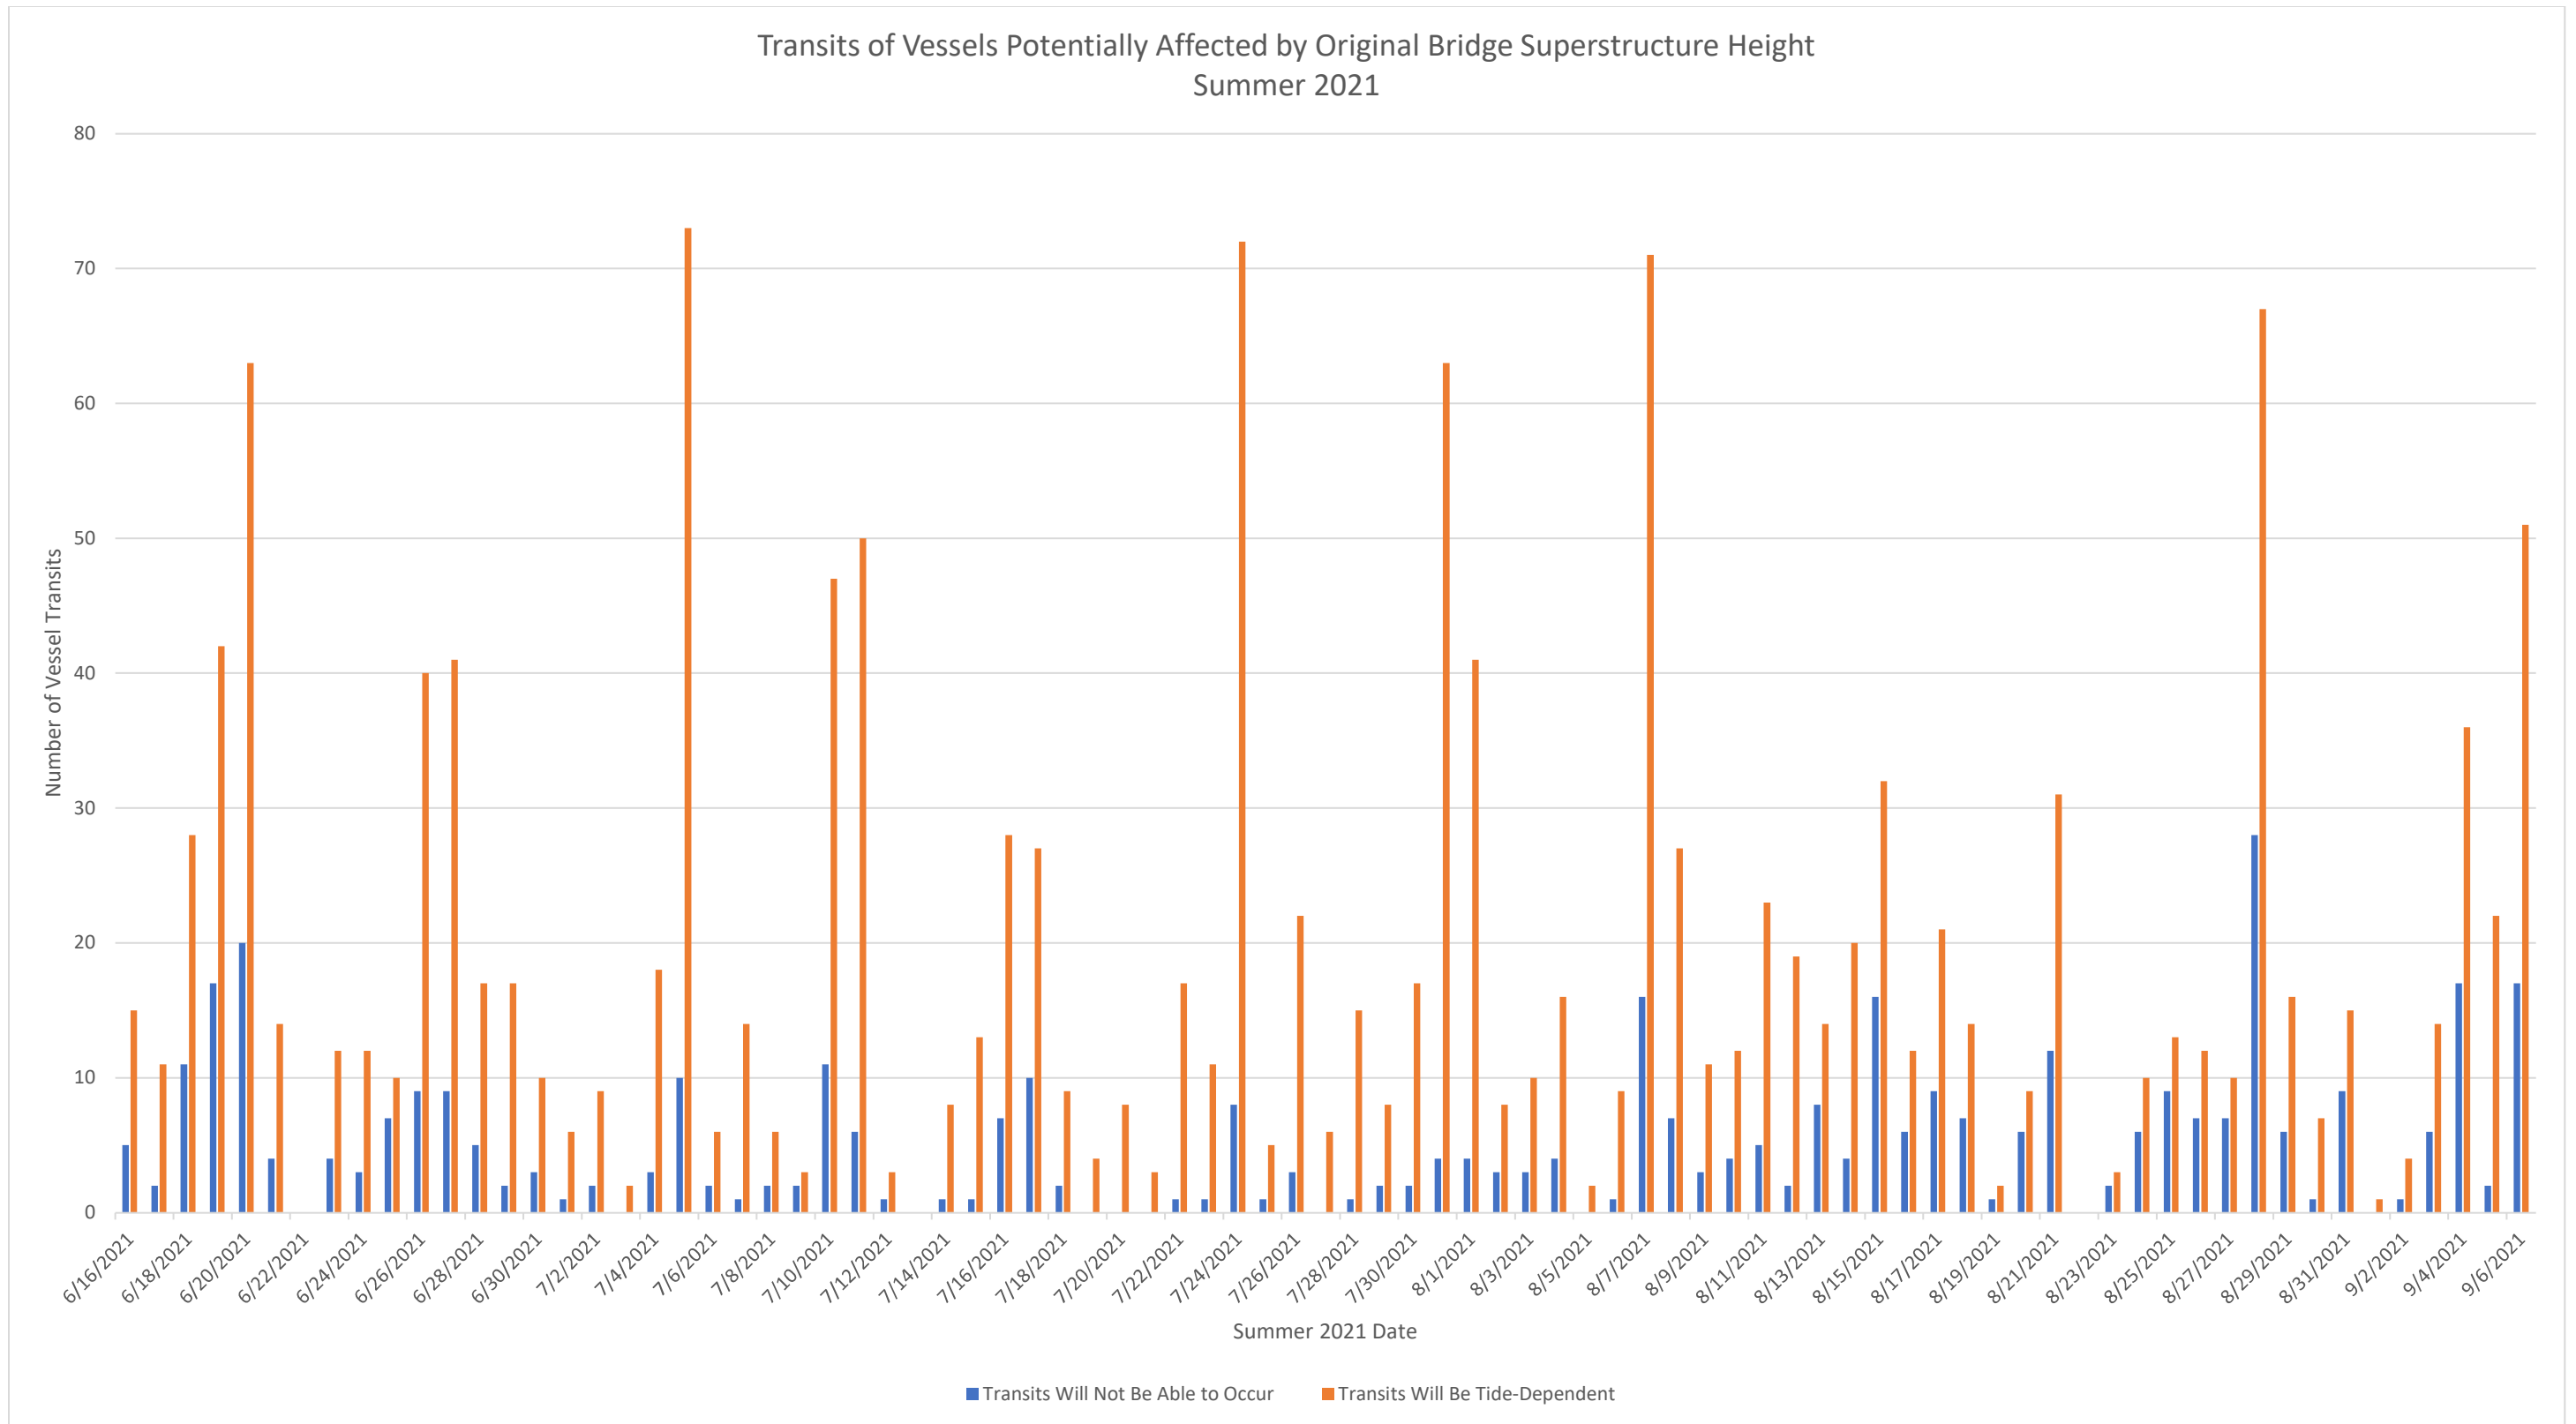
Chart 1: Summer 2021 Recorded Vessel Transits by Date

The chart on the following page shows the number of transits per day in the two categories that were logged.

The following tables summarize the number of transits between June 16th and September 6th, 2021 by vessels that would potentially have been affected by the height of the original Long Island Bridge superstructure.
