Boston Landmarks Commission

280 Summer Street // Façade Restoration

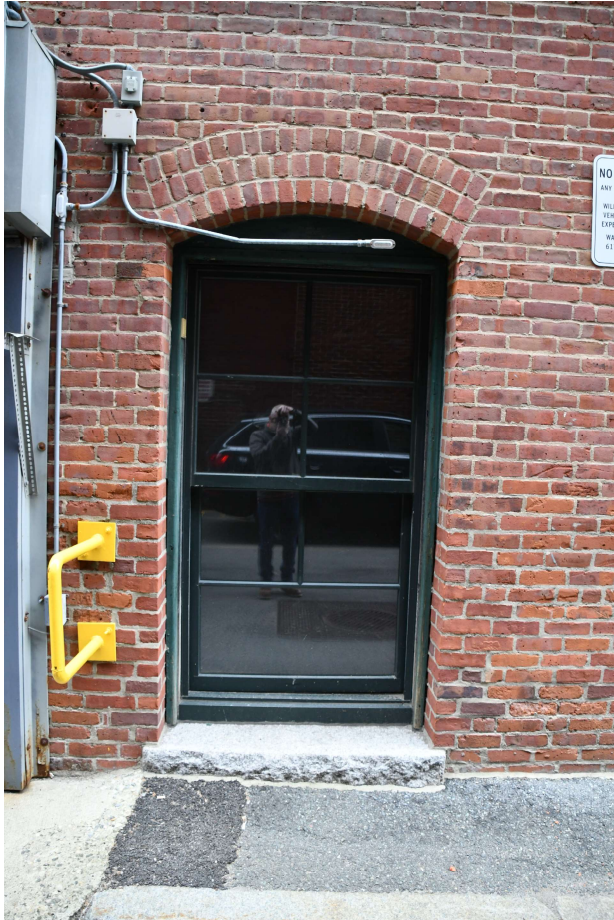
Existing wood trim surrounding the aluminum window systems.

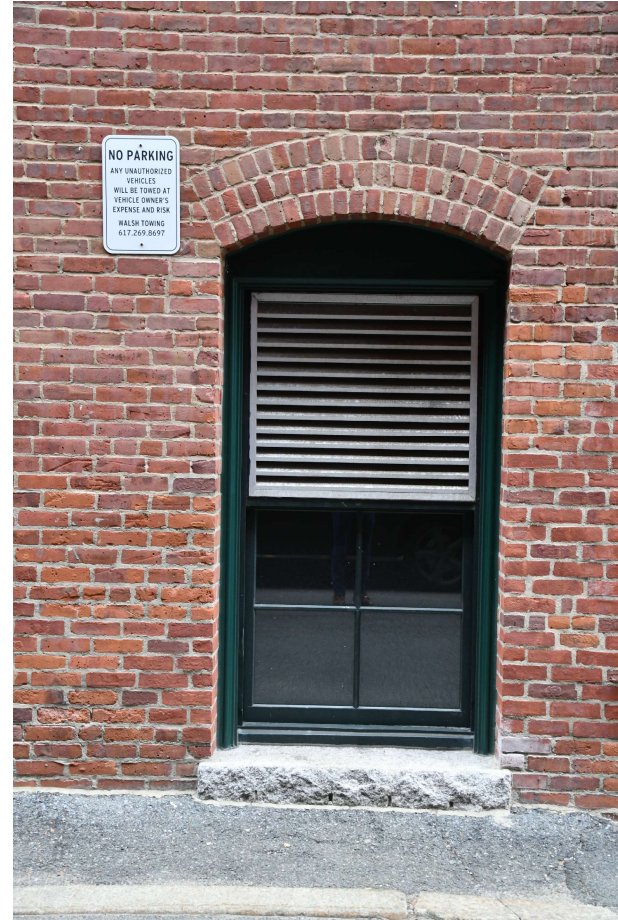
Aluminum window panning trim installed over original wood trim;
Window Mockup

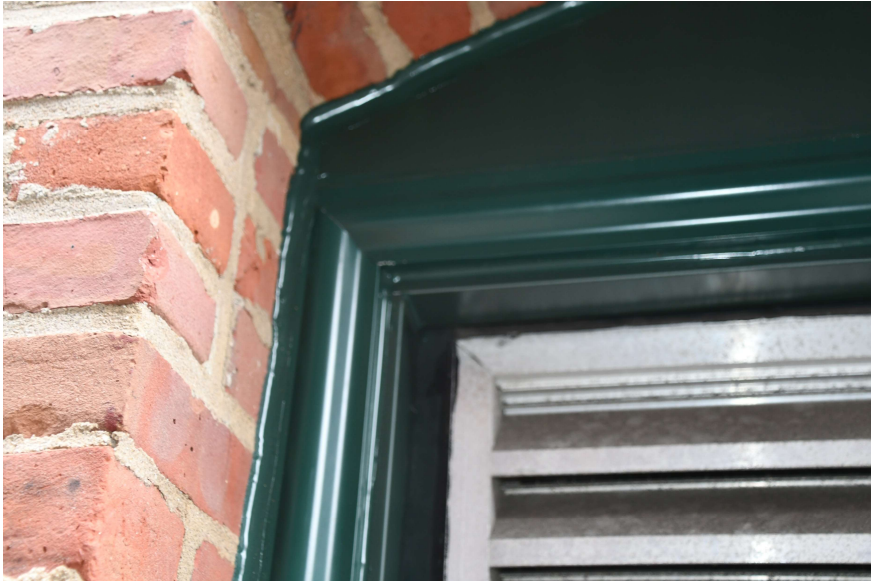
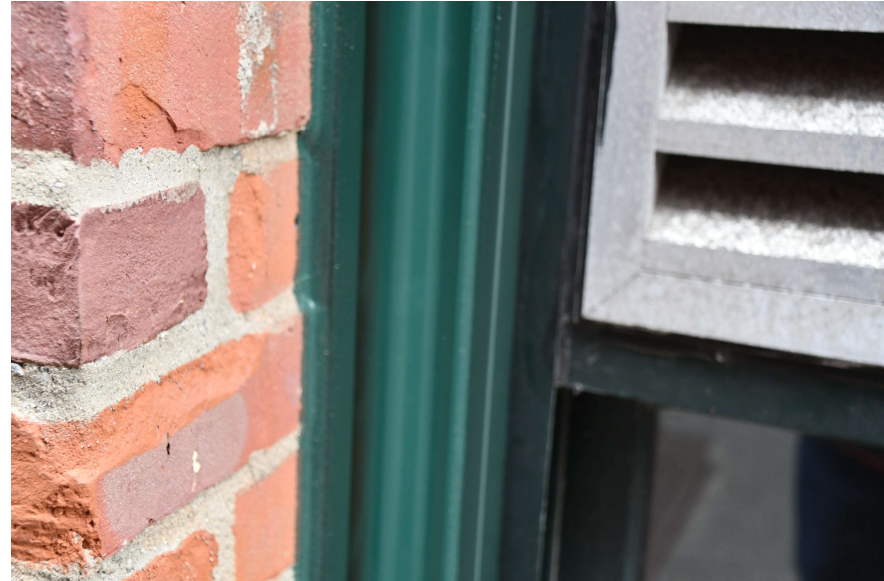
Close-ups Metal Mockup; Note the sealant joint between the masonry and aluminum will lose its shine as time passes.

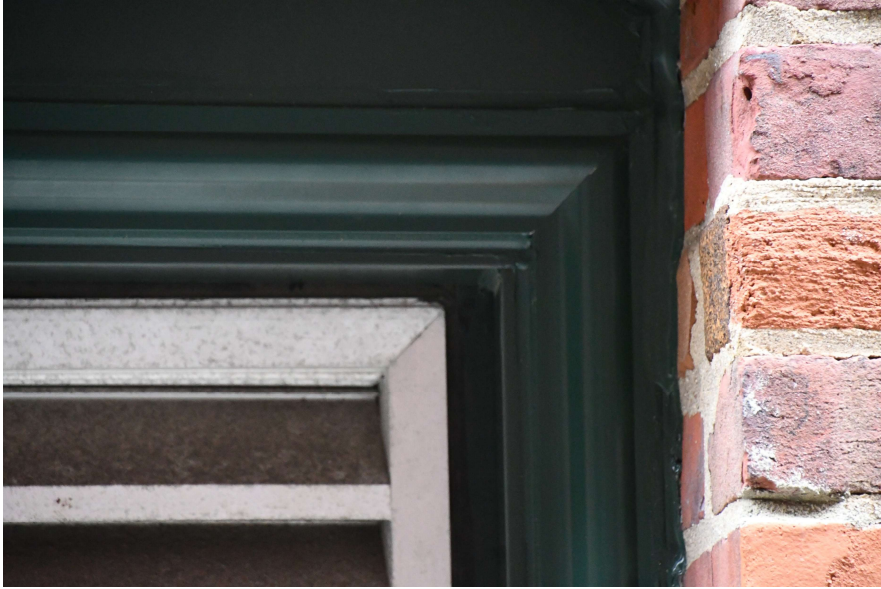
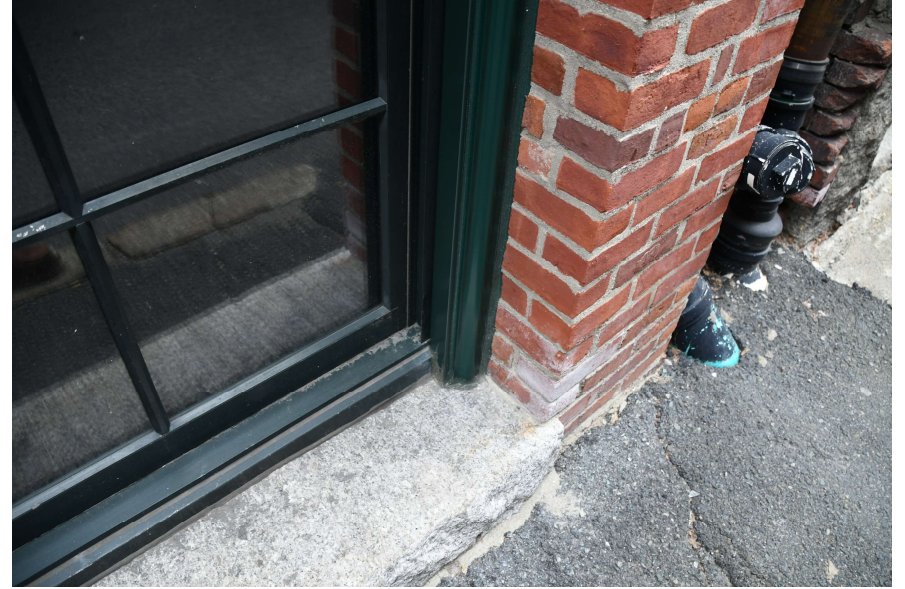
Close-up photograph of aluminum
trim mockup

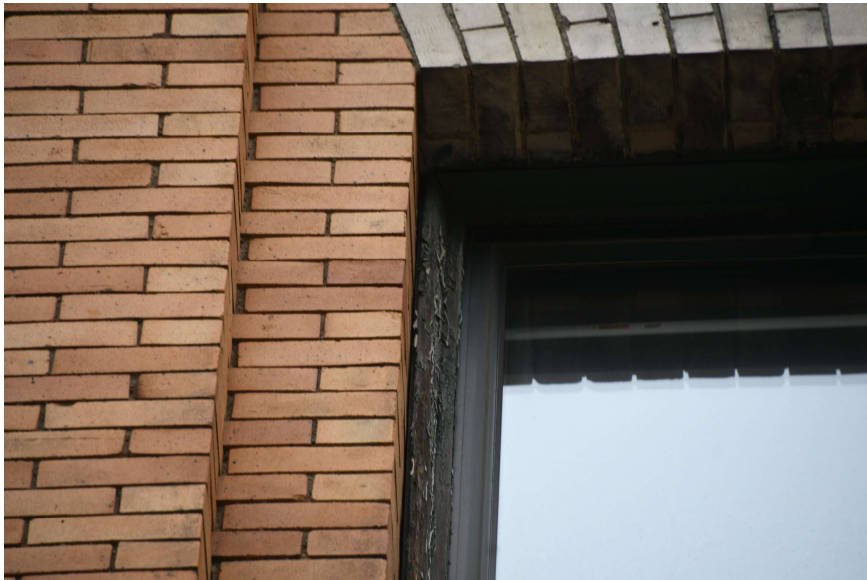
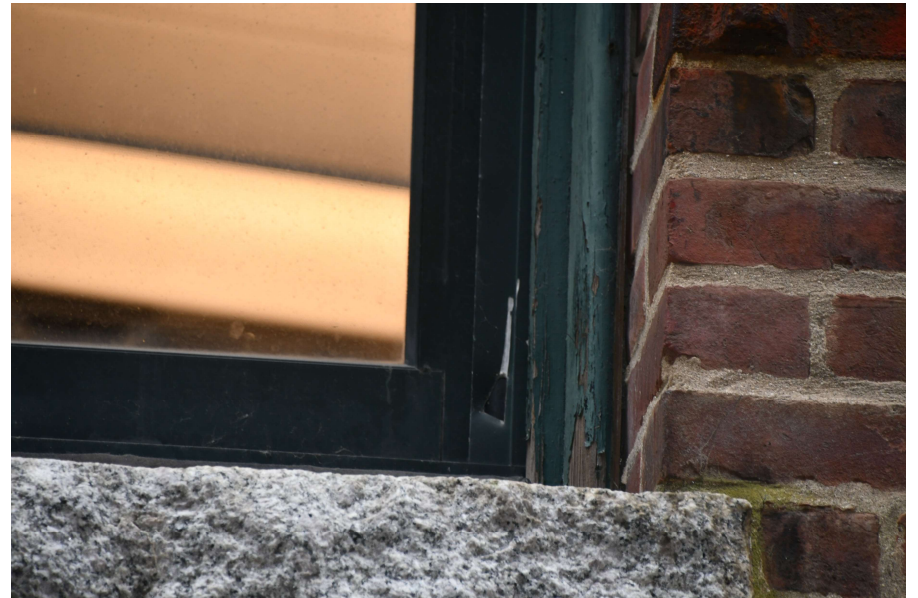
Close-up of existing wood molding.
Front Elevation left and Rear
Elevation right.
