13 Wigglesworth St.

Proposed Project: Dig Window Well & Replace 3 Basement Windows

1. Dig window well (24" depth, 36" projection)
2. Enlarge rough opening vertically for 3 existing basement windows
3. Replace windows with new, energy efficient model
4. Repair/replace wood framing and paint black
5. No structural work

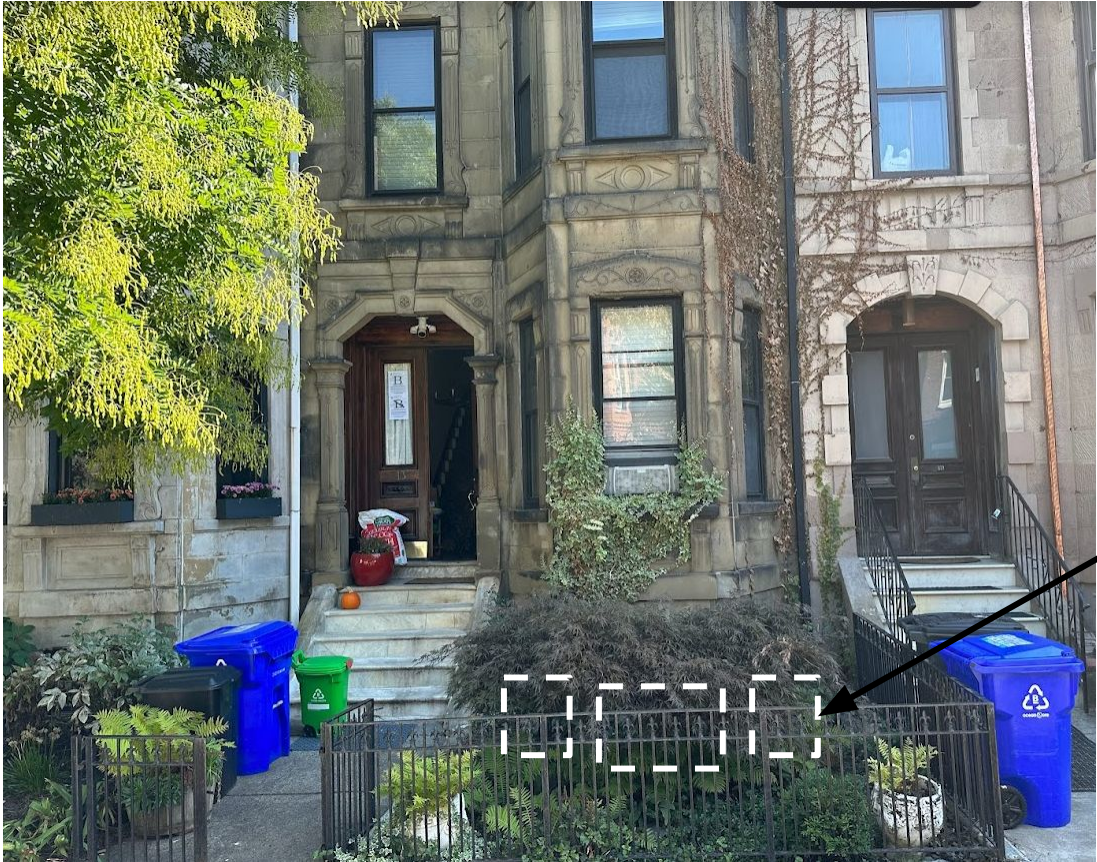
Current Conditions of 13 Wigglesworth (1/3)

Three existing basement windows hidden behind Japanese maple tree (bush)

Note 1: There are currently three existing windows. These will be replaced by new windows.

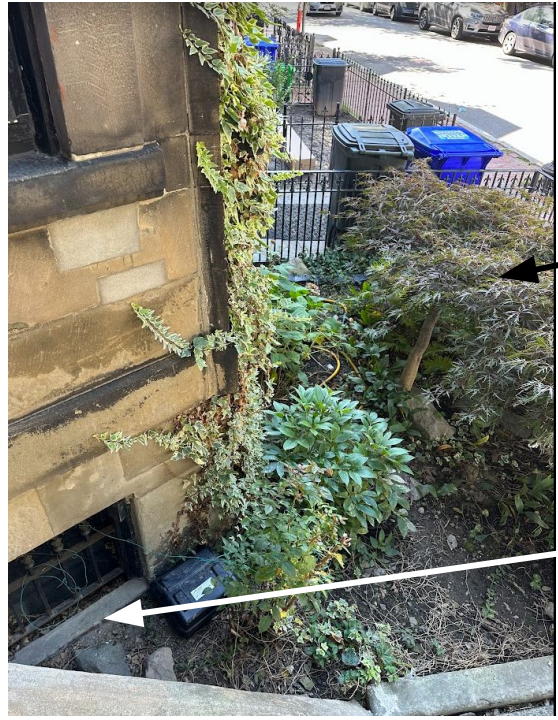
Current Conditions of 13 Wigglesworth (2/3)

Brownstone molding

Stairs

Bush in front yard

Left window

View from Stairs

Three existing windows hidden by bush

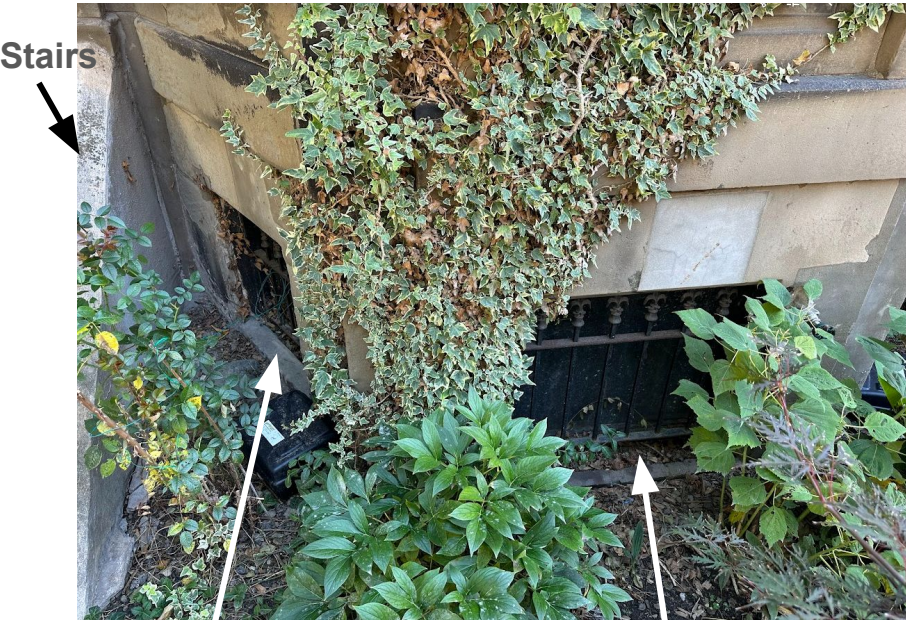
Current Conditions of 13 Wigglesworth (3/3)

Left Side

Center Window

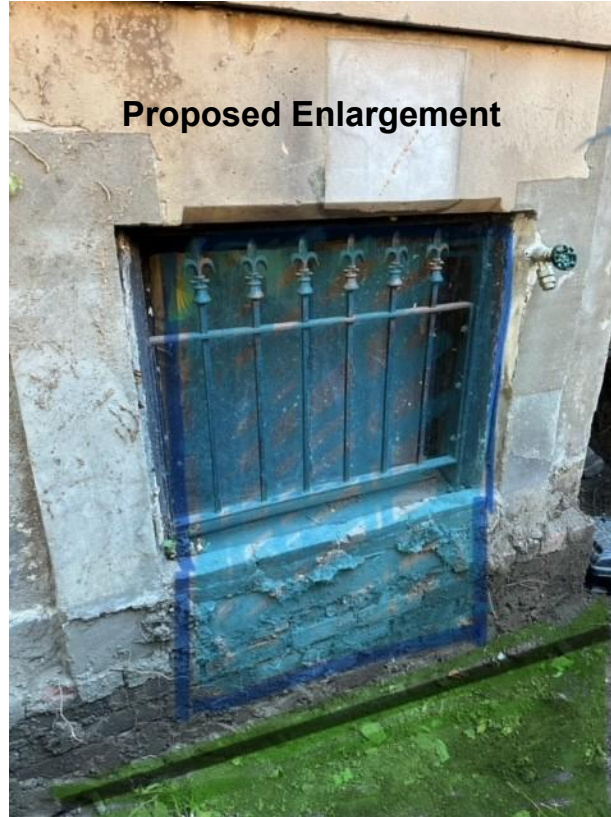
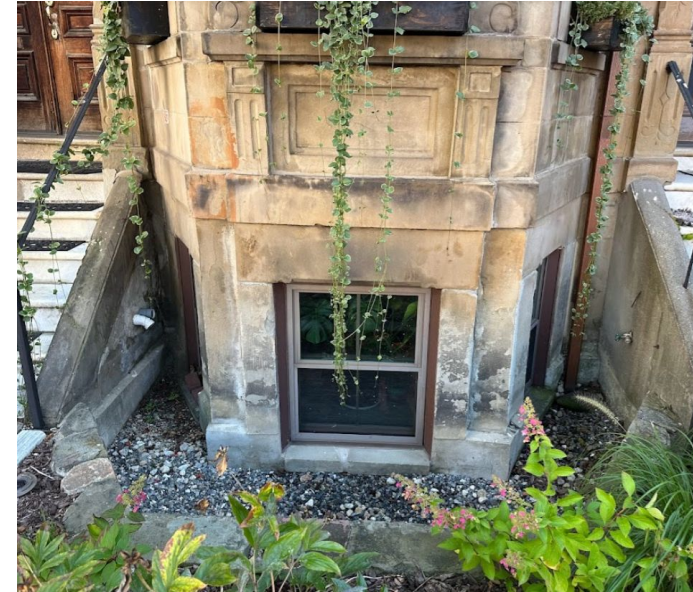
Example: 21 Wigglesworth Street

Proposed Vertical Enlargement

The window will be enlarged vertically by removing rows of brick

The horizontal opening will not be enlarged

Note 3: Applicant property is brown stone. Proposed window & well to resemble 21 Wigglesworth

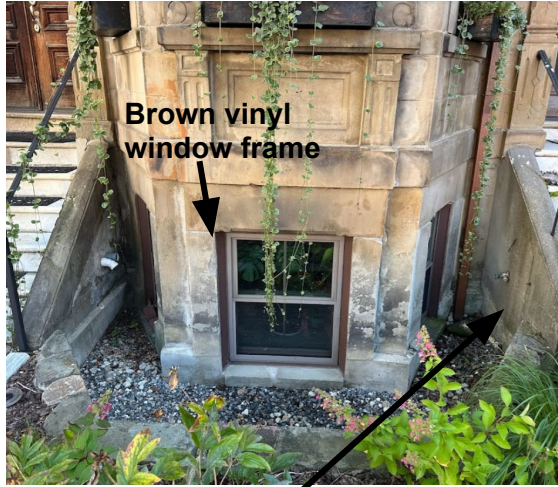
21 Wigglesworth Street

Rock and poured cement wall

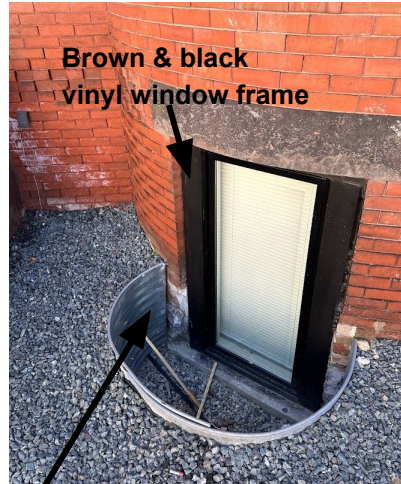
35 Wigglesworth Street

Metal sheet retainer in gravel

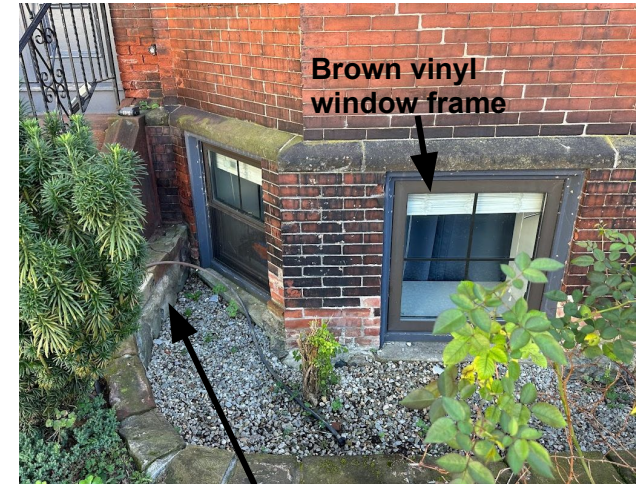
27 Wigglesworth Street

Rock retainer wall

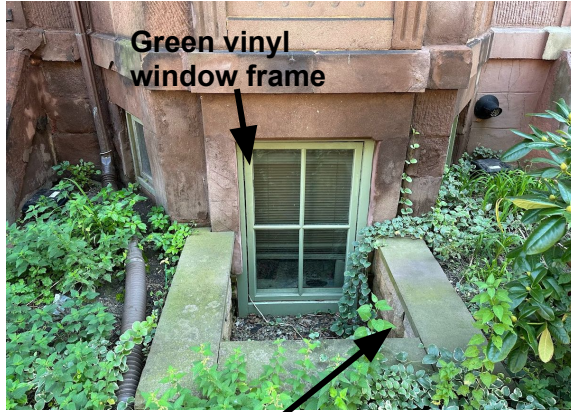
5 Wigglesworth Street

Center block retaining wall

Note 2: Photos of these wells show that the pre-existing house walls extend at least 2 feet below ground level

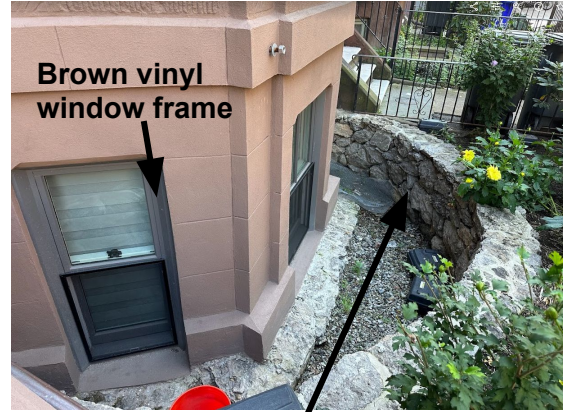
7 Wigglesworth Street

Natural stone wall

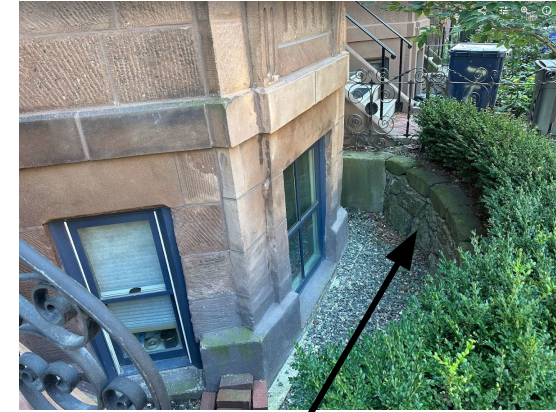
9 Wigglesworth Street

Brick and rocks wall
