THE NAZZARO COMMUNITY CENTER

BOSTON LANDMARKS COMMISSION

STUDY REPORT

The Nazzaro Community Center

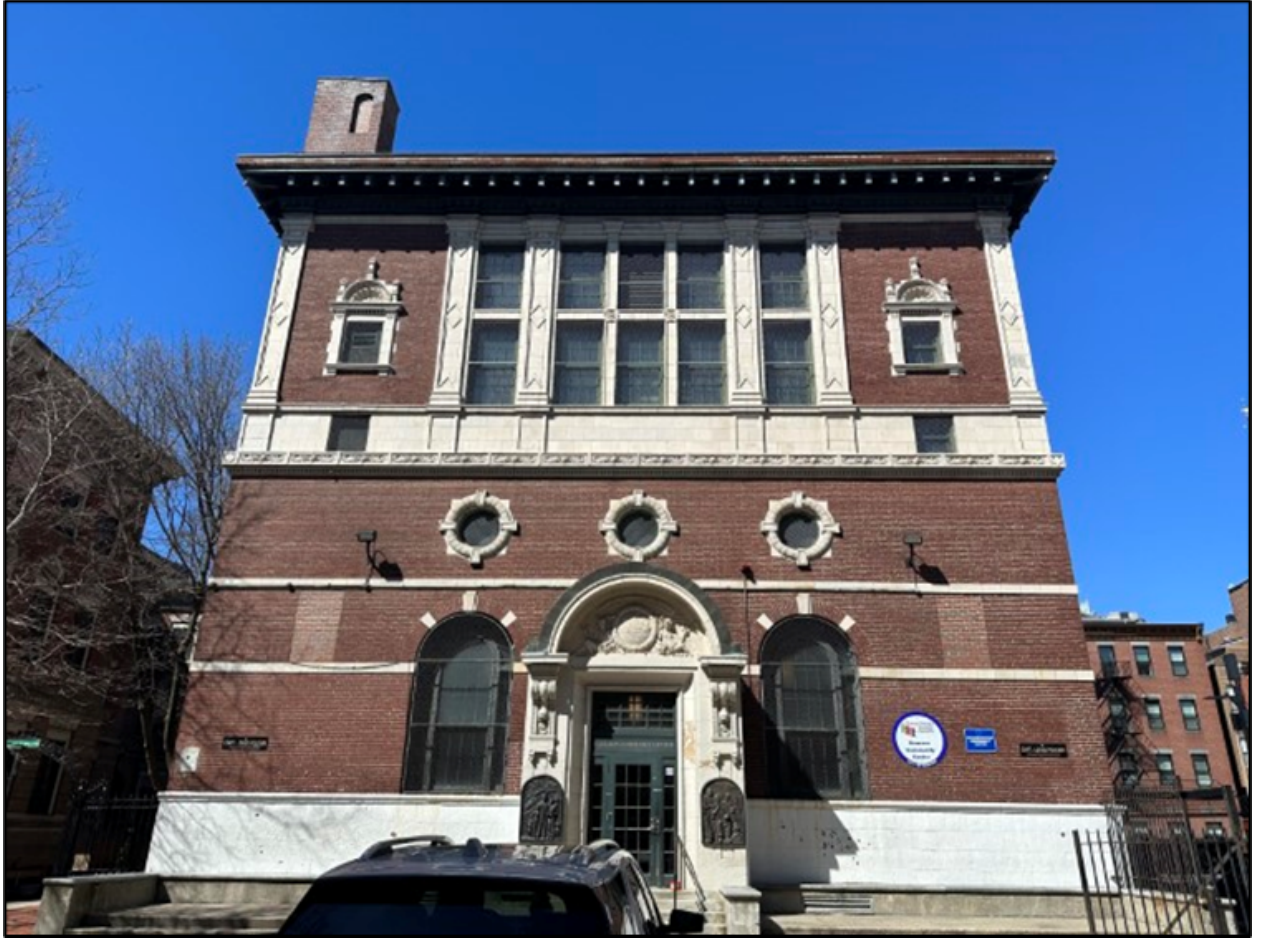
Figure 2. Façade of the Nazzaro Community Center.

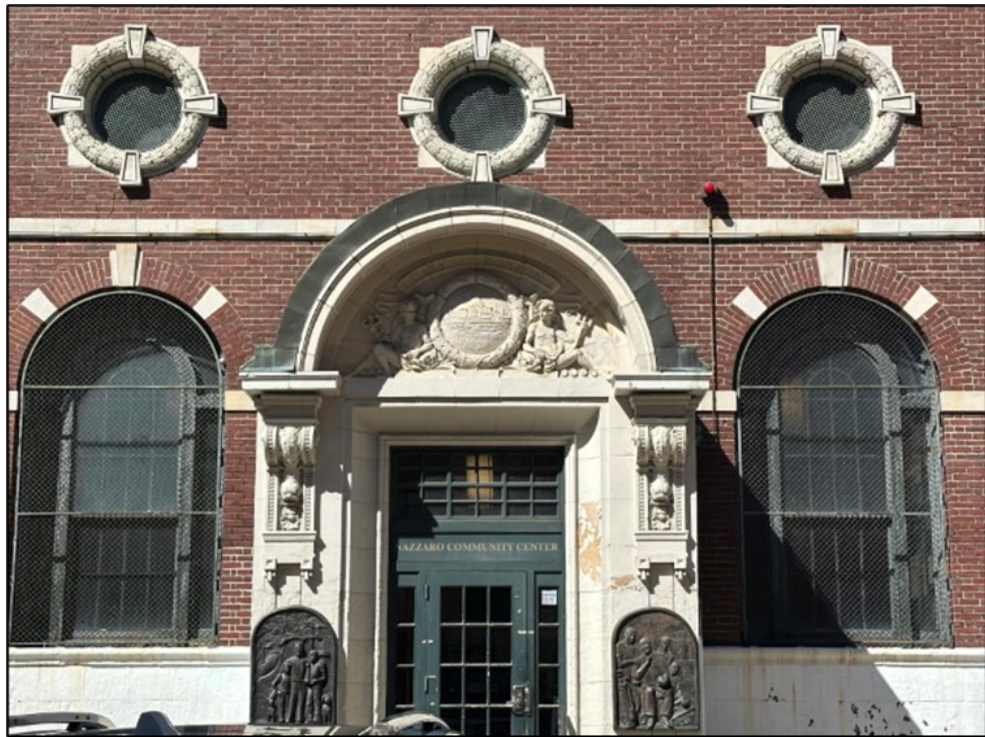
Figure 3. Detail of the Nazario Community Center façade.

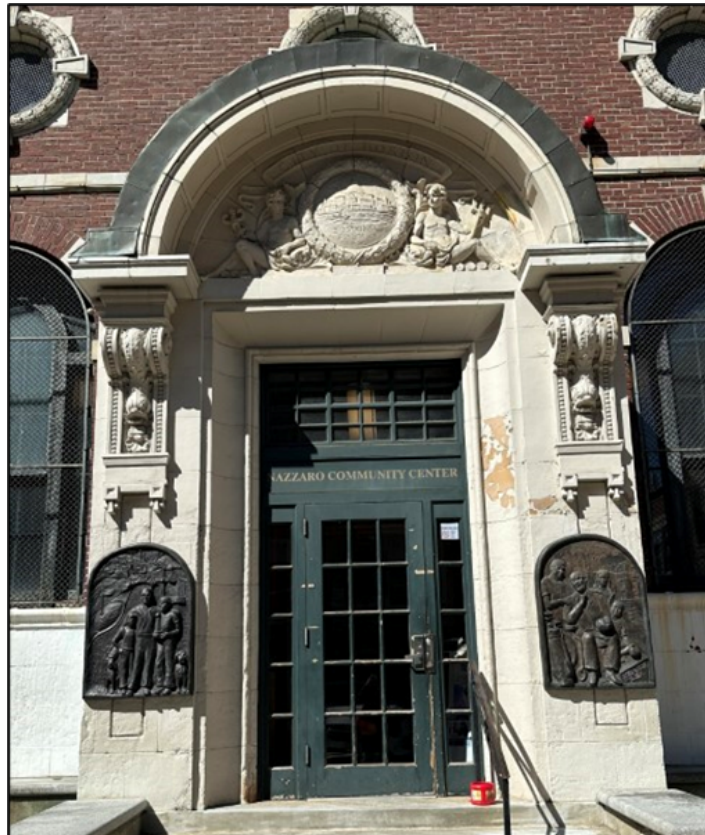
Figure 4. Closeup of front entrance.

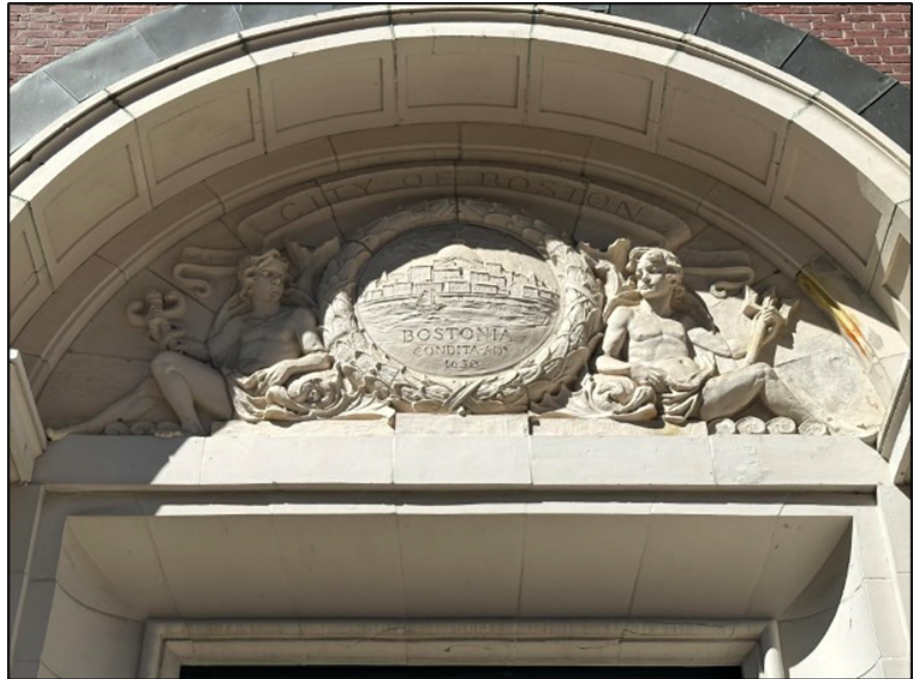
Figure 5. Lunette over the front entrance.

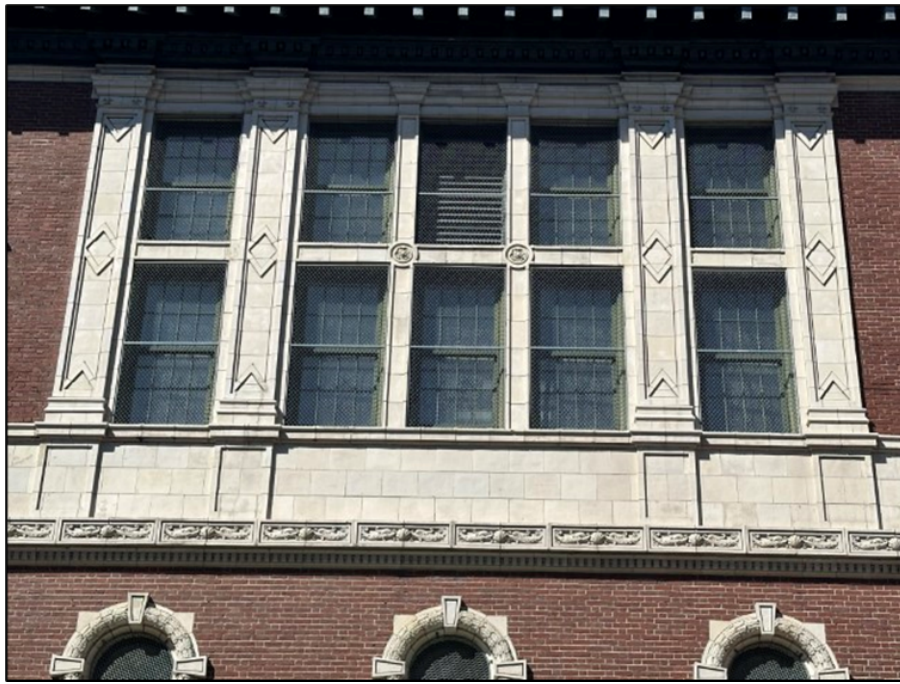
Figure 7. Detail of double rectangular windows on the façade.

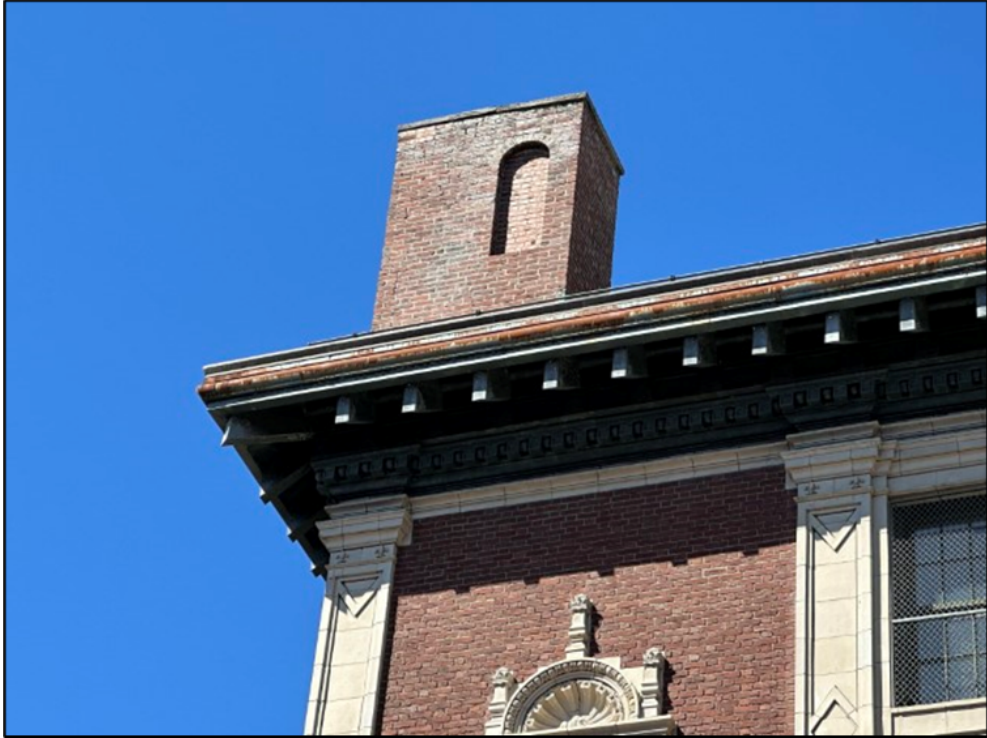
Figure 9. Façade view of cornice and chimney.

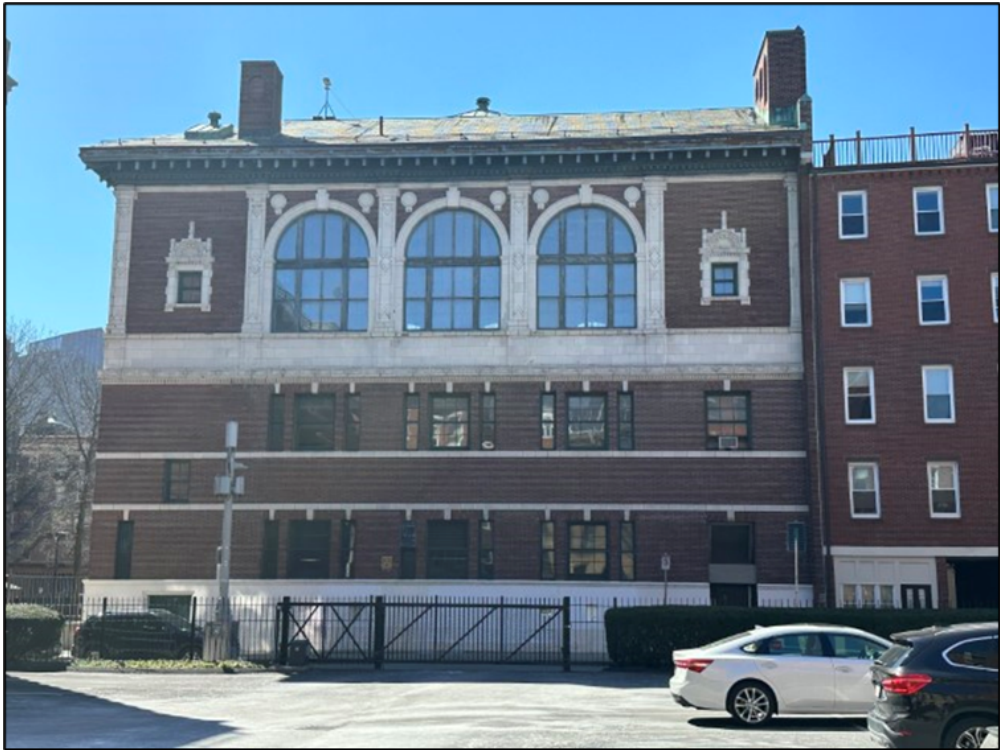
Figure 10. View of northeast elevation at North Bennet Street.

The first floor of the northeast elevation is defined by three sets of identical, coupled-style windows consisting of two vertical two-over-two fixed windows with a flat arch and terra-cotta keystone on either side of a six-over-six sash window with a flat arch and terra-cotta keystone. The original casement windows were replaced with sash windows, most likely during the 1947 update. A single, vertical two-over-two window is located on the left side of the façade. A terra-cotta belt extends across the building above the windows, creating a visual distinction between the first and second floor. Above this a single two-over-two sash window exists on the left side of the building and is bordered above by an additional terra-cotta belt course. This window pattern is repeated on the upper level of the second floor with an additional six-over-six sash window on the right side of the building.

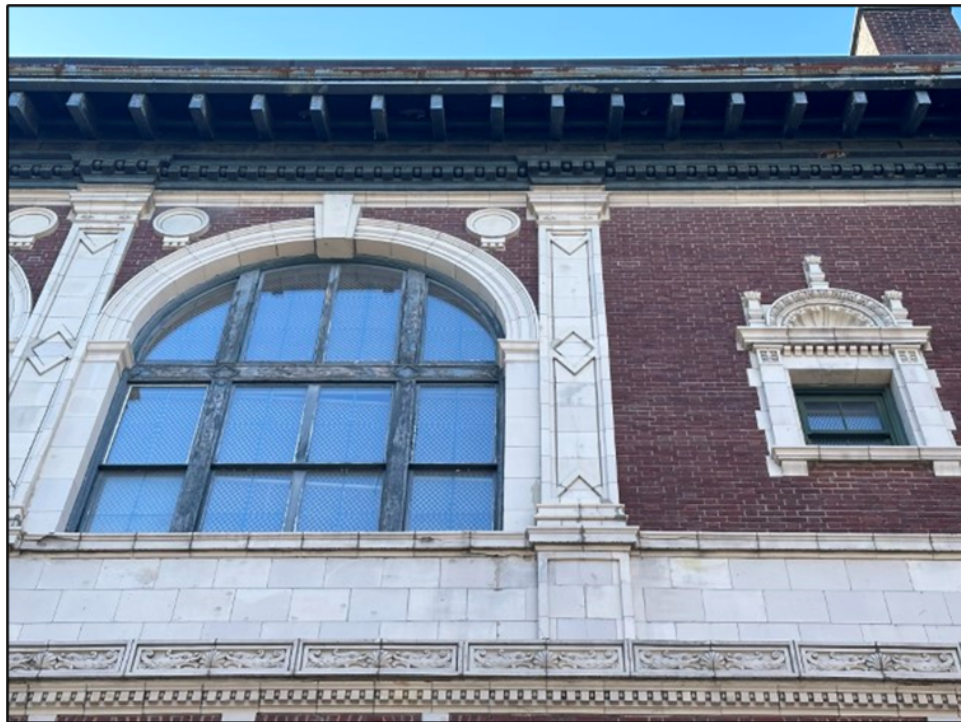
Figure 11. Rounded arched window at the North Bennet elevation.

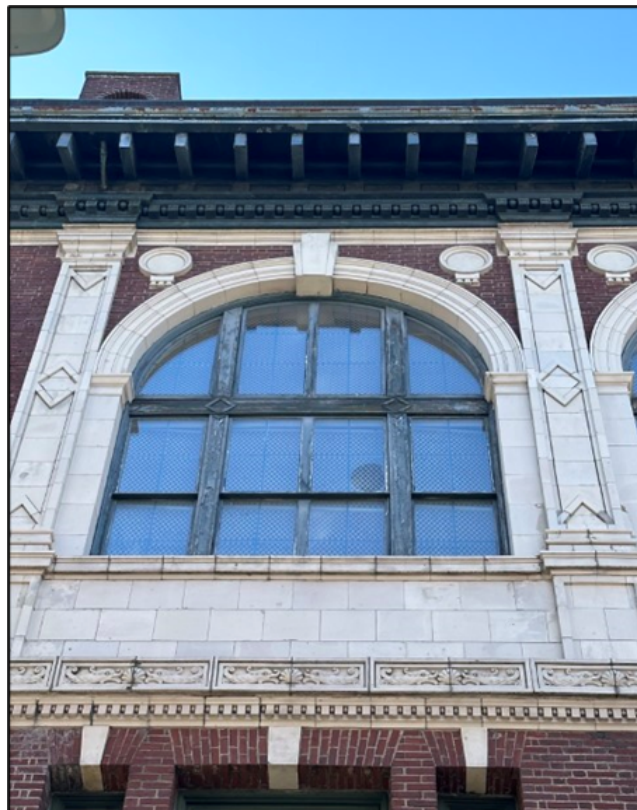
Figure 12. Detail of North Bennet Street elevation rounded arch.

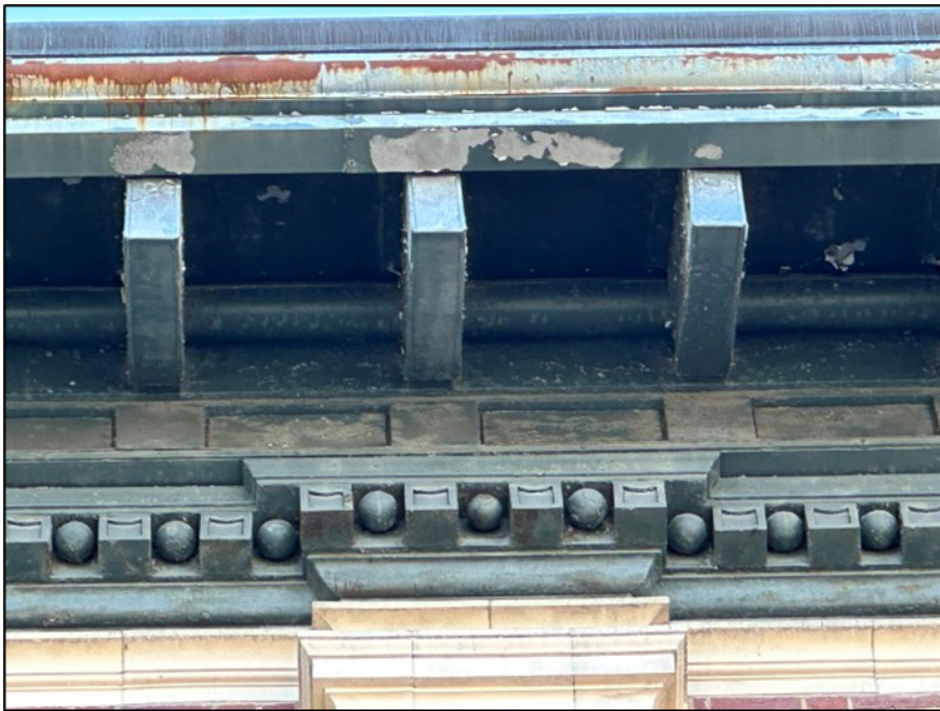
Figure 13. Detail of cornice, North Bennet Street elevation.

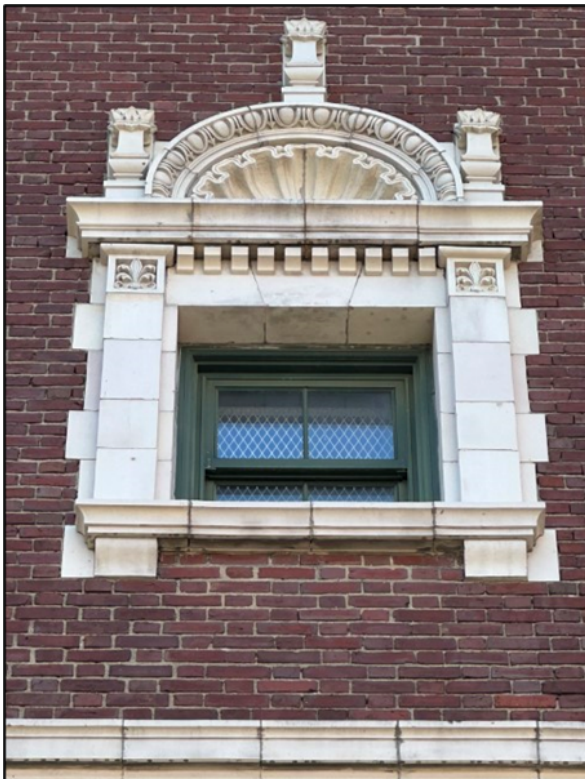
Figure 14. Third-story window on North Bennet Street elevation.

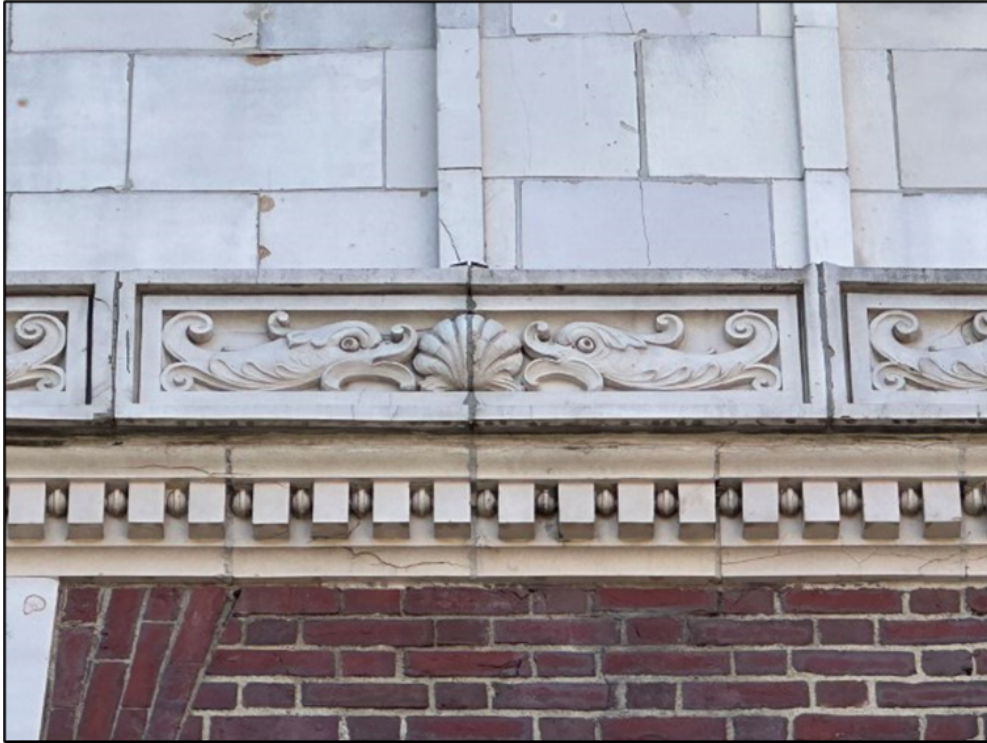
Figure 15. Detail of frieze, North Bennet Street elevation.

This concept is further solidified in the terra-cotta ornamentation of the building. A general sea/sea-creature motif is carried across three façades of the building in the belt courses and window surrounds. The notable sculptor, Hugh Cairns, was commissioned in 1907 to sculpt the lunette located above the entrance of the vestibule; this element continues this motif. The 9 x 5-foot bas-relief sculpture represents Boston’s connection with land and sea by situating the God Neptune and Mercury on either side of the City insignia, encased in a wreath. It should be noted that the artist chose to depict a more youthful Neptune rather than the traditional bearded God with a trident. This level of artistic style and detail is indicative of the Arts and Craft movement that was ongoing across the country at that time.

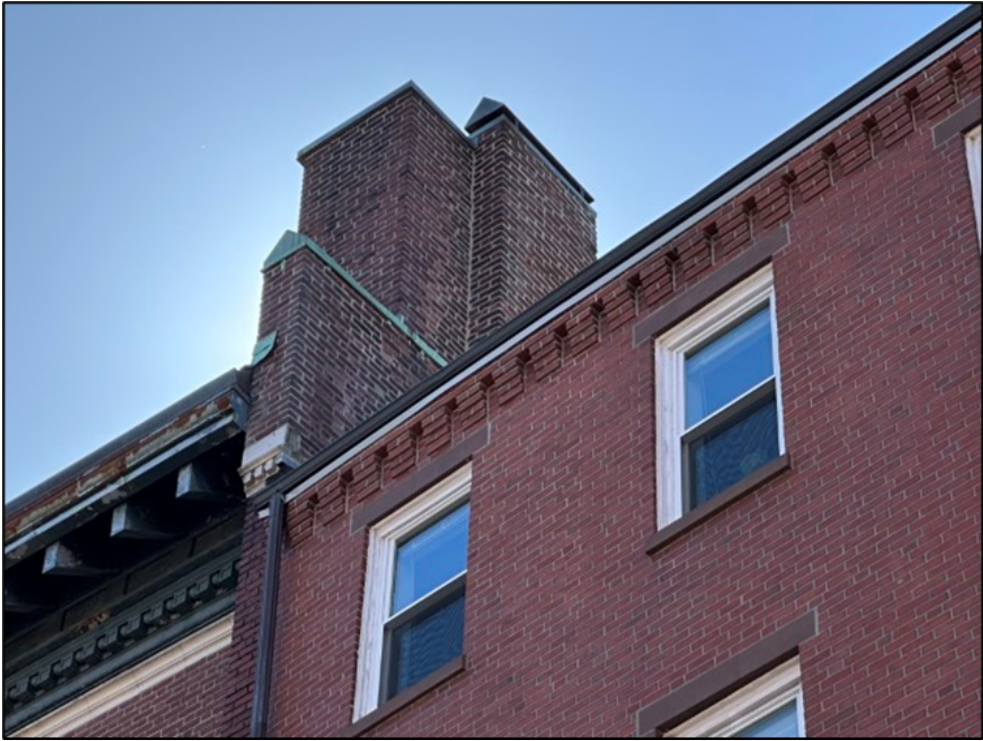
Figure 16. Chimney, cornice, and brick dentil elements.

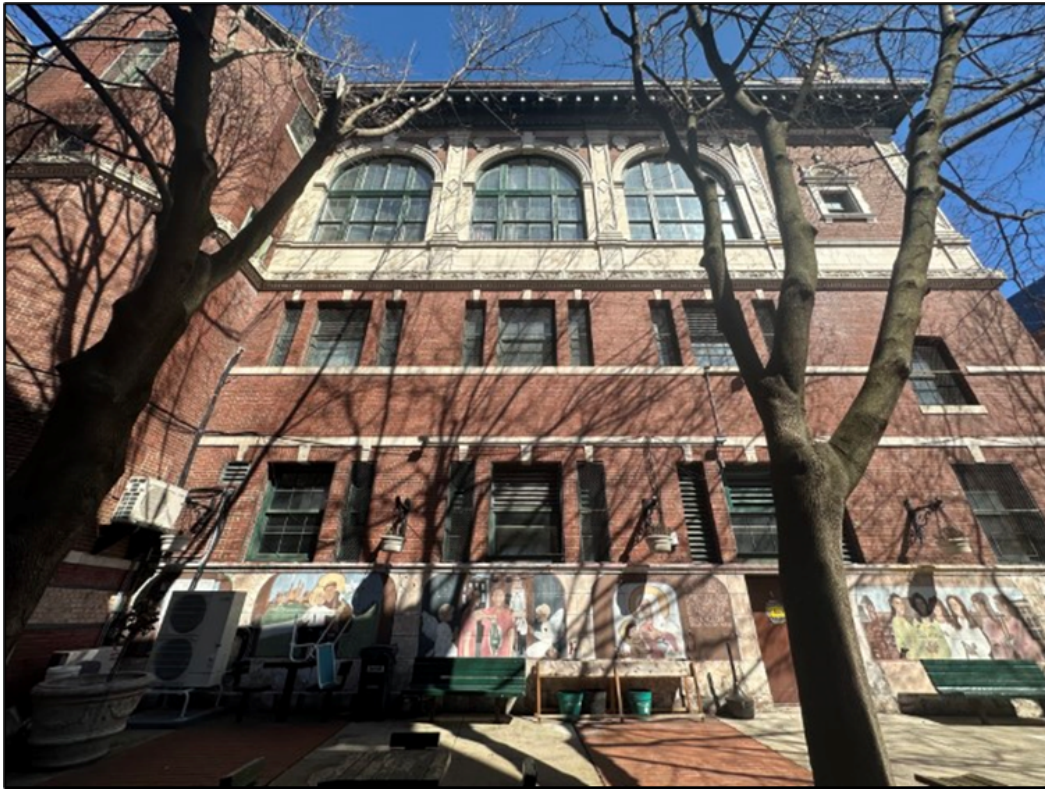
Figure 17. Park-side elevation.

This elevation of the building is called the park side because it opens onto a small park defined by a brick patio and brick walls. The park is named the George “GiGi” Reppucci Garden. This elevation is almost identical to the North Bennet Street (northeast) elevation in structure and ornamentation. The main difference is the tower extending off the back of the elevation. An entrance is located at the raised basement level on the right side. The granite composite blocks with terra-cotta seme glaze have been covered with current-day murals painted by children who frequent the community center. The murals depict religious scenes and motifs. The tower is hexagonal and contains a two-over-two sash window at the second and third stories on the southeast side and four six-over-six sash windows on the southwest side, two at each story, with an entrance at the ground level. Much like the North Bennet Street elevation, the first and second stories of the park-side elevation are defined by three sets of identical coupled-style windows consisting of two vertical two-over-two fixed windows with a flat arch and terra-cotta keystone on either side of a six-over-six sash window with a flat arch and terra-cotta keystone. Each level is defined by a terra-cotta belt course that continues around the tower at the first and third stories. The ornamentation and windows of the third story are identical to those of the North Bennet Street elevation.

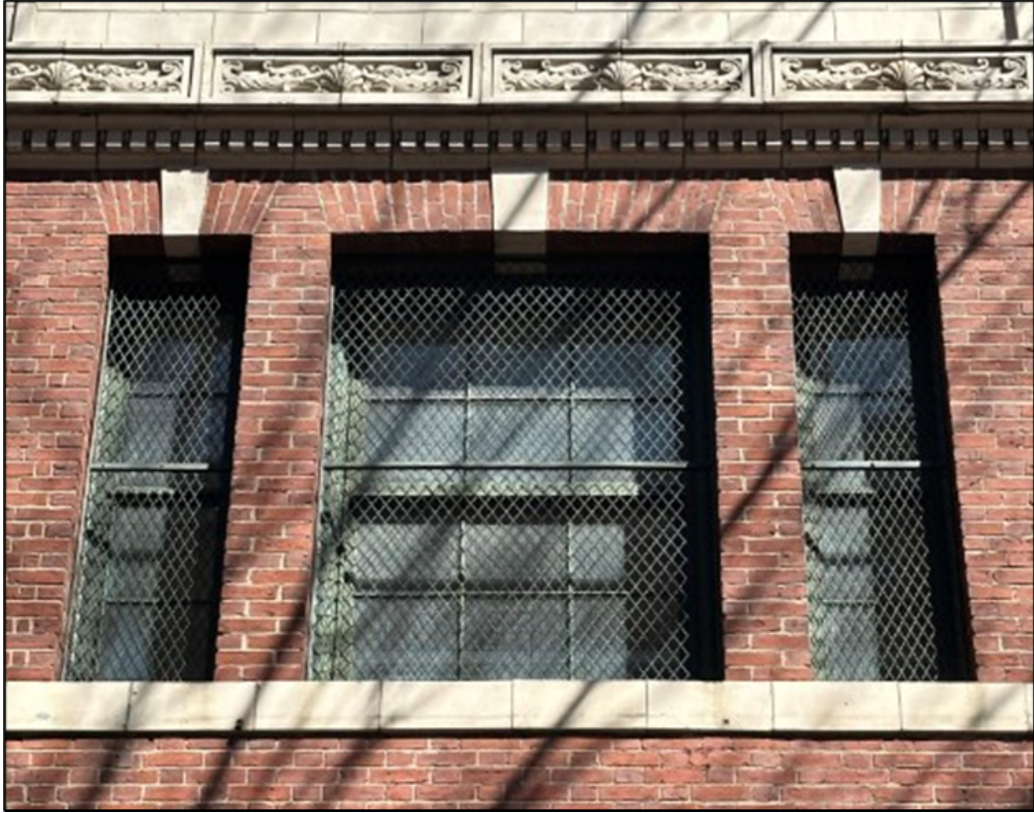
Figure 19. Frieze on park-side elevation.

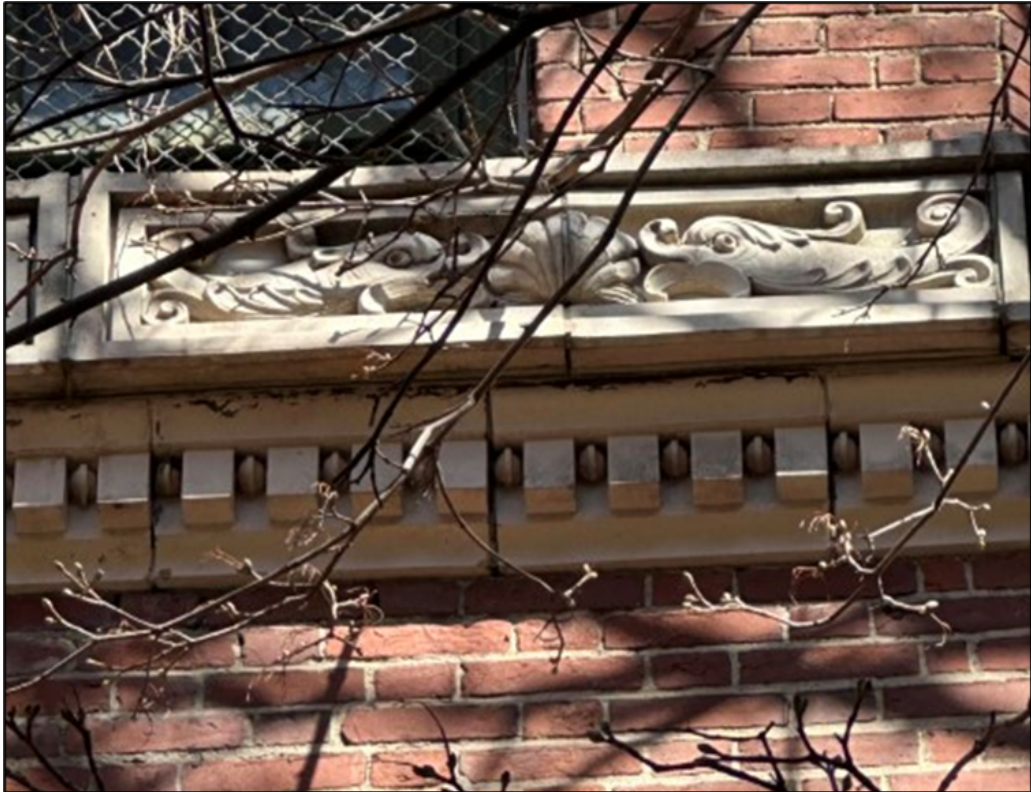
Figure 20. Detail of park-side elevation frieze.

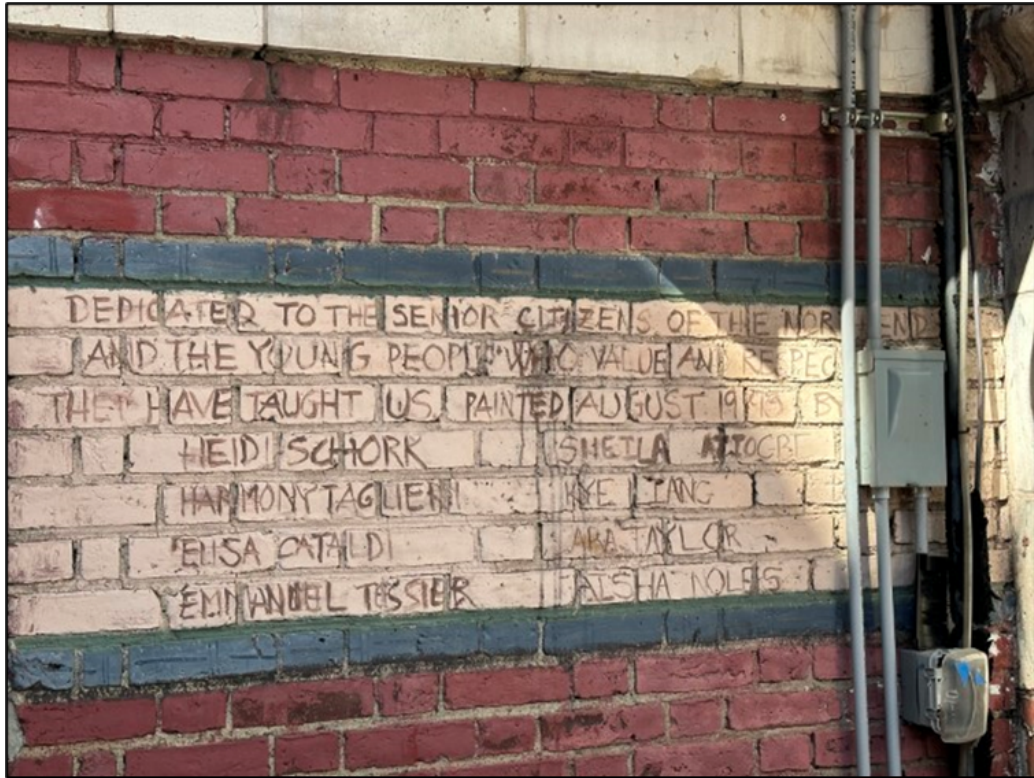
Figure 21. Brick detail on park-side elevation.

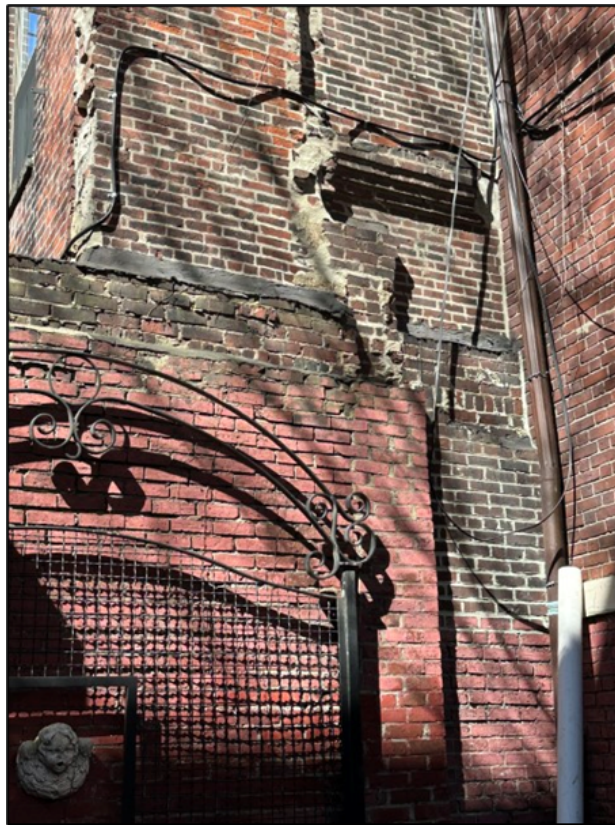
Figure 23. Detail of abutting brick walls at park-side elevation.

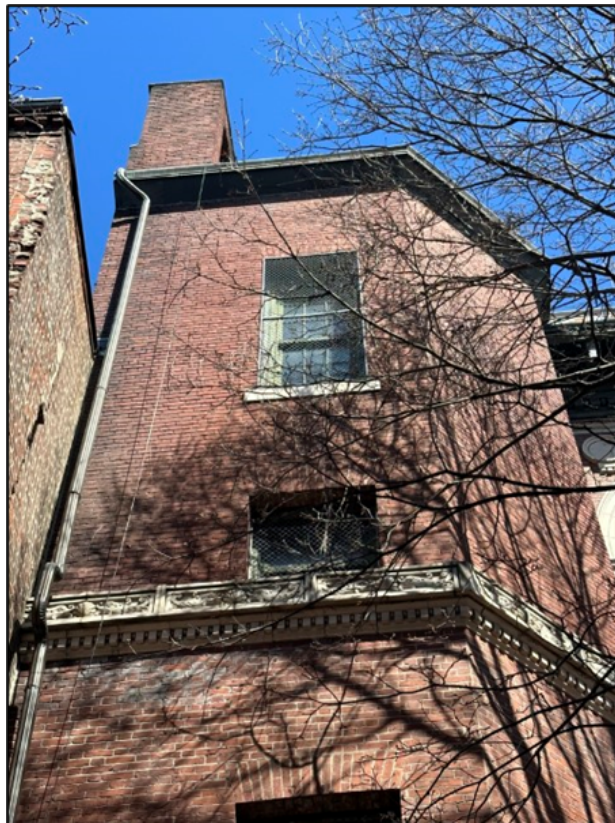
Figure 24. Tower and chimney at park-side elevation.

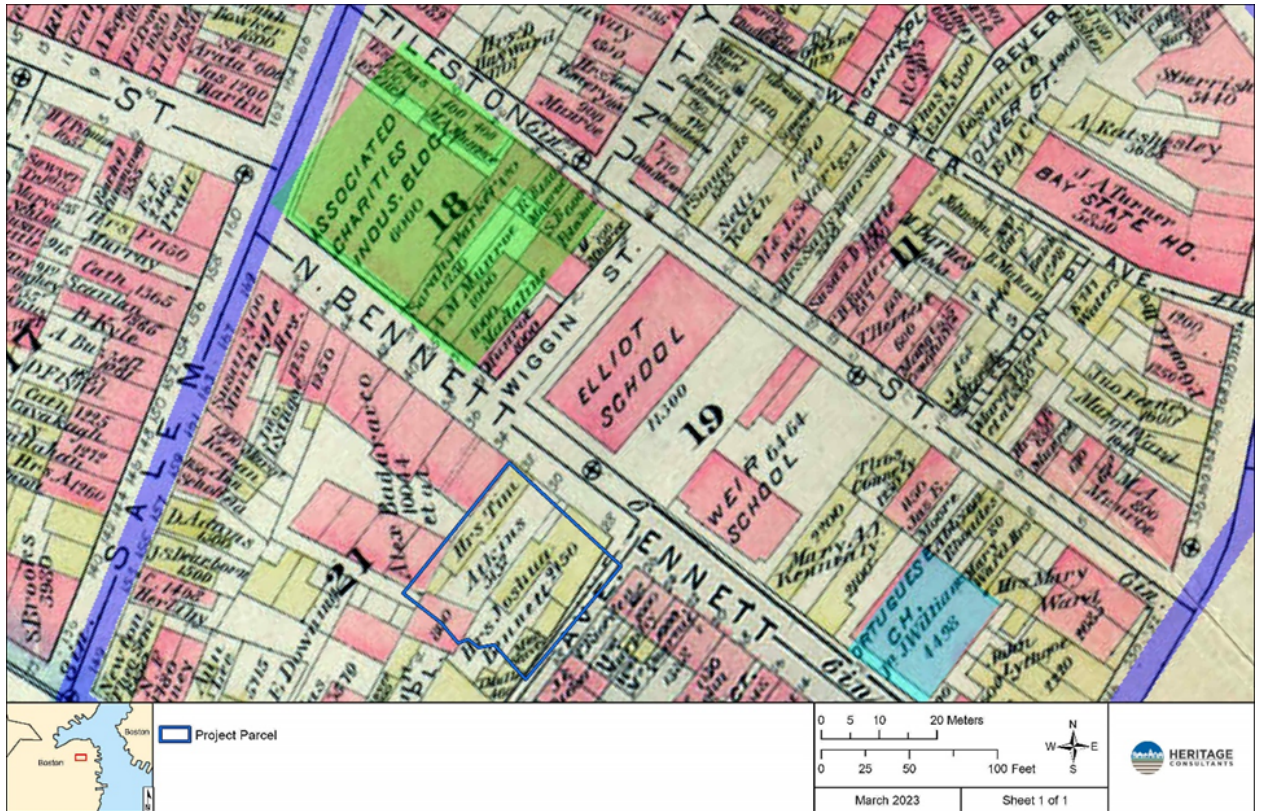
Figure 29. 1883 map showing bathhouse project parcel outlined in blue.

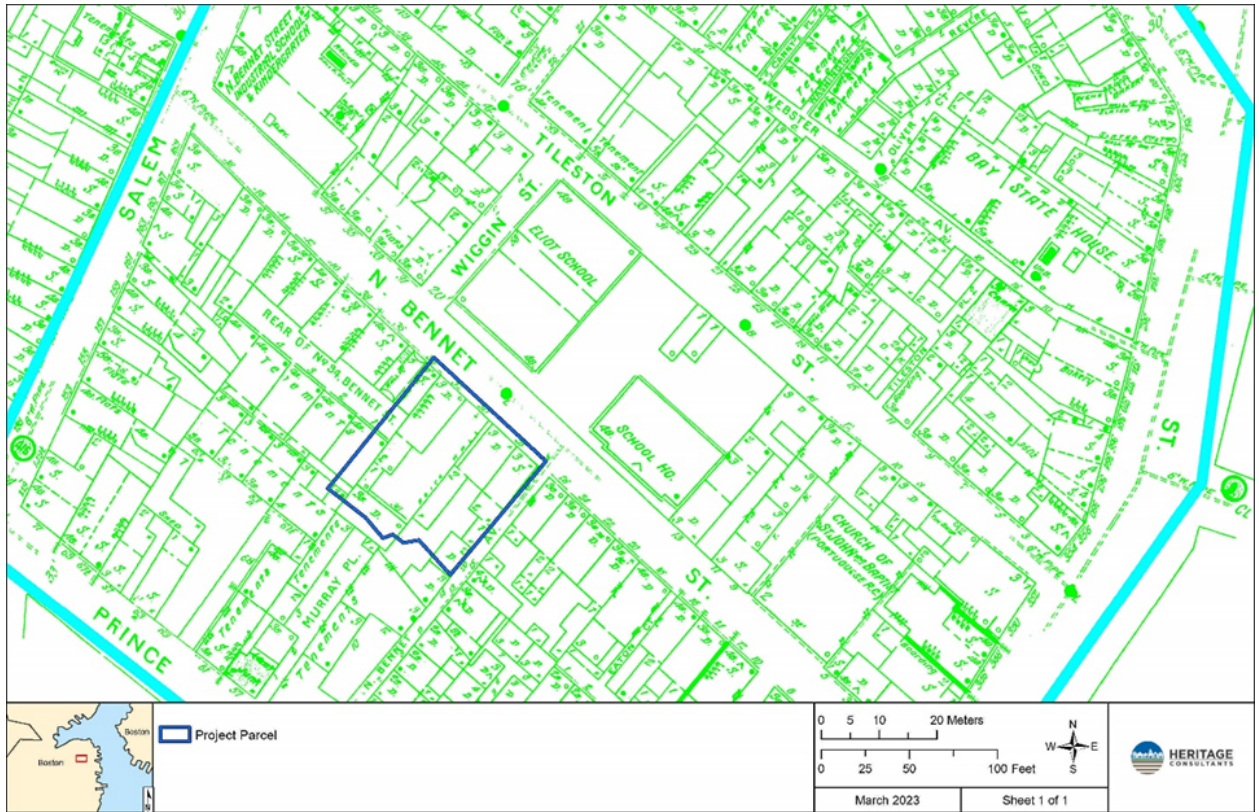
Figure 30. 1895 map with bathhouse project outlined in blue, as well as the change in the spelling of the street name from N. Bennett to N. Bennet.

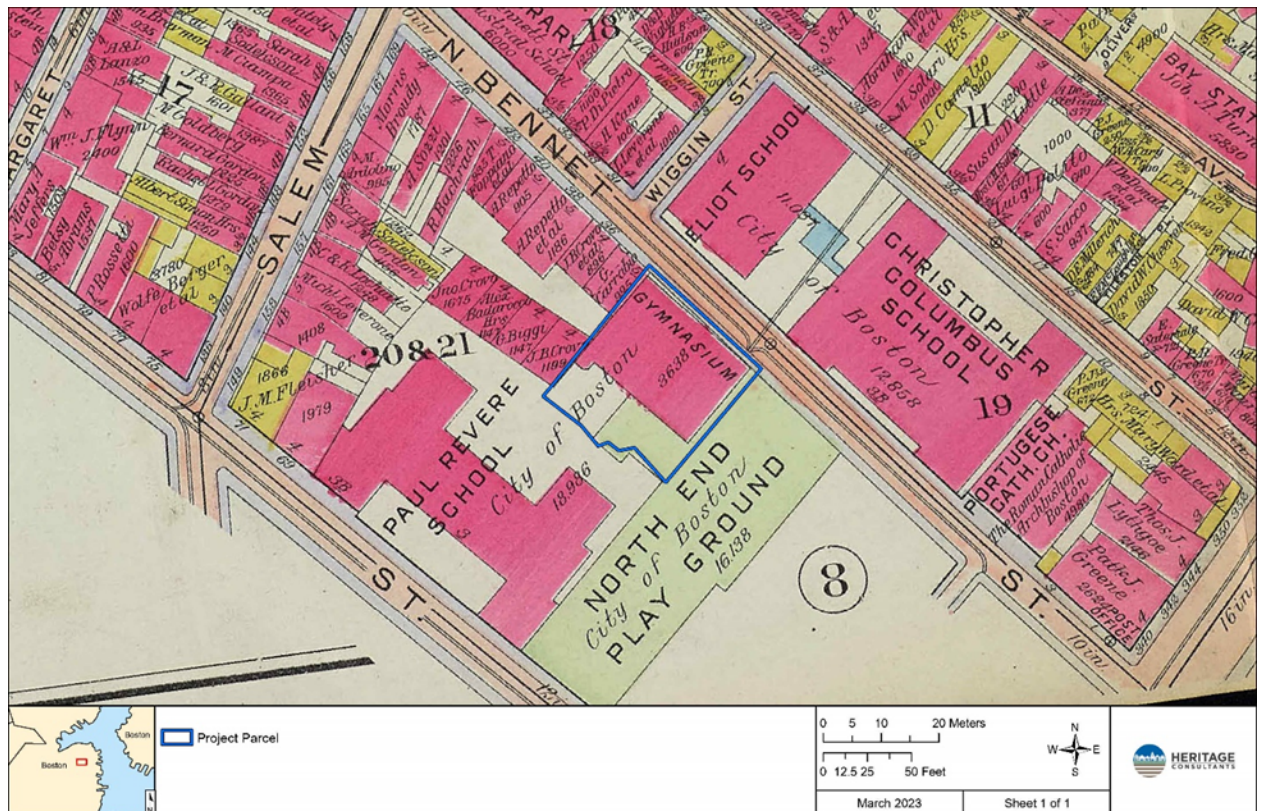
Figure 33. 1908 map with gymnasium on North Bennet Street.

The building the city constructed at 30–32 Bennet Street was both a bathhouse and a gymnasium, as shown on the 1908 Boston atlas map (Figure 10).¹⁴ It should be noted that documents of the period can cause some confusion for modern-day readers because people of the time tended to use the term “bathing” interchangeably for both recreational swimming and taking baths for personal hygiene. This building accommodated only the hygiene version of baths. The city’s decision to build such a structure is related to its late-19th- and early 20th-century public health policies and programs, as well as to the type of neighborhood the North End was and remains today. Figure 9 and Figure 17 illustrate the neighborhood’s densely crowded conditions, with little open space and buildings fronting directly on the streets.¹⁵ The combined effects of industrialization, urbanization, and poverty during the 19th century contributed to high rates of endemic and epidemic disease in Boston and throughout the North End. In response, Boston’s leaders implemented a series of

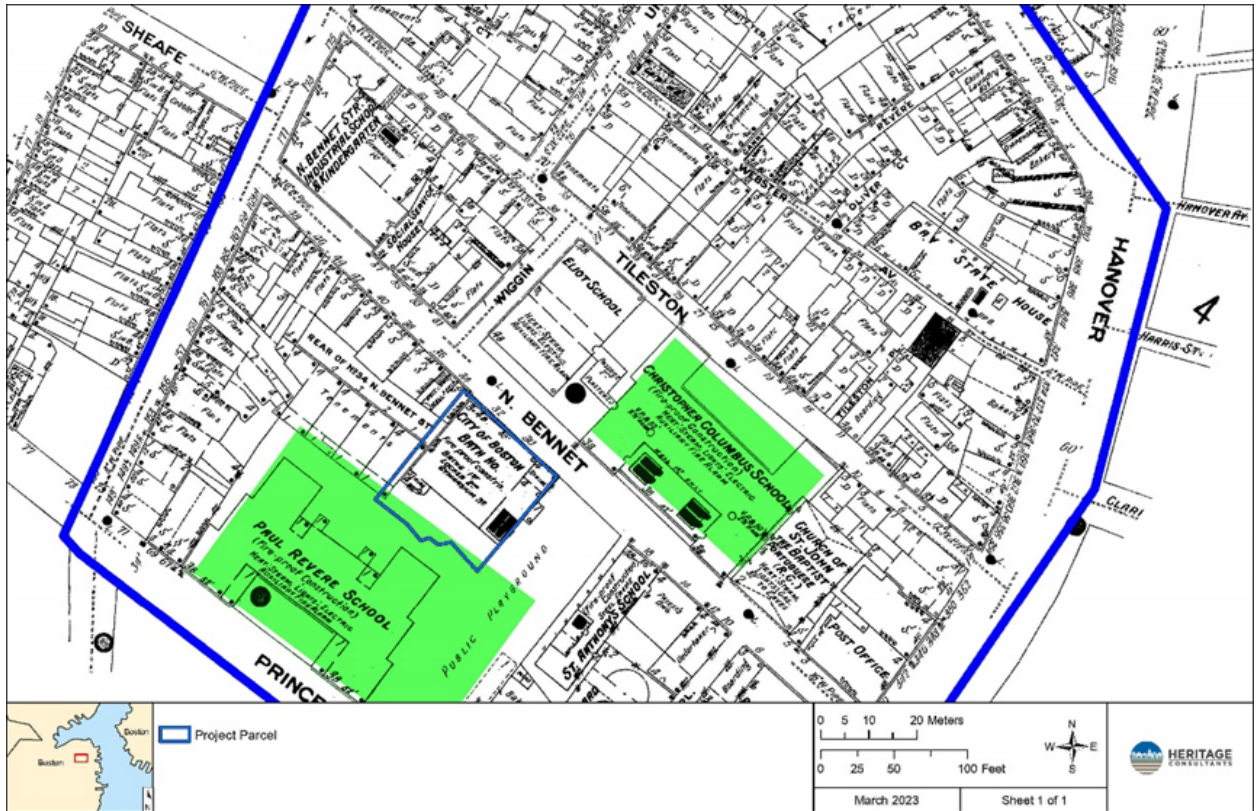
Figure 34. 1909 map featuring the municipal bathhouse.

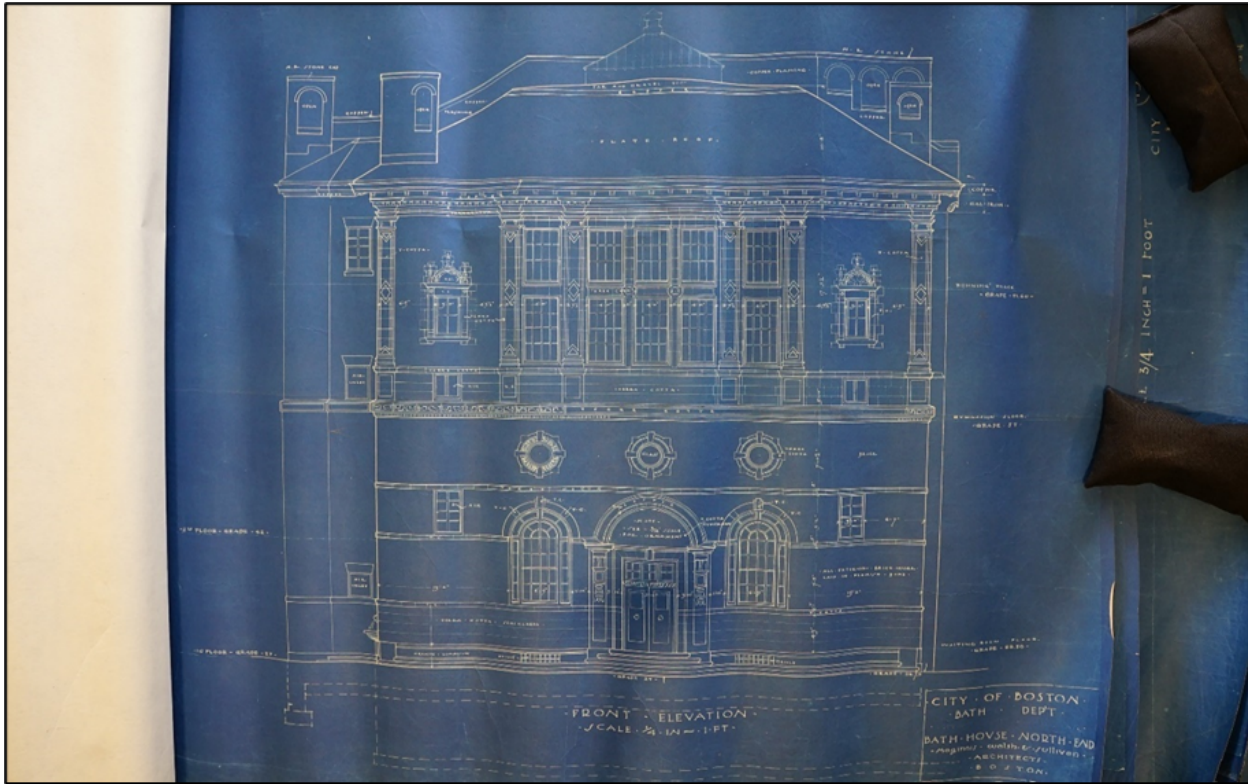
Figure 41. 1903 architectural plans labeled “Front Elevation.”

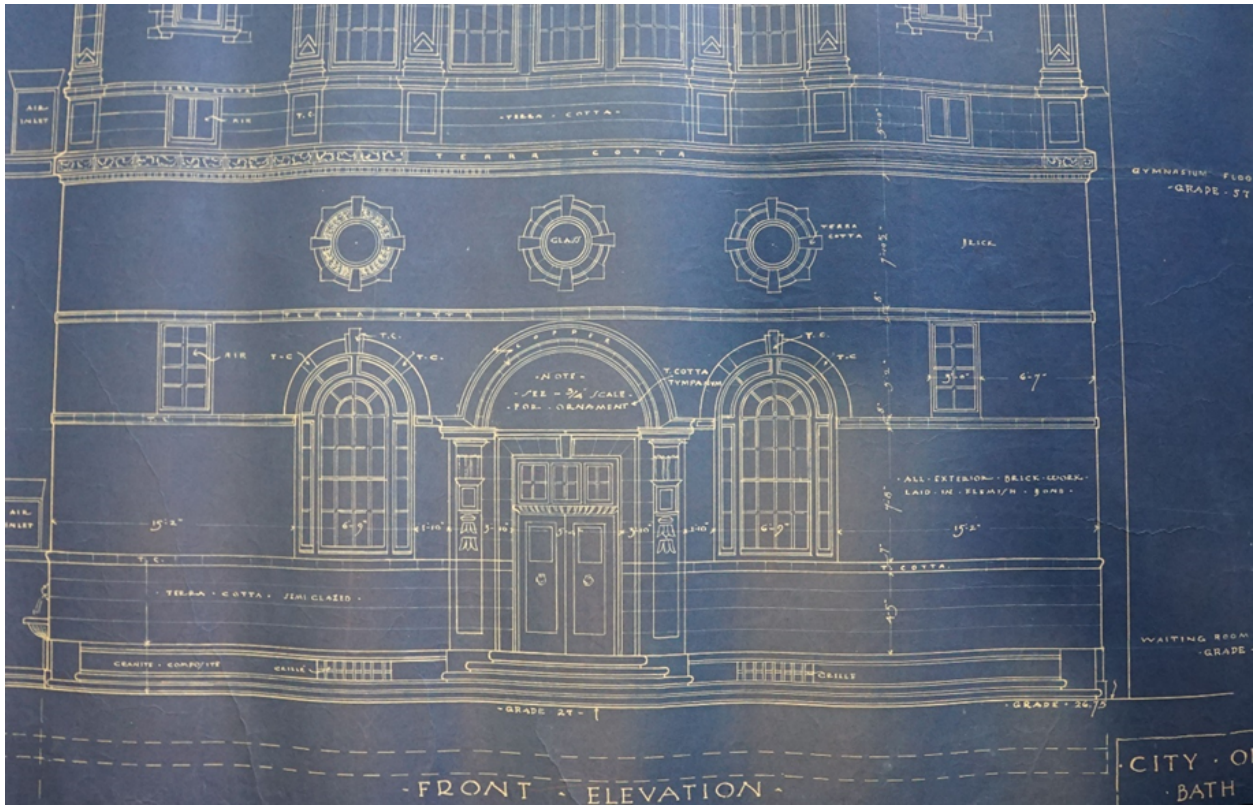
Figure 42. 1903 architectural plans, detail of front elevation, lower level.

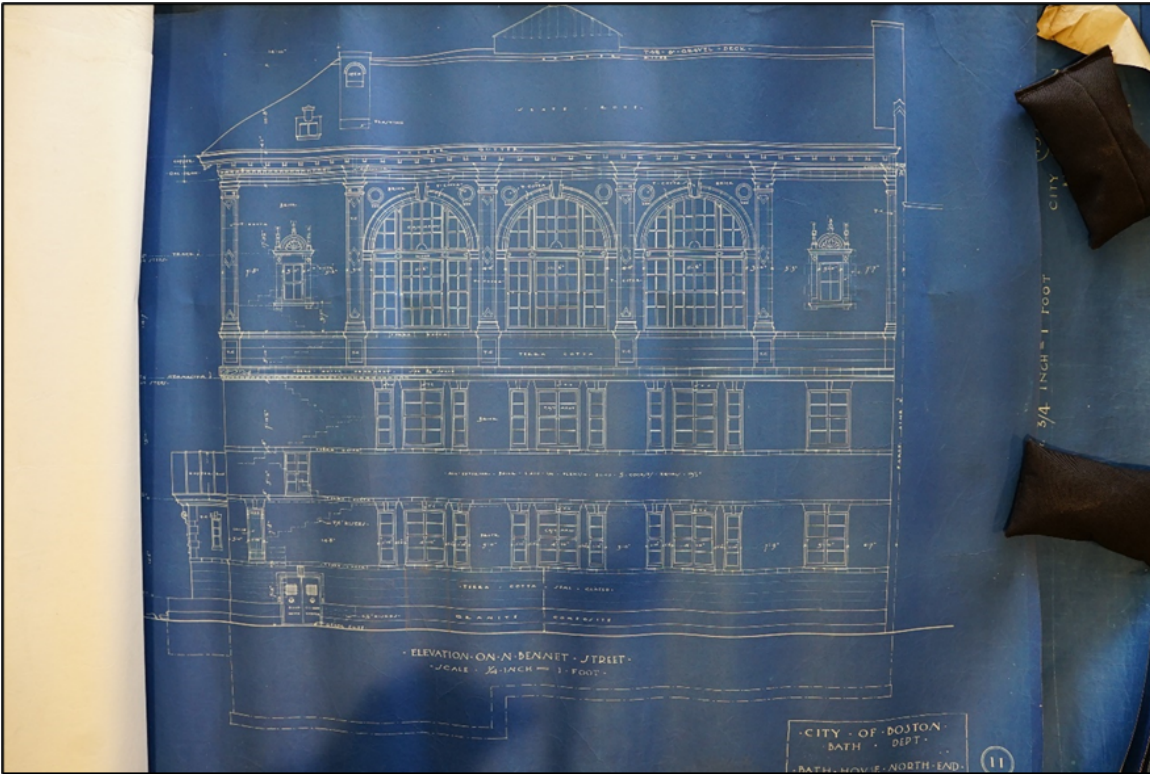
Figure 44. 1903 Architectural plans, North Bennet Street elevation.

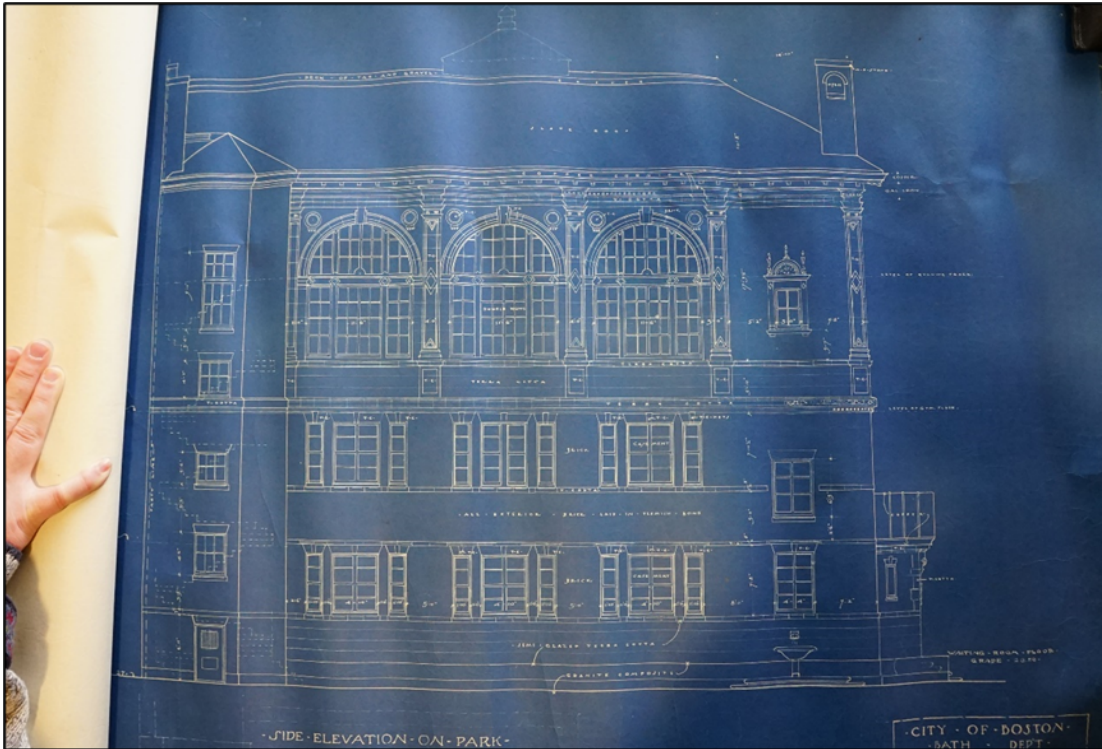
Figure 45. 1903 architectural plans of the Park Side elevation.
