THE NAZZARO COMMUNITY CENTER

BOSTON LANDMARKS COMMISSION

STUDY REPORT

The Nazzaro Community Center

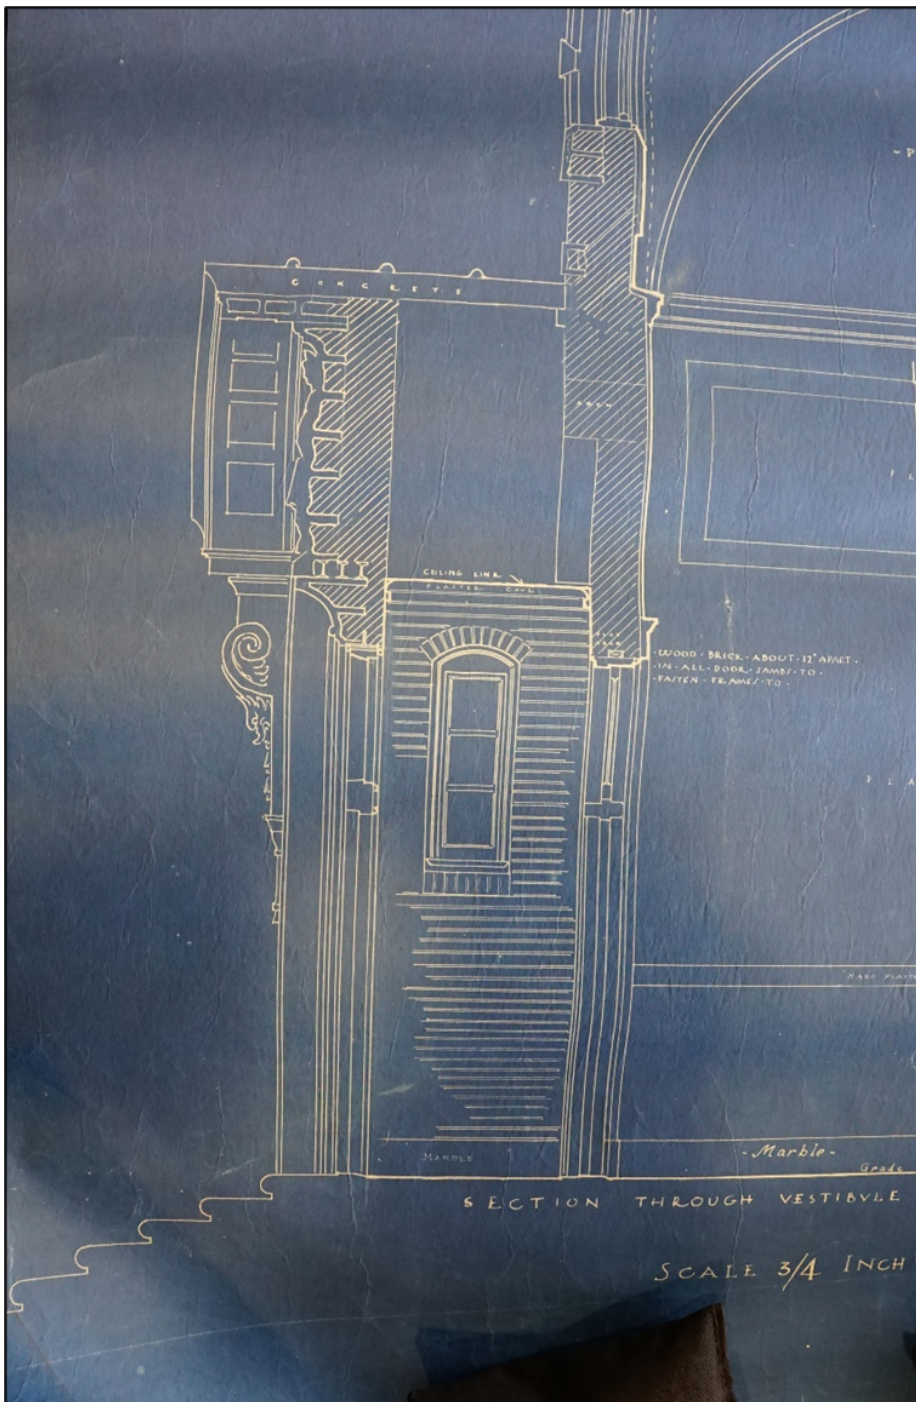
Figure 46. 1903 architectural plan of vestibule.
