THE JEWELERS BUILDING

Boston Landmarks Commission Study Report

The Jewelers Building

371-379 Washington Street, Boston, Massachusetts

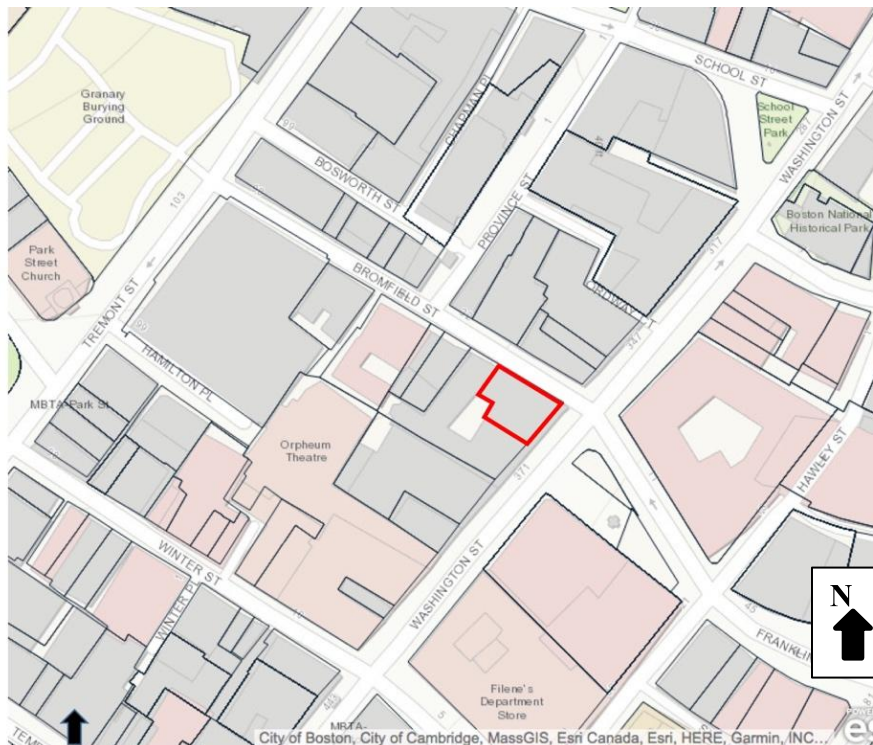
Figure 1. Map showing the footprint of the building within parcel 0304734000

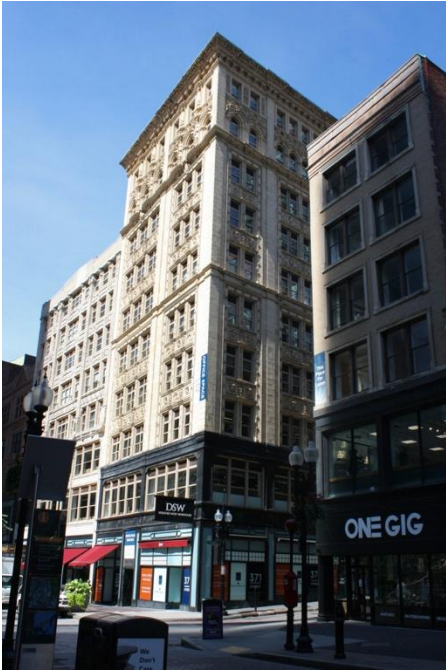
Figure 2. Washington Street (L) and Bromfield Street (R) facades.

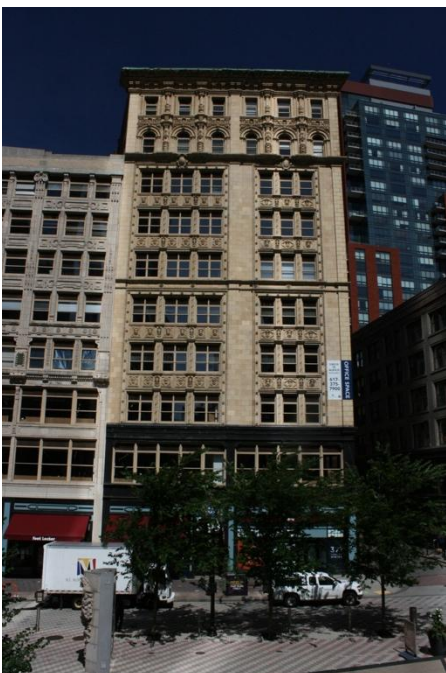
Figure 3. Washington Street (east) façade.

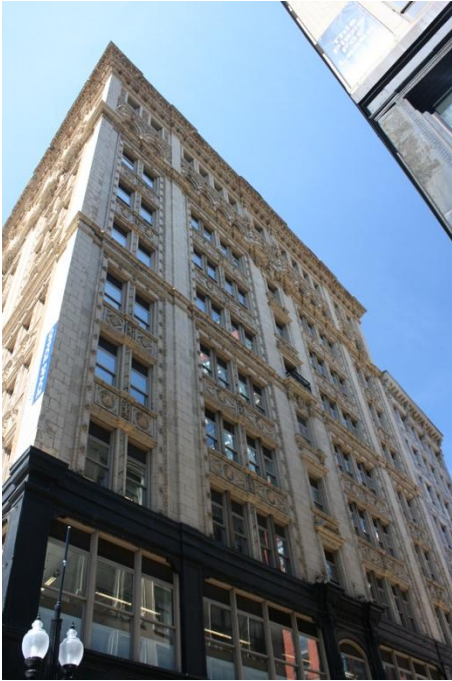
Figure 4. Bromfield Street (north) façade.

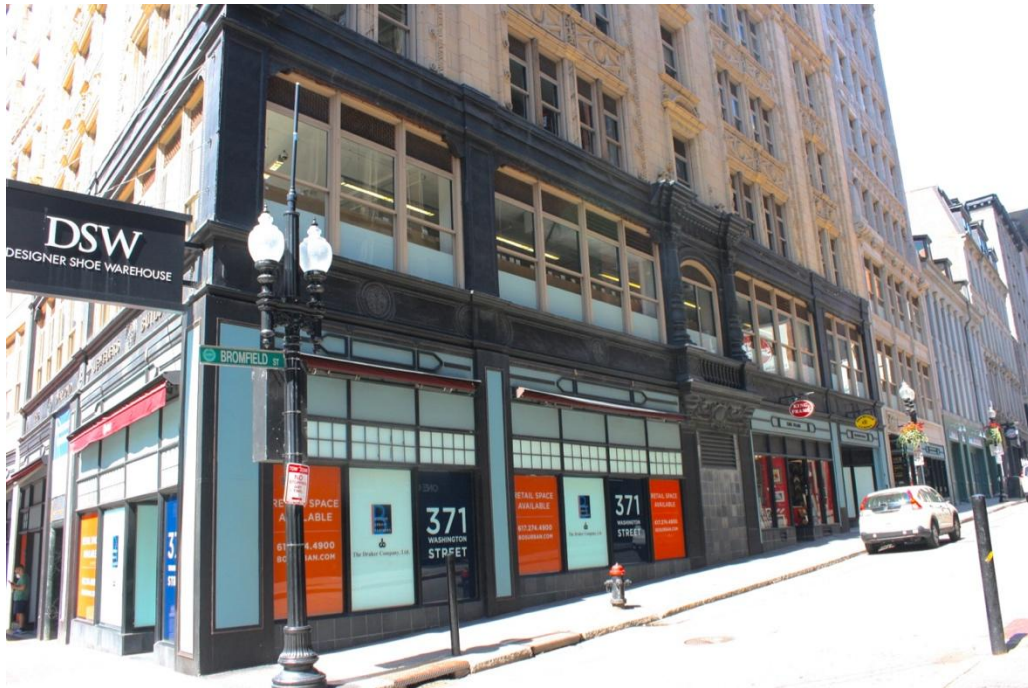
Figure 5. Bromfield Street facade, storefronts.

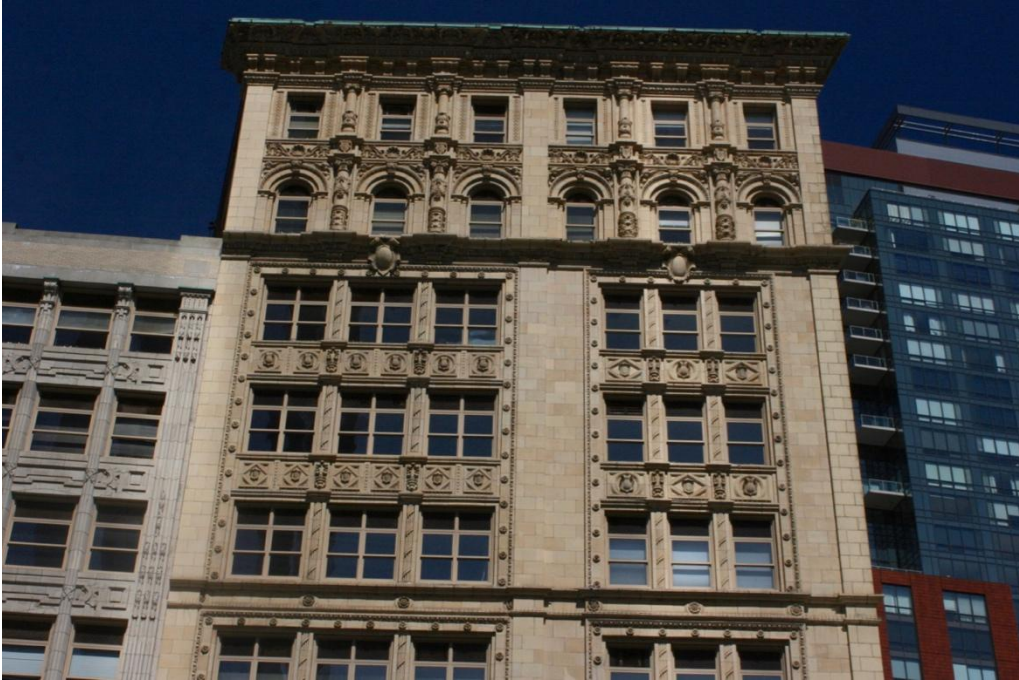
Figure 6. Washington Street façade, floors 6 through 10.

Above the two-story, cast iron base, the street facades are clad with terra cotta tiles on the piers and occasional flat wall surfaces, and with elaborate cast terracotta trim at the window openings, spandrel panels, and entablatures (Figures 3 and 4). Secondary elevations, including the top stories of the west and south elevations, are clad with course red brick having simple stone and brick trim around the window openings (Figure 10). Typical windows originally contained 1/1 double hung sash; most of these were replaced in 1989-1990 with 1/1 windows with transom panels above.

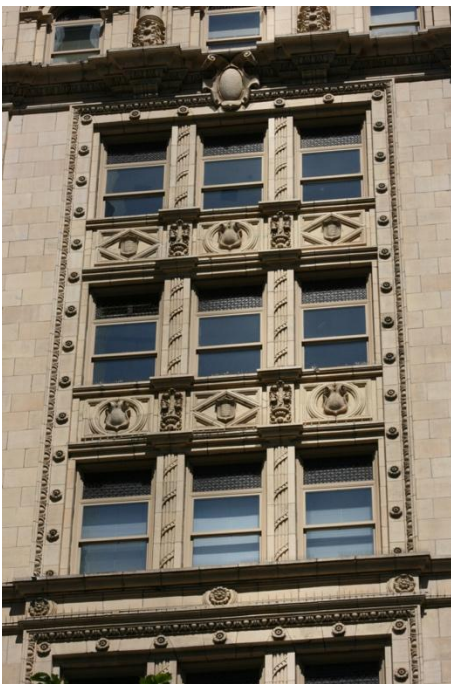
Figure 7. Washington Street façade, detail of floors 6, 7, and 8.

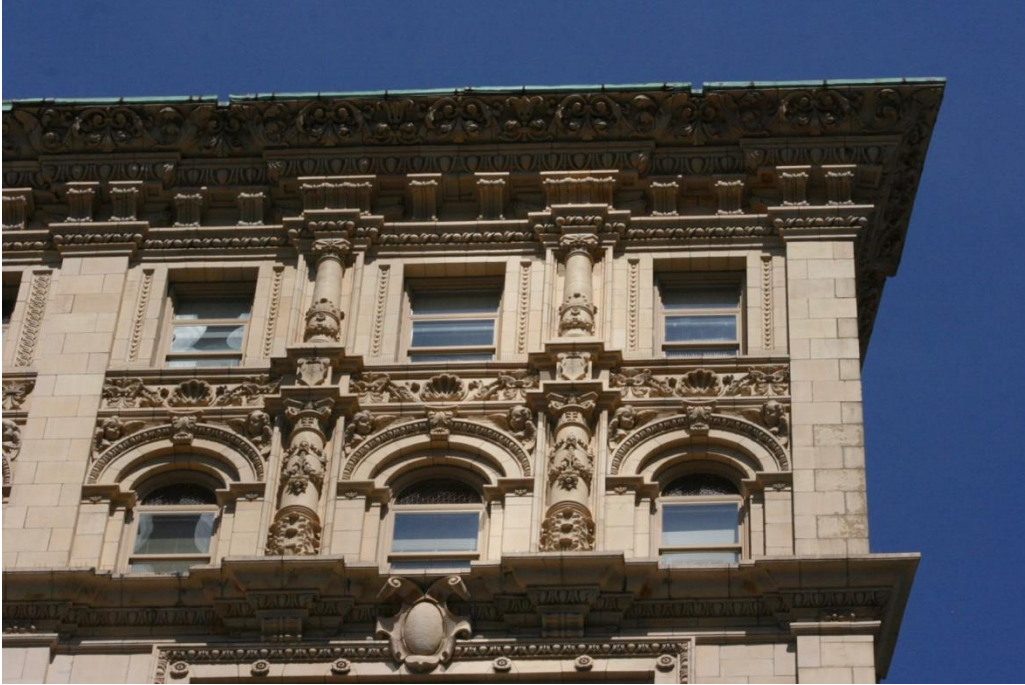
Figure 8. Washington Street elevation, detail of floors 9 and 10.

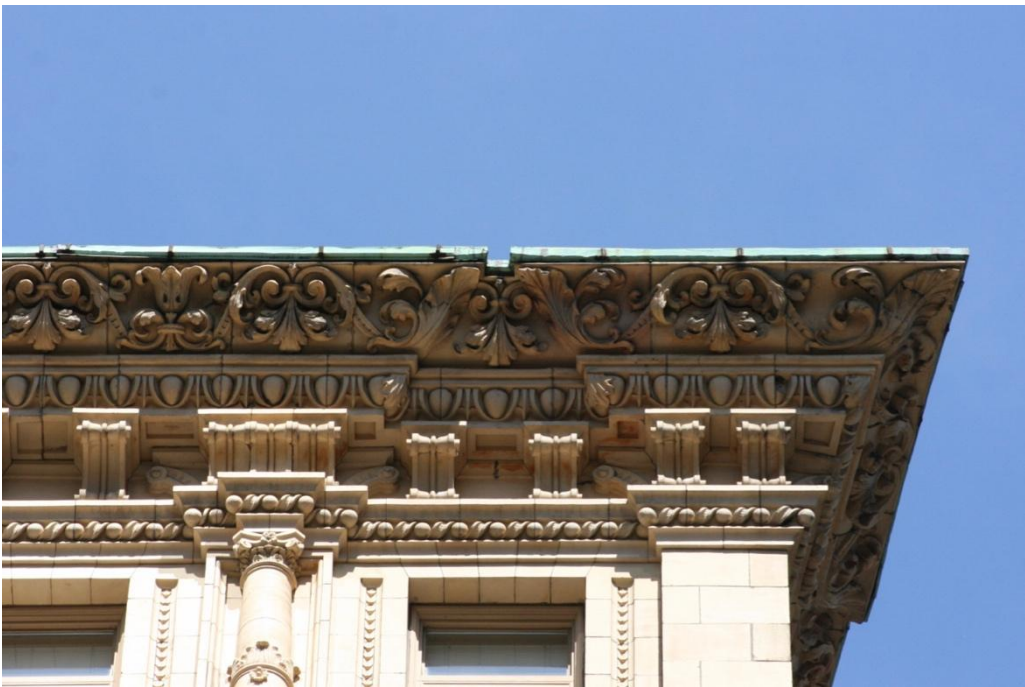
Figure 9. Washington Street elevation; detail of cornice.

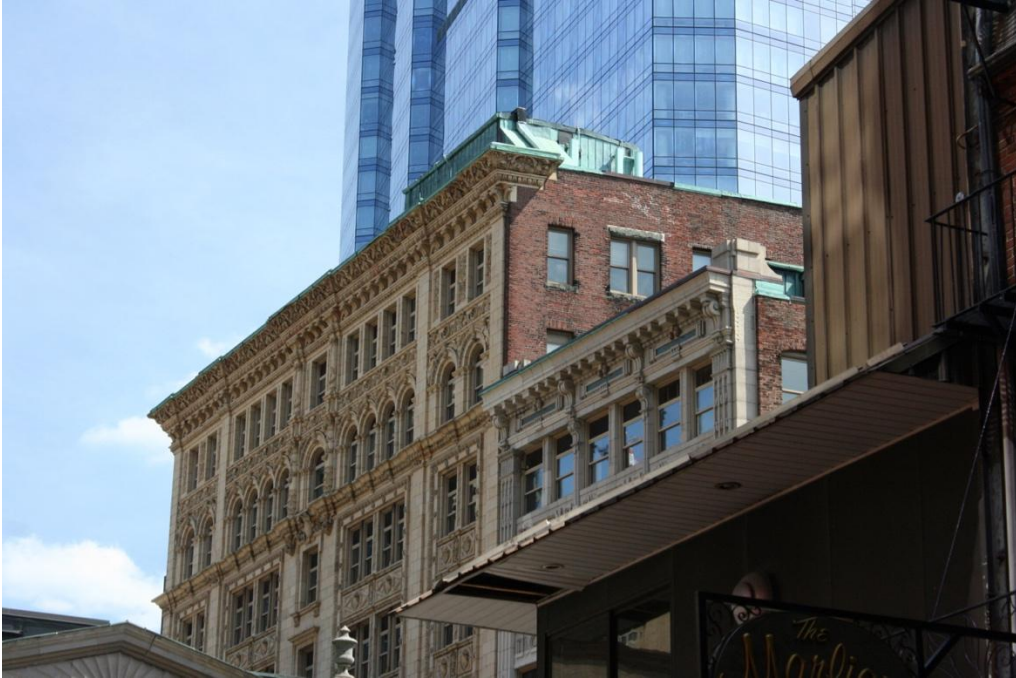
Figure 10. Bromfield Street (north) and west elevations.

Visible portions of the southern and western elevations of the Jewelers Building are utilitarian in character, with course red brick walls and single and paired, rectangular windows ornamented only with rock-faced granite sills and lintels of either rock-faced rectangular granite or brick soldier courses (Figure 10).

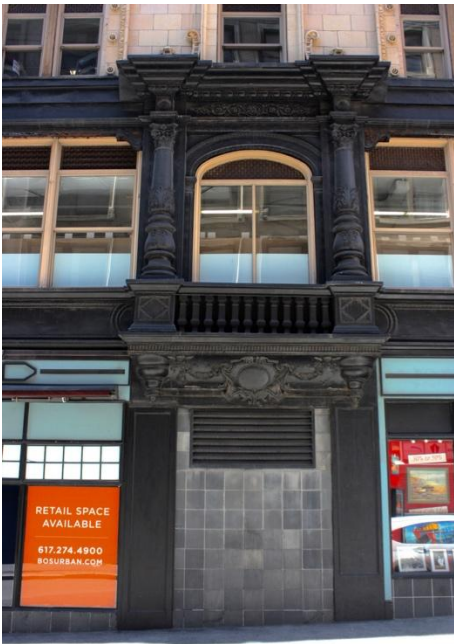
Figure 11. Bromfield Street building entrance.

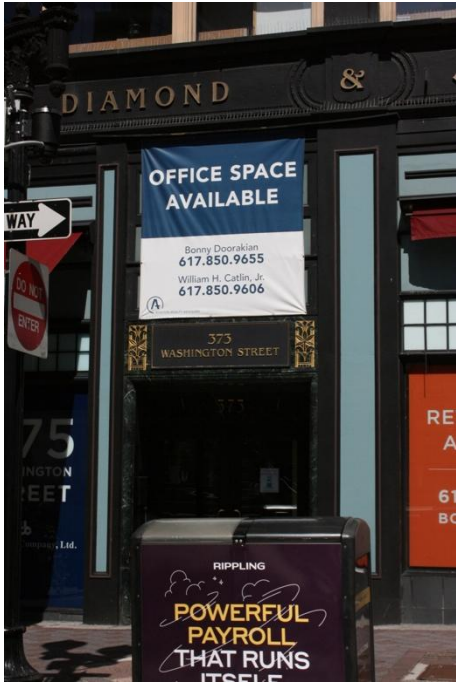
Figure 12. Washington Street building entrance.

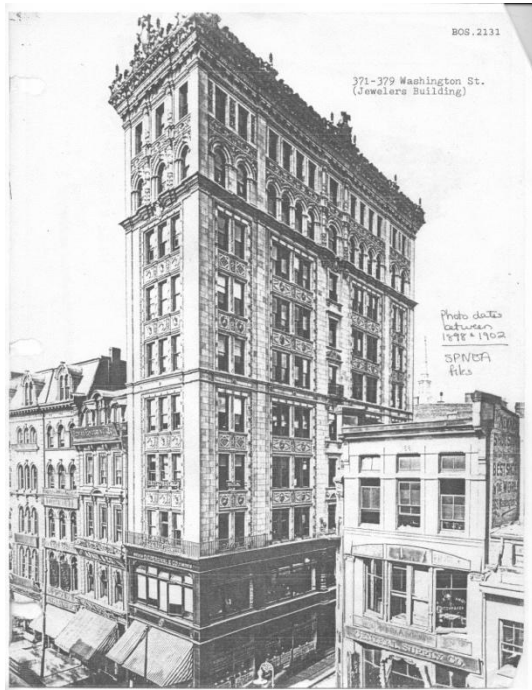
Historic Image 2. Original part of the Jewelers Building, ca. 1898-1902. Courtesy of Historic New England.
