Taffe Residence
30 West Cedar Street
Boston, MA

City of Boston Landmark Commission

Dryer Termination proposal:

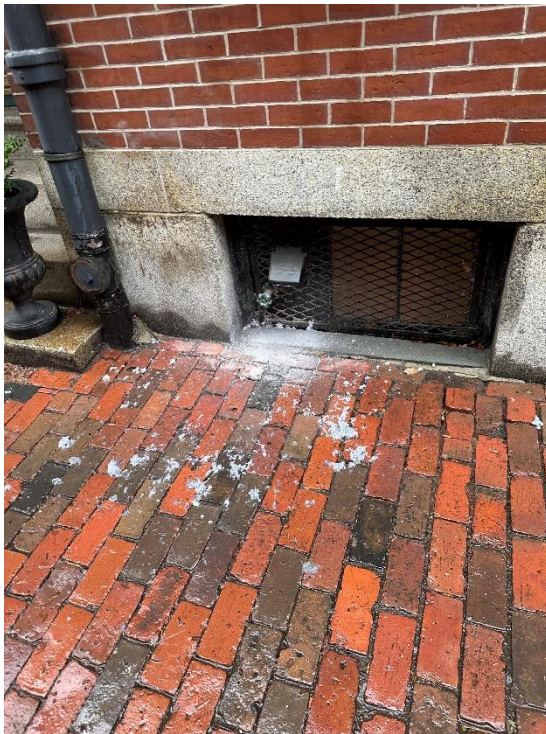
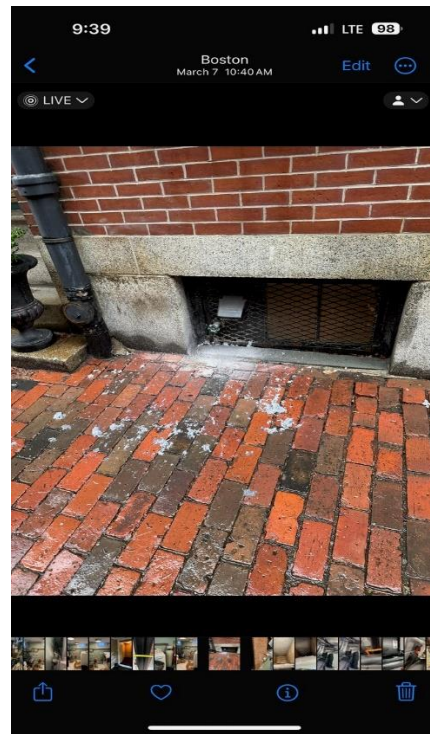
Existing condition prior to Wellen Construction commencing work at 30 West Cedar St.

(Timestamp photo included from March 7, 2024)

- **Existing Conditions:**
 - Prior to Wellen starting construction at 30 W. Cedar St. the dryer exhaust termination was at the public way exiting the building via a basement window. The dryer exhaust was leaving lint on the sidewalk creating an unsightly appearance.
 - Our client is stating that the termination was present in 2011 when they purchased the property. This can be seen on a Google Street view dating back to 2014.

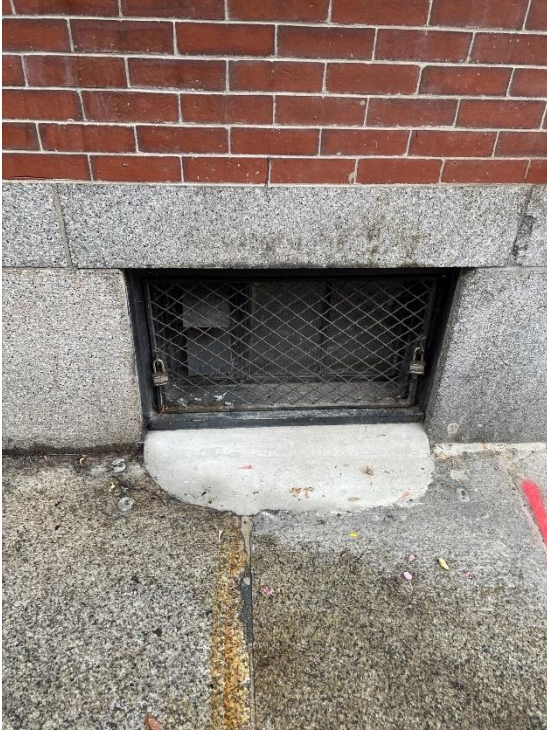
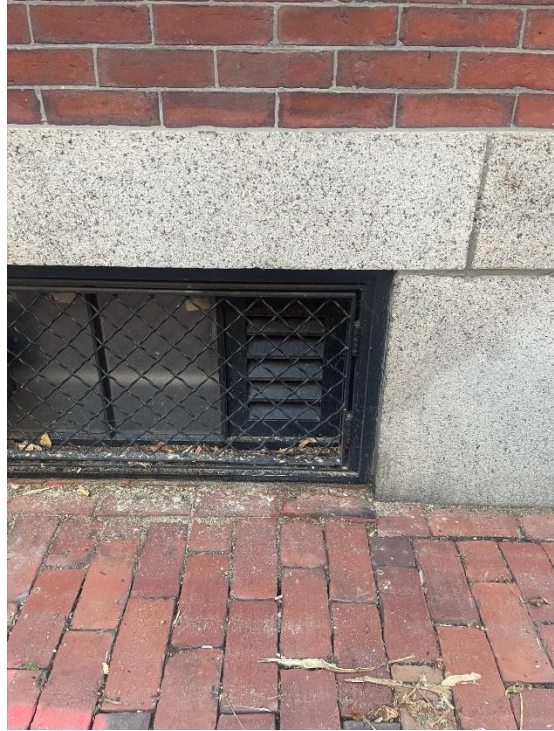
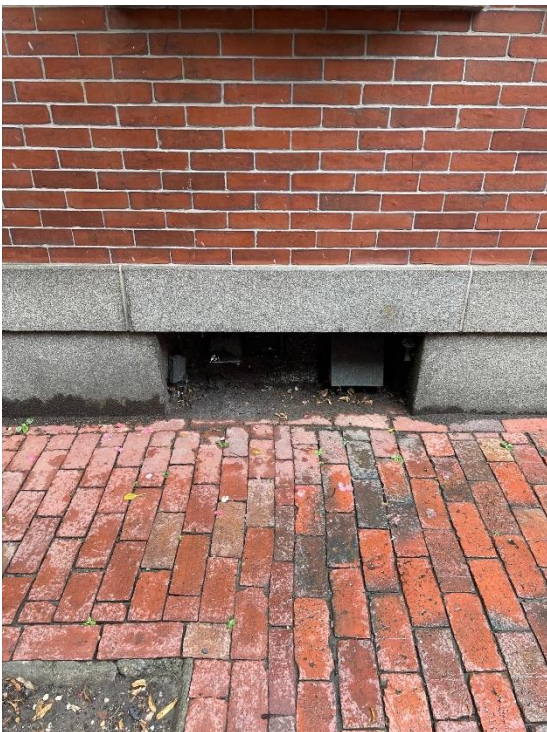
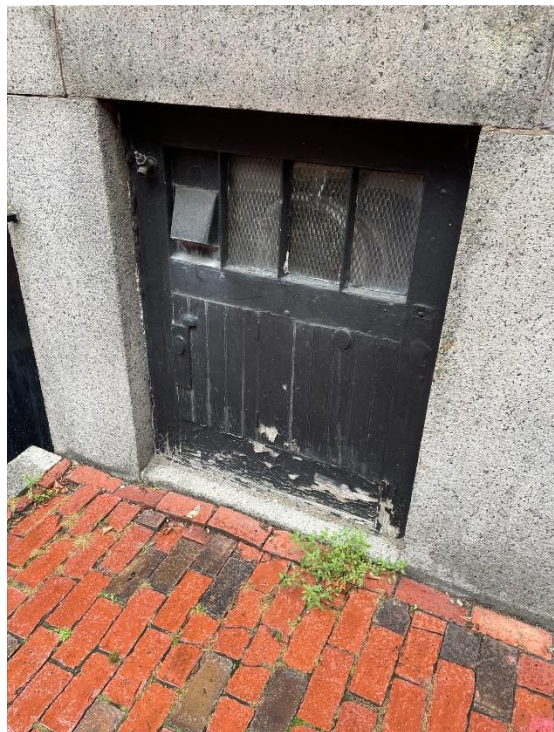
Examples of existing wall terminations on West Cedar Street

- During a short walk on W. Cedar St. multiple examples of similar conditions presented themselves.

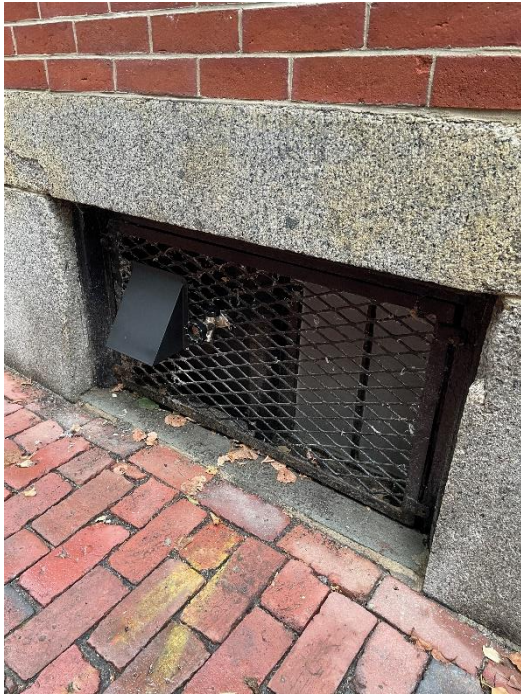
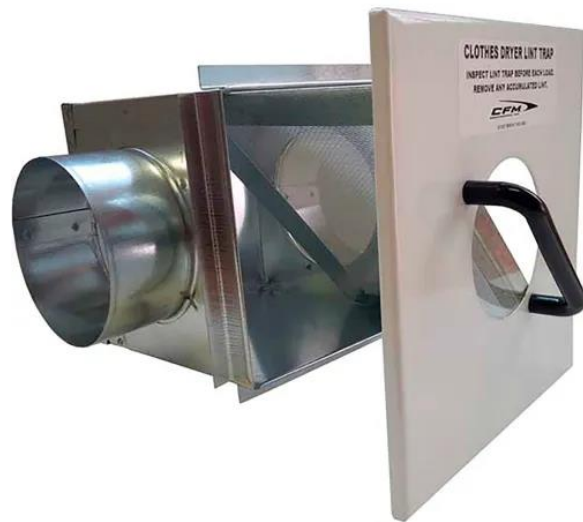
Current condition which we will improve upon by installing a louvered low-profile termination behind the security screen. (louvered example below) All items will be painted black to match windows.

- We would like to re-use the existing location of the termination and clean up the appearance. To achieve this, we would like to install a low-profile wall termination that can be installed behind the security screen on the basement window.
- In addition, we will install an in-line lint trap to capture any lint that exits the dryer appliance. This in-line lint trap is installed on the interior of the house and will not be visible from the public way.
