1 ELWOOD

HPACD DESIGN REVIEW 2

10/24/2024

TRIPLE W DEVELOPMENT 1 ELMWOOD ST
WEST WORK

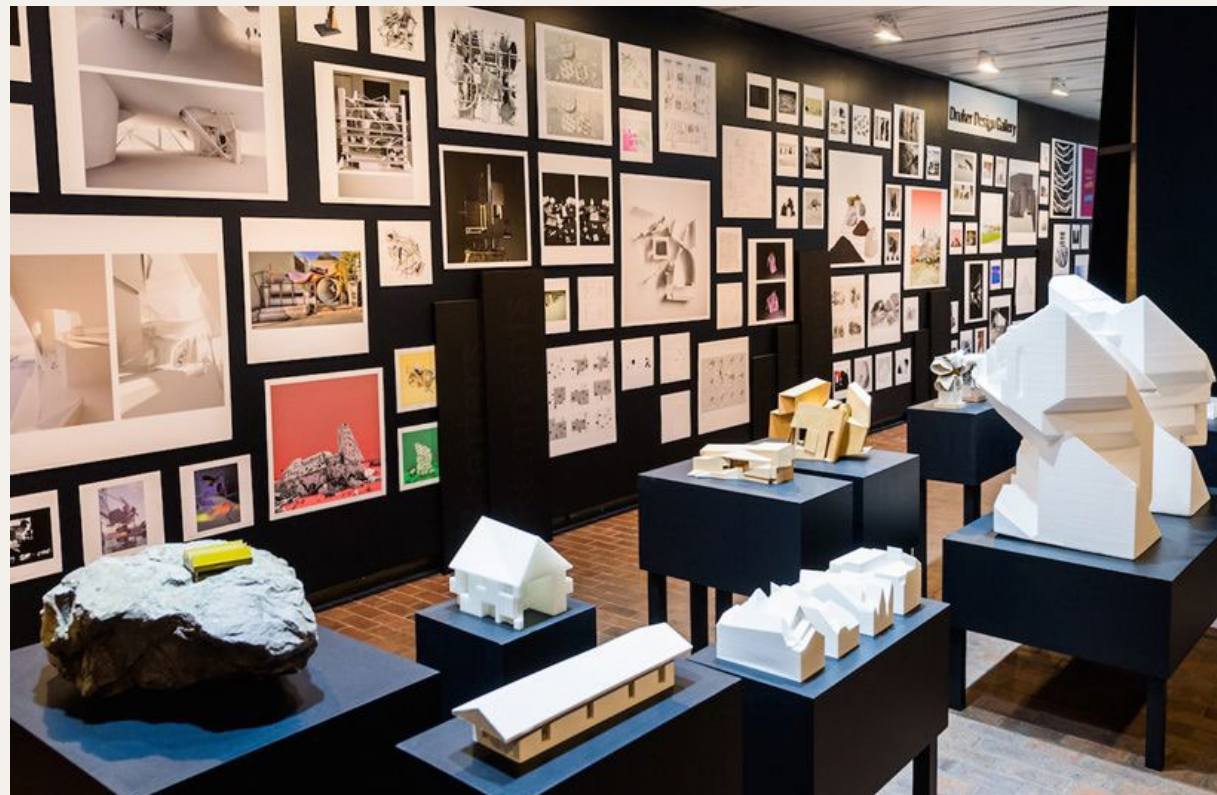
OPTION A: Online Archive + Exhibition

Make the research publicly accessible via online archive and exhibition.

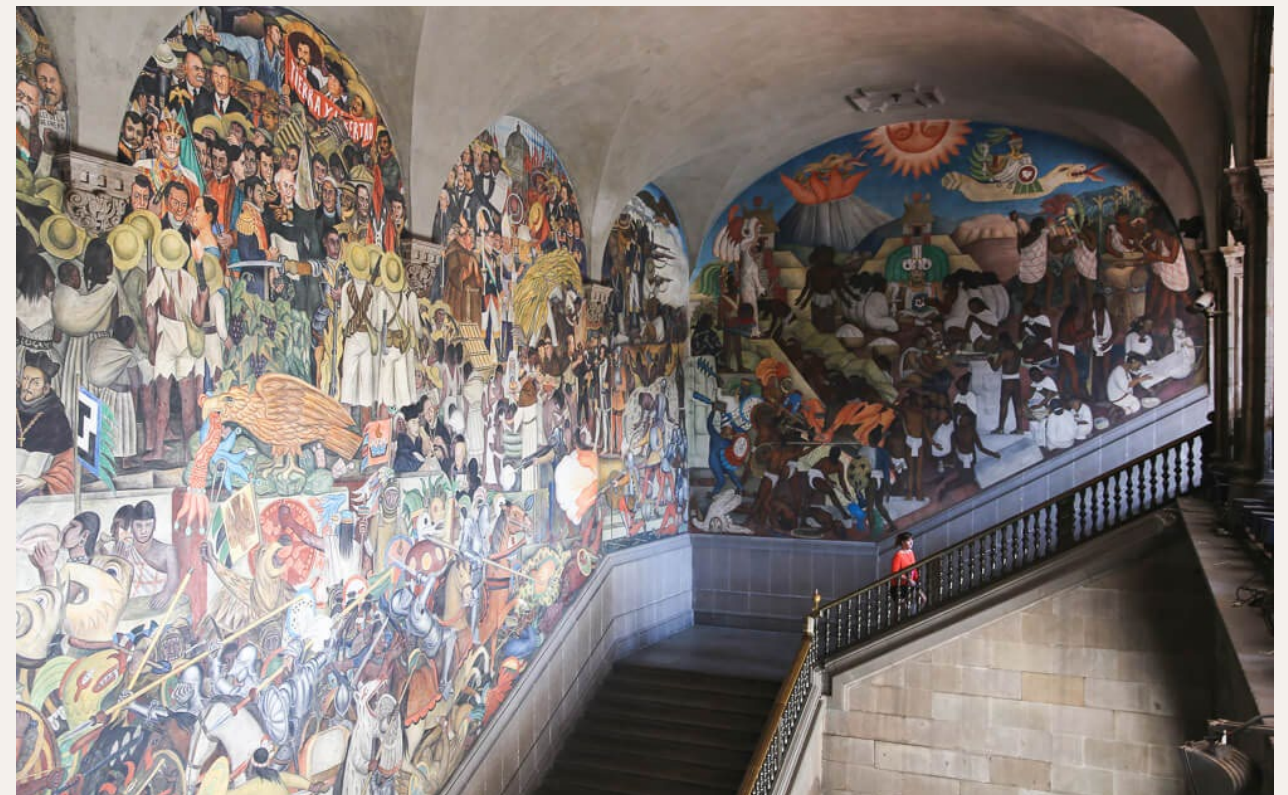
OPTION B: Online Archive + Mural

Artistic re-creation of neighborhood history in the form of a mural.
