HISTORIC BURYING GROUNDS INITIATIVE NEWSLETTER

Preserving Boston's 16 Historic Burying Grounds

JANUARY 2013
VOLUME 2 EDITION 2

FIELD NOTES: COPP'S HILL BURYING GROUND DESIGN DILEMMA

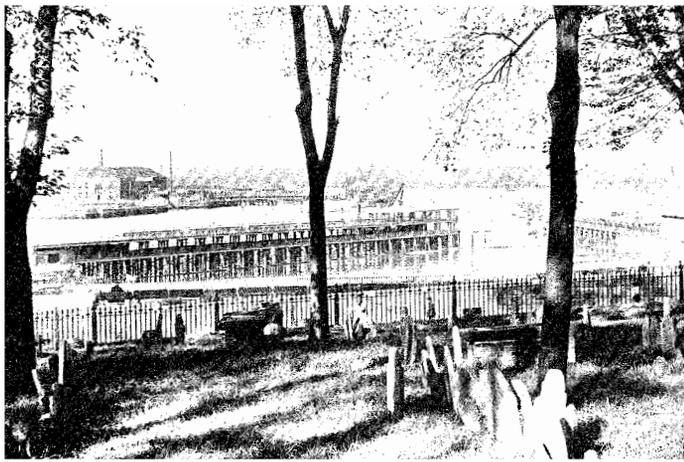
A photograph from ca 1900 showing the Charter Street fence. If you look closely you can see that a few finials are missing.

The largest work item in this project is a run of 19th-century cast-iron fencing that extends along the edge of the site on Charter Street. The fence sits atop a brick retaining wall and a concrete capstone was poured around the base of the fence. This is an unusual configuration; we can see from old photos that it is not original but we are not sure what the circumstances were that led to this set up. Traditionally old cast-iron fences like this were set into pre-drilled holes in a granite capstone. The fence posts and pickets were placed in these holes and lead was packed around them. Old photos from before 1900 show metal straps wrapped around three sides of the granite capstone, indicating that the granite was splitting, most likely because of rust from the iron fence pickets. This would also indicate there was a problem with the origi-

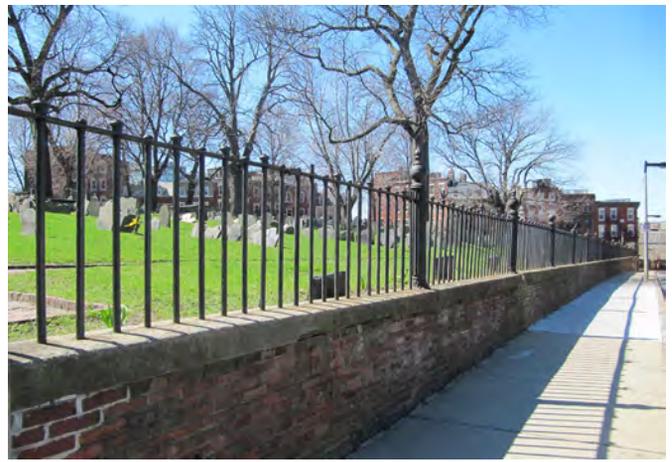
The Charter Street fence in 2012. Almost all of the finials are missing on this fence now.

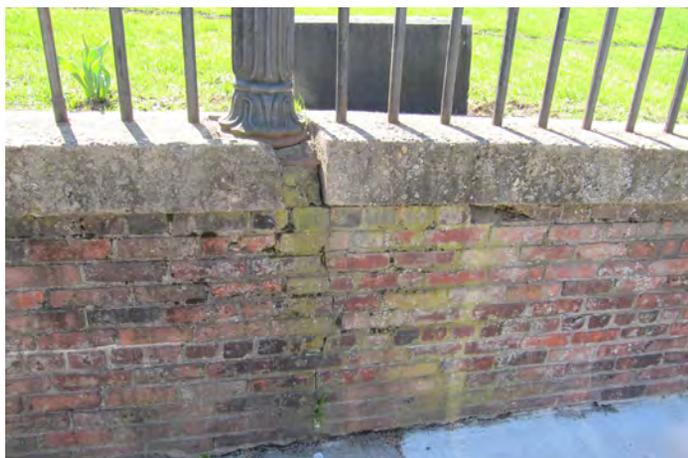
The concrete capstone was poured over the bottom of the fence post causing rusting and spalling.

In any case the original capstone was replaced by a concrete capstone. Instead of pouring the capstone and drilling holes in it for the fence posts and pickets, this capstone was poured over the bases of the posts and pickets, encasing them in concrete. The fence posts are hollow and the bottoms of the posts are open. Normally they are mounted on top of the capstone, which allows any water to drain out. But since they were encased in concrete, the drainage openings were closed and rust and debris built

up inside the posts, causing some of them to crack and causing chunks of the capstone to spall off. In an attempt to prolong the life of the posts, concrete was poured into some of them which exacerbated the situation. Over the years the reinforcing bars in the concrete have also rusted causing more concrete spalling and creating unsafe conditions with rusty bars sticking out of the wall.

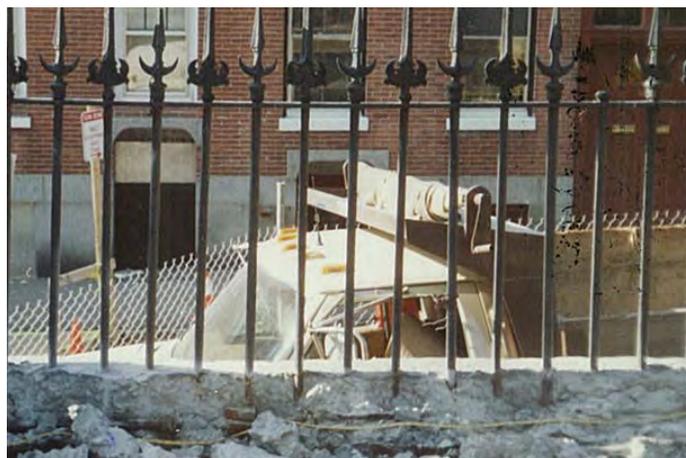
A photo from the 1992 Hull Street fence restoration shows the old concrete capstone partially removed. Notice the rusty picket ends.

capstone replaced by a new, correctly configured capstone in 1992. Our goal would be to match this capstone.

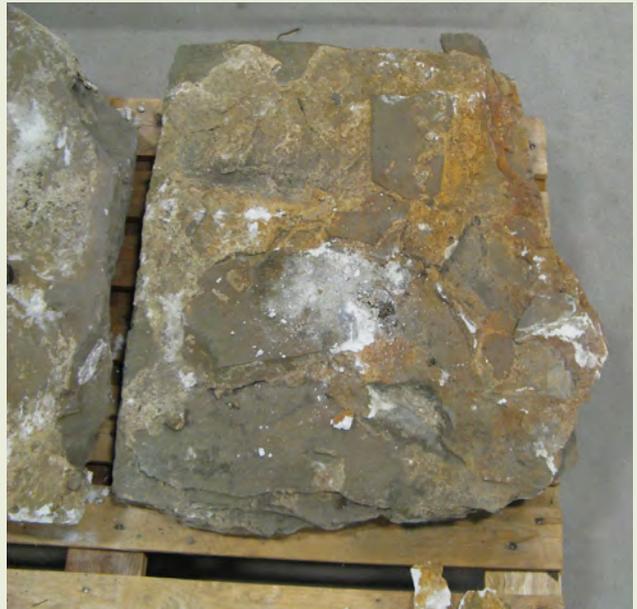
This headstone fragment was found in 1989, mortared into the Bellingham-Sullivan tomb in the Granary Burying Ground.

Another solution for broken headstones has been to reuse them to repair something else, such as a tomb monument or a masonry wall. The Bellingham-Sullivan tomb in the Granary Burying Ground illustrates this method. The monument was built in 1808 and its original configuration was a pair of stone slabs supported by six legs each. However these legs became unstable at some point and in the early 20th century stabilization work was carried out on the tombs, rebuilding the bases out of brick. During a second restoration effort in 1989, the conservators found that a number of headstones and pieces thereof had also been incorporated into the tomb structure by masons during its first repair. Another example of the re-use of old headstones is in the low wall between the upper and lower grounds in Copp's Hill Burying Ground. In 2006 we repaired that wall. Upon dismantling the crumbling wall, a second, older, wall was found behind the first wall. The masons found several old headstones in this wall, some of them in perfect condition except for the mortar that was stuck to them. Those headstones were cleaned off and reset in the burying ground. We do not know how many other headstones are currently in use in the historic burying grounds as "masonry units." Headstones have also been found in some very curious places: used as a manhole cover on a Boston street, as a table, used to bake bread on and in a landfill in Connecticut.

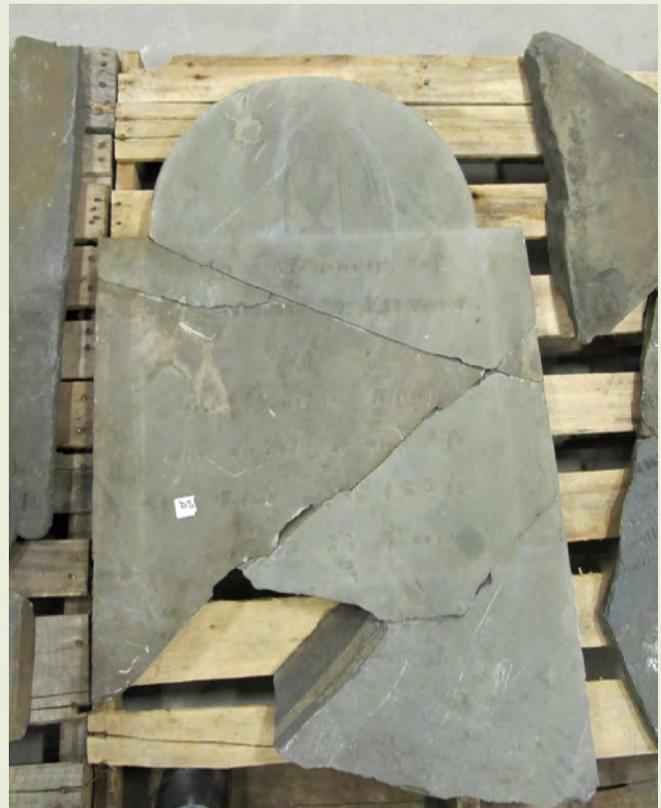
Six pieces of this gravestone have been located and put together. Hopefully the other pieces will be found. This stone is a category 3.

- Category 1) Able to be reset in site as is
- Category 2) Able to be reset in site with minor conservation work
- Category 3) Able to be reset in site with more complicated conservation work
- Category 4) Fragment with carving, unable to be reset
- Category 5) Fragment without carving, site known, unable to be reset
- Category 6) Fragment without carving, site unknown, unable to be reset.

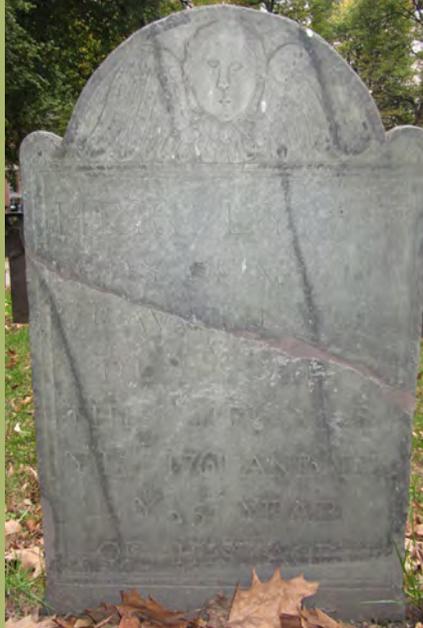
This stone was repaired in 2004. There was one break across the front of the stone. It was re-adhered with a combination of epoxy to attach the pieces and a special mortar to fill any areas of lost stone along the break. This treatment was very successful and is in perfect condition. Clean breaks across the middle of a stone are usually easier to repair than those which run across the top edge or those which involve delamination of the slate.

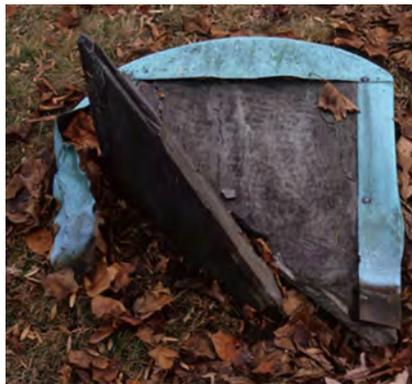
This headstone was repaired in 1991. Here is the same headstone in 2005. What happened? The epoxy used in this repair was not resistant to ultra-violet light. Most of the grave markers conserved with this material did not hold up. Today we would use a different epoxy which would last longer.

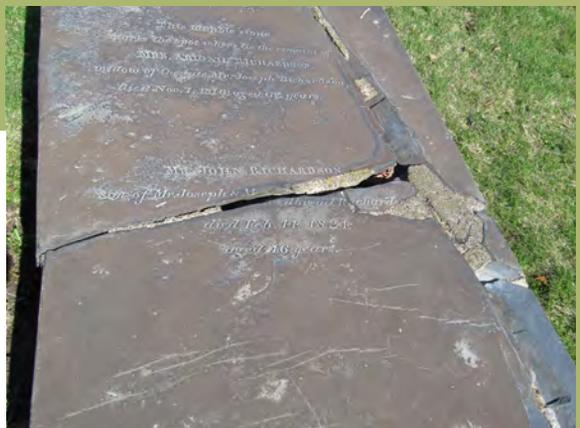
This headstone in Walter Street Burying Ground was encased in a new slate frame. This is an attractive setting but slate is expensive. Also when water manages to get between the gravestone and the frame, it can cause a lot of new damage.

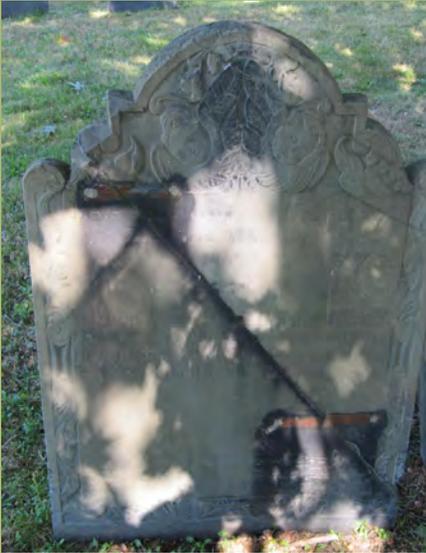
At one point this stone was repaired with iron straps. To prevent future degradation of the stone from the rusty iron, the straps were removed, the holes were filled with mortar and the two pieces were reattached with epoxy.

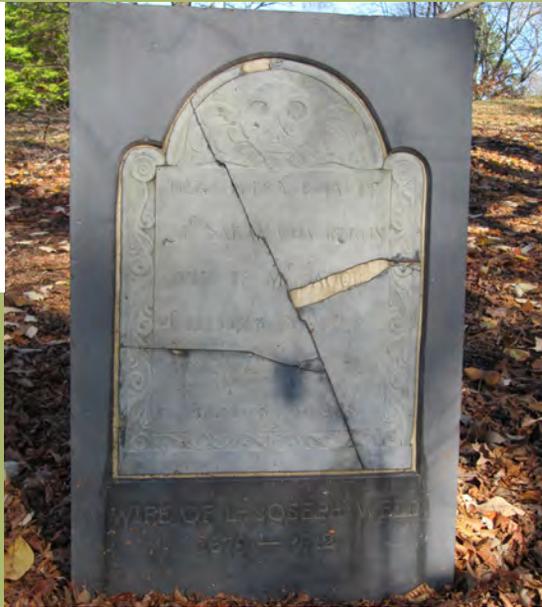
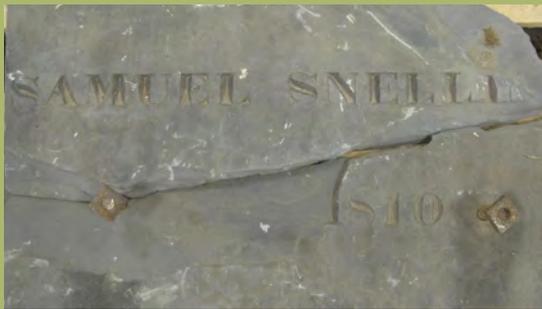
This tomb plaque from the fragment collection used to be bolted to a wall. The large crack goes through the bolt hole. This is a typical failure point. Making a hole in the slate creates a weak point. The bolts can rust, causing additional problems.

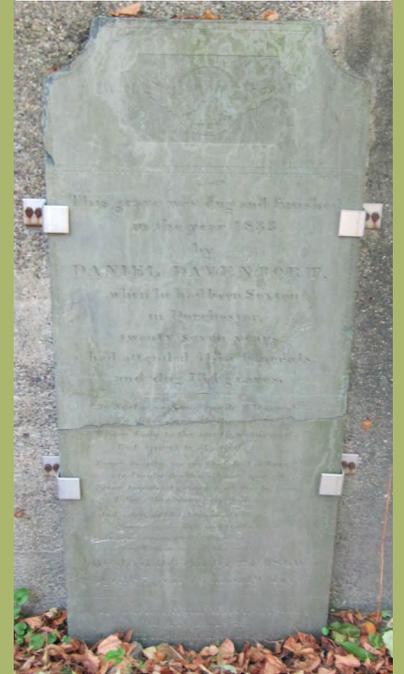
This large headstone at Dorchester North Burying Ground was attached to the wall by using stainless steel brackets. It is broken in the middle and at ground level. No holes were drilled into the stone. It is nearly 5 feet tall. It commemorates Daniel Davenport, a sexton in Dorchester from 1806-1857. According to his epitaph he buried 1,837 persons.
