# **Project Team**

- Take a landscape rehabilitation approach to address several key issues in the Ward's Pond and Nickerson Hill area of Olmsted Park (Project Site)
- Understand the historic design intent and landscape evolution of the project site in order to preserve and bring historic integrity back to the Project Site.
- Identify and implement opportunities to combine landscape preservation and environmental enhancement.
- As a pilot project, apply principles and lessons learned to future Emerald Necklace park improvement projects.

**Landscape Improvements Project**

Community Meeting - May 10, 2017

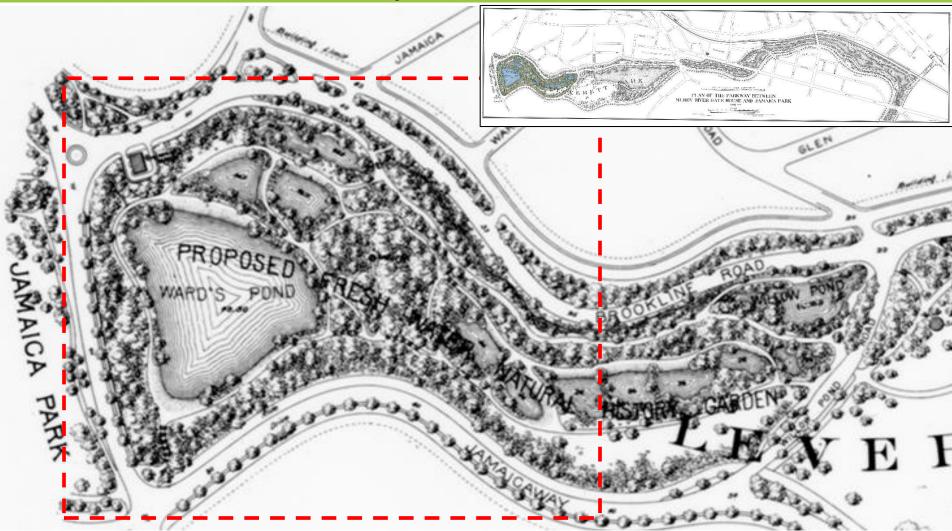
Plan of the Parkway Between Muddy River Gate House and Jamaica Park 1892, Frederick Law Olmsted

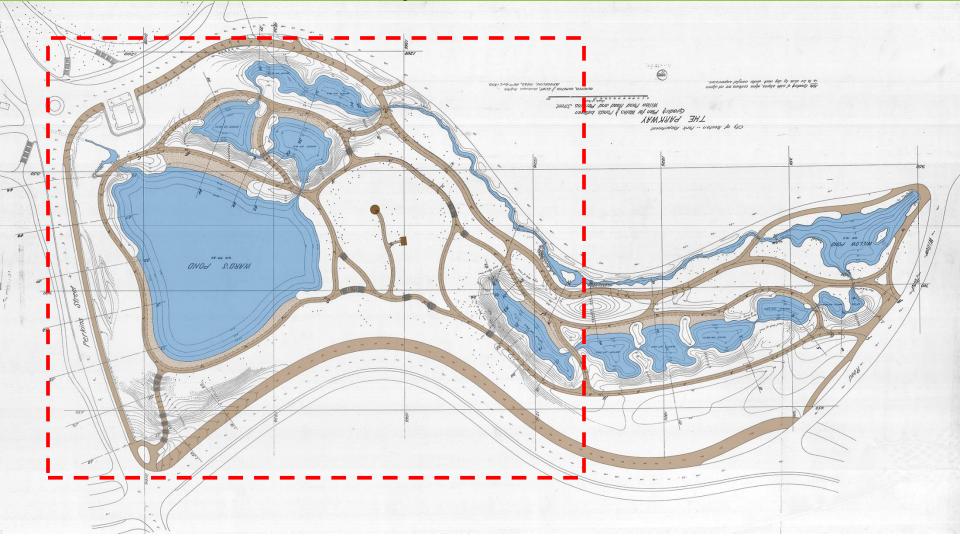
The Parkway – Grading Plan for Walks and Ponds between Willow Pond Road and Perkins Street 1893 Olmsted, Olmsted, and Eliot. (rotated)

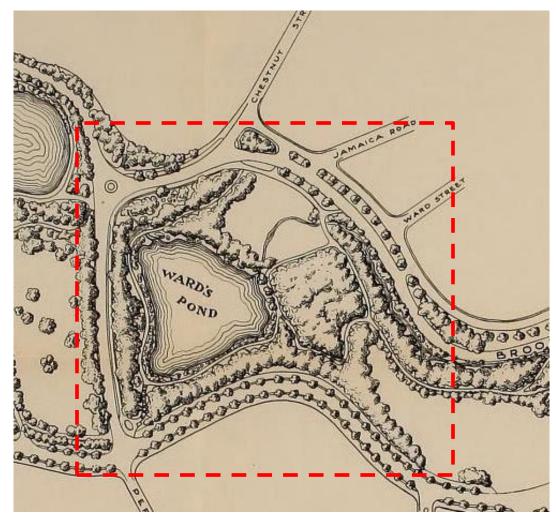
1900 Olmsted Park Plan

- Two natural history pools at Willow Pond.
- Path from Ward's Pond to Chestnut

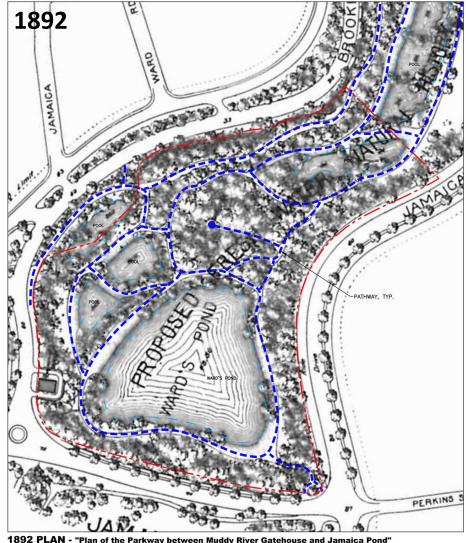
1892 PLAN - "Plan of the Parkway between Muddy River Gatehouse and Jamaica Pon

**EXISTING CONDITIONS PLAN WITH 1892 PATHS OVERLAY**

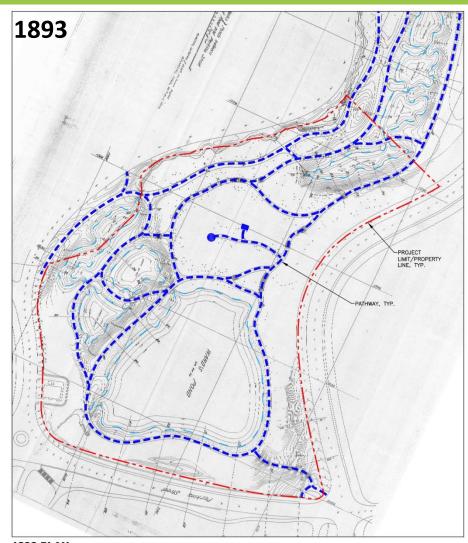
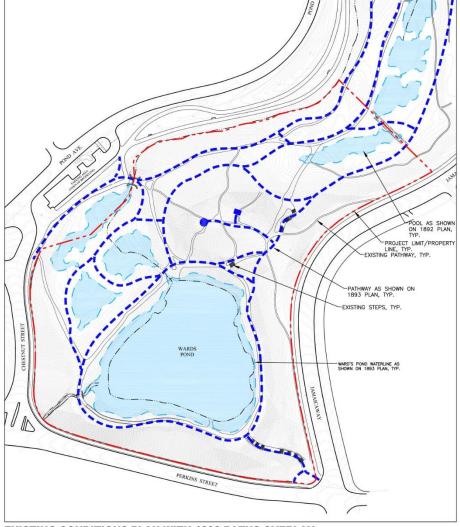
1893 PLAN - "The Parkway - Grading Plan for Walks and Ponds between Willow Pond Road and Perkins Street"

**EXISTING CONDITIONS PLAN WITH 1893 PATHS OVERLAY**

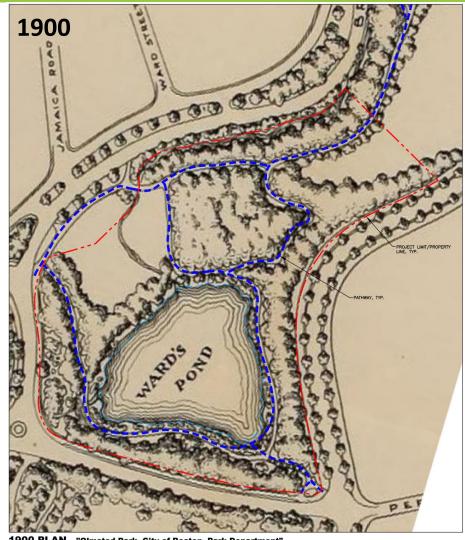
1900 PLAN - "Olmsted Park, City of Boston, Park Department"

**EXISTING CONDITIONS PLAN WITH 1900 PATHS OVERLAY**

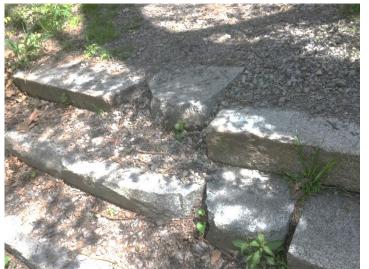
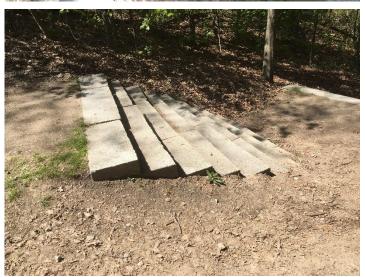
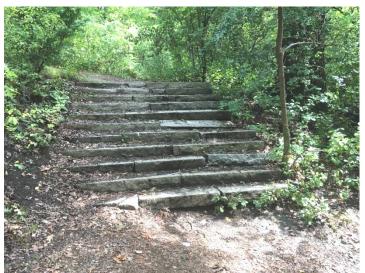
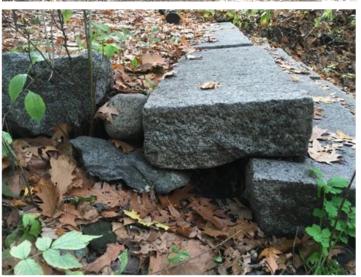
# Site Rehabilitation – Infrastructure - Historic Stairways

- Most stairways require granite resetting and replacement.
- Must be reset for long-term stabilization.

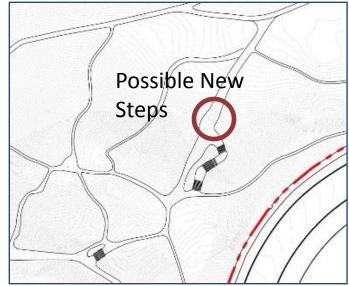
Steep Area of Path on north side of Nickerson Hill – Possible new steps

- High priority tree pruning
- Significant focus on infrastructure improvements
  - Historic granite steps resetting/tread replacement plus addition of new risers to improve path grades at top and bottom of steps
  - New set of granite steps on north side of Nickerson Hill
  - Paths improvements (surfacing; grading; clearances; accessibility)
  - Partial path closures on Nickerson Hill
  - Improvements at Perkins St./Jamaicaway entrance (path surfacing; drainage)
  - New plantings as needed in areas of infrastructure improvements
