**Report for Intensive (Locational) Archaeological Survey of the Old North Church Crypt,  
Boston (North End), Massachusetts**

Joseph Bagley  
Jane Lyden Rousseau

2018

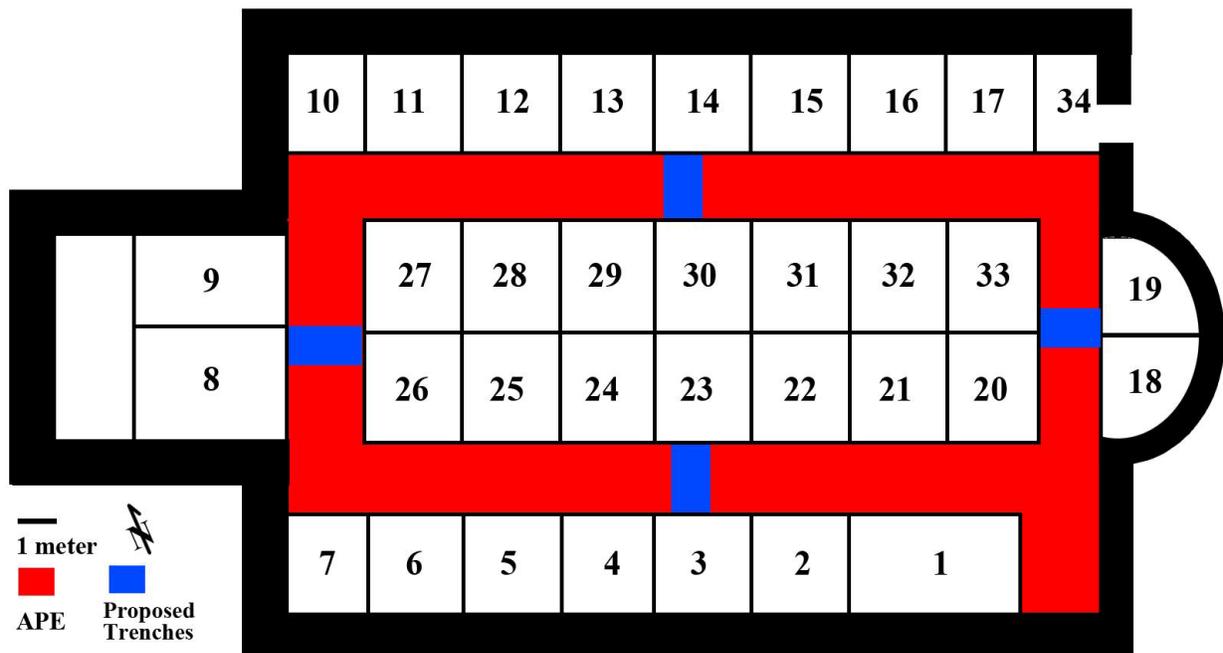
Figure 2: Map of Old North Crypt showing walkway (red), tombs (numbered) and proposed location of excavation trenches (blue).

Initial phases of the work included two primary goals: to lower the floor of the Crypt's walkway (Figure 2-3) to increase clearance within the space for visitor safety, and document the conditions of the doorways to individual tombs where rust, rotting wood, and other condition issues make stability of the tombs and their contents an issue.

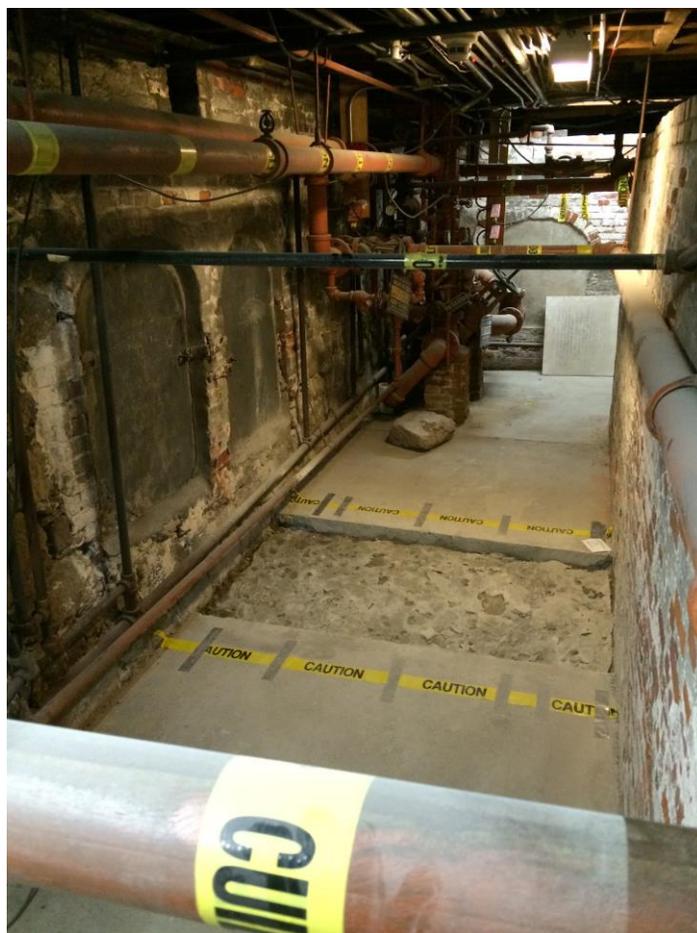
Figure 3- View facing North of the western walkway area. Unit 3 visible in floor. Note the utility lines obstructing easy mobility within the space. The arched doorways of Tombs 8 and 9 are visible on the left. From left-right, unit cut into floor is 180cm wide.

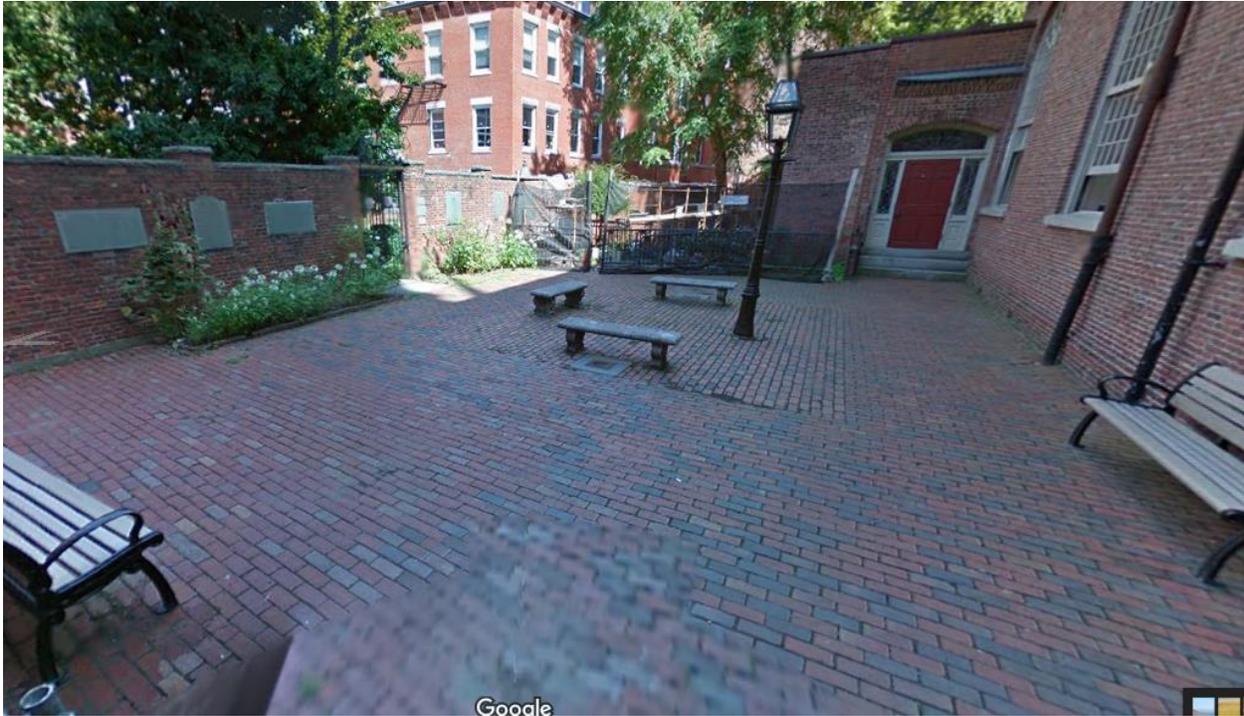
Figure 7- Washington Courtyard facing east with Old North to the right (2013 Google street view). Small crypt vents are visible along base of Old North between red door and downspout. This property was built on land transferred in 1726 (Suffolk County Deed Book 40, pg. 58), though the church itself was built in 1723. As the property was transferred after the construction of the church, it is not known what, if anything, was erected on the property, prior, and there is no mention of structures on the property in the deed transfer indicating that it may have been undeveloped at that time. The church has remained in the same footprint since its construction.

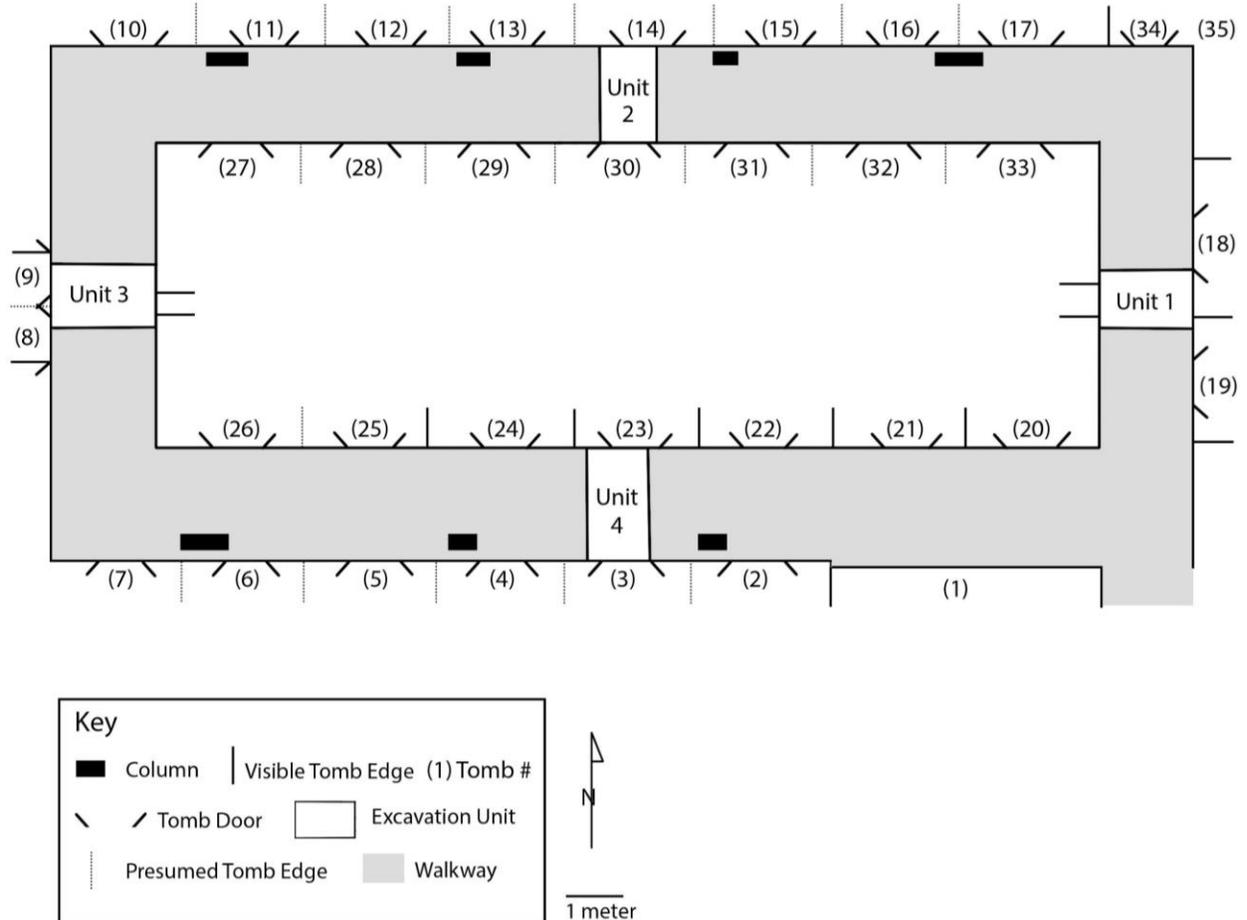
Old North Church Crypt  
Plan of 2017 Excavations

Figure 10- Scale drawing of Old North Church crypt walkway showing edges of existing tombs, tomb doorways, walls, columns, and the location of the four test units.

The project APE consisted of the entirety of the walkway of the crypt under Old North Church. After consultation with the City Archaeologist, Old North Church Foundation Executive Director and Old North Vicar, Stephen Ayres, instructed private contractors to cut 1-meter wide trenches through the concrete near the center point of each of the four walkways in the crypt. A plan drawing of the crypt (Figure 10) indicates the location and size of each of these units. The trenches/units were numbered 1-4 beginning on the eastern walkway and continuing counterclockwise.

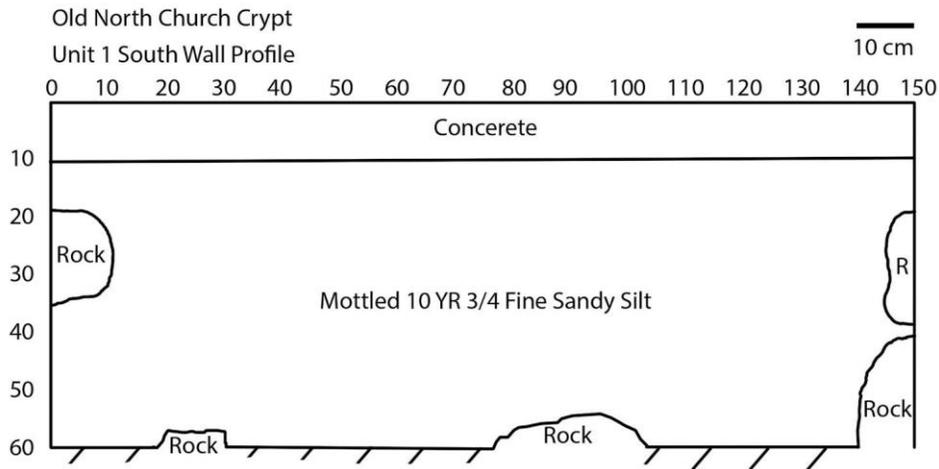
Figure 11- South wall profile of Unit 1, Old North Church crypt.

Two strata were encountered in Unit 1 (Figure 11). Strata 1 consisted of the existing concrete walkway, which was removed prior to the arrival of the survey team. No artifacts were collected from this strata. Strata 2 was a dark yellow-brown fine sandy silt. Excavations stopped at 60 cmbs as proposed in the archaeological permit with the assumption that if burials existed within the floor of the crypt, their presence would be visible by this depth. No evidence of grave shafts was encountered.

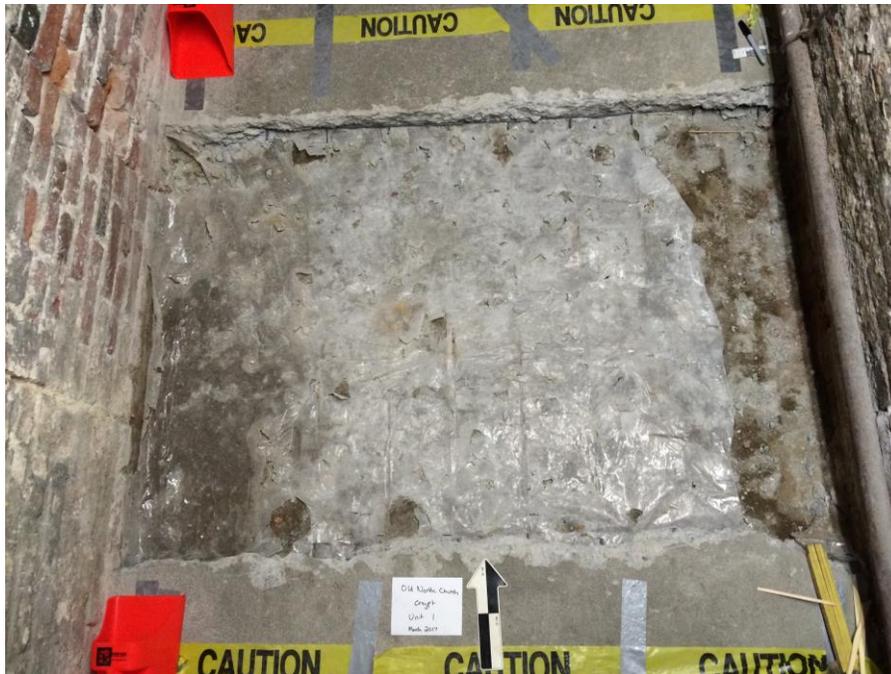
Figure 12. Unit 1 showing plastic just under concrete layer. North arrow is 20 cm long.

Just below the concrete and metal mesh was a layer of plastic, assumed to be a vapor barrier placed in the 1960s just before the pouring of concrete. When the plastic was removed a layer of very compact soils was encountered with pockets of mortar dust (Figure 12).

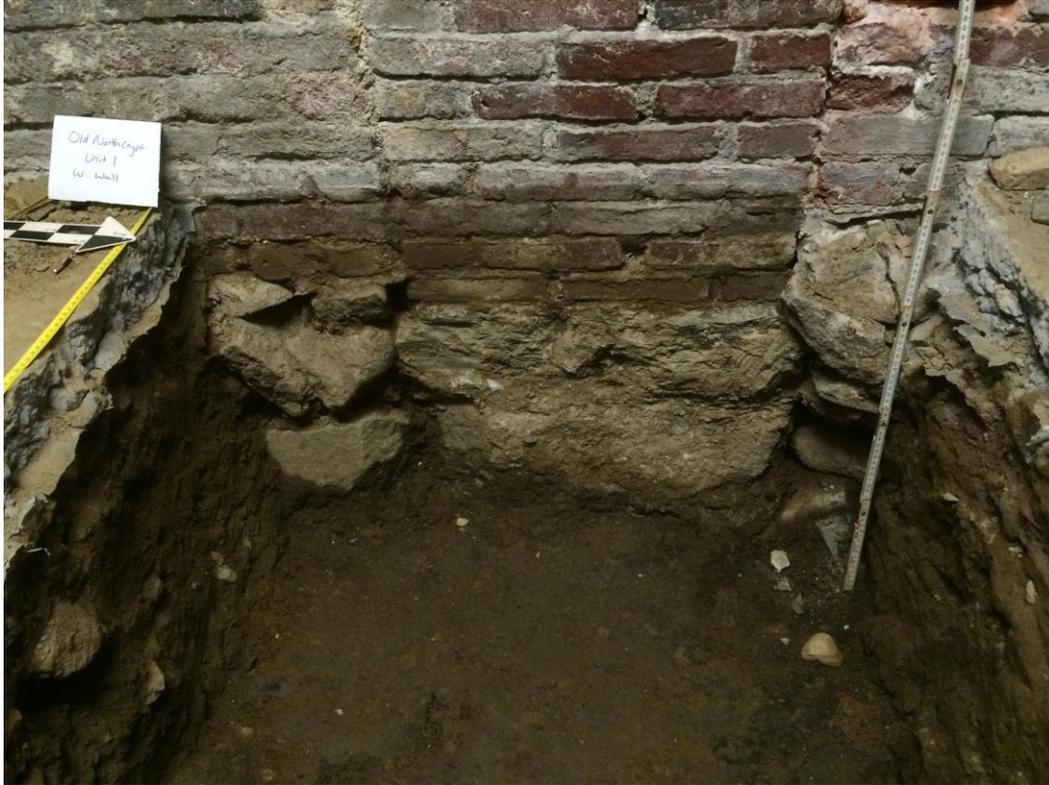
Figure 13- West wall profile of Unit 1 showing foundation of central wall in crypt (center) and stone foundation of Tombs 20 (left) and 33 (right). Depth from bottom of measuring tape to surface is 50 cm.

The soils themselves appear to be disturbed, with the foundations of the abutting tombs extending below the 60 cmbs depth of the unit (Figure 13) suggesting that the soils excavated in Unit 1 were likely disturbed during the construction of the tombs themselves. If graves existed within the floor in this area, their presence may be obscured by disturbances done to the ground during tomb construction, but as the floor lower will not go below these disturbances, no intact grave shafts will be disturbed in this area of the crypt, if they were ever present, with the proposed lowering of the crypt floor plans.

As each tomb was created, it appears that fieldstone were used for below-grade foundations, with brick above. The profile in Figure 13 suggests gradual buildup of soils within the crypt walkway. The central column/wall in Figure 13 has a stone foundation slightly deeper than Tomb 20 (left) and significantly deeper than Tomb 33 (right).

Assuming Tomb 20 is earlier than Tomb 33, it would suggest approximately 10 cm of deposits accumulated in the crypt between the two tomb construction episodes. This also resulted in earlier wall elements having their brick components buried, which likely contributes to current issues with salt and water infiltration into the brick walls of the tombs.

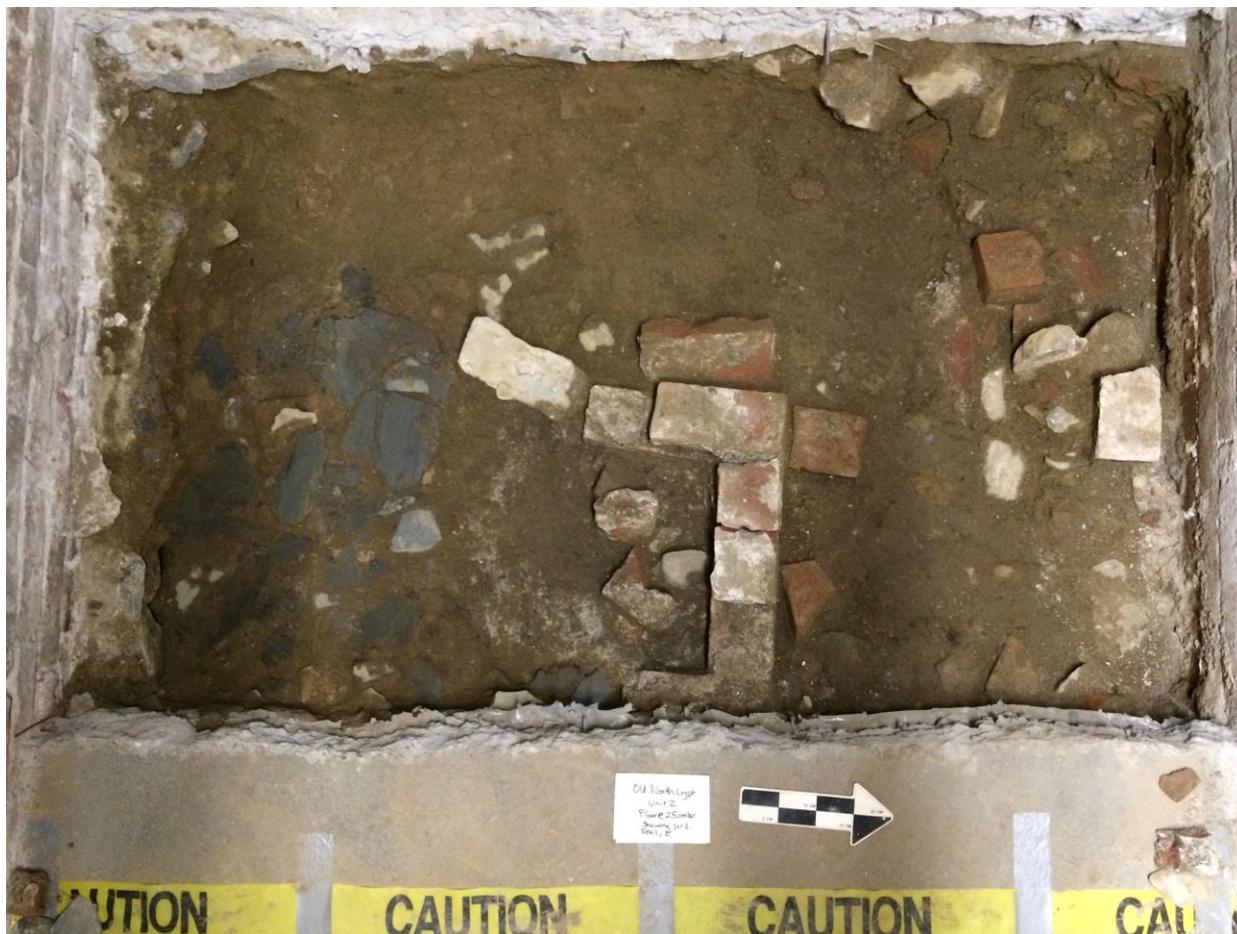
Figure 14- Plan of Unit 2 at 25 cmbs showing slate to south (Feature 2), mortared brick in center (Feature 1), and demo debris to east. Arrow is 20 cm long.

slate fragments were encountered between 15-20 cm suggesting the presence of a floor at some point that was later removed leaving behind a rind of slate mortared to stone foundation walls (Figure 14)

The square-shaped brick wall element was labeled Feature 1 with the slate area labeled Feature 2.

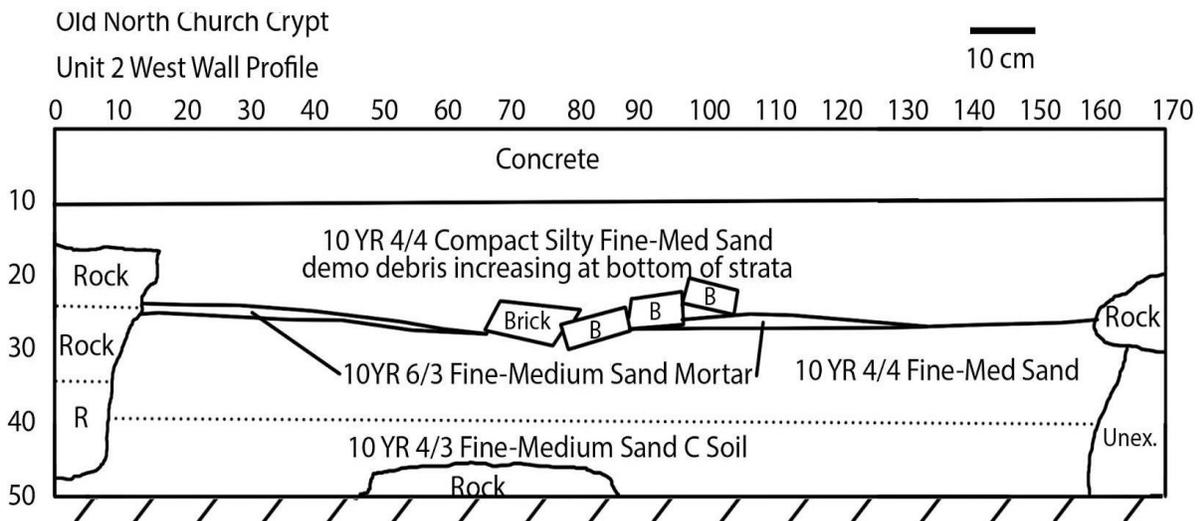
Figure 15- West wall profile of Unit 2.

The unit appears to have two main strata (Figure 15), a compacted fill that was once covered in a slate floor and rubble fill (Features 1 and 2), all over a C soil (Strata 4). As the Old North Church was built into Copps hill, this suggests that excavations will encounter deeper natural soils within the units as the foundations were excavated further into the hill as they progressed westward. Unit 2 suggests that the floor of the crypt in this area was C soils prior to the construction of tombs in the crypt.

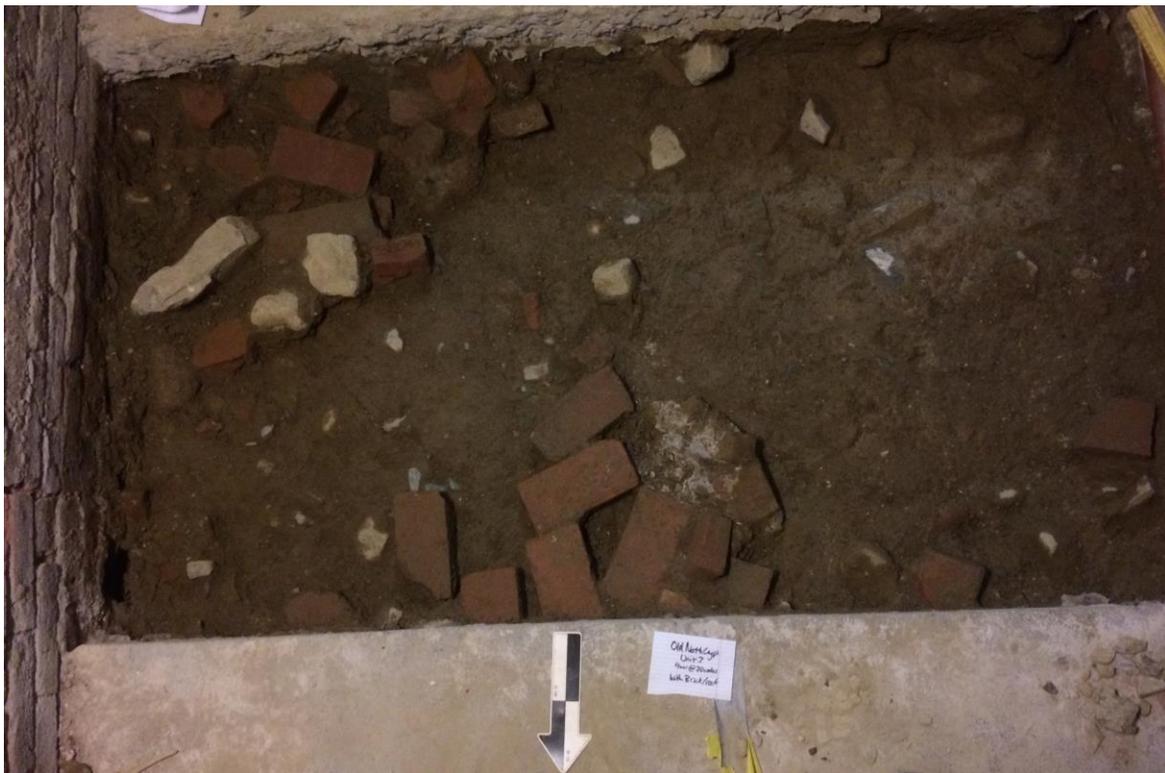
Figure 16- Unit 3 at 25 cmbs showing bricks and clay substrate. Arrow is 20 cm long.

The first 10 cm of the unit were the concrete floor, but soils were only excavated to a depth of 30 cmbs due to the presence of large quantities of water. Just below the concrete was a greenish clay deposit embedded with large quantities of brick (Figure 16).

Though the bricks appeared as a single layer, it was not entirely clear if they represented a path or a general scatter. The moisture in the soil suggests that they may have been deliberately placed onto the walkway to provide slightly dryer areas to walk if groundwater seeped into the floor making the clay slippery.

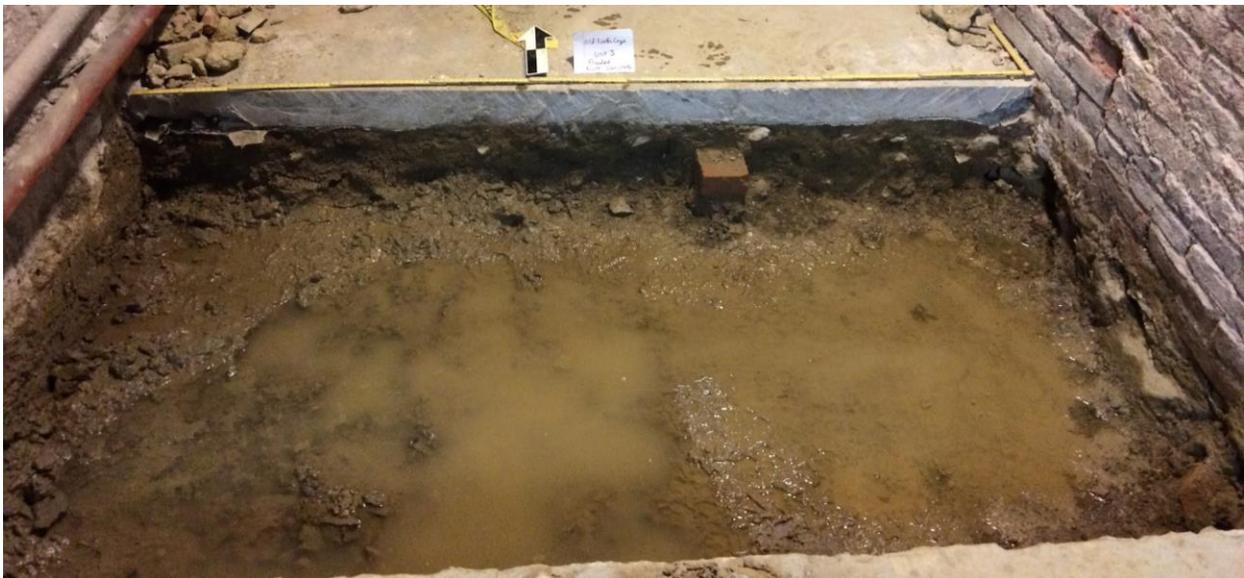
Figure 17- Standing water in Unit 3

At 25 cmbs, bands of iron began to be visible in the clay suggesting the clay was subsoil, but large quantities of water seeping into the pit made further excavation and confirmation of C soil impossible. Besides the depth of the excavation of the foundation into the Copps hillside, which could increase the likelihood of reaching groundwater saturation, a leaking pipe nearby likely contributed to the overall saturation of the soils in this area of the excavation (Figure 17-18).

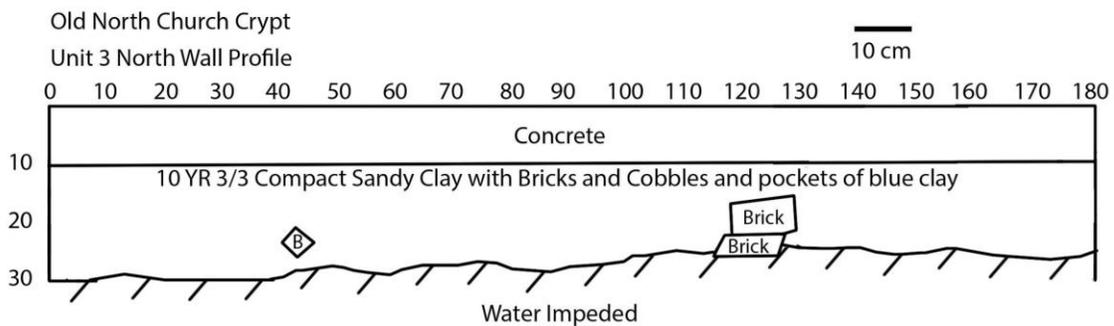
Figure 18- Profile of Unit 3

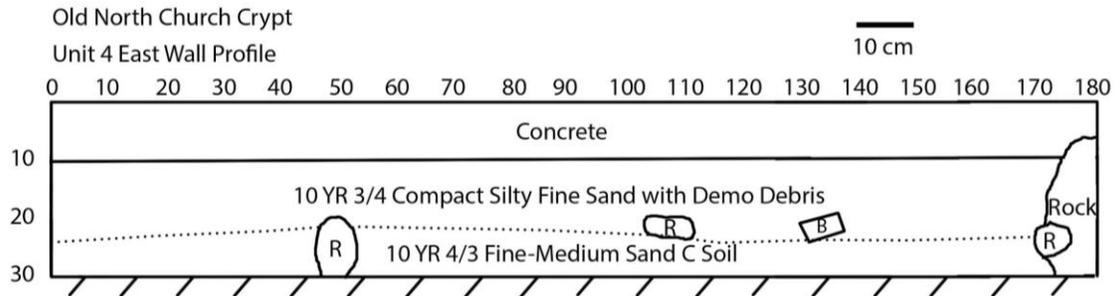
Figure 19- Profile of Unit 4 in Old North Church crypt.

Unit 4 was located on the southernmost end of the walkway. It contained just three strata and the fewest artifacts at 82, total. Strata 1 was the concrete layer, and Strata 2 was a mixed deposit, likely present while the walkway was active. The disturbed layer with demo debris transitioned into C soil, similarly to what happened in Unit 2 (Figure 19). This stratigraphic profile confirms the hypothesis that the foundations of Old North cut deeply into natural soils of Copps Hill exposing sterile subsoil in the central and western ends of the church foundation.

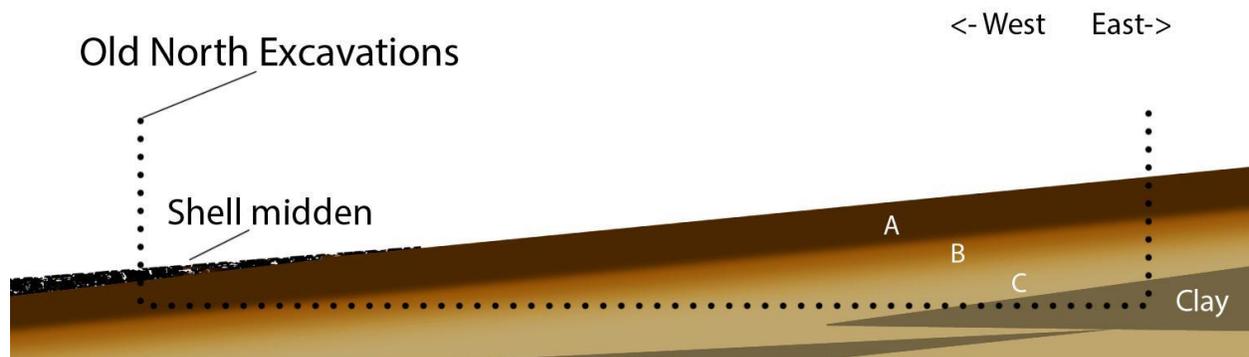
Figure 20- Hypothetical east-west cross section of Old North showing reconstruction of original soils and slope of hill where Old North was built including possible shell midden, and C soils consisting of varying beds of clay and sand.

Stratigraphy of the units suggests the original landscape of the North End prior to the construction of Old North. There may have been a Native American shell midden present near the rear of Old North Church prior to the construction of the church. In the easternmost end of the property some soils were mixed to the ground in order to build up the crypt surface, possibly including a shell midden. Near the center point of the church, excavations exposed the sandy C soils under the topsoil of the hill, with deeper glacial clay lens deposits present in the western end of the excavations. A hypothesized soil profile of the eastern slope of Copps Hill is shown in Figure 20.

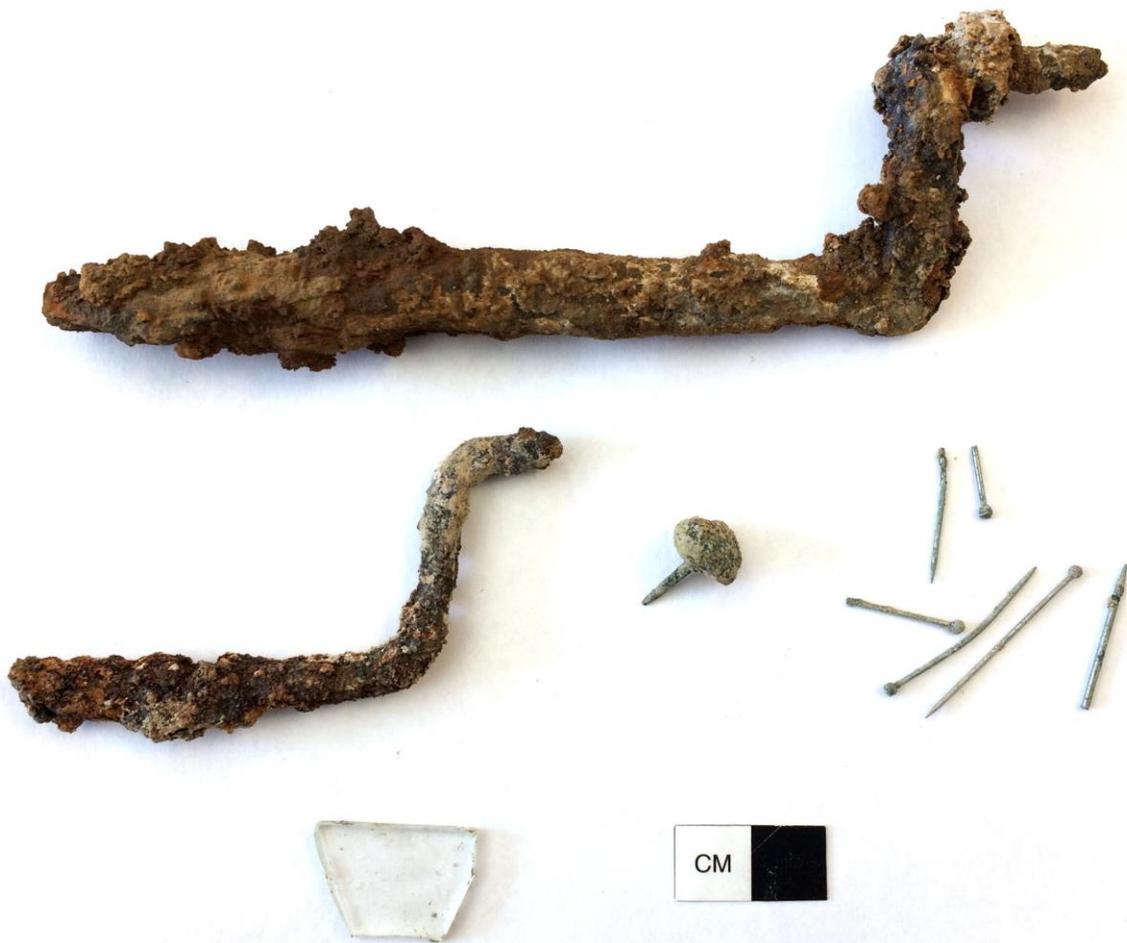
Figure 21. Sample of possible coffin/burial-related goods. Top to bottom, left to right: coffin handle (Unit 2 ONC.016.001), coffin handle (Unit 4 ONC.027.023), tack (Unit 4 ONC.027.008), pins (Unit 4 ONC.027.010), and window glass

In total 668 artifacts were found within the excavation units. The majority of these were nails and animal bones. Although the crypt floor was exposed in the 1960s prior to cement being added, there is a relative lack of later materials within the excavation units. Late 18th and early 19th century Westerwald, pearlware, and tin-glazed earthenware were the most common, datable ceramics, which aligns well with the c. 1730-1840 use of the crypt, but artifact density was very low in the crypt. All artifacts could be associated with visitors to the tombs, fill deposits, or the eating or depositing of food within the crypt for some unknown reason. No clear funerary practices outside of the coffin hardware can be determined from these artifacts.

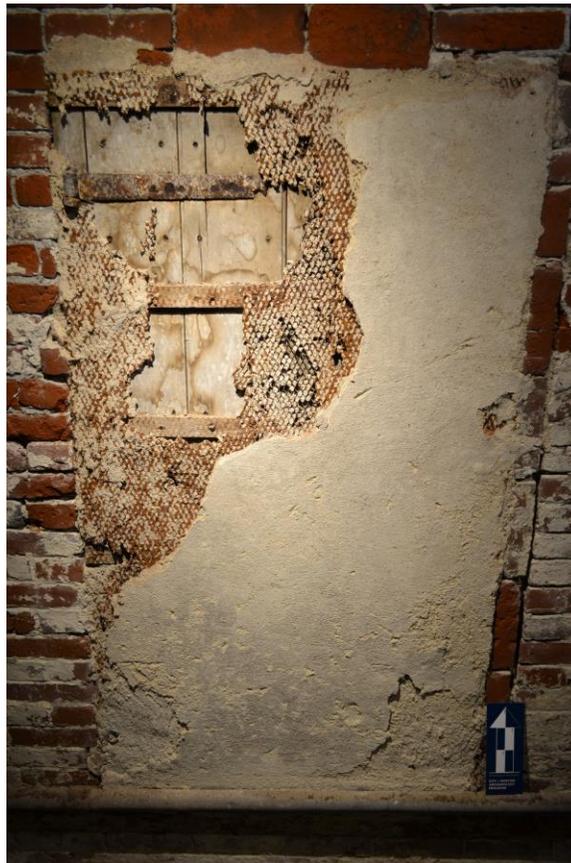
Figure 22- Door to Tomb 12 prior to opening. Scale in lower right is 15 cm long

On the morning of the opening, the door of Tomb 12 was as it appears in Figure 22 with partial elements of mortar and wire mesh over wood lathe. The wooden door and iron hinge were partially visible.

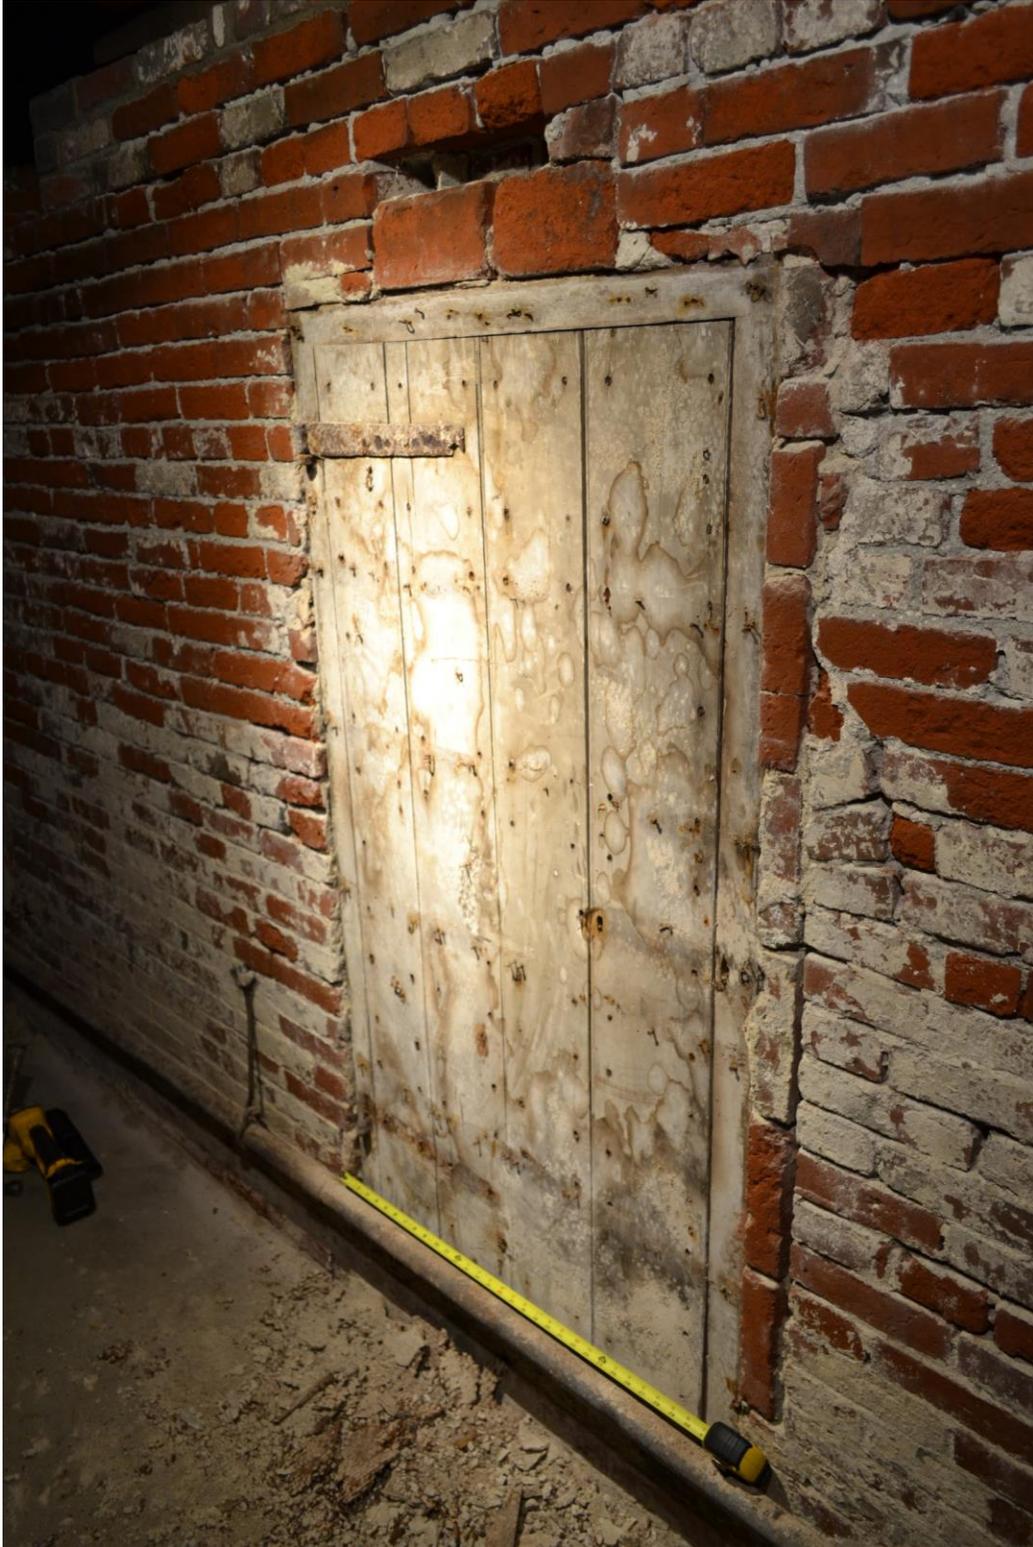
Figure 23- Tomb 12 door after removal of mortar, metal mesh, and lathe. Exposed yellow portion of Measuring tape is 75 cm in length.

After removing mortar, mesh, and wood lathe, the door of Tomb 12 was fully exposed (Figure 23).

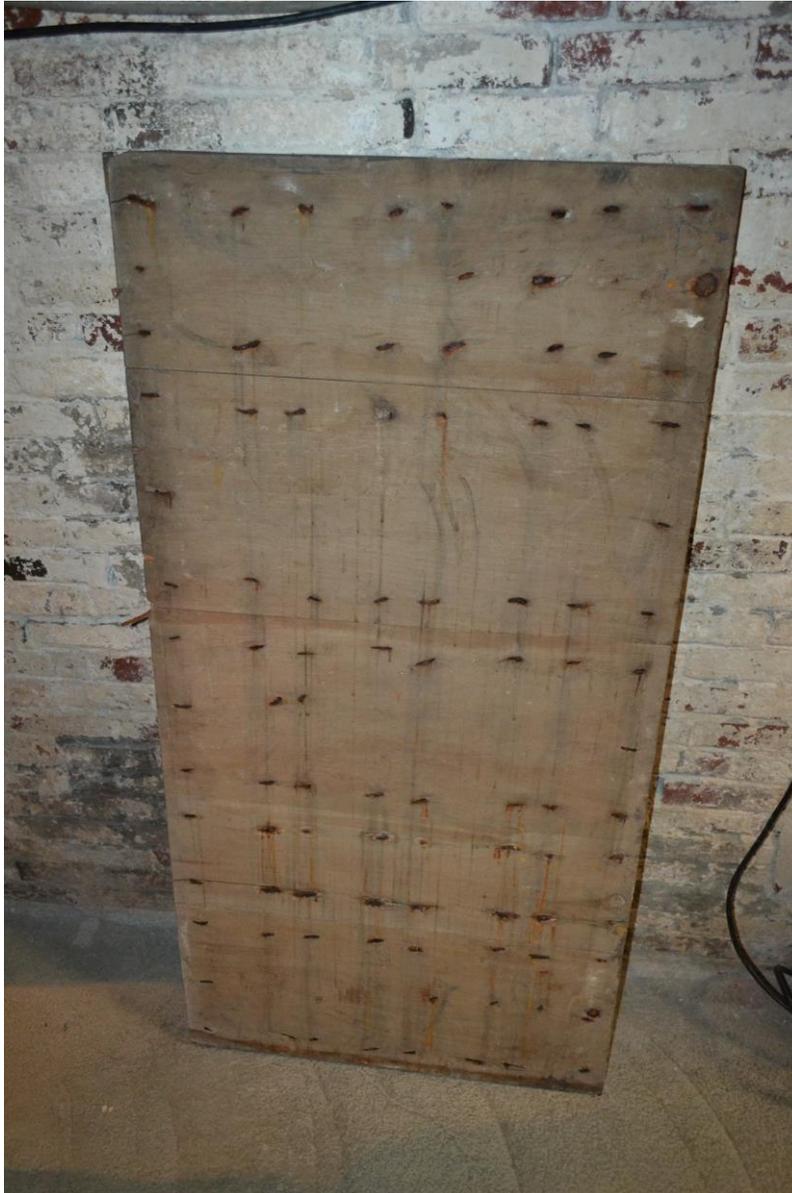
Figure 24- Interior of Tomb 12 Door. Note cinched wire nails. Door measures approximately 32x50 inches (75x125 cm).

The door to Tomb 12 consists of an interior layer of five horizontal boards, approximately 1" thick each, and varying in width from between approximately 8 to 12 inches. These were sandwiched with four exterior boards measuring approximately 1" thick and each measuring approximately 7 inches wide. These two layers were held together by wire nails cinched on the interior side. The presence of wire nails likely confirms the earlier hypothesis that this door is a replacement door installed in 1912.

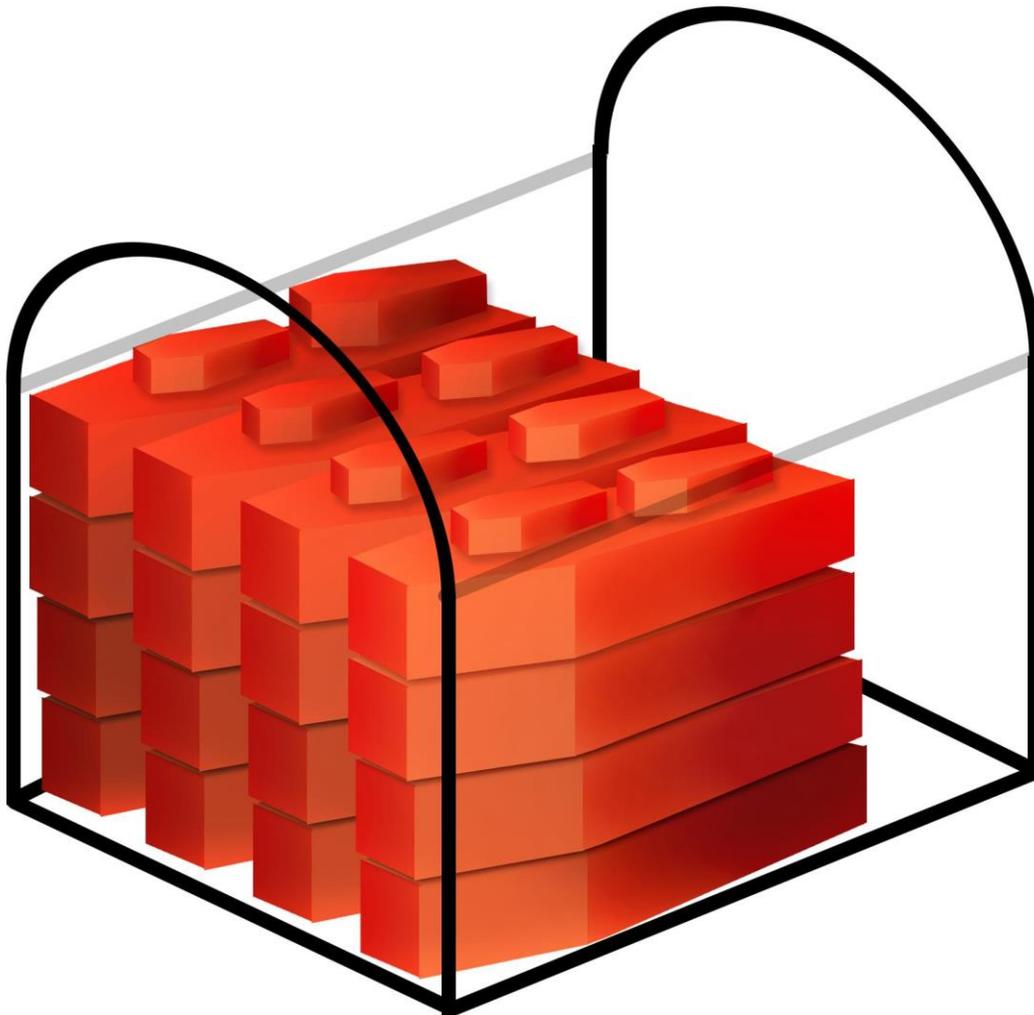
Figure 27- Hypothetical reconstruction of the contents of Tomb 12 prior to coffin collapse. Door to left near heads of coffins.

Adult-size Coffins appear to have been originally placed into four stacks of four coffins stacked close to the opening of the tomb allowing for a cap at the tomb's rear. The coffins were stacked to the height of the wall transition to arched roof with smaller children's coffins placed on top of the larger adult coffins within the arch of the tomb (Figure 27). For the purpose of discussion, the stacks of coffins will be numbered 1-4 from west to east.

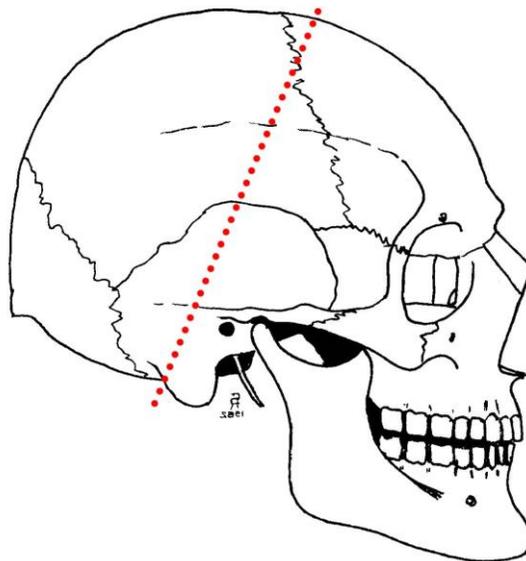
Figure 40- Illustration of coronal cut of Individual 1.
