HISTORIC FACADE RESTORATION

14 BEACON STREET
BOSTON, MA 02108

NORTH ELEVATION MARBLE CONDITIONS

A-201

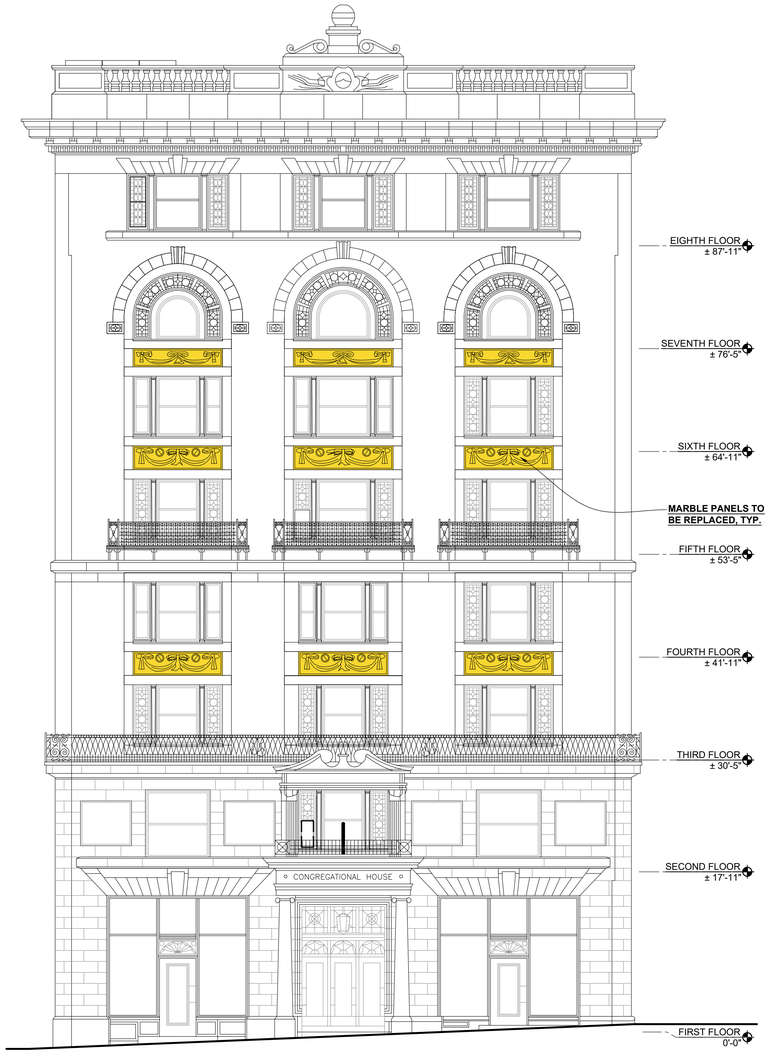
1 NORTH ELEVATION - BEACON STREET
1/8"=1'-0"

DEBRIS NETTING INSTALLED OVER
MARBLE PANELS IN EARLY 2025

TYPICAL MARBLE SPANDREL PANELS TO BE REPLICATED
NOTE: THIS PHOTOGRAPH IS FROM 2018 AND IS INCLUDED ONLY TO BETTER SHOW DETAIL AND EMBELLISHMENTS TO BE REPLICATED WITH NEW PANELS. PANELS HAVE SINCE DETERIORATED FURTHER AND ARE NOW BEYOND REPAIR, SEE THE OTHER PHOTOGRAPHS ON THIS PAGE

ENLARGED VIEW OF MARBLE SPANDREL PANEL TO BE REPLICATED

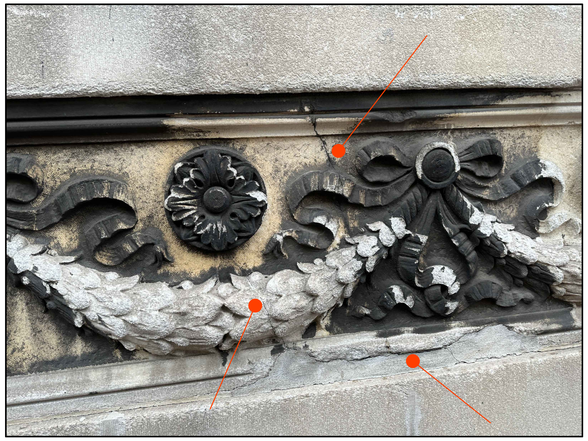
TYPICAL SEVERELY ERODED, SPALLED, AND CRACKED
MARBLE SPANDREL PANEL

TYPICAL SEVERELY ERODED AND CRACKED
MARBLE SPANDREL PANEL

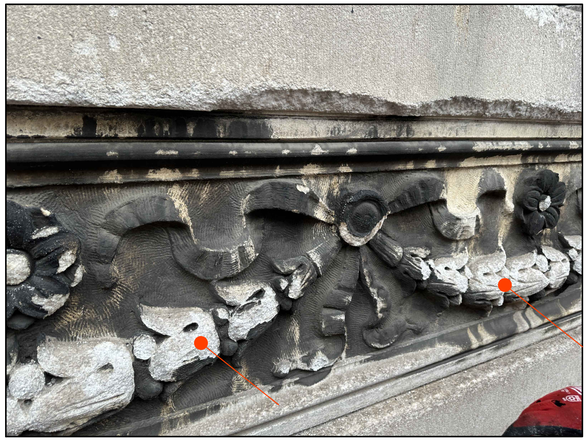
TYPICAL SEVERELY ERODED
MARBLE SPANDREL PANEL
