34 Beacon Street

PRESERVATION TECHNOLOGY ASSOCIATES, LLC

34 Beacon Street, Boston, MA
Condition of Entry Door
February, 2018

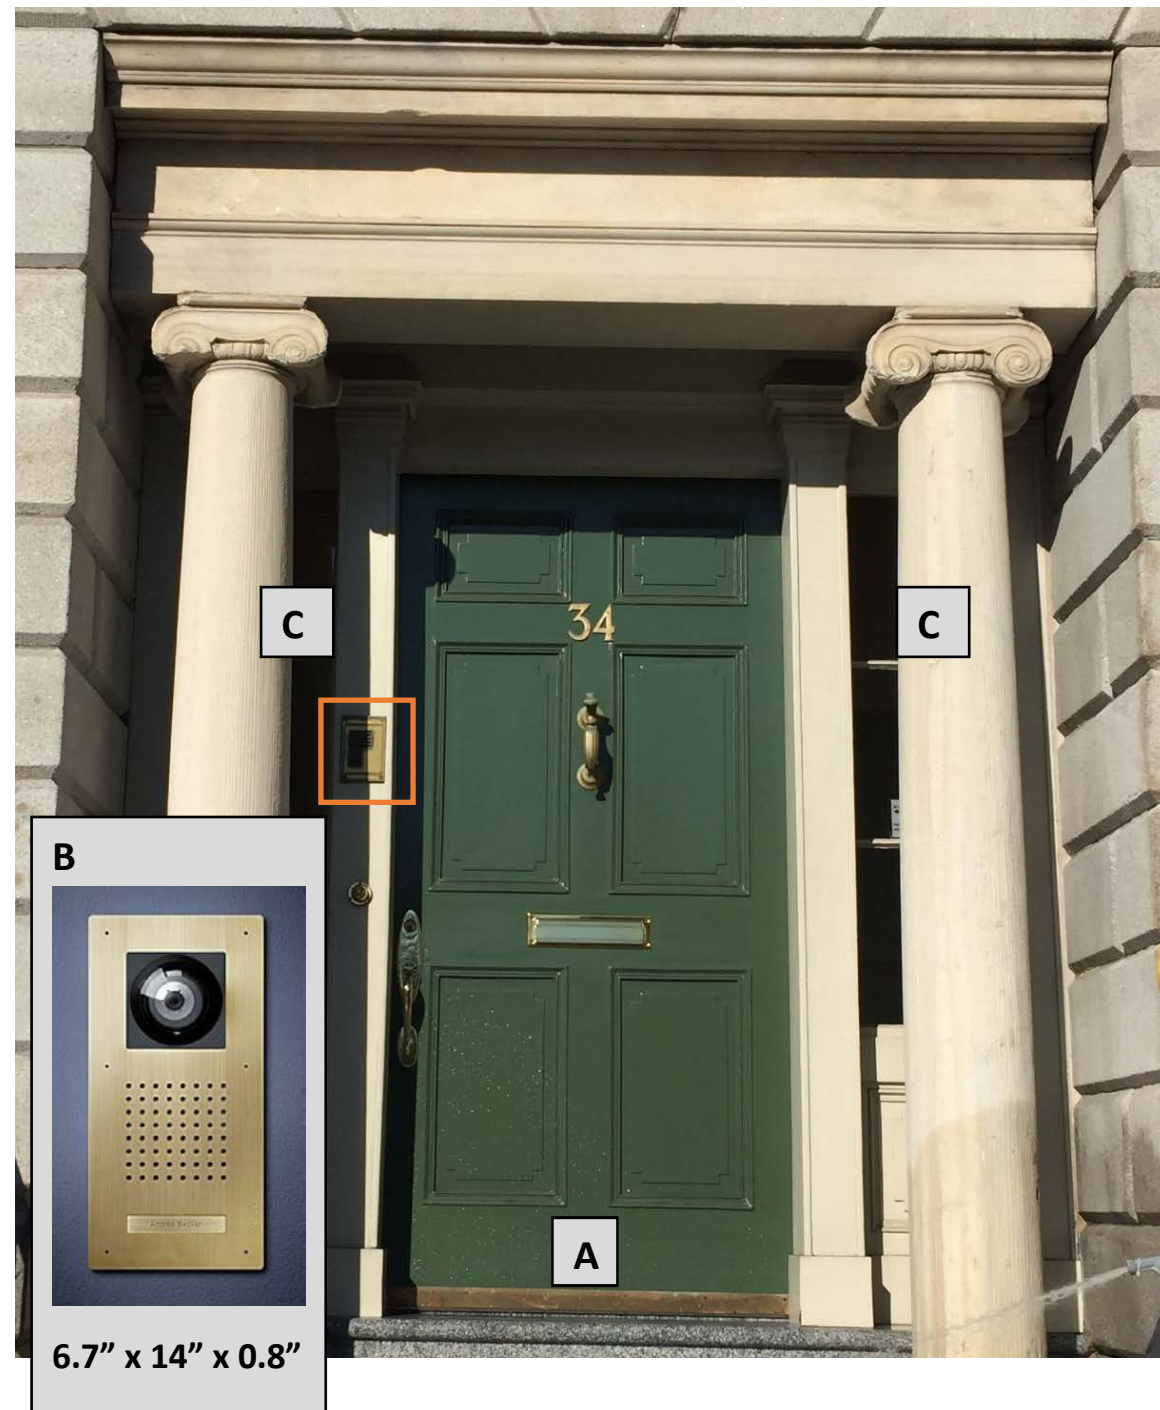
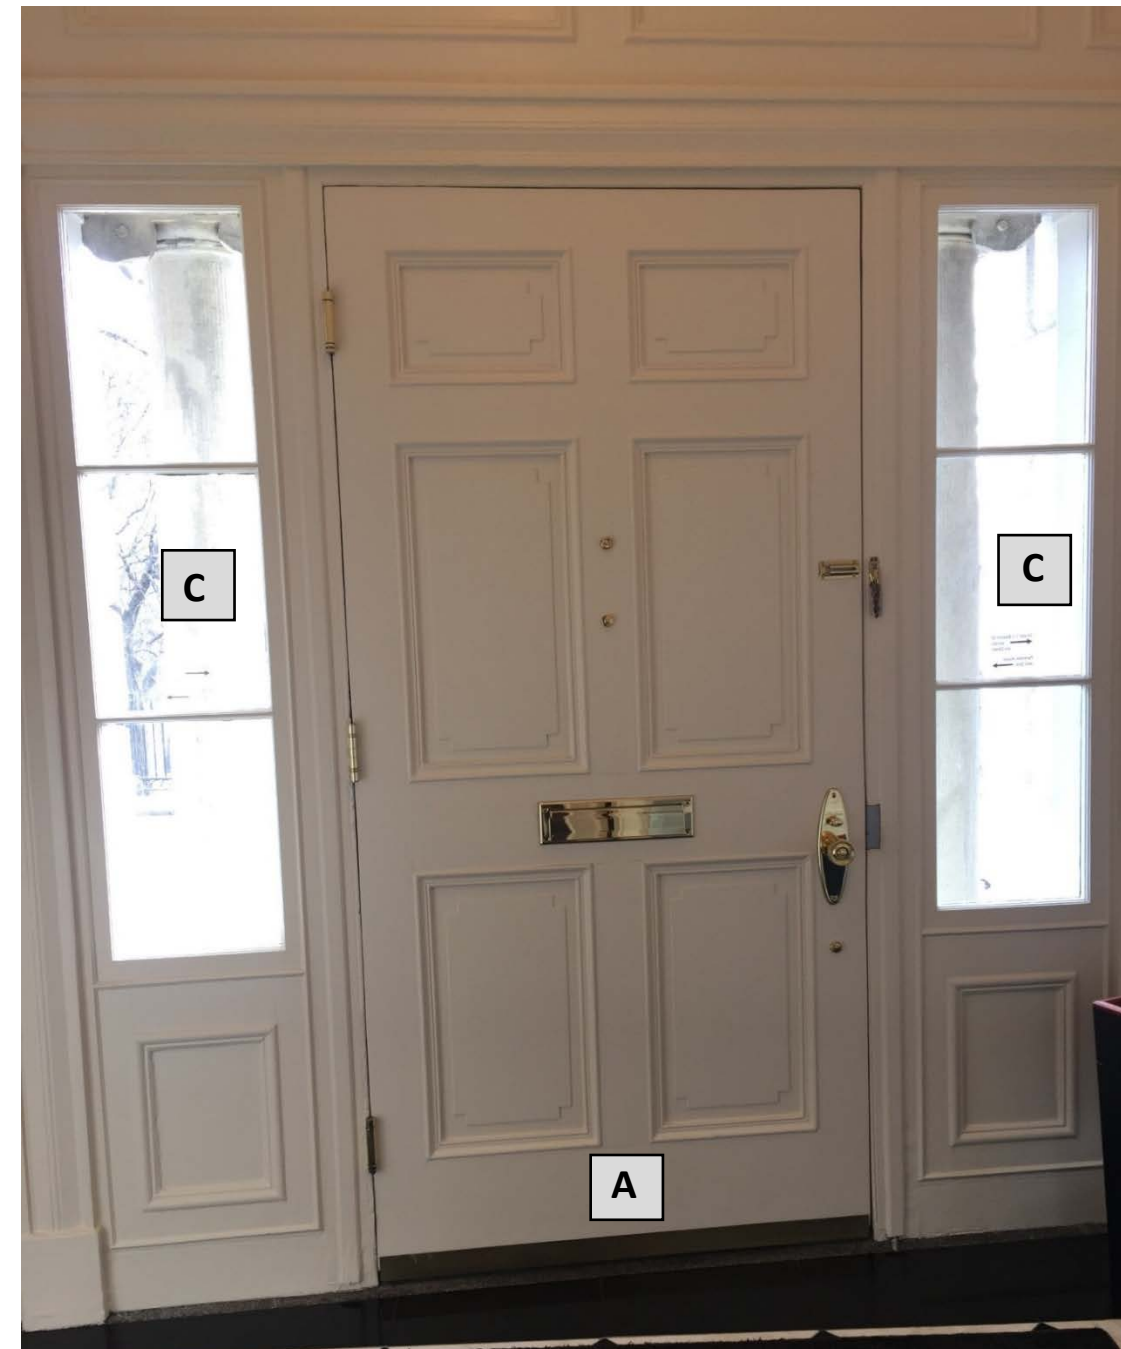
Front Entrance

- A. Per Preservation Technology Associates, report dated February 18'. It was found the entry door is currently in good and serviceable condition with little evidence of concern about strength or structure. Four samples were taken and inspected. Per recommendation, we propose to fully repaint the existing door including removing and replacing sealants between sections and moldings and minor consolidation and filling. This would require paint to be stripped and reapplied in these small areas. All paint to match existing.
- B. Upgrade intercom system with modern system. Finish to match.
- C. Replace (6) existing sidelight glass to laminated glass. For durability and security purposes. Putty color and installation to match.

Based on this examination we find that the door is in good condition, with little evidence of damage or concern about its strength and structure.

Cracks were noted in areas that were anticipated as a result of the cyclic thermal movement of the various components of the wood door such as the joining of the styles and rails and corners of moldings. Additional cracks were also noted at the center rail, some of which were very short. At the east end of this rail the crack was probed with a fine blade and found to be at least 3/4" deep, but no distress was noted on either side of the cracks and some of the cracking at the center rail may be the joining/lamination of boards to form this wider rail.

This inspection found the door to be in good and serviceable condition with no sign of weakness or excessive wear for a door of its age and type. The last restoration clearly stripped the paint and performed some level of repair. Most of that repair appears to be well done, with very minor exceptions at the very small areas noted that could have been consolidated before they were filled. At this time we recommend no additional treatment except for repair to paints or sealants probed during this inspection. Future work when full repainting is anticipated should include removing and replacing sealants between sections and moldings and minor consolidation and filling (paint must be stripped from these small areas to accomplish this work).
