CUSTOM HOUSE

Boston Landmark Commission Presentation

23 July 2019

SIMPSON GUMPERTZ & HEGER

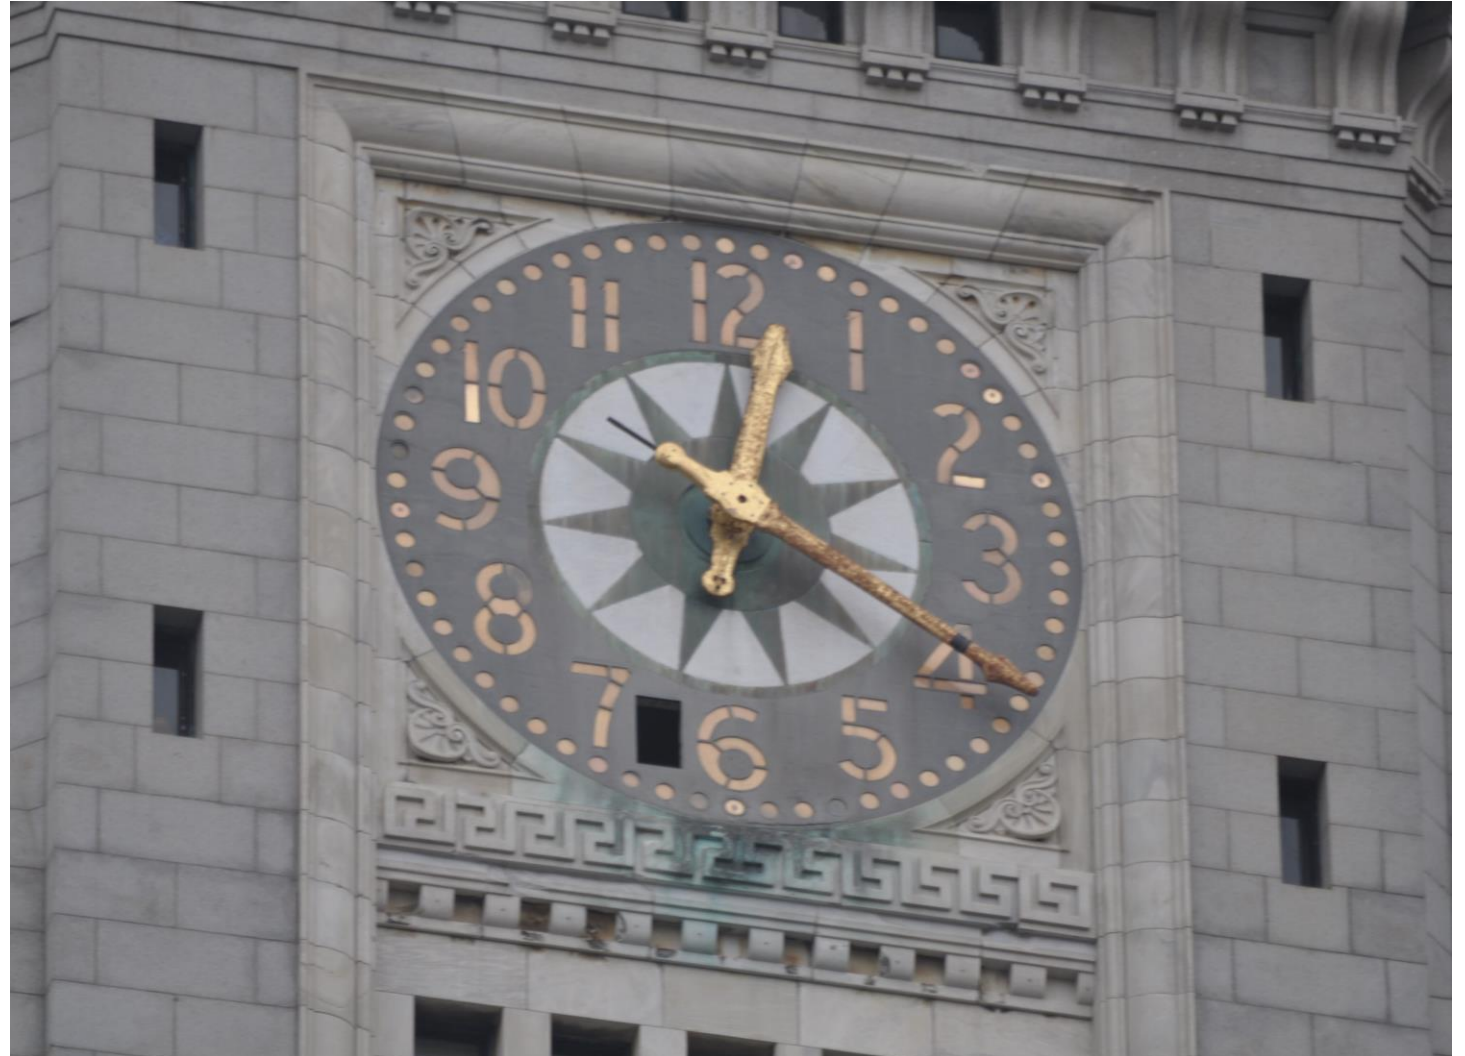
Current Construction

- Clock Face
 - Gray/black background with glass/acrylic numerals and green star with white background at center.
- Clock Hands
 - Minute Hands – Fiberglass composite replacement hand with gold leaf
 - Hour Hands – Wood with gold leaf (likely original)

- Replace all hands on all elevations (8 hands total)
 - Epoxy carbon fiber composite clock hands
 - Lighter material clock hands will improve clock function and durability
 - Integral color to improve appearance
- Retain 4 original hands and display within building
- Maintain existing clock face
