300 A Street

south facade finish upgrade

LOCUS PLAN
EXISTING DEFICIENCIES
PROPOSED IMPROVEMENTS

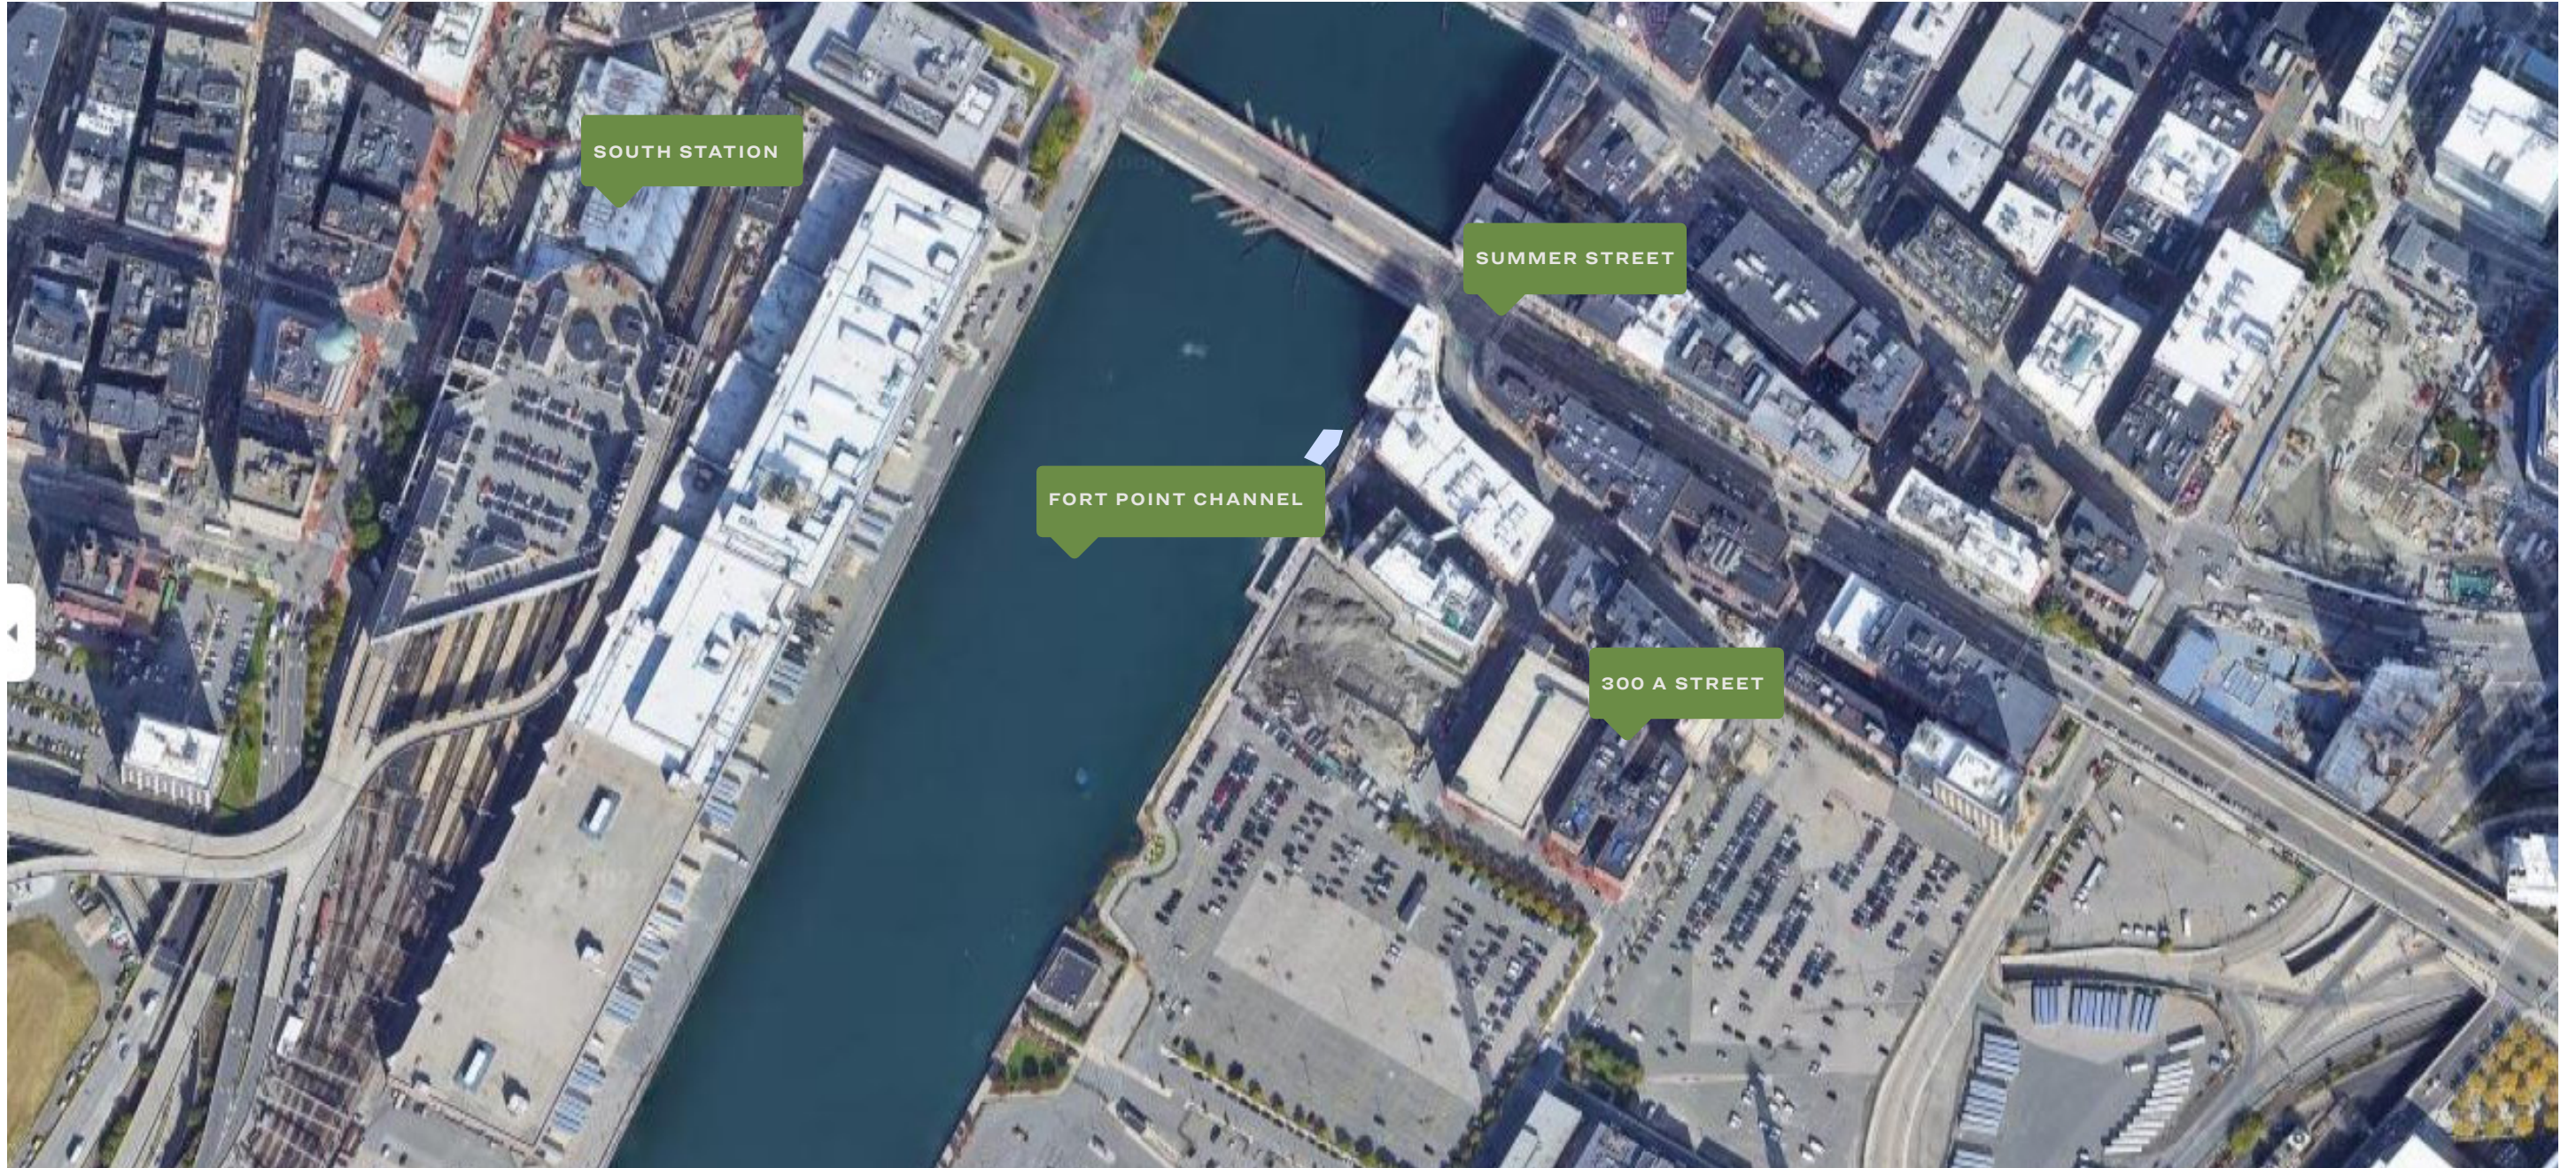
Existing Deficiencies

The existing south facade at 300 A Street is exhibiting significant finish deterioration including paint peeling, rusting and fading due to sun exposure.

The existing canopy structure and metal panels will remain in place. The existing painted steel shall have loose and spalled paint removed while well adhered paint may remain.

Entire steel members will receive a lead-free, corrosion resistant coating - Tnemec AK02 Universal Primer and (2) coats of semi-gloss, low VOC epoxy paint - Tnemec Series 104 H.S. Epoxy for salt spray and weathering protection.
