CHABAD CENTER FOR MISSION HILL

1615-1617 Tremont Street

Architectural Conservation District Commission

Advisory Review Application

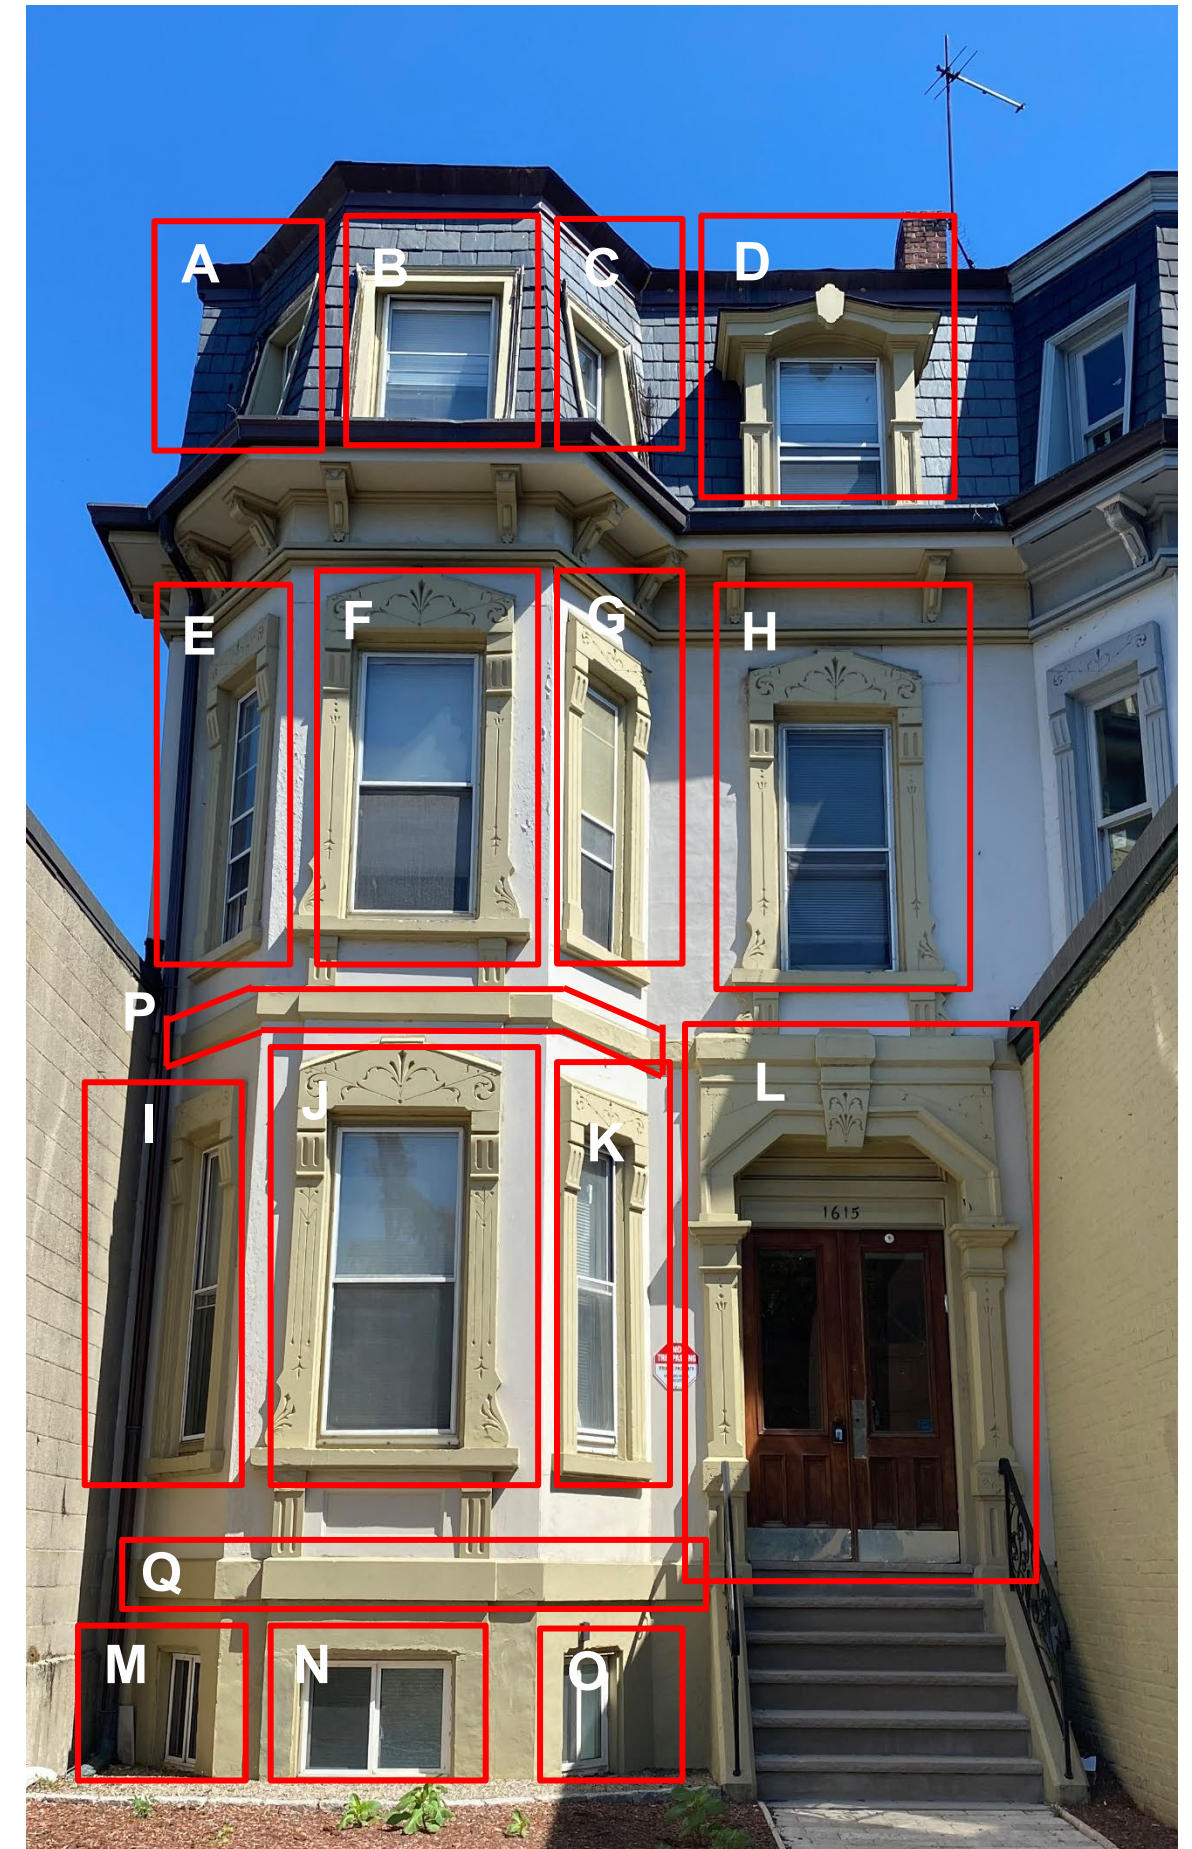
| No. | Feature | Current Condition | Treatment |
|---|---|---|---|
| | Window Sash | Poor condition | Reconstruct to match historic double hung two over two windows |
| | Sill | Poor condition | Reconstruction |
| | Window surrounds | Poor condition | A,B,C to be reconstructed |

| No. | Feature | Current Condition | Treatment |
|---|---|---|---|
| | | | D to be reconstructed based on historic design to incorporate the decorative molding and medallion |

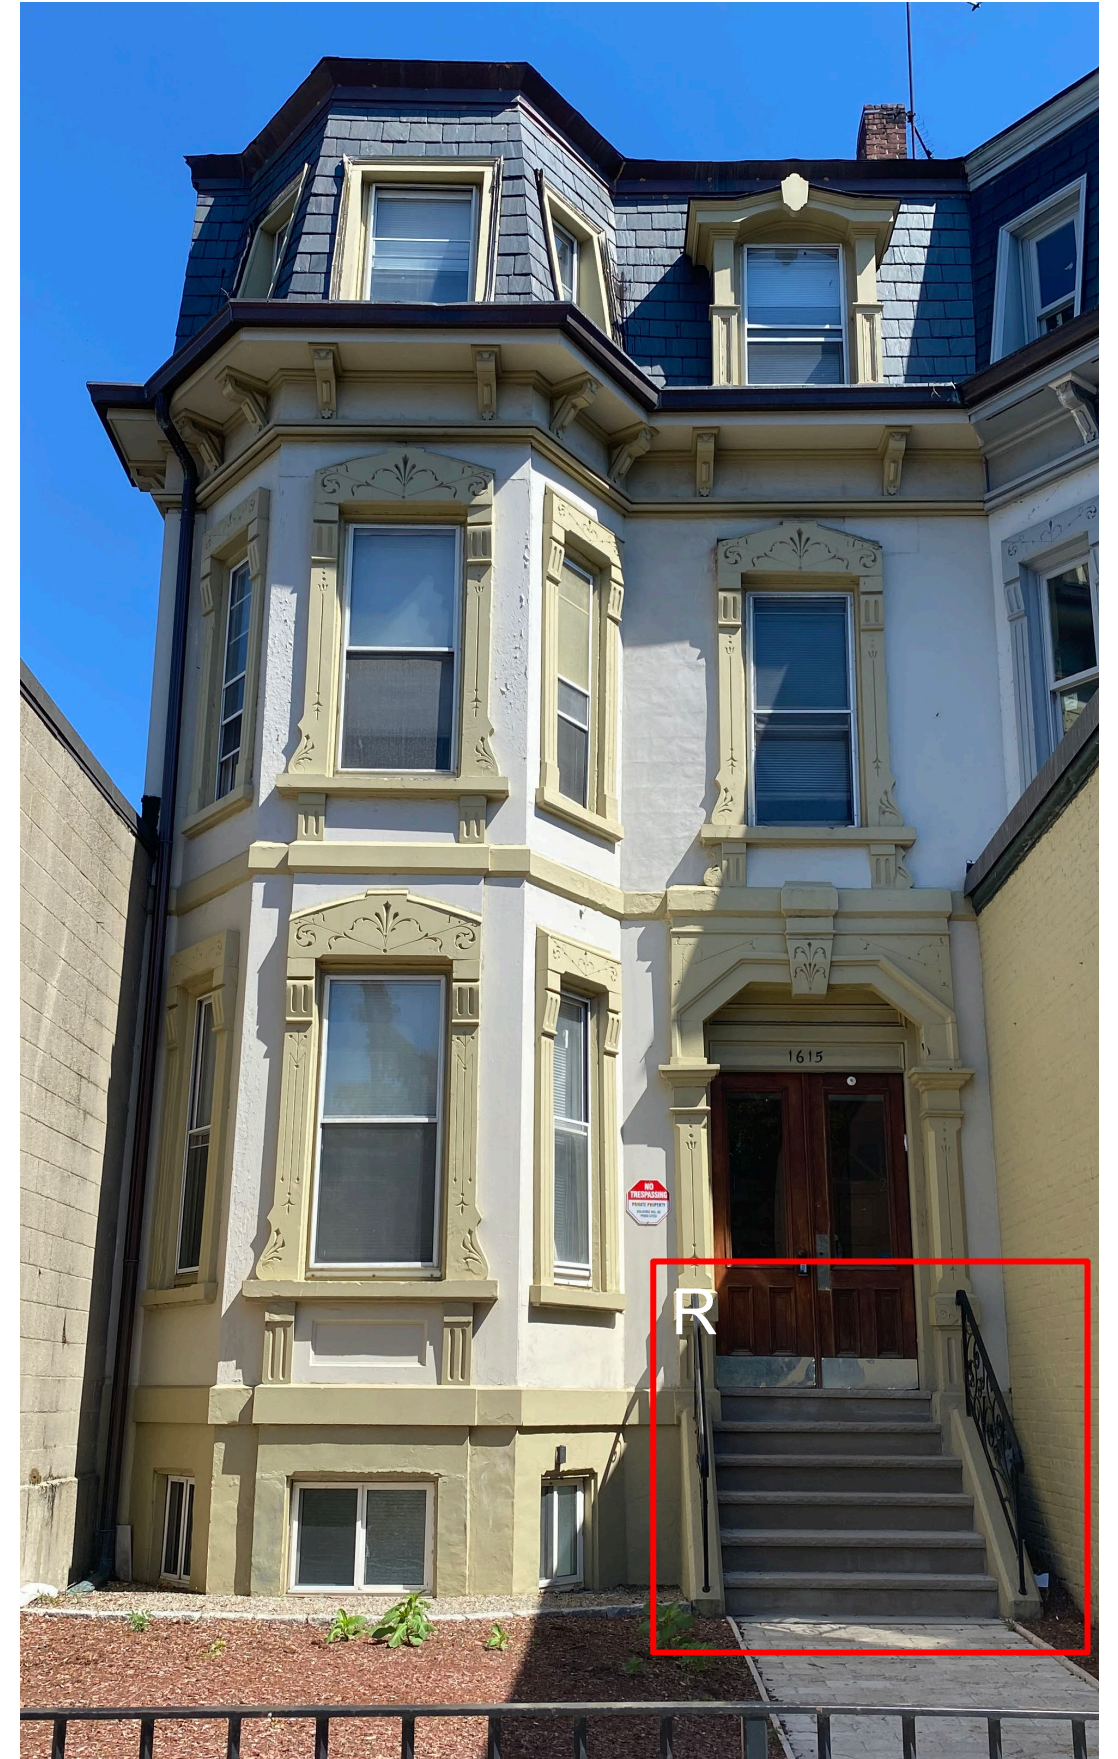
| No. | Feature | Current Condition | Treatment |
|---|---|---|---|
| 1 | Stringer | Possibly original sound condition | Exploratory work to reveal stringer material. If stone in good condition, leave exposed. If not, repaint, color TBD |
| 2 | Riser | Stone replacement (not original) Limestone sound condition | Remove and reinstall |
| 3 | Tread | Limestone sound condition | Remove and reinstall |
| 4 | Railing | Recent steel, insecure Ornamental design out of character | Remove and replace with period appropriate balustrade/handrail Relocate from stringer to treads and separate from ornamental door surround |

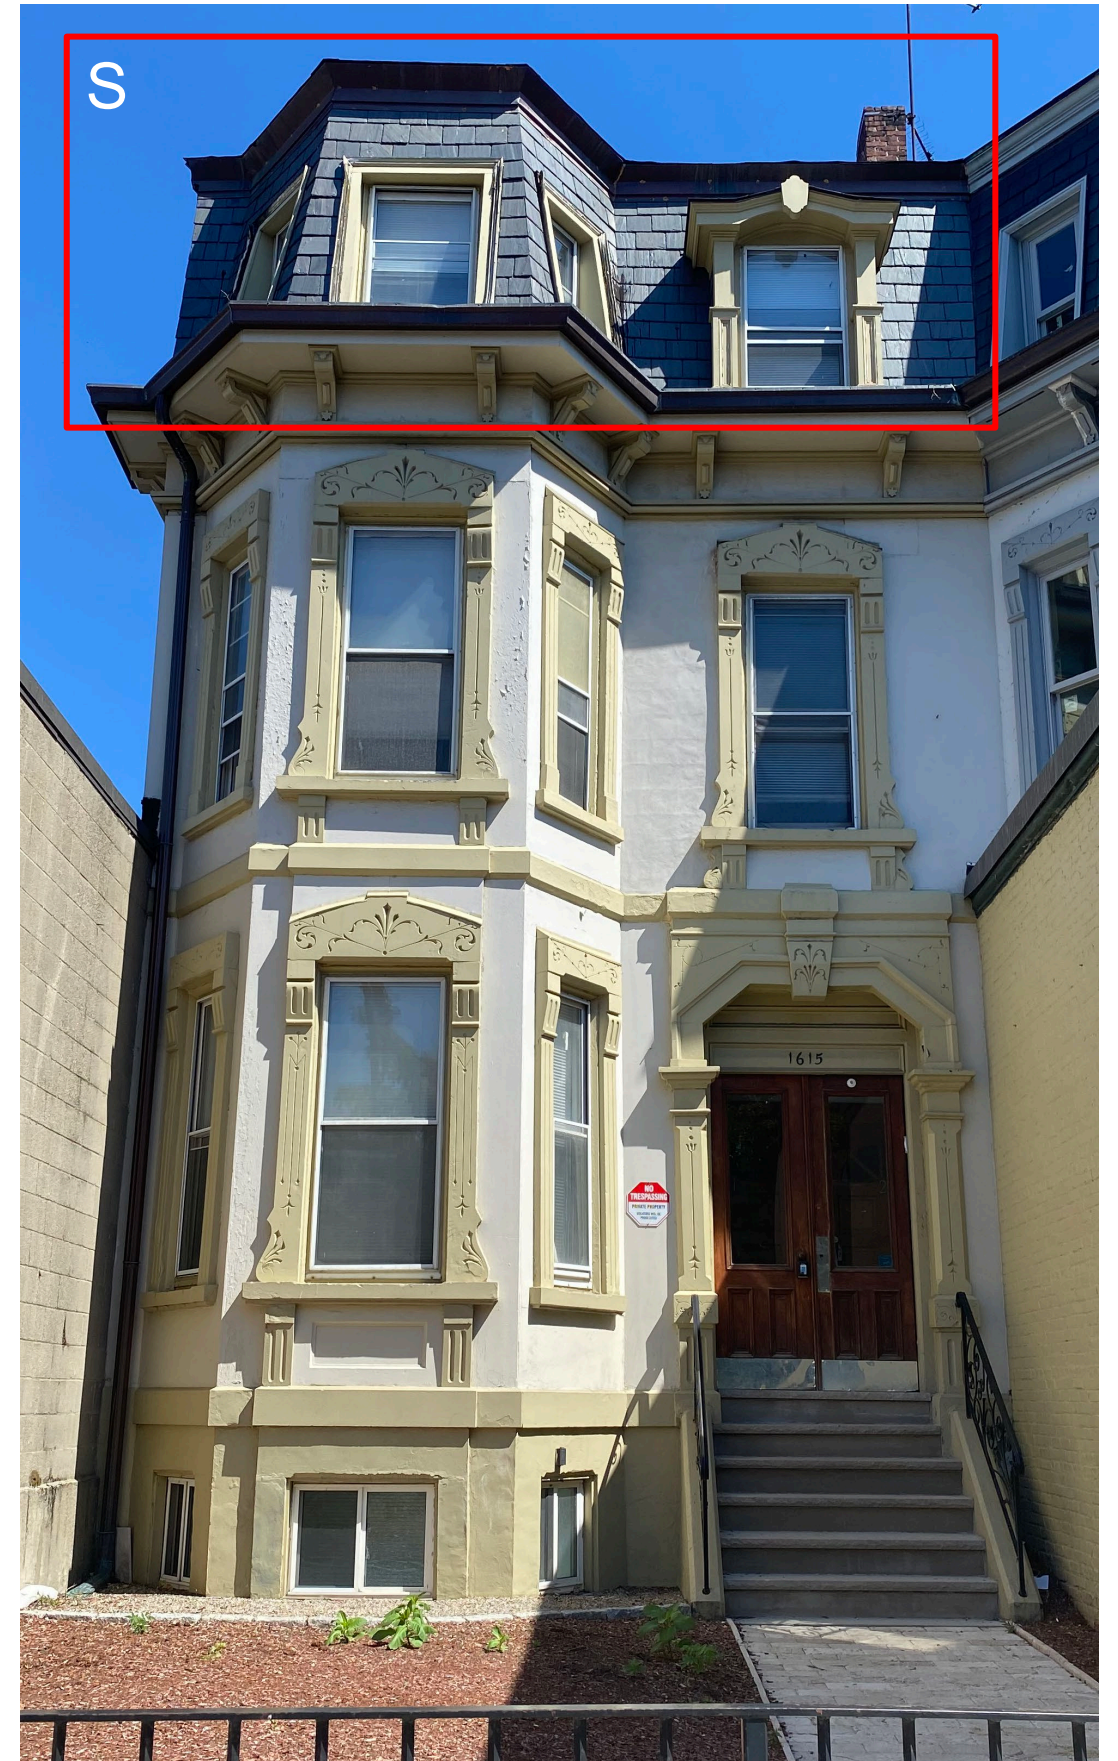
| No | Feature | Current Condition | Treatment |
|---|---|---|---|
| | Exterior | Slate appears to be in good condition Eave copper in poor condition | To be assumed that some damage will occur during demolition and new construction – reuse salvaged slate shingles or replace slate to match Replace copper trim with wood moldings |
| 2 | Chimney | Poor condition | Rear chimney to be demolished; front chimney to be repaired |
| 3 | Gable Roof | To be evaluated | Front roof replacement as required to match existing |

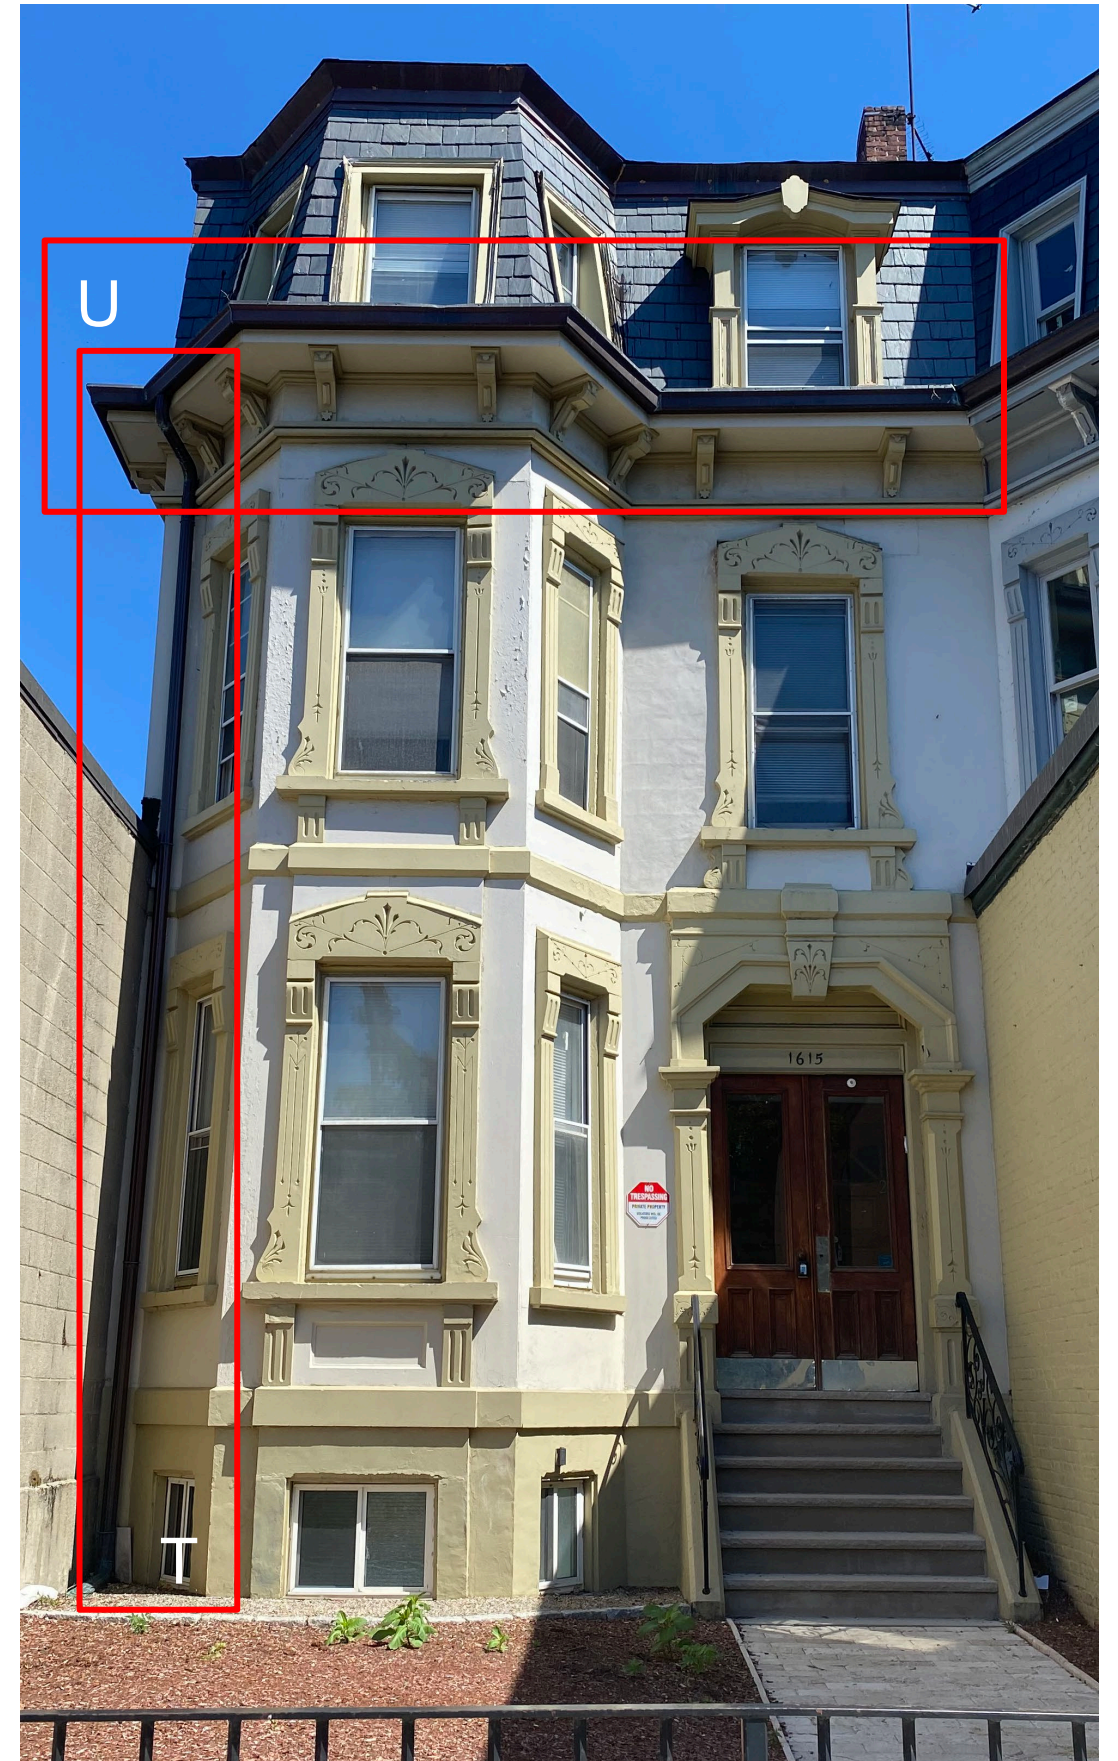
| No. | Feature | Current Condition | Treatment |
|---|---|---|---|
| U | Cornice | Decent condition Woodwork intact | Remove return at new construction |
| T | Gutter and Flashing | Poor condition Water problem above parlor and second floor window surrounds to be investigated | Change gutter profile – similar to adjacent rowhouse Existing flashing over window surrounds to be removed and sealed |
| T | Downspout | Poor condition | Change profile |

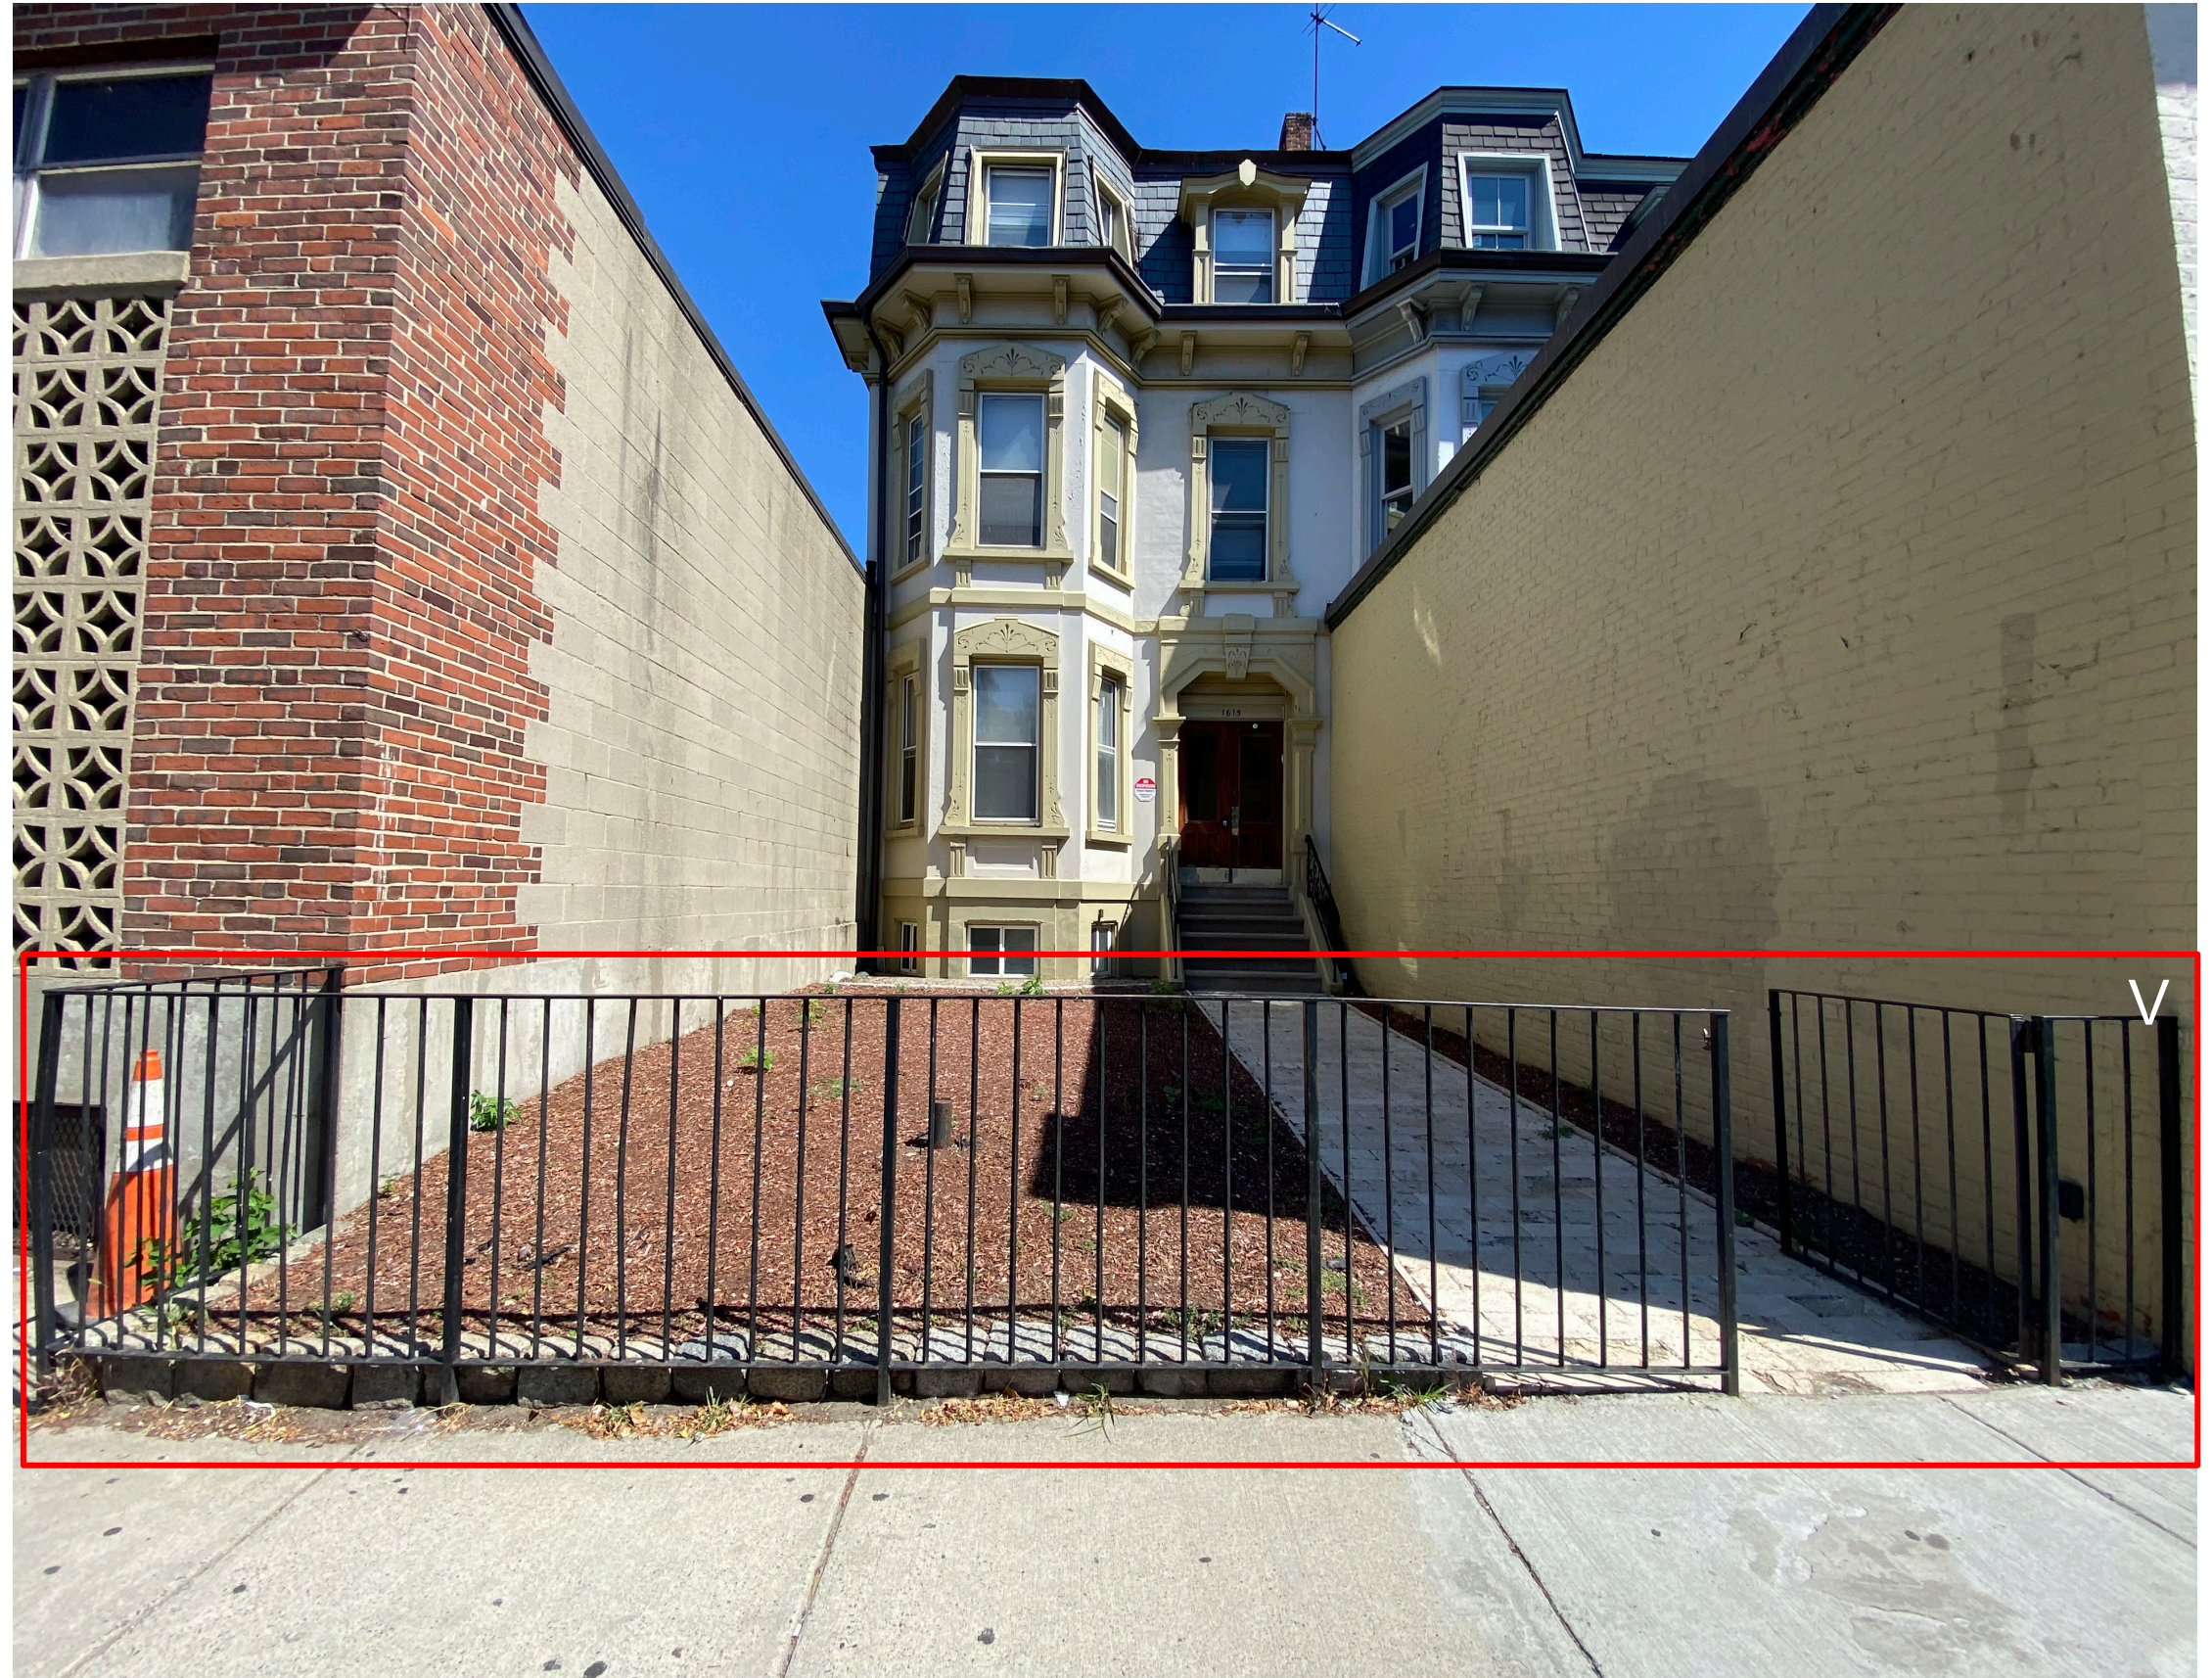
| No. | Feature | Current Condition | Treatment |
|---|---|---|---|
| | 1.1 | Recent Steel Insecure Out of historic character | Remove fence gate and replace in kind |
| | 1.2 | Recent Steel Insecure Out of historic character | Remove fence and replace in kind |
