# CHABAD CENTER FOR MISSION HILL

1615-1617 Tremont Street

Architectural Conservation District Commission

Advisory Review Application

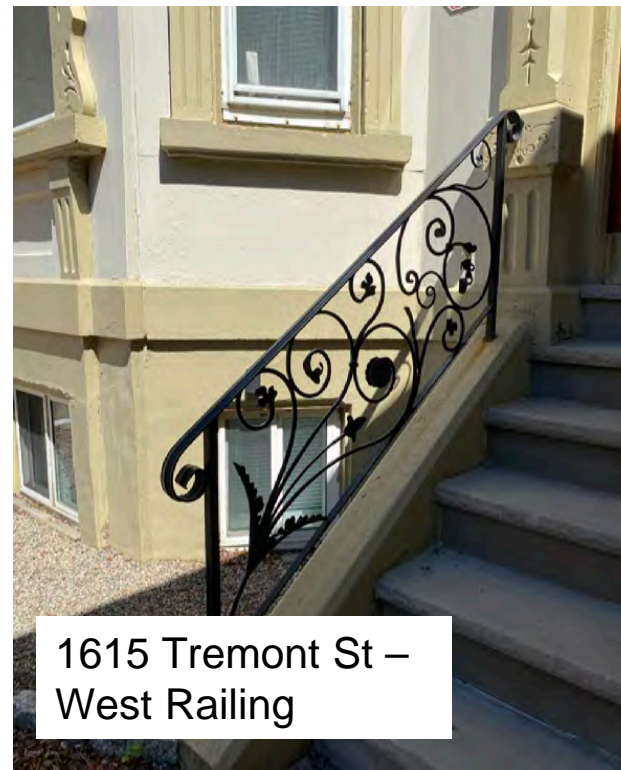
1615 Tremont St –  
West Railing

No.	Feature	Current Condition	Treatment
1	Stringer	Possibly original sound condition	Exploratory work to reveal stringer material. If stone in good condition, leave exposed. If not, repaint, color TBD
2	Riser	Stone replacement (not original) Limestone sound condition	Remove and reinstall
3	Tread	Limestone sound condition	Remove and reinstall
4	Railing	Recent steel, insecure Ornamental design out of character	Remove and replace with period appropriate balustrade/handrail Relocate from stringer to treads and separate from ornamental door surround

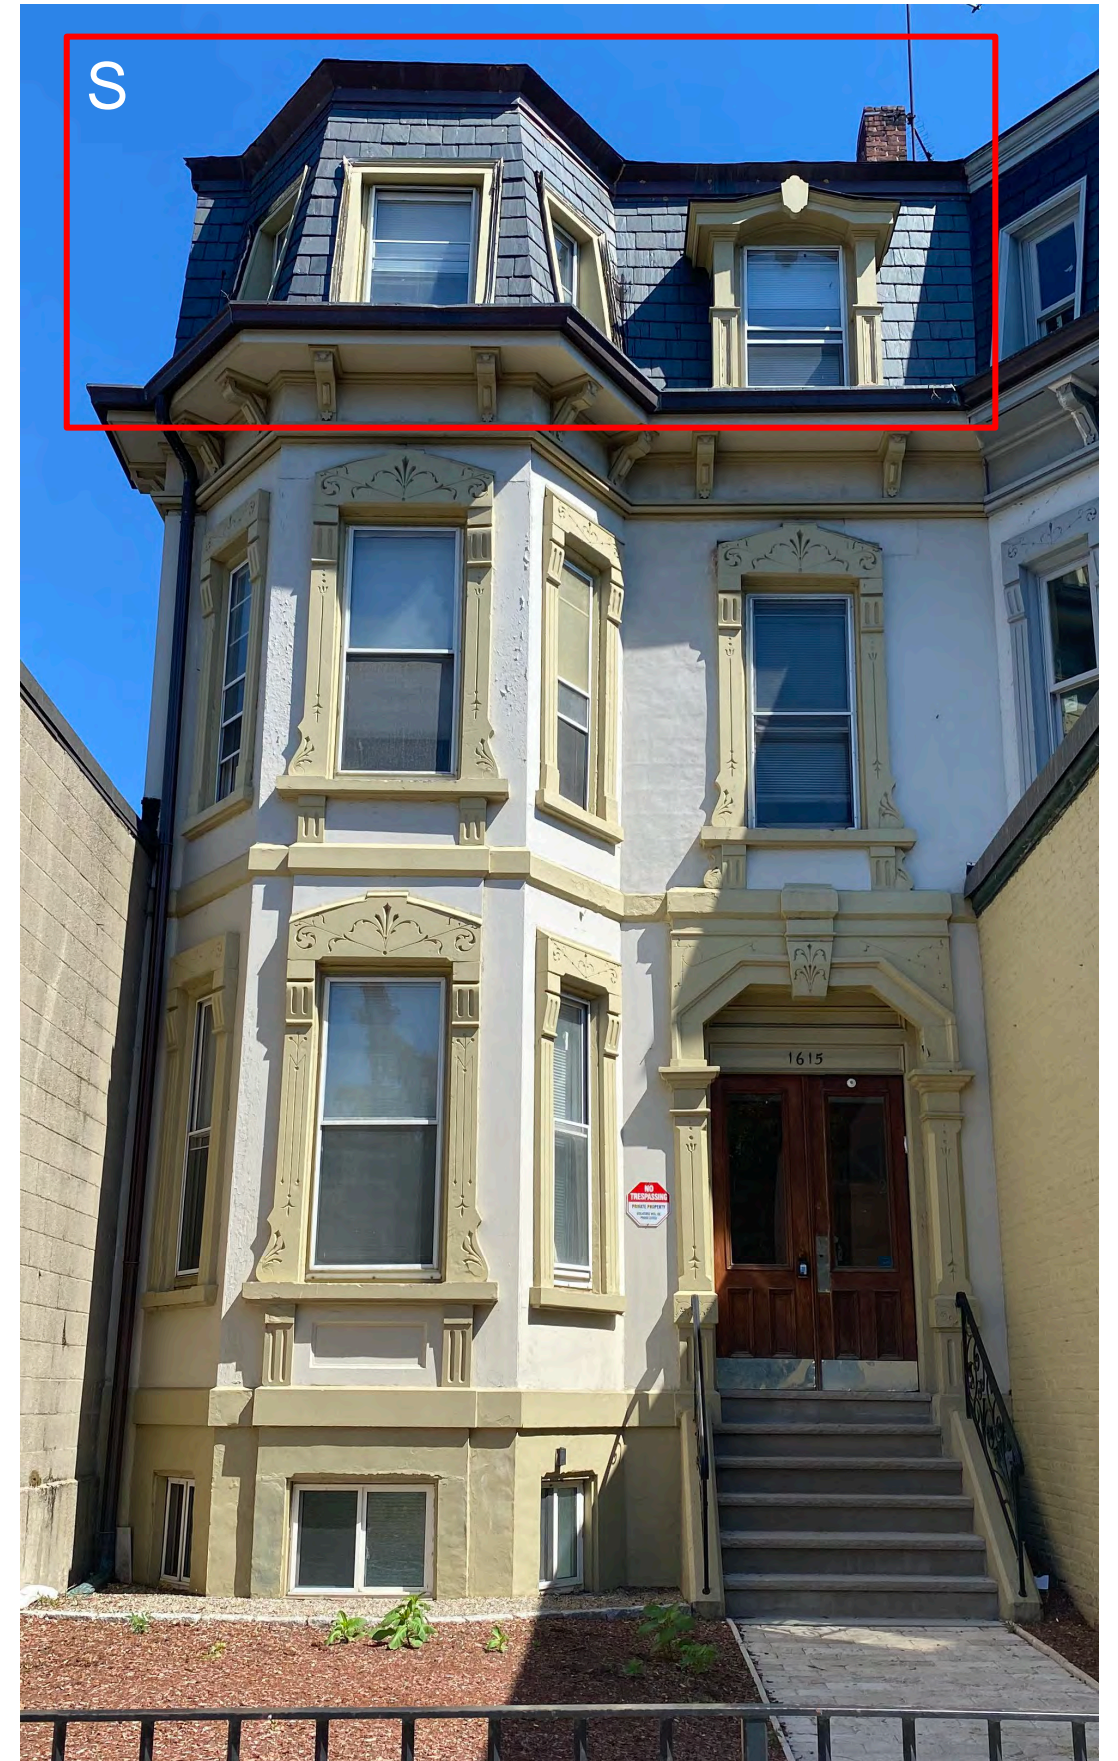
- Mansard Roof
- Chimney

No	Feature	Current Condition	Treatment
1	<b>Mansard Roof</b>		
	Exterior	Slate appears to be in good condition Eave copper in poor condition	To be assumed that some damage will occur during demolition and new construction – reuse salvaged slate shingles or replace slate to match Replace copper trim with wood moldings
	Interior	Boarded and plastered on the inside	
2	<b>Chimney</b>	Poor condition	Rear chimney to be demolished; front chimney to be repaired
3	<b>Gable Roof</b>	To be evaluated	Front roof replacement as required to match existing

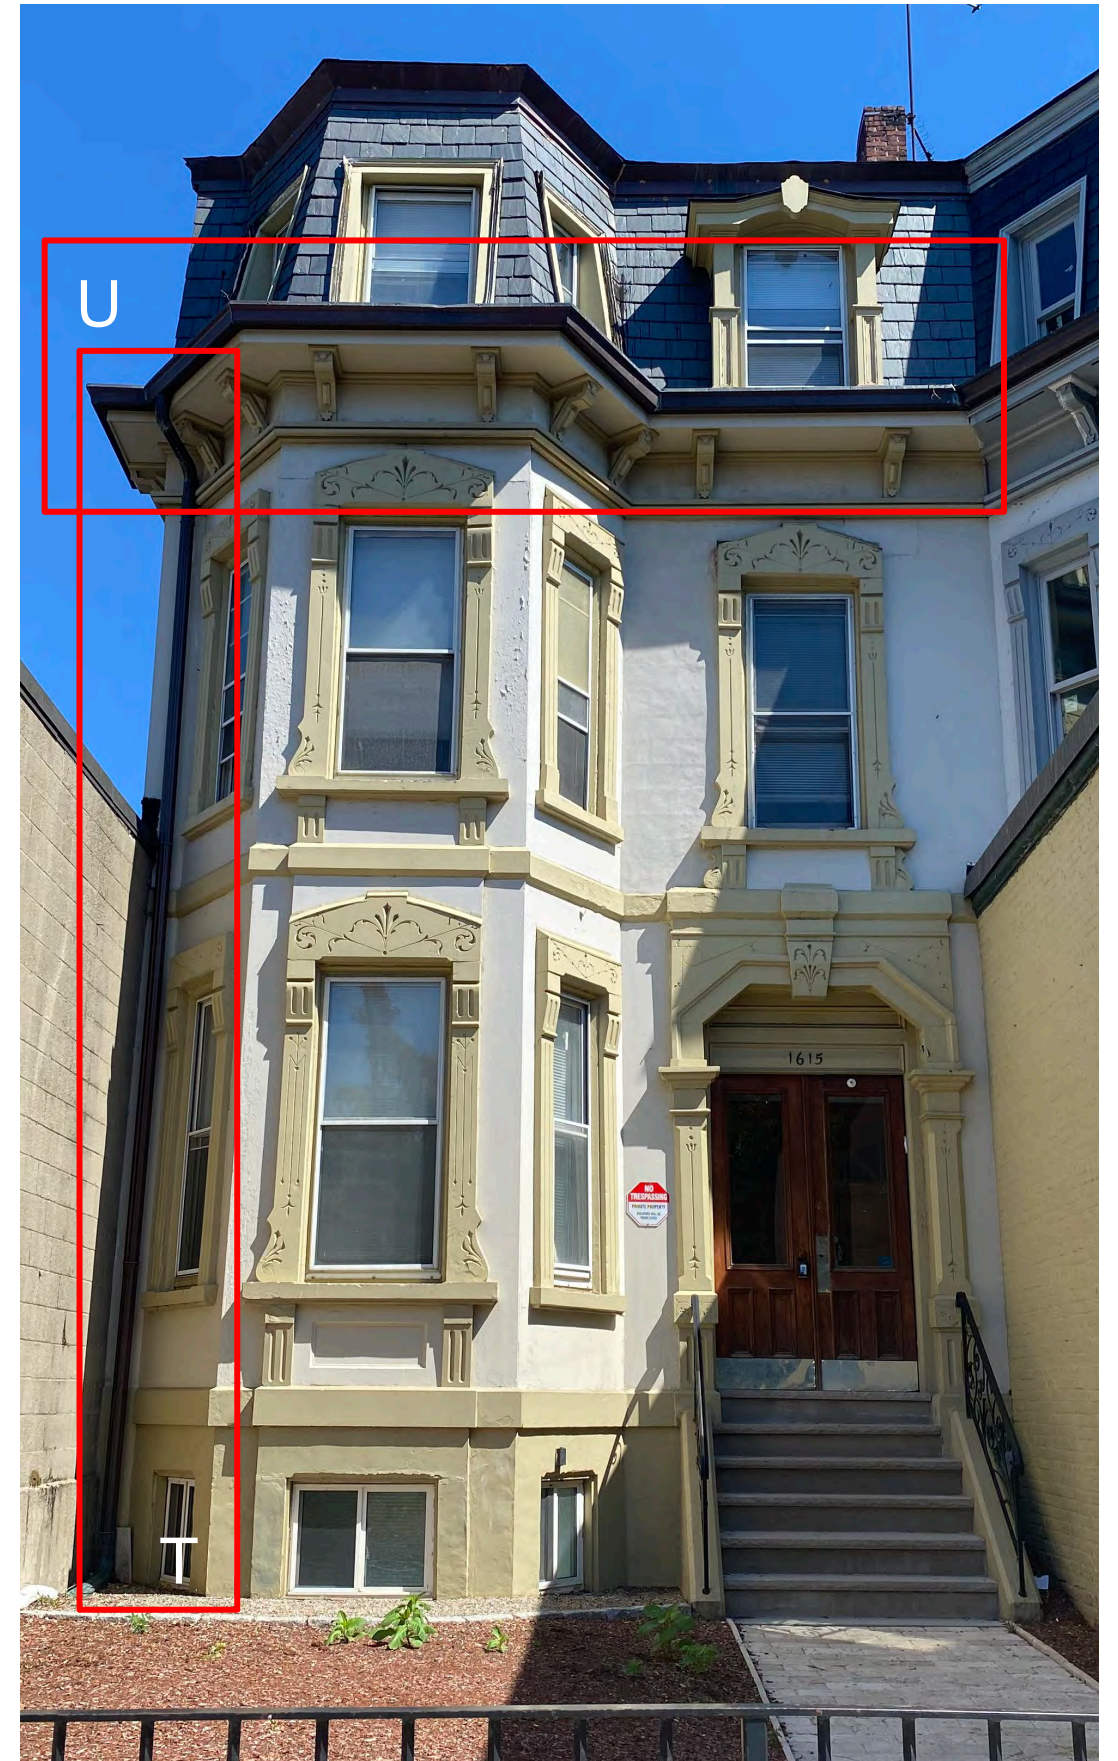
- Cornices
- Gutters and Flashing
- Downspout

No.	Feature	Current Condition	Treatment
U	<b>Cornice</b>	Decent condition Woodwork intact	Remove return at new construction
T	<b>Gutter and Flashing</b>	Poor condition Water problem above parlor and second floor window surrounds to be investigated	Change gutter profile – similar to adjacent rowhouse Existing flashing over window surrounds to be removed and sealed
T	<b>Downspout</b>	Poor condition	Change profile

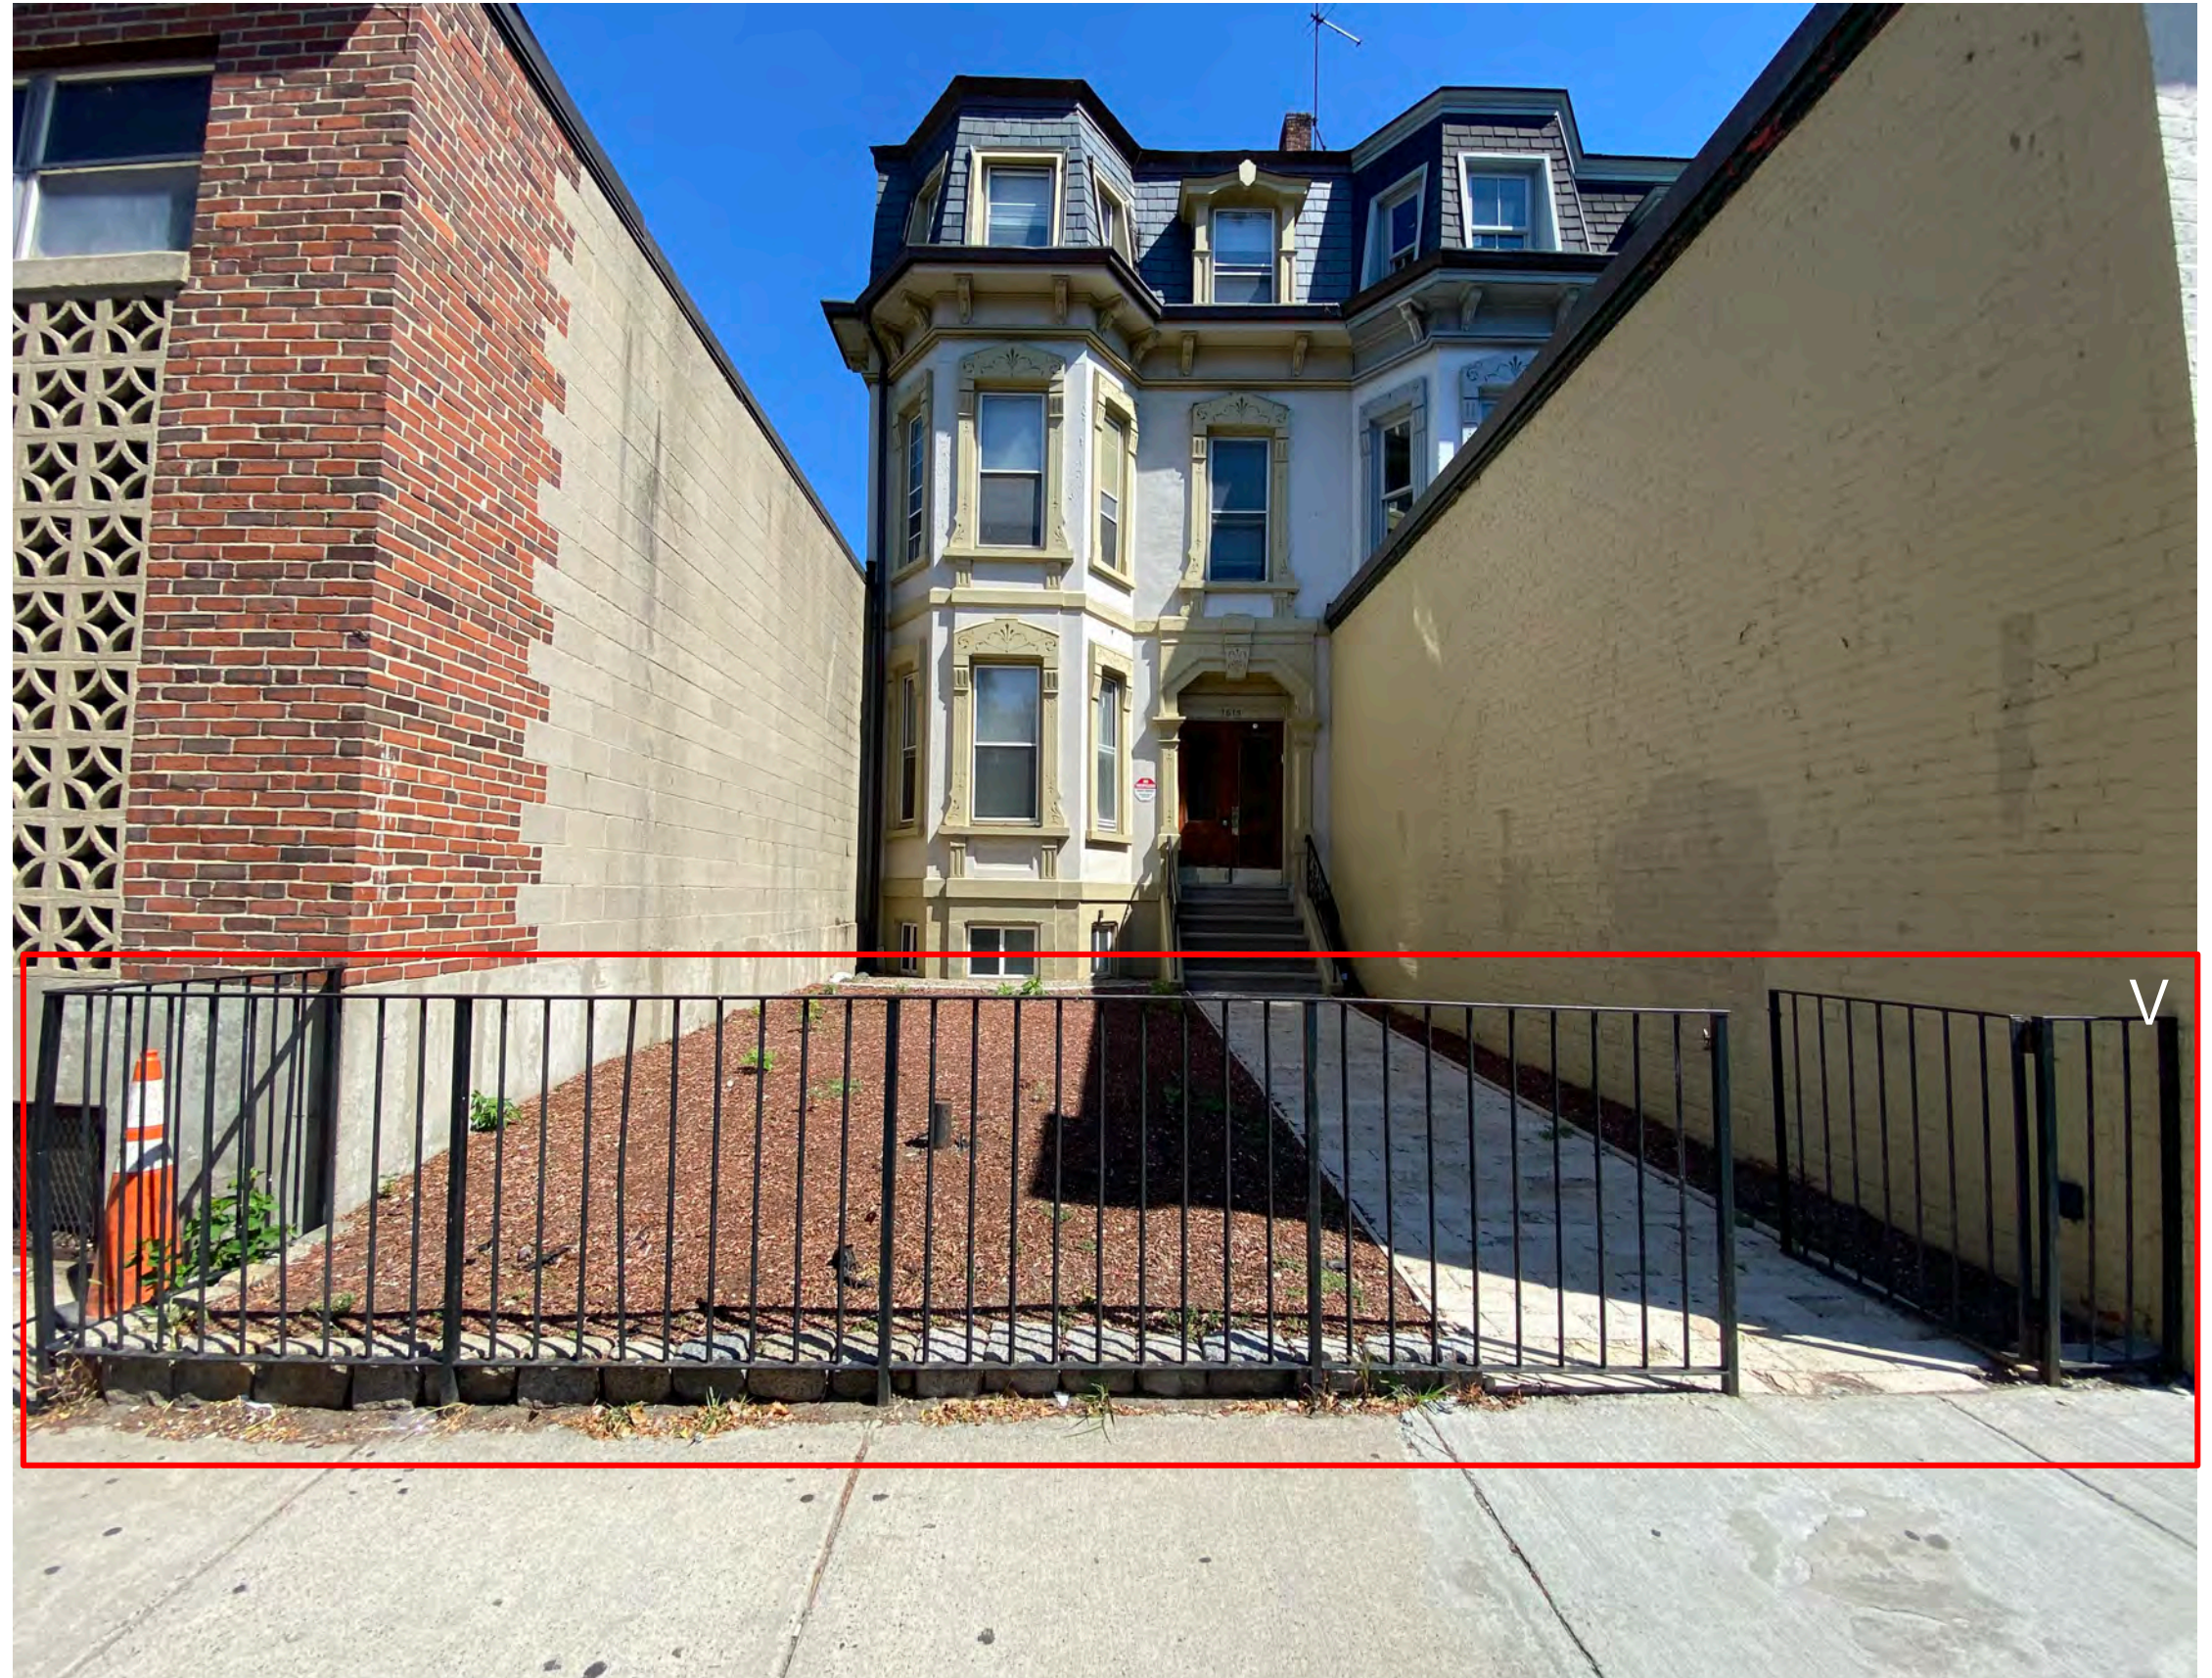
1. Front Fence
2. Front Walkway Materials
3. Front Yard

No.	Feature	Current Condition	Treatment
<b>V</b>	<b>Front Fence &amp; Gate</b>		
	1.1	Recent Steel Insecure Out of historic character	Remove fence gate and replace in kind
	1.2	Recent Steel Insecure Out of historic character	Remove fence and replace in kind

No.	Feature	Current Condition	Treatment
2	<b>Front Walkway</b>	Stone is poor condition Stone spalling due to freeze and thaw	Install new walkway pavers
3	<b>Front Yard</b>	Recent Addition – mulch and gravel	Install new green landscape planting
