15 CHANNEL CENTER ST
BOSTON, MA

MIDWAY ARTIST STUDIOS

EXISTING CONDITION PHOTOS

Sheet Number: P-004
 Project Number: 22096
 Date: 10/6/2023

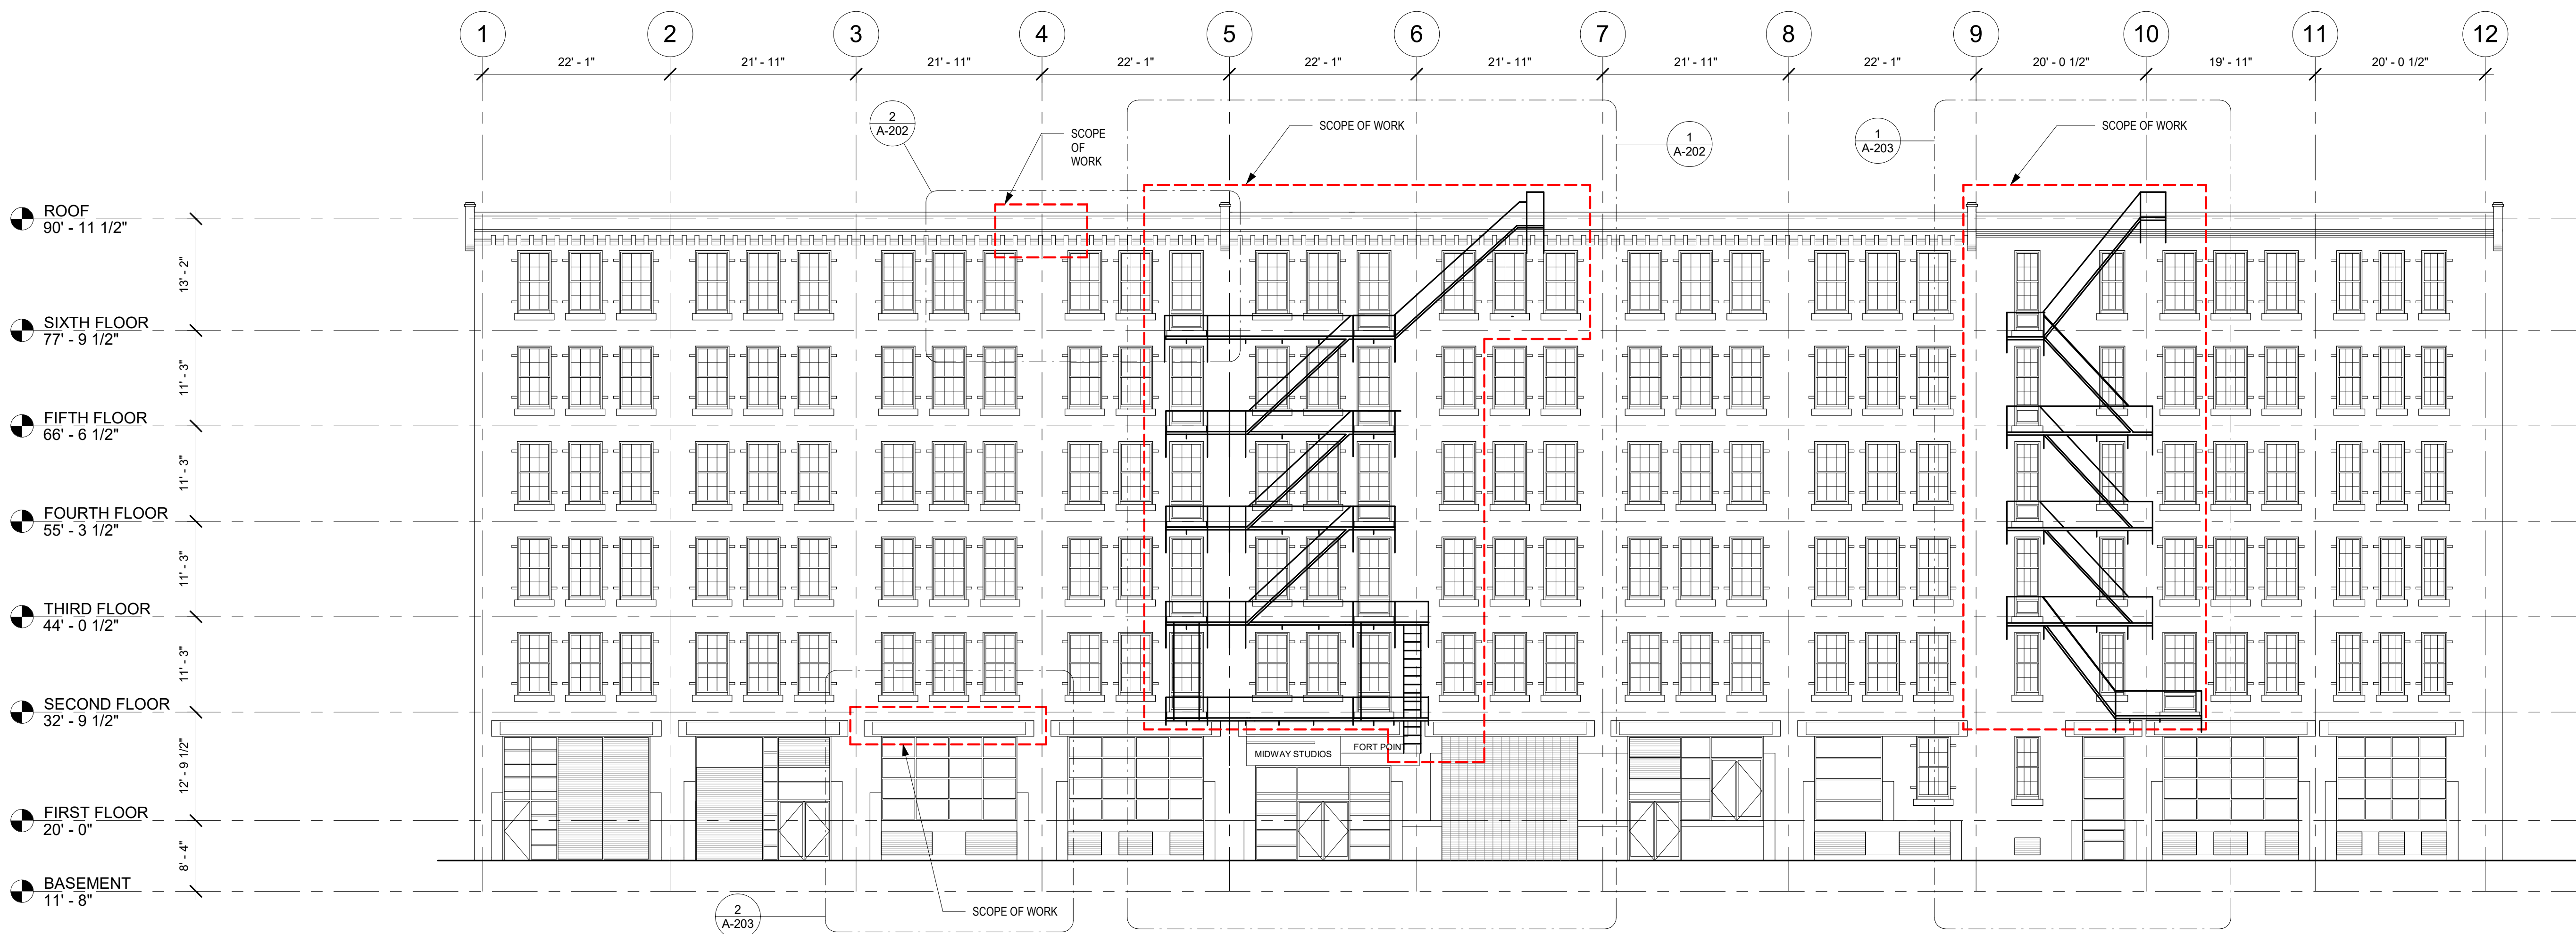
EXISTING EAST ELEVATION -
 MEDALLION AVE
 1/32" = 1'-0"

A RECENT SURVEY CONDUCTED THIS YEAR THAT FOCUSED EXTENSIVELY ON THE REAR FACADE WAS PERFORMED DUE TO MULTIPLE DEFICIENCIES IDENTIFIED IN THE MASONRY WALL SURROUNDING THE TWO EXISTING FIRE ESCAPES. THESE FIRE ESCAPES, IN THEIR RUSTED STATE, APPEAR TO BE NEGATIVELY IMPACTING THE MASONRY WALL'S INTEGRITY. MOREOVER, THEY ARE IMPEDING THE NATURAL FLOW OF RAINWATER, EXACERBATING THE DETERIORATION OF THE MASONRY WALL

F1 - FIRE ESCAPE TO BE REMOVED AND DISPOSED OF.

M2 - DISASSEMBLE AND RECONSTRUCT THE MASONRY IN THE AREA INDICATED. THIS REPAIR IS DUE TO BRICK MOVING OUT OF PLACE OR REMOVAL OF FIRE ESCAPE SUPPORTS (SEE DETAILS 3 AND 4 / A-301)

M3 - BRICK CRACKS: REPLACE CRACKED MASONRY. REPOINT SURROUNDING MORTAR JOINTS WITHIN 1'-0" OF THE UNITS REPLACED. (SEE DETAILS 1 AND 2 / A-302)
