16-18 & 22 GARDNER ST.

Structural Investigation Report

16-18 Gardner St, Boston, MA 02119

Prepared by
**SurfZone Engineering
Consultants LLC**
August 21, 2023

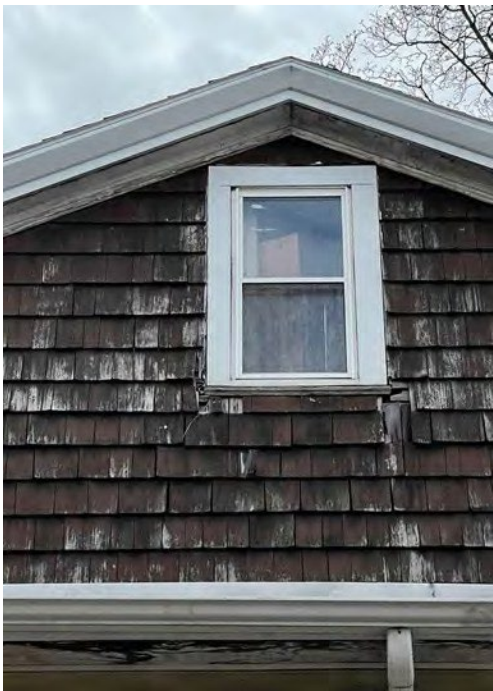
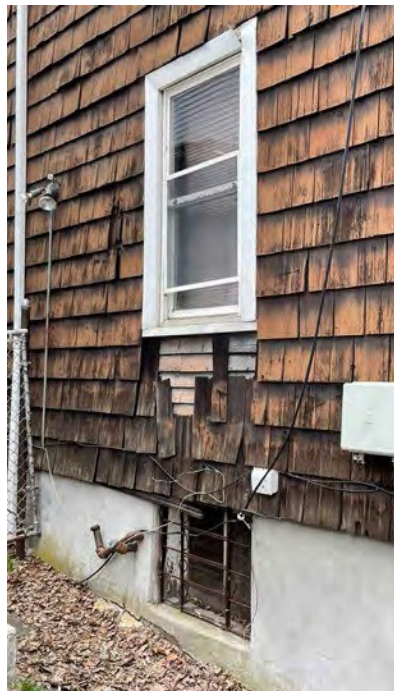
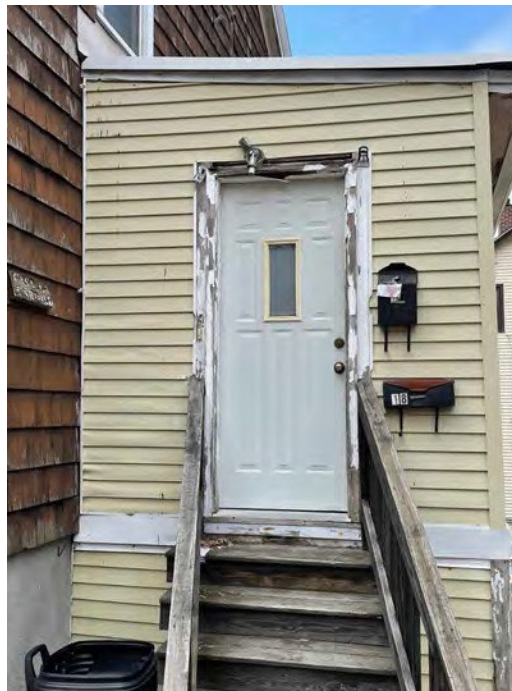
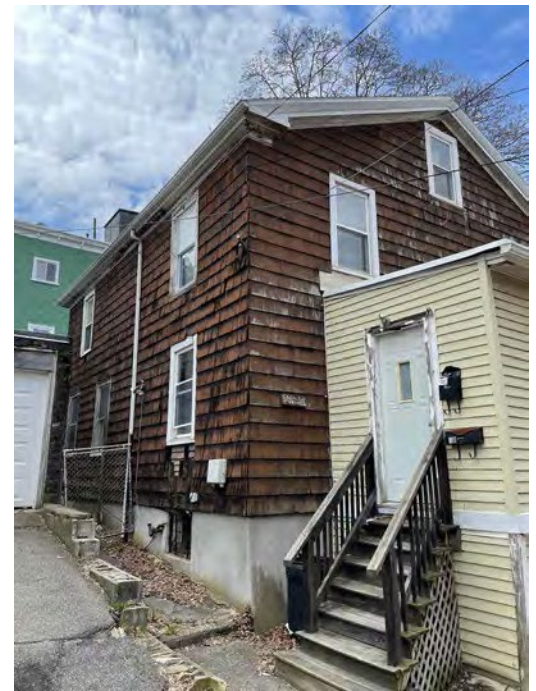
Exterior

The building's exterior conditions exhibit failing materials. The wood deck, soffits, and trims are damaged, and the masonry shows signs of water leakage.
